NASA CR-1897

DESIGN AND APPLICATION OF POLYCARBONATE CAPACITORS IN AEROSPACE AC POWER SYSTEMS

by J. F. Gosda, A. C. Elles, and R. R. Bailey

TRW

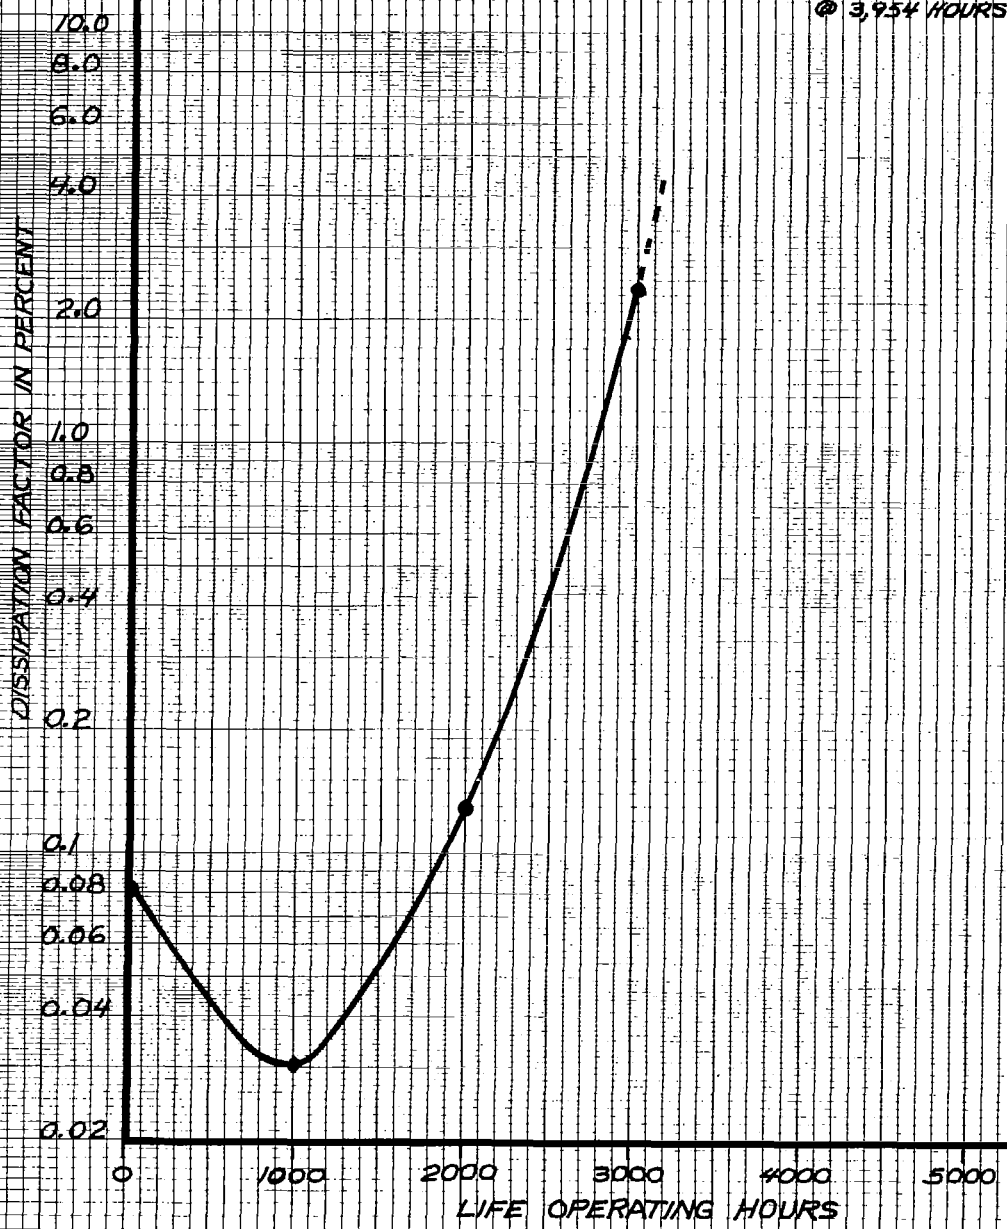
FIGURE 22

- a. Design B-1 See performance curves in Figures 21, 22, and 23, photograph Figure 24 and refer to Failure Analysis 41 in Appendix B. The increase in DF with time is apparent when reviewing the curve of Figure 22. This was caused by a deteriorating termination which resulted in excess heat at the termination and led to eventual failure.

DISSIPATION FACTOR
OF
SERIAL NO. 42XB06
DURING
400-HZ AC LIFE TESTING @ 125°C
DESIGN B-1 1.0 μ F

UNIT SHORTED
@ 3,954 HOURS

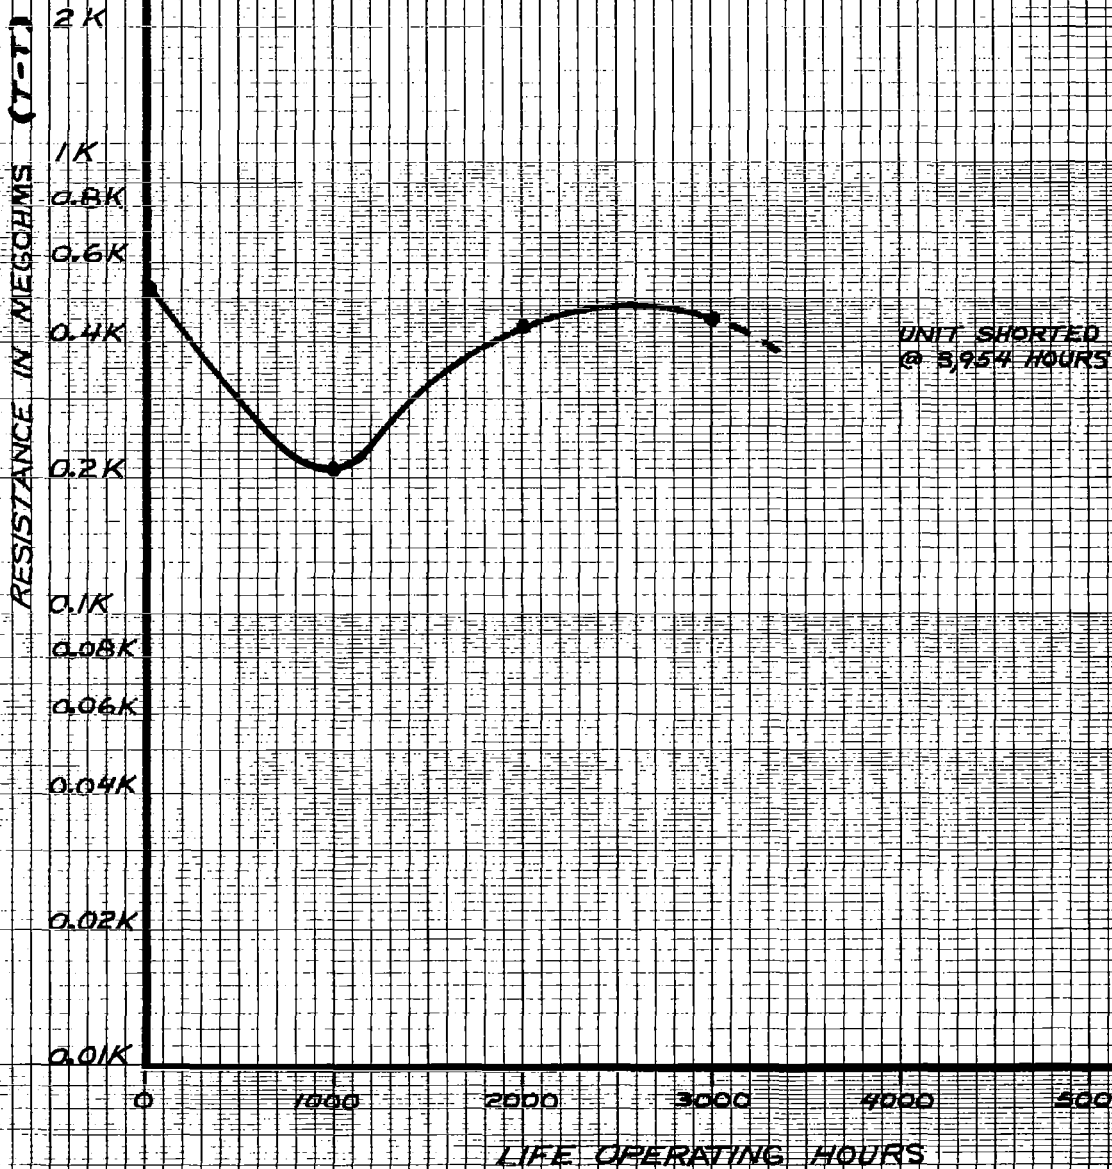
FIGURE 23

INSULATION RESISTANCE CHARACTERISTICS
 OF
 SERIAL NO. 42X806
 DURING
 400-HZ AC LIFE TESTING @ 125°C
 DESIGN B-1 1.0 μ F

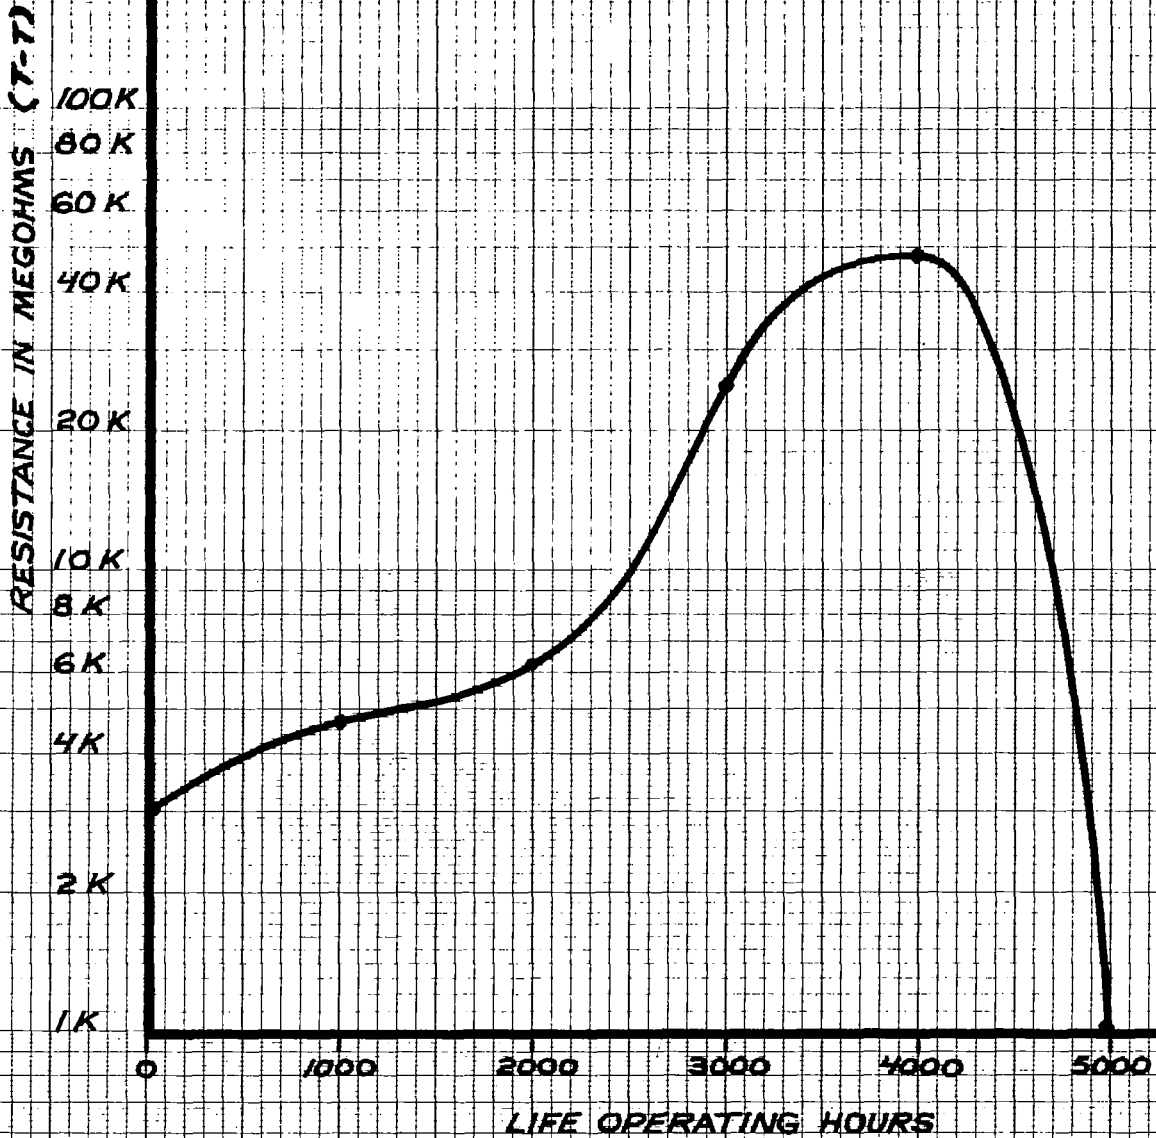
FIGURE 27

- b. Design A-1 See performance curves in Figures 25, 26, and 27, photograph Figure 28 and Failure Analysis 48 in Appendix B. A review of Figure 26 illustrates a continually increasing DF after 1000 hours on test. The part was considered a failure due to exceeding the 0.5% maximum DF allowable and though it made it through 5000 hours without shorting, would have eventually failed. Reason for the curious and short lived low DF at the 1000-hour point in time could have been due to some physical changes in progress due to the termination problem which gave a temporary improvement in DF.

INSULATION RESISTANCE CHARACTERISTICS
OF
SERIAL NO. 42XA03
DURING
400-HZ AC LIFE TESTING @ 125°C
DESIGN A-1 1.0 μ F

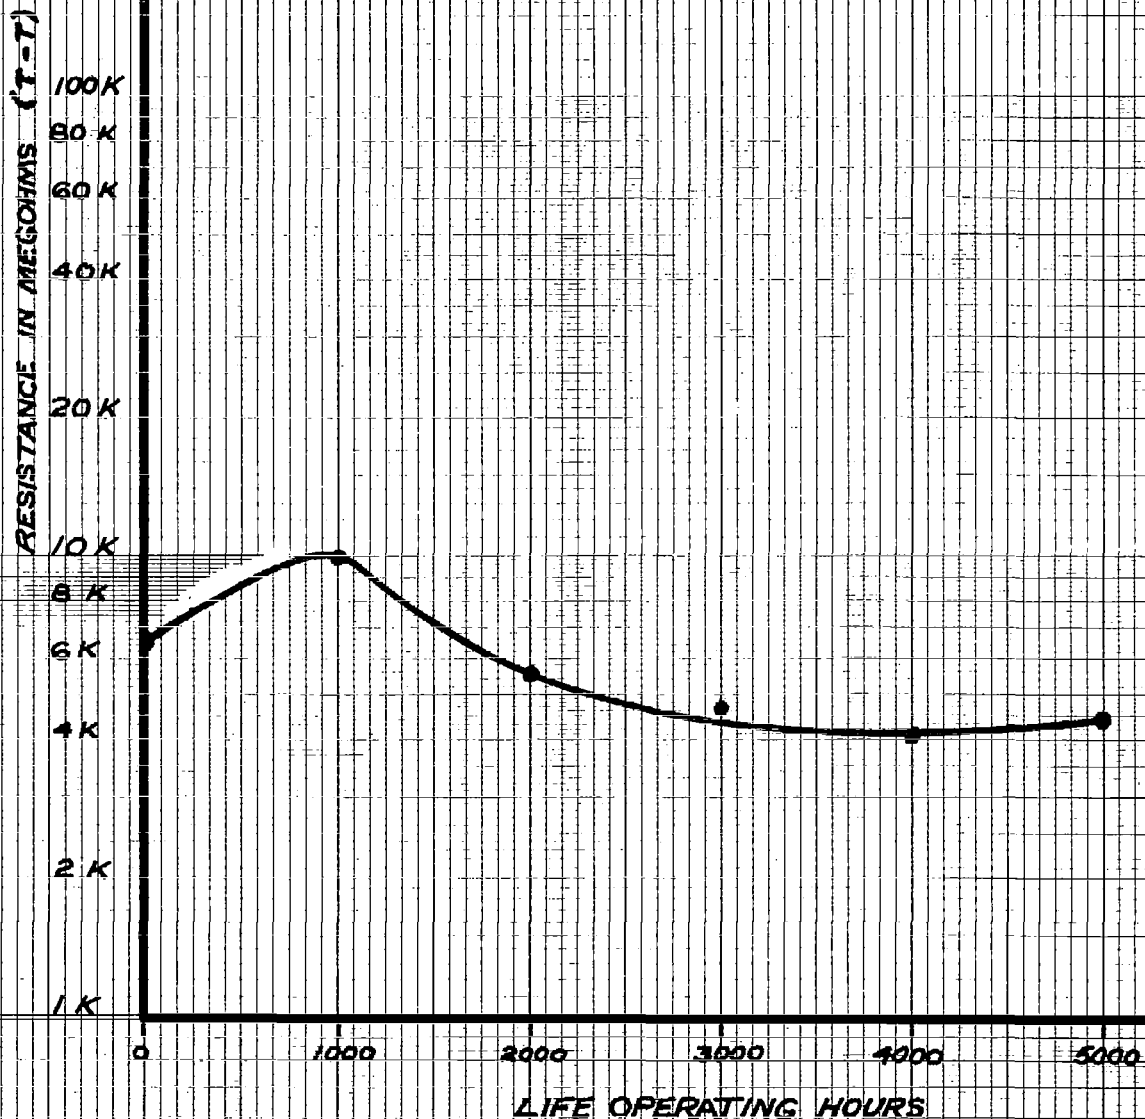
FIGURE 31

- c. Design A-2 See performance curves in Figures 29, 30, and 31, photograph Figure 32 and Failure Analysis 46 in Appendix B. This capacitor was still operating at the end of the 5000 hour test but is considered a failure since the 0.5% maximum DF was exceeded. As evidenced by Figure 30, the DF was increasing with time and the resulting heat losses would have caused failure.

INSULATION RESISTANCE CHARACTERISTICS
OF
SERIAL NO. 41FA12
DURING
400-HZ AC LIFE TESTING @ 125°C
DESIGN A-2 1.0 μF

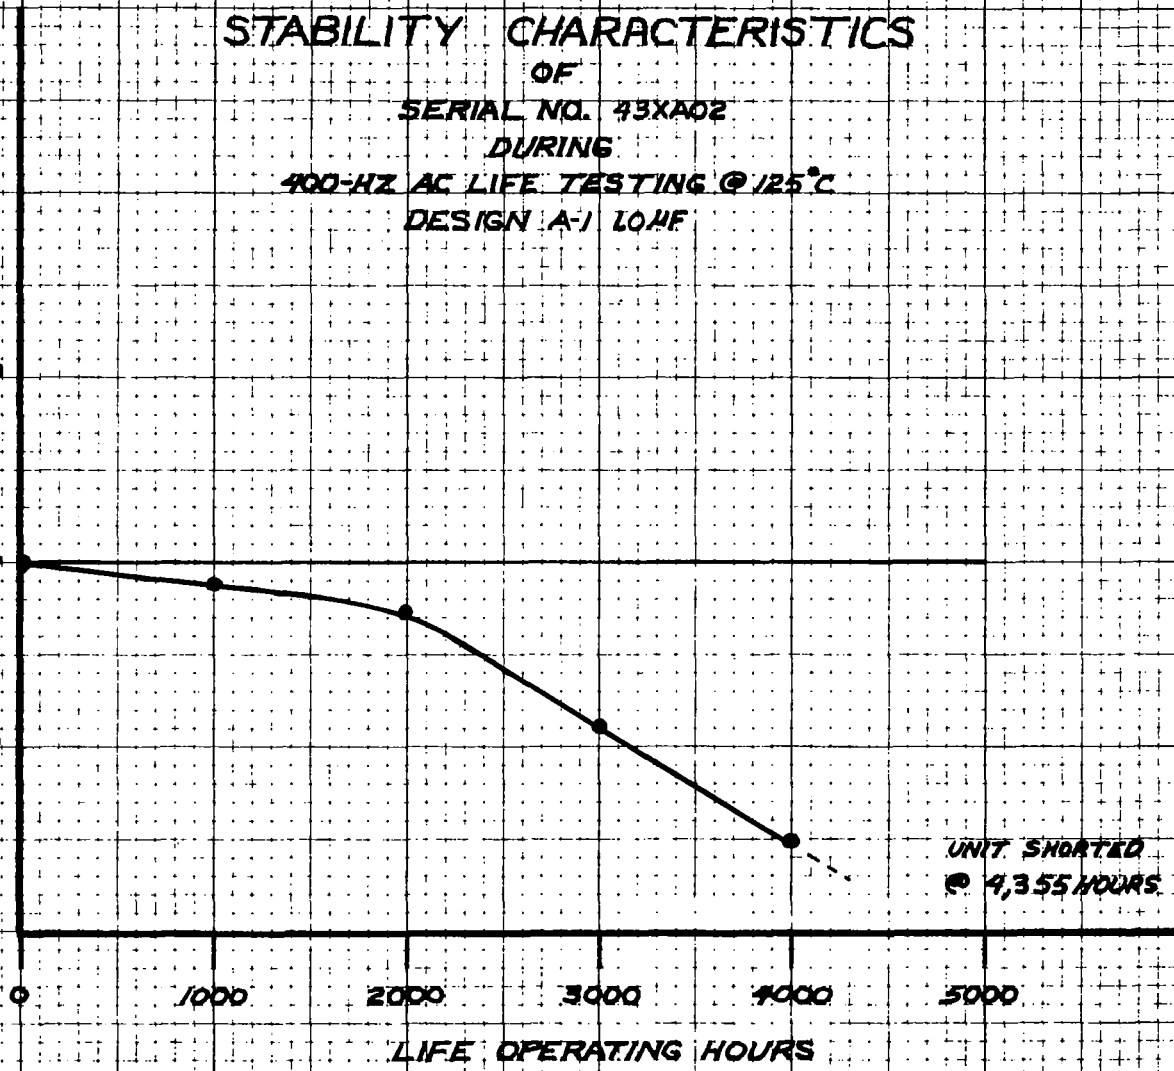
FIGURE 33

- a. Design A-1 The performance curves applicable are shown in Figures 33, 34, and 35 with photograph Figure 36 and Failure Analysis 42 in Appendix B. Review of the performance curves indicates a gradual deterioration of the capacitor. The photograph of Figure 36 illustrates the raised eyelet indicating a broken eyelet rim-to-can solder seal.

UNIT SHORTED
@ 4,355 HOURS

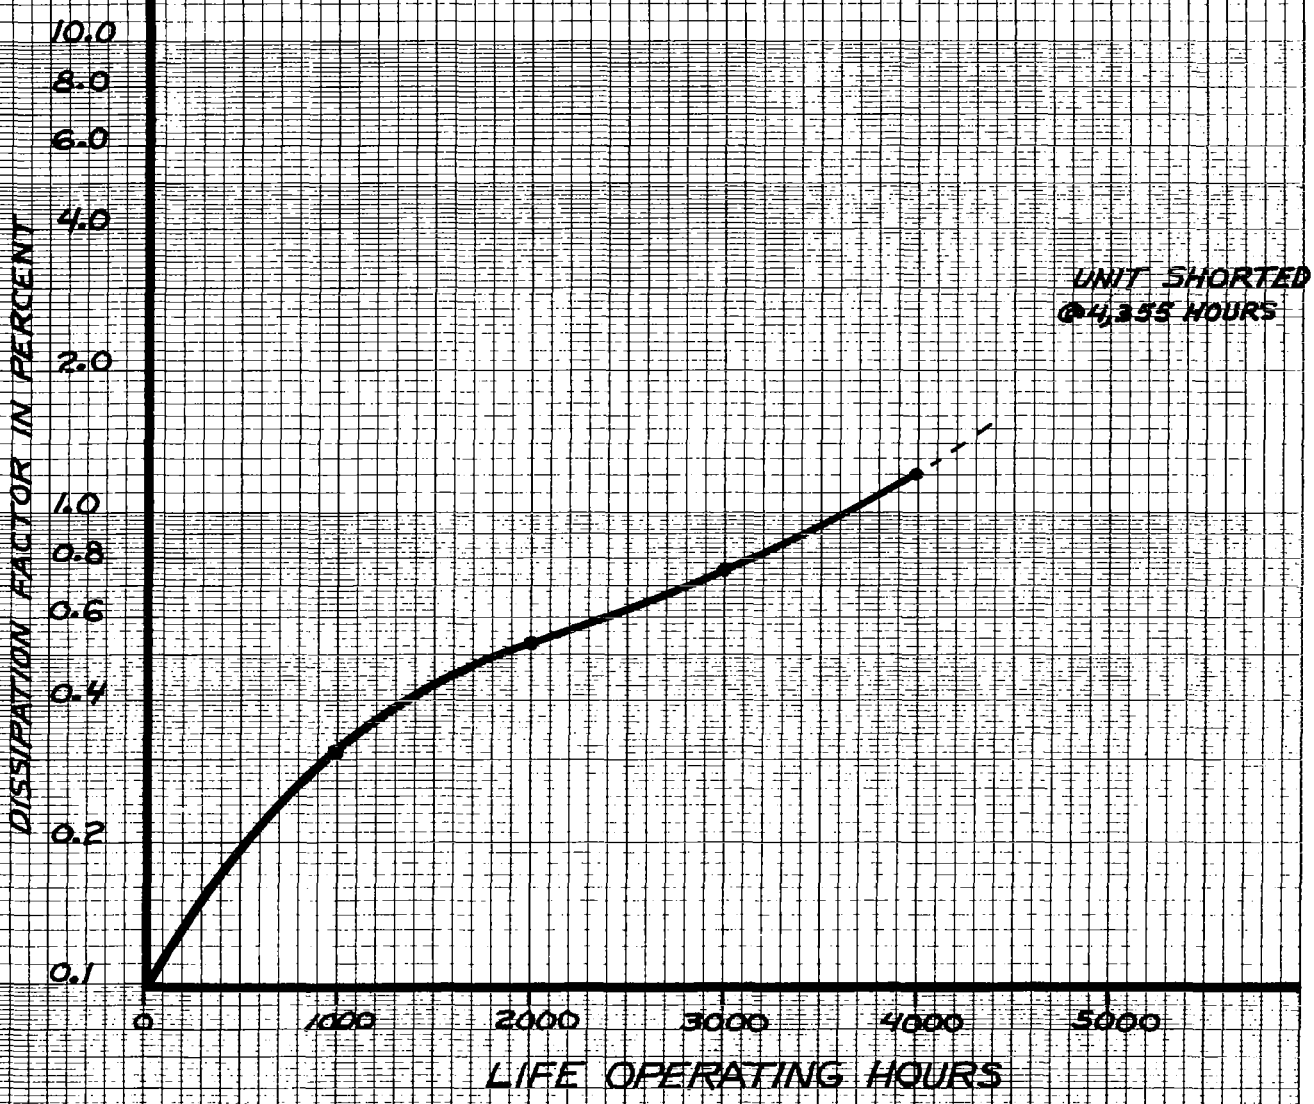
FIGURE 34

DISSIPATION FACTOR
OF
SERIAL NO. 43XA02
DURING
400-HZ AC LIFE TESTING @ 125°C
DESIGN A-1 1.0 μ F

UNIT SHORTED
@ 4,355 HOURS
