THREE-STAGE POTASSIUM VAPOR TURBINE TEST

by B. L. Moor and E. Schnetzer

Prepared by
GENERAL ELECTRIC COMPANY
Cincinnati, Ohio 45215
for Lewis Research Center

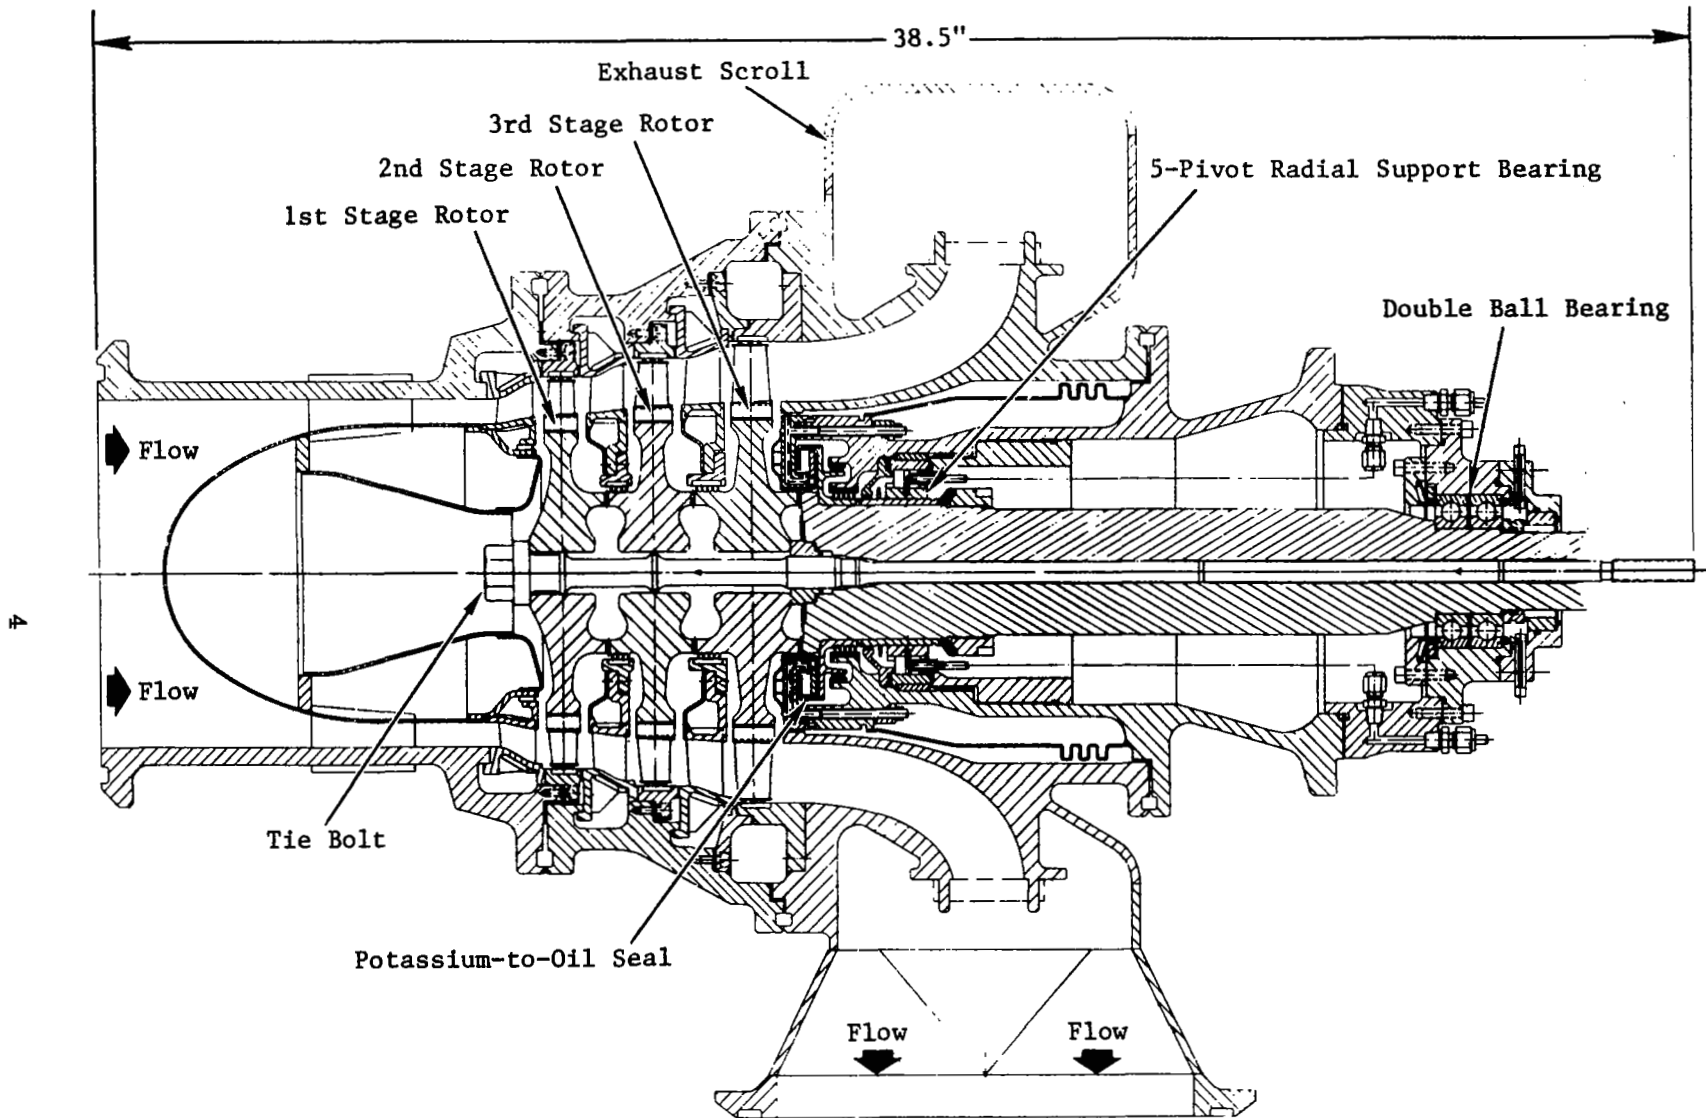
By adding a third stage to a turbine otherwise the same, Figure 1,⁽²⁻⁴⁾ the calculated moisture level entering the last turbine stage was increased from 3.3 to 8.9 percent, a value more representative of utility practice. At the same time, the tip diameter and tip speed of the final stage were increased (Table I). The basic test objective was to find out whether blade erosion at this more severe combination of moisture level, blade speed, blade material and temperature could be tolerated in space turbines with a three- to five-year life objective. The 5000 hour endurance test period was assumed to be representative of the difficulties to be encountered in operating three to five years.

Figure 1. Three Stage Potassium Vapor Test Turbine.

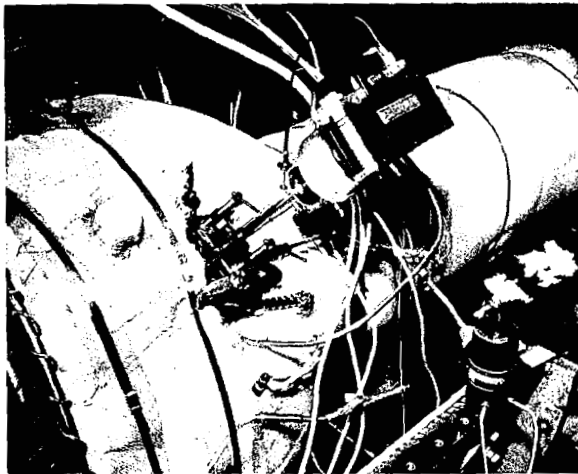
Figure 4. Blade Inspection Port Equipped With Borescope and Camera. (P69-8-1D)

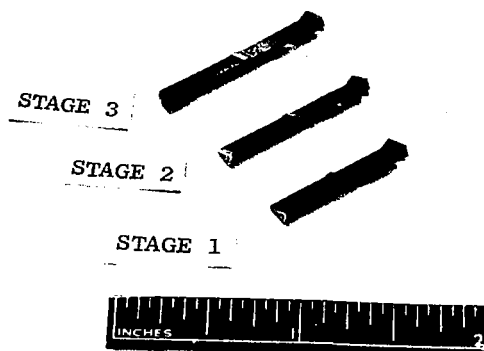
Figure 7. Three-Stage Turbine Blade Retainers - Material, Rene' 41. (P69-5-38Q)

To eliminate the previous source of mechanical damage, new spring type bucket retainers, Figure 7, were developed and incorporated in the turbine. The tip shrouds of the third-stage rotor blades were removed to eliminate another potential for damage, Figure 8. This permitted direct visual blade tip inspection.

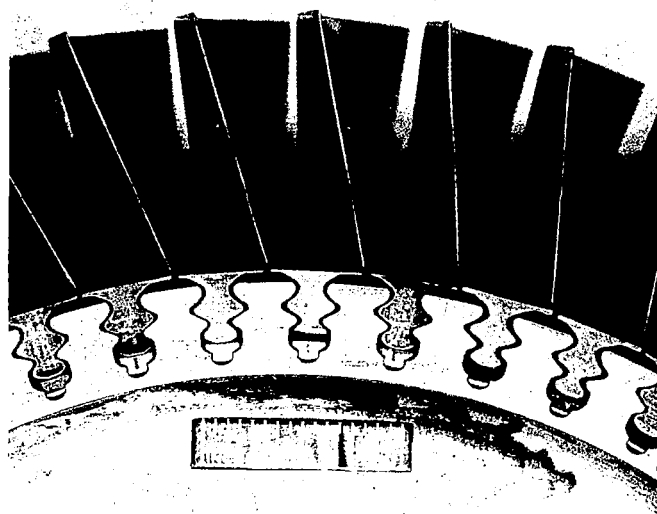
Figure 8. Third-Stage Rotor Blades With Tip Shrouds Removed and New Blade Retainers. (P69-5-38AG)

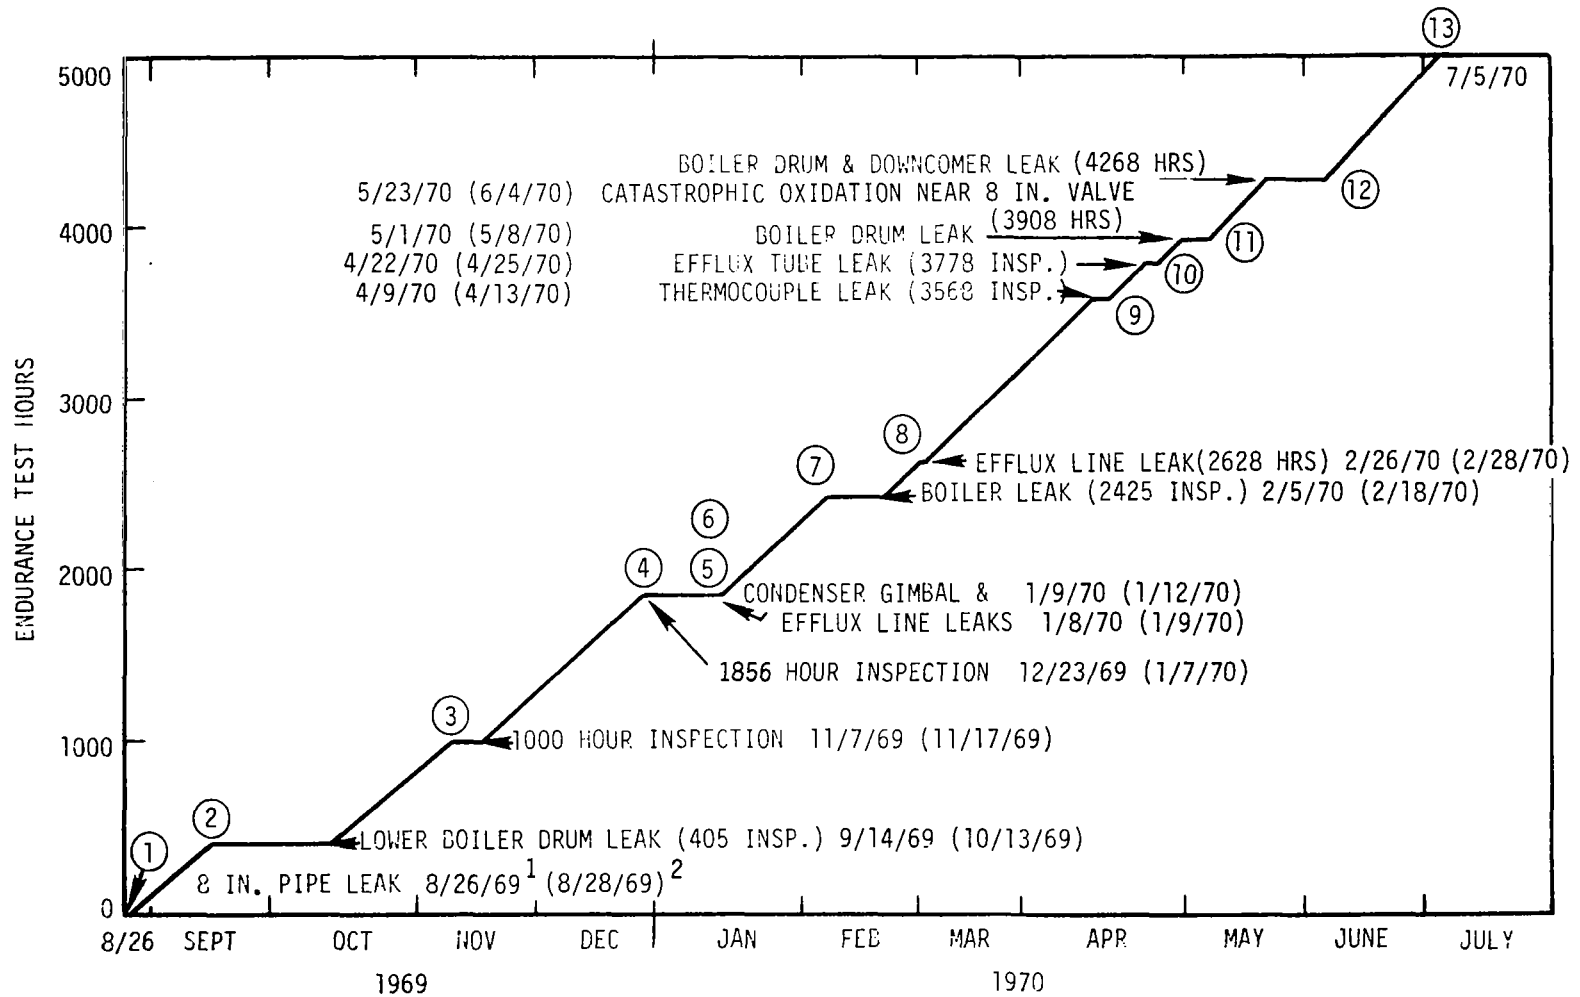
of the two-stage turbine after 2000 hours of testing. Originally shutdowns were planned every 500 hours to inspect the third-stage rotor blades. However, a facility breakdown at 405 hours replaced the first planned shutdown and provided sufficient time for blade inspection. The next two shutdowns at 1000 hours and 1856 hours were scheduled, as was the final shutdown at 5000 hours. All other inspections utilized facility breakdown and repair periods. Figure 9 details the shutdown and startup dates, causes of shutdowns, and total testing hours.

Figure 9. Three Stage Potassium Turbine Accumulated Endurance Test Hours Versus Time
1 = Shutdown Date, 2 = Startup Date.

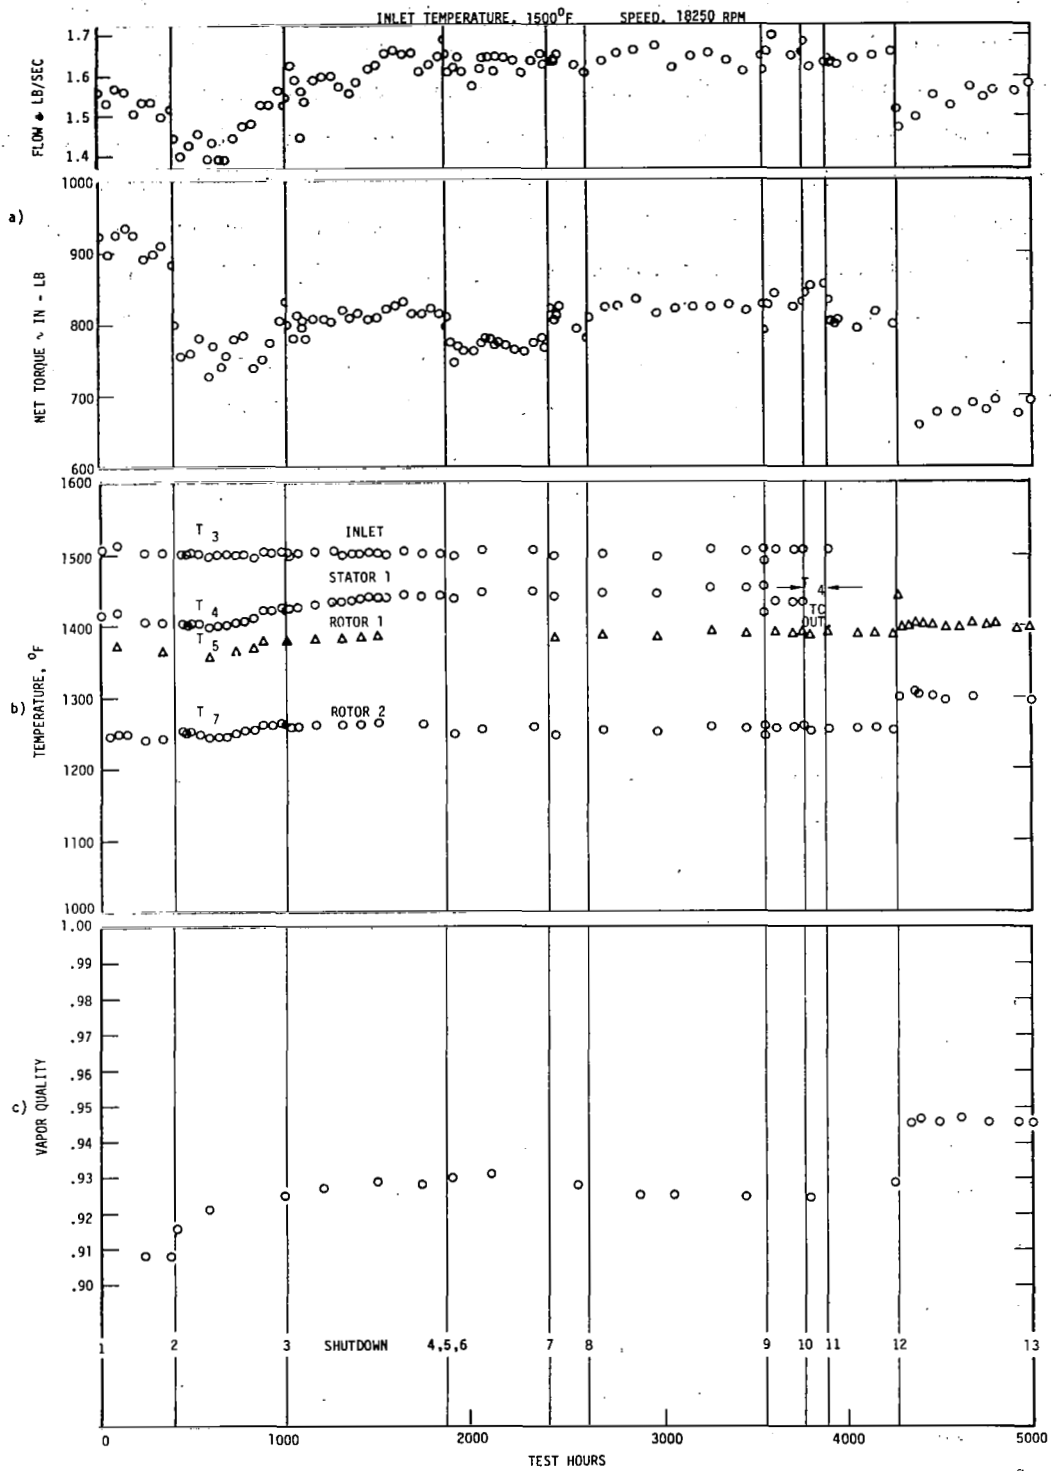
Shown in Figure 14 are the important performance parameters plotted as a function of time. It can be seen that the flow rate and net torque decreased significantly after the first shutdown. Subsequently the flow rate increased to a value greater than the initial value while the torque increased only slightly. It appears likely that the initial decrease in flow and torque was caused by potassium dizirconate or iron-nickel deposits on the turbine blades, and the subsequent increase in flow rate was due to the hole in the bulletnose which eventually permitted about one-third of the flow to bypass the first stage nozzle. This rationale is supported by the temperature plot which shows an increase in the first stage nozzle exit temperature, T_4 , in the 700- to 1500-hour time period when the flow rate was increasing. Thus the hole in the bulletnose seems to have occurred after 700 hours. The decreases in torque at 1856 and 4268 hours are attributed to potassium dizirconate deposits found on the turbine blades. The decrease in flow after 4200 hours is attributed to heavy potassium dizirconate deposits on the third stage nozzle vanes. This conjecture is supported by the significant increase in the temperature after the second stage rotor, T_7 , which could result, for instance, from the partial blockage of the third stage nozzle.

Figure 14. Flow Rate, Net Torque, Temperature, and Stage 3 Inlet Vapor Quality Performance During 5000 Hour Test.

agreement with the 1968 performance test results⁽⁴⁾ which determined a benchmark turbine efficiency. For subsequent test points the turbine efficiency was estimated from measured values of flow rate, speed, and net torque. The turbine efficiency, exit pressure, and inlet conditions locate the condition line of the turbine on the potassium Mollier diagram. The quality at the inlet to the third stage was estimated from the measured value of the second rotor exit temperature, T_7 , (Figure 14) and its location on the turbine condition line on a Mollier diagram. The third stage inlet quality varied from 0.91 at the beginning of the test to 0.93 after the bulletnose was fully opened, continuing at 0.93 until 4268 hours. After the next shutdown the quality rose to about 0.95 when the performance decreased due to heavy deposits on the third stage nozzle vanes.

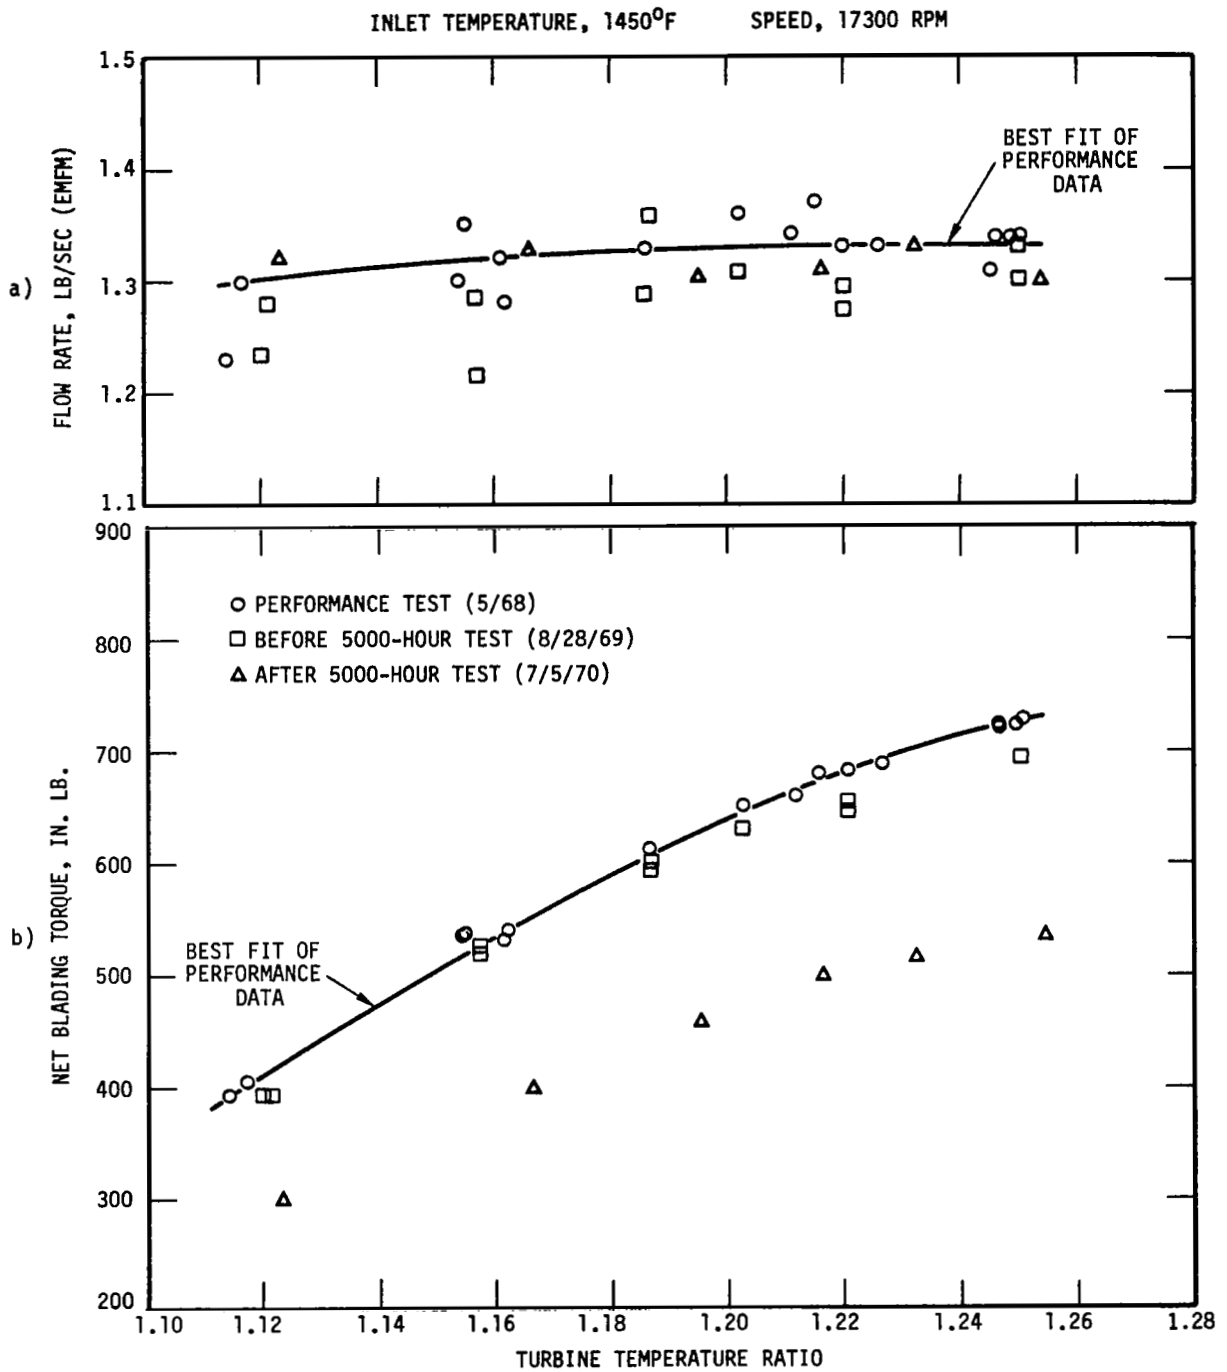
Shown in Figure 15 is a comparison of performance test results obtained from the 1968 performance test, before the 5,000 hour endurance test, and after the endurance test. The flow rate is about the same for all three tests, but the torque after 5,000 hours is about 25% lower than the original values. This is about the same decrease shown on Figure 14 for the 5,000 hour endurance test.

Figure 15. Net Blading Torque and Flow Rate Performance in 1968 and Before and After 5000 Hour Test.

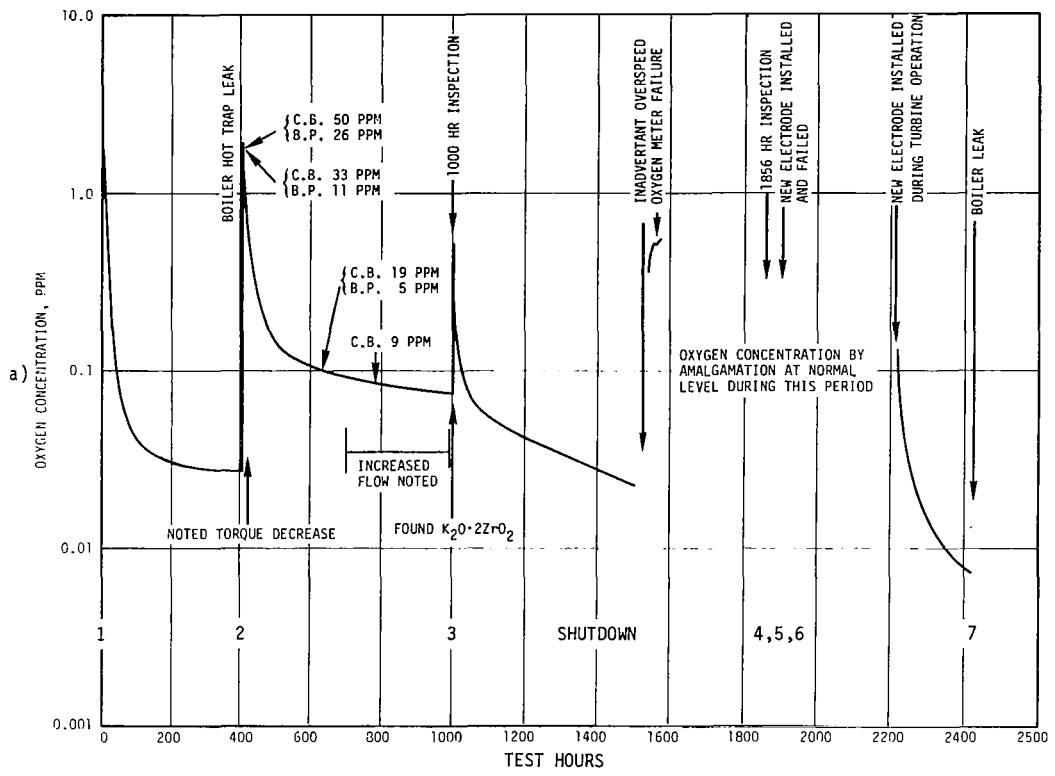
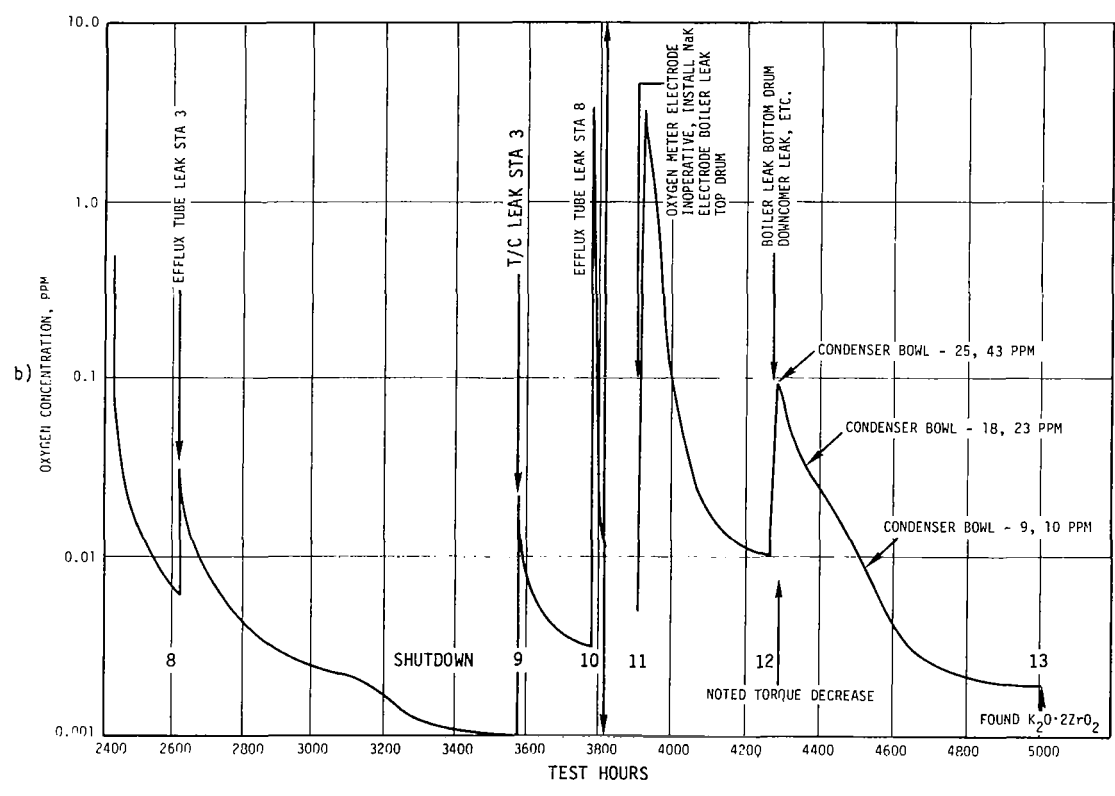
Figure 16a shows the oxygen meter data for the first 2425 hours of endurance testing. During the initial operation the indicated oxygen concentration dropped rapidly. After the boiler hot trap leak the rate of decrease was much less. During this same period the condenser bowl and bypass samples also showed higher than normal values (5 to 10 ppm) with the bypass values being lower, as expected. The oxygen meter values were, of course, still lower because of the blank in the amalgamation data. The data indicated that the loop was contaminated to a considerable extent. A torque decrease was noted at the 405-hour startup and potassium dizirconate ($K_2O \cdot 2ZrO_2$) was noted on the stator vanes at the 1000-hour inspection. The ensuing data indicated that subsequent problems did not result in serious contamination, as indicated by the very rapid drop in oxide concentration during startups and the continually decreasing values during normal operation. Analysis of condenser bowl samples, during the period when no oxygen meter was operating, indicated the usual values between five and ten ppm. At about 2200 hours a new electrode was installed during operation and the noted spike was due to cleanup of the oxygen meter loop.

Figure 16b shows that the boiler leak which occurred after 2425 hours of operation did not result in serious contamination nor did subsequent mishaps until the leak in the top boiler drum at about 3900 hours. Another electrode was installed at this point. It had been used previously in a NaK system and had to be cleaned up by an alcohol washing before installation in the turbine facility. It is not possible to say whether the apparent slow cleanup of the loop after this mishap was due to contamination or to conditioning of the electrode. However, the condenser bowl

Figure 16. Three Stage Turbine Oxygen Meter Data During 5000 Hour Test.

sample indicated seven ppm oxygen at the startup and supports the contention that contamination was not excessive. In contrast, the boiler leak at 4268 hours definitely resulted in contamination, as indicated by the relatively slow decrease in oxygen meter concentration and by the high values obtained from the condenser bowl samples. A decrease in torque was again seen and at the final inspection potassium dizirconate was again found to be deposited on the stator vanes. After the 5000-hour test, visual inspection of the condenser zirconium hot trap showed it to be cracking, but essentially intact. X-ray diffraction indicated that the black powder found on the surfaces consisted of Zr_4Fe and a trace of potassium dizirconate. In contrast, inspection at the boiler bypass zirconium hot trap showed that it was disintegrating and contained a considerable quantity of potassium dizirconate. Therefore, it was the principal source of the turbine deposits.

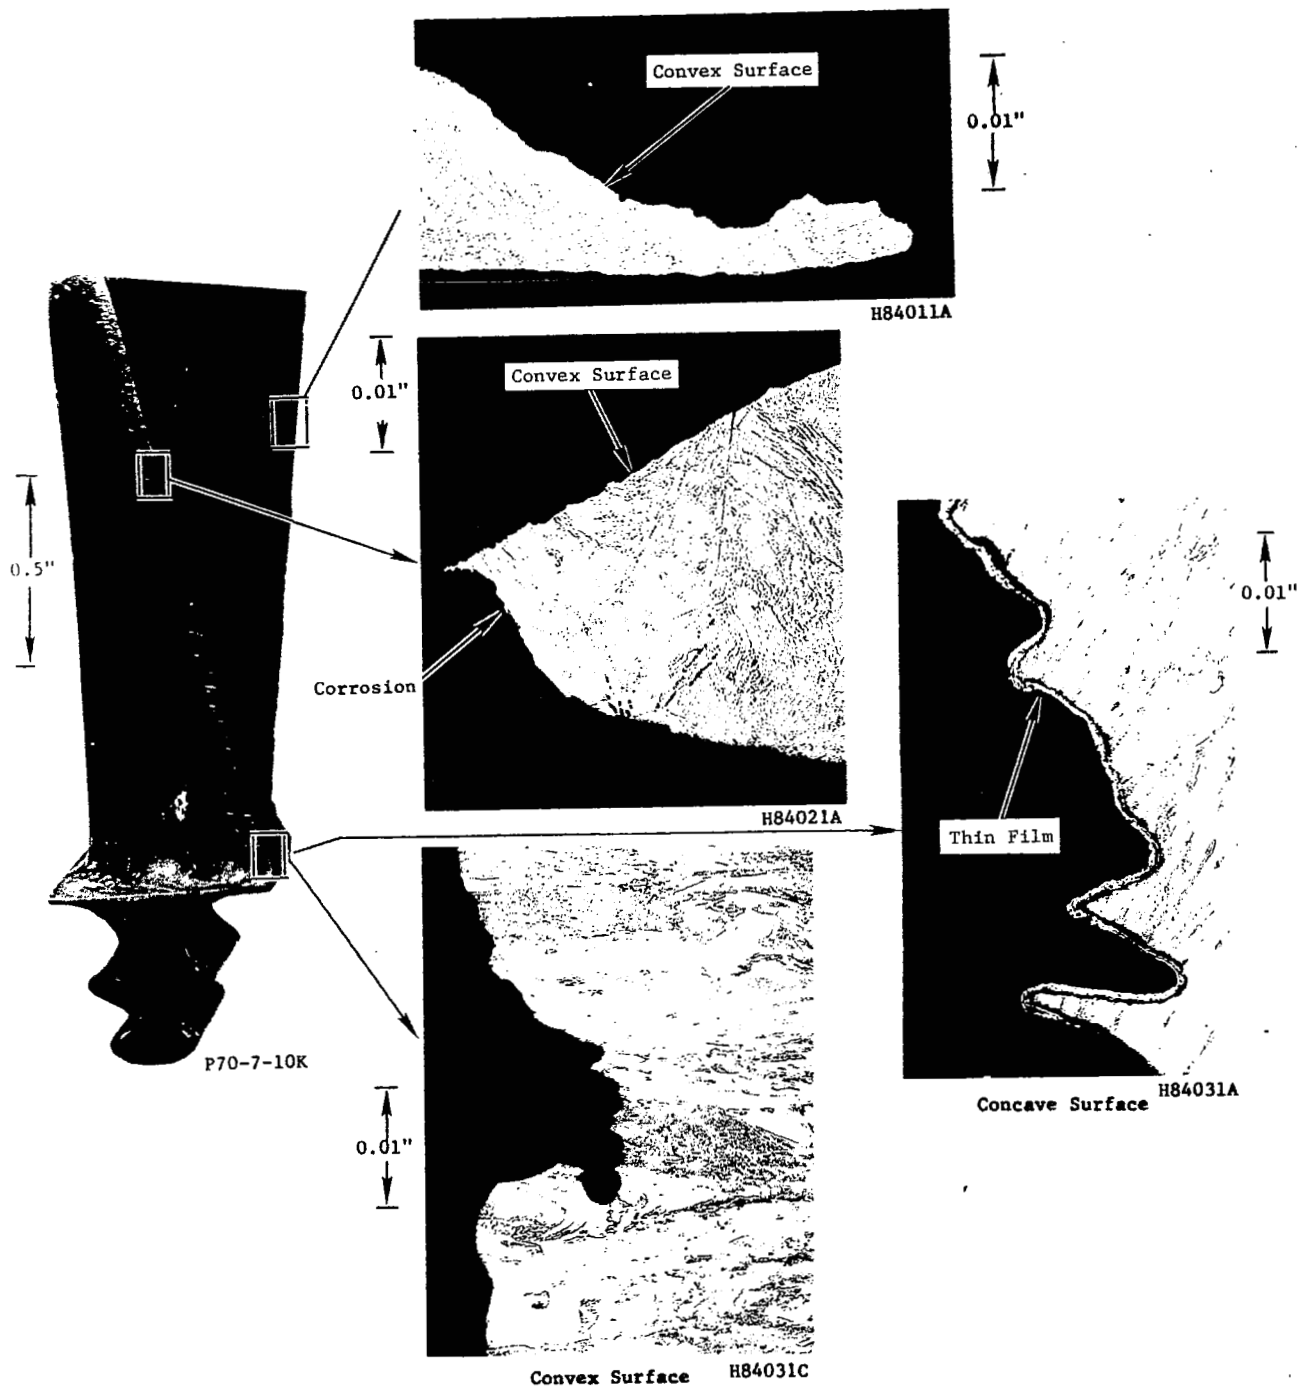
Figure 19 shows the microstructure of a third-stage Mo-TZC bucket. Washing corrosion has occurred on both the concave and convex surfaces at the base of the airfoil leading edge. Some of the material removal occurred on the concave surface of the thinned leading edge. Also, signs of corrosion are seen at the trailing edge convex surface where a groove runs almost the entire length of the convex surface of the airfoil. The groove is 0.030 inch wide and has a maximum depth of 0.005 inch.

Figure 19. Microstructure of Mo-TZC #U Third Stage Rotor Bucket.
