CR-72690  
MDC G0729

# SPACE-STORABLE OXIDIZER VALVE

FINAL REPORT  
NOVEMBER 1970

McDonnell Douglas Astronautics Company—West  
McDonnell Douglas Corporation  
5301 Bolsa Avenue  
Huntington Beach, California 92647

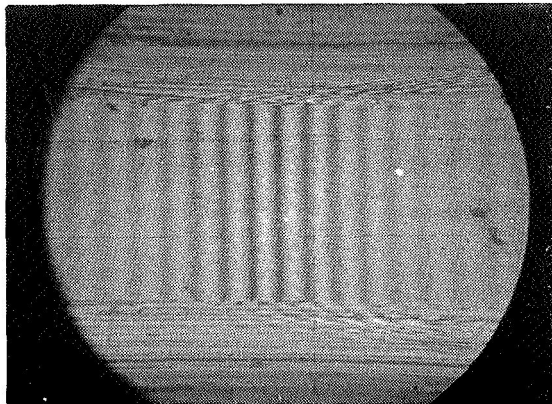
The unplated A286 poppet seat used in the -1 configuration had the sealing surface lapped to a finish less than  $1\mu$  in. ( $2.54 \times 10^{-8}$ m) arithmetic average (AA). The photomicrograph of a typical section of seal is shown in Figure 3-1. The lapping technique used on this valve employed a hand-held lap moved in a circular pattern. This method of lapping produces a high-quality multidirectional lay, but not the specified circular lay. The differences between a multidirectional lay made in this manner and a theoretically circular lay were discussed with the Parker Hannifin Lapping Department personnel. Due to the anticipated difficulty in maintaining the required surface finish while lapping with a truly circular motion, a decision was made to approve the multidirectional finish for acceptance testing. The final inspection of the seal was conducted just prior to the assembly of the valve to ensure that no damage had occurred to the seat due to cleaning and handling of the part. This last inspection showed no scratches or other damage which would hinder proper valve sealing. The bumper height was 0.0002 to 0.00025 in. ( $5.08 \times 10^{-6}$  to  $6.35 \times 10^{-6}$ m) ( $0.0003 \pm 0.0001$  in. [ $7.62 \times 10^{-6} \pm 2.54 \times 10^{-6}$ m] specified). The spring rate of the bellows portion of the seat was measured and found to be 5,880 lbf/in. ( $10.30 \times 10^5$  N/m), which is well within the  $5500 \pm 500$  lbf/in. ( $9.62 \times 10^5 \pm 0.88 \times 10^5$  N/m) specified. Since this value was near the upper end of the specified range, it tended to compensate for the undersized seat diameter discussed in Section 3.2.1.4. The poppet seat for the -501 valve had the same spring rate as the -1 valve part. This poppet seat was given a light surface lapping prior to gold plating because the surface was scratched, was not flat, and did not provide the proper bumper height. The seat was lapped to an acceptable flatness and surface finish before the gold plating was completed. A second lapping operation was completed after the gold-plating process. This second lapping was to eliminate slight irregularities of the gold plating with the removal of a minimum amount of material.

**Figure 3-1. Photomicrograph of Typical Seat-Seal Section (100X)**

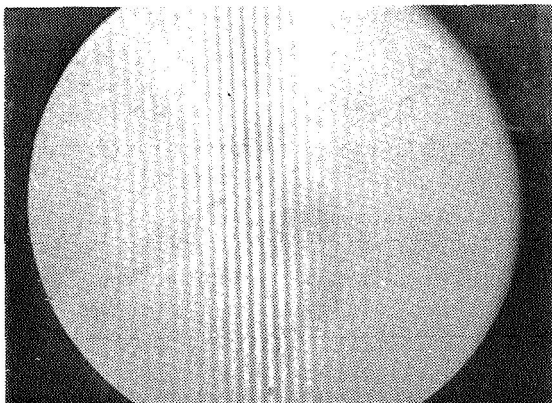
The shape of the poppet assembly prevented its installation into the optical device used to determine surface finish. Therefore, the poppet sealing surface was not completely inspected. Instead, a sample of the same dimensions and material as the poppet was lapped, using the same technique used on the valve poppet. The sample was then inspected and found acceptable. The photomicrograph of the Inconel 718 sample piece is shown in Figure 3-2. Based on the acceptable condition of the sample, the two poppets were accepted for testing.

**Figure 3-2. Photomicrograph of Inconel 718 Sample Piece (100X)**

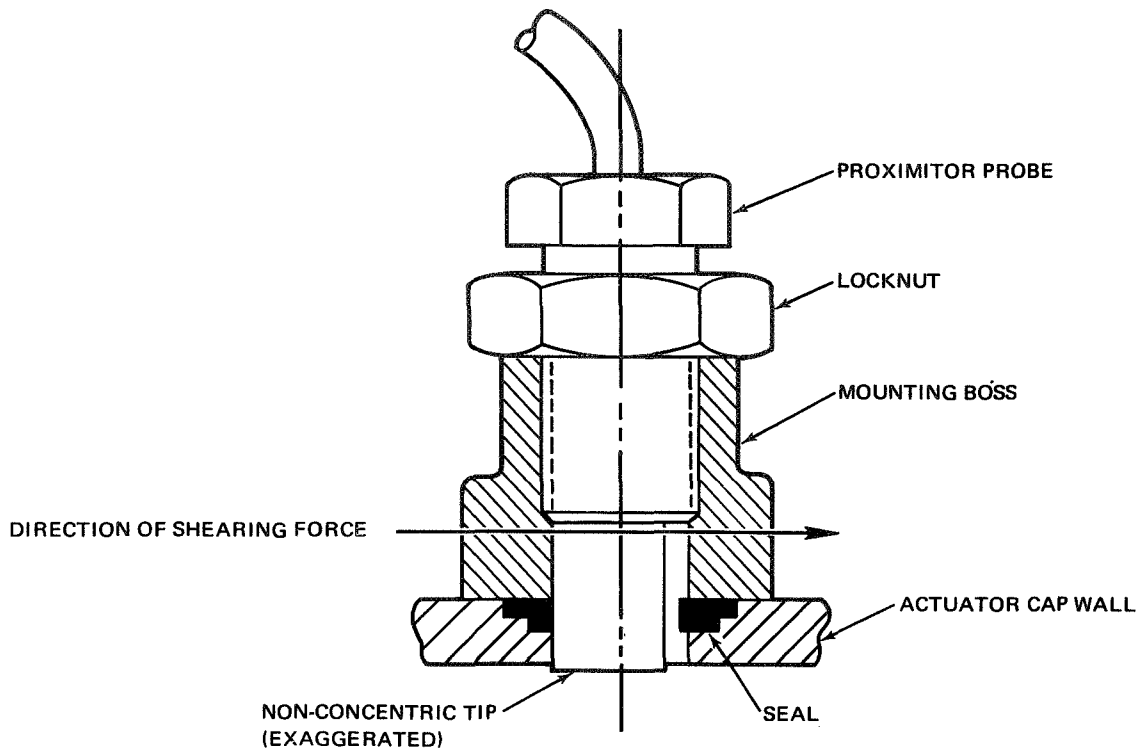
Figure 3-5. Proximito-Seal Installation

After removing all safety wires, disassembly began with the actuator portion of the valve. All breakaway torque values were within specification. Visual inspection of the removed proximitors showed an obvious nonconcentricity between the sensing tip and the mounting threads (Figure 3-5). This condition can result in excessive leakage and/or proximitor tip breakage, but is easily avoided by specifying the desired concentricity when ordering new parts. At this time, several correctly-specified spare units were on order. A small quantity of Teflon dust was observed in the actuator cap. This had been produced by friction between the actuator piston and Omniseal, and is considered normal. An imprint of the actuator piston face inside the end of the actuator cap and light impact marks on the piston face were probably produced during the 250-psig ( $1.73 \times 10^6$  pascals) GHe proof tests, and are also normal. Disassembly of the valve actuator disclosed a potential problem which can easily be eliminated by a minor revision to the assembly procedure. The cotter-key hole in the threaded portion of the poppet shaft should be aligned with its axis perpendicular to a plane passing through the position indicators. If it is not, the cotter key that retains the indicator nut can damage or interfere with the proximitor tips when the poppet moves. The alignment of the cotter-key hole is determined by the clocking of the bellows adapter to the main valve body when the poppet assembly is installed. During the original assembly of the -501 valve, the bellows adapter was misclocked by one bolt hole, resulting in a 45-degree ( $7.85 \times 10^{-1}$  rad) error in cotter-key position. As a result, the bent end of the cotter key narrowly missed one of the proximitor tips during prior operation.

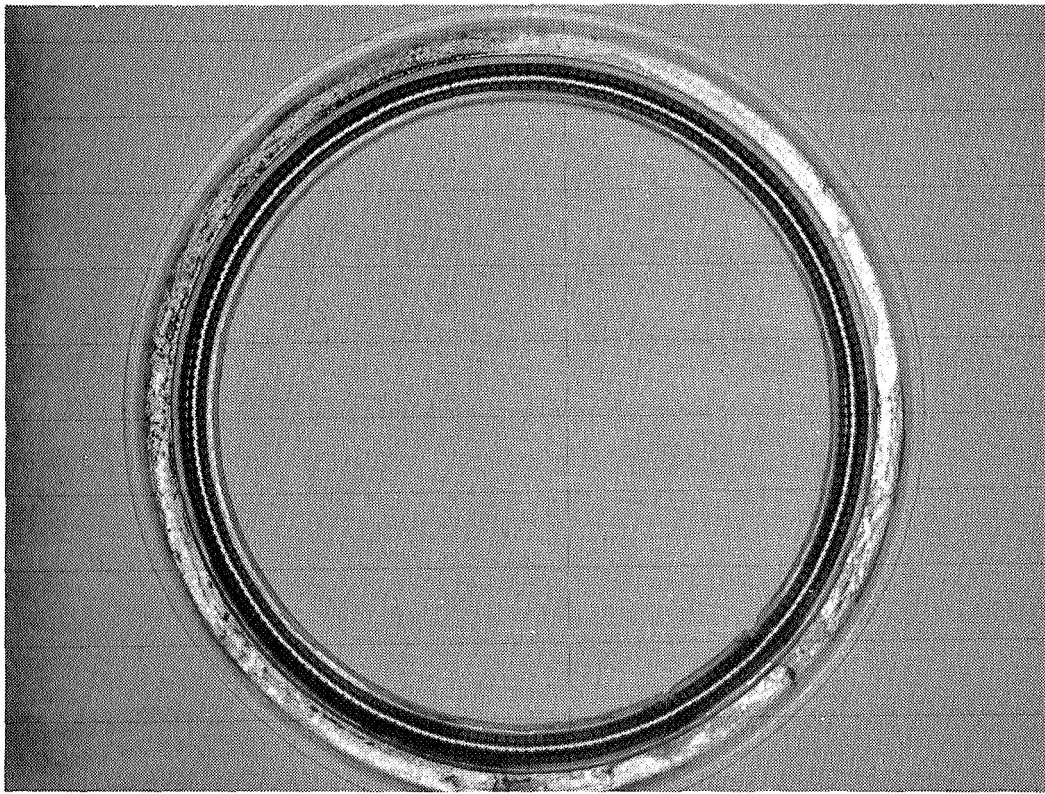
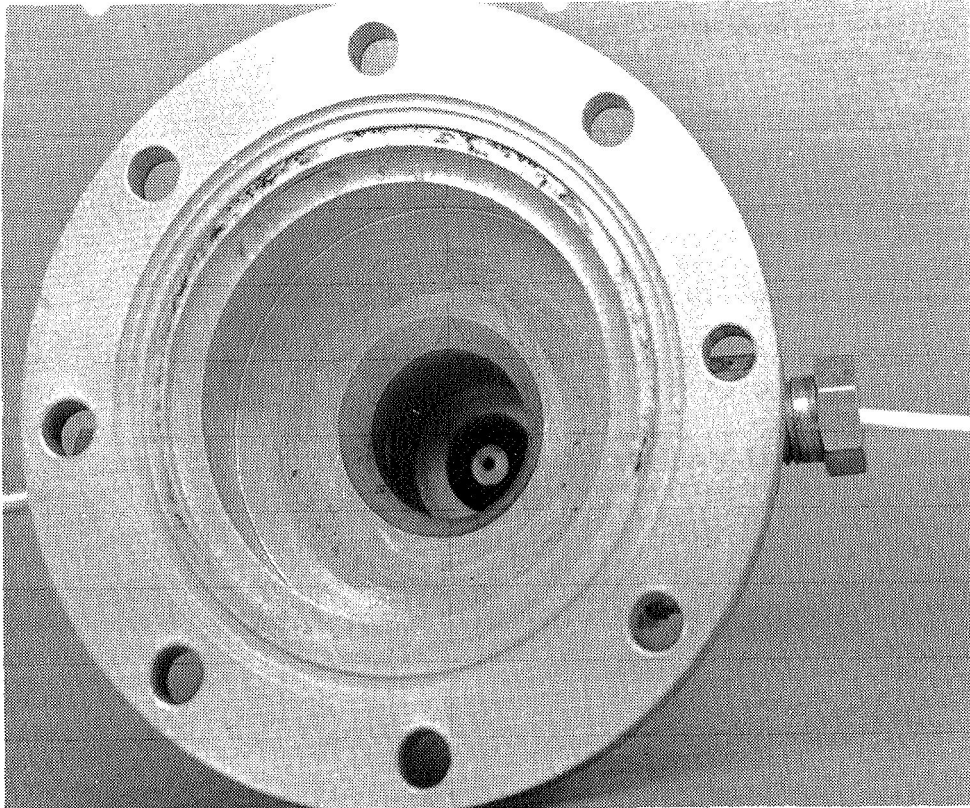
Figure 3-15. -1 Valve Actuator Piston Seal (Front Side) After Task III Testing

Figure 3-16. -1 Valve Actuator Cap Interior After Task III Testing

The -1 valve was disassembled for failure isolation purposes after it failed during the high-pressure cycle-life test (Section 3.3.2.15). A thorough inspection was made of all the internal parts and surfaces not visible in the assembled valve. It was observed that the portion of the valve designed for direct  $LF_2$  exposure was virtually unaffected. Although surface discolorations were present in a few areas on the static seals and static seal recesses, they were easily removed by use of the standard cleaning process for  $LF_2$  components. There was no evidence of subsurface etching in the affected areas, and external leakage checks performed after valve assembly disclosed no loss in sealing efficiency. The fatigue crack in the shaft bellows seal allowed fluorine to enter the actuator cavity, an area normally not exposed to the oxidizer. Damage within the actuator was only superficial: two small grooves were burned in the actuator piston seal, depositing a sootlike film on the seal and adjacent surfaces within the actuator housing (Figures 3-15 and 3-16).

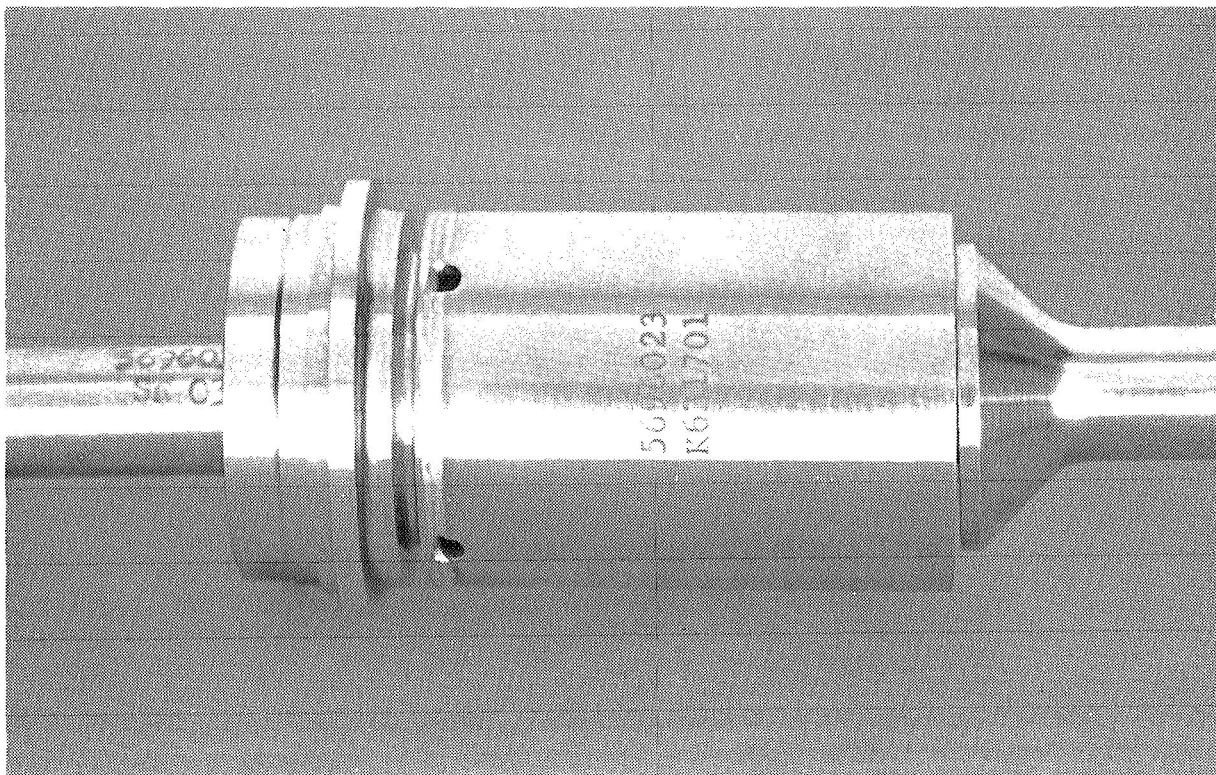
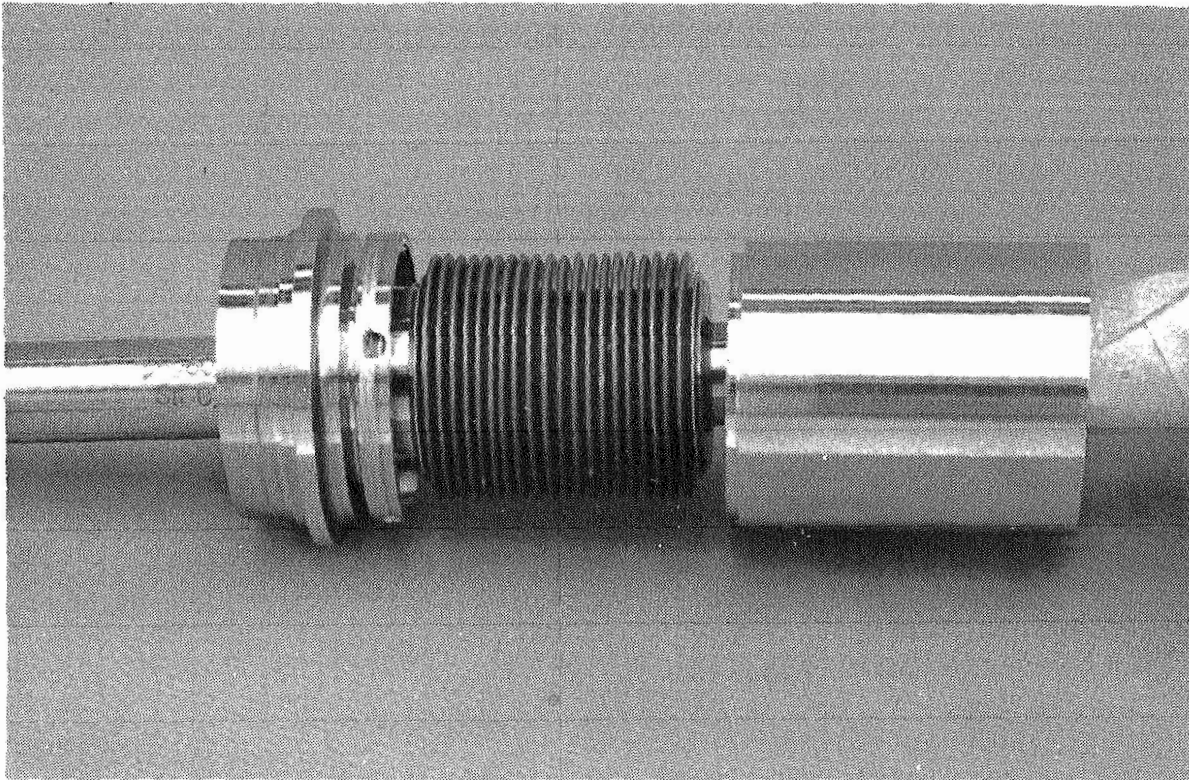
Confirmation that the poppet bellows had failed required removal of the bellows shield by machining, which was accomplished at Parker Hannifin. The shield was separated from its adapter with a single lathe cut, exposing the bellows (Figures 3-25 and 3-26). Then, by use of shop air and bubble solution, the failure was determined to be a circumferential crack in the root of the first full convolution from the poppet end (Figure 2-27). Looking toward the poppet sealing surface, the crack extended approximately 50 degrees ( $8.73 \times 10^{-1}$  rad) in a clockwise direction from the center of the shaft keyway.

Figure 3-25. -1 Valve Poppet-Shaft Bellows Seal Assembly After Task III Testing.

Figure 3-26. -1 Valve Poppet-Shaft Bellows Seal Assembly (With Shield Removed) After Task III Testing
