NASA CR 72732

CRYOGENIC POSITIVE EXPULSION DIAPHRAGMS

NASA Lewis Research Center
Contract NAS 3-11204
R. F. Lark, Project Manager

Final Report

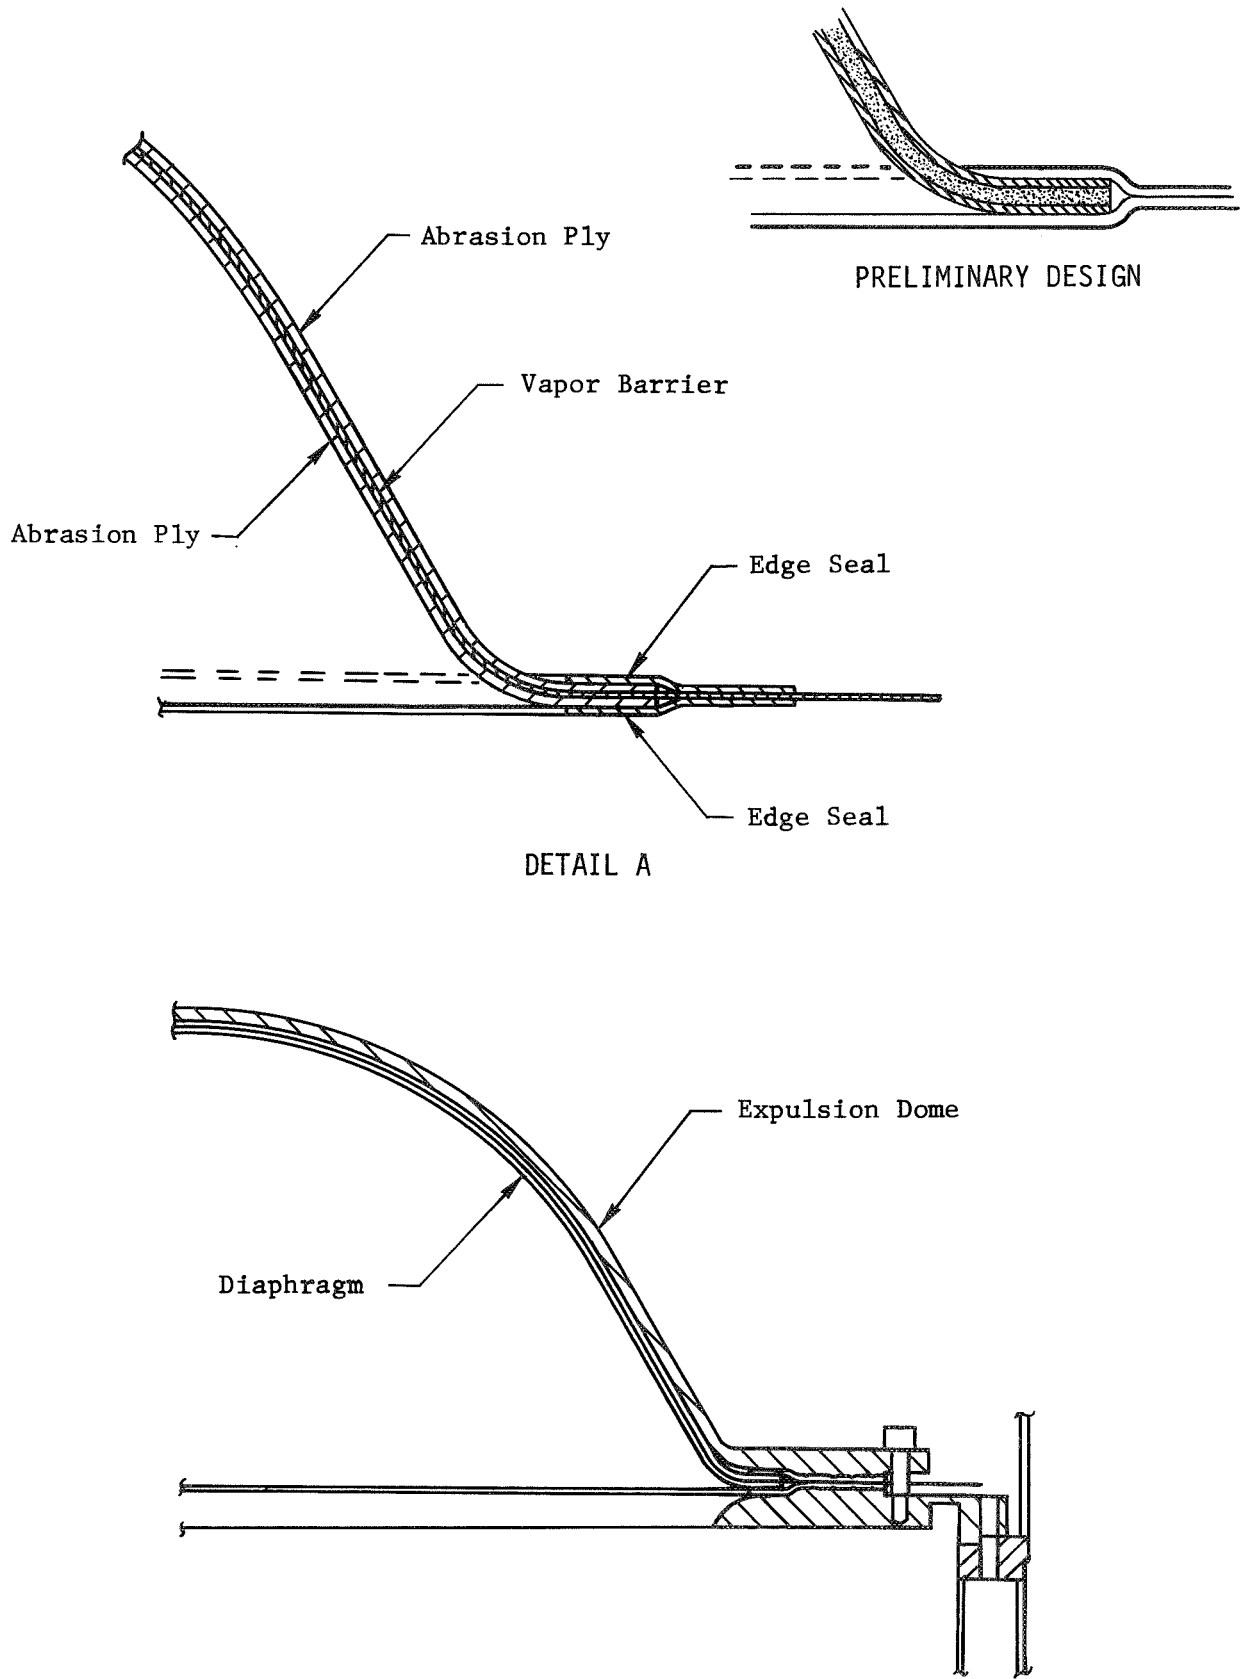
Figure 11: FLANGE SEAL

Flange Seal---The flange seals for the diaphragms were fabricated of two identical discs of Mylar bonded to the vapor barrier film with 46971 adhesive as shown in Figure 11, did not make provisions for sealing the Mylar discs to the vapor barrier ply thus allowing the helium gas and liquid hydrogen to pass through the lower felt, around the vapor barrier through the top felt. Sealing the vapor barrier to the Mylar discs eliminated the flange leakage. Bonding is shown in Figure 12.

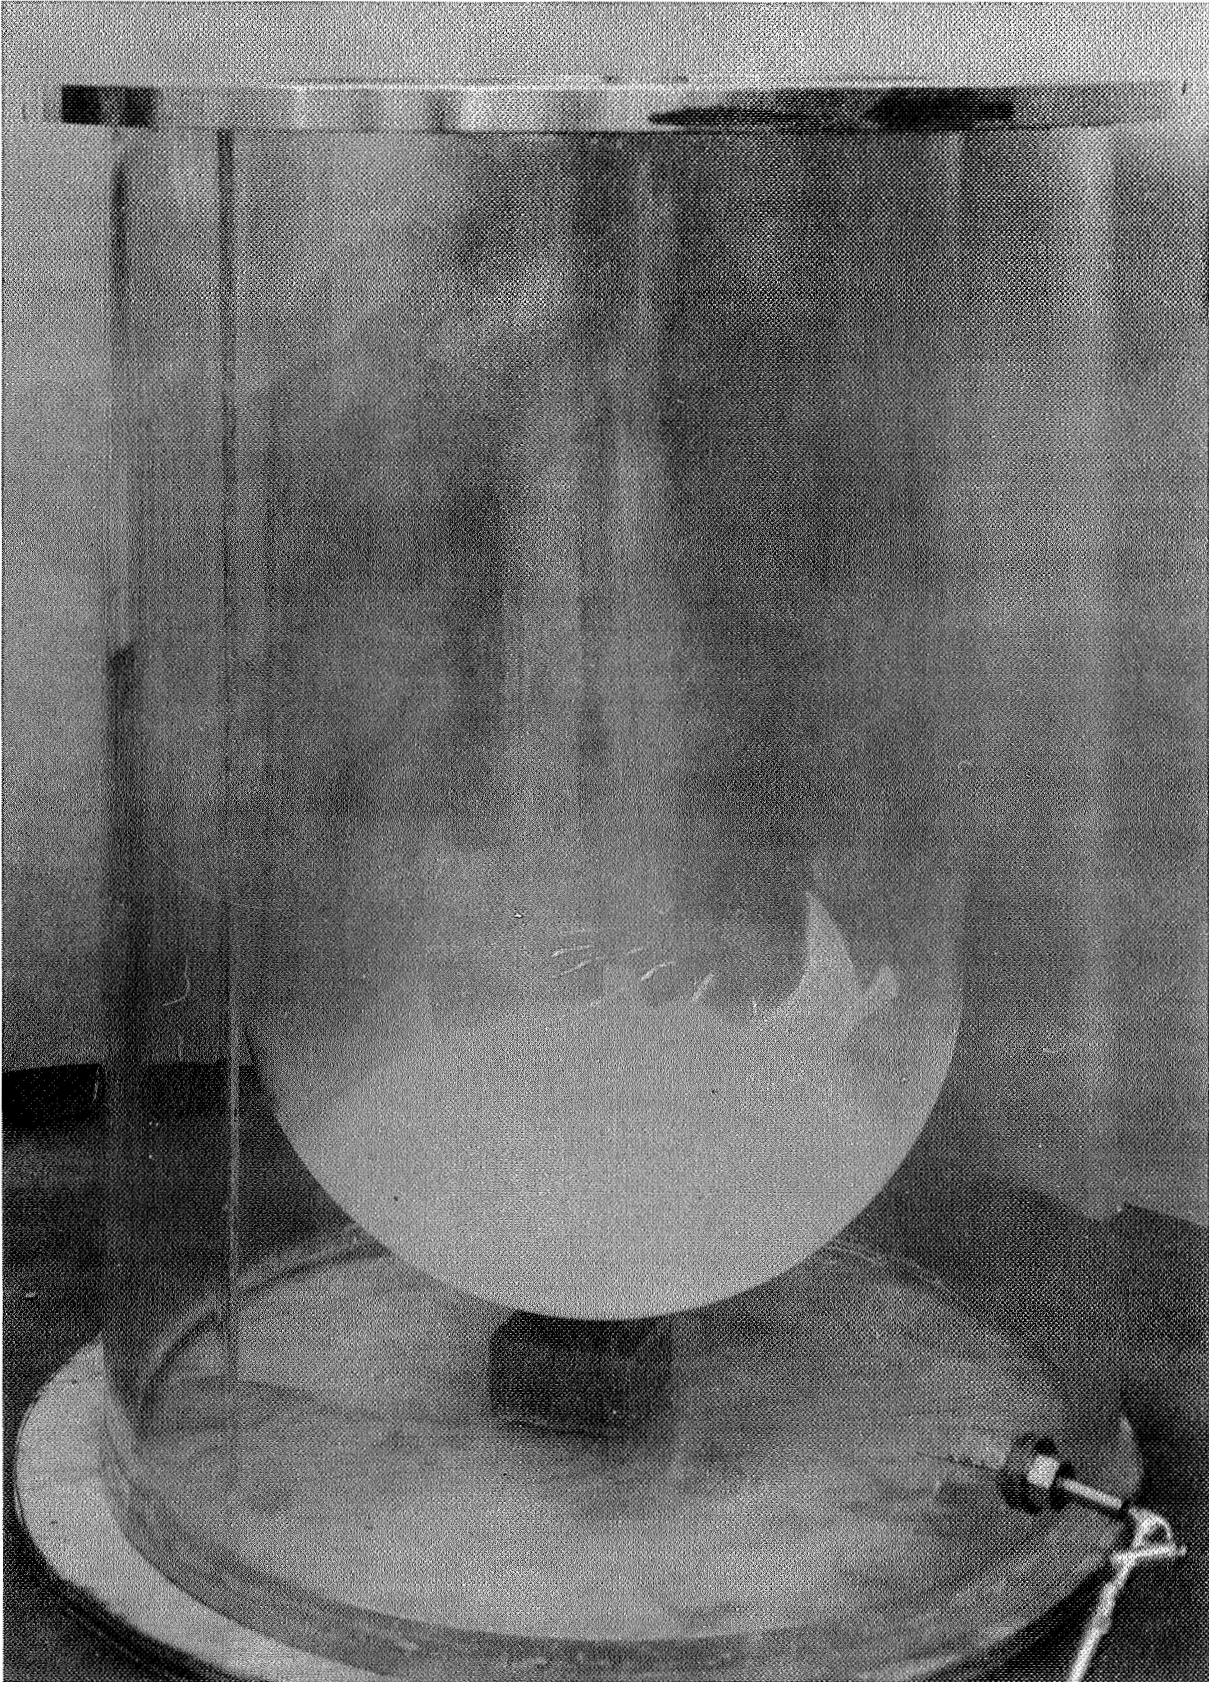
Figure 27: GLASS-PLEXIGLASS DEWAR

A second unit, shown in Figure 27, was fabricated of an inner pyrex glass container, 18-inch diameter, and the same plexiglass outer cylinder potted into a stainless steel base plate dovetailed to receive the unit. Having leak checked and cold shocked the unit with LN₂, the unit was partially filled with LH₂. After approximately one hour the inner pyrex vessel, shown in Figure 28, disintegrated again from differential thermal expansion of the components.

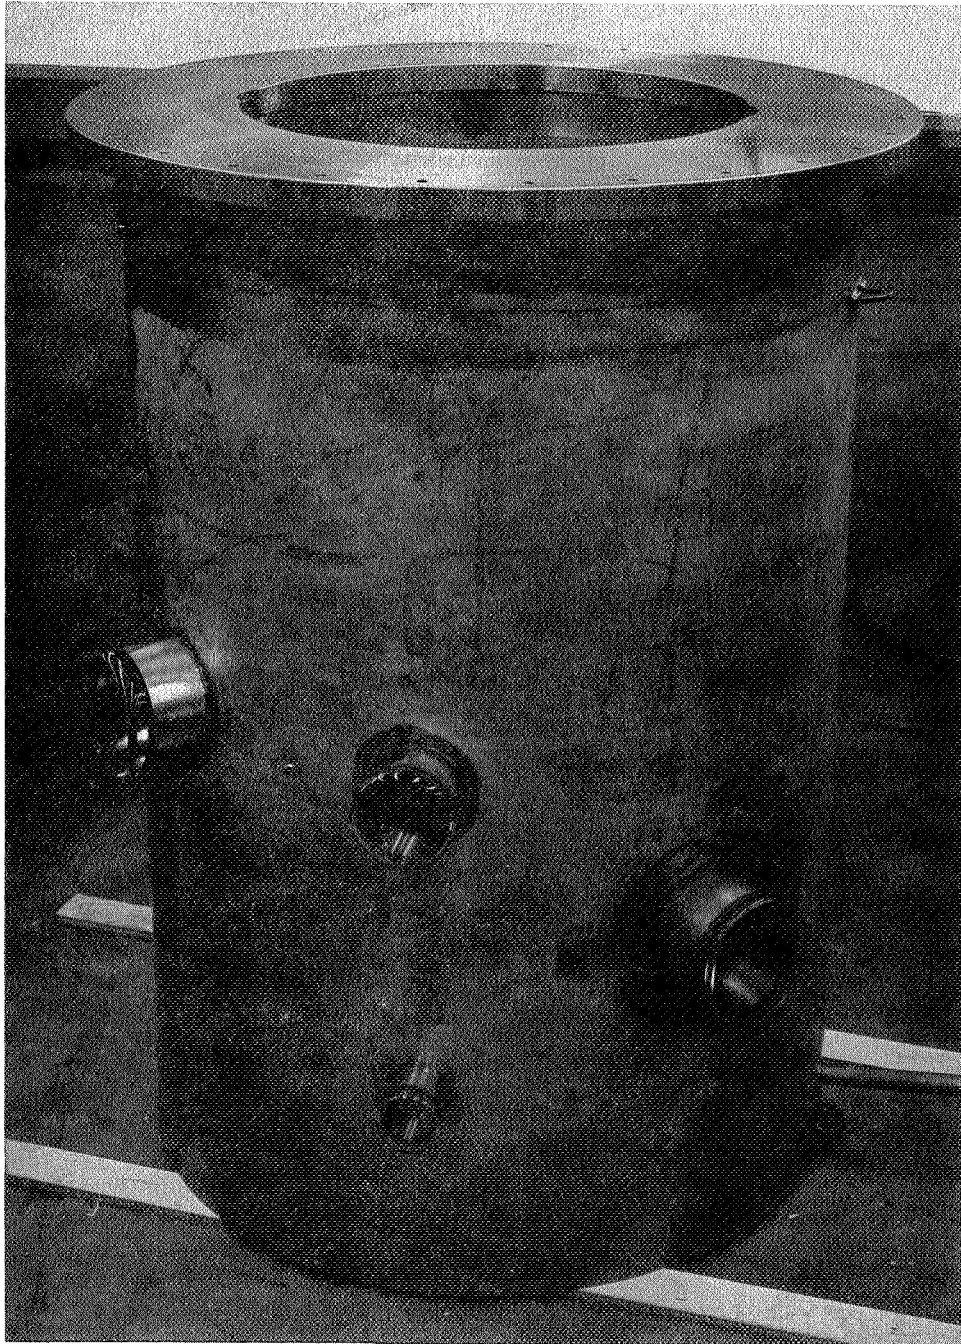
Figure 29: GLASS-STEEL DEWAR

A third container using an expansion band attaching the inner container to the mating flange and a stainless steel outer container with the view ports was fabricated. The finished dewar is shown in Figure 29. This unit lasted longer with LH_2 in the inner vessel but it also disintegrated.

A mutual decision with the NASA program manager was made to revise the approach to the test unit and fabricate a unit of stainless steel with bolt-in view ports. This unit is shown in Figure 30. The double ports allowed camera coverage through one while the TV camera and light source utilized the second port. The unit was vacuum insulated and the areas above the dome and around the GHe expulsion side were filled with liquid hydrogen. The dome was removable to allow placement of the diaphragms. This unit mated with the existing upper cryostat used for preconditioning of G Helium. The lower cryostat, shown in Figures 31 through 34, was designed for upward expulsion of the liquid hydrogen using preconditioned helium gas on the bottom (camera) side of the test diaphragm.
