HARVARD COLLEGE OSO-IV  
POINTED EXPERIMENT  
AN ANALYSIS OF THE  
MALFUNCTION DURING  
ORBIT 637

BY: R. Dower  
N. Hazen  
J. Rechavi

Technical Report No. 7  
NASA Contract NASw-184

February 1969

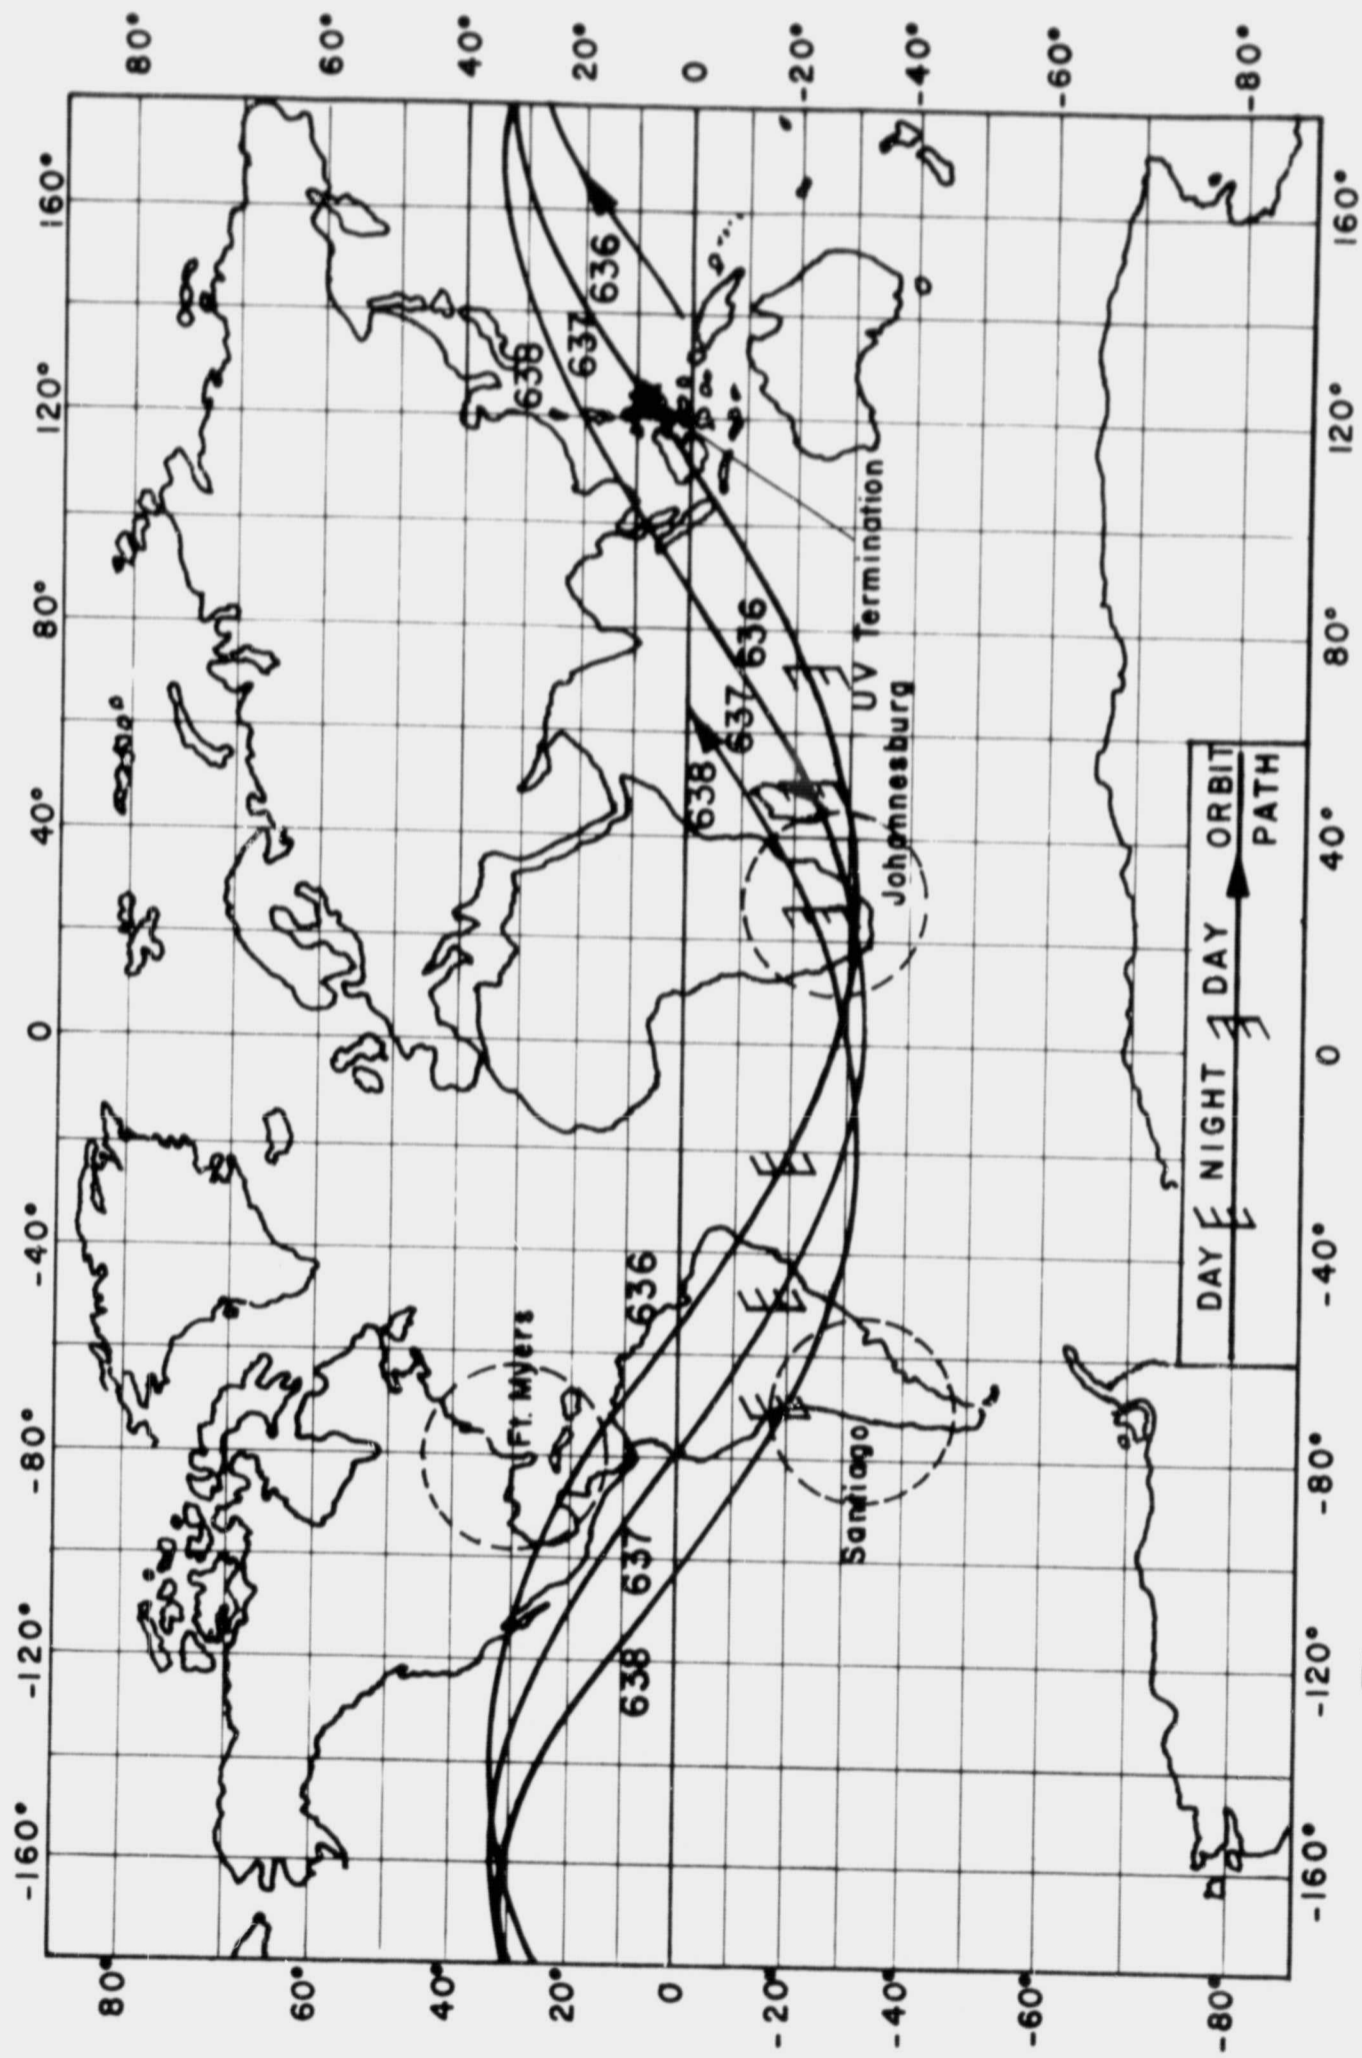
Figure 4— OSO-IV ORBITS 636 - 638

As the OSO-IV satellite passed near the Ft. Myers, Florida, STADAN station during orbit 636, the HCO instrument was routinely commanded to step its diffraction grating into position to examine the emission of Ne VIII ions in 770Å radiation. After the data were taken for two complete raster scans of the sun at this wavelength, the satellite entered darkness. Figure 4 illustrates the relevant satellite orbits as reconstructed from data in the Predicted Satellite Map furnished by NASA. While in darkness the satellite tape recorders played back data acquired during orbit 636 to the Johannesburg, South Africa STADAN station. The satellite entered the sunlight again as it headed north toward the equator and began (by definition) orbit 637 as it crossed the equator heading North.

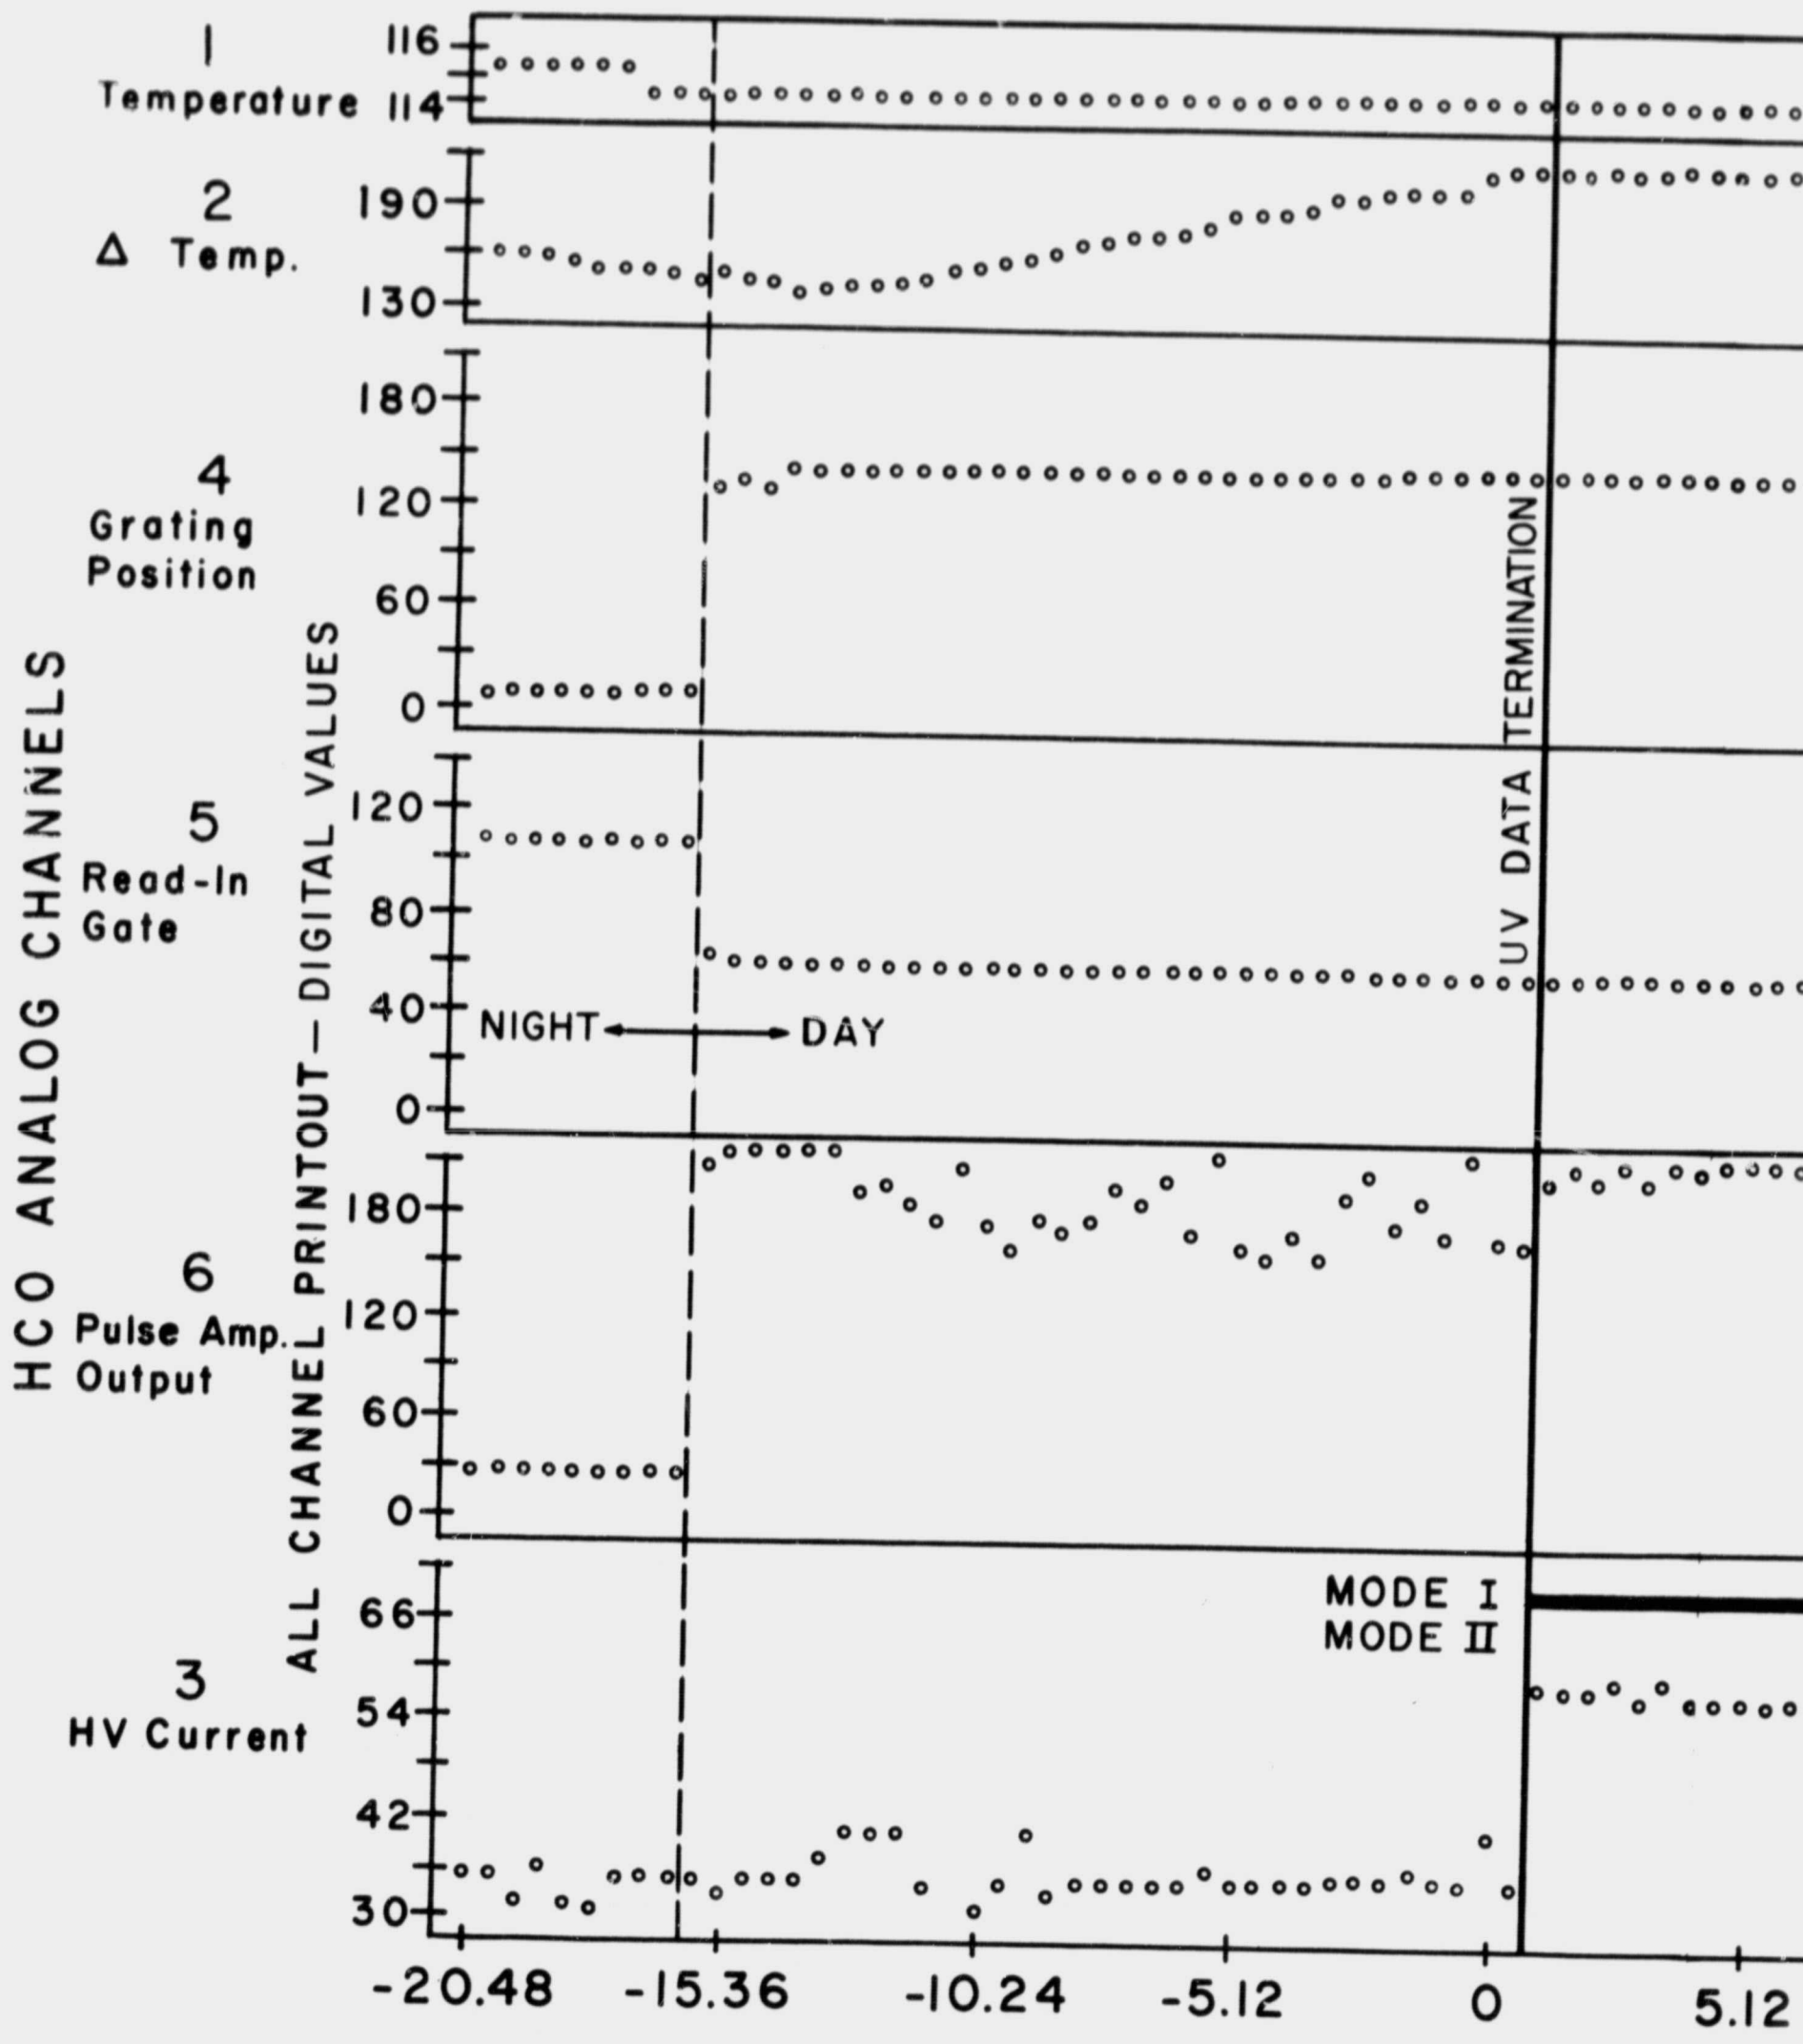
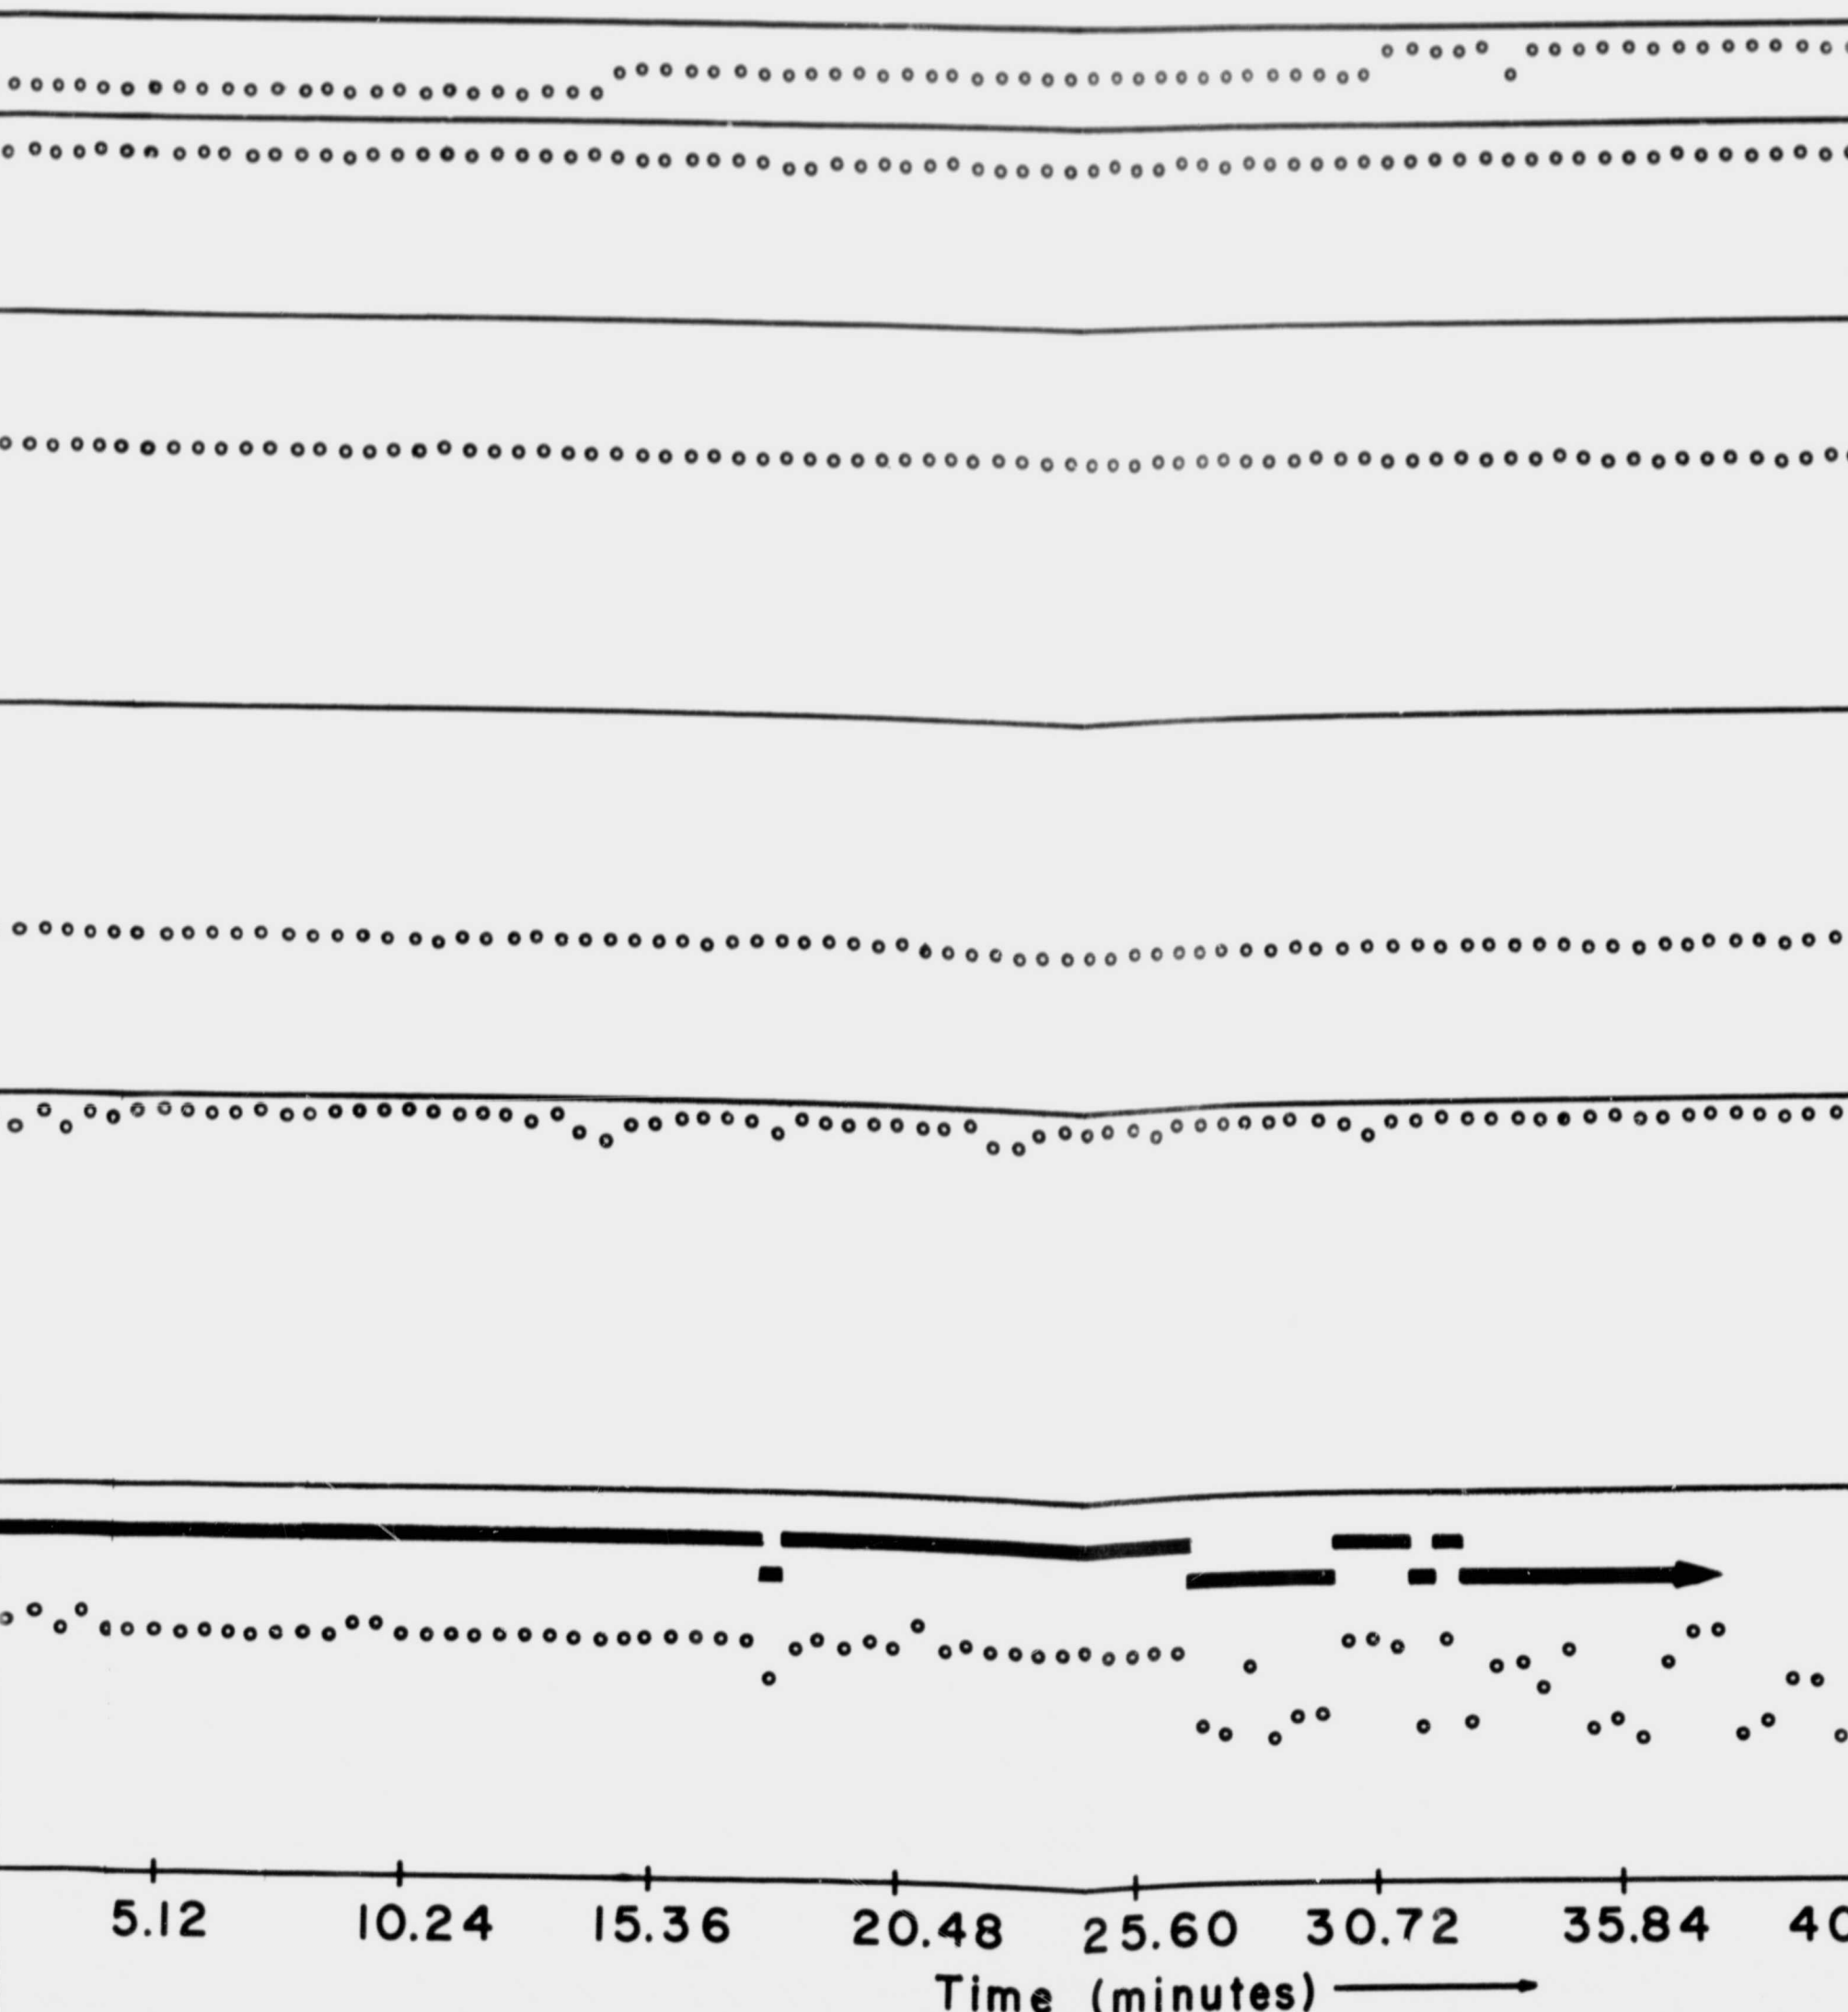
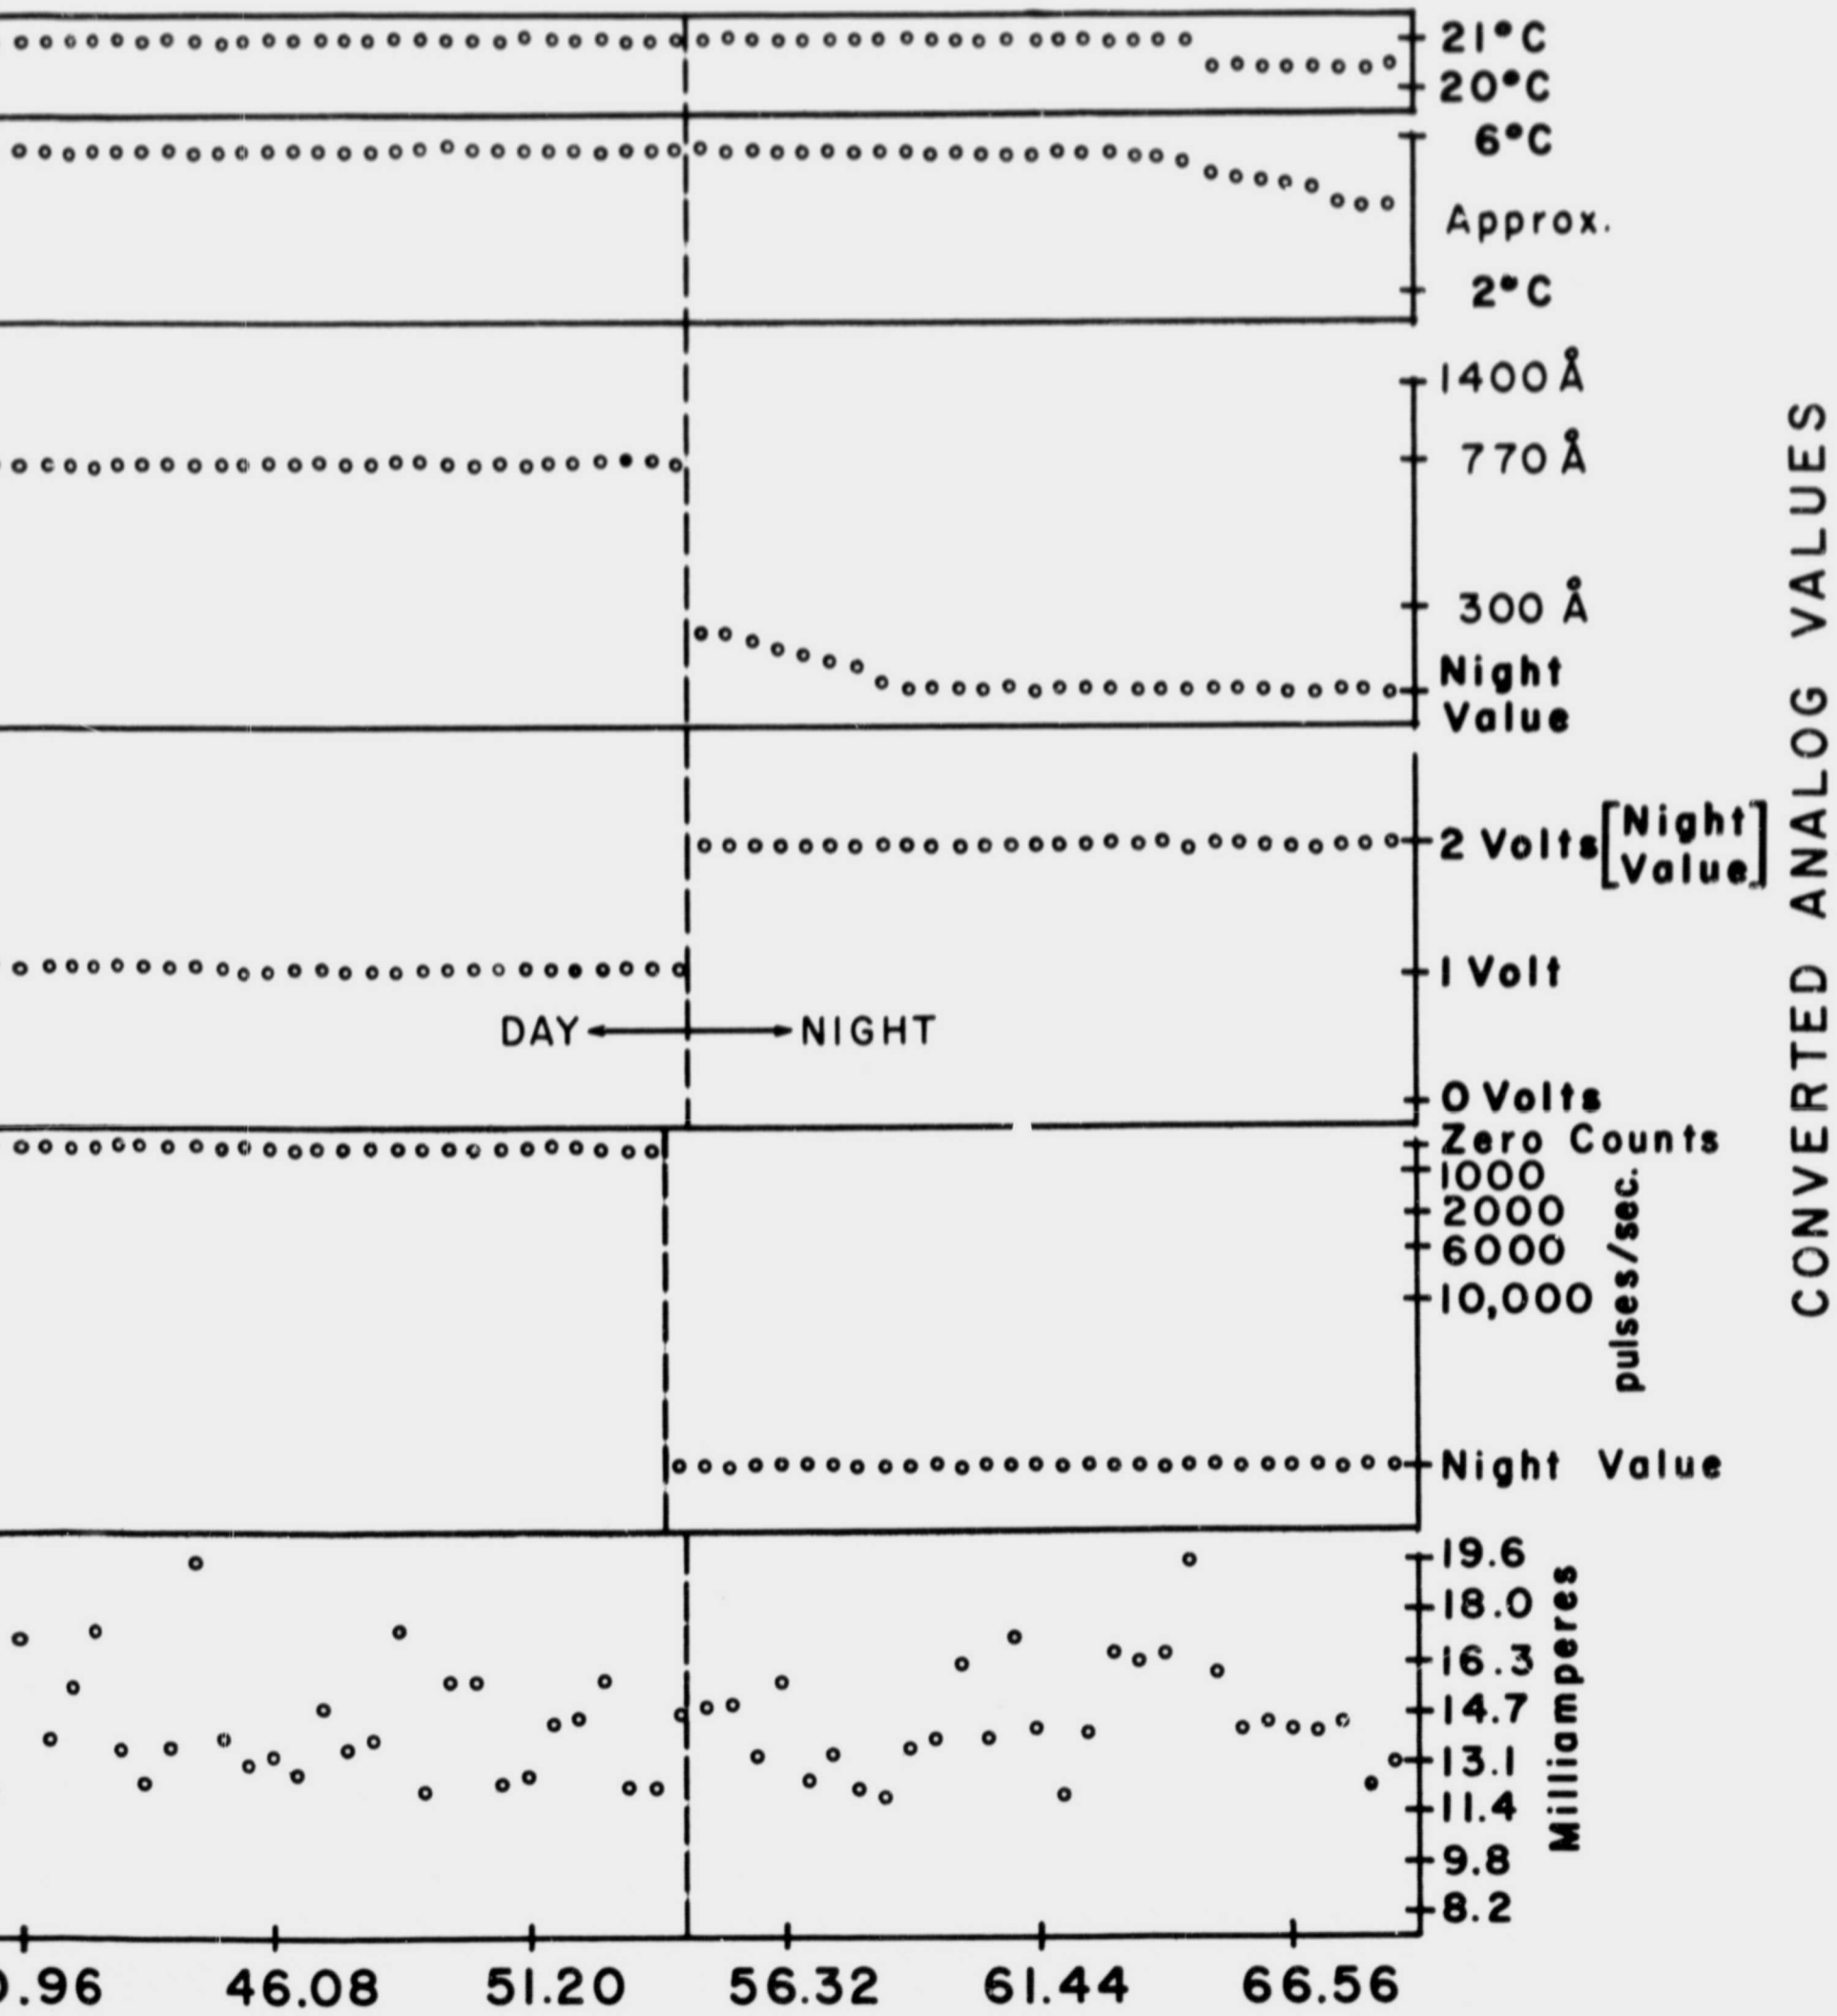
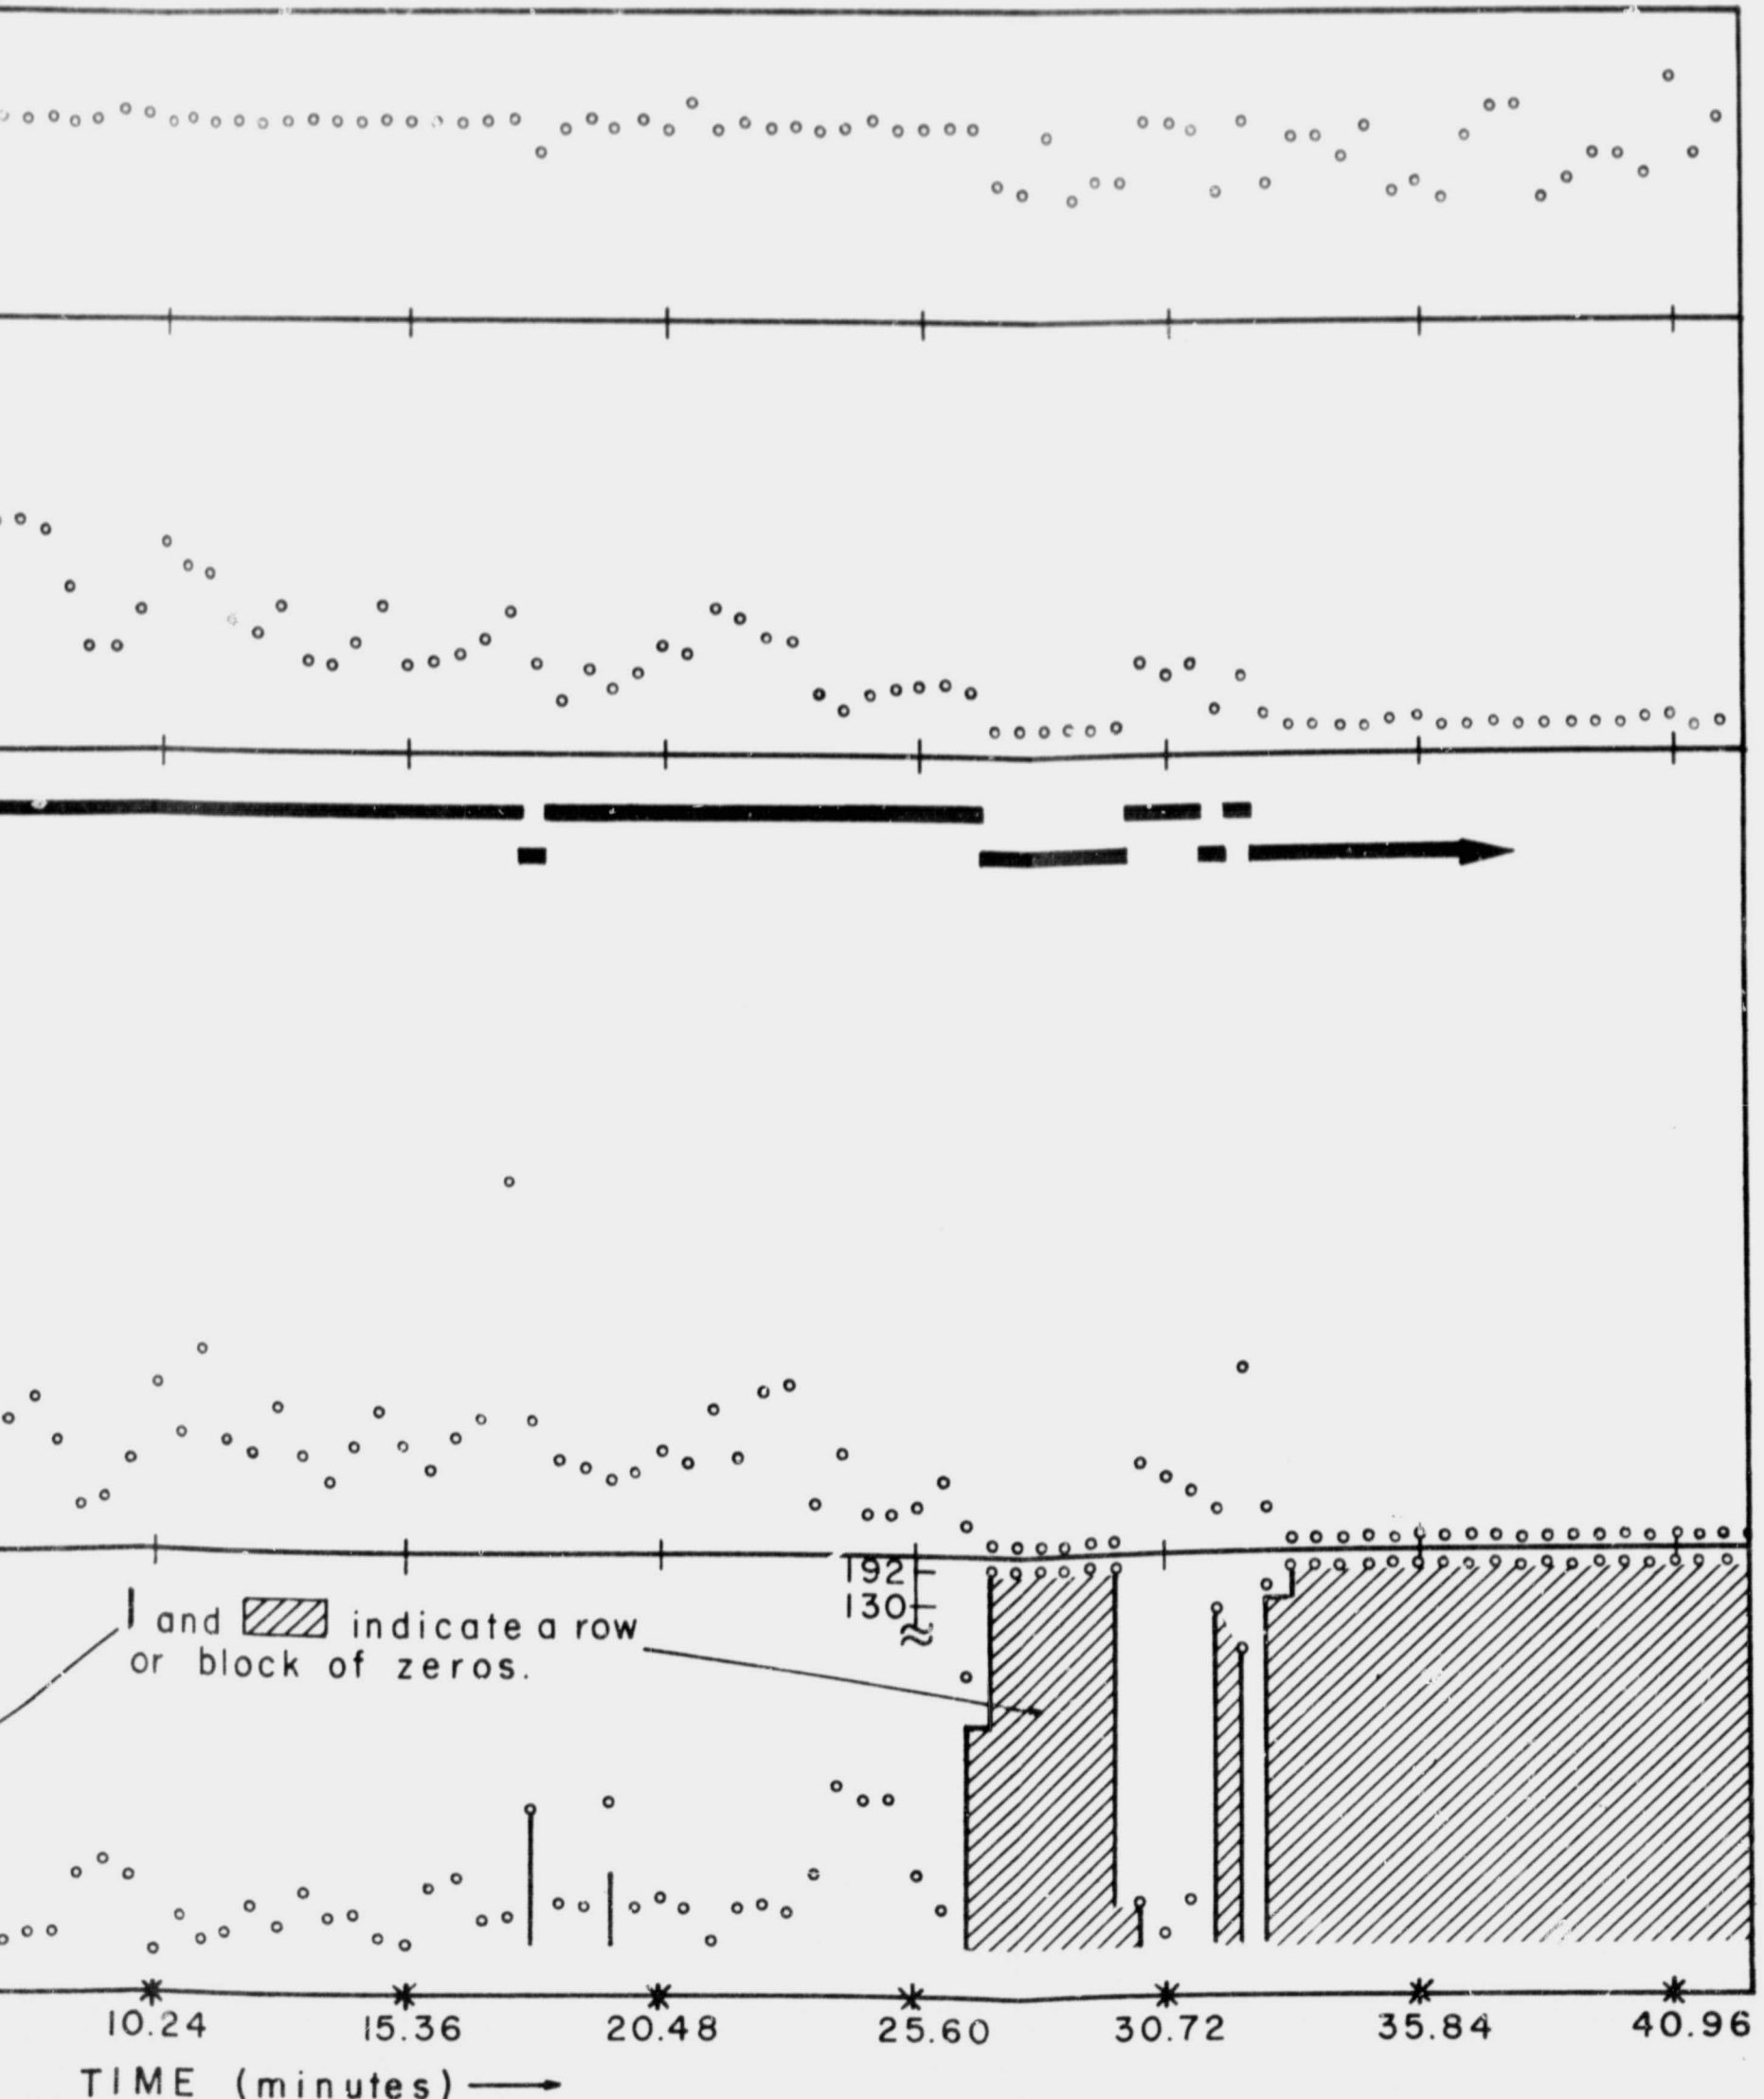
Figure 8 - HARVARD ANALOG DATA ORBIT 6

Readings of the HV current monitor and the five other HCO Analog Channels recorded during orbit 636-637 are plotted in Figure 8. The zero time indication again refers to word 3 in line one of raster 4. The readings plotted above each time mark were recorded during the 30.72 seconds following the time indicated. The scales on the left side of the plot refer to the digital values contained in the All-Channel data printout. The scales on the right were derived from calibration curves for the HCO Analog Channels.

current reading remains fairly constant near the maximum value of 16 milliamperes allowed by the power supply circuit. In Mode II data counts in the main data words are consistently zero and false MR indications do not occur. HV readings remain higher than normal but fluctuate widely.

At the point of UV data termination the instrument changed from normal operation to Mode I operation. Within one minute a series of nine "00000C" printout data words followed by noise counts and false MR indications indicated a possible transition to Mode II and back to Mode I. Unfortunately the HV monitor was not read out during the occurrence of the zeros. About 17 minutes after UV termination a series of thirty-two "00000C" data words occurred. The HV monitor was read out during the series of zero counts. The HV monitor reading was significantly lower than Mode I readings. Here we have a clear indication of a transition to Mode II for about five seconds then back to Mode I. A minute later a series of eighteen "00000C" words indicate another possible occurrence of Mode II (see Figure 9) followed by Mode I. About 26 minutes after UV termination the instrument went into Mode II operation for 3 minutes. This was followed by 1 minute of Mode I, 30 seconds of Mode II, 30 seconds of Mode I, and finally, Mode II. The instrument continued in Mode II until it was turned off fifteen hours later during orbit 646.

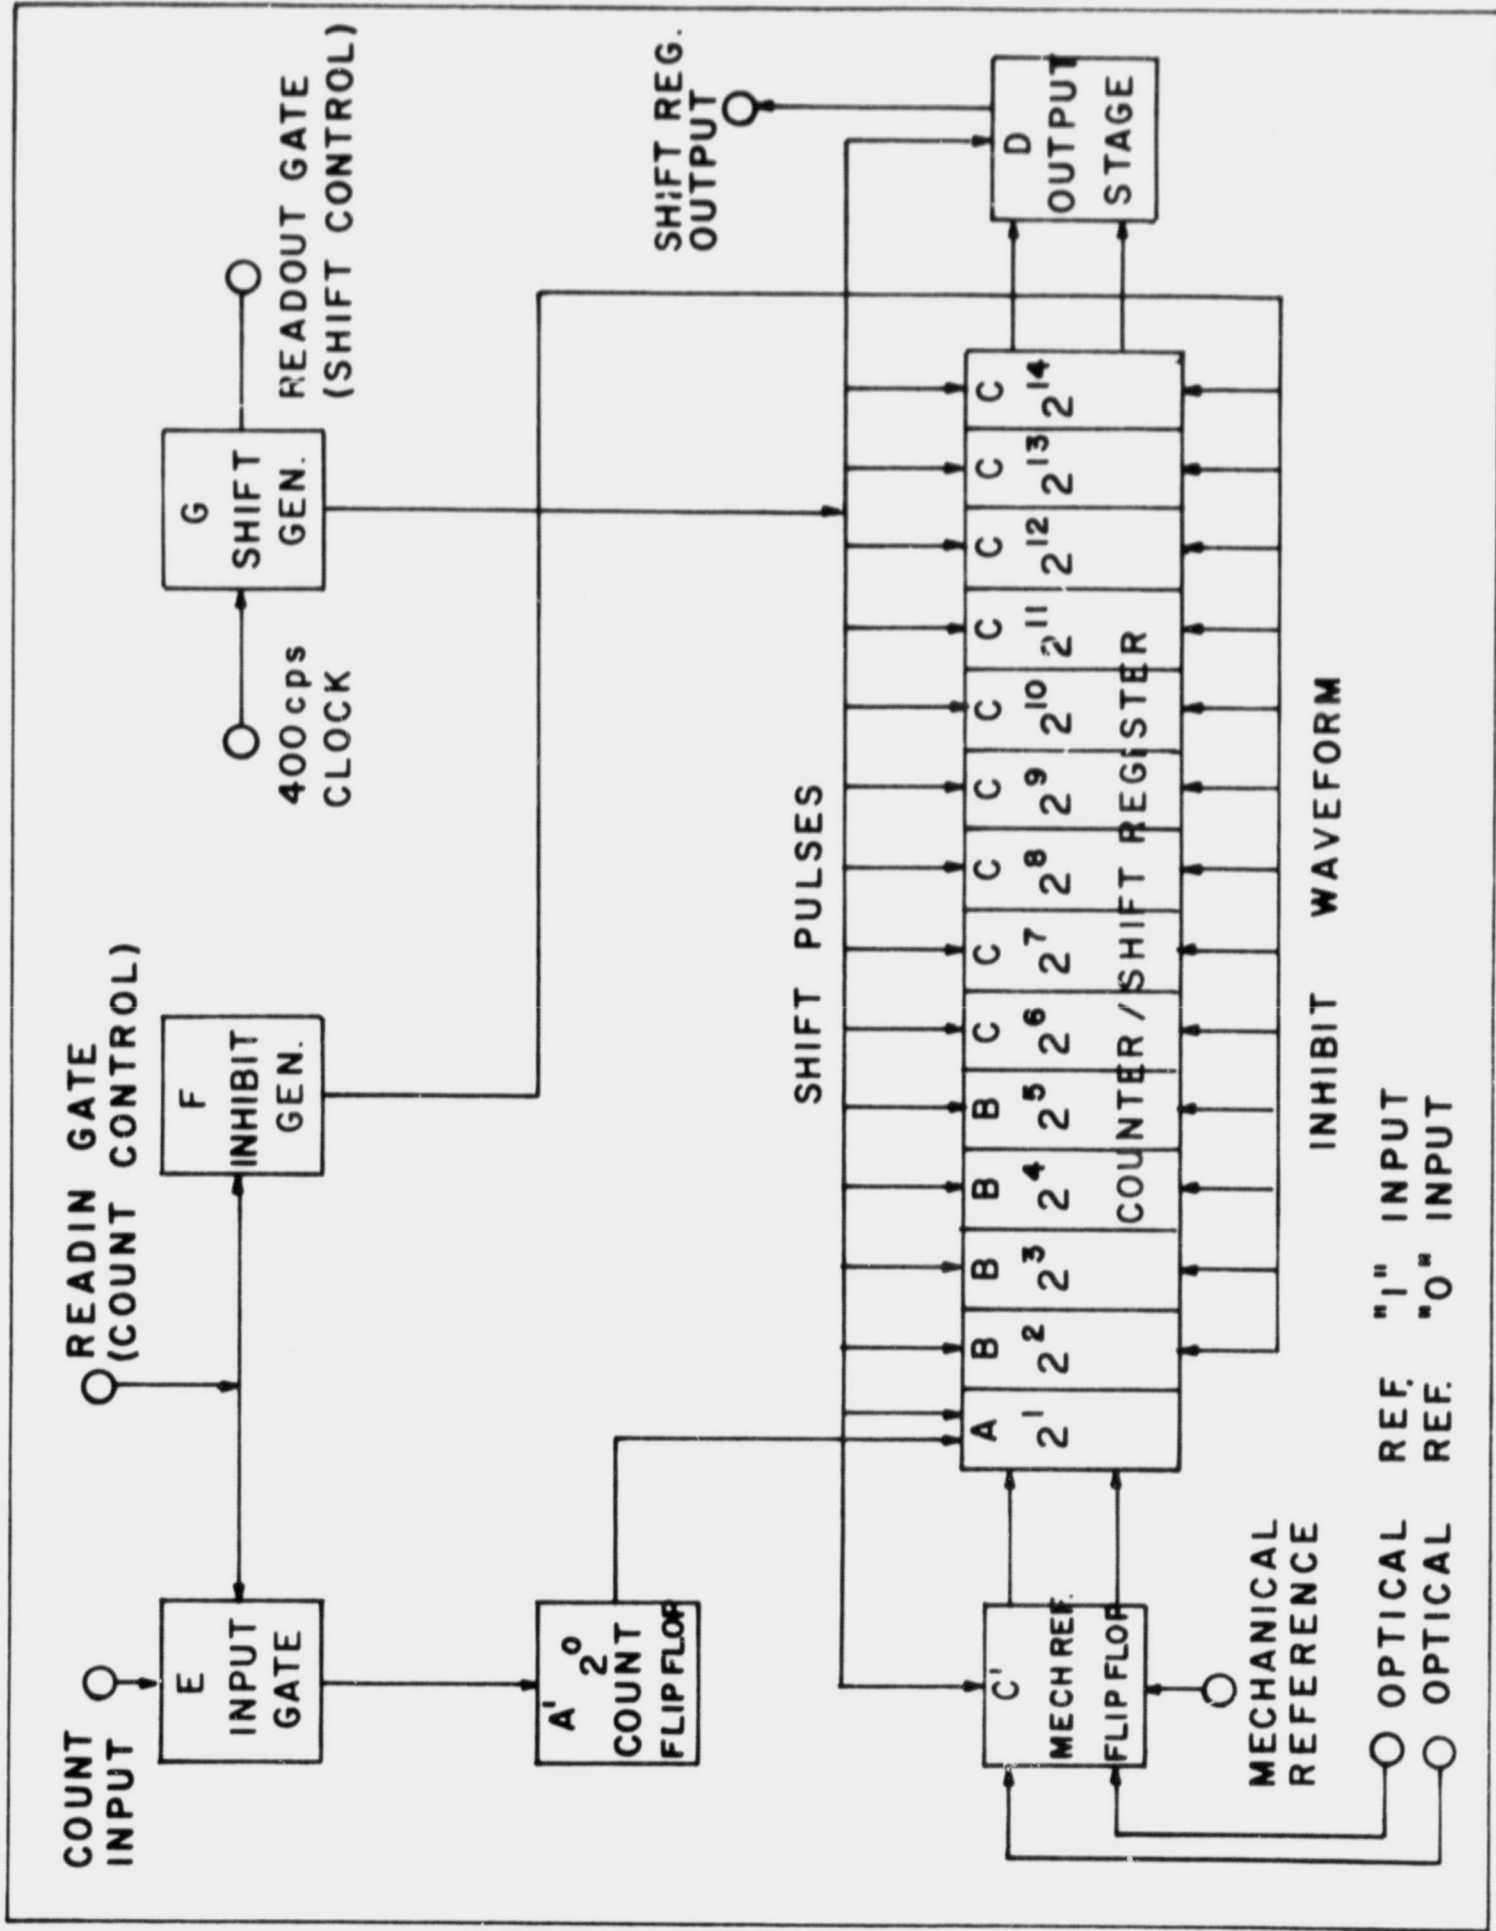
Figure 12 - HARVARD OSO-IV COUNTER  
BLOCK DIAGRAM

A block diagram of the counter in the HCO instrument is presented in Figure 12. The signal from the pulse amplifier arrives at the count input in the upper left corner of the diagram. During the 80-millisecond (ms) readin gate signal the inhibit generator is prevented from operating, and the input gate circuit is made operable, allowing the counter stages A', A, B, and C to count incoming pulses. Following the end of the readin gate signal the counter remains inactive for 40 ms. Then the readout gate signal from the spacecraft activates the shift generator for 40 ms. During that time the "1's"

How did the noise counts and false MR bits that appear in the data printout get into the counter? The noise counts immediately after the malfunctions are high compared with expected count levels. They are low compared with the capacity of the counter ( $2^{15}-2 = 32,766$ ). If the noise were present in the inhibit generator or shift generator, it seems reasonable that the noise would excite a "1" state in any of the counter stages with equal probability. Since the highest count recorded after UV termination was 4,080, and since the average count per word remained comparatively low and generally decreased after UV termination (see Figure 9), we infer that the noise did not come from the inhibit generator or the shift generator. In that case, the noise must have arrived at the counter from the count input.

bit remained in the "O" state that it had maintained during the rasters before termination. From this constancy we infer that the noise which produced spurious "A'S" in the printout did not enter the mechanical reference flip-flop through the optical reference lines. Since we have already eliminated the shift pulse line as a source of noise, the reference bit noise must have entered the MR flip-flop through the mechanical reference input line. Thus, the noise in the instrument was recorded in the counter but did not originate in the counter.
