HARVARD COLLEGE OSO-IV  
POINTED EXPERIMENT  
AN ANALYSIS OF THE  
MALFUNCTION DURING  
ORBIT 637

BY: R. Dower  
N. Hazen  
J. Rechavi

Technical Report No. 7  
NASA Contract NASw-184

February 1969

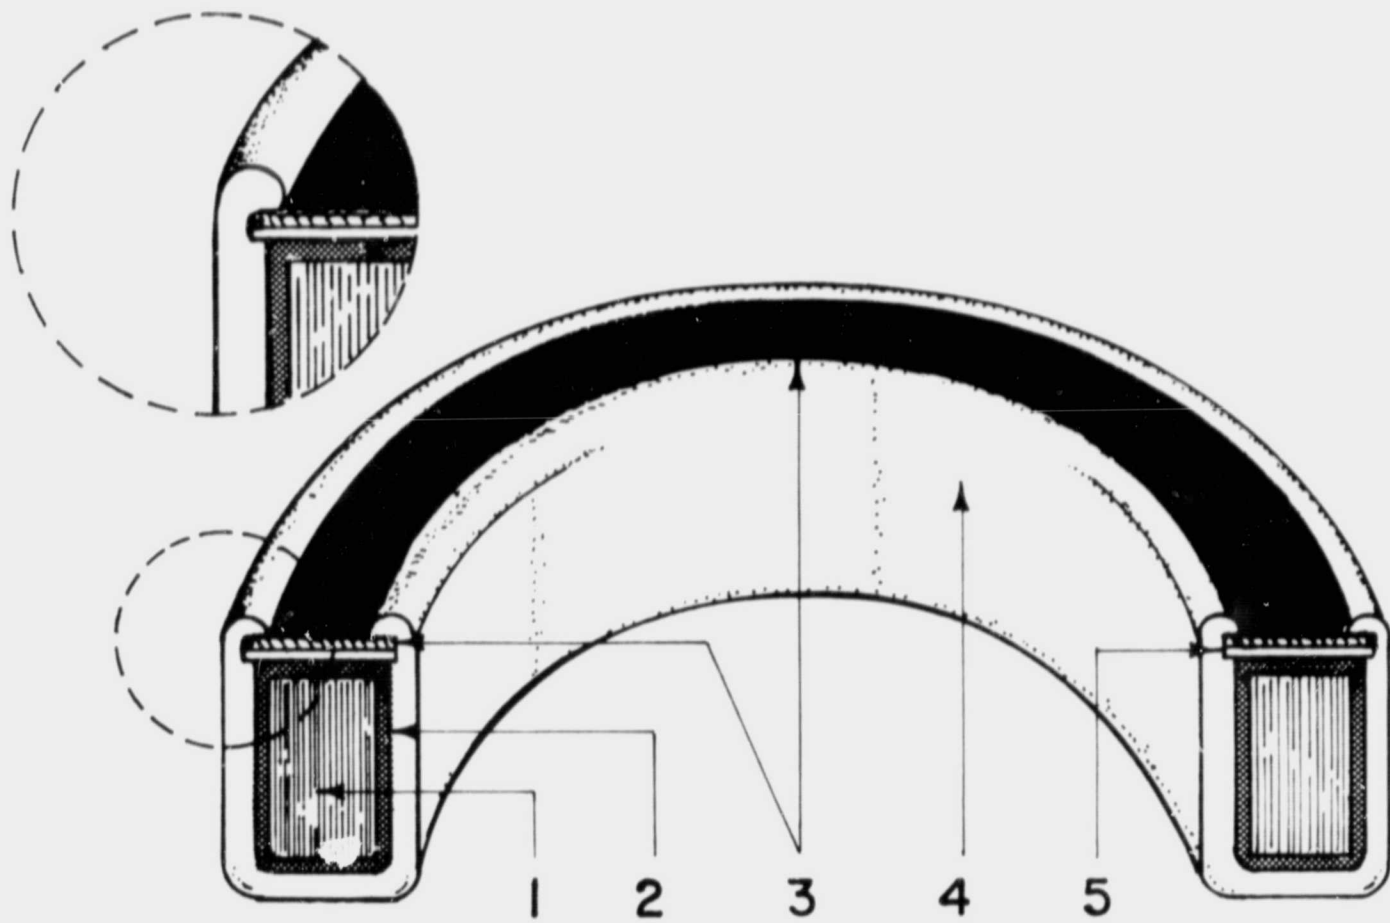
Figure 16  
HV TRANSFORMER CORE

We now consider the high voltage transformer. The toroidal core assembly used in this transformer is manufactured by GL Electronics (Part No. GL-A-4057-M1). The core tape is supermalloy foil and is embedded in a silicone grease within an aluminum housing. The housing is sealed by a crimp seal against a rubber washer backed up by a glass-laminate board. The housing is black anodized and has rounded corners. The silicone grease is used to protect the core from mechanical stresses on the box due to winding which might alter the magnetic properties of the tape. The grease also cushions the core during vibration and shock testing.

The glass-laminate board serves to break the electrical path around the core box. The core construction is illustrated in the cut-away view of Figure 16.

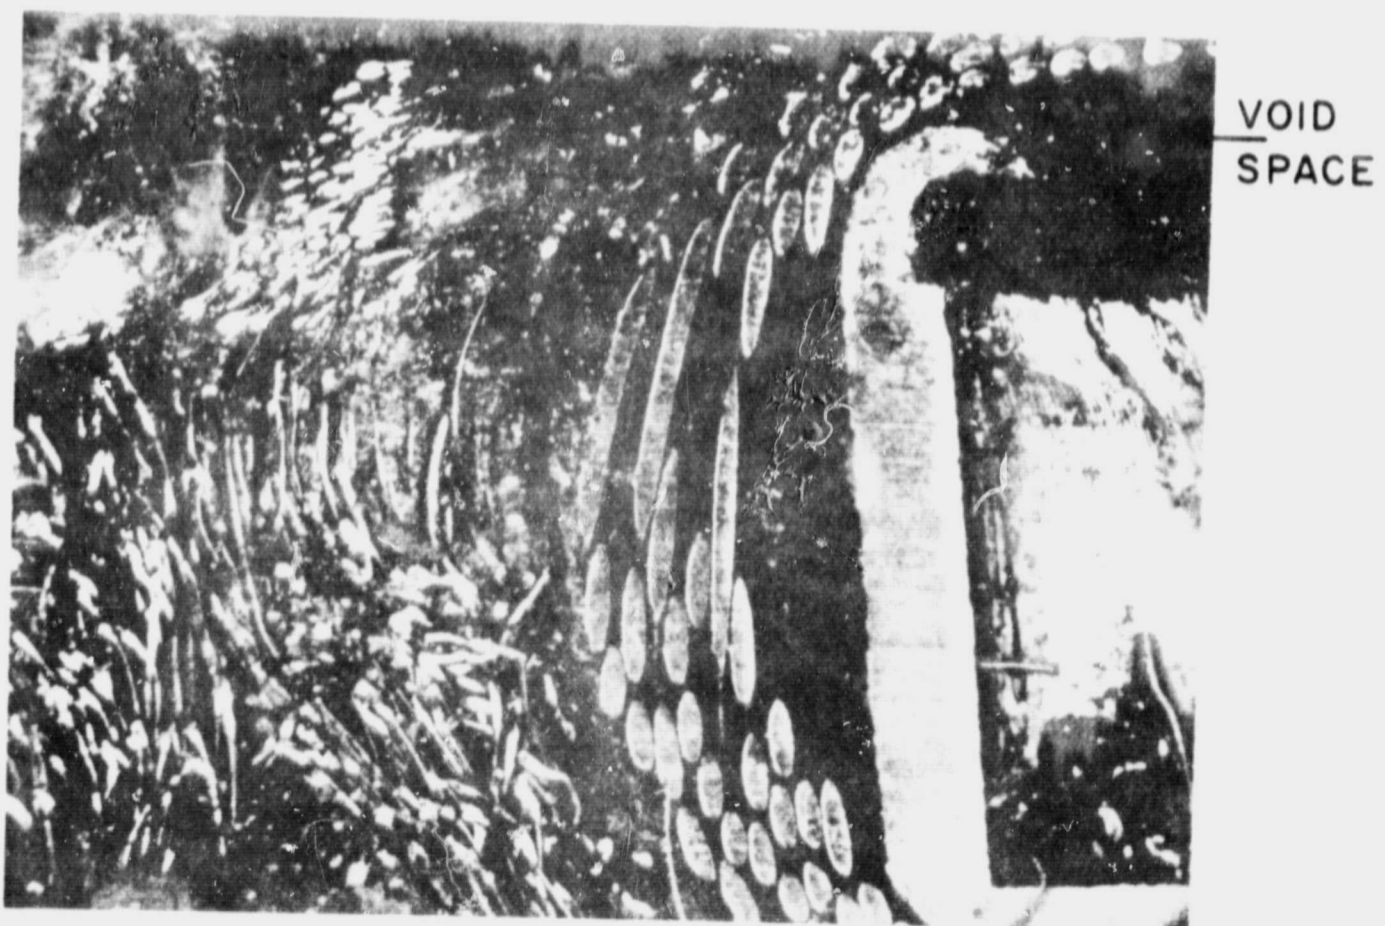
Figure 17 — UV TRANSFORMER CORE MODULE

Inspection of a sample module (see Figure 17) in our laboratory indicates that the C-7 did not penetrate through the RTV into the secondary winding area. However,

it did penetrate down the primary leads and partially encapsulated the primary winding. The manufacturer of the HV power supply said that this was a random occurrence. In our sample the C-7 had not bonded to the aluminum box of the core. The TFE tape winding on the core box was stretched across the top of the rolled aluminum edges on the core box and this created a void space between the rubber washer seal of the box and the TFE tape.

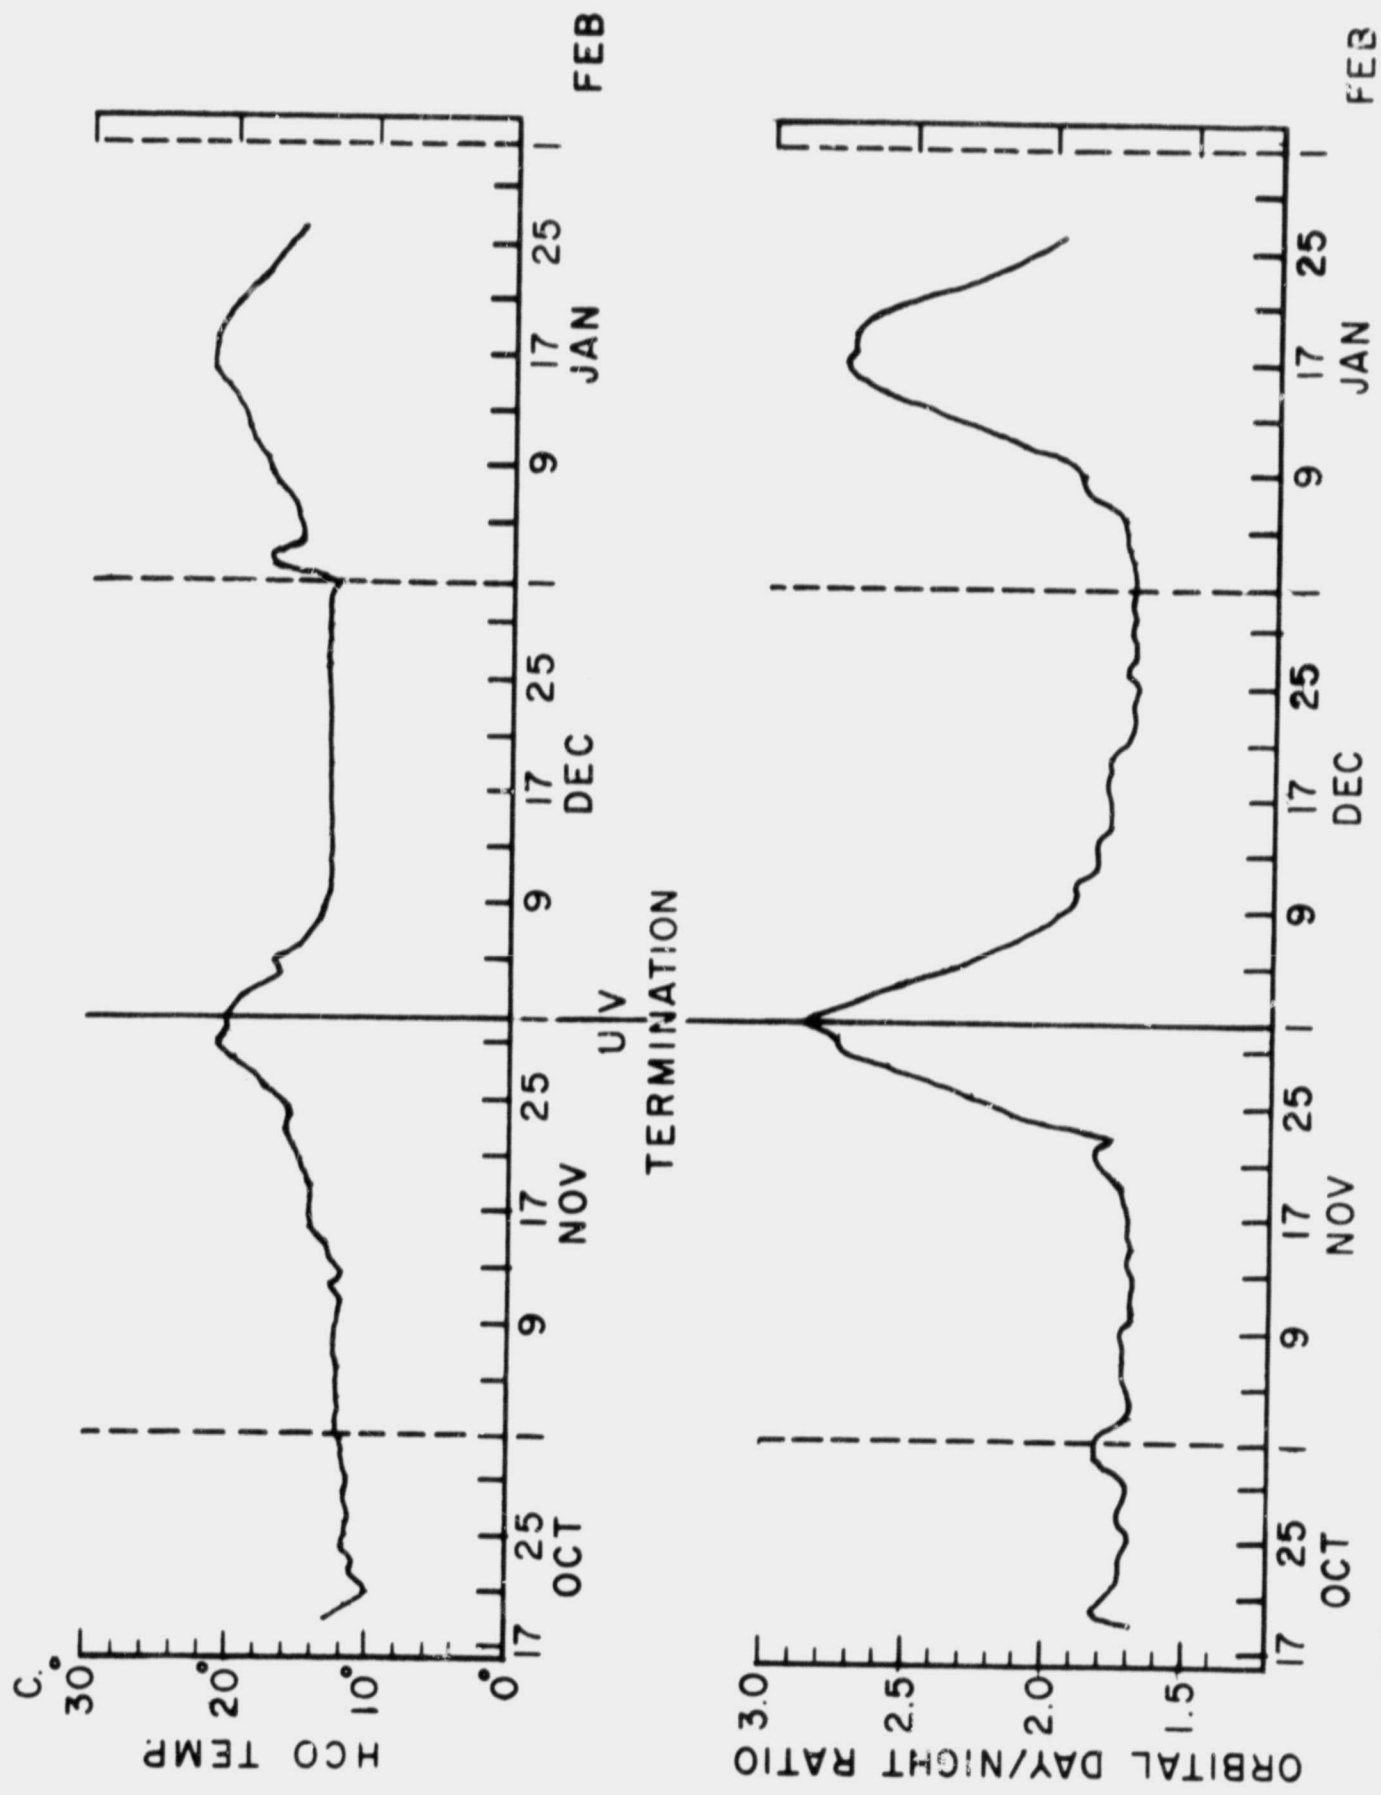
Figure 18 -- OSO-IV ORBITAL CHARACTERISTICS

Shortly after the malfunction, it was observed that the instrument's absolute temperature had risen from 17°C to 21°C in the period from November 25, through November 30. This was at the end of a long gradual rise in temperature (from 11°C) beginning in late October. In the eight days following the malfunction while the instrument power was off, the absolute temperature returned to 15°C and subsequently went even lower. How this related to the failure was uncertain. The instrument and its sub-assemblies had of course been acceptance tested over a much wider temperature range, in excess of 0°C through 30°C.

summarized in Figure 18. Fairly abrupt rises occur in this ratio periodically, because of the precession of the orbital plane at intervals of approximately 47 days. The instrument temperature appears to have followed these intervals faithfully. This was confirmed when the next peak occurred in mid-January and the instrument temperature performed a similar excursion. This effect has been noted on previous OSO's. Therefore the fluctuation in instrument temperature are believed to be a result of external causes rather than any pre-failure self-heating effect. However, it should be noted that the fluctuation in temperature might still have had a secondary relationship to the malfunction by altering the physical geometry of the gas leakage paths from the high voltage transformer by thermal expansion. A check of orbit 1238, in which a mode transition was observed, has shown that the thermal expansion occurred shortly before but not during one of these temperature excursions.

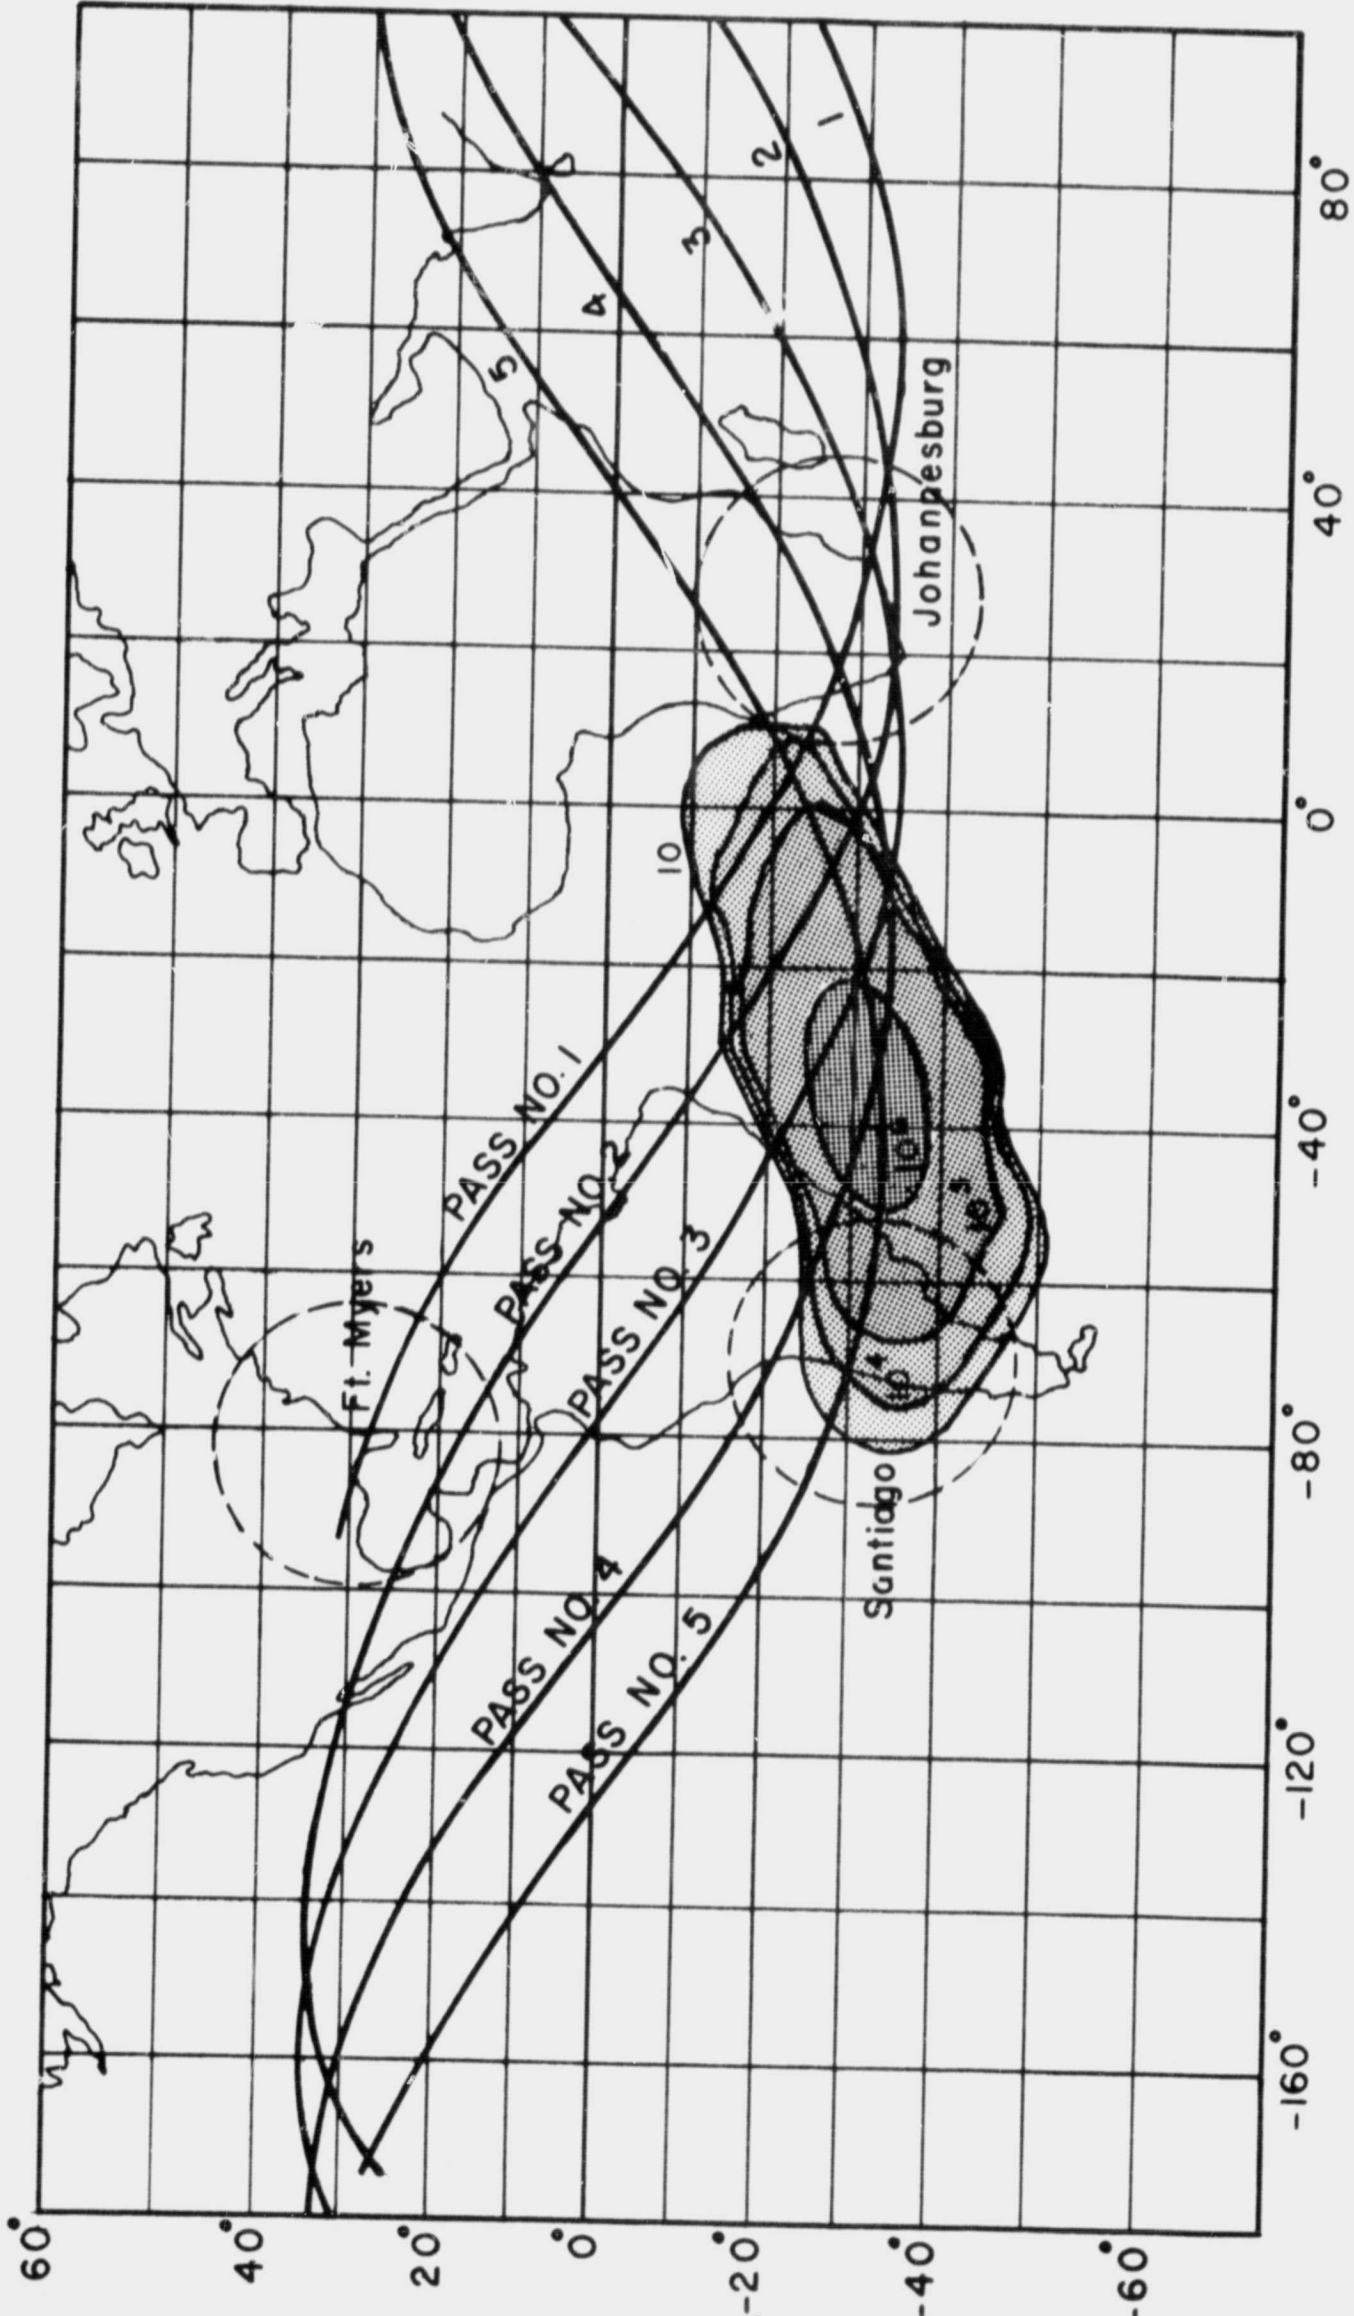
**Figure 19- SOUTH ATLANTIC ANOMOLY**

As a result of HCO experimental difficulties on OSO-II and data from other experimenters, a substantial amount of study and testing had been performed on the HCO instrument for OSO-IV in order to avoid harmful effects on the instrument while passing through the South Atlantic Anomaly. Considerable testing of the plasma environment performed on the prototype model at the GSFC test facilities had convinced us that a modest but harmless effect on the data count would be observed.

Approximately five to six of the fifteen daily orbits pass through the anomaly. As illustrated in Figure 19, the first of these contact with the anomaly occurred after the last daily pass over the Fort Myers STADAN Station. Thus the Fort Myers Station never received data which were recorded while the instrument was in the South Atlantic Anomaly. Because Fort Myers was the only station with which a Quick-Look data link had been established and we had not received any data from the other ground stations by the end of November, 1967, there was no occasion until the malfunction to observe any effects of the anomaly on the instrument. The data which we recovered especially from the Johannesburg Station after the failure, covered orbit 636 (equivalent to Orbit No. 1 in the illustration). These were the first data received that showed the interaction effects. Because it was the first observation, and made within the 30 minutes of failure, it caused some immediate concern. Later data analyses have discounted any immediate casual relationship to the failure.
