NASA CR-66814

COMPREHENSIVE REPORT
ON
NASA ROCKET MOTOR DEFECTS INVESTIGATION

VOLUME II - TABLES AND FIGURES

COMPREHENSIVE REPORT
ON
NASA ROCKET MOTOR DEFECTS INVESTIGATION
FROM AUGUST 1966 TO JUNE 1968
by R. B. Enie and C. R. Hitt, Jr.

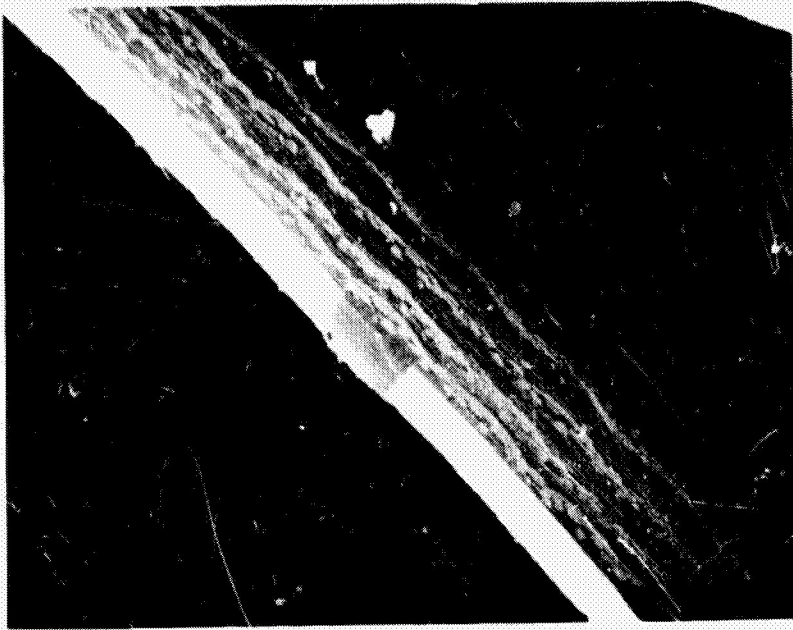
FIGURE 24 - CROSS SECTION OF DEFECT AND PATCH ON NPP-261 (A5)
MAGNIFICATION 5 TIMES
