HYDRAZINE ELECTROLYSIS CELL
SAFETY LIMITS TESTS

SUMMARY REPORT
TASKS VII AND VIII
JPL CONTRACT No. 951720
3 JUNE 1969

HUGHES AIRCRAFT COMPANY
SPACE SYSTEMS DIVISION
EL SEGUNDO, CALIFORNIA

CALIFORNIA INSTITUTE OF TECHNOLOGY
Jet Propulsion Laboratory
4800 Oak Grove Drive
Pasadena, California

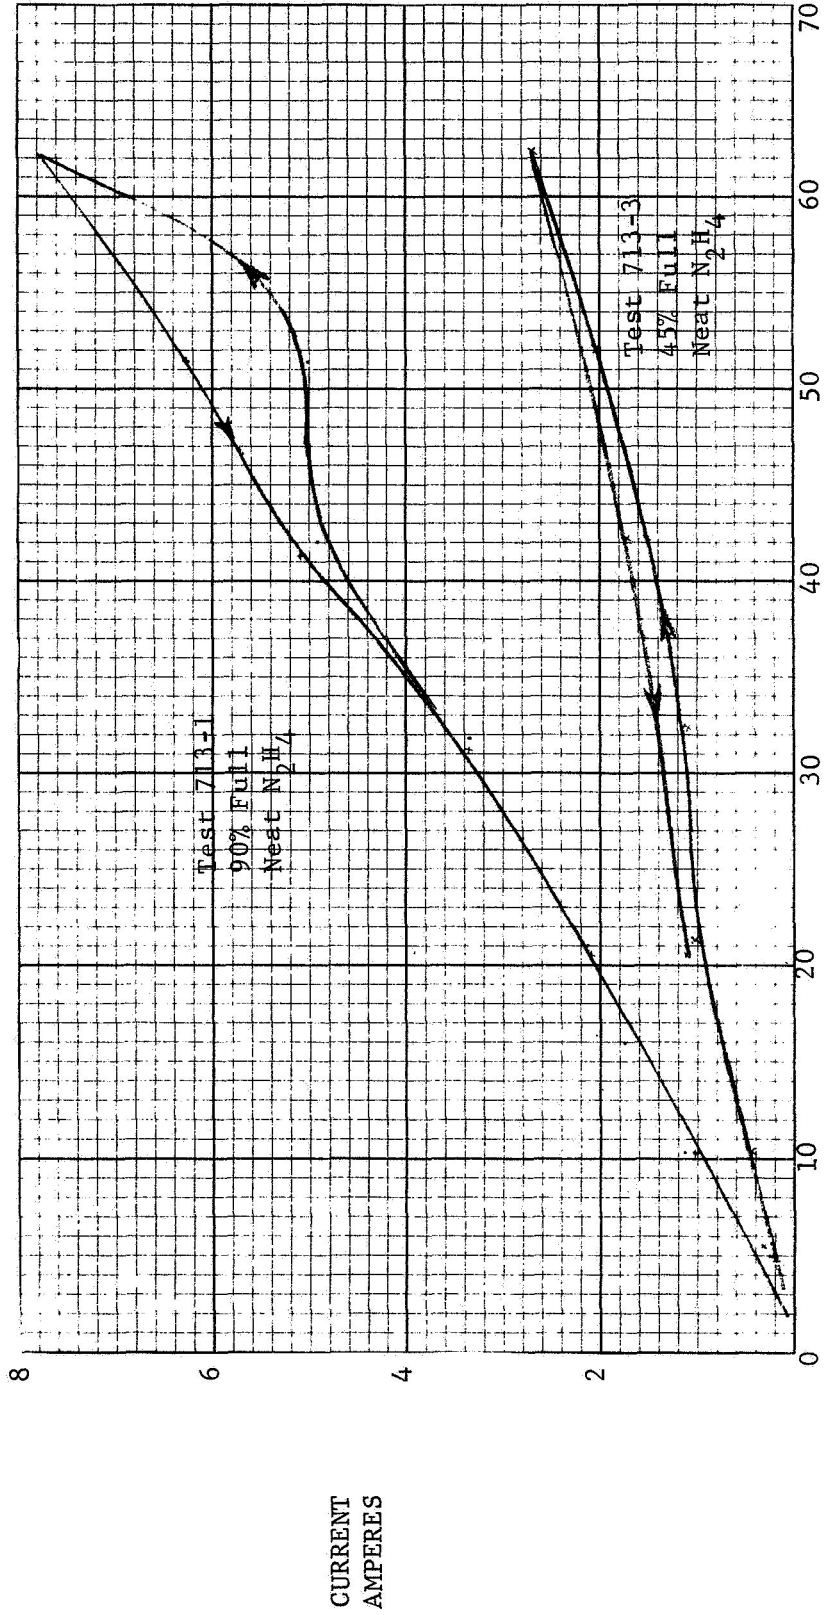
FIGURE 6

In accordance with the test plan, the first test was a survey of voltage-current characteristics with the tank 90% full of neat hydrazine. At this loading the liquid level was approximately one inch below the top of the anode. The data from this test are plotted in the upper curve of Figure 6. The inflection and hysteresis in the curve is not unusual and is caused by polarization characteristics of the electrolysis cell and by variation in effective electrode area due to formation and expulsion of gas bubbles in the wick/electrode interface.

After completion of propellant off-loading and leak testing, the voltage-current survey was started. Voltage was increased in steps up to 60V. Cell operation appeared normal and satisfactory. Data from this test are included in Appendix B, and the current-voltage data are plotted in the lower curve of Figure 6.

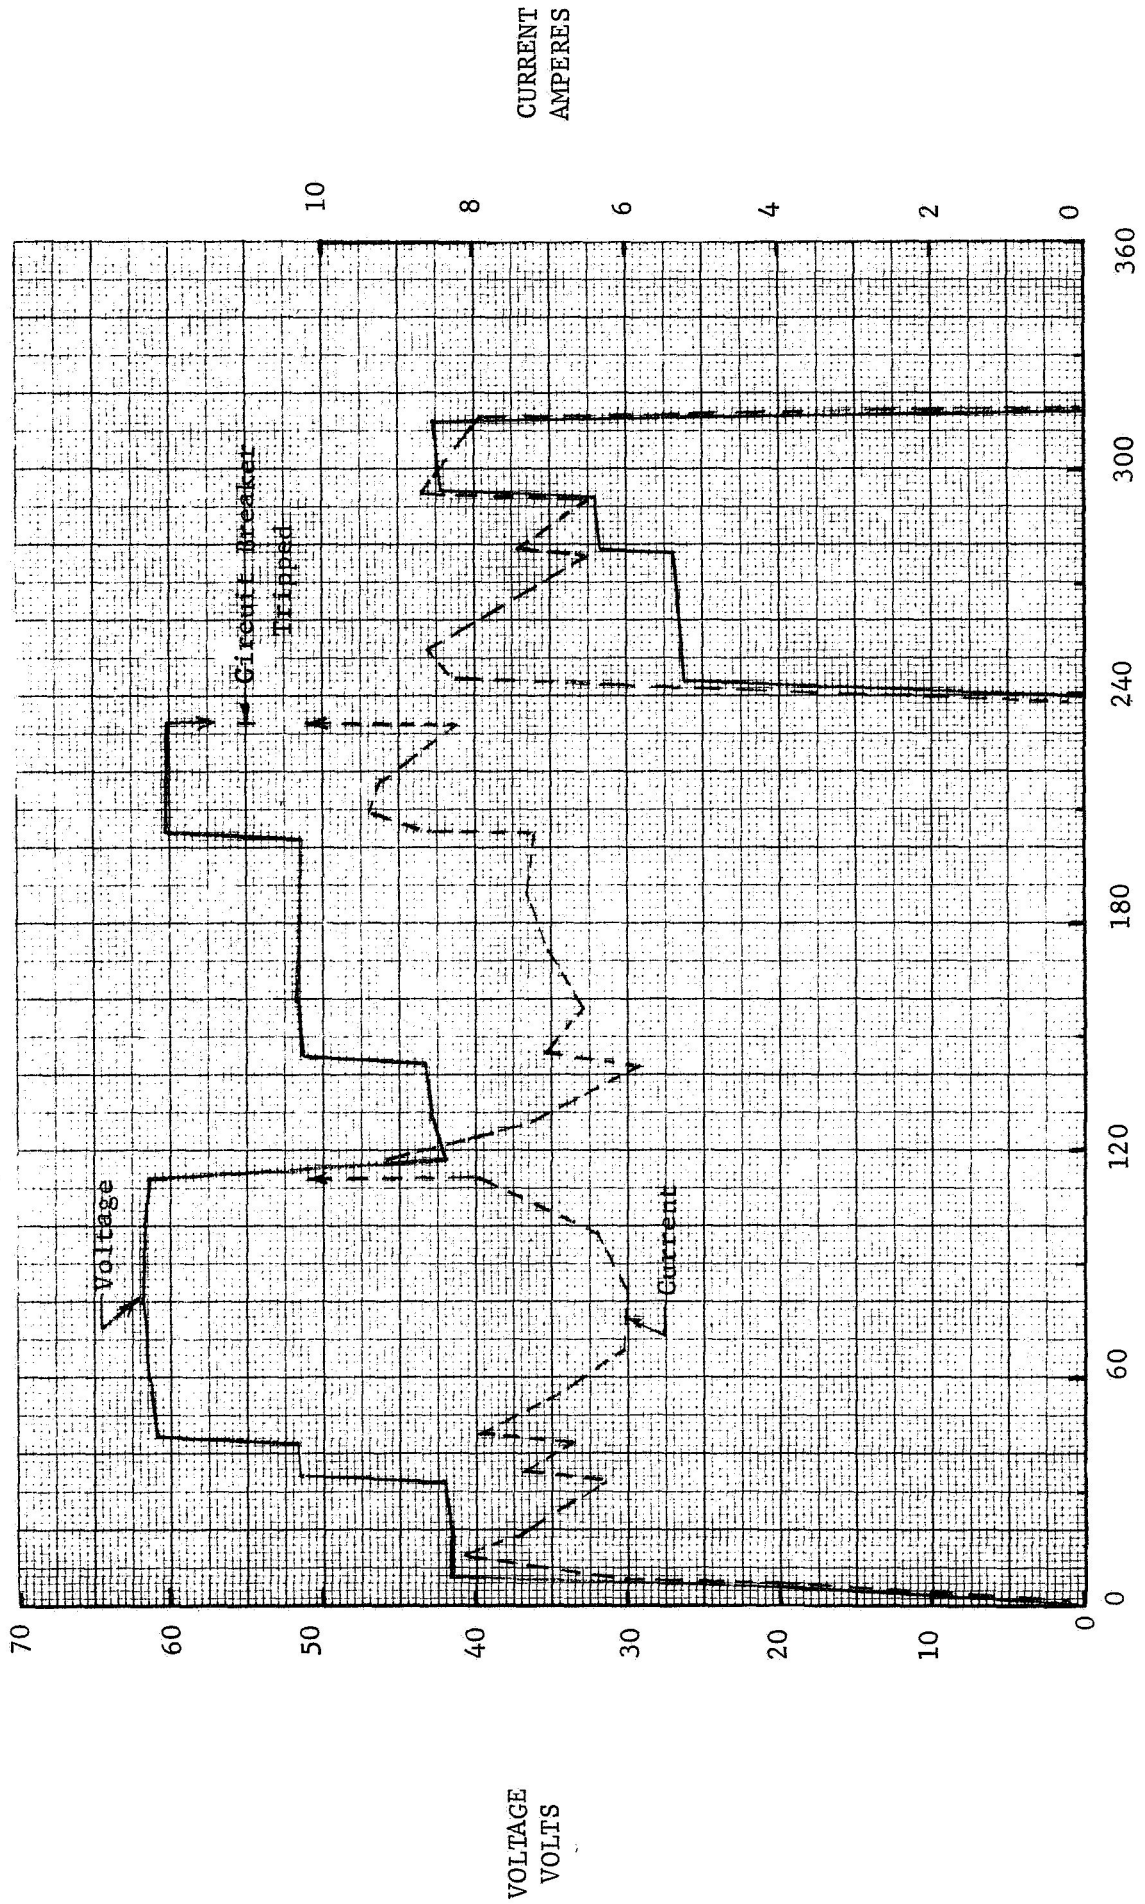
FIGURE 7

On the day following the voltage-current survey, the first electrolysis test at high voltage was conducted in accordance with the test plan. With the tank still 90% full of neat hydrazine, the voltage was increased in steps up to 60V. The voltage, current, temperature and pressure history of this test is shown in Figure 7 & 8. The data acquired during this test is included in Appendix B.

During this test an unexpected current increase occurred on two occasions. After 118 minutes of operation it was noted that the current was increasing and exceeded 10 amperes. This necessitated a reduction of voltage to keep the current below that value. Later in the test, the current suddenly increased and tripped the 15 ampere circuit breaker on the power supply. This current surge was coincident with the first vent cycle of the system relief valve.

These current surges were probable due to the near-short area of the cathode contacting the anode. It could have been caused by higher pressure, deformation of the screen at much higher temperatures, or the action of gas bubbles when the relief valve opened.

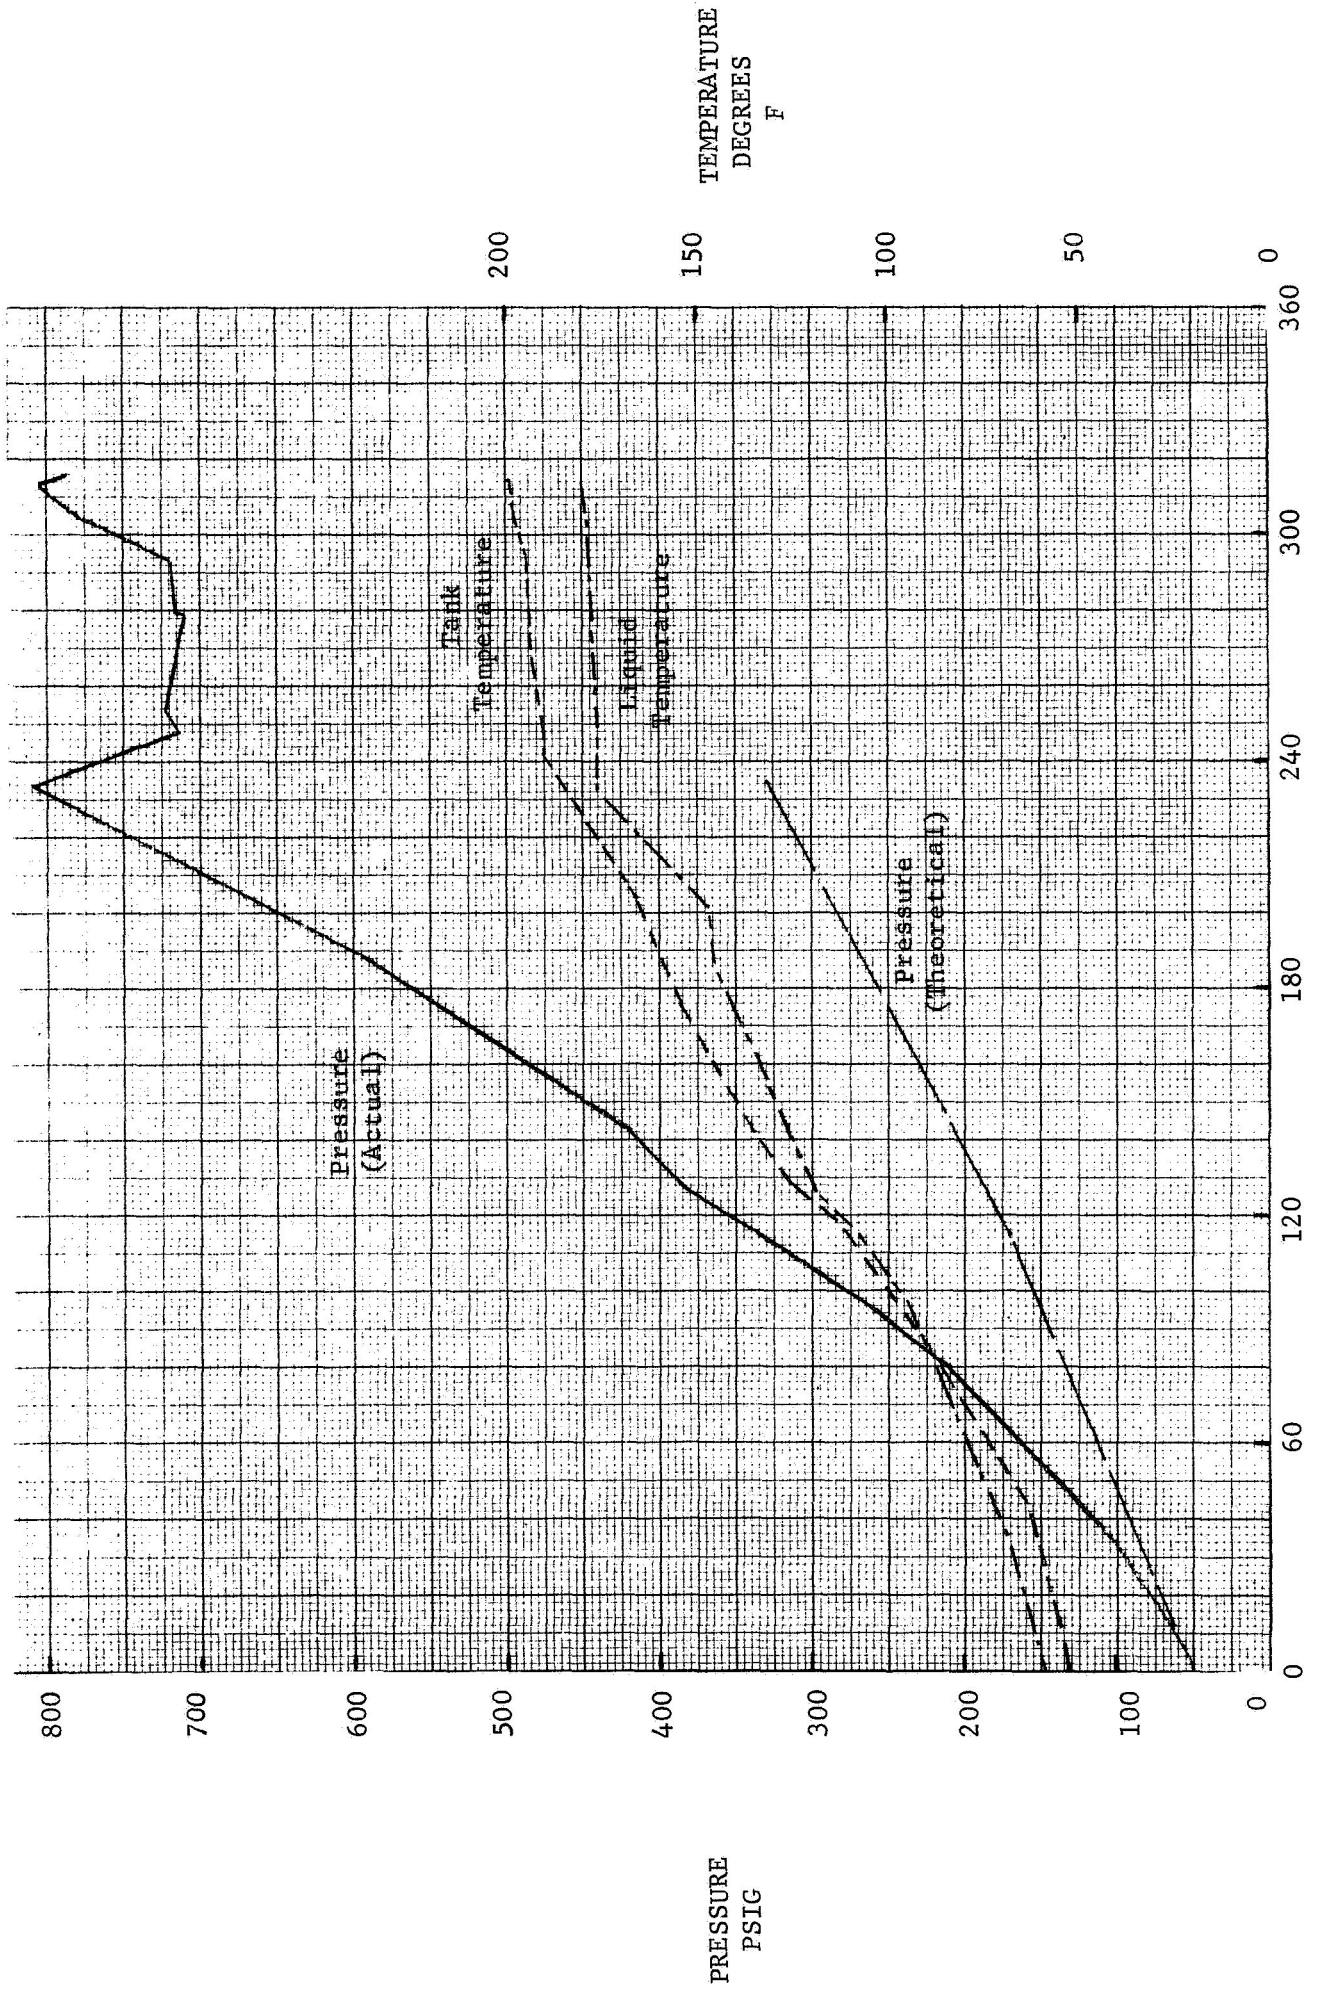
FIGURE 8

Aside from these events the operations of the cell appeared to be normal throughout this test. However, later analysis of the data showed that the actual pressure rise during the first 238 minutes of this test (i.e., up to the time the relief valve first vented) was much greater than could be accounted for by temperature rise and electrolytic gas generation. For reference purposes the pressure increase due to these two factors is plotted in Figure 8. For further discussion of this abnormal pressure rise and current surges see paragraph on "Failure Investigation".
