NASA CR-925

TWO-STAGE POTASSIUM TEST TURBINE

Volume IV
Materials Support of Performance
and Endurance Tests

Prepared by
GENERAL ELECTRIC
Cincinnati, Ohio
for Lewis Research Center

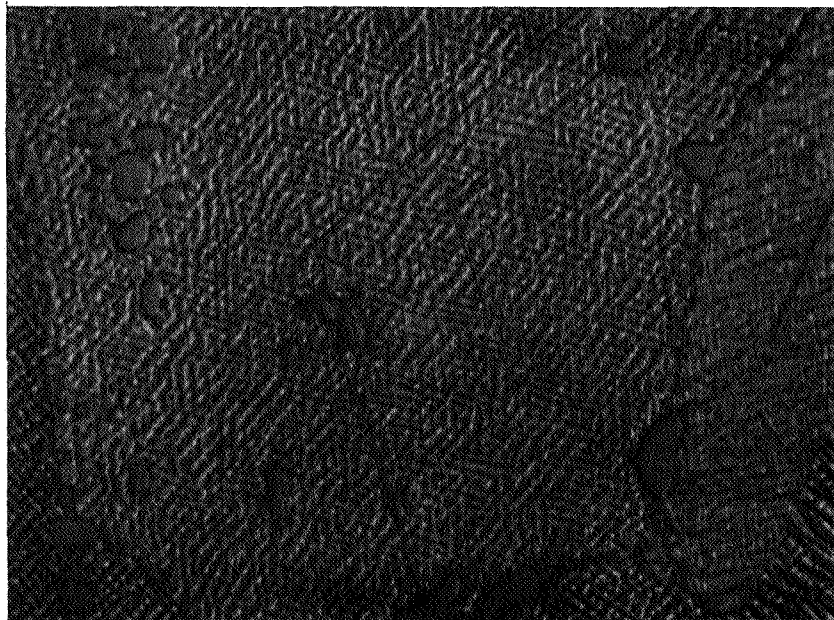
Figure 7. First Stage U-700 Blade Dovetail After 2000-Hour Endurance Test Showing Concentration of Accicular Structure Presumed to be Sigma Phase. (B322311)

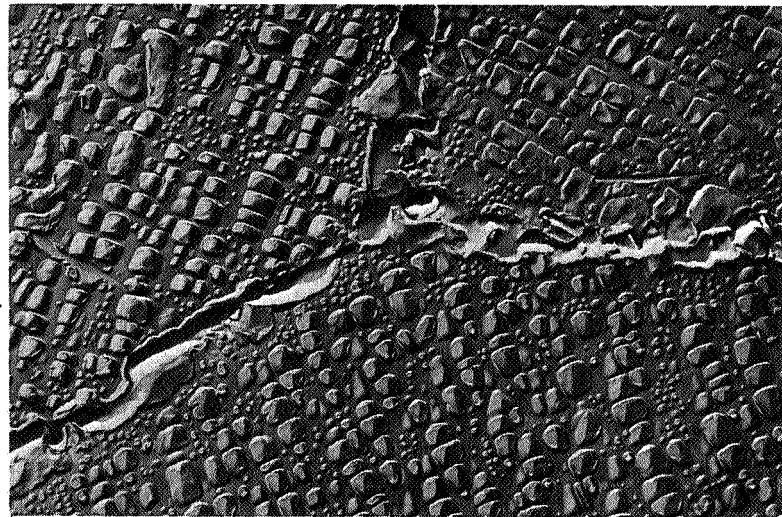
Figure 5. Electron Micrograph of a U-700 First Stage Blade After 2000-Hour Endurance Test at Approximately 1450°F. Note Coalescence of Gamma Prime Precipitate Within Grains and Growth of Intergranular $M_{23}C_6$ Carbides. (B3215)

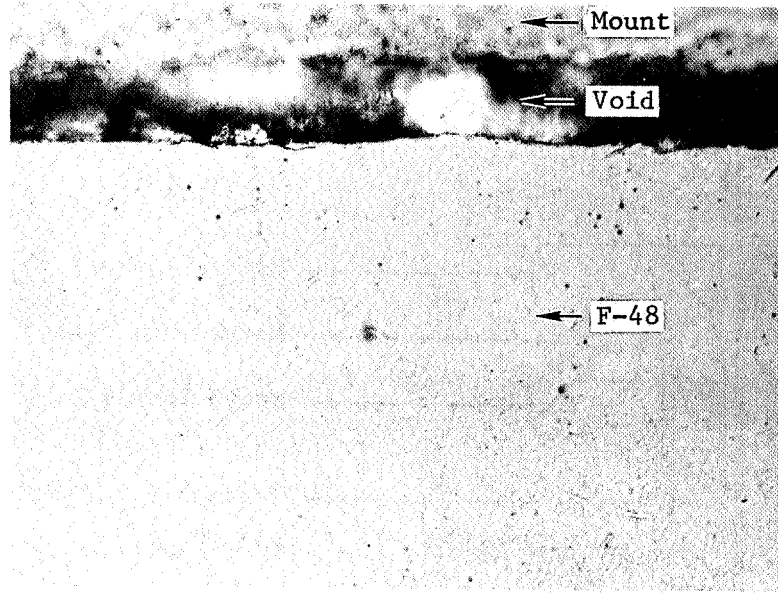
Metallographic examination of the surface of the refractory alloy probe specimens revealed subtle indications of contamination of the F-48 alloy in the form of a new phase which is apparently non-metallic in nature. It could be seen in the as-polished conditions and became more apparent when etched with 60% Glycerine - 20% Hf - 20% HNO_3 etchant. The phase is best defined by an electrolytic anodizing treatment, as is shown in Figures 18 and 19. The pale yellow color of the phase is similar to that observed by Harrison and Delgrosso⁵ in the low pressure oxidation of Cb-1Zr and which they identified as CbO. A

Figure 18. Contaminated Surface of F-48 Probe Specimen from Station One After 12 Hour Exposure to Inlet Potassium Vapor During Turbine Performance Test. (A320113)

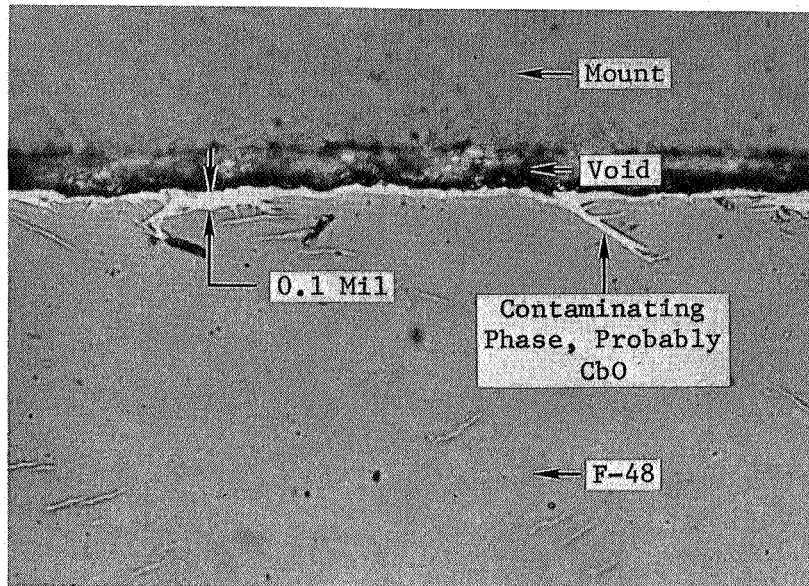
Figure 19. Contaminated Surface of F-48 Probe Specimen from Station One After 56 Hour Exposure to Inlet Potassium Vapor During Turbine Performance Test. (A320614)

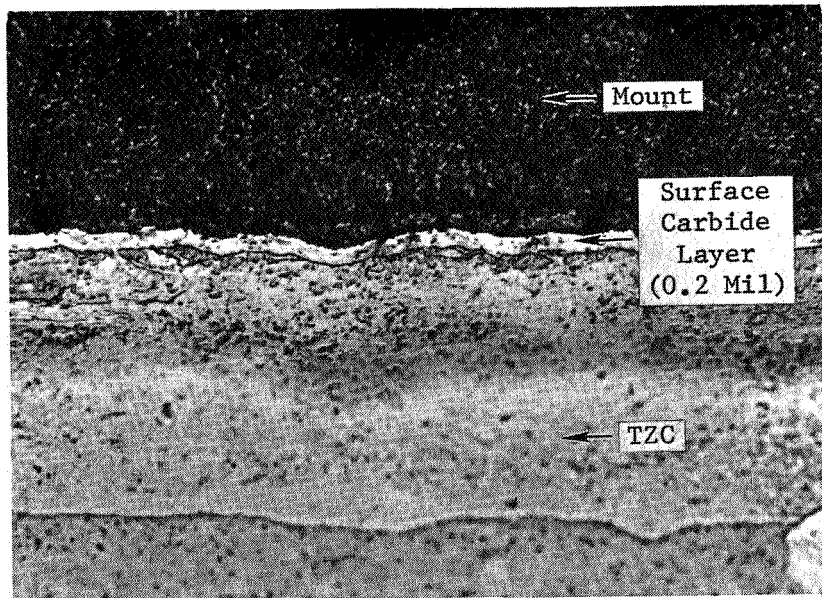
Table VIII shows the tensile test results of these TZC test specimens; they exhibited no ductility at temperatures as high as 650°F, which is the maximum reasonable temperature for turbine preheat. Ductile failure occurred at 1200°F. Figure 20 shows the presence of 0.0002-inch thick carbide film which was identified by x-ray diffraction as Mo_2C and MoC. Carbon analysis of a 0.030-inch thick section from the end of a tensile specimens indicated a carbon content of 2200-2500 ppm compared to an original vendor analysis of 1470 ppm.

Figure 20. Carbide Formed at the Surface of TZC Exposed for 100 Hours at 1400°F in Liquid Potassium Containing Carbon. (A890111)

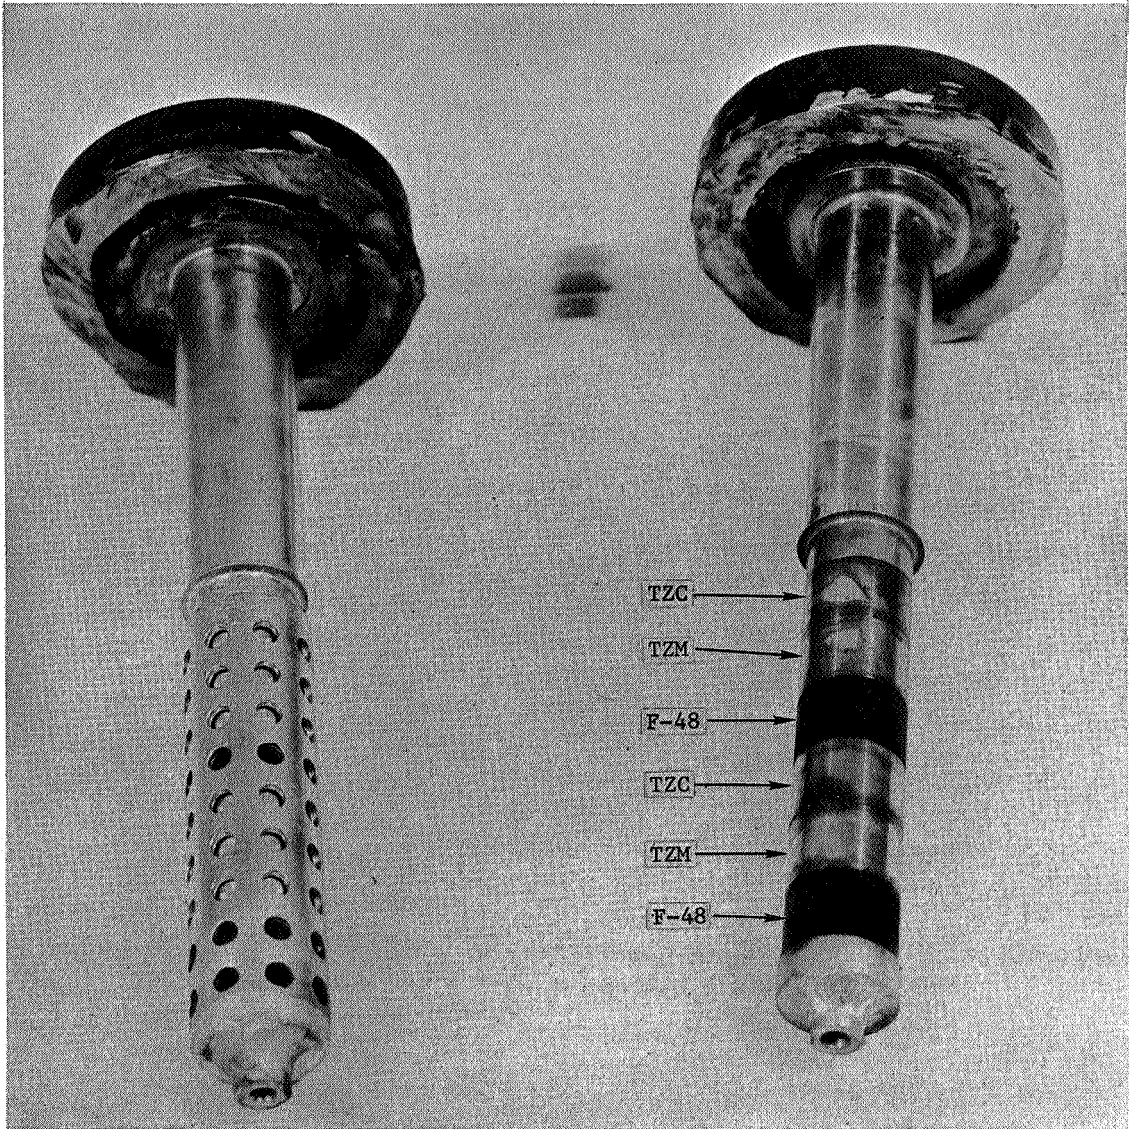
Endurance Test Refractory Alloy Contamination Results - When the turbine was shut down after 254 hours of endurance run, evaluation of the TZC, TZM and F-48 probe specimens was made. The probe at Station One, which operated at 1520°F, and one of the probes from the condenser, which operated at 1260°F, were removed and cleaned in hexane and alcohol. These two probes are shown in Figure 21. One ring specimen of each of the alloy compositions on the probe at Station One was removed and replaced with a fresh specimen. The condenser probe which was removed for specimen evaluation, was modified to contain four TZC tensile bars for subsequent exposure during potassium turbine testing.

Figure 21. Refractory Alloy Specimen Probes from Station One, Left, and Condenser, Right. (Note Darkening of F-48 Specimens)
(C65032822) Mag: 1X

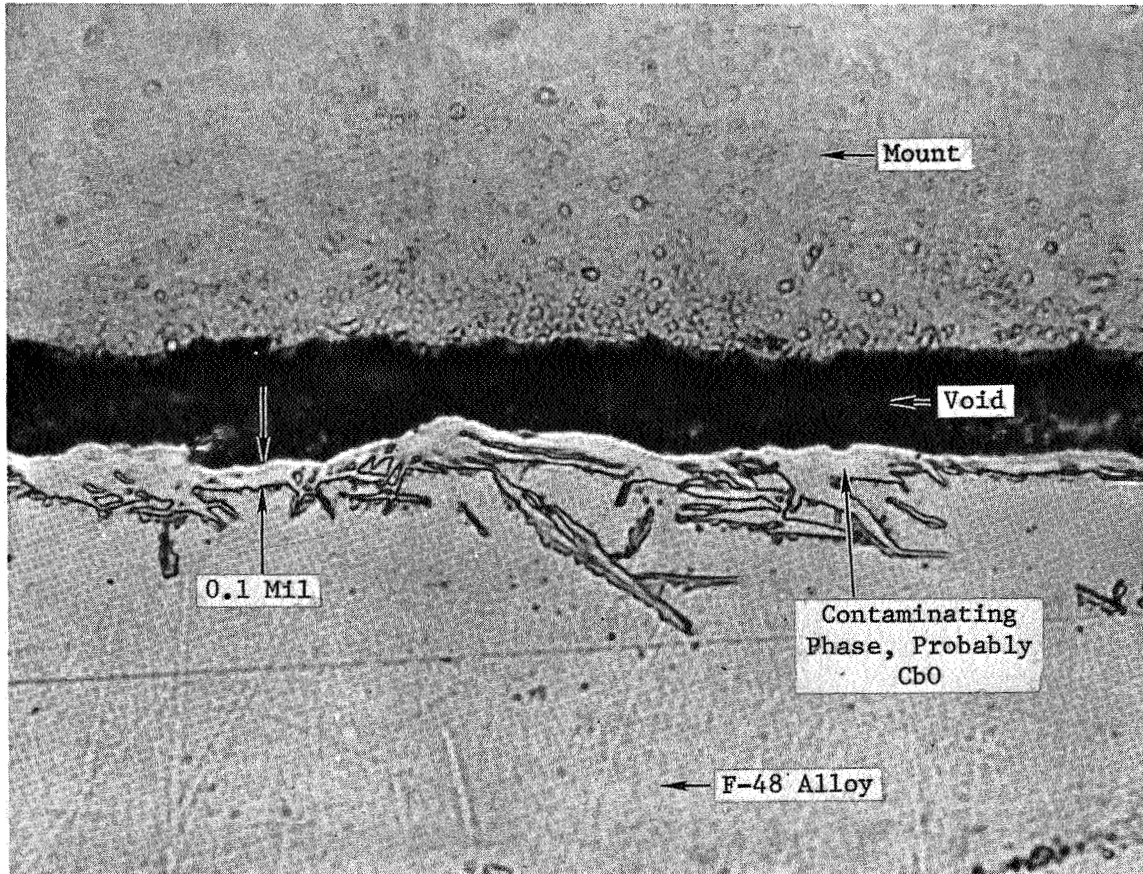
Metallographic evaluation of the refractory alloy specimens after 254 hours and after 2000 hours of the turbine endurance test revealed interesting structures only in the F-48 alloy. As shown in Figures 23 and 24, the contamination of an F-48 specimen at Station One, which operated at a higher temperature, is more extensive after 254 hours than that of an F-48 specimen taken from a lower temperature location downstream of the turbine. After 2000 hours of testing, the surface contamination was much more extensive at the surface of the F-48 specimen located at the turbine inlet, as shown in Figure 25. The contamination has penetrated well over a mil along grain boundaries. The F-48 specimen located aft

Figure 23. Contaminated Surface of F-48 Specimen from Station One After 254-Hour Exposure to Inlet Potassium Vapor During Turbine Endurance Test. (A930114)

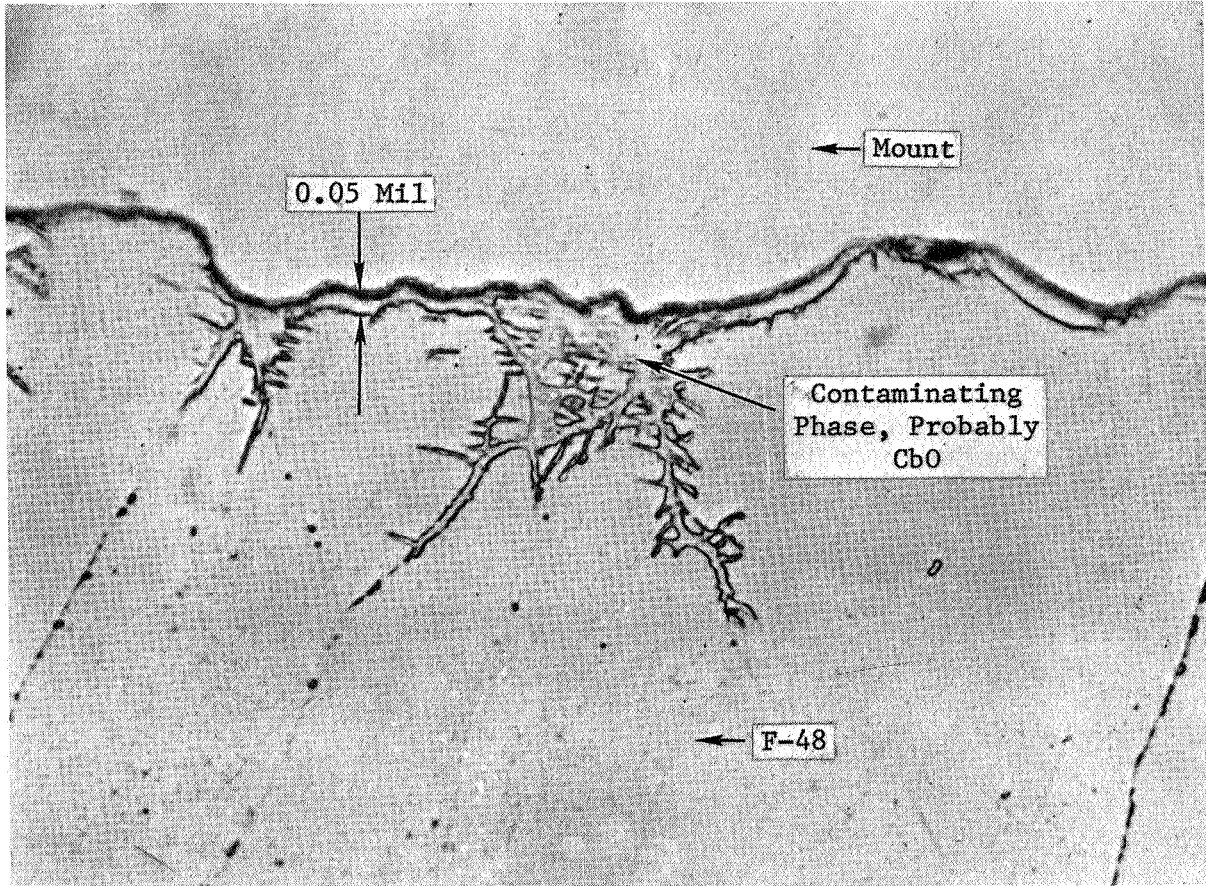
Figure 24. Contaminated Surface of F-48 Specimen from Condenser After 254-Hour Exposure to Exit Potassium Vapor During Turbine Endurance Test. (A930312)

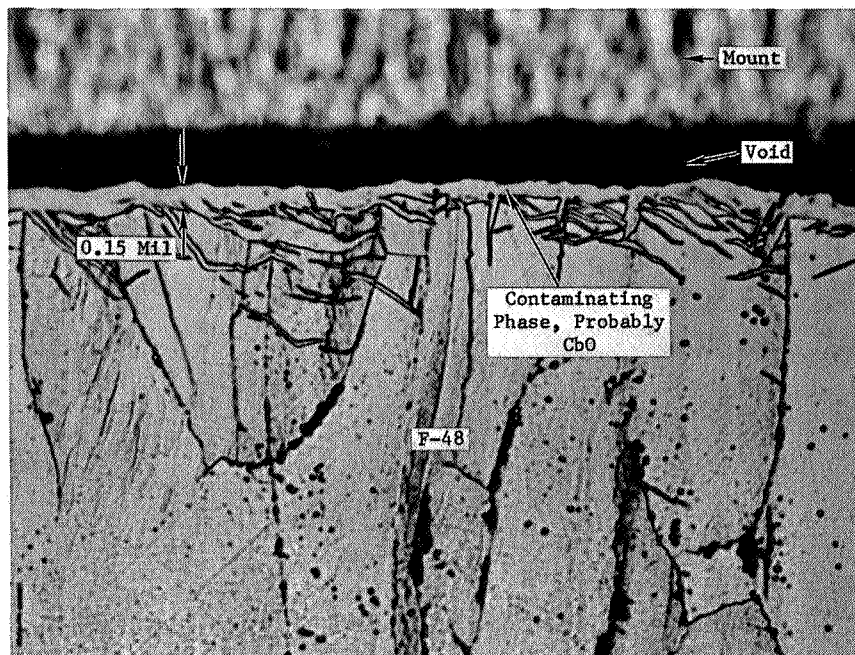
Figure 25. Contaminated Surface of F-48 Specimen from Station One After 2000 Hour Exposure to Inlet Potassium Vapor During Turbine Endurance Test. (B280911)

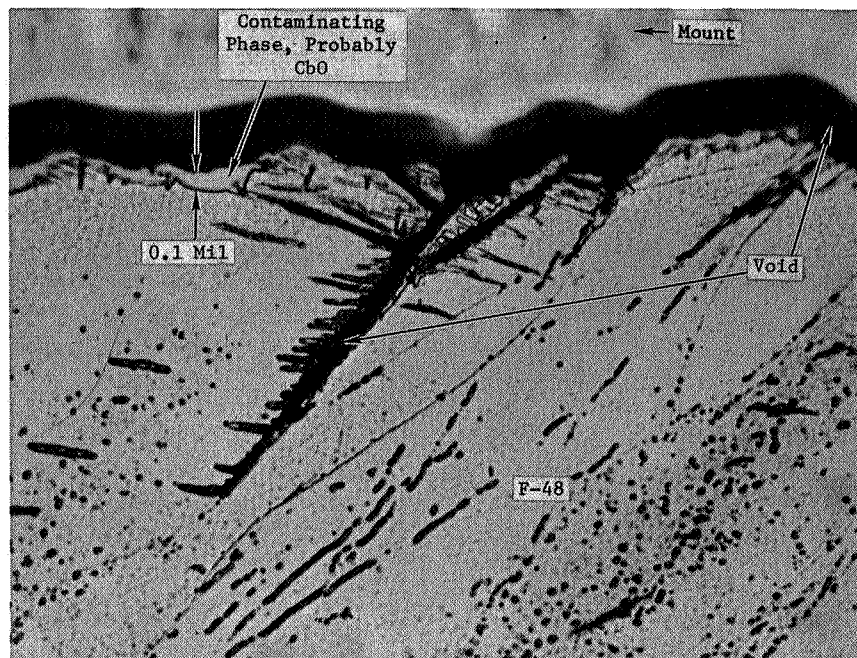
of the turbine does not show this same degree of either extensive surface contamination or of intergranular penetration (see Figure 26).

Figure 26. Contaminated Surface of F-48 Specimen from Condenser After 2000 Hour Exposure to Exit Potassium Vapor During Turbine Endurance Test. (B281212)

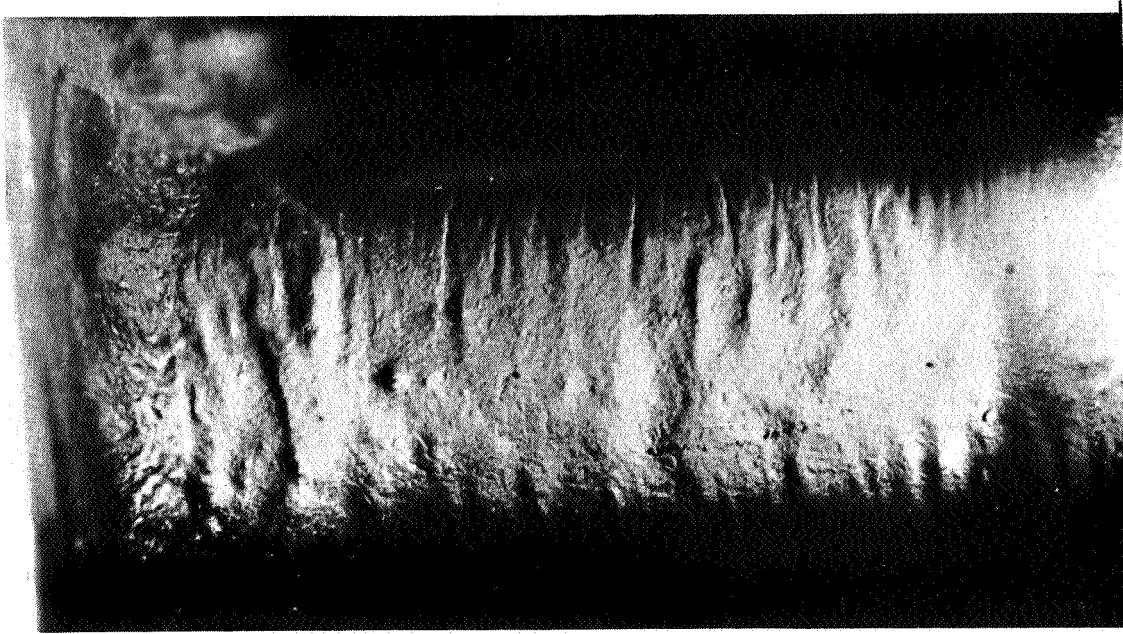
Damage by liquid metal occurred in many places and resulted in the removal of metal from the components. A single set of L-605 nozzle partitions, which were used for all turbine tests, were lightly corroded at their leading edges as shown in Figure 27. The trailing edges of the first stage partitions were corroded by liquid droplets rebounding from the first stage blades and the honeycomb turbine tip shroud was corroded where droplets were slung in a radial direction from the turbine blades; see Figure 28. The damage to the first stage wheel assembly can be seen in Figure 29. Rene' 41 turbine blade fasteners were corroded along the upstream sides of the turbine wheels as seen in Figure 30. Some corrosion occurred along the face of the first stage wheel near the bucket dovetails. Severe solution corrosion occurred underneath the bucket platforms of the first stage buckets as shown in Figure 31. Corrosion patterns on the bucket are shown in Figures 32, 33 and 34. Damage to the second stage was significantly less as indicated by the appearance of these turbine buckets, shown in Figure 35.

Figure 27. Enlarged View of Leading Edge of the First Stage L-605 Nozzle Vane. (C64122369) Mag: 9X

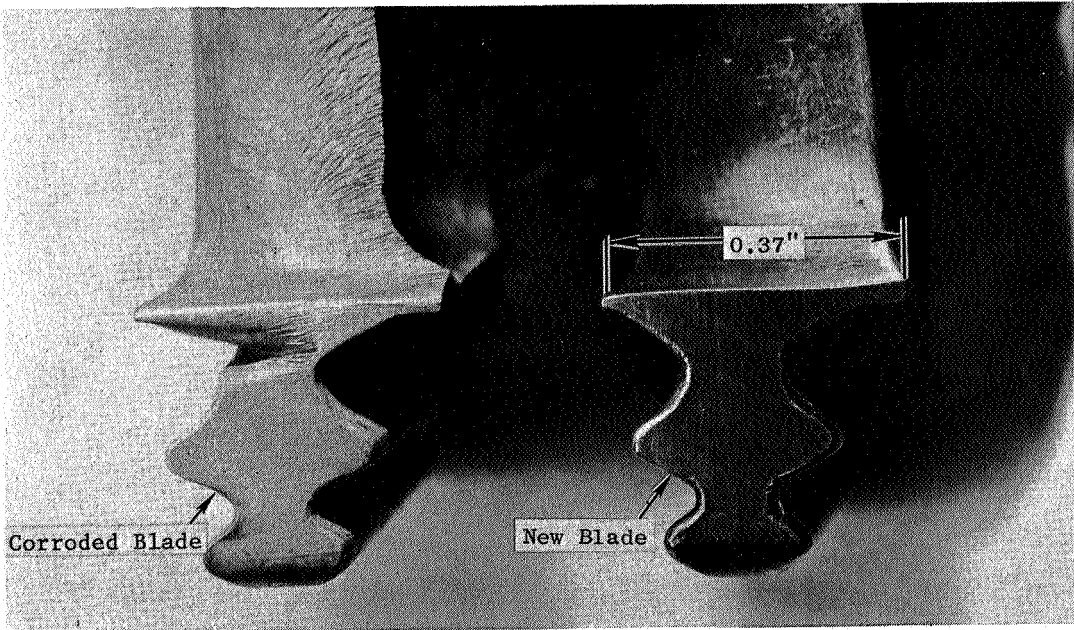
Figure 31. Comparison of Root-Region of First Stage Blade Before and After 35 Hour Turbine Checkout. (C64120910)

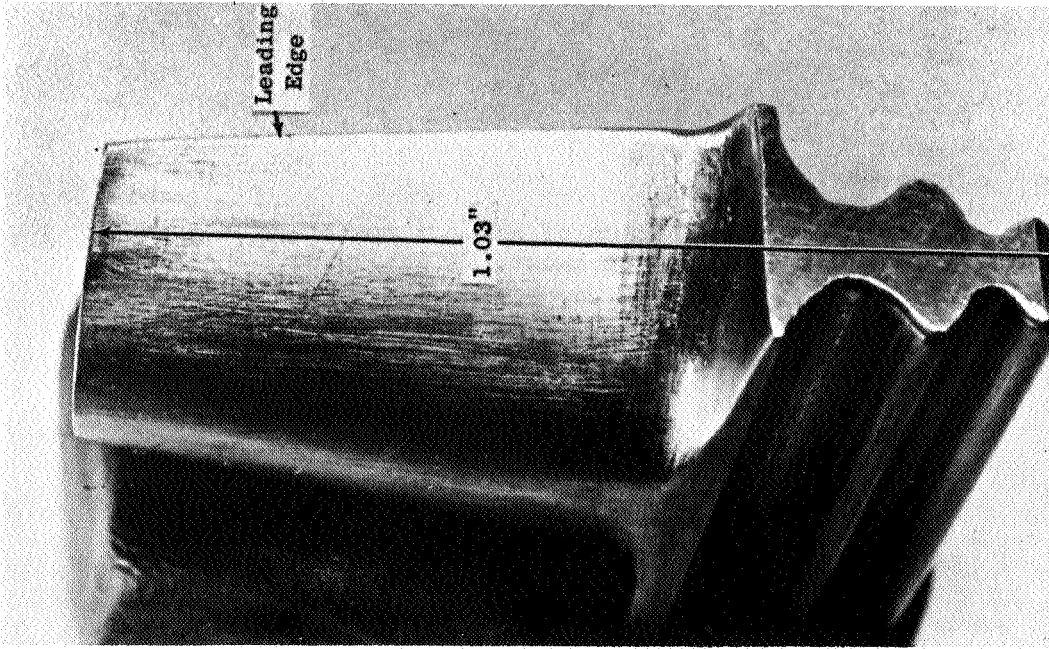
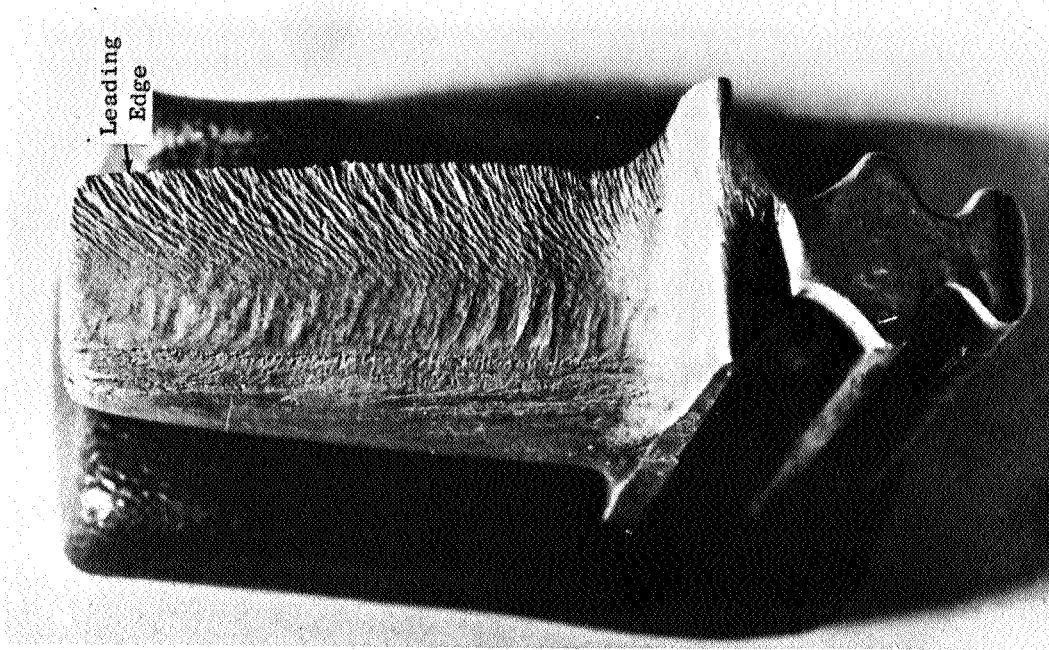
Figure 32. Comparison of a First Stage Blade Before and After 35-Hour Turbine Checkout.

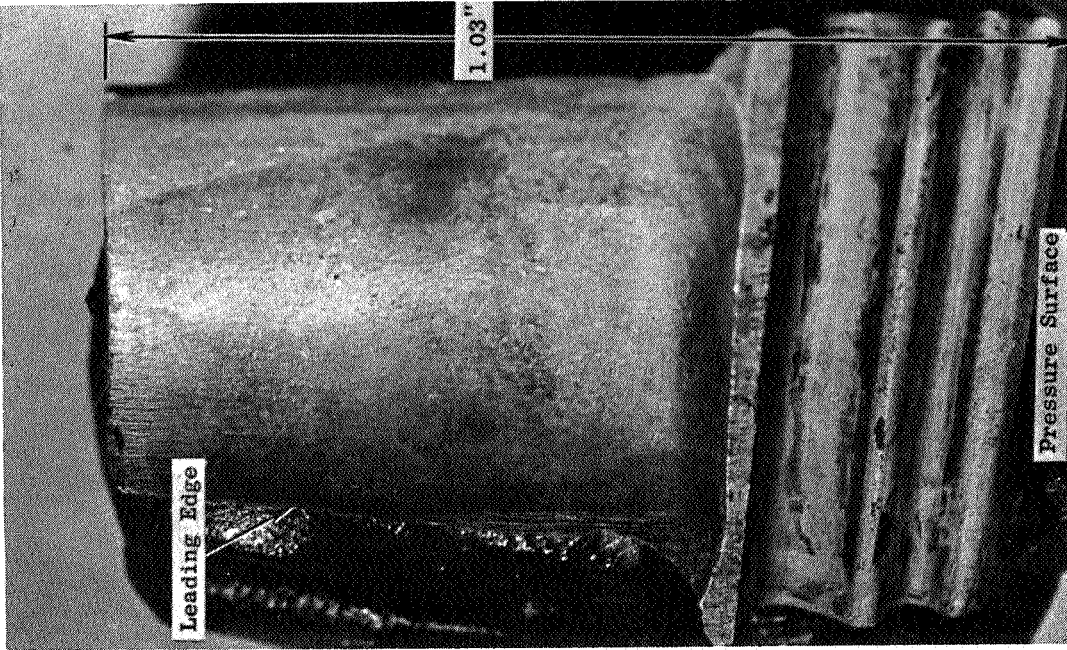
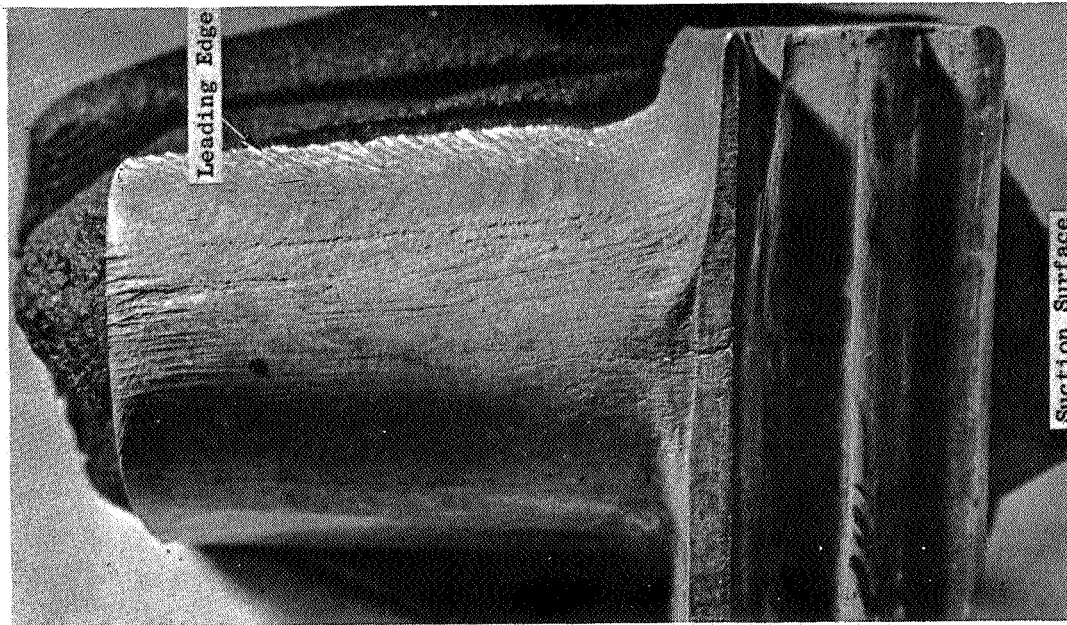
Figure 33. Suction and Pressure Surfaces of a First Stage Blade After 35-Hour Turbine Checkout.

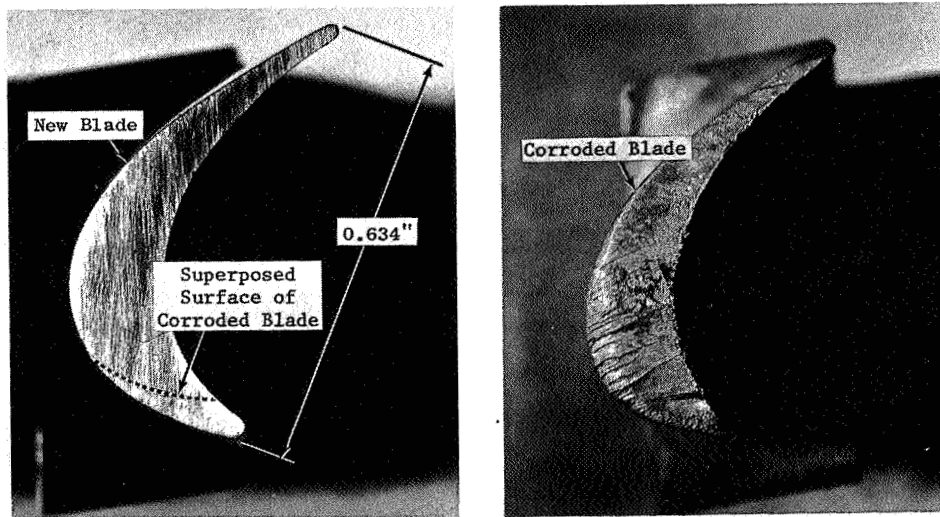
Figure 34. Comparison of Tip Section of First Stage Blade Before and After 35 Hour Turbine Checkout. (C64120911)

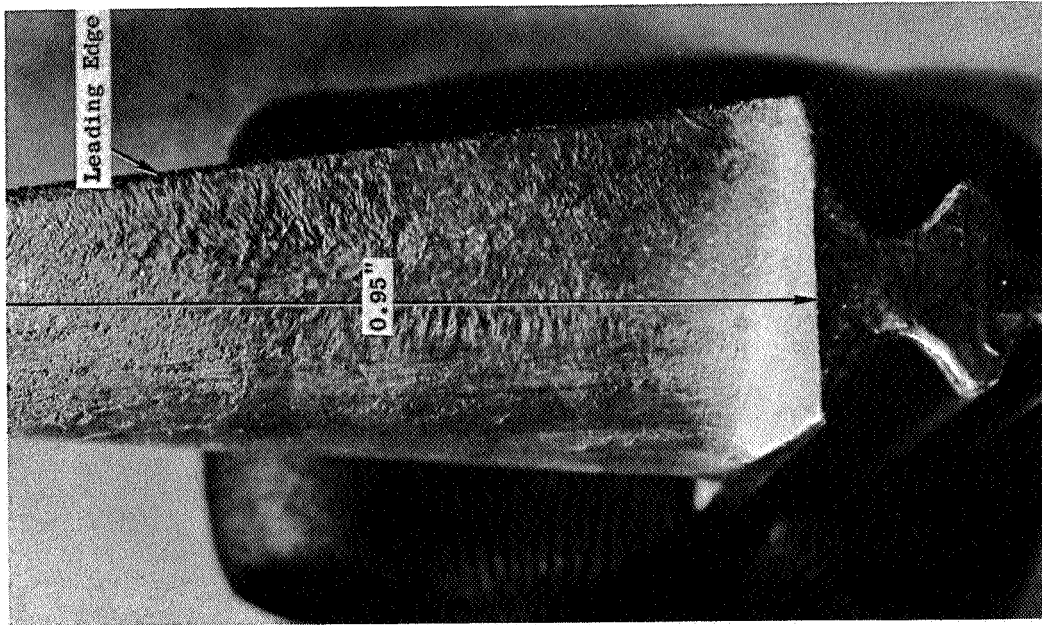
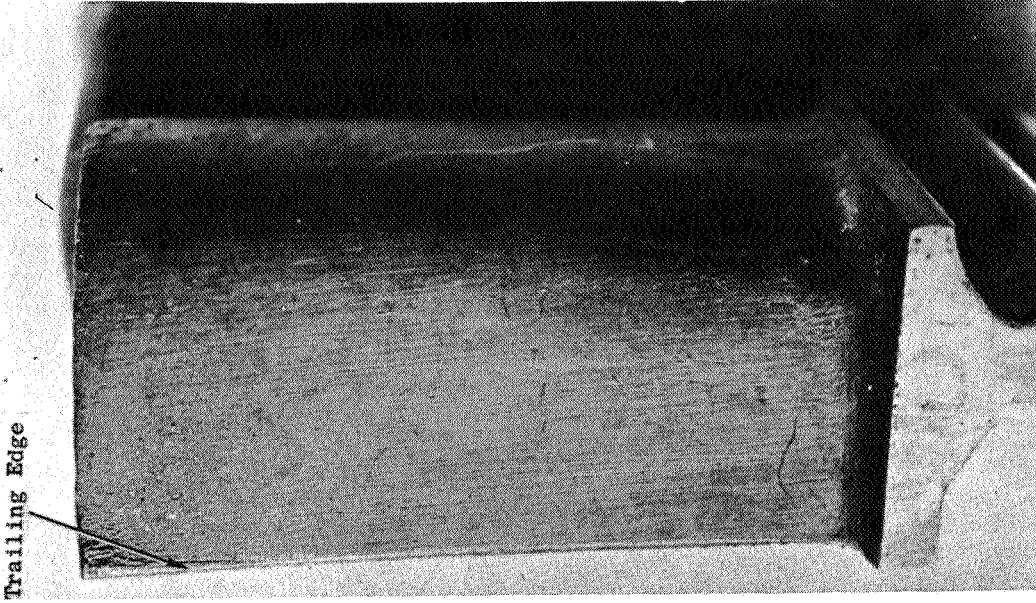
Figure 35. Leading and Trailing Edge of a Second Stage Blade After 35-Hour Turbine Checkout.

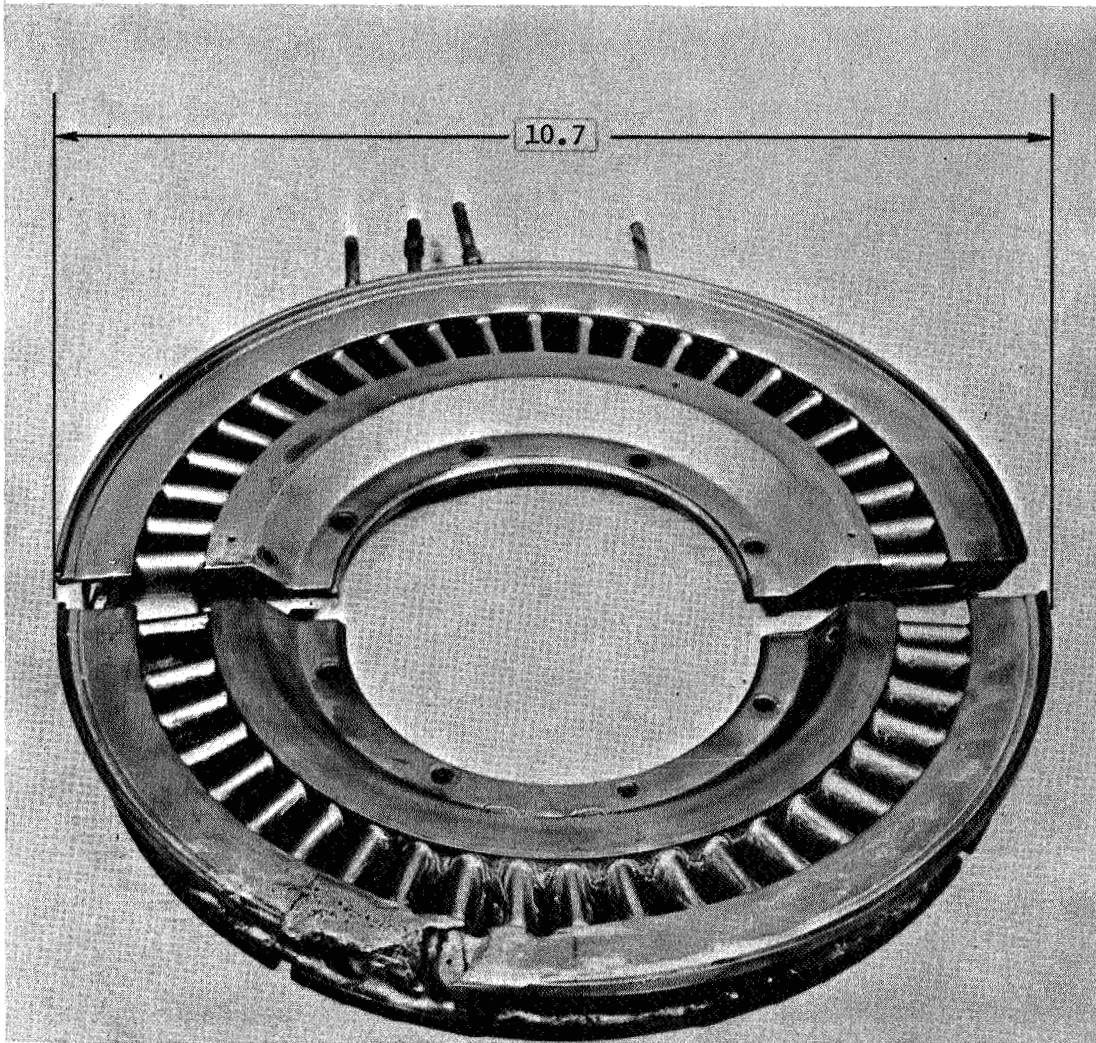
Figure 37. Second Stage Nozzle Diaphragm After Removal from Casing Following 35-Hour Turbine Checkout. (C64121805)

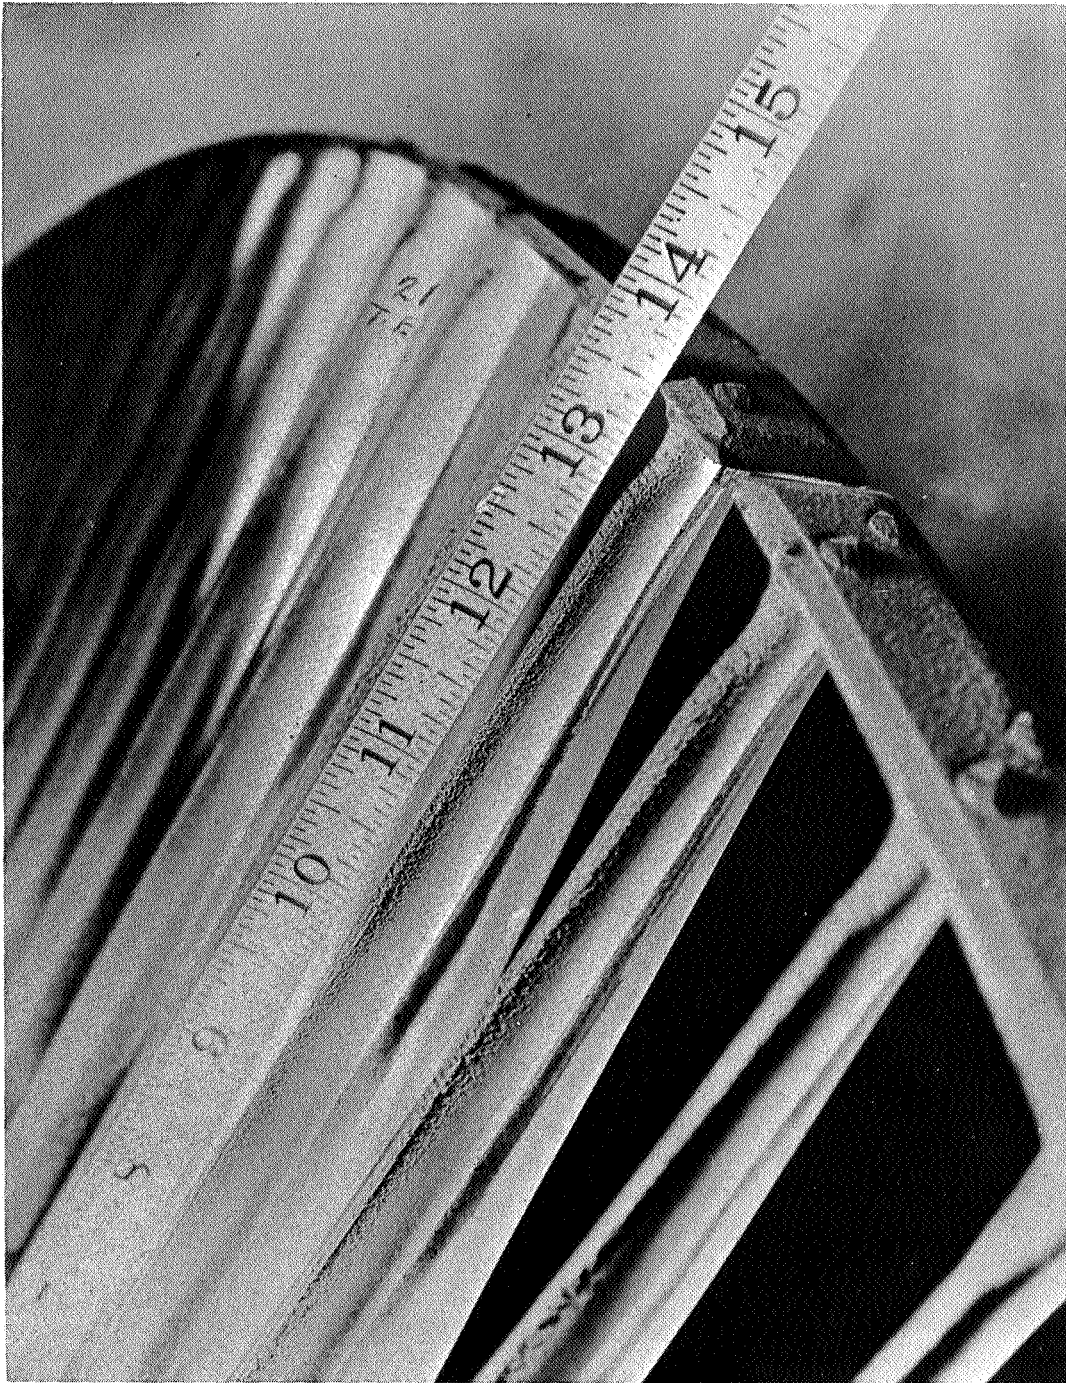
These erosion inserts gave the first evidence of what could be classical liquid droplet impact erosion in the U-700 specimens and similar in nature to steam turbine erosion as seen earlier in macro form in Figure 43, and at larger magnification in Figure 98. The deep holes formed in the exact area where droplets would have been released from the second stage trailing edge blade tips and would have impacted on the erosion insert. The micro-cracks at the base of the holes are indicative of the impact erosion or cavitation erosion methods or mechanical damage. The surface areas between adjacent holes deteriorated either by an apparent randomness in the location of impacting droplets or by disruption of the surface between adjacent holes. At the periphery of the cluster of holes there existed occasional deep holes, with depths 4 to 5 times that of their diameters; these holes had formed in the original surface of the U-700 insert without doing damage to the adjacent surface. This type of erosion was similar to that reported by Hays⁸ for ductile materials in steam turbine erosion. In other examples of erosion, pits in otherwise unaffected surfaces have been noted in multiple droplet impact specimens and in cavitation damaged specimens. In water droplet impact in Stellite 6B erosion shields in steam turbines, deep pits or irregular cross section have been observed with depths of one to two diameters in areas where no adjacent surface damage was noted.

Figure 43. Impact Erosion in the Last Stage of a Central Station Steam Turbine.

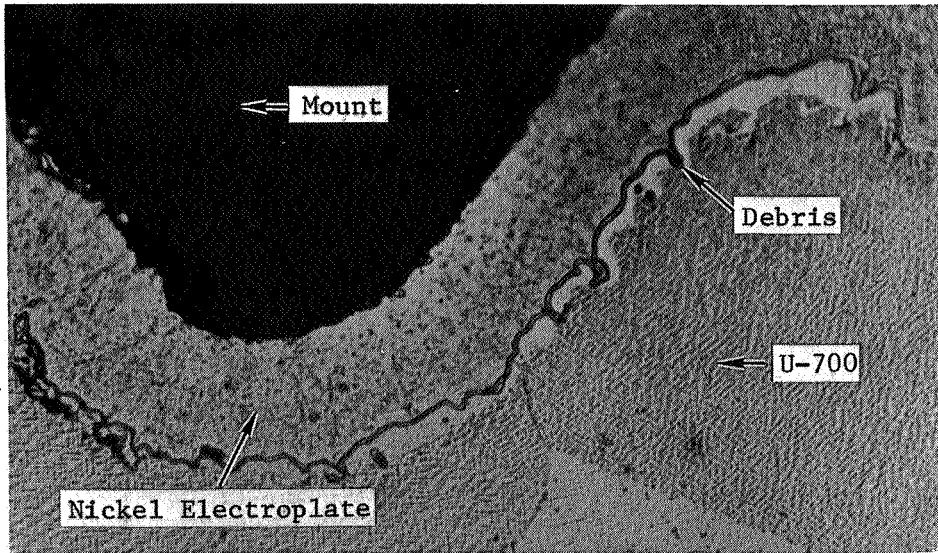
Figure 45. Optical Photomicrograph of Area of Electron Microprobe Analysis, Convex Surface of Stage One Blade.

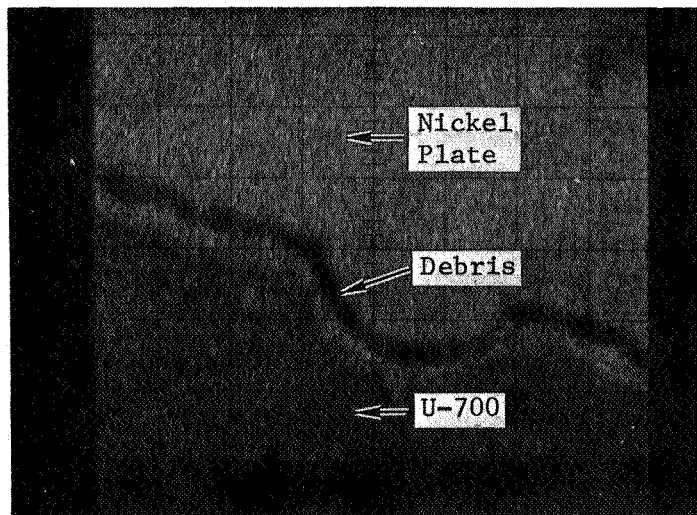
Figure 46. Electron Microprobe Oscilloscope Plot of Nickel Trace at the Convex Surface of a First Stage Blade.

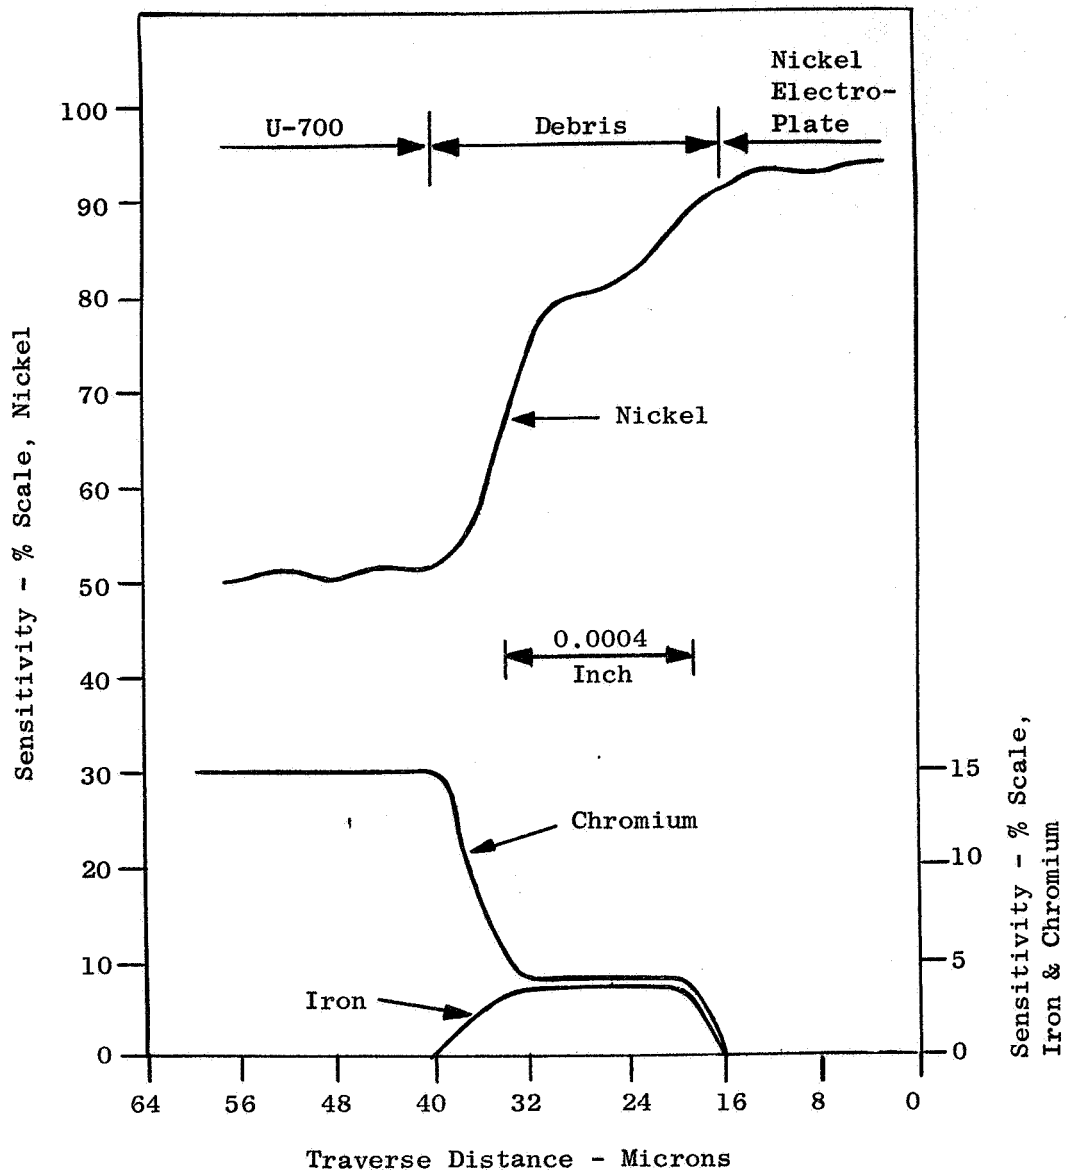
Figure 47. Electron Microprobe Beam Traverse of U-700 Blade.

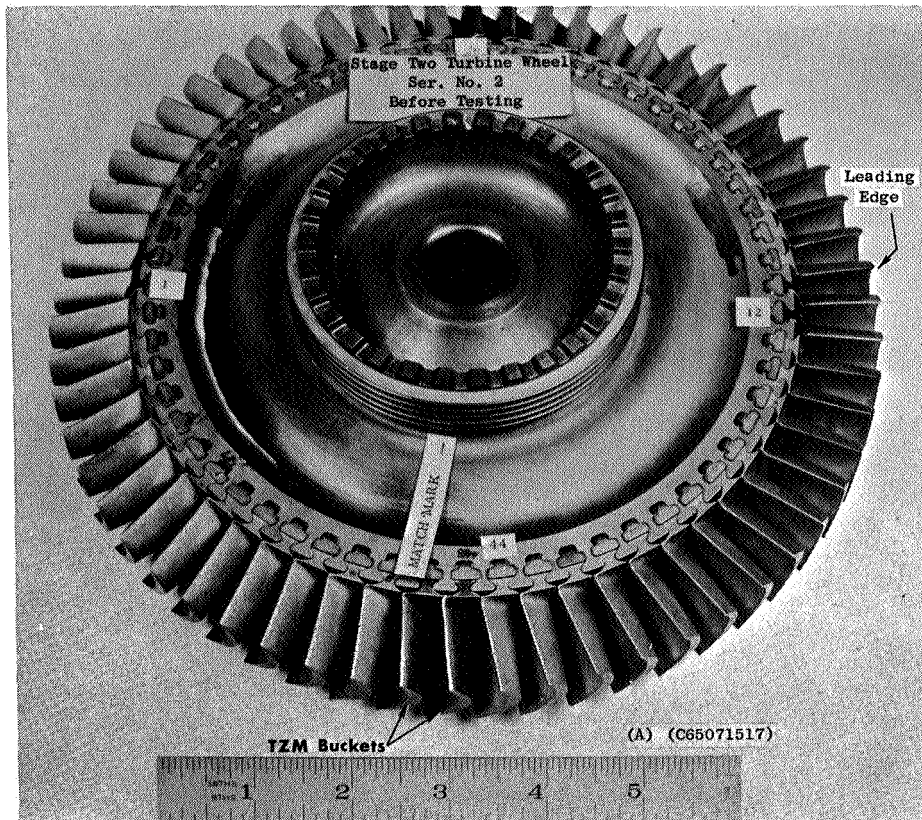
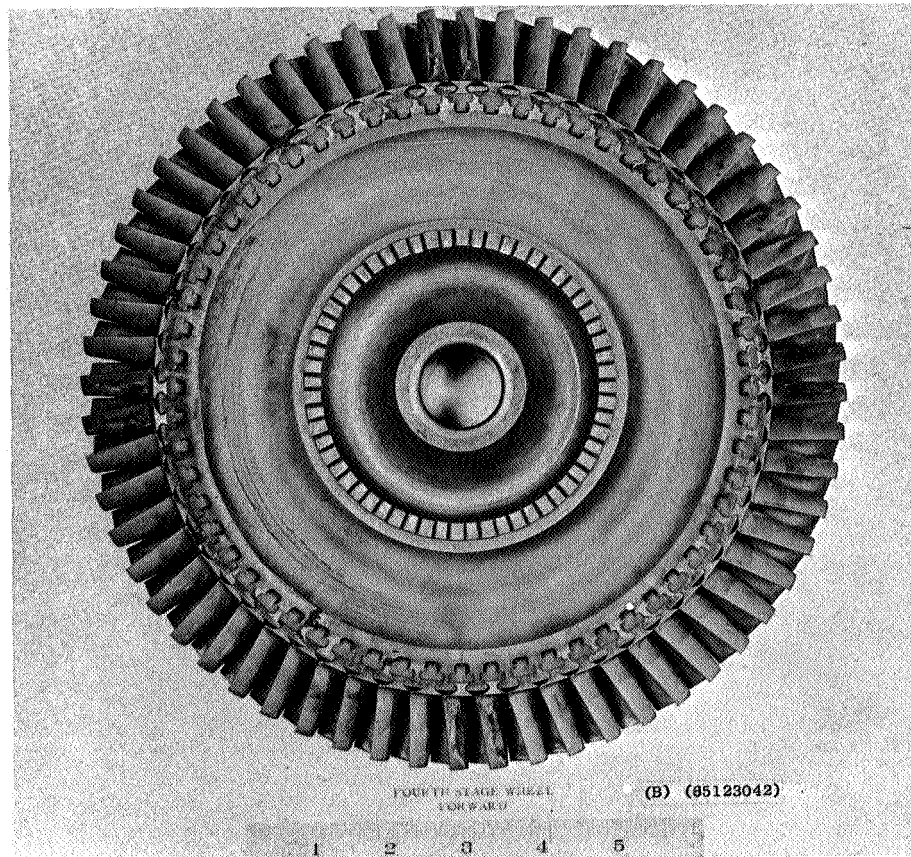
Figure 48. Second Stage Turbine Wheel Assembly Before, (A) and After, (B), 2000 Hour Endurance Test.

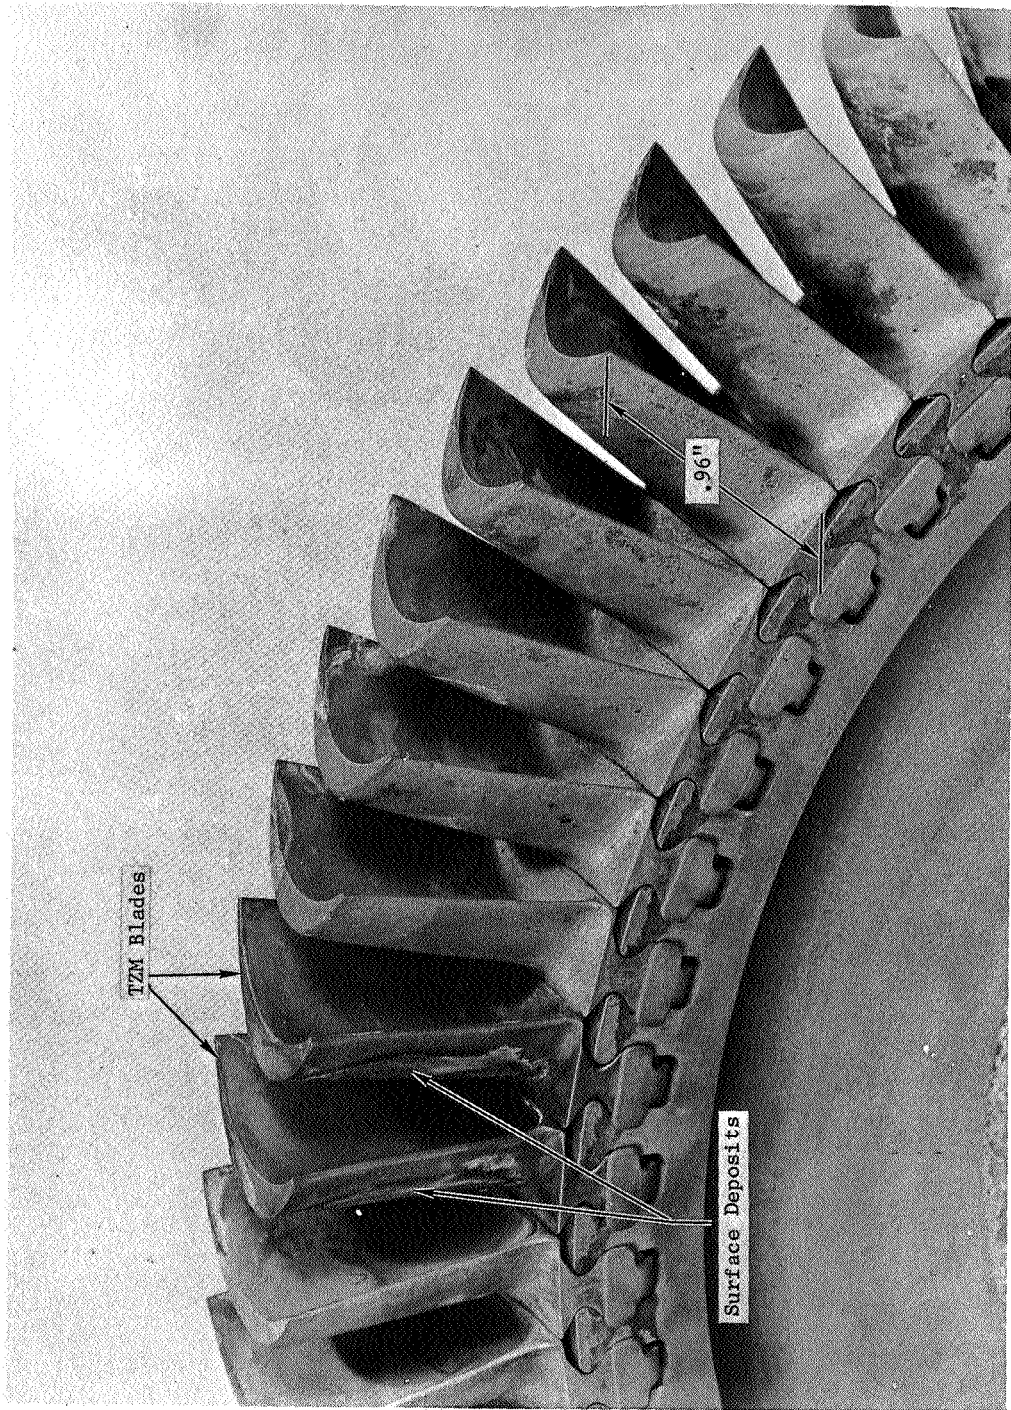
Figure 49. Second Stage Turbine Wheel Assembly After 2000 Hour Endurance Test. (C65123016)
