NASA CR-925

TWO-STAGE POTASSIUM TEST TURBINE

Volume IV
Materials Support of Performance
and Endurance Tests

Prepared by
GENERAL ELECTRIC
Cincinnati, Ohio
for Lewis Research Center

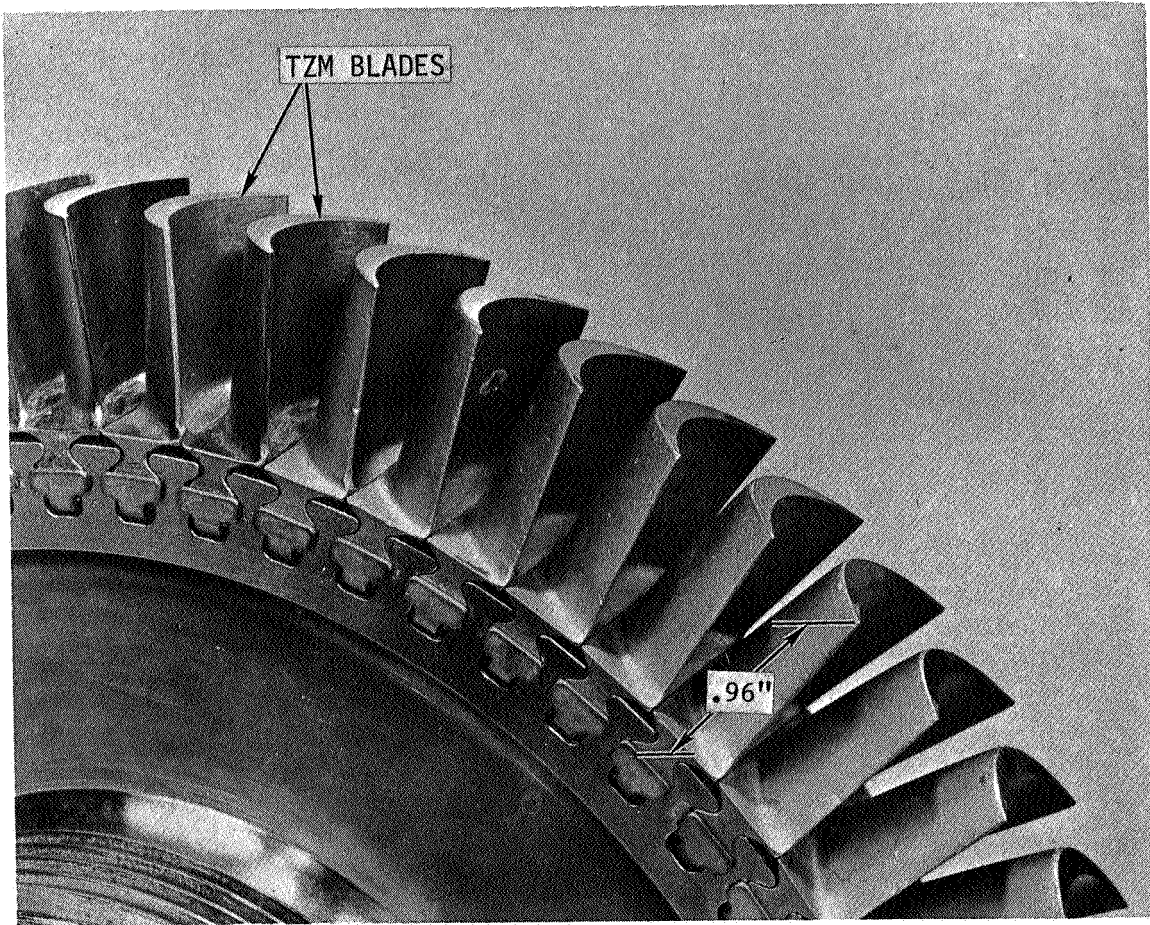
Figure 50. Second Stage Turbine Wheel Assembly After 2000 Hour Endurance Test, Vapor Blast Cleaning and Reassembly. (C6602215)

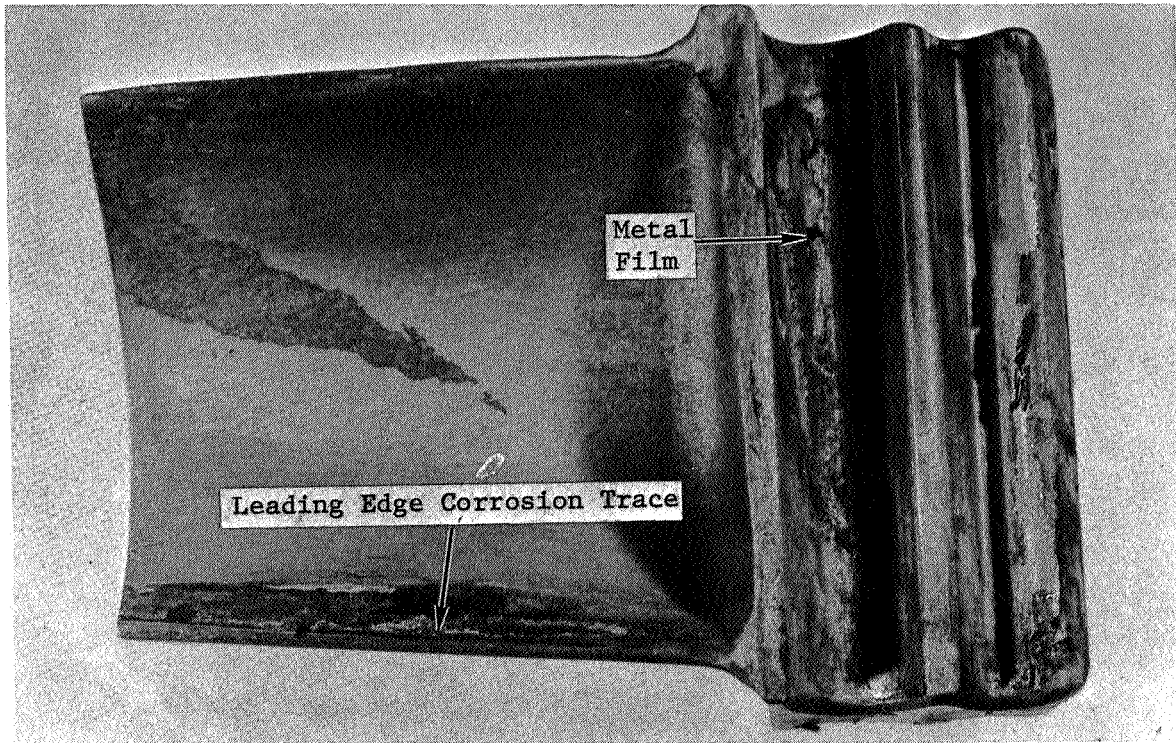
Turbine Blade Corrosion - The post-test appearance of the first stage U-700 turbine blades is shown in Figures 51 through 54 and that of the second

Figure 51. Concave Side of U-700 First Stage Turbine Blade After 2000 Hour Endurance Test. (C66011343)

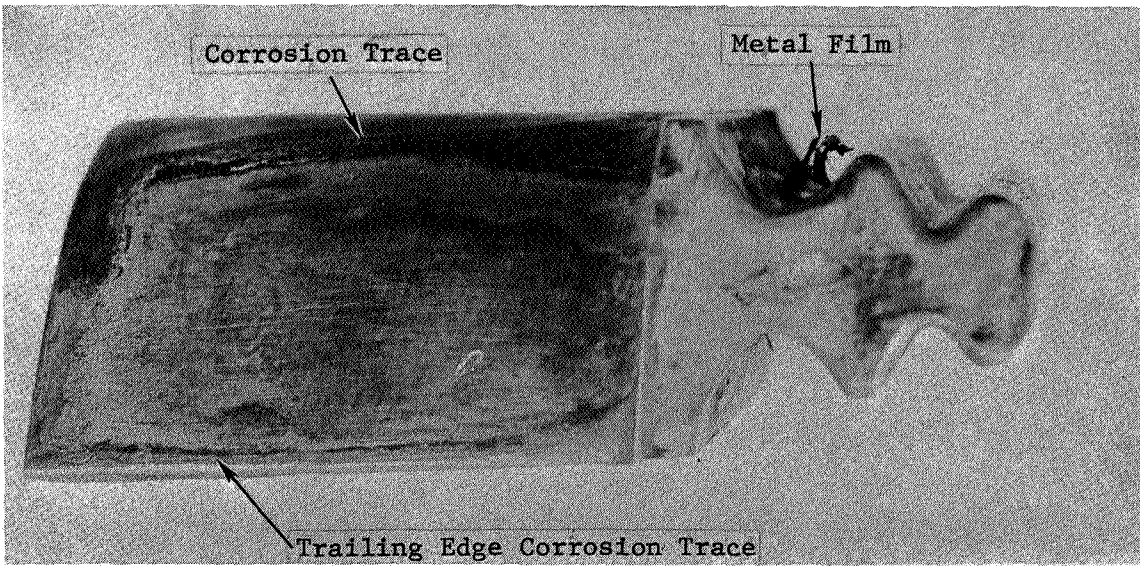
Figure 52. Trailing Edge of U-700 First Stage Turbine Blade After 2000 Hour Endurance Test. Note Metal Foil on Dovetail. (C66011340)

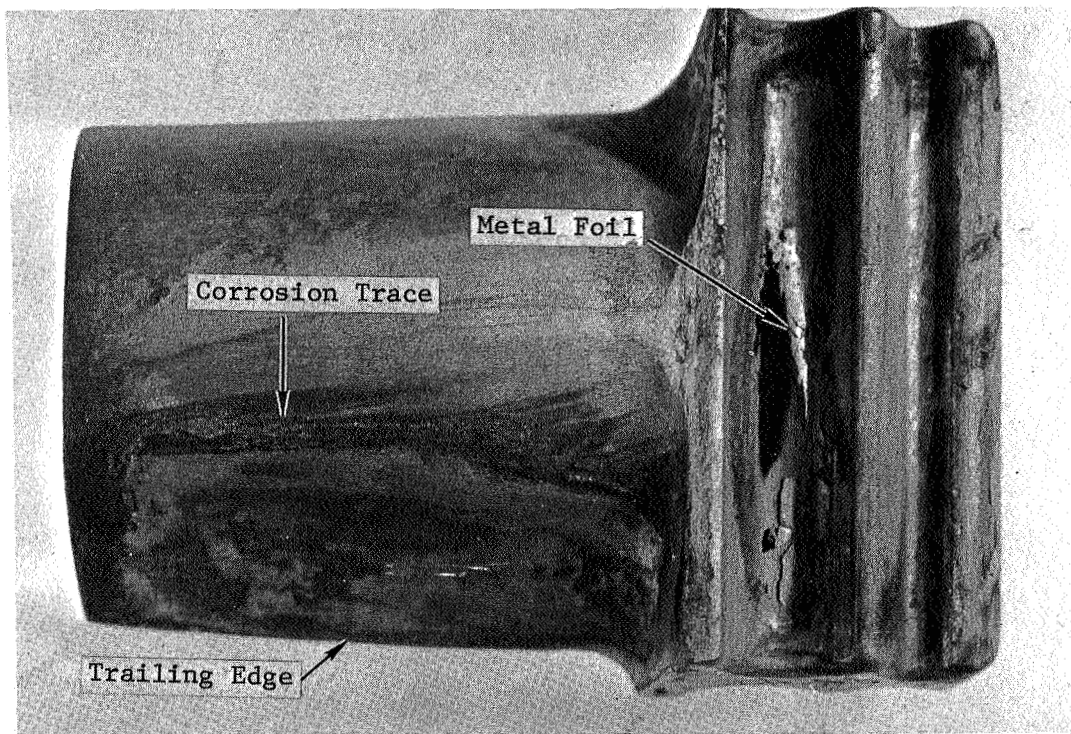
Figure 53. Convex Side of U-700 First Stage Turbine Blade After 2000-Hour Endurance Test. (C66011346) Mag: 5X

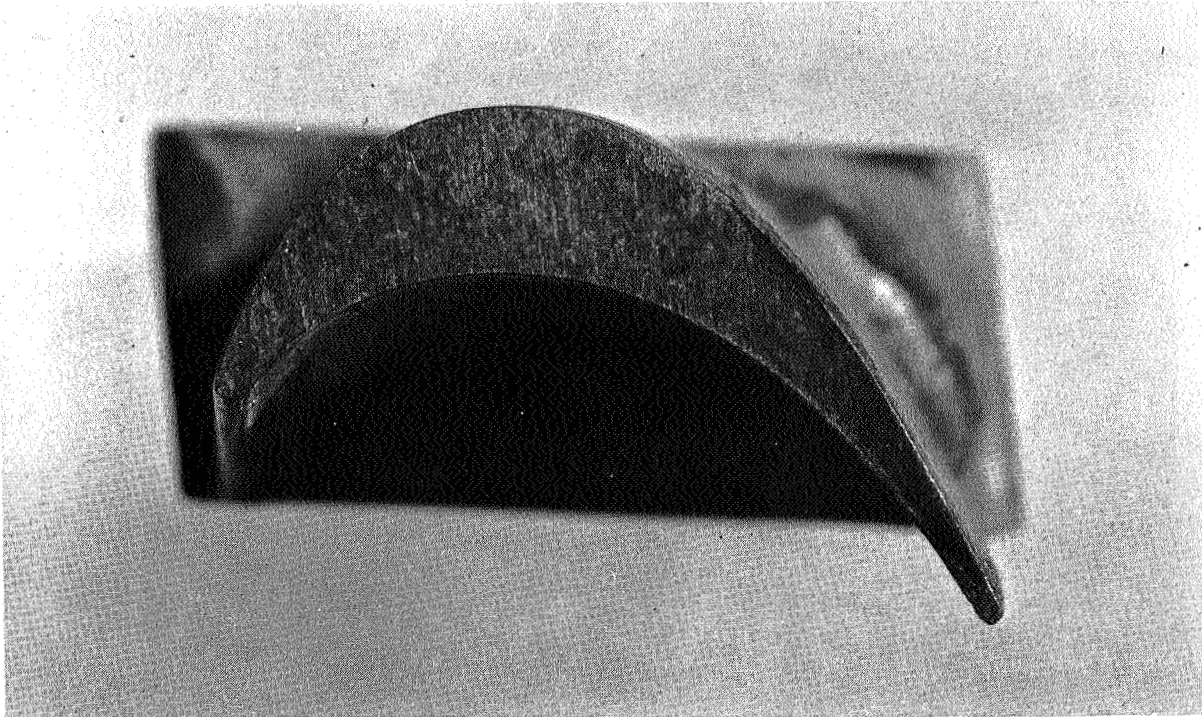
Figure 54. Tip of U-700 First Stage Turbine Blade After 2000 Hour
Endurance Test. (C66011338)

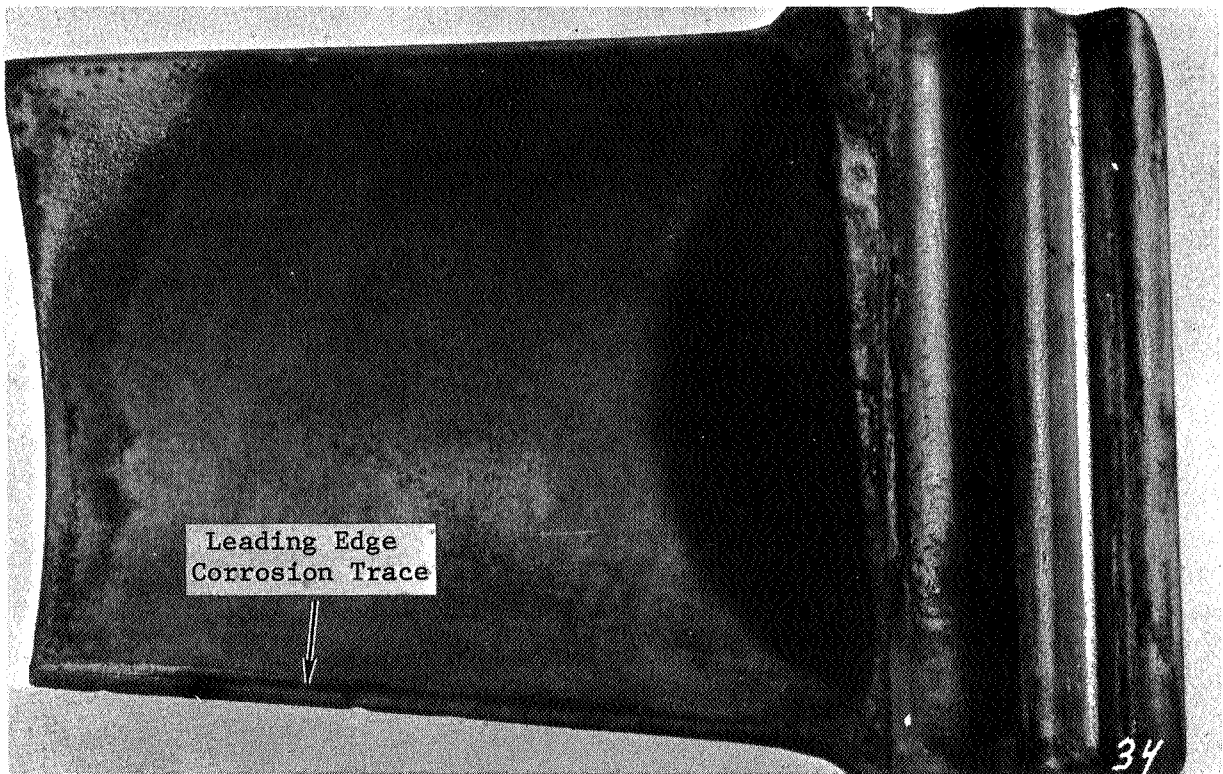
Figure 55. Concave Side of U-700 Second Stage Turbine Blade After
2000-Hour Endurance Test. (C66011345) Mag: 5X

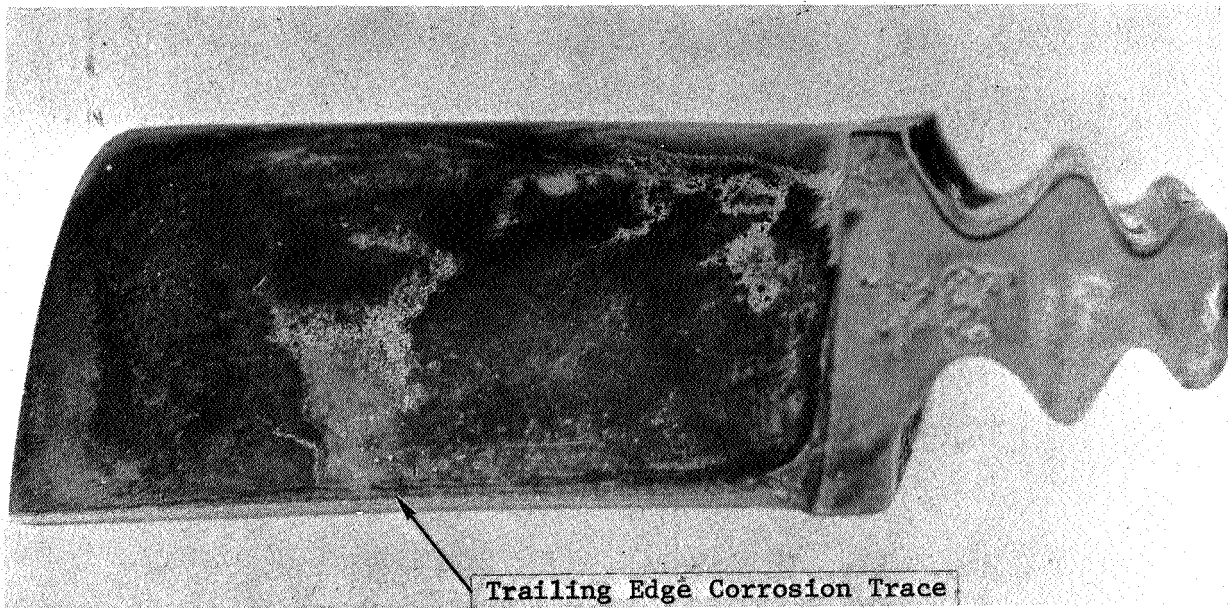
Figure 56. Trailing Edge of U-700 Second Stage Turbine Blade After
2000-Hour Endurance Test. (C66011341) Mag: 5X

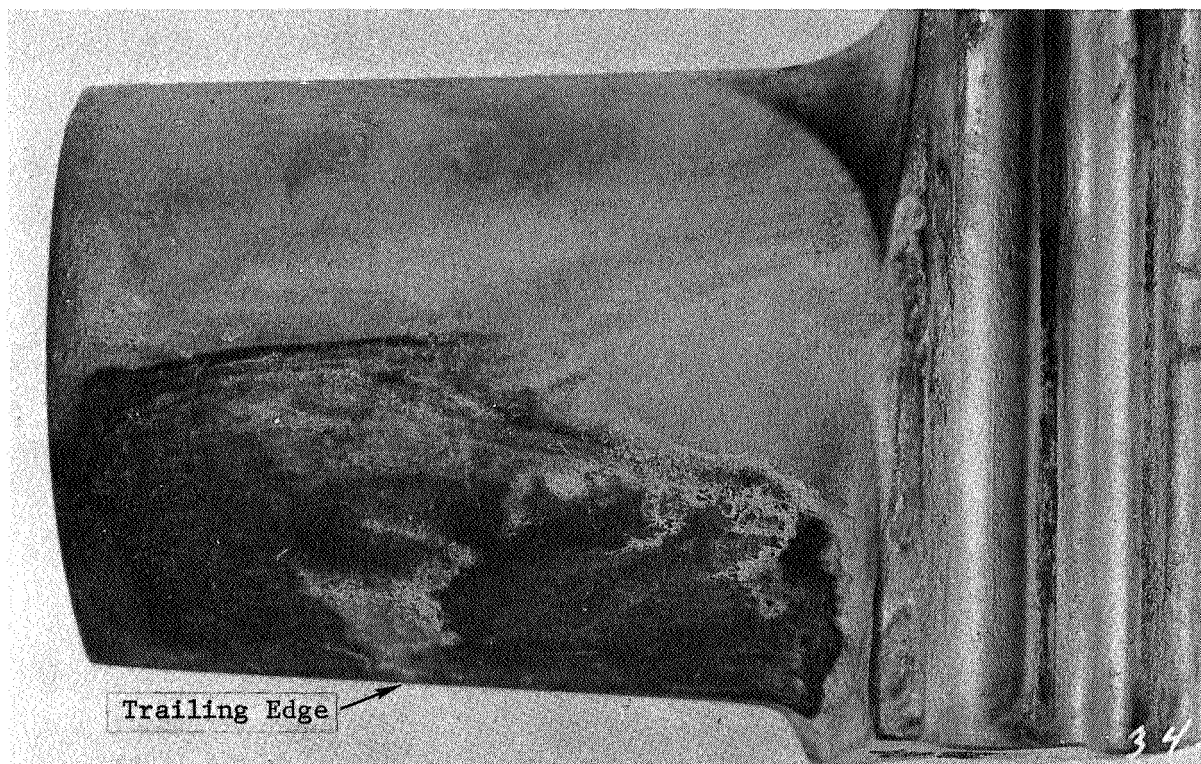
Figure 57. Convex Surface of U-700 Second Stage Turbine Blade After
2000-Hour Endurance Test. (C66011344) Mag: 5X

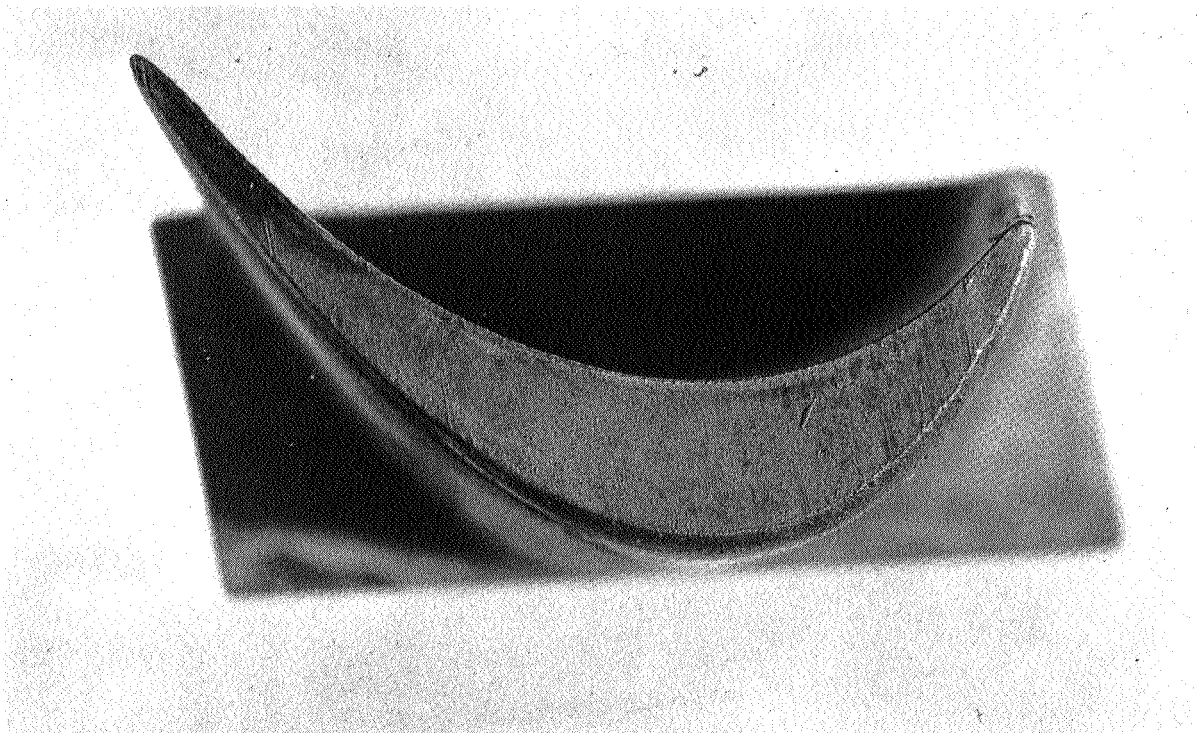
Figure 58. Tip of U-700 Second Stage Turbine Blade After 2000 Hour Endurance Test. (C66011337)

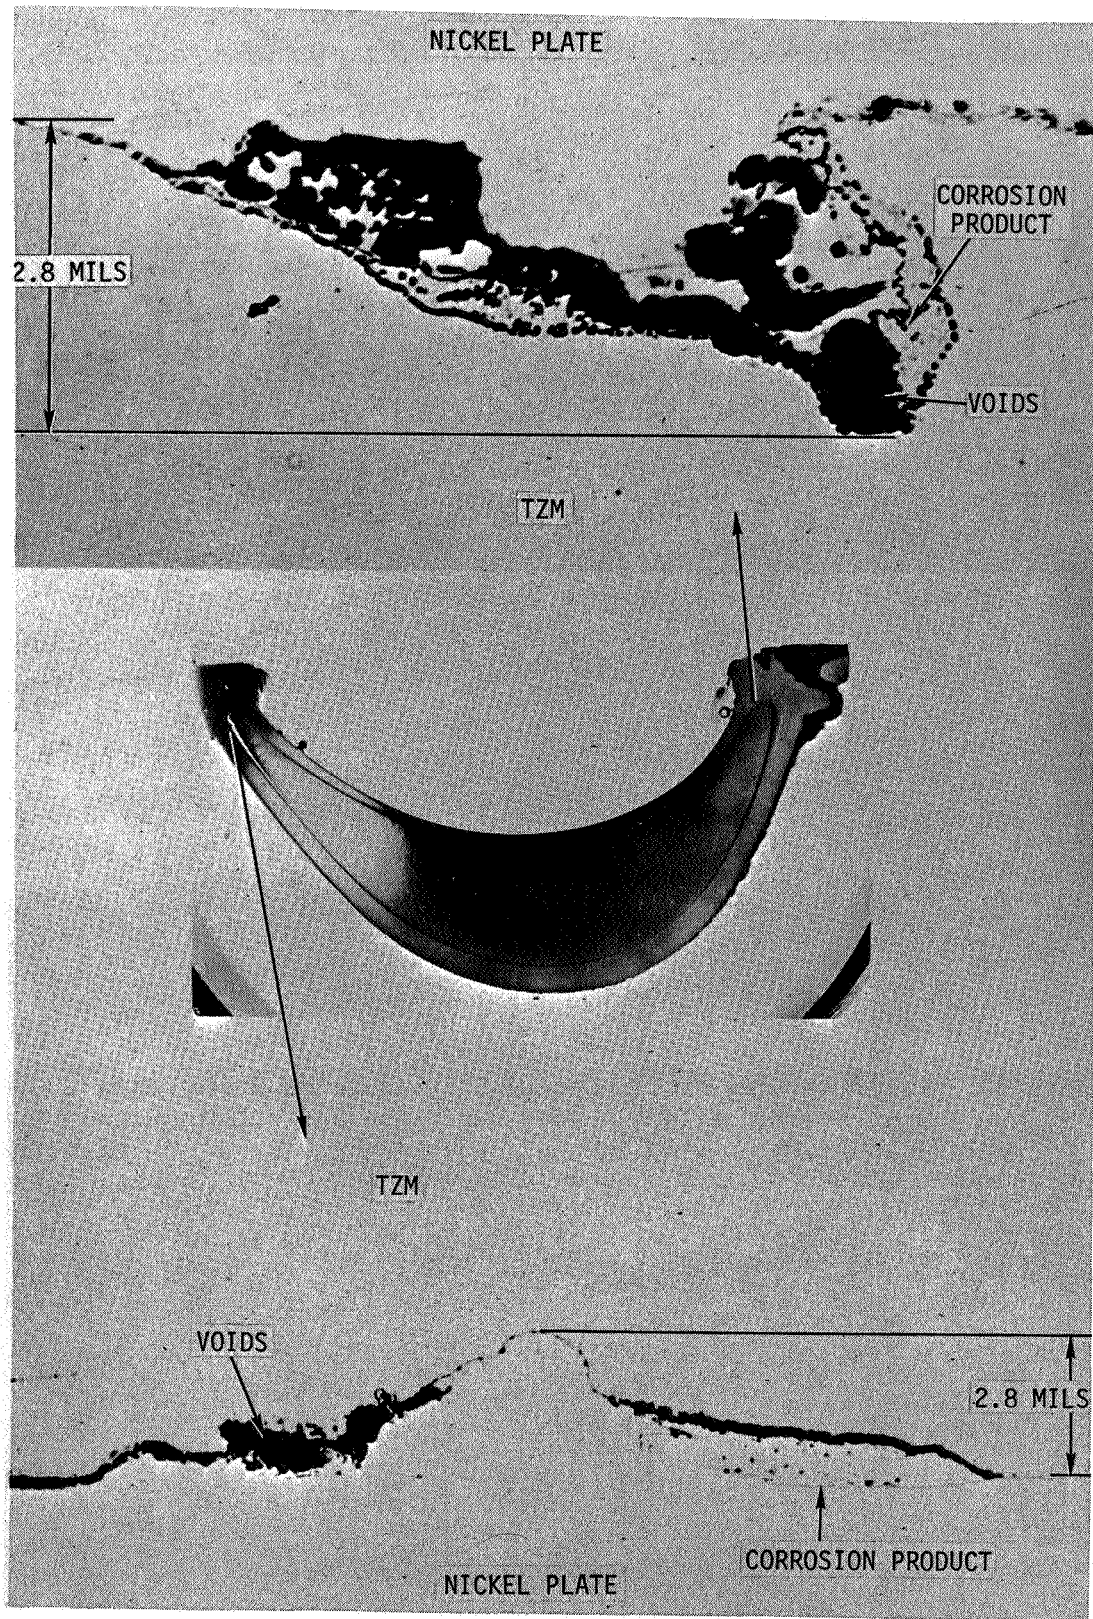
Figure 61. Leading and Trailing Edge Corrosion Traces and Micrographs of a Second Stage TZM Blade After 2000 Hour Endurance Test.

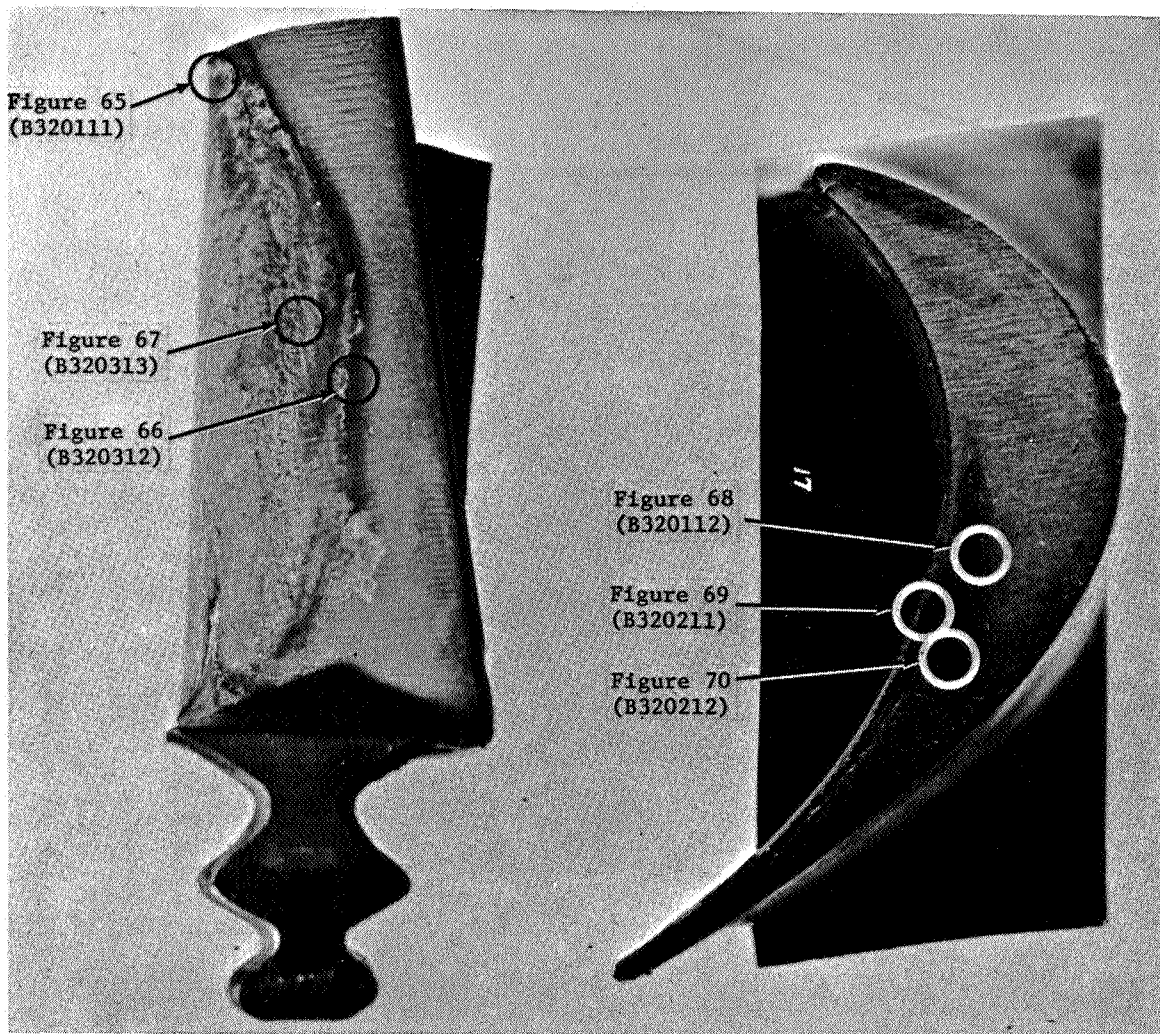
Figure 63. Location of Selected Micrographs Taken from the Convex Airfoil Surface and Tip of a TzM Second Stage Blade After 2000-Hour Test.

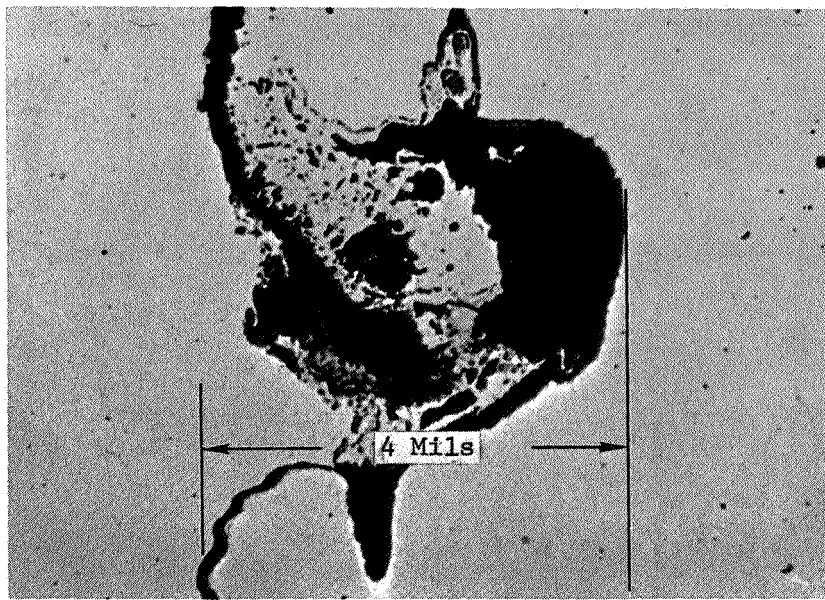
Figure 64. Convex Surface Near Tip of TZM Second Stage Blade After 2000 Hour Test. (B320111)

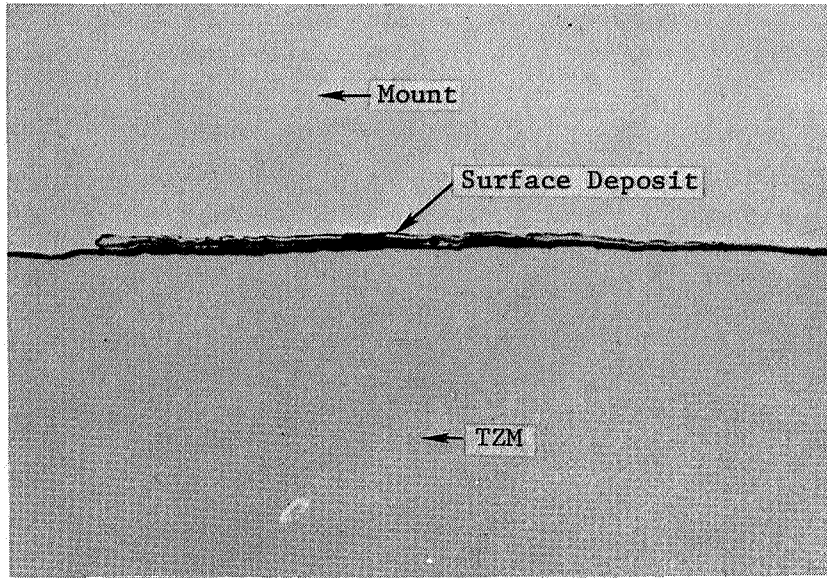
The location of a corrosion groove, located along the length of the convex airfoil surface, appears to be controlled by aerodynamic forces and is thought to represent a channel in which local liquid metal accumulations migrate toward the tip of the blade. The characteristics of this groove are shown in Figure 65; it is about 1-mil deep and 2 1/2 mils wide with corrosion product accumulations along its edges. Figure 66 illustrates a deposit which was localized just aft of this groove.

Figure 66. Convex Surface of TZM Second Stage Blade After 2000 Hour Test. (B320313)

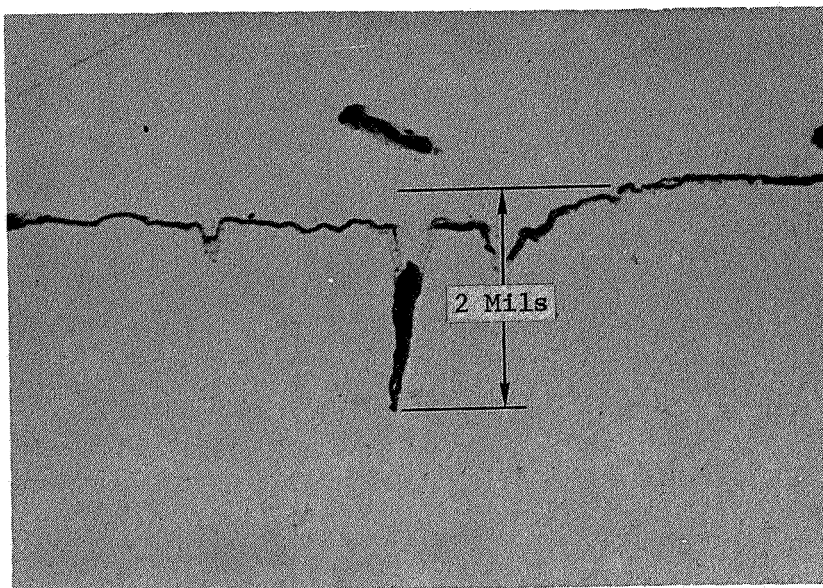
At the tip of the blade, re-entrant grooves have been cut into the surface along the major corrosion trace; these are shown in Figures 67 and 68. At the blade tip and away from the principal corrosion trace, corrosion crevices were noted as shown in Figure 69; it is possible that these represent a form of cavitation corrosion activated perhaps by pressure pulsations as the blade tips pass the pockets in the honeycomb turbine tip shroud.

Figure 69. Tip of TZM Second Stage Turbine Blade Away from Major Corrosion Trace After 2000 Hour Test. (B320212)

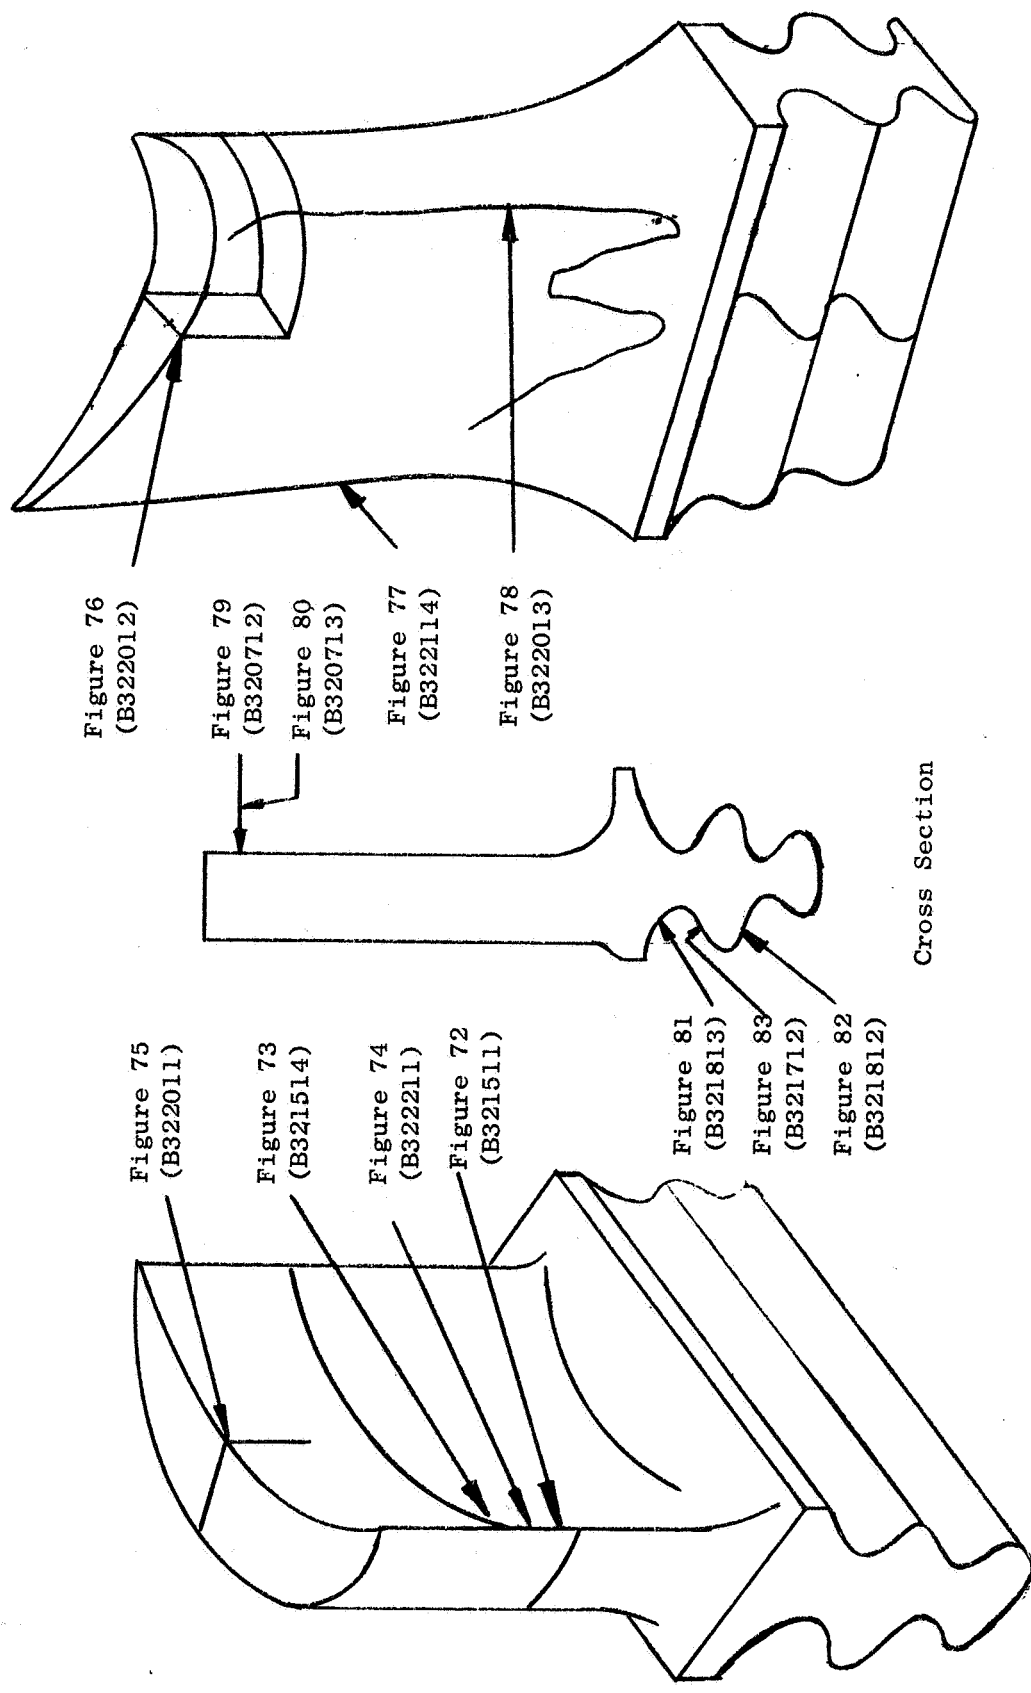
U-700 Blade Micrographs - Figure 70 (sketch) illustrates the locations of typical corrosion areas of a first stage U-700 alloy turbine blade which were examined metallographically for comparison with similar areas of the TZM turbine blade previously discussed. Photomicrographs of these and other areas of interest are shown in Figures 71 through 82.

Figure 70. Location of Selected Micrographs of a U-700 First Stage Blade after 2000-Hour Endurance Test at Approximately 1450 °F.

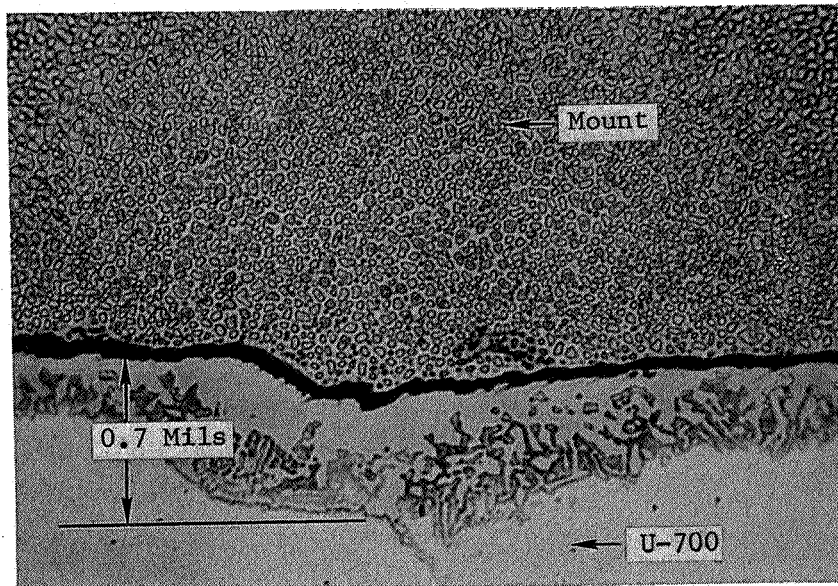
Figure 71 shows the re-entrant nature of the concave leading edge corrosion cavity which is approximately 2 mils deep. Figure 72 shows a surface reaction product 0.7-mil deep which formed immediately aft of the leading edge corrosion

Figure 72. Surface Reaction Product at Concave Leading Edge of a First Stage U-700 Blade After 2000 Hour Endurance Test. (B321514)

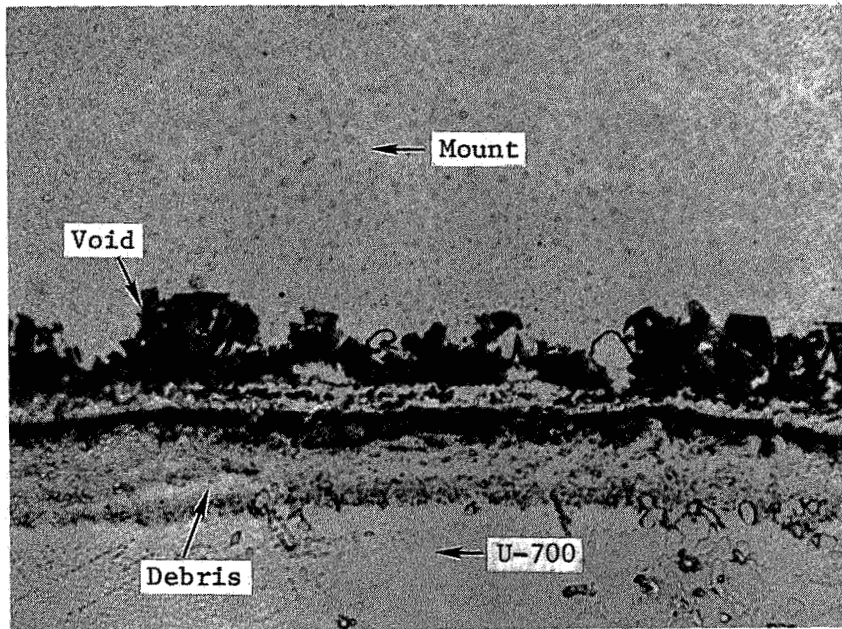
cavity. This formation was observed in several areas of the blade, through the depths measured generally less than 0.2 mil. Figure 73 shows a high magnification of the surface deposit on the concave surface at the leading edge. Figure 73 shows the light surface corrosion and metallic deposit at the concave tip.

Figure 73. Surface Deposit on the Concave Leading Edge of a First Stage Turbine Blade After 2000 Hour Endurance Test. (B322211)

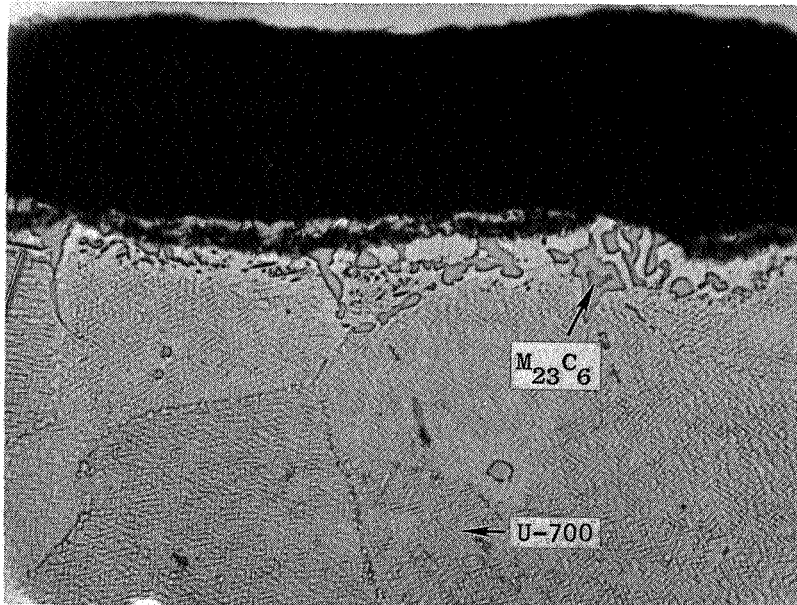
Figures 80 and 81 illustrate the extent of alloy depletion observed on the dovetail surfaces. The dovetail stresses, being considerably higher than the airfoil stresses, could have influenced the coalescence of the particles, probably $M_{23}C_6$ carbides, in the alloy depleted layer visible in dovetail photomicrographs. Figure 82 illustrates an area of the dovetail which had constant contact with the wheel; in this area, which had restricted contact with liquid potassium, no alloy depleted layer is present.

Figure 80. Alloy Depletion at Dovetail Surface of a First Stage U-700 Turbine Blade After 2000 Hour Test. (B321813)
 Etchant: 3% H₂O₂, Electrolytic Mag: 1000X

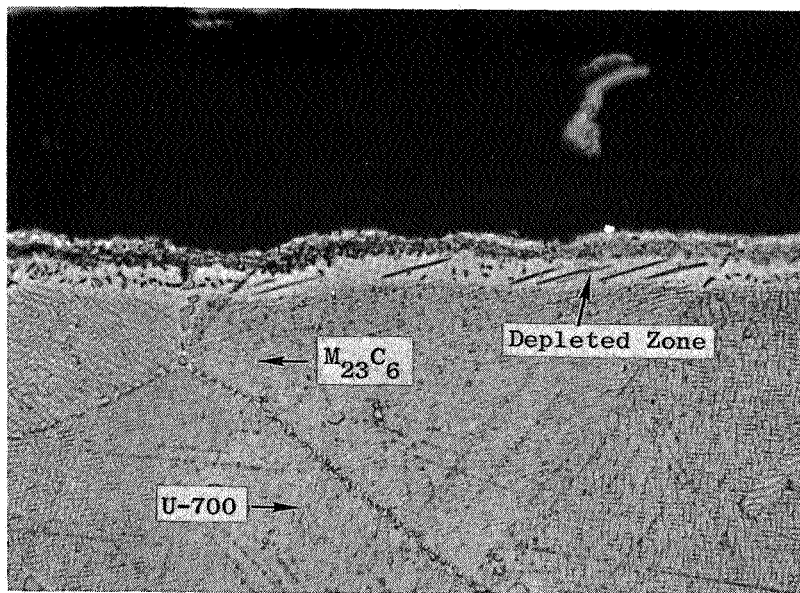
Figure 81. Alloy Depletion at Dovetail Surface of a First Stage U-700 Turbine Blade After 2000 Hour Test. (B321812)
 Etchant: 3% H₂O₂, Electrolytic Mag: 1000X

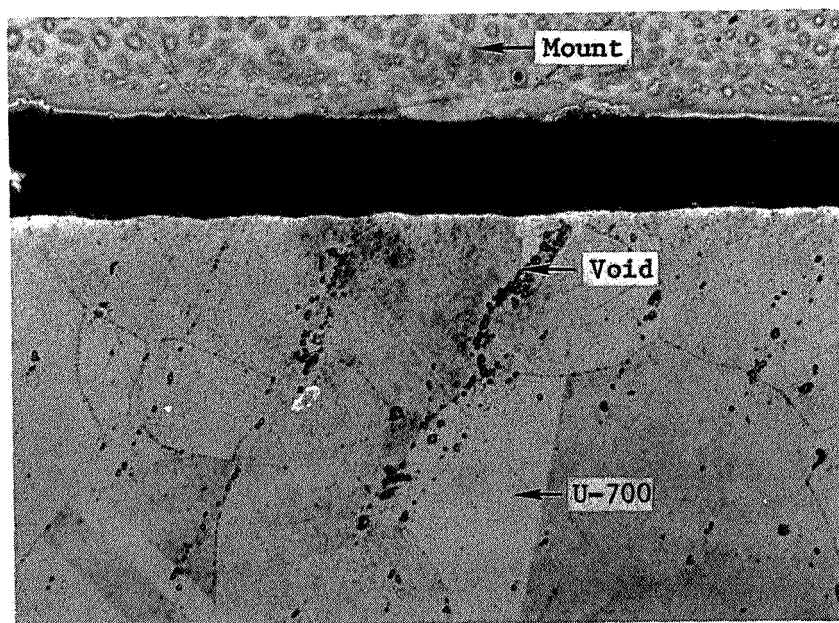
Figure 82. Dovetail Contact Area of a U-700 First Stage Turbine Blade After 2000 Hour Test. Note Lack of Depletion or Corrosion in Area Protected from Potassium. (B321712)

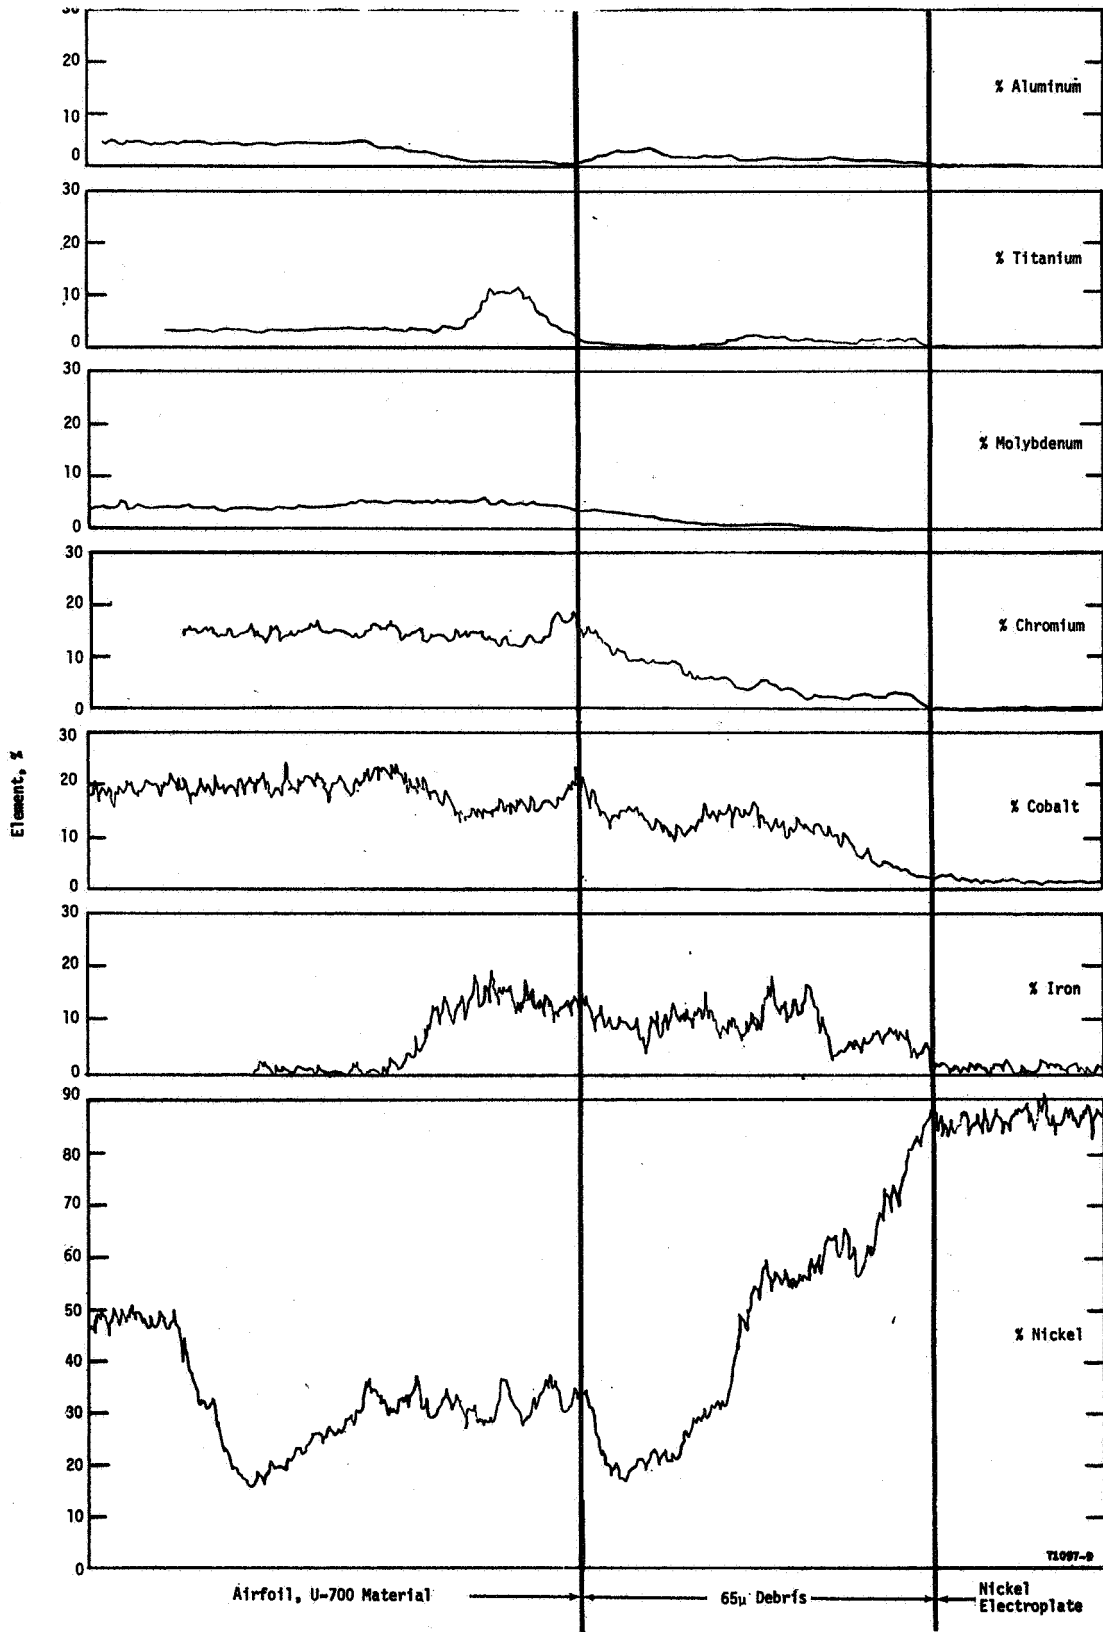
Electron Microprobe Evaluation - Electron microprobe traces were made across the cross section of a first stage U-700 turbine blade from the 2000-hour endurance test hardware. Nickel, iron, chromium, cobalt, molybdenum, titanium, and aluminum content were determined in the nickel electroplate, across the surface of the blade and to a depth of approximately 150 microns (.006 inches) below the surface of the blade. From the traces presented in Figure 83 it is evident that the elements molybdenum, chromium, and cobalt were gradually depleted in the base alloy to a depth of about 4 mils. The iron content was increased to a similar depth from an original value of 5 percent to an average of 15 percent, and the nickel in this same region was reduced from an original value of 50 percent to 20-30 percent. It is also evident that the titanium and aluminum content were altered near the surface. The surface debris was enriched in nickel and iron; it contained approximately 60-80 percent nickel and approximately 10 percent iron. That the surface debris was a deposit was confirmed by (1) its appearance in the photomicrographs, (2) the high iron content diffused into the U-700, and (3) the presence of a high nickel content layer over an area of U-700 which was depleted in nickel.

Figure 83. Electron Microprobe Traces of Surface Debris on First Stage U-700 Turbine Blade from the 2000-Hour Endurance Test.

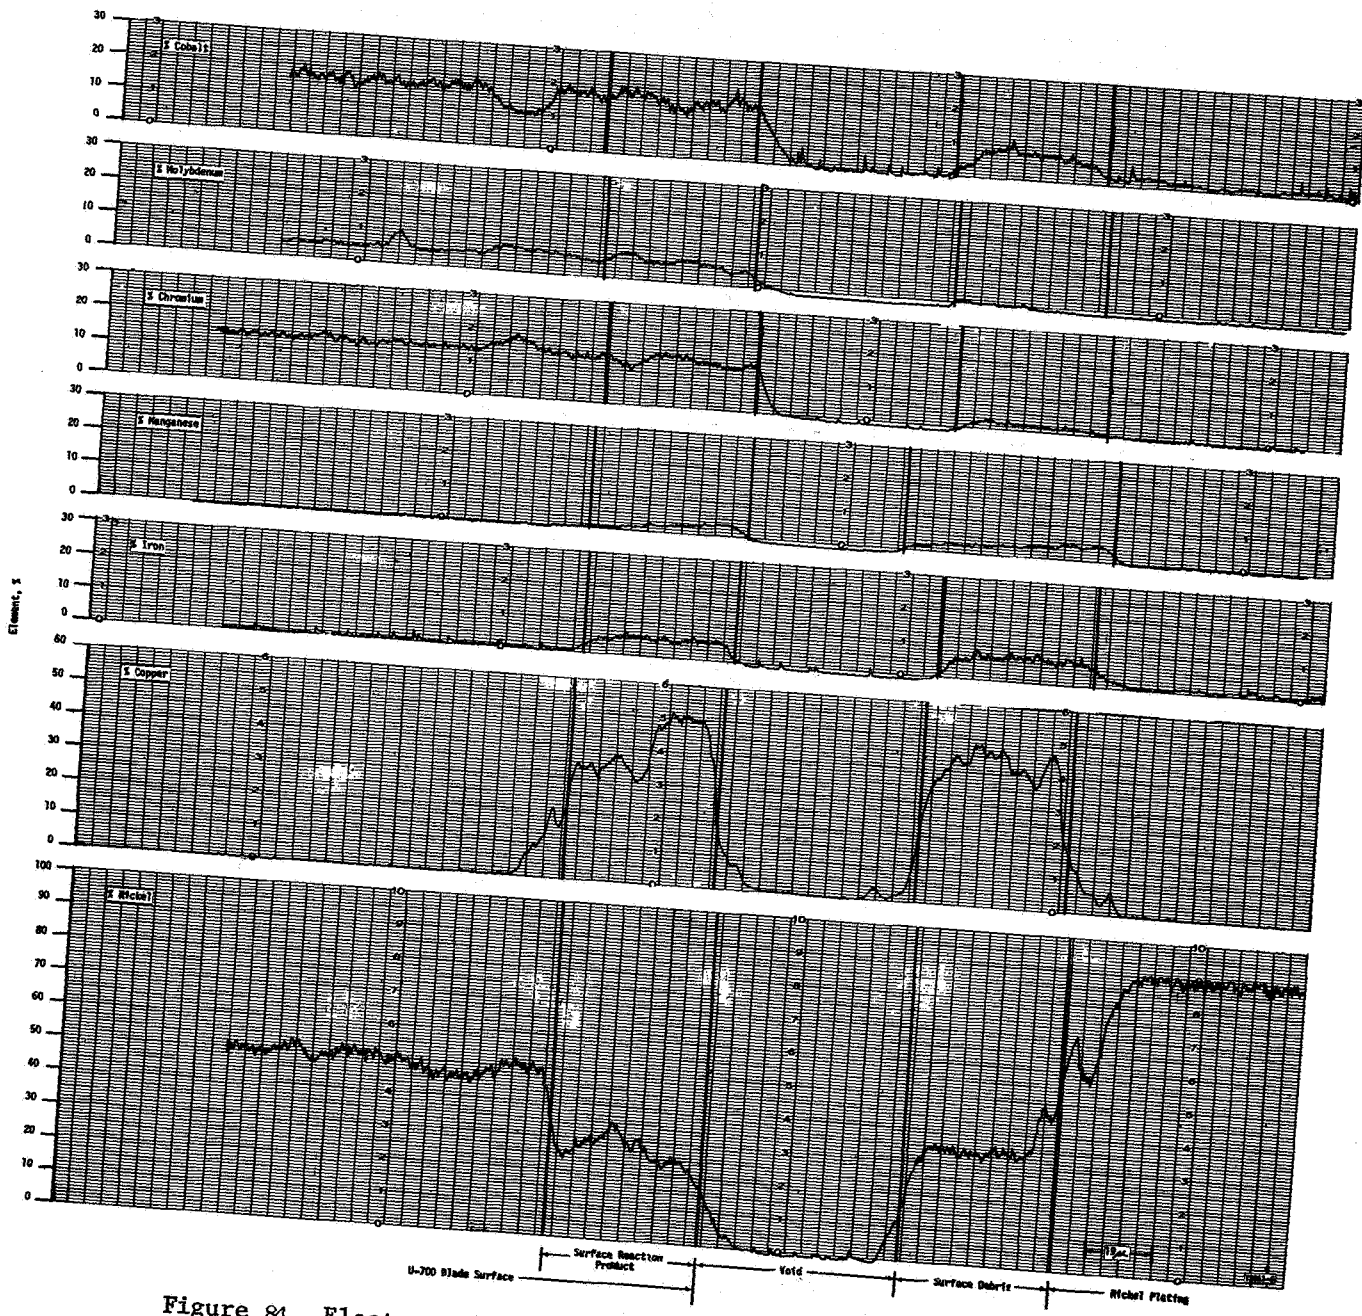
In addition to the above microprobe trace of a surface debris area, a microprobe trace was made of a surface reaction product observed at the convex airfoil surface immediately aft of the leading edge corrosion groove of a 2000-hour, first stage U-700 blade. This phase, which appeared pink when viewed with the optical microscope was found to contain the surprising amount of 40-50 percent copper to a depth of about 2 mils; an increase of 8-9 percent iron over the nominal base metal composition was also observed. The nickel content was found to have dropped to approximately 25 percent from the normal 50 percent alloy content. The electron microprobe traces of this pink phase are presented in Figure 84; in general, study of the other traces indicate that no change occurred in the molybdenum, aluminum, titanium, chromium and cobalt within this phase as compared to the base metal; however, the characteristic compositions of the surface debris were similar in both the above microprobe traces with respect to the base composition.

Figure 84. Electron Microprobe Traces of Surface Reaction Product and Overlaying Debris of First Stage Blade from 2000-Hour Test.

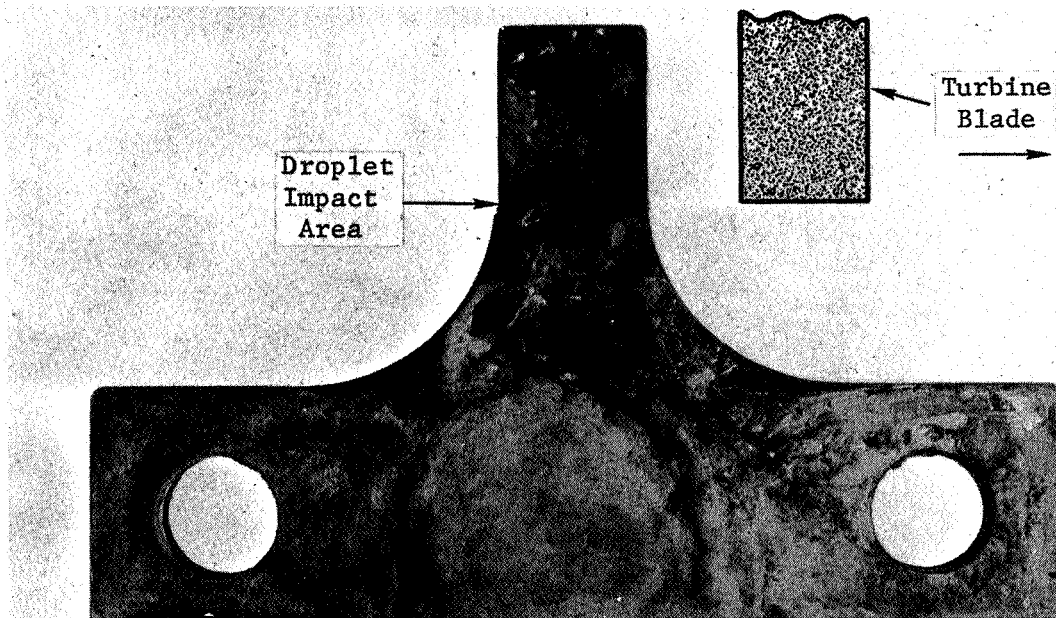
Binocular examination of the inserts after 2000 hours of testing disclosed minor, non-uniform surface deposits and discoloration. These deposits are found to consist of corrosion products and mass transported material similar to that observed on the endurance test blades. Figure 87 shows a typical example of the light surface corrosion and discoloration found on the erosion inserts.

Figure 87. Erosion Insert Showing Typical Discoloration.
(C66012437) Mag: 4X

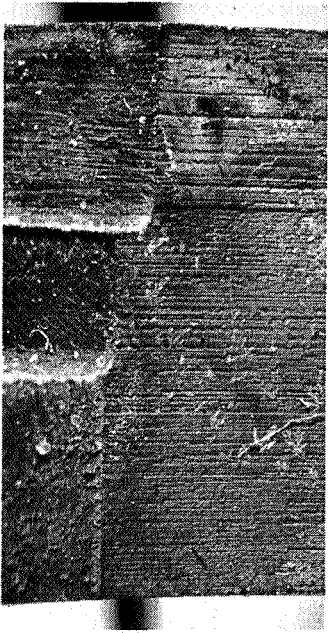
Figure 89. Liquid Potassium Impact Surface of Recrystallized TZM Erosion Insert Specimen Number B-2. Mag: 9X (C66012761)
