NASA CR-925

TWO-STAGE POTASSIUM TEST TURBINE

Volume IV
Materials Support of Performance
and Endurance Tests

Prepared by
GENERAL ELECTRIC
Cincinnati, Ohio
for Lewis Research Center

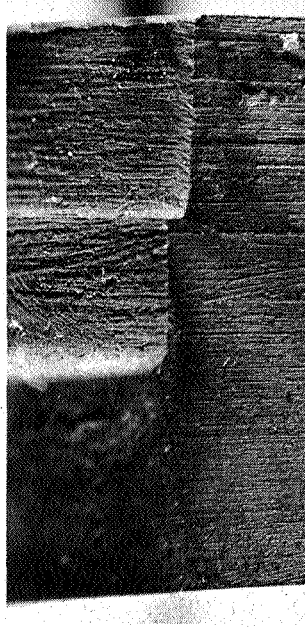
Figure 90. Liquid Potassium Impact Surface of Stress Relieved TZM Erosion Insert Specimen Number C-1. (C66012763) Mag: 9X

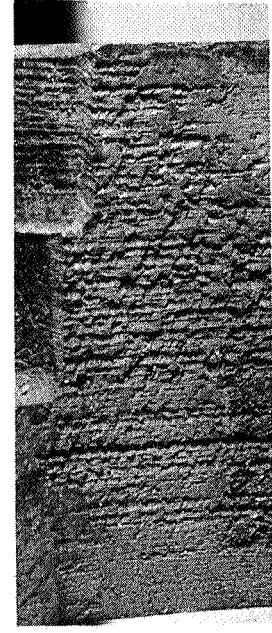
All of the erosion inserts were examined macroscopically before and after surface vapor blasting at magnifications as high as 60X for evidence of erosion. Macrophotos of these are shown in Figures 88 and 91.

Figure 91. Liquid Potassium Impact Surface of As-Received * TZC Erosion Insert Specimen Number D-2. (C66012757) Mag: 9X

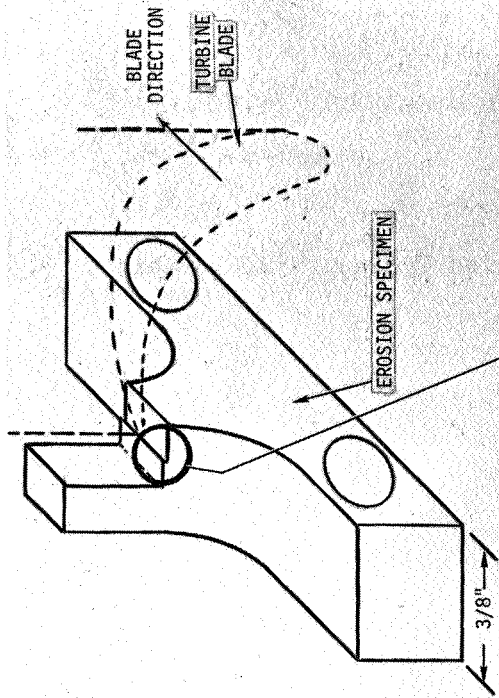
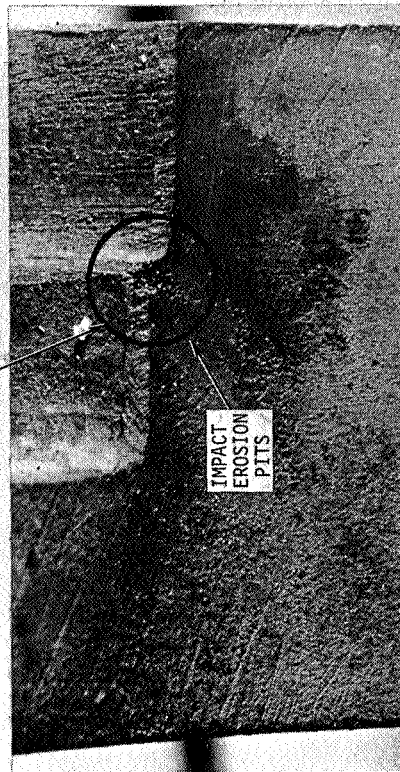
of the second stage blades as seen in Figure 88. These holes in the U-700 erosion inserts were examined metallographically at several planes through the impact erosion area. The holes were found to have a depth-to-diameter ratio of approximately 3 to 5 for the deeper holes. The interior surfaces of the holes were crazed with very small cracks penetrating inward approximately 0.0005-inch in some areas. Photomicrographs of the impact erosion area of U-700 erosion insert number A-3 are presented in Figures 92 through 96. Alloy depletion similar to that observed on the U-700 blades was observed on the U-700 erosion insert as seen in Figures 96 and 97; this surface effect was apparently unrelated to liquid impact as it was present on all exposed surfaces of the insert; this implied that a thin corrosive liquid potassium film was present over the entire insert surface.

Figure 88. Liquid Potassium Impact Surface of U-700 Erosion Insert Specimen Number A-1. Note Impact Erosion at Upper Center. Mag: 9X

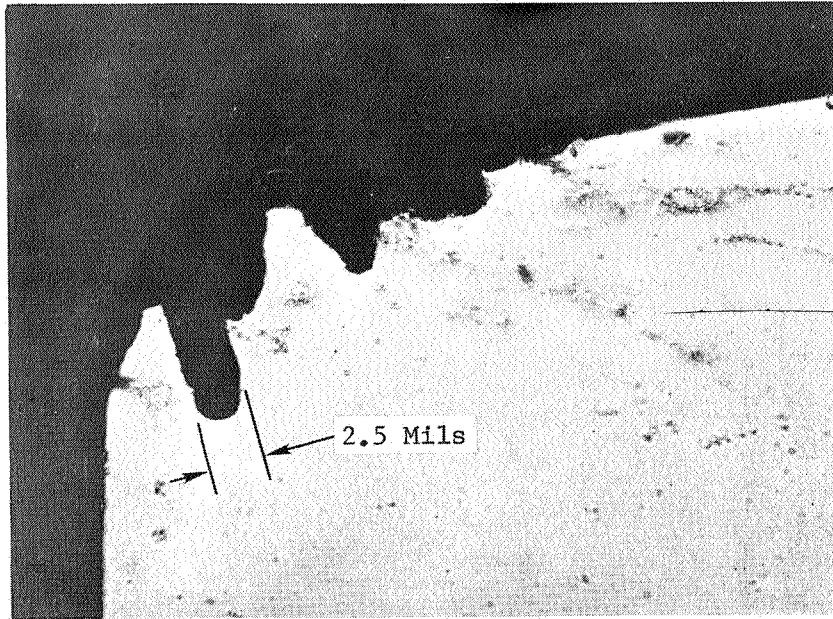
Figure 92. Impact Erosion Pits in U-700 Erosion Insert A-3. (B340111)
Etchant: Unetched Mag: 100X

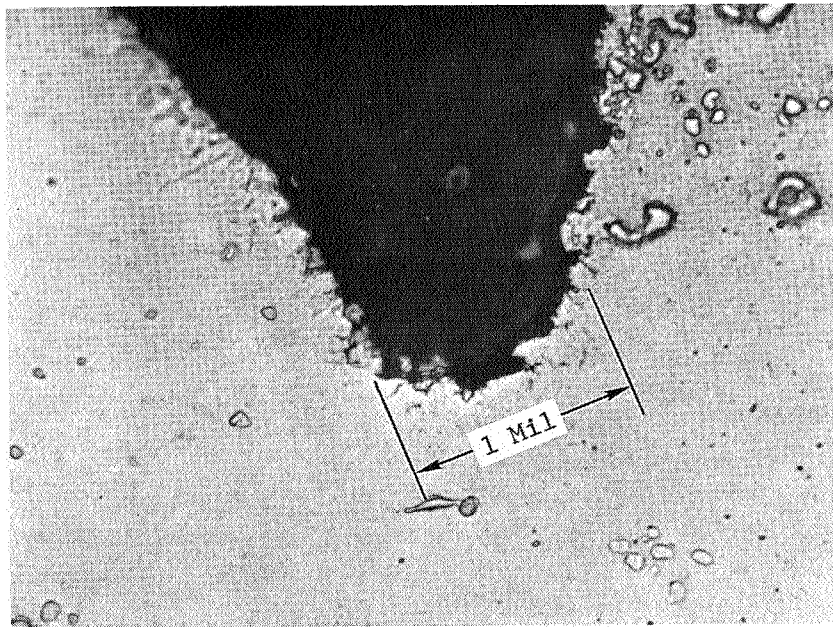
Figure 93. Impact Erosion Pits in U-700 Erosion Insert A-3 (Center Pit
in Above Figure). (B340112)
Etchant: Unetched Mag: 1000X

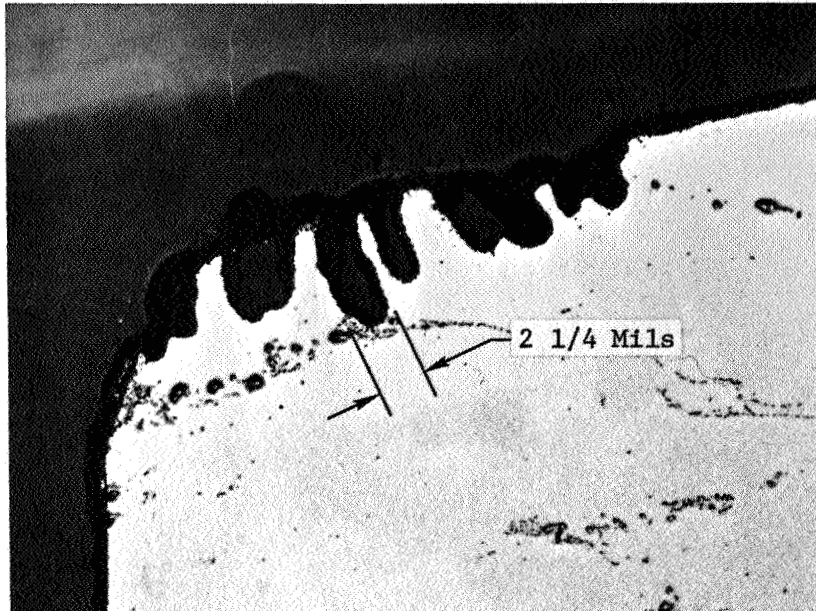
Figure 94. Impact Erosion Pits in U-700 Insert A-3 at a Third Planar Position. (B340117)

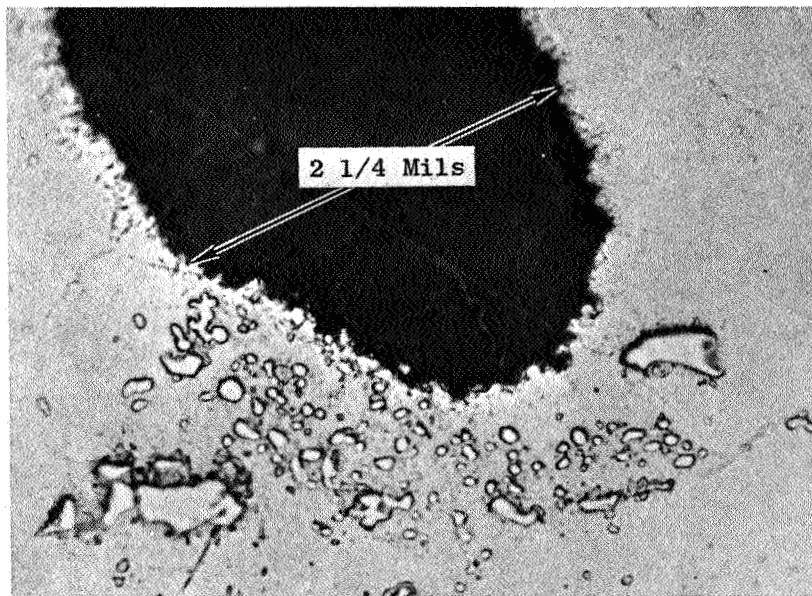
Figure 95. Impact Erosion Pit in U-700 Erosion Insert A-3. (Deepest Pit in Above Figure). (B340116)

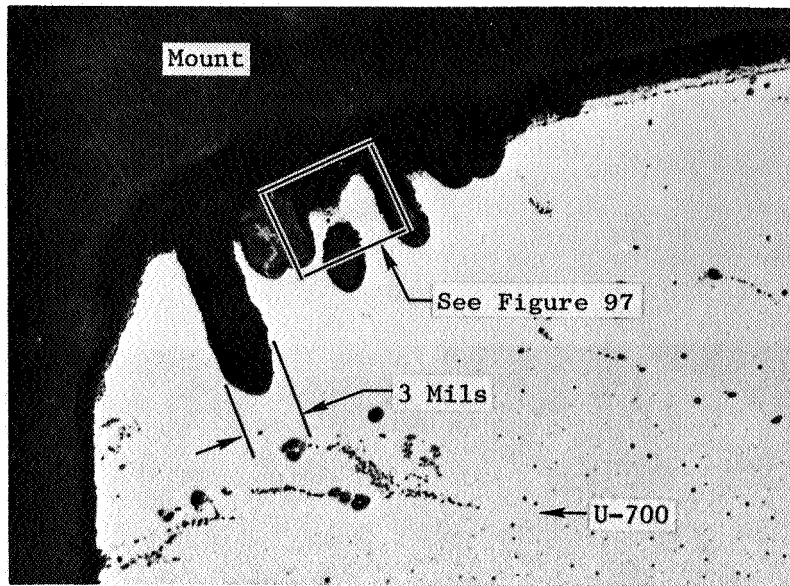
Figure 96. Impact Erosion Pits in U-700 Erosion Insert A-3 at a Second Planar Position. (B340113)

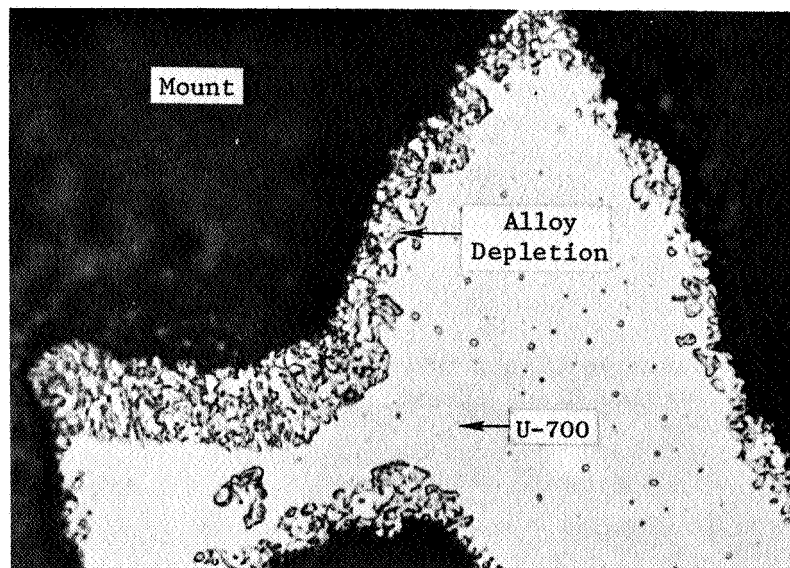
Figure 97. Alloy Depletion in Area of U-700 Impact Erosion Pits (See Above Figure). (B340115)

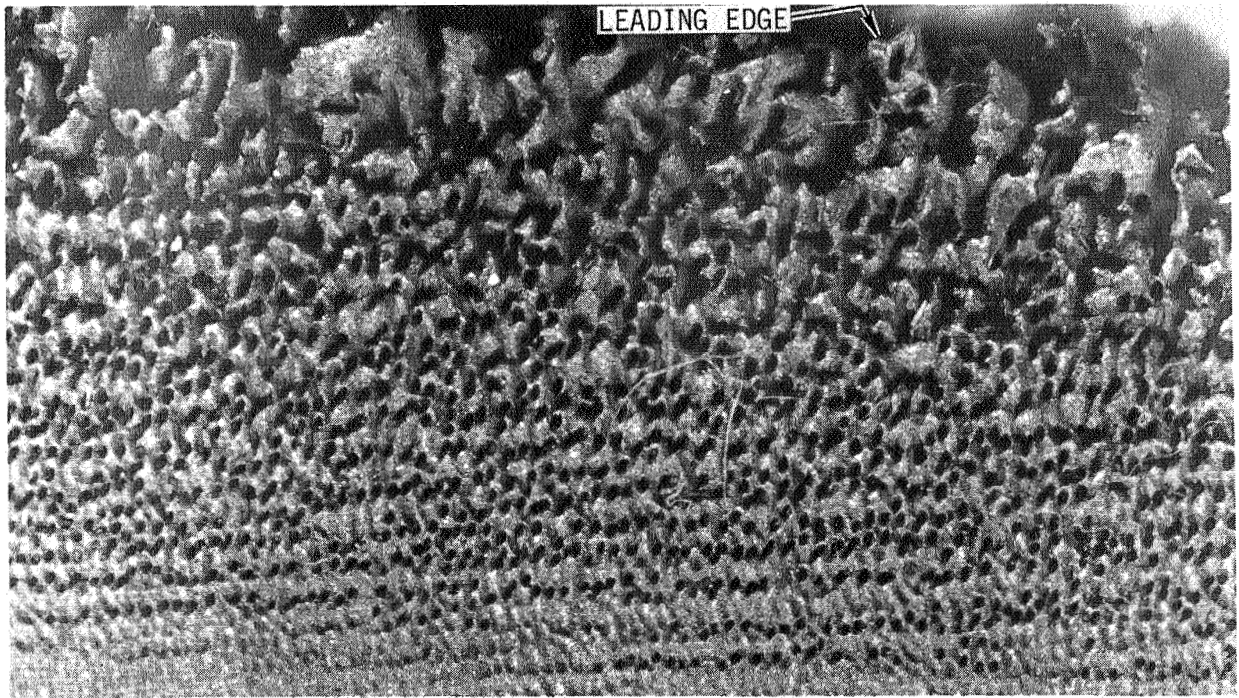
These erosion inserts gave the first evidence of what could be classical liquid droplet impact erosion in the U-700 specimens and similar in nature to steam turbine erosion as seen earlier in macro form in Figure 43, and at larger magnification in Figure 98. The deep holes formed in the exact area where droplets would have been released from the second stage trailing edge blade tips and would have impacted on the erosion insert. The micro-cracks at the base of the holes are indicative of the impact erosion or cavitation erosion methods or mechanical damage. The surface areas between adjacent holes deteriorated either by an apparent randomness in the location of impacting droplets or by disruption of the surface between adjacent holes. At the periphery of the cluster of holes there existed occasional deep holes, with depths 4 to 5 times that of their diameters; these holes had formed in the original surface of the U-700 insert without doing damage to the adjacent surface. This type of erosion was similar to that reported by Hays⁸ for ductile materials in steam turbine erosion. In other examples of erosion, pits in otherwise unaffected surfaces have been noted in multiple droplet impact specimens and in cavitation damaged specimens. In water droplet impact in Stellite 6B erosion shields in steam turbines, deep pits or irregular cross section have been observed with depths of one to two diameters in areas where no adjacent surface damage was noted.

Figure 98. Characteristic Liquid Droplet Impact Erosion on Stellite 6B Steam Turbine Blade Insert. (C65061410)

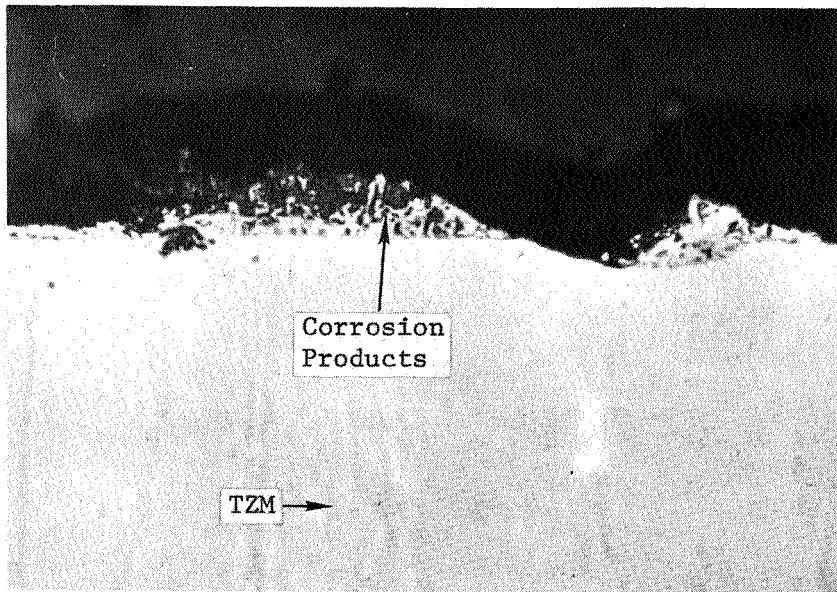
Refractory alloy erosion inserts (stress relieved TZM and as-received TZC) were examined metallographically in an attempt to define more clearly possible indications of corrosion and erosion observed on those specimens. A photomicrograph showing the corroded area on the tip of insert C-3 is presented in Figure 99; it can clearly be seen, by the absence of microcracks and the presence of corrosion products, that corrosion was the cause of metal loss in this particular area.

Figure 99. Liquid Potassium Impact Surface of Stress Relieved TZM Erosion Insert. (B370111)

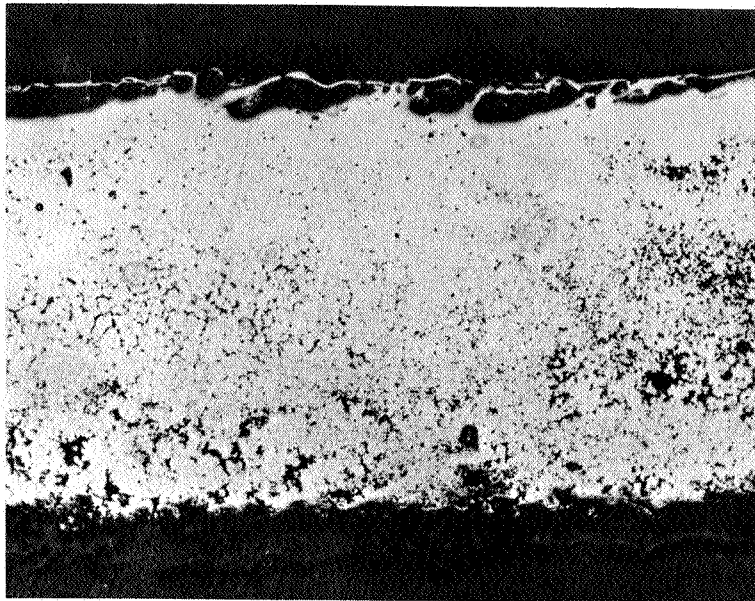
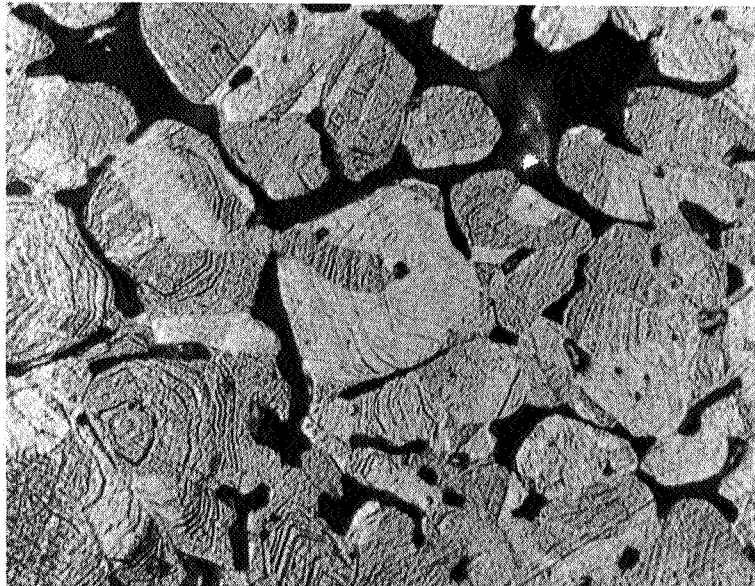
When the convergent-divergent nozzle test section was removed for flange modifications in November 1963, a thick metallic deposit occurred on the far side of the inside surface of the elbow leading into the condenser. The deposit was thickest directly opposite the nozzle, and from that location thinned-out in all directions. The deposit, at its thickest, measured approximately 0.030-inch, and appeared to consist of large laminated particles sintered together. Photomicrographs showing the structure of this deposit are presented in Figure 102. Qualitative spectrographic analysis of the deposit indicated a major concentration of nickel (greater than 10%), a minor concentration of iron (less than 10%) and trace concentrations of chromium, aluminum and cobalt (less than 1%).

Figure 102. Cross Section of Metallic Deposit from CD Nozzle Test, 100X (Top); Enlarged and Etched Section of Metallic Deposit from CD Nozzle Test Showing Vapor Deposition Characteristics, 1000X (Bottom). (C63121252)

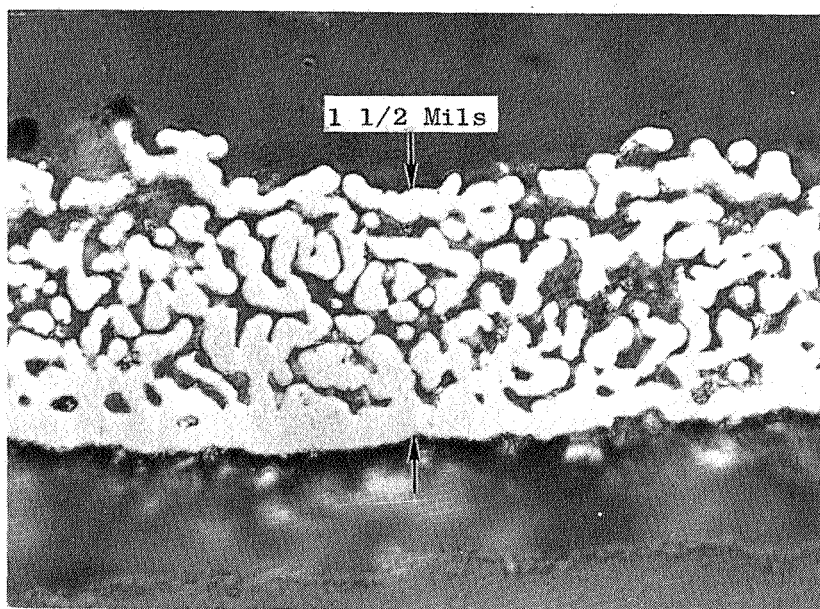
The metallic, mass-transfer deposits which occurred during performance testing were observed in several places. A foil deposit on the 8-inch turbine inlet vapor line immediately downstream of the throttling valve resulted when liquid droplets containing metallic elements in solution were dried-out as they passed through the partially closed valve. This foil deposit was porous and appeared to have grown from the evaporation of liquid droplets and not as impacted, or sintered solid particles of the type previously observed in the convergent-divergent nozzle test. The foil thickness ranged between 0.005-to 0.010-inch thick. The texture of the foil deposit from the 8-inch line is shown in Figure 103.

Figure 103. Metal Foil Removed from the 8-Inch Vapor Line of the 3000 KW Turbine Facility After Performance Testing. (A680111)

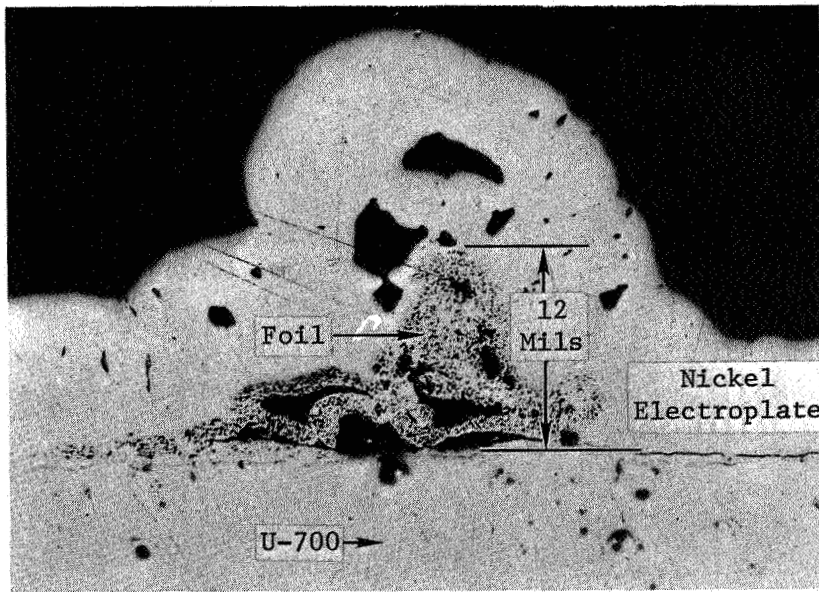
During performance testing, after the facility had been modified to supply drier vapor, a portion of foil deposit, of the above origin, became detached from the inner surface of the 8-inch line and was carried downstream by the high velocity potassium vapor to be re-deposited upon surfaces such as the refractory alloy specimen probe and the inlet guide vanes. Figure 104 shows the nature of foil deposits on the first stage nozzle diaphragm. Figure 105 shows some of these foil particles on the convex side of the first stage turbine blades and to a very minor extent on the second stage blades. Apparently, the foil was ground into very small particles within the first stage, allowing most of these fine particles to pass through the second stage without becoming attached to the airfoil surfaces. The microstructure of impacted foil deposits on the convex airfoil surface of a first stage blade is shown, at two magnifications, in Figures 106 and 107. These foil deposits on the blades were identical in texture to the foil pieces taken from the wall of the 8-inch vapor line downstream of the throttling valve.

Figure 106. Foil Deposit Impacted on a Stage One Blade During Performance Testing. (A610111)

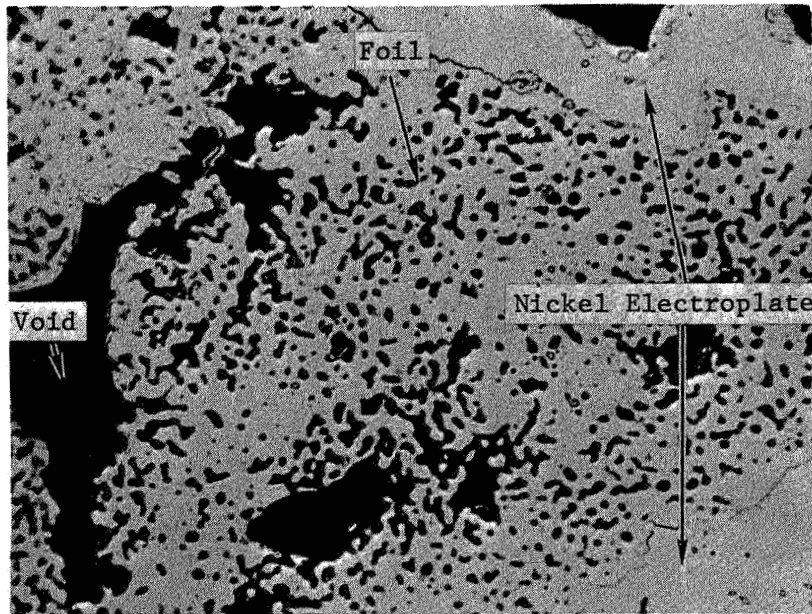
Figure 107. Foil Deposit Impacted on a Stage One Blade During Performance Testing (A610117)

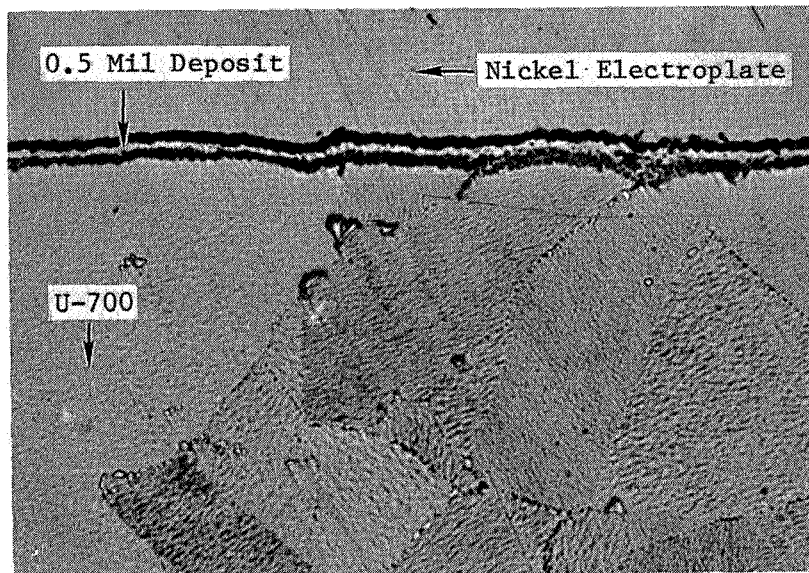
In addition to the presence of impacted metallic foil on the turbine blades, which was noted after performance testing, thin metallic films formed directly on the blades from the evaporation or cooling of liquid droplets in two separate instances. First, very minor traces of such deposits were found on the grossly corroded turbine blades after the first period of turbine checkout, in which the film was detected by electron microprobe analysis. Second, during the 12- and 56-hour periods of performance testing, in which corrosive liquid potassium was not sprayed into the vapor line, a uniform, but thin film of deposited metal accumulated on the airfoil sections of blades from both stages in the turbine. The uniform film thickness on the first stage blades was 0.5-mil as seen in Figure 108 and only 0.2-mil on the second stage blades as seen in Figure 109. As the result of pickup of metallic elements, the first stage blades experienced an average weight gain of 1.13% per blade and the second stage blades gained an average of only 0.023% per blade.

Figure 108. Uniform Metal Film Deposit on a First Stage Blade After 65-Hour Performance Test. (A61011-10)

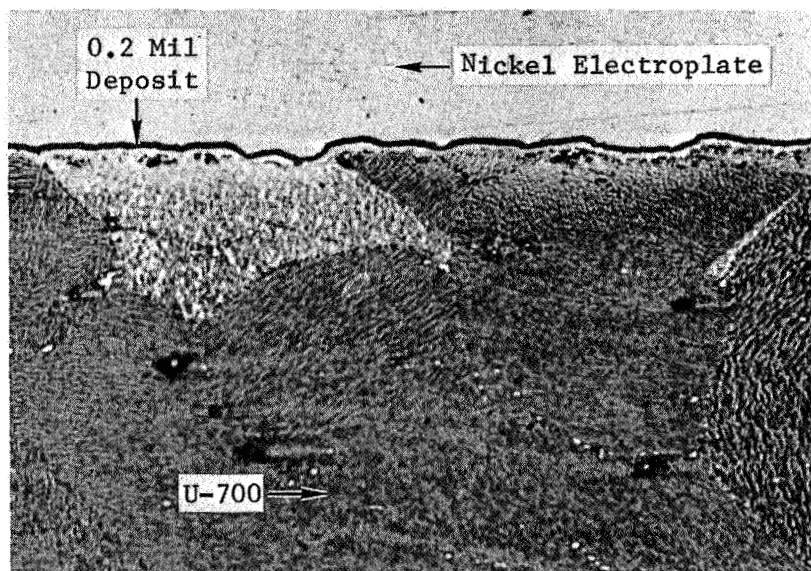
Figure 109. Uniform Metal Film Deposit on a Second Stage Turbine Blade After 65-Hour Performance Test. (A750118)
