GEMINI PROGRAM MISSION REPORT

GEMINI IV

JUNE 1965

NATIONAL AERONAUTICS AND SPACE ADMINISTRATION MANNED SPACECRAFT CENTER

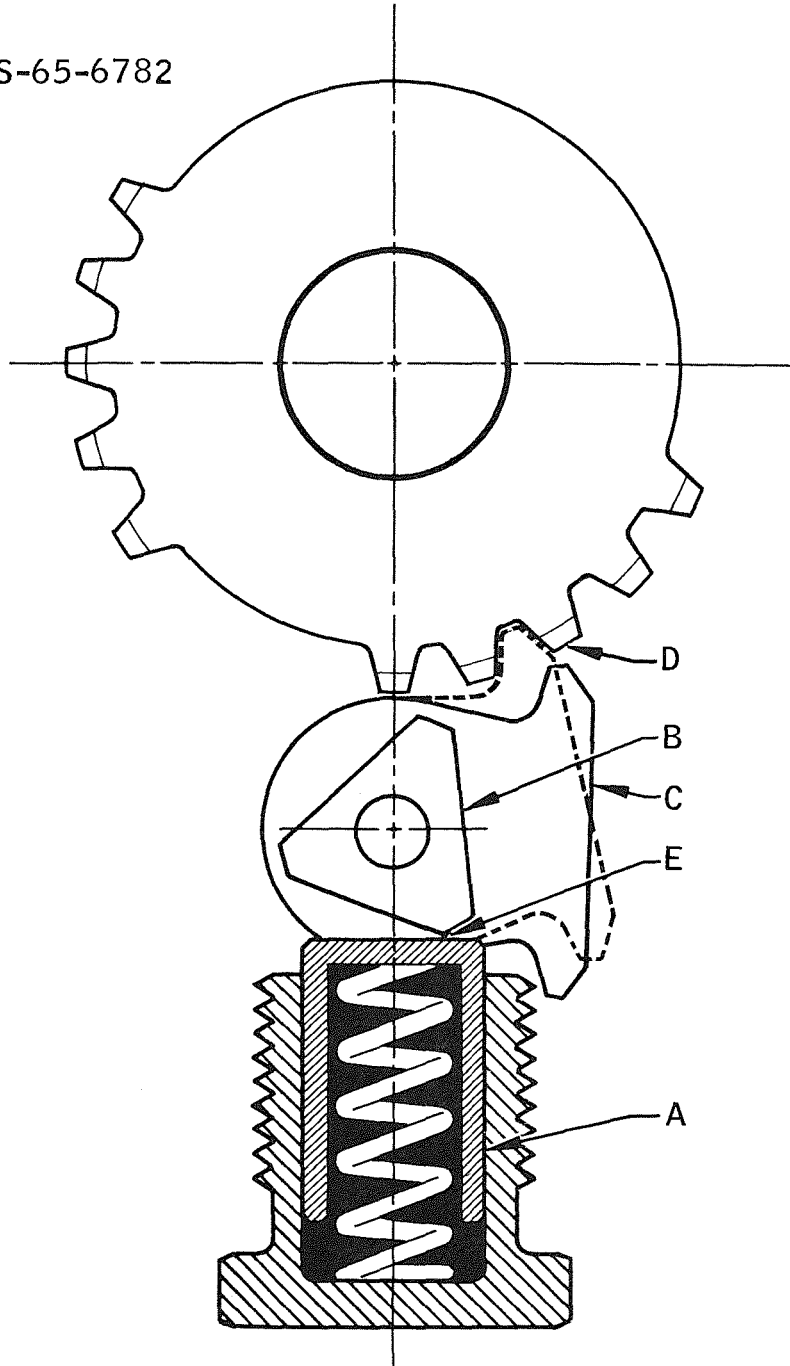
Figure 5.1-7. - Schematic of hatch latching ratchet.

5.1.1.4 Hatch closing and latching difficulty.- The flight crew reported difficulty in closing and latching the hatch after the EVA operation. They reported that the latching system's manual handle moved back and forth freely and that the gain pawl spring return mechanism failed. After moving the handle back and forth several times and manually working the gain pawl, the handle finally caught and the latch mechanism was driven overcenter, locking the hatch to the sill.

Postflight analysis of the spacecraft revealed that the drive pawl spring return was failing, which accounted for the free motion of the handle reported by the pilot. The gain pawl mechanism performed satisfactorily; however, quantitative measurements indicated that its spring return was also marginal in the "lock" position.

Failure of the pawl spring cartridge to operate properly had been experienced on Spacecraft 3 and 6 and corrective action had been taken. Figure 5.1-7 is a schematic diagram illustrating this portion of the

hatch locking mechanism. In the case of the previous failures, it was determined that the spring-driven piston A was sticking in its cylinder and thus preventing it from rotating cam B to cause the ratchet pawl C to engage the drive gear D. The sticking was caused by excess dry film lubricant collecting between the piston and cylinder. The corrective action was to clean all excess lubricant from both the piston and the cylinder, and extensive testing showed no further tendency for the corrected article to fail.

The postflight examination showed that the failure mode was not in the piston and cylinder which moved freely, but in excessive friction at point E where cam B slides on the face of piston A. The piston face was found to be rough and there was an accumulation of the dry film lubricant adhering to cam B at point E.

This corrective action was taken on spacecraft 4. Also, in order to be as safe as possible and to be prepared for any formation of ice in the mechanism, the pilot was instructed in a method to manually assist the spring piston if necessary. This method consists in manually rotating the external selector handle which is on the same shaft as B and C in the direction to cause the pawl to engage the gear.
