# SNAP-8 MATERIALS REPORT FOR JULY - DECEMBER 1965

SEMIANNUAL MATERIALS REPORT

By H. Derow and B. E. Farwell

February 1966

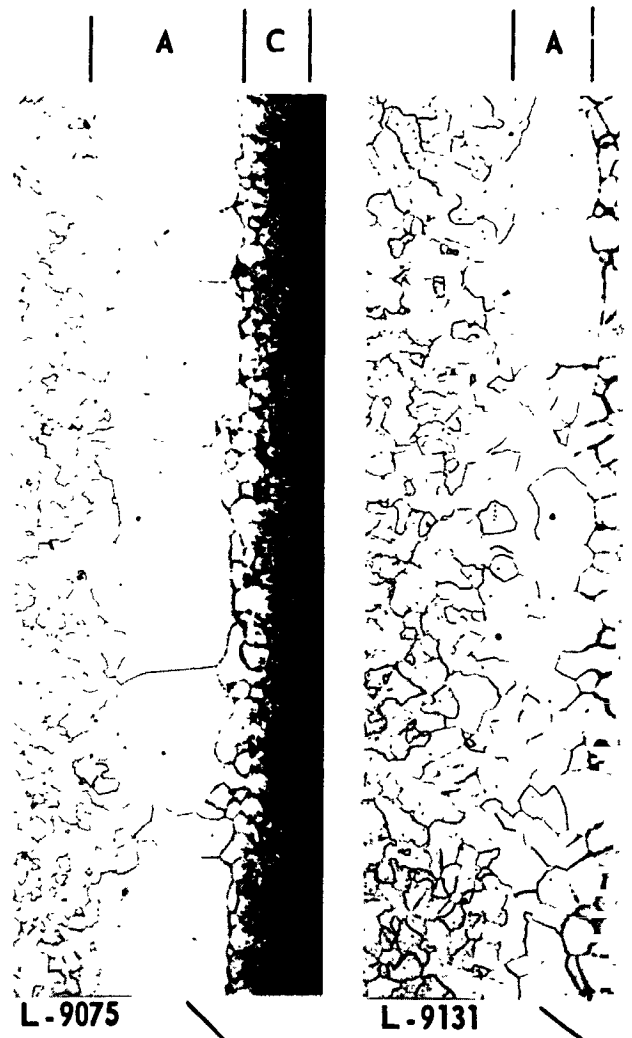
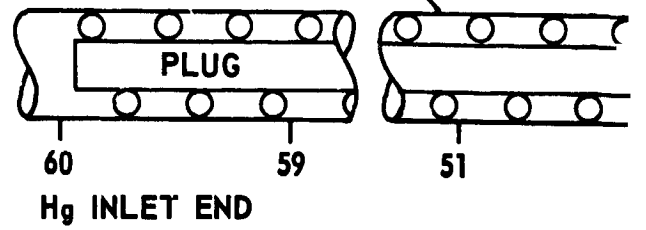
NaK MASS TRANSFER DEPOSIT AT NaK OUTLET

NaK-Exposed Surfaces of Hg Containment Coil No. O-4  
 After 2350 hr of NaK-Side Operation in RPL-2 (Vile:  
 All Areas Show Concomitant Decarburization and Grai.  
 The Former is Delineated at Higher Magnification.  
 Corrosion (Area B) and Mass-Transfer Deposits (Area  
 Present.

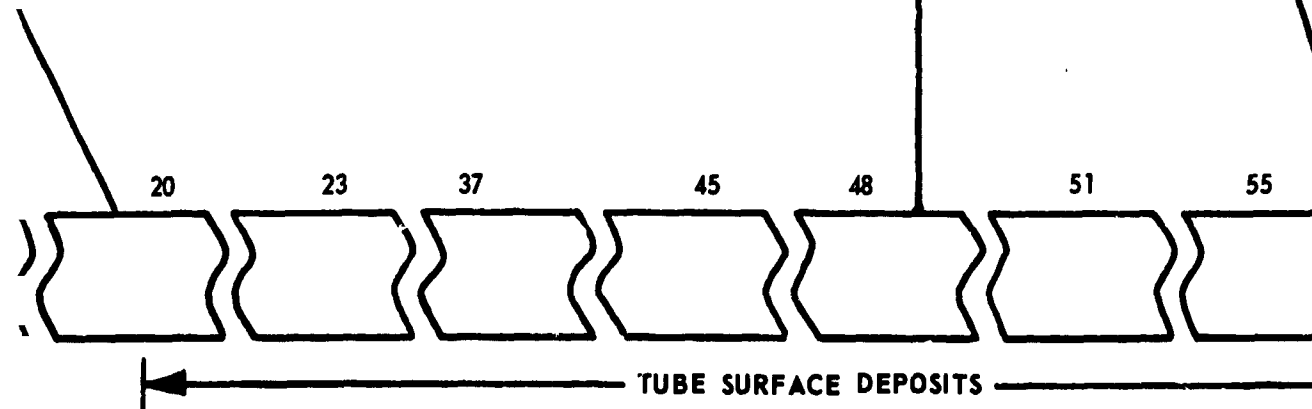
The No. 0-4 tube coil, one of the 2 coils in the outer of the two-layer tube bundle, see Figure 10, was completely dissected, using a band saw. The coil was cut transversely into sections comprising 180° of a single turn. Each section was then cut longitudinally. The surfaces of the tube, twisted tape, and the Hg inlet plug and associated wire were examined for surface effects. Significant findings are summarized below and in Figures 13 and 14.

UNIFORM MASS TRANSFER  
DEPOSIT

Mercury Side of Tube Coil No. 0-4 of -1 Boiler Removed From RPL-2  
After 1415 hr of Mercury Operation

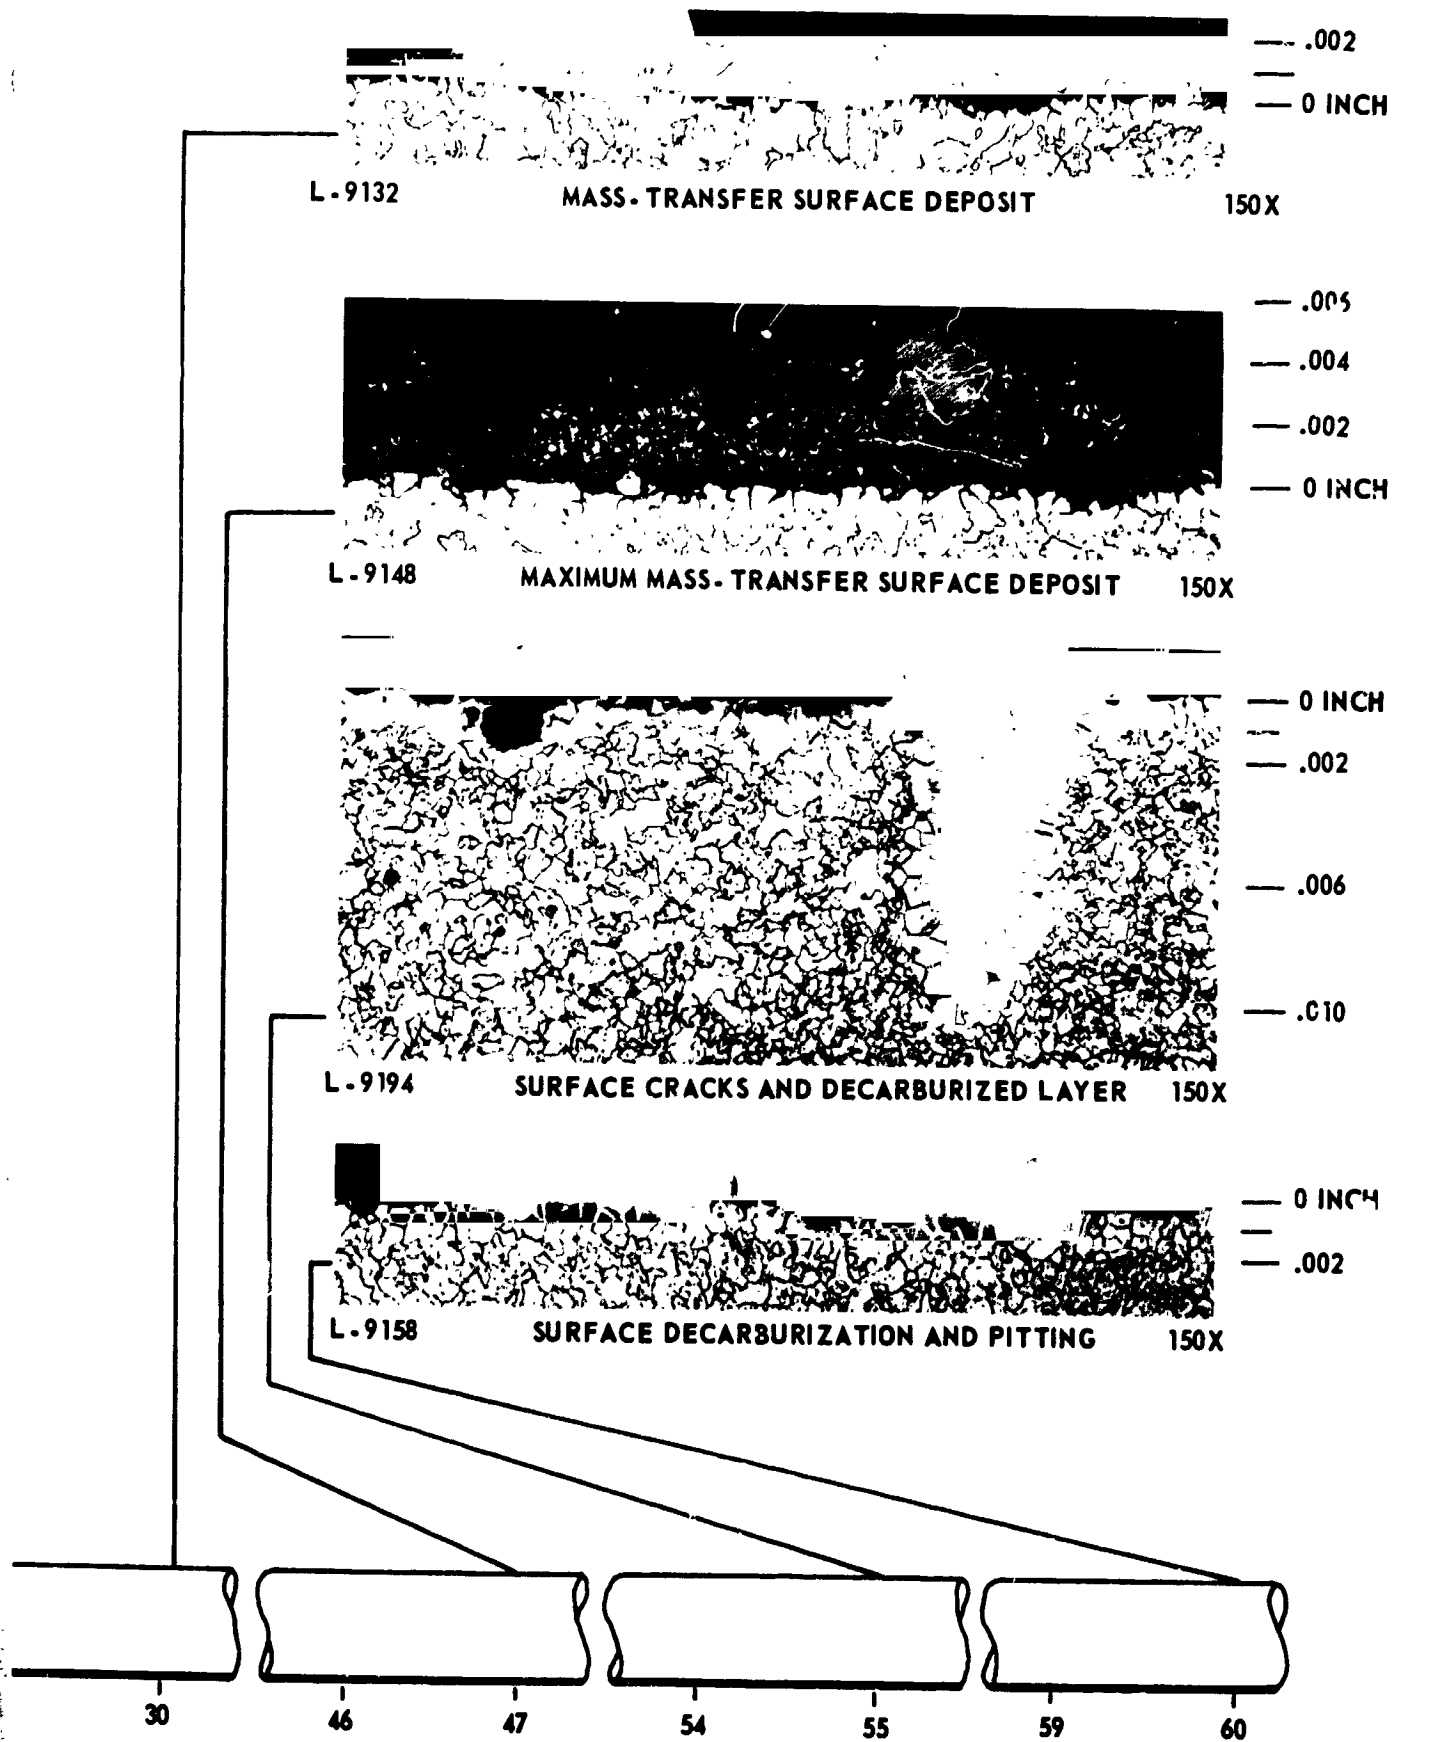
Pitting was found in the first 23 ft of the No. 0-4 tube (measured from the Hg inlet). Figure 14 shows a micrograph of a section of the tube 11 ft from the inlet. The pits were approximately circular, with a diameter-to-depth ratio between 1 and 10 and a maximum depth of 5.5 mils. Figure 15 describes the maximum pit depth distribution along the tube length. There was no apparent orientation of pitting or maximum pit depth with respect to either gravity or centrifugal forces on the flowing Hg. An analysis of the data with respect to temperature, or vapor quality, or both, will be performed in an effort to correlate pitting with localized Hg conditions.

Mercury Exposed Surfaces of Tub  
Boiler After 1415 hr of Operat

Coil No. O-4 Removed from -1  
ion in RPL-2 (Vilella's Etch)

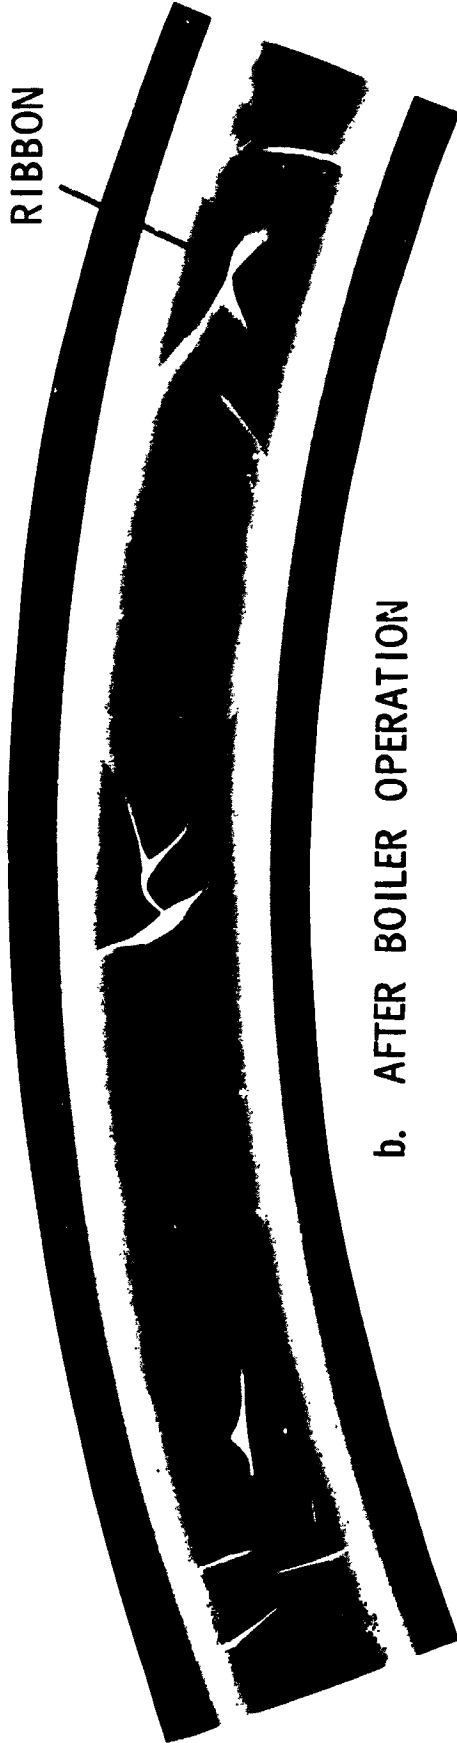
a. DURING BOILER FABRICATION - X-RAY DIRECTION IN PLANE OF COIL

b. AFTER BOILER OPERATION  
X-RAY DIRECTION TRANSVERSE  
TO PLANE OF COIL

X-ray of Twisted Ribbon in Mercury Containment Tube of -1 Boiler  
(P/N 092020-1F, S/N A-1) Boiler Removed from RPL-2 After  
1415 Hr of Mercury-Side Operation

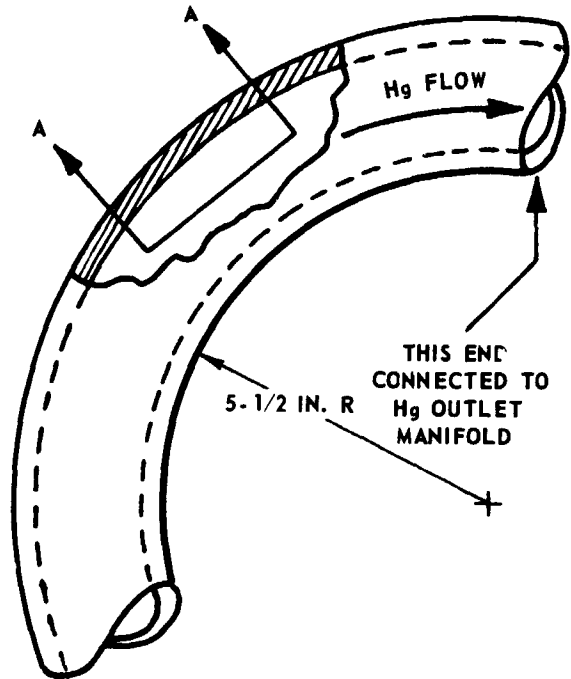
Figure 17

The maximum depth of the internal surface defects in Coil O-4 was 0.012 in. (Figure 17). Some cracks were nearly as wide as they were deep. External intergranular cracks extended to a depth of 0.045 in. (Figure 17). A layer of marked grain growth extended to a depth of approximately 0.030 in. This is consistent with the structure found further down the tube length toward the Hg inlet.

C. MAXIMUM EXTERNAL SURFACE (NaK SIDE) CRACK DEPTH AT SECTION A-A

B. INTERNAL SURFACE (Hg SIDE) CRACKS AT SECTION A-A

Surface Cracks at the 5-1/2-in. Radius Bend at the Hg Outlet Manifold in -1 Boiler Removed from RPL-2. Hg Side Operated 1415 hr; NaK Side Operated 2350 hr.
