SATURN S-1B STAGE
FINAL STATIC TEST REPORT

STAGE S-1B-2

AUGUST 27, 1965

This report describes the acceptance test firing of the Saturn flight stage S-1B-2 conducted at the Static Test Tower East, Marshall Space Flight Center (MSFC), Huntsville, Alabama.

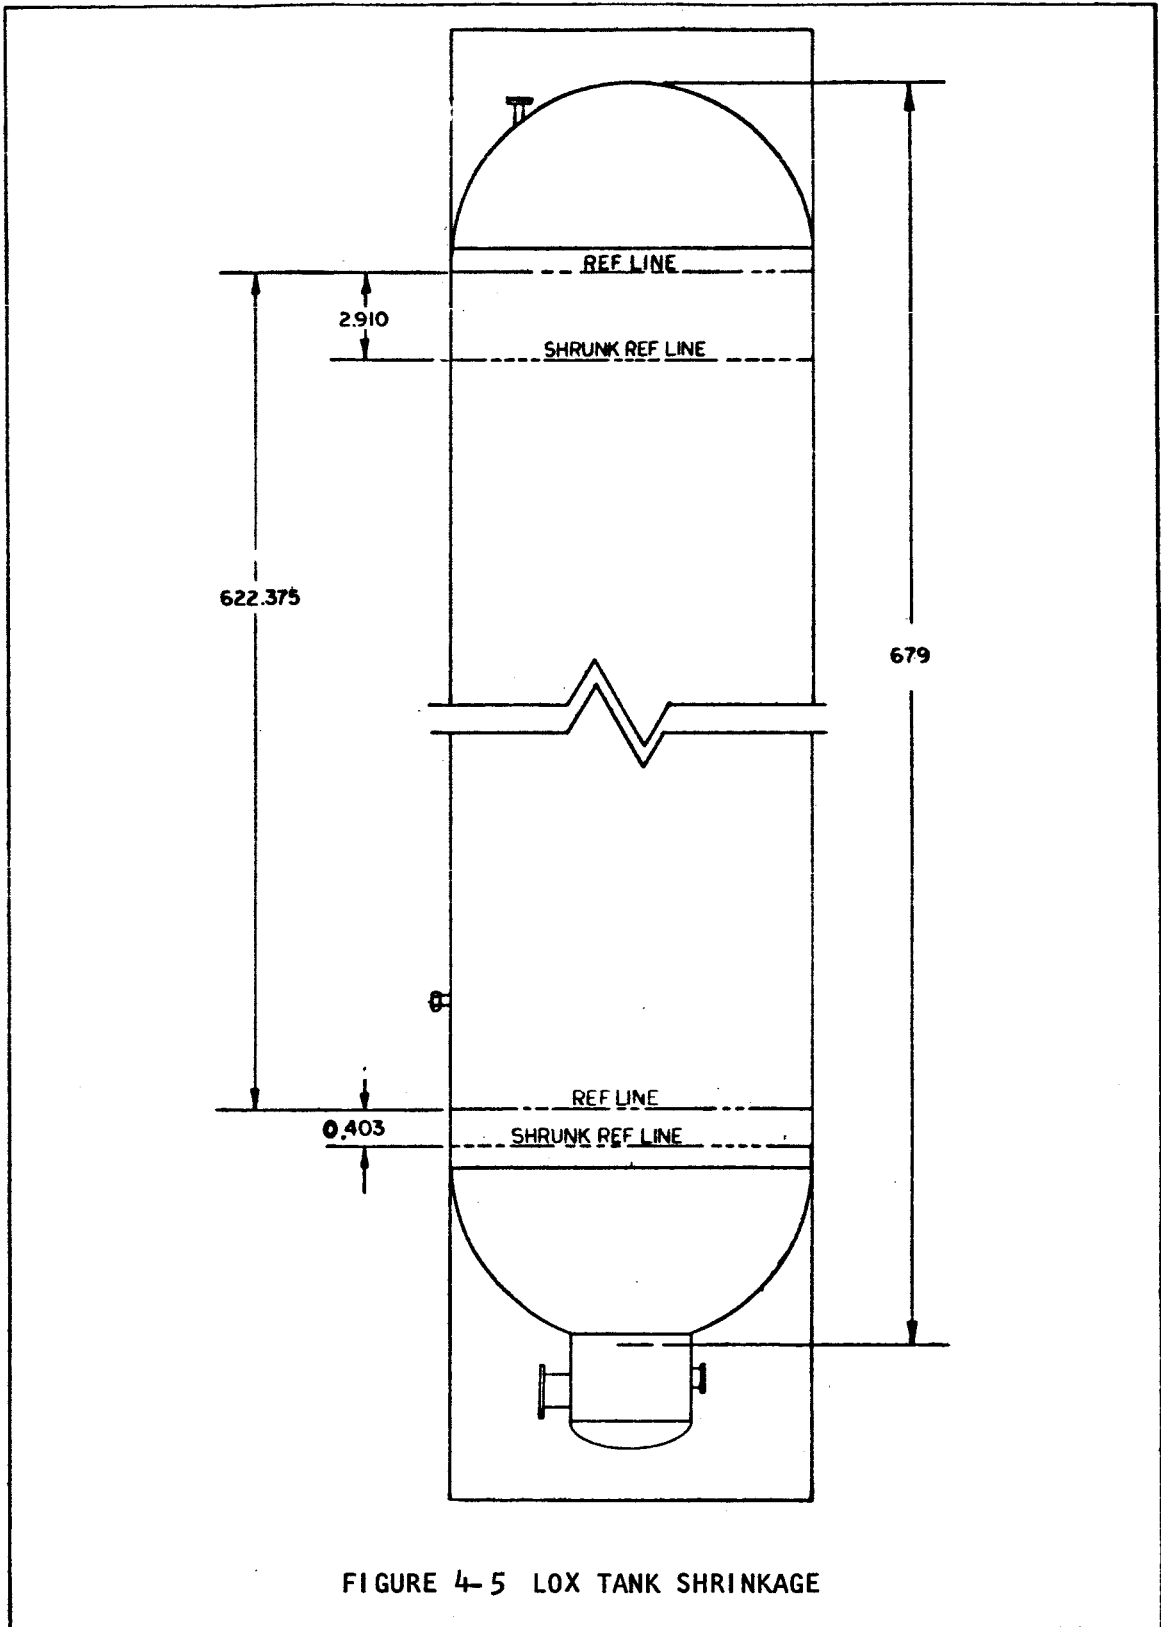
FIGURE 4-5 LOX TANK SHRINKAGE

During the static testing of stage S-1B-2, a shrinkage factor for the LOX tanks was determined. This factor was determined by comparing elevations of the LOX tanks before and after LOX was loaded (see FIGURE 4-5). The result of these comparisons indicate that when LOX is on board, the LOX tanks shrink to 0.9958 of their length at ambient temperature.
