SATURN S-IB STAGE FINAL STATIC TEST REPORT

STAGE S-1B-4

SATURN S-1B STAGE
FINAL STATIC TEST REPORT
STAGE S-1B-4

FEBRUARY 25, 1966

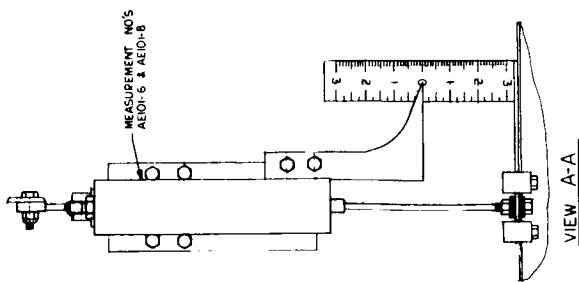
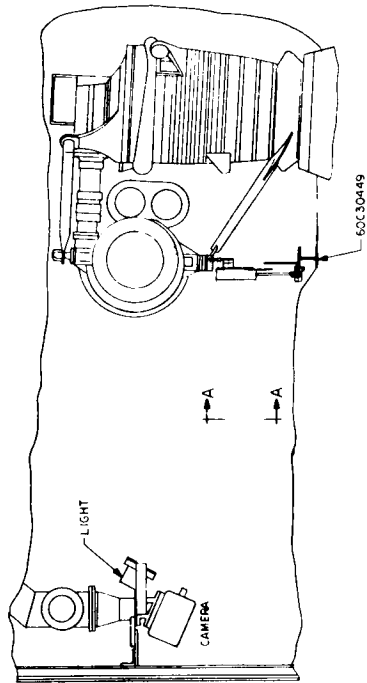
BEAM 60C30459-1
 MAXIMUM DISTORTION NOTED
 FIGURE 5-1

Following, test SA-33, an inspection of the boattail section revealed that these four heat shield support beam assemblies were distorted. The top flanges were deformed as shown in FIGURE 5-1. It is recommended that the study of heat shield beam assembly damage during static firings be continued.

REFERENCE FIG. 5-1	EXTENT OF DAMAGE
1	25 square inches of M-31 fallen away.
2	22 square inches of M-31 fallen away.
3	75 lineal inches of cracked M-31.
4	60 lineal inches of cracked M-31.
5	23 lineal inches of cracked M-31.
6	65 lineal inches of cracked M-31.
7	20 lineal inches of cracked M-31.
8	Tattered reflective heat shield curtain.
9	30 lineal inches of cracked M-31.
10	55 lineal inches of cracked M-31.
11	65 lineal inches of cracked M-31.
12	27 square inches of M-31 fallen away.
13	31 square inches of M-31 fallen away.
14	21 lineal inches of cracked M-31.
15	54 lineal inches of cracked M-31.
16	50 lineal inches of cracked M-31.
17	Tattered reflective heat shield curtain.
18	15 square inches of M-31 fallen away.
19	20 lineal inches of cracked M-31.
20	38 lineal inches of cracked M-31.

REFERENCE FIG. 5-1	EXTENT OF DAMAGE
21	Tattered radiation shield curtain.
22	65 lineal inches of cracked M-31.
23	22 lineal inches of cracked M-31.
24	35 square inches of M-31 fallen away.
25	25 lineal inches of cracked M-31.
26	20 lineal inches of cracked M-31.
27	35 lineal inches of cracked M-31.
28	Tattered reflective heat shield curtain.
29	35 lineal inches of cracked M-31.
30	48 lineal inches of cracked M-31.
31	65 lineal inches of cracked M-31.
32	40 lineal inches of cracked M-31.
33	21 lineal inches of cracked M-31.
34	25 lineal inches of cracked M-31.
35	Tattered reflective heat shield curtain.
36	28 lineal inches of cracked M-31.
