SATURN S-IB STAGE

ASSEMBLY AND TEST REPORT

S-IB-1

SATURN
S-IB STAGE
ASSEMBLY AND TEST REPORT
S-IB-1

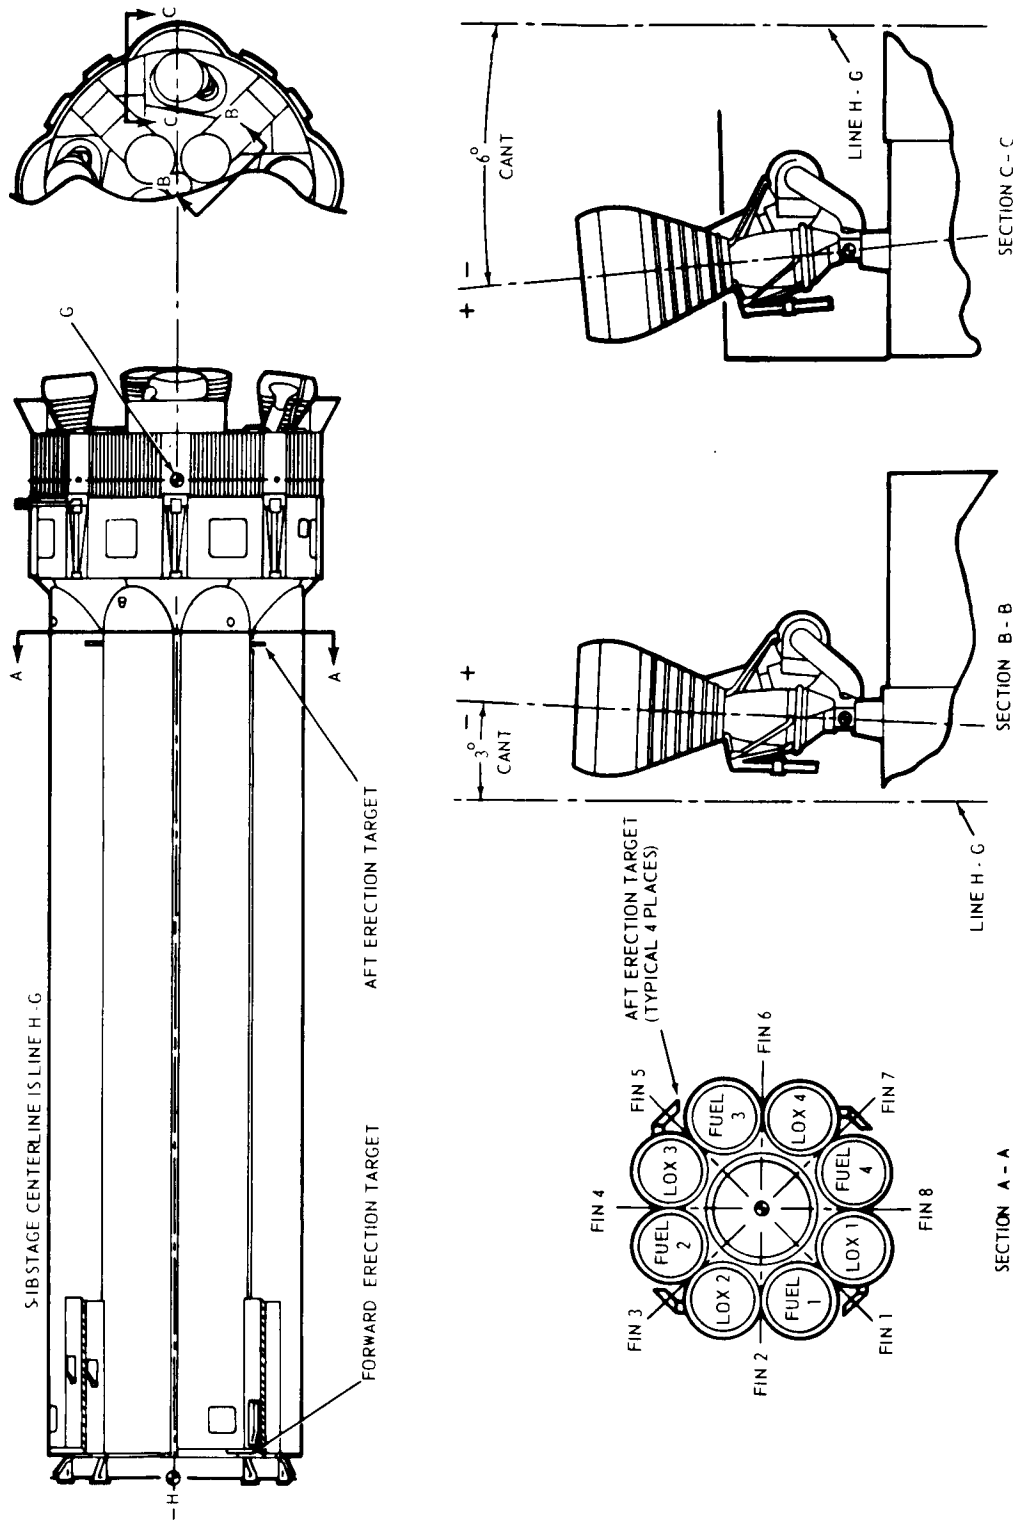
Figure 3-1. S-IB Stage Alignment Data

3.2.1.2 The engine rotational deflection tests on stage S-IB-1 were conducted and accepted on February 22, 1965. The maximum gimbal-joint deflection recorded on stage S-IB-1 was 11 degrees which occurred on the lox wraparound gimbal-joint, middle bellows, on engine 2 and on the lox wraparound gimbal-joint nearest the engine, on engine 1 when fin 1 was at 45 degrees counterclockwise (aft looking forward).
