SATURN STAGE S-1-8
FINAL STATIC TEST REPORT

by
J. K. Crawford
August 5, 1964

Chrysler Corporation Space Division
Huntsville, Alabama

This report describes the acceptance test firing of the Saturn flight stage S-1-8 conducted at the Static Test Tower East, Marshall Space Flight Center (MSFC), Huntsville, Alabama.

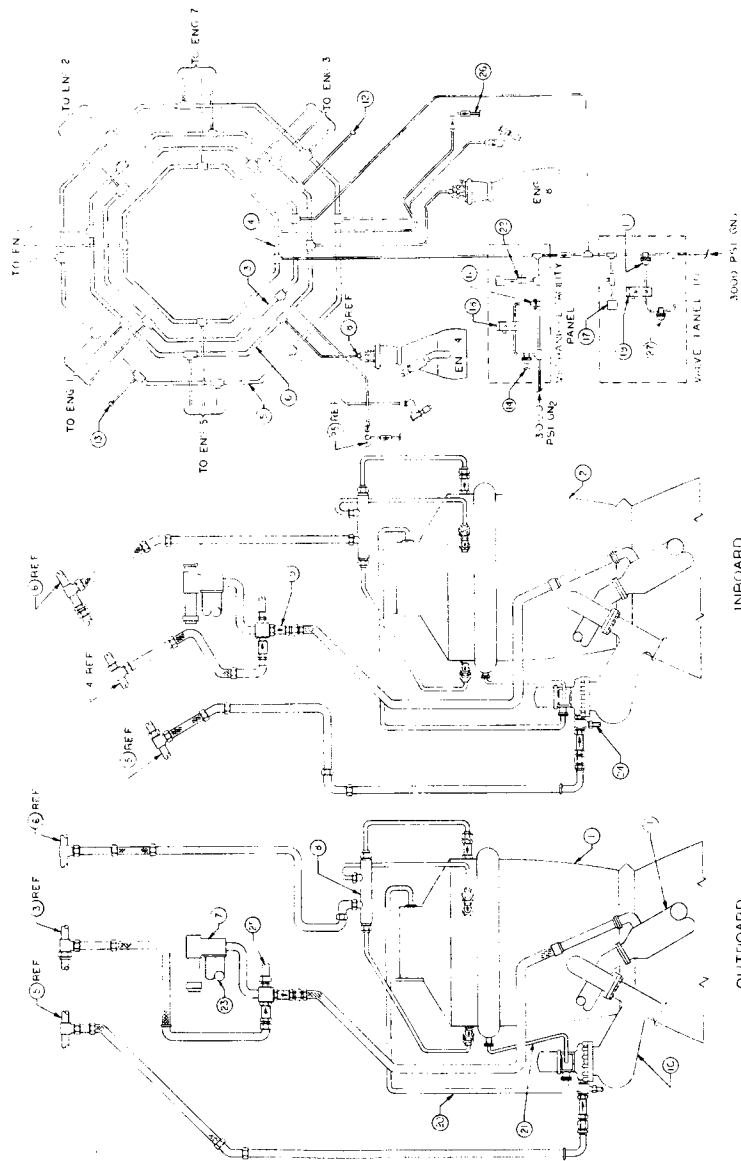
H-1 ENGINE PURGE SYSTEM FIGURE 2-3

In an attempt to alleviate the problem of contamination on the inboard engine LOX domes and injectors, a separate purge manifold identical to the one that was installed on stage S-1-9, was incorporated on stage S-1-8. This purge manifold has two supply lines, one for the regular 250 psig LOX dome purge, and a second supply line for the auxiliary 650 psig LOX dome purge. The auxiliary LOX dome purge supply solenoid is programmed to open at inboard engine cutoff signal and remain active until reset (reference FIGURE 2-3).

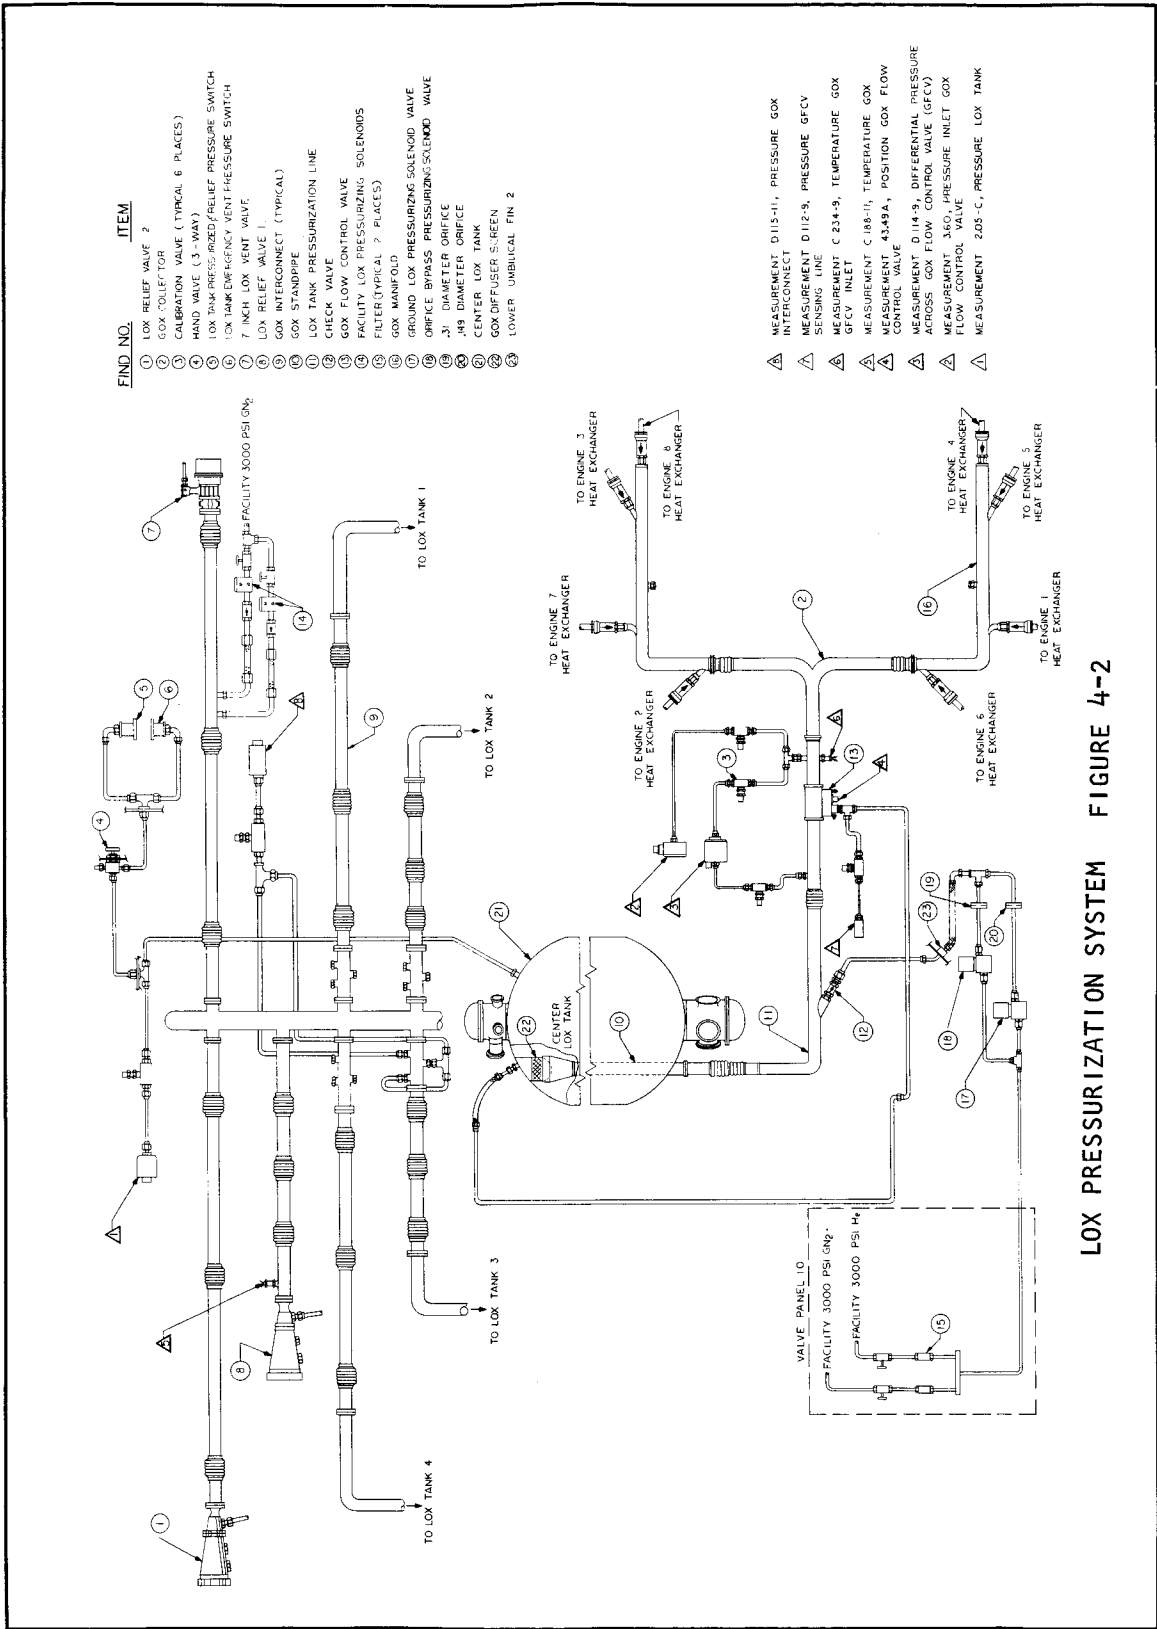
LOX PRESSURIZATION SYSTEM FIGURE 4-2

Items 4 and 5 are peculiar to the small LOX tank ullage. LOX in the GOX standpipe is characterized by heavy frost on the GOX line beneath LOX tank 0-C. LOX was observed emitting from the 7-inch vent and LOX relief No. 1 vent extensions, which increased when LOX bubbling was initiated. These problems were investigated by Systems Static Test

2. Venting of the LOX tanks at small ullages causes the LOX level in the center tank to rise and flow out the vents and overflow into the GOX line.
3. Helium bubbling causes liquid level disturbance and increases the height differential between the center LOX tank and the outer LOX tanks. Helium bubbling at the small ullages also causes LOX to flow out the vents and overflow into the GOX line.

LOX tank pressure exceeded the specified limits of 50 ± 2.5 psia during tests SA-20 and SA-21 as it did during tests SA-18 and SA-19 of stage S-1-9. After test SA-20 ignition, LOX tank pressure decayed to 51.1 psia at X+9 seconds, then gradually increased and reached a maximum of 54 psia at X+30 seconds, after which time it slowly decayed to 52.7 psia at cutoff. Following ignition on test SA-21, LOX tank pressure dropped to 53.9 psia at X+9 seconds, then gradually increased to a maximum of 54.4 psia at X+28 seconds, after which time it slowly decayed to 49.9 psia at outboard engine cutoff signal. A plot of center LOX tank pressure (measurement 2.05-C) versus time for tests SA-20 and SA-21 is shown in GRAPH 4-1. Due to this recurring problem of LOX tank overpressurization, UCR CSD-S-00091 was written. This UCR recommends that further studies be initiated to determine whether the LOX-to-heat-exchanger orifices are too large, whether the closed stop setting on the GOX flow control valve (GFCV) is improper, or whether LOX tank overpressurization is caused by a combination of these factors. If this study indicates that the LOX pressurization system performance is satisfactory, it is recommended that the LOX system pressure specification be changed to comply with system performance. An additional factor to consider is that the GFCV did not go fully closed. This problem is discussed in the following paragraph.

The GFCV position trace (measurement 43.49A) did not indicate that the GFCV reached the fully closed position during either test SA-20 or SA-21. The GFCV reached 98 percent closed and 96 percent closed during tests SA-20 and SA-21, respectively, and since the LOX tank pressure was above 52.5 psia, the GFCV should have been 100 percent closed (reference GRAPH 4-2). No cyclic movement of the GFCV gate was noted during either test. Similar indications of the GFCV not going fully closed were observed during the static tests for stages S-1-7 and S-1-9. During post-static checkout of both of these stages, the GFCV thrust bearings were inspected and found to be damaged. The indication of the GFCV not going fully closed tends to substantiate the theory that the thrust bearing of the valve is damaged. It was recommended in the Preliminary Static Test Reports for tests SA-20 and SA-21 that the GFCV on stage S-1-8 be inspected for thrust bearing damage during post-static

As a result of the special LOX loading test, it was recommended that the LOX tank vents should be closed during the final stages of LOX topoff and should remain closed until the conclusion of the test firing.

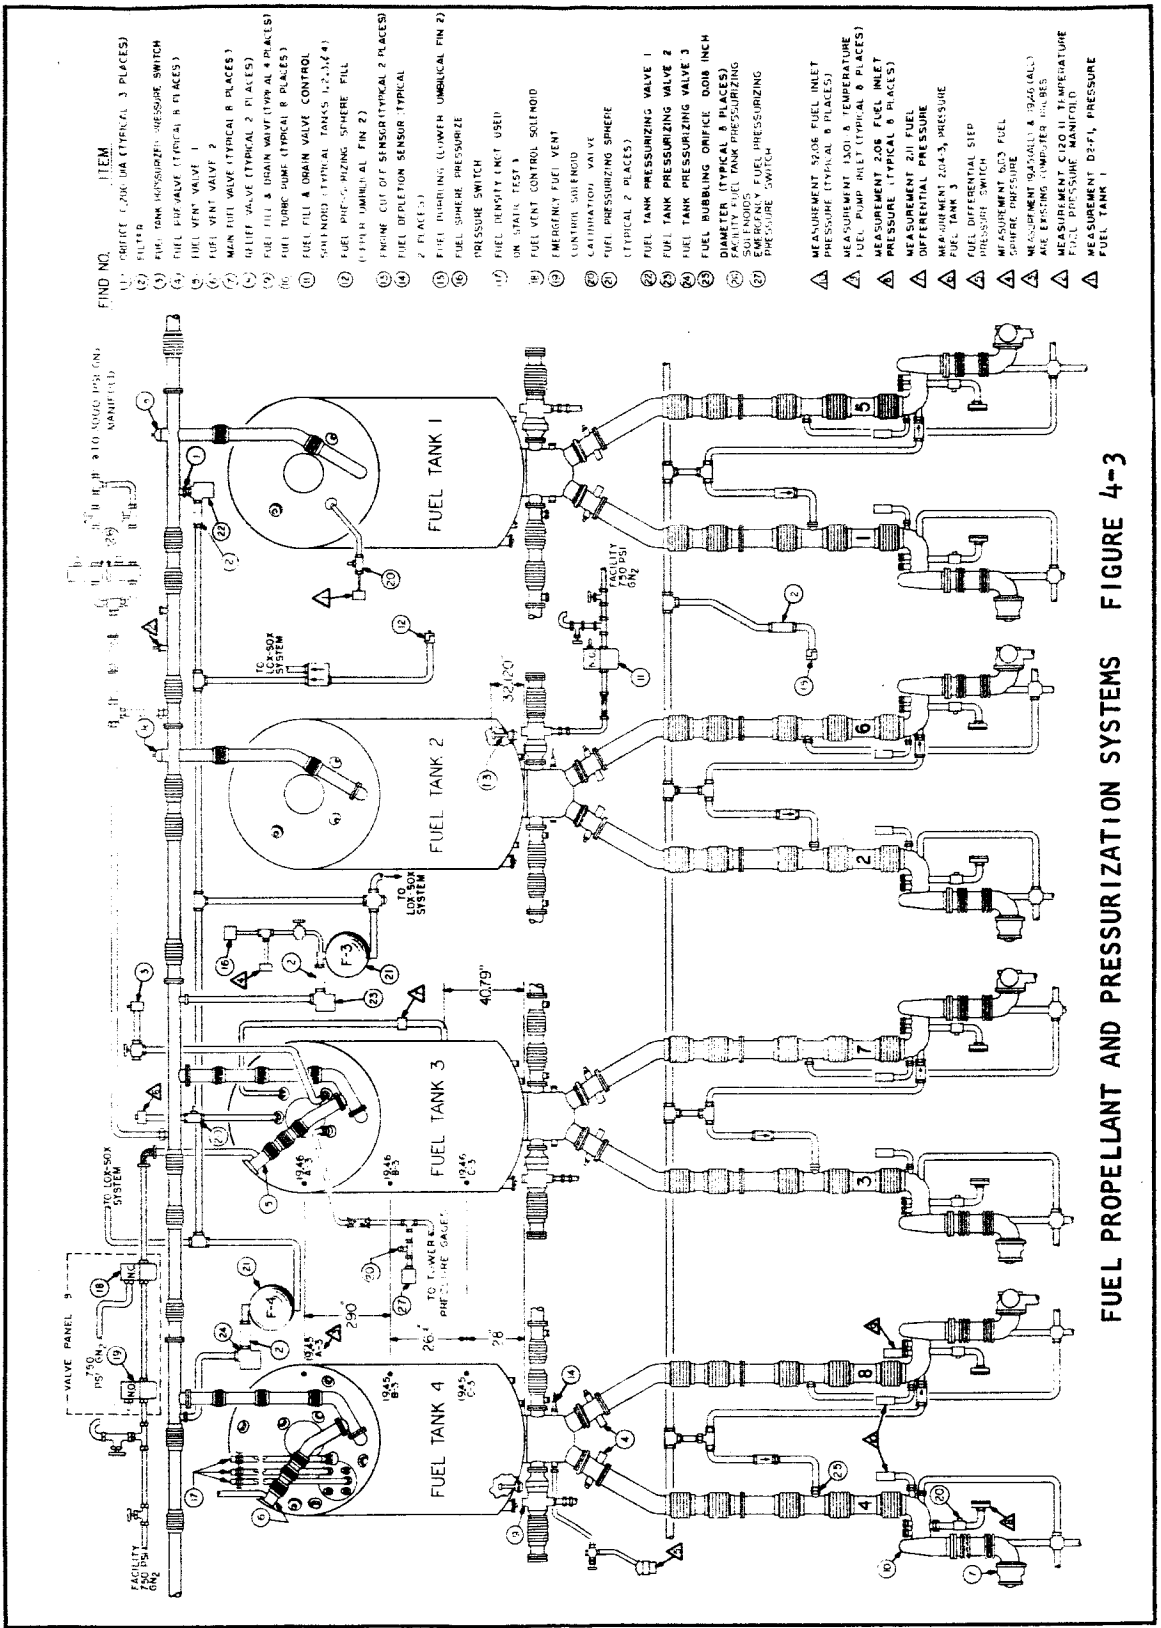
FUEL PROPELLANT AND PRESSURIZATION SYSTEMS FIGURE 4-3

FUEL SYSTEM. The fuel system functioned satisfactorily during the acceptance test firings. The system configuration for the test is shown in FIGURE 4-3. TABLE 4-1 presents fuel tanking and pressurization data for tests SA-20 and SA-21.

During post-test SA-20 inspection immediately following the firing, fuel was observed leaking from the heat shield panels around engine 4. The source of this leakage was traced to a calibration valve (P/N 10414076) in the sensing line leading to the Fuel Differential Step Pressure Switch (P/N 20M30154), located under fuel tank 4. The gland nut, which retains the valve stem in the valve body, vibrated loose and fuel pressure forced the valve stem out of the valve body. The valve stem was reinstalled in the valve body and the leakage stopped. Further inspection revealed that the calibration valve and mounting bracket had been drilled for safety wire, but that it had not been safety wired for this test. All stage calibration valve gland nuts were safety wired prior to test SA-21.
