CNLM-6031
QUARTERLY PROGRESS REPORT NO. 2
March 1, 1965 to July 2, 1965

INVESTIGATION OF CAVITATION DAMAGE OF A MECHANICAL
PUMP IMPELLER IN HIGH TEMPERATURE POTASSIUM

PRATT & WHITNEY AIRCRAFT DIVISION, UAC
CANEL - Middletown, Connecticut

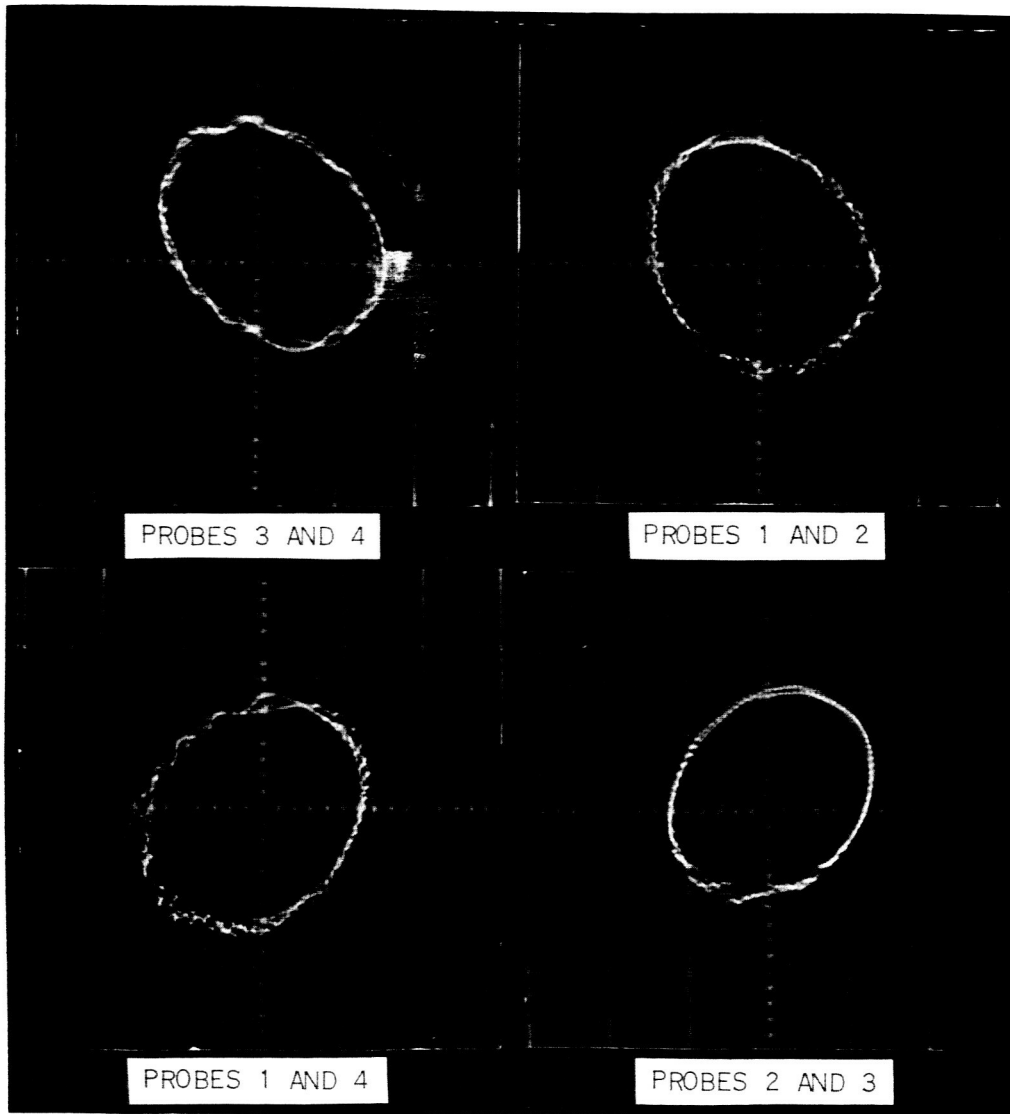
FIG 11

Upon completion of this work, the flow rate was set at 700 gpm at a constant shaft speed of 6375 rpm, and data were recorded from the distance detectors. Photographs of the oscilloscope screen are given in Figs. 11, 12, and 13. These photographs were obtained in orderly steps of decreasing NPSH.

OSCILLOSCOPE TRACES AT HIGH NPSH VALUES

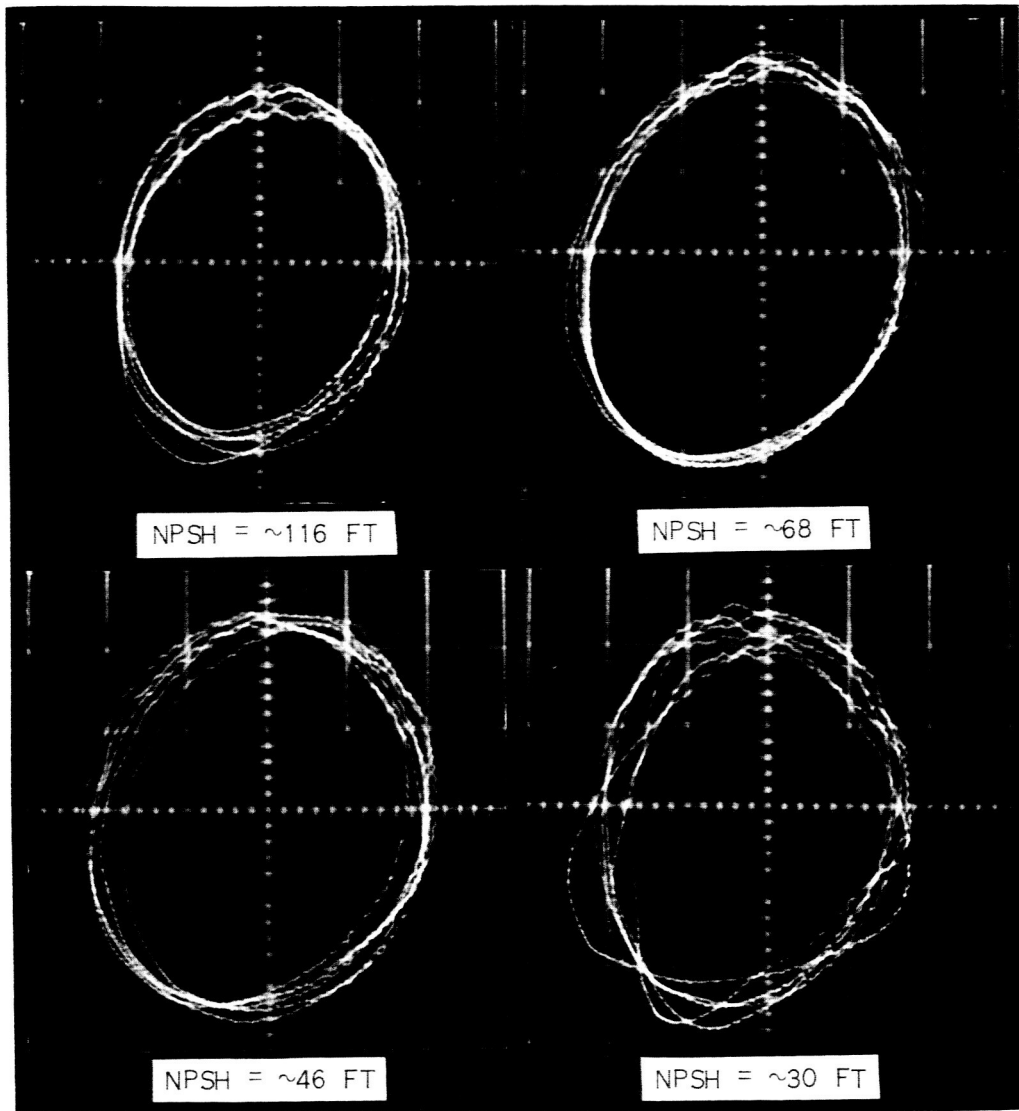
FIG 12

The oscilloscope traces of Fig. 12 show instabilities of the shaft position which are attributed to a relatively small, randomly applied hydraulic load at an NPSH value of 22 feet. When the NPSH value was decreased to 18 feet, oscillations occurred causing the trace to shift between Fig. 12B and Fig. 12C. These oscillations appeared to have approximately six seconds duration at each point. After about one minute, the trace stabilized to that of Fig. 12C and remained so for the duration of the time at this point. Fig. 12D is the same as Fig. 12C but with scale factor changed. Further decreases in NPSH values yielded the traces as shown in Figs. 12E and 12F.

Calculations based on the oscilloscope traces (and taking into account initial eccentricities and centrifugal forces due to imbalance) indicate radially applied hydraulic loads of about 150 pounds. Forces of this magnitude are quite capable of having caused the rubbing contact experienced during the liquid metal test described in Reference 3 (Final Report Under NASA Contract NAS3-2541).

OSCILLOSCOPE TRACES FROM DISTANCE DETECTORS
