OPERATION OF A FORCED CIRCULATION, HAYNES ALLOY NO. 25, MERCURY LOOP TO STUDY CORROSION PRODUCT SEPARATION TECHNIQUES

by David B. Cooper

Prepared under Contract No. NAS 5-462 by
THOMPSON RAMO WOOLDRIDGE, INC.
Cleveland, Ohio
for

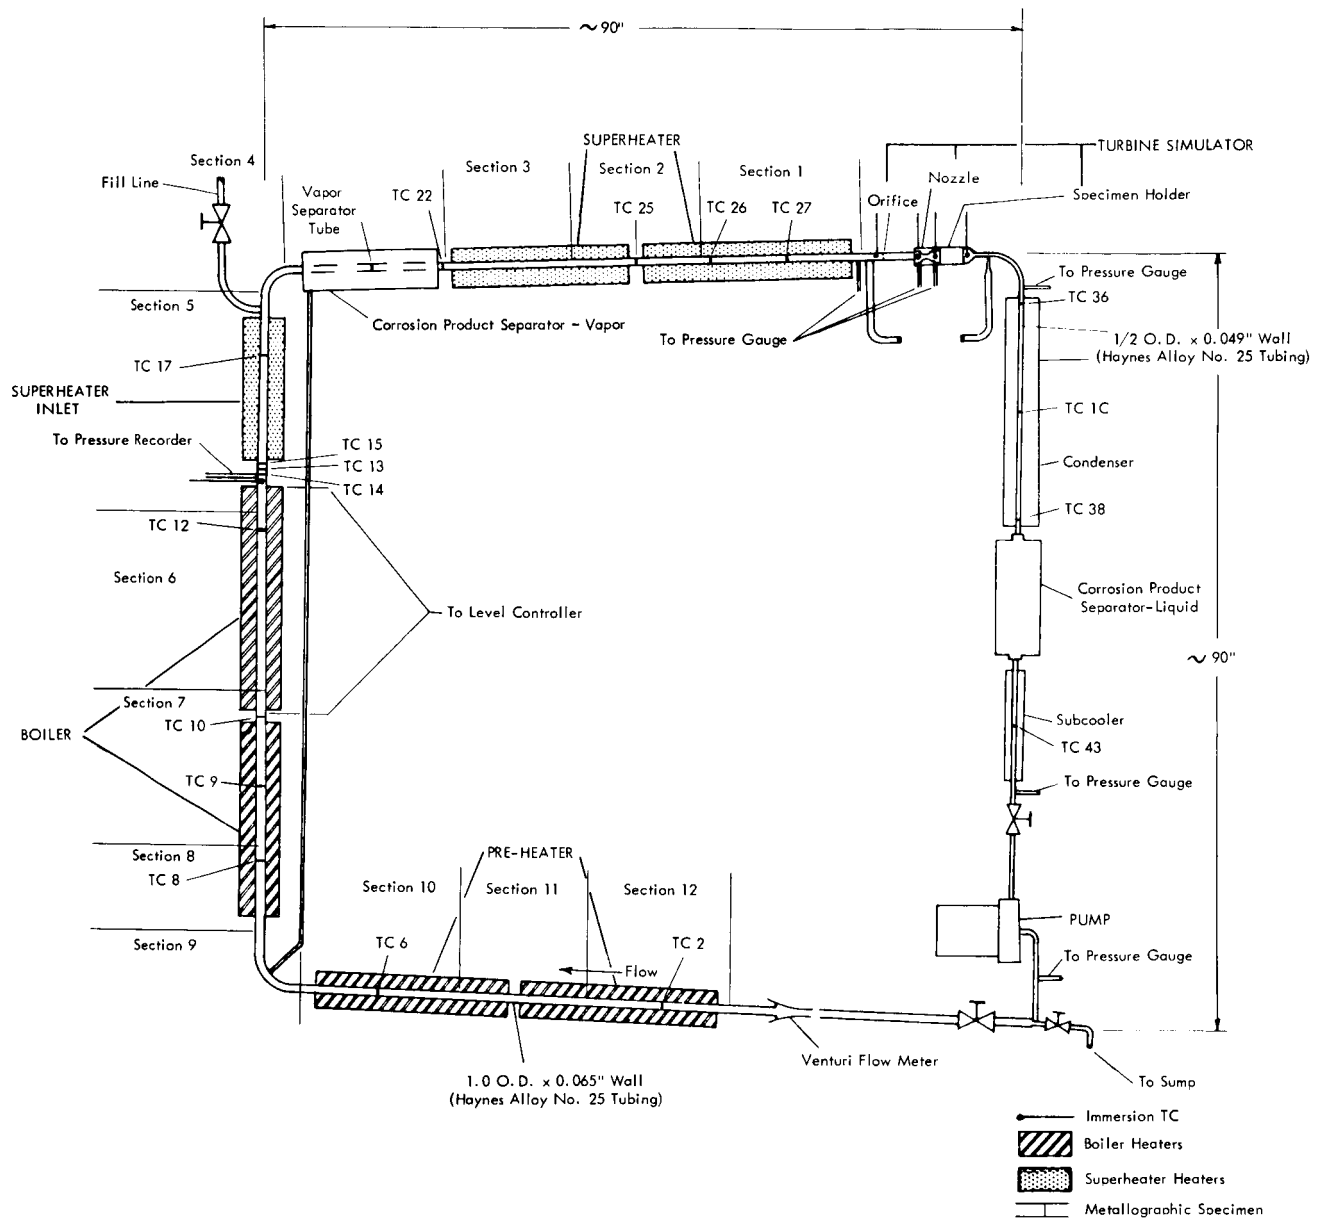
FIGURE 10. SCHEMATIC OF LOOP SHOWING SECTIONING LOCATIONS AND LOCATION OF METALLOGRAPHIC SPECIMENS

Upon sectioning the loop, deposition was revealed in various locations. All deposits in the system were collected and submitted for analysis. Specimens were also removed from the loop and were submitted for metallurgical evaluation.

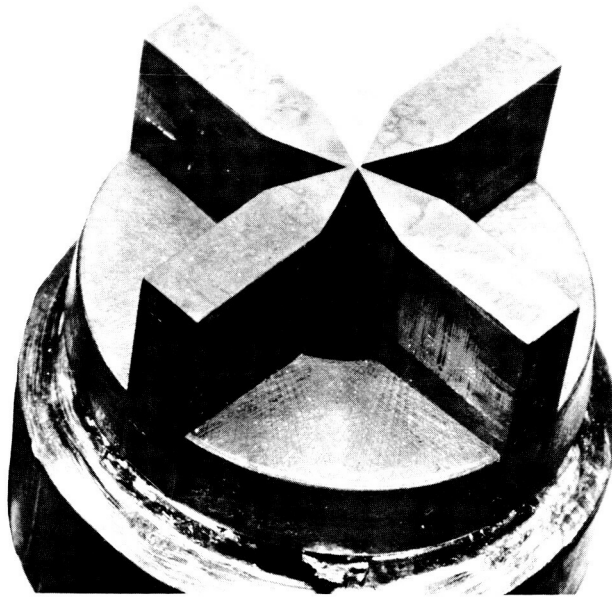
a) Inlet

The nozzle was also observed to contain a deposit, as shown in Figure 17. Although there was a small amount of deposition on the inlet side, the majority of the deposit was found on the outlet.

Figure 17. Deposit Found in Loop Nozzle.

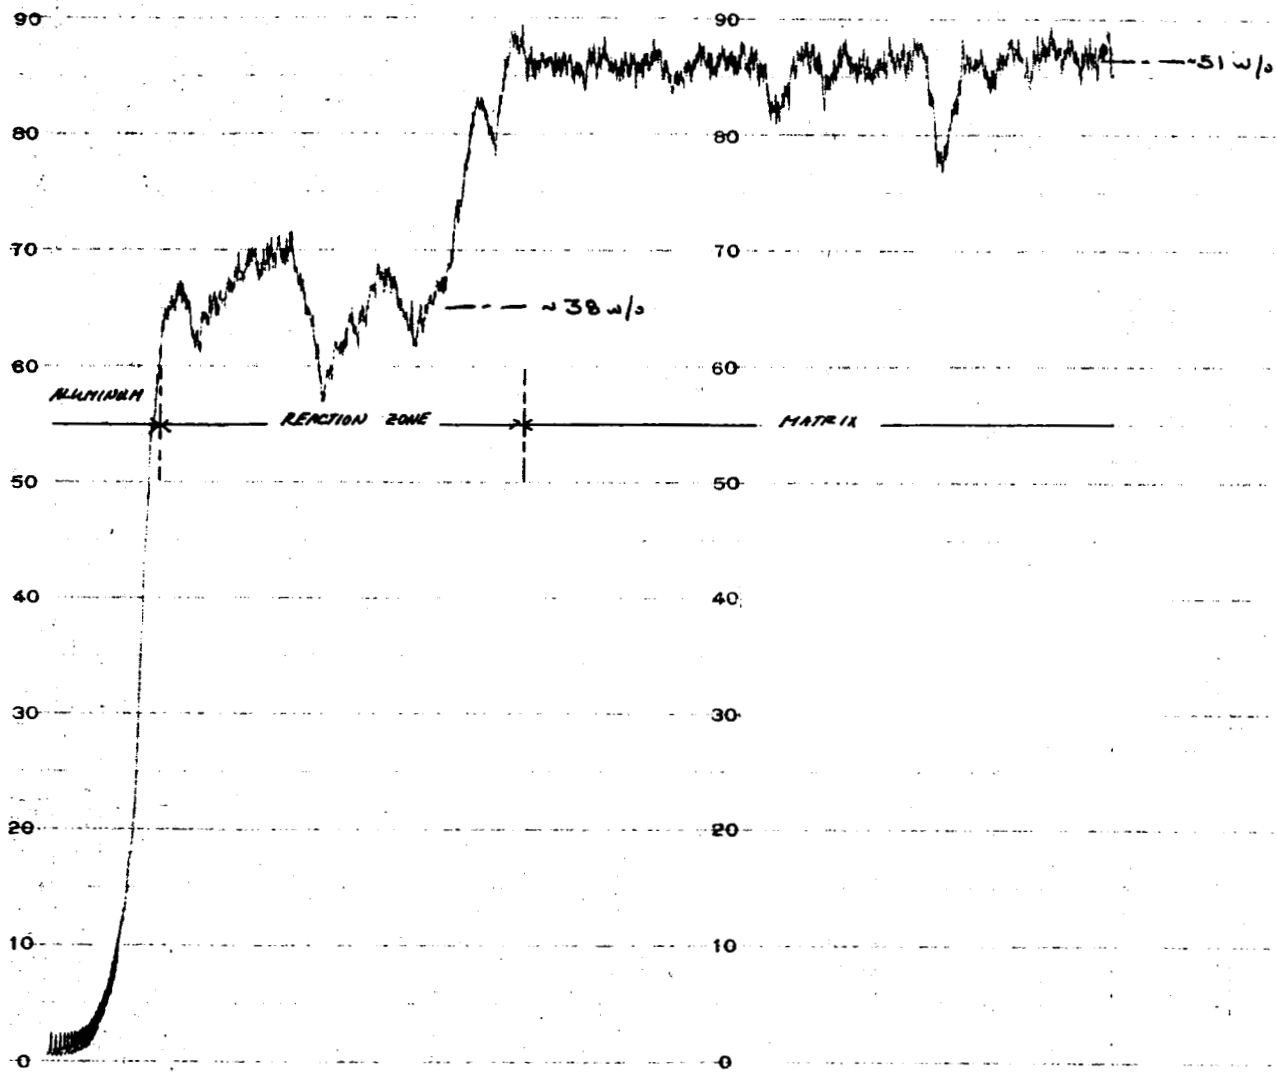
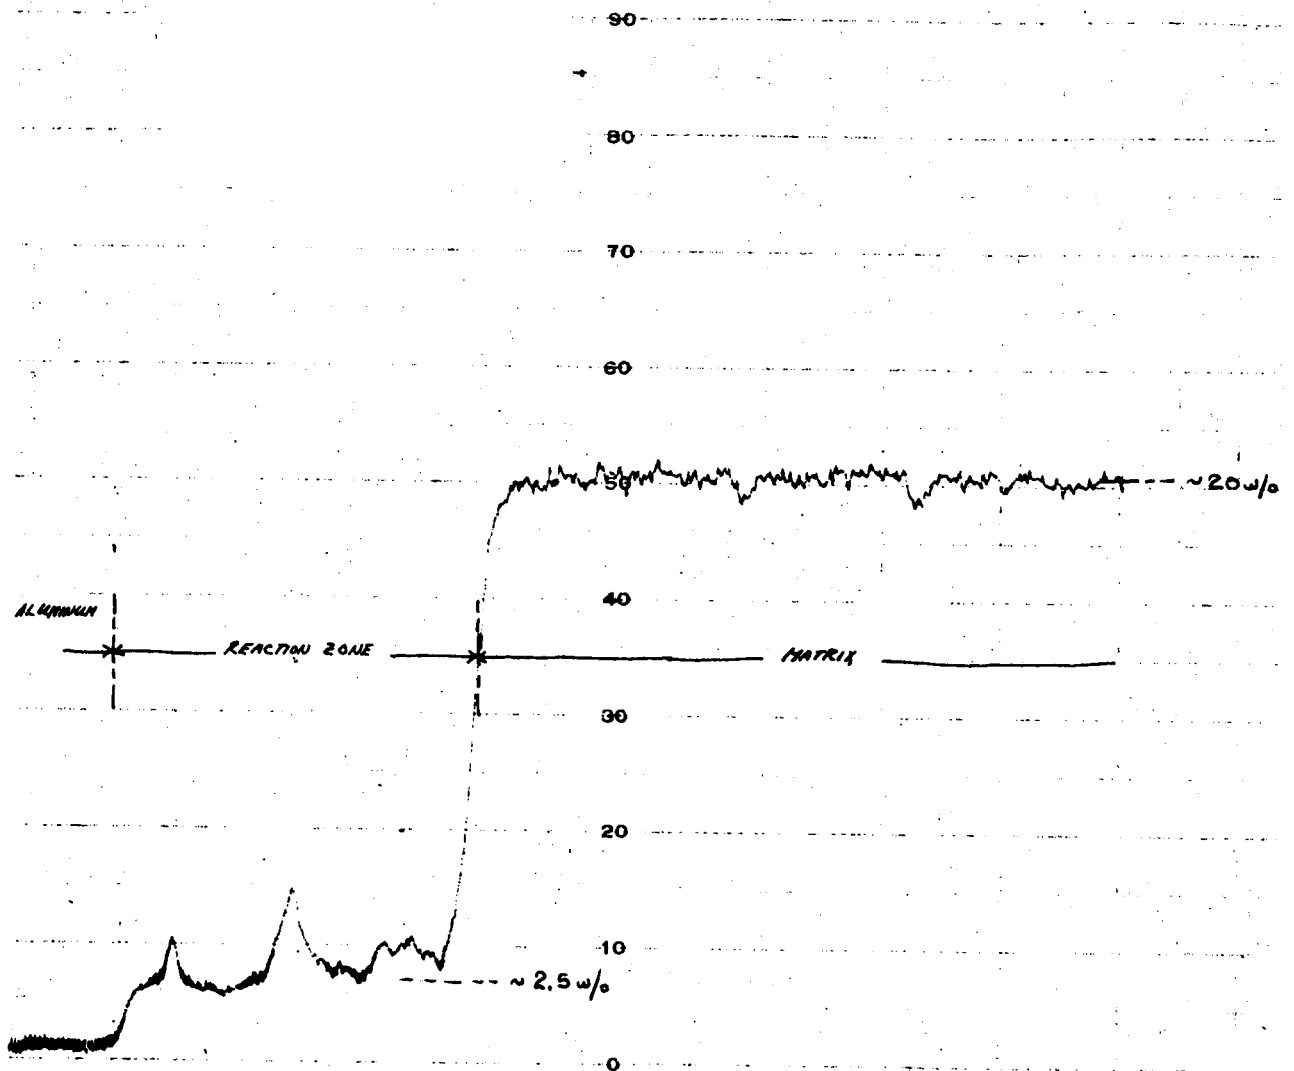
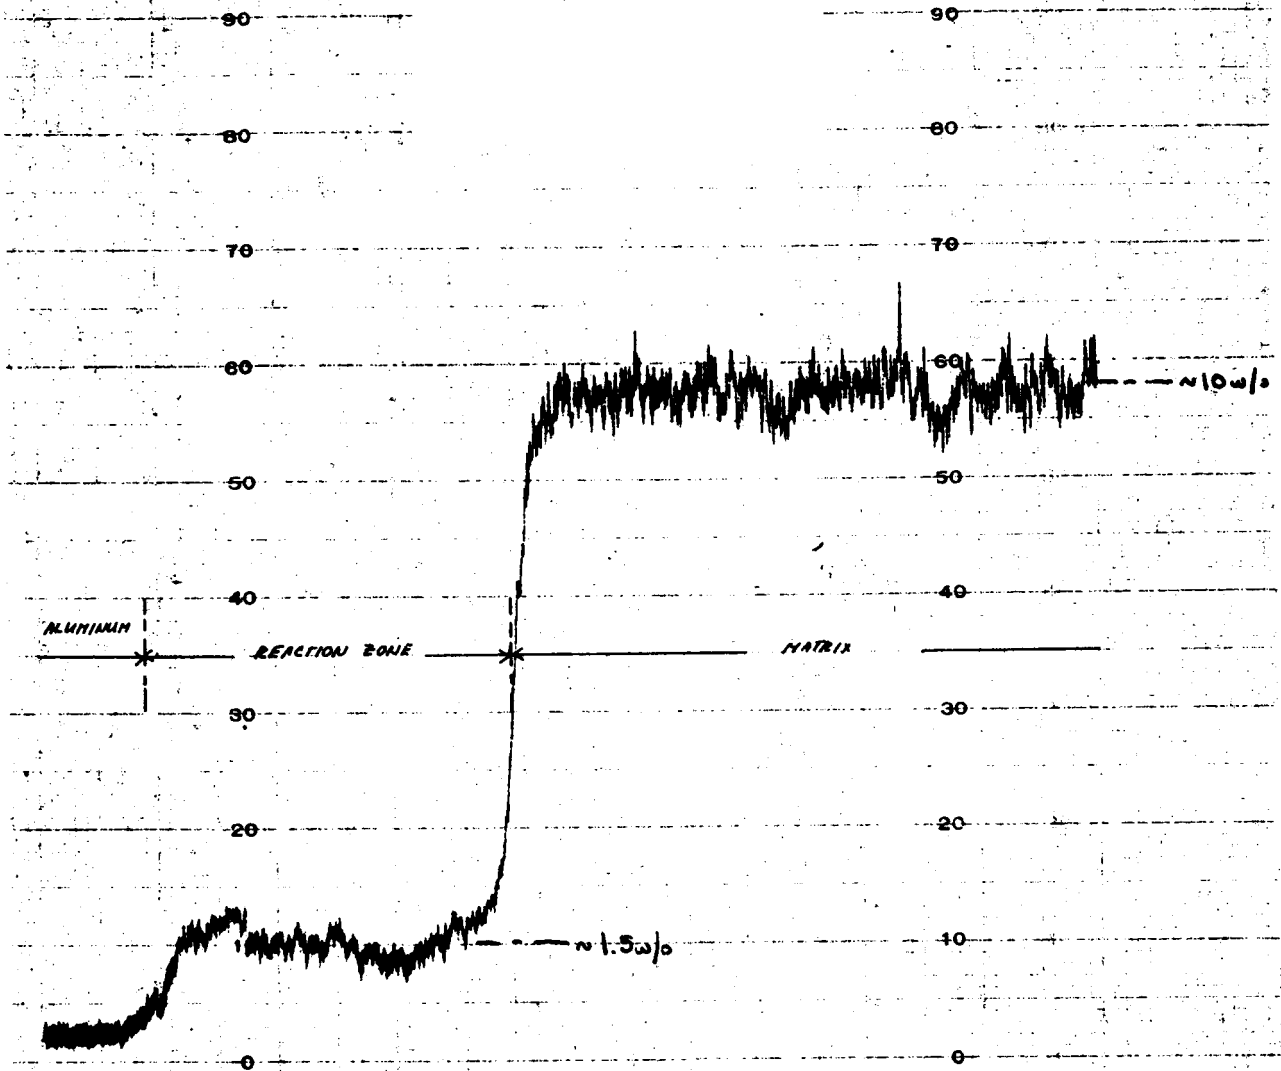
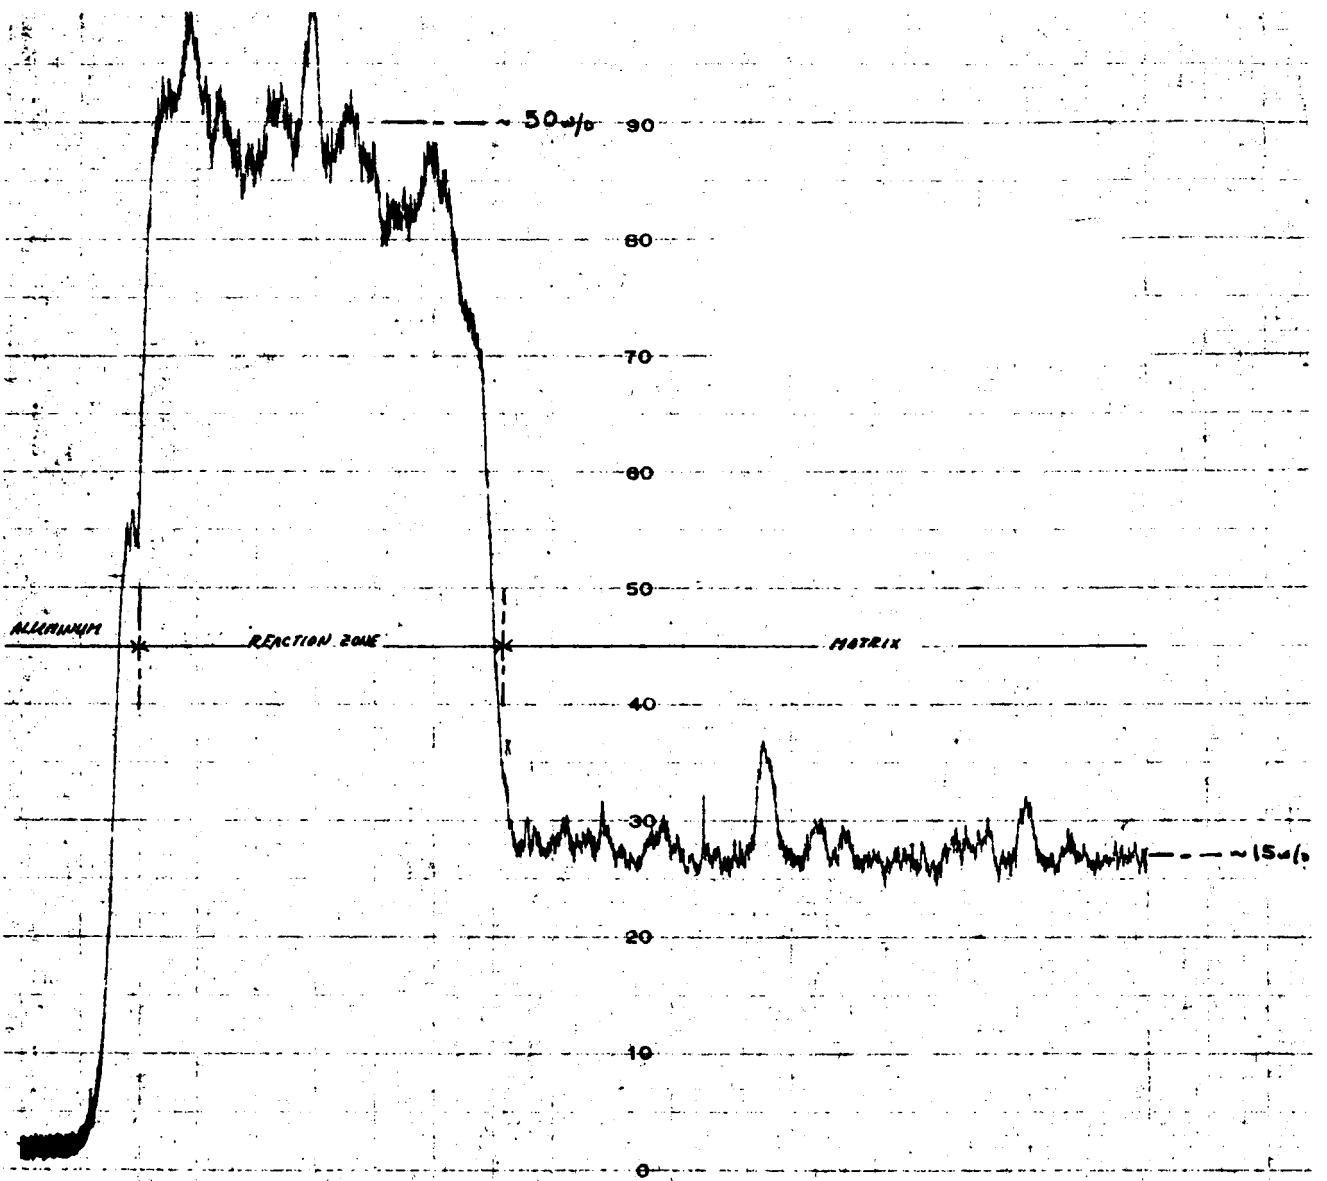
As seen in Figures 31 through 34, the electron beam microanalysis on the pre-heater outlet specimen (see Figure 20b) revealed a leached layer with an abrupt concentration discontinuity approximately 40 to 45 microns from the surface. The corrosion layer was found to be enriched in tungsten and depleted in nickel, chromium, and cobalt. Zirconium was found in the matrix as tungsten-zirconium carbides and comprised less than 0.05 percent. The zirconium concentration rose to 0.05 to 0.08 percent in the corrosion layer; however, the background intensity also rose as a result of the increased tungsten content. The titanium and columbium concentrations were consistently less than 0.05 percent.

Figure 31. Distribution of Cobalt in the Pre-Heater Outlet Specimen.

Figure 32. Distribution of Chromium in the Pre-Heater Outlet Specimen.

Figure 33. Distribution of Nickel in the Pre-Heater Outlet Specimen.

Figure 34. Distribution of Tungsten in the Pre-Heater Outlet Specimen.

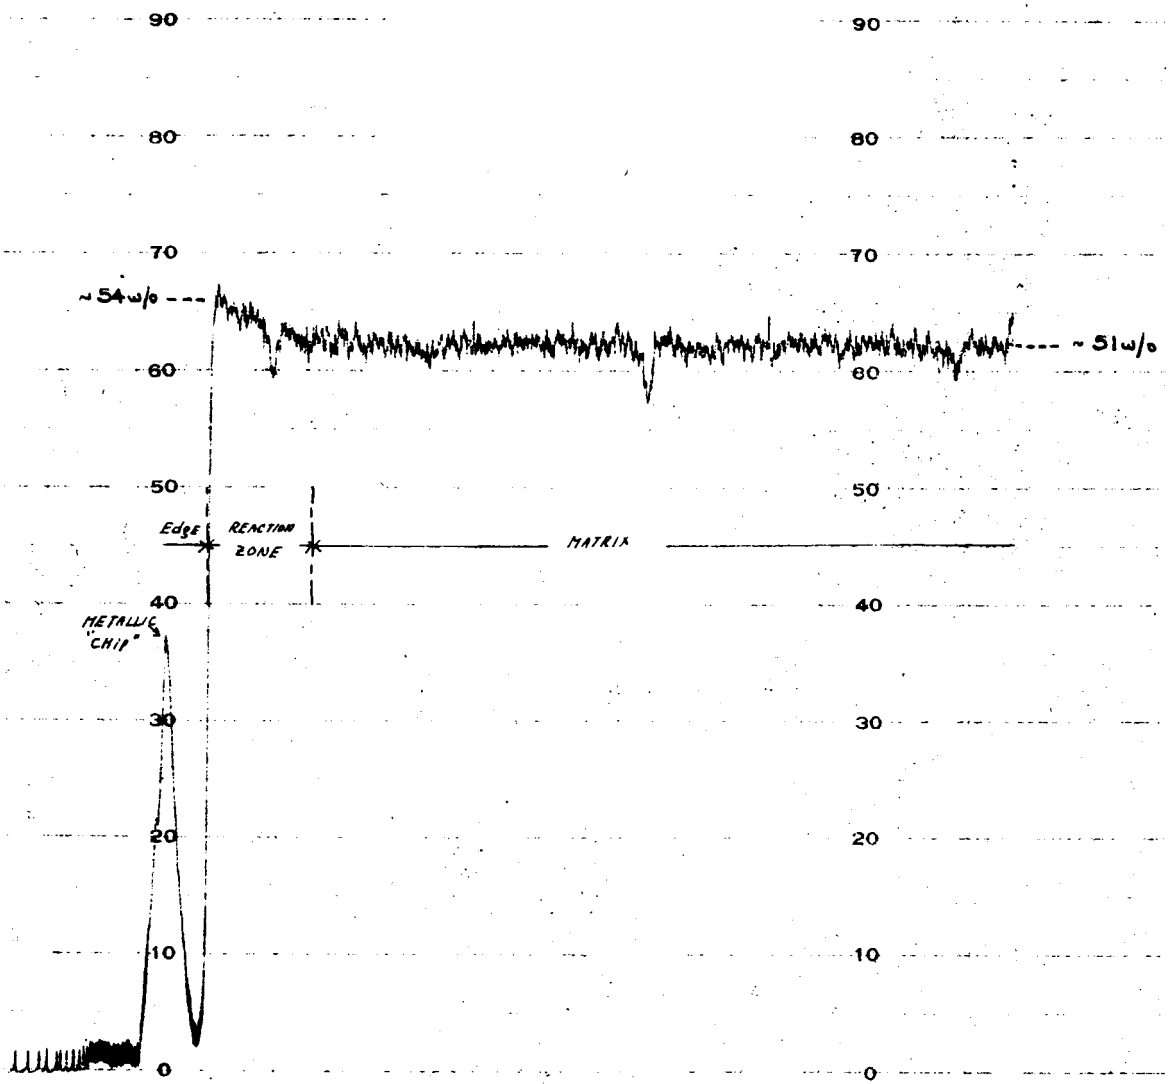
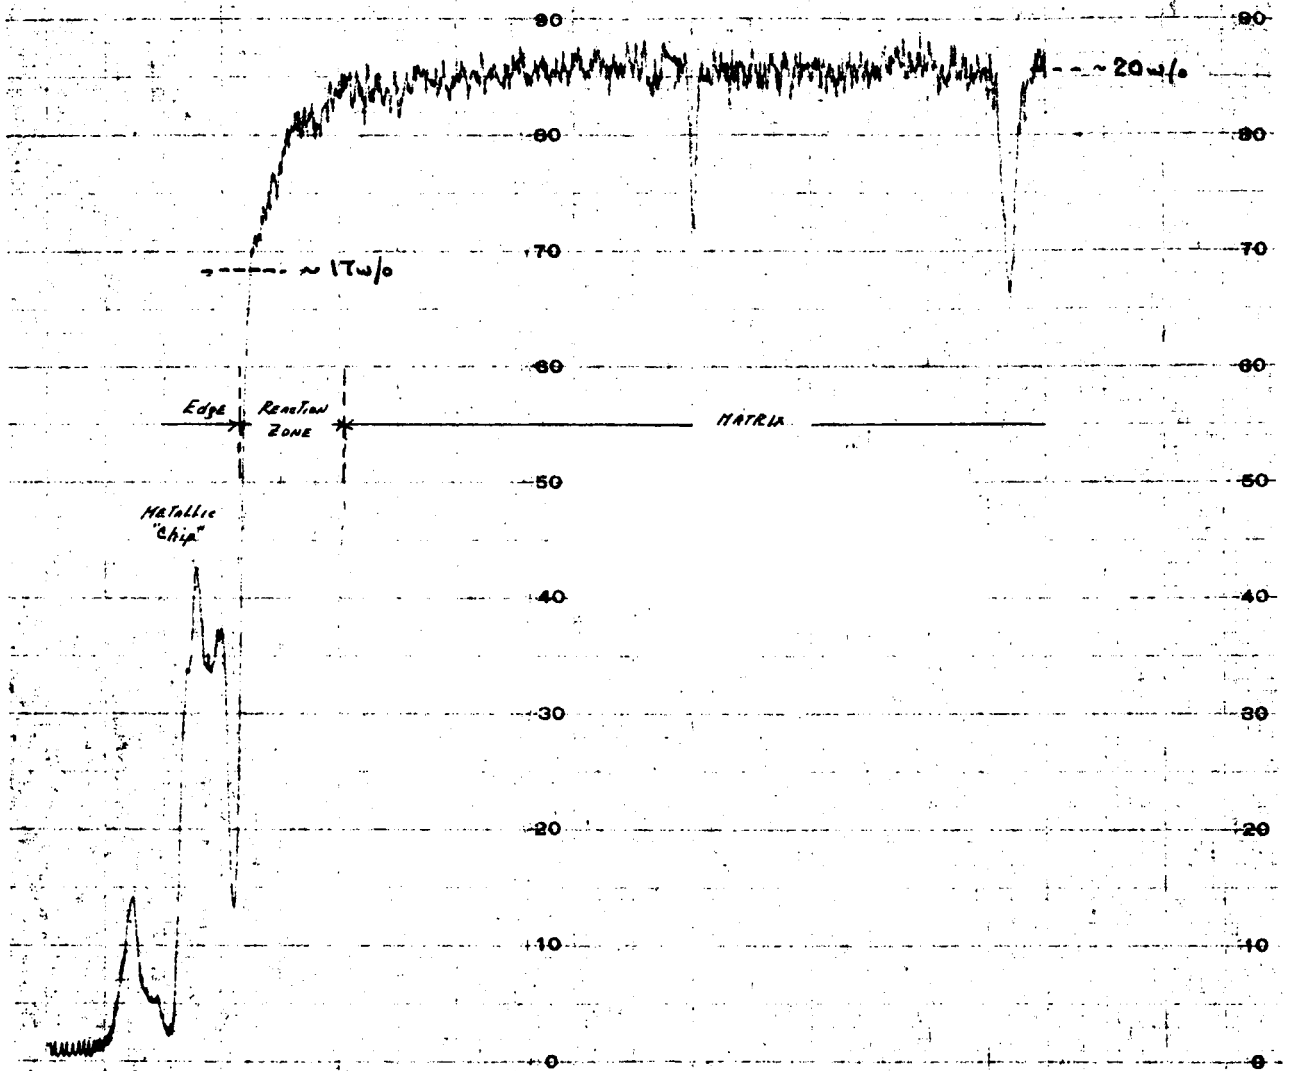
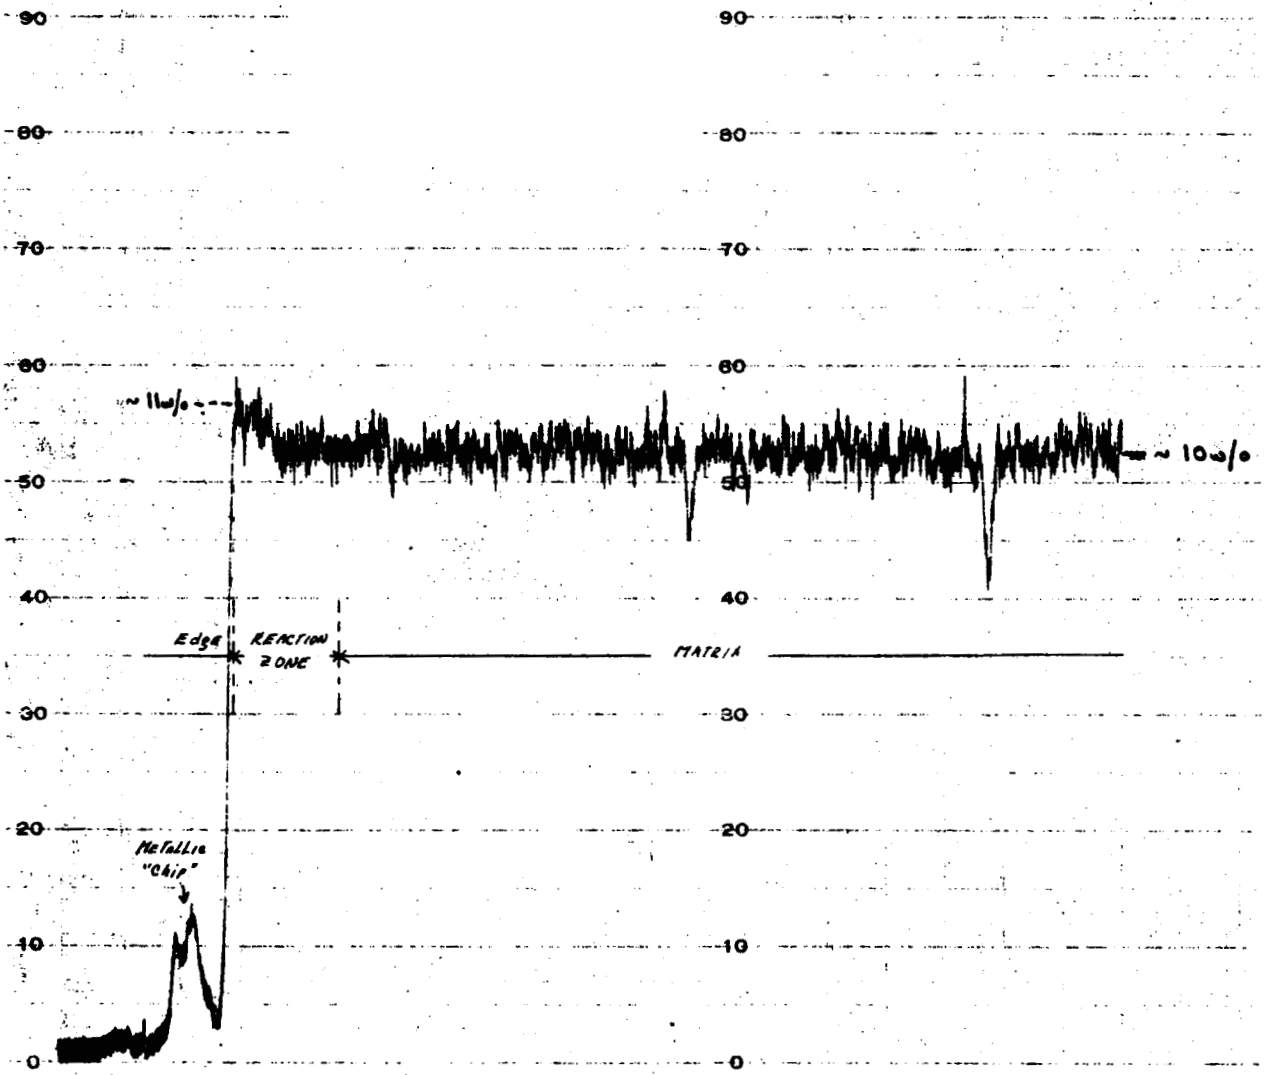
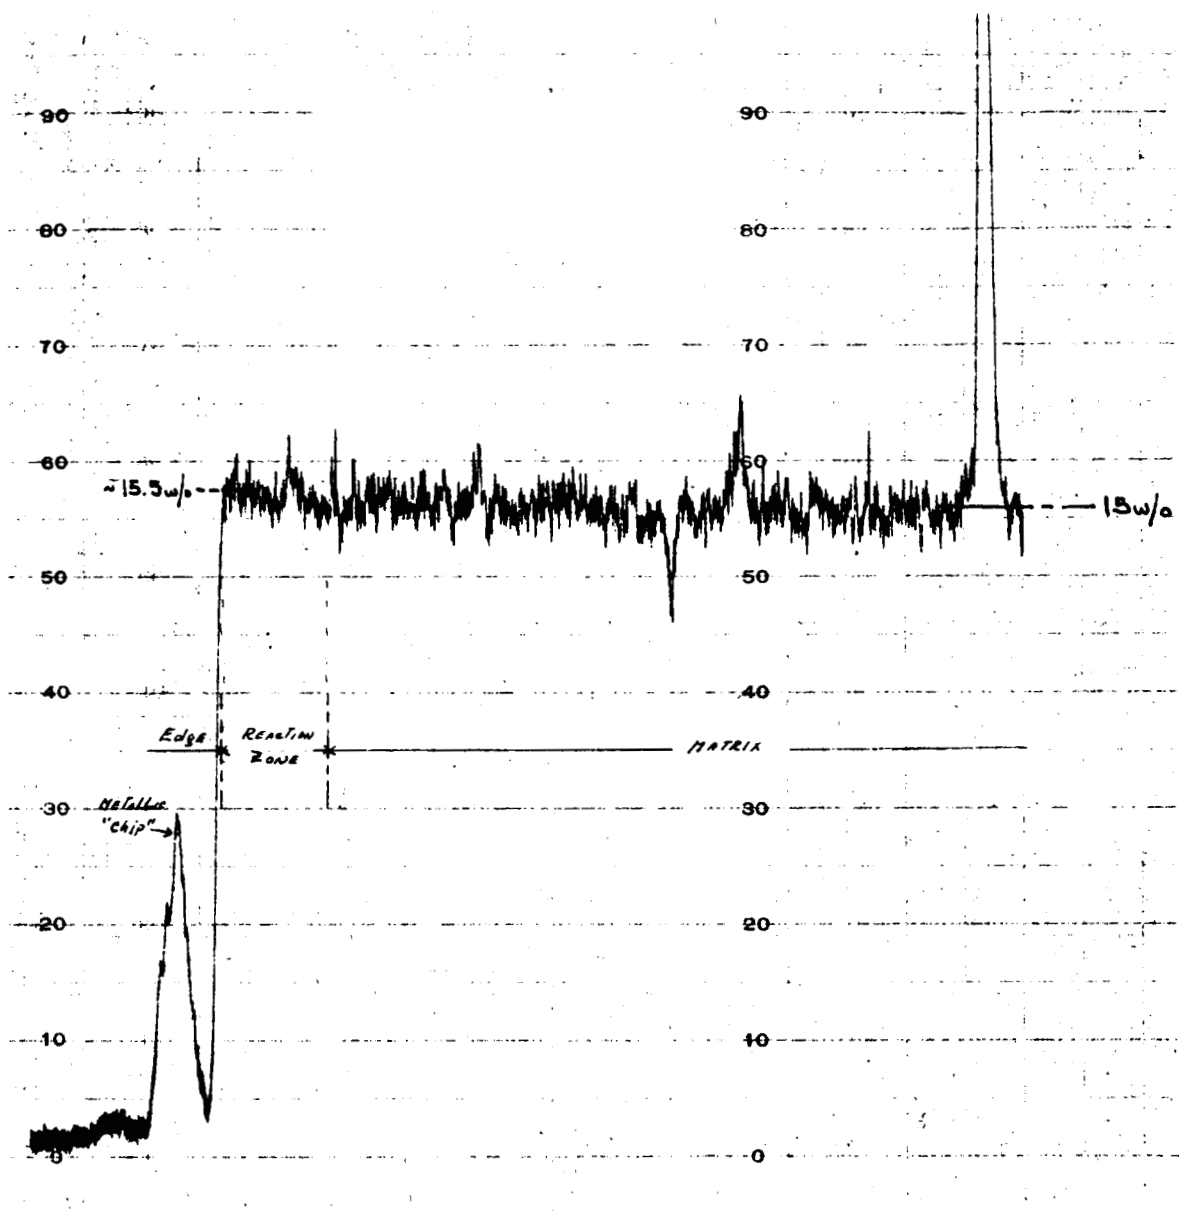
The condenser outlet specimen (see Figure 22d) revealed no visible evidence of a surface chemistry change. However, the concentration distributions (Figures 35 through 38) showed the presence of a slowly varying gradient to a depth of 25 to 30 microns. Cobalt, nickel, and tungsten showed an increase at the I.D. surface of the specimen, while chromium was found to be depleted. A small metallic chip, partially buried in the mount material, was included in the traverse. This chip was the only one noted in the area selected for analysis and is considered insignificant. Except for some zirconium in the matrix tungsten-zirconium carbides, the zirconium, titanium, and columbium concentrations were consistently less than 0.05 percent.

Figure 35. Distribution of Cobalt in the Condenser Outlet Specimen.

Figure 36. Distribution of Chromium in the Condenser Outlet Specimen.

Figure 37. Distribution of Nickel in the Condenser Outlet Specimen.

Figure 38. Distribution of Tungsten in the Condenser Outlet Specimen.

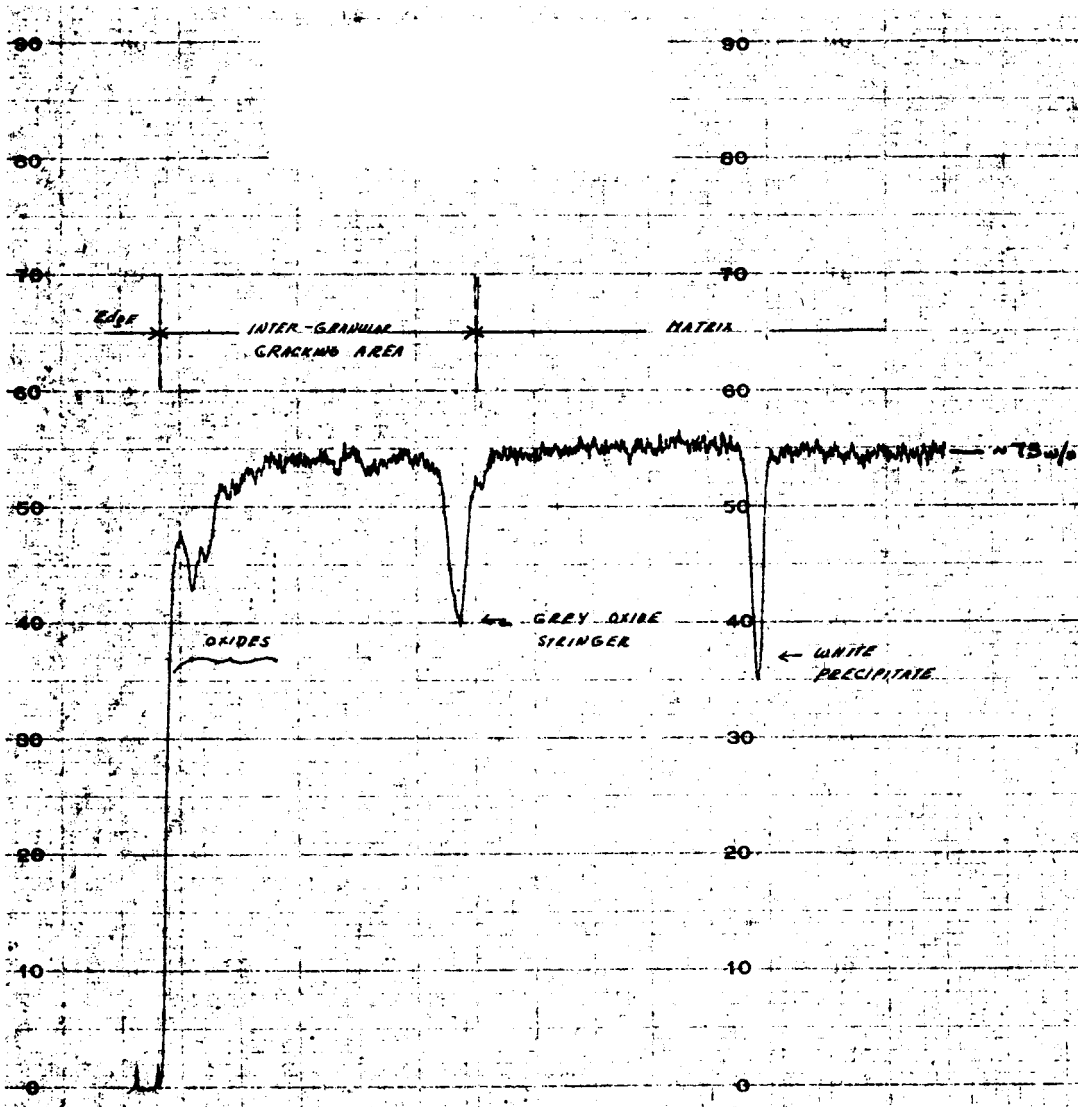
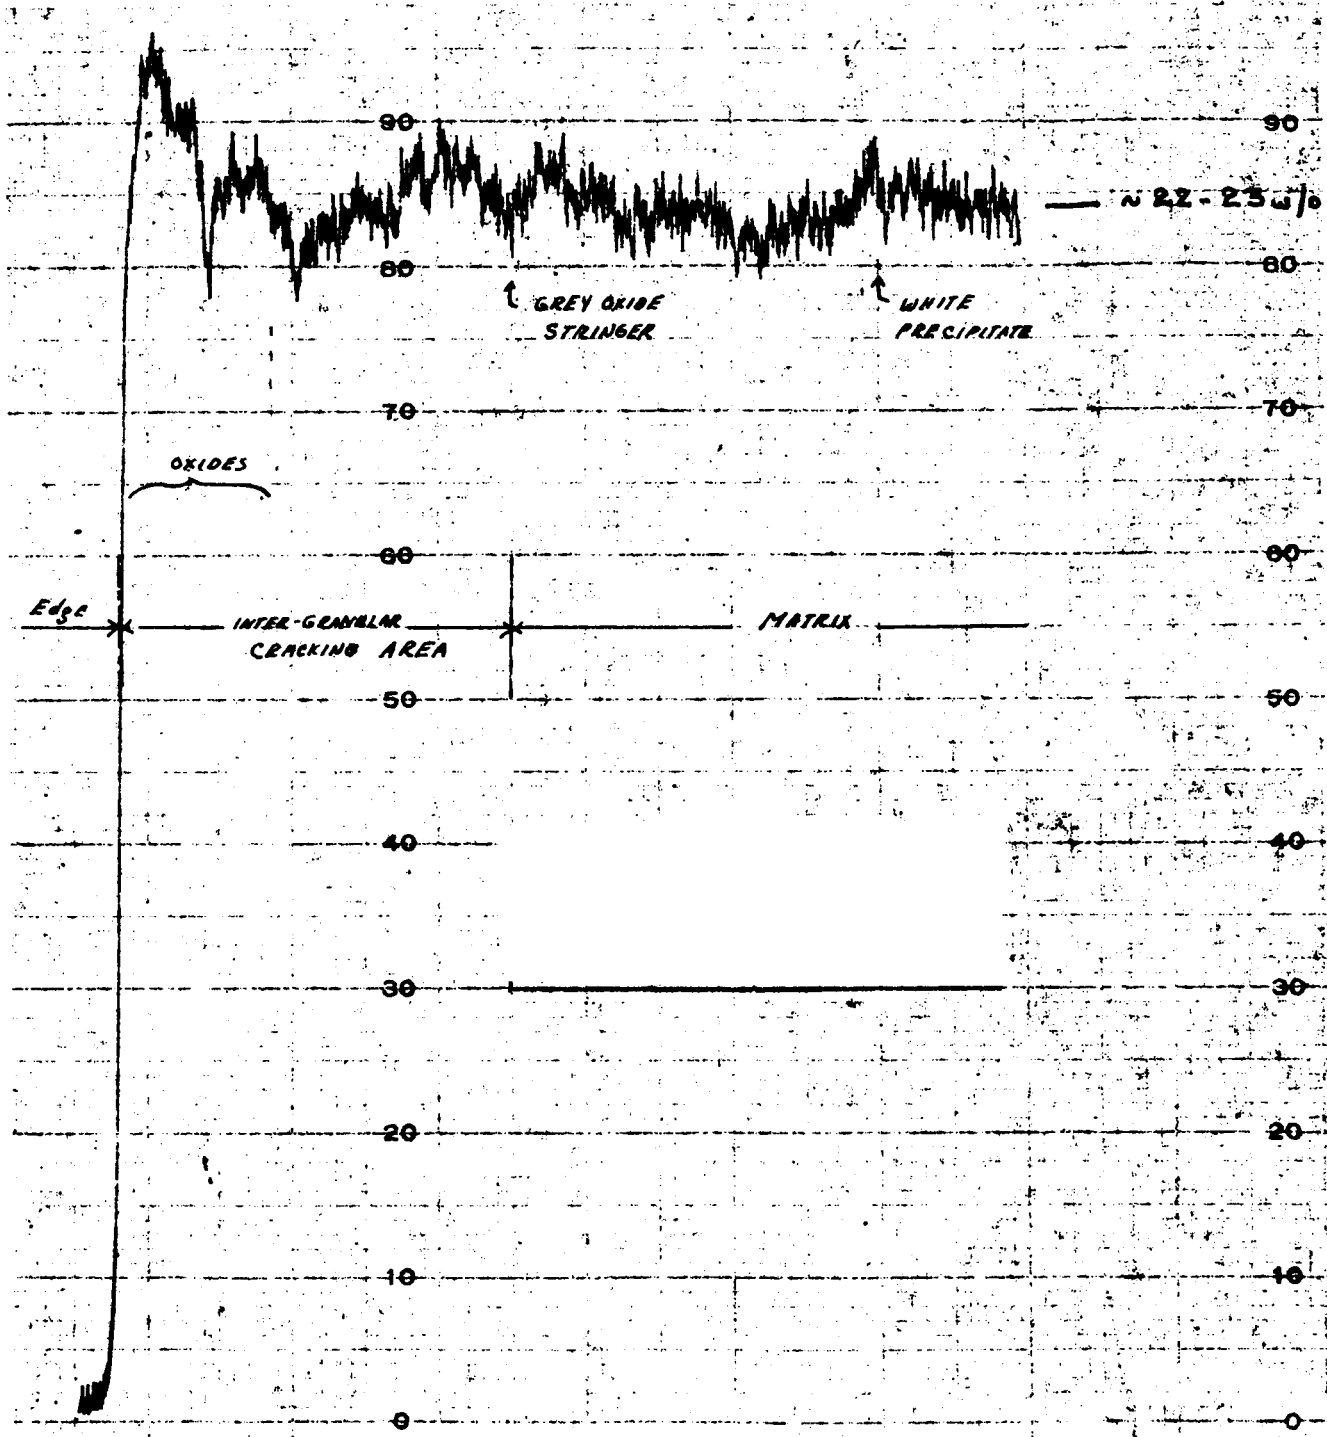
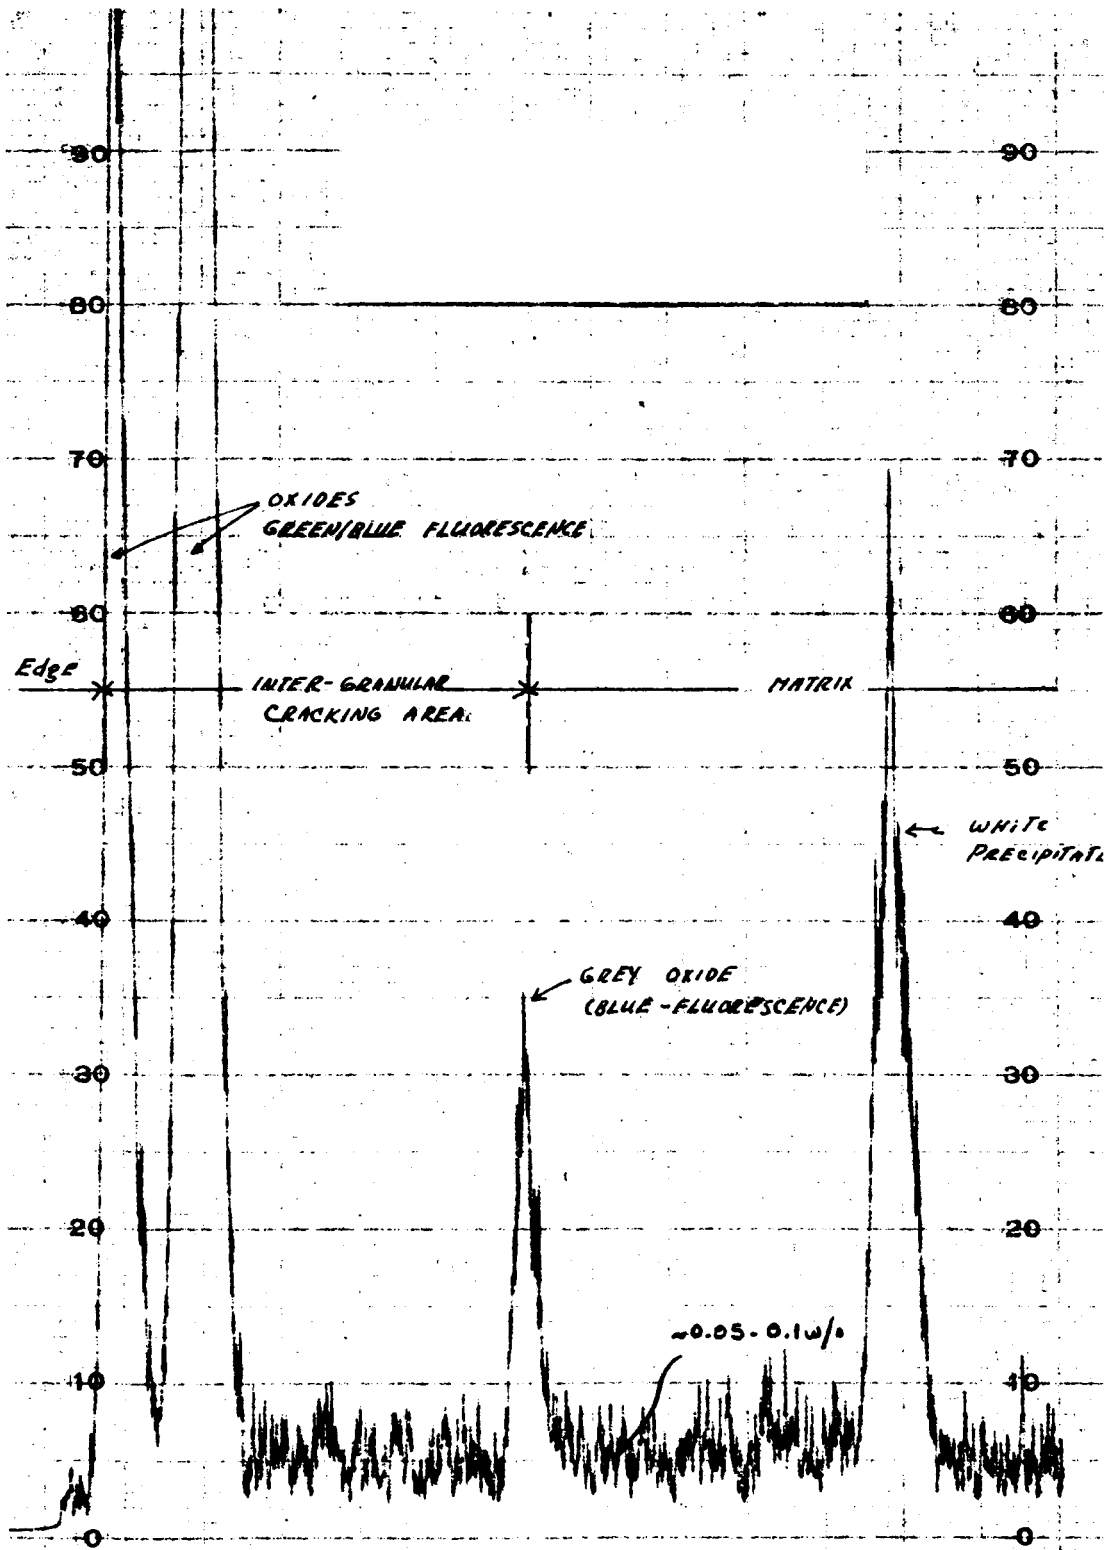
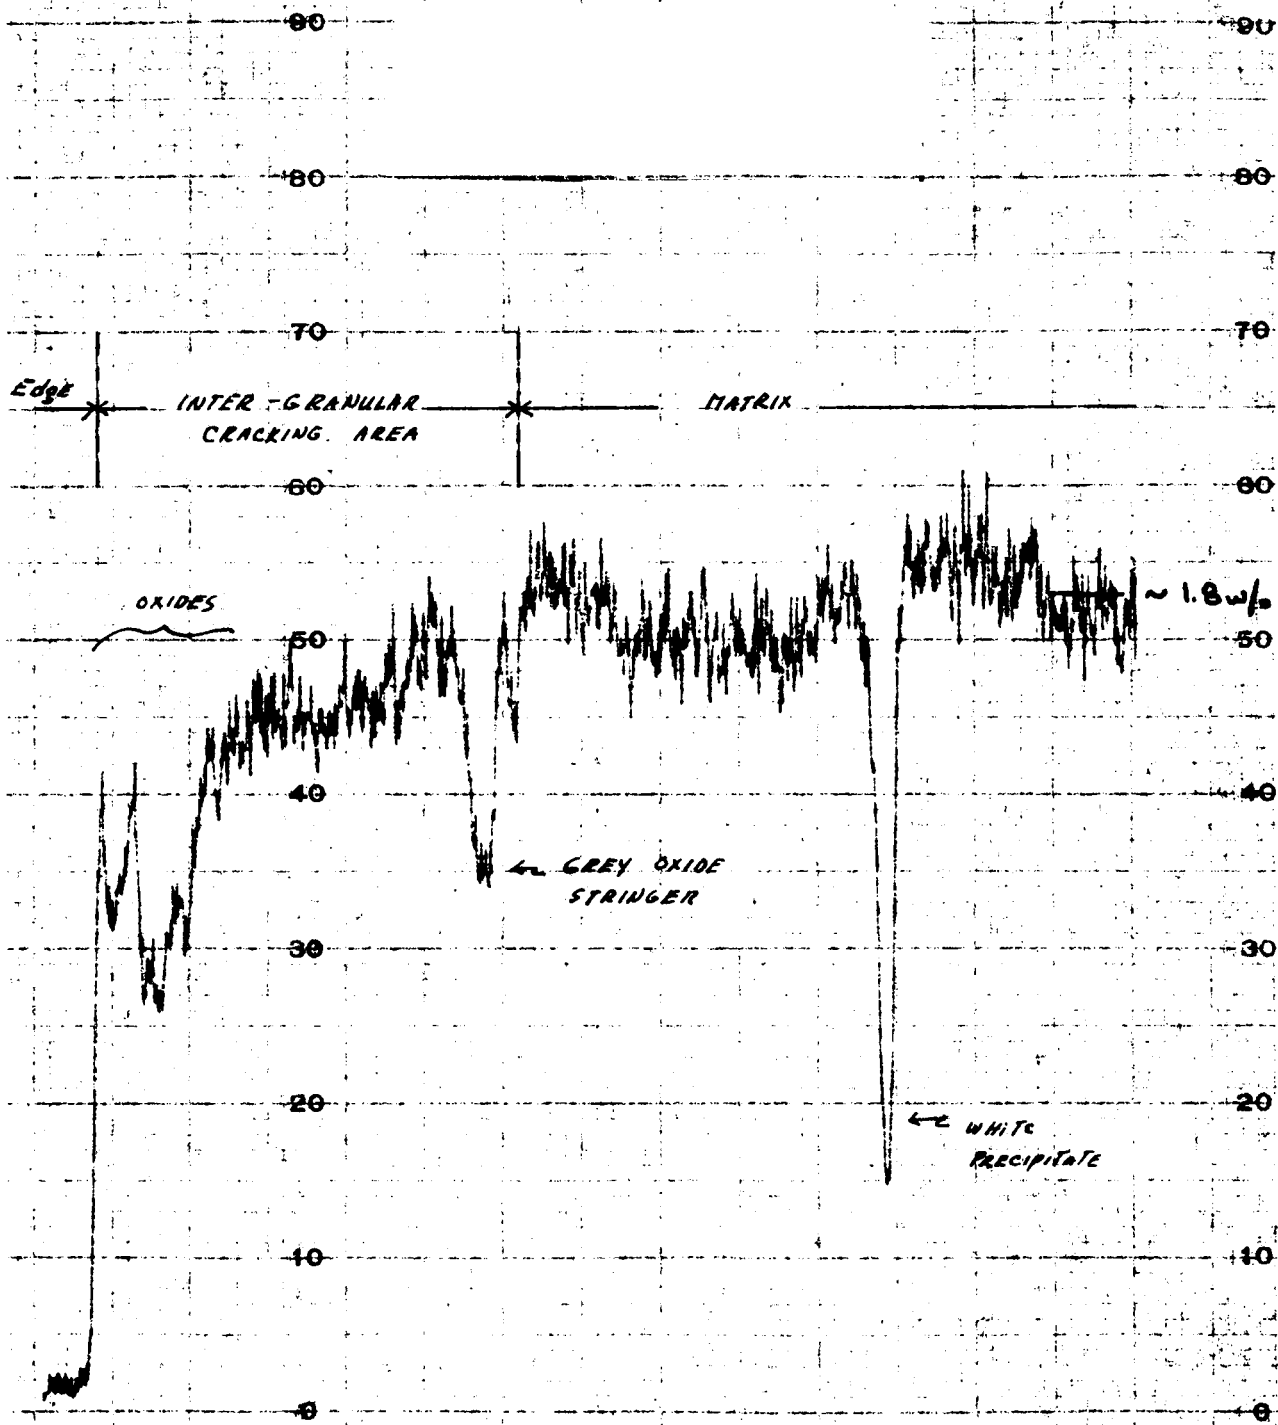
Examination of the nozzle throat specimen (see Figure 27b) revealed a surface zone of intergranular precipitation extending to a depth of approximately 70 microns. A series of large gray precipitates near the base metal-end of the surface zone were also noted. The gray phases and oxides were found to be zirconium oxides that appeared to also contain some nickel in solution. These phases were identified as oxides since they yielded a visible fluorescence when struck by the electron beam. This fluorescence is typical of the presence of combined oxygen. The composition of the metal matrix surrounding the oxides was found to be essentially the same as the base metal. The concentration distributions for chromium and tungsten were consistent at less than 0.05 percent.

Figure 39. Distribution of Cobalt in the Nozzle Throat Specimen.

Figure 40. Distribution of Nickel in the Nozzle Throat Specimen.

Figure 41. Distribution of Zirconium in the Nozzle Throat Specimen.

Figure 42. Distribution of Titanium in the Nozzle Throat Specimen.
