P&WA CNLM-6028  
QUARTERLY PROGRESS REPORT NO. 1  
December 7, 1964 to February 28, 1965

INVESTIGATION OF CAVITATION DAMAGE OF A MECHANICAL  
PUMP IMPELLER IN HIGH TEMPERATURE POTASSIUM

CONTRACT NAS3-6468

PRATT & WHITNEY AIRCRAFT DIVISION, UAC  
CANEL - Middletown, Connecticut

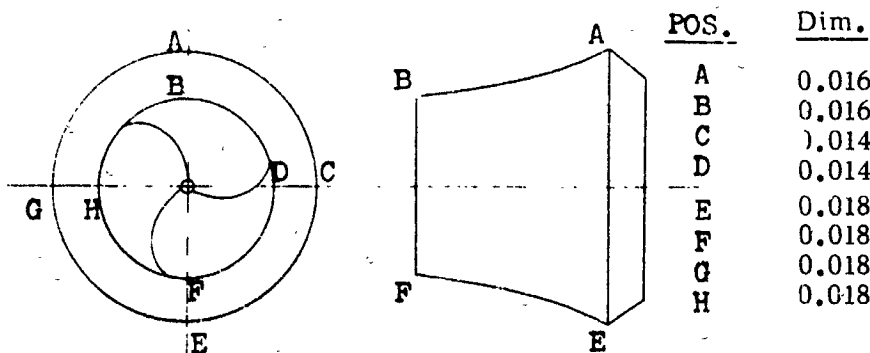
**INSTALLED VANE TIP CLEARANCE**

The RI-7A3 impeller was initially installed with a nominal vane tip clearance of 0.014 inch that was essentially constant throughout the tip arc. A variation of approximately 0.004 inch was present due to tip contour eccentricity with the impeller centerline. Installation accuracy was held within  $\pm 0.001$  inch. Actual measured values of the installed clearance are given in the following sketch:

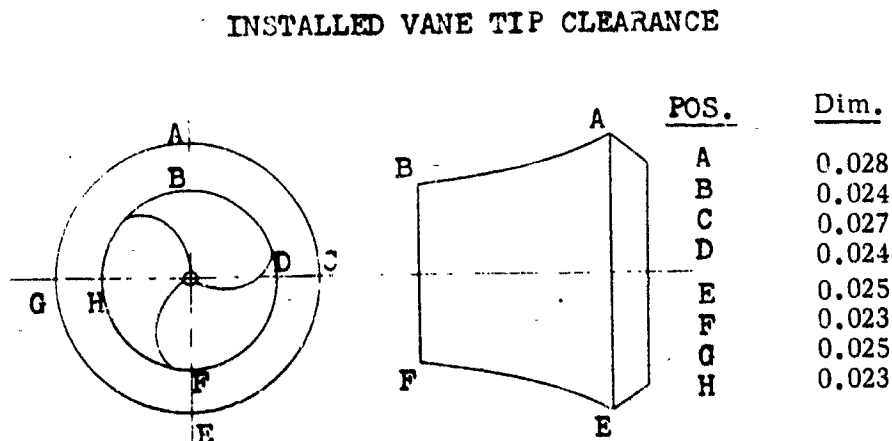
At the completion of the 0.015 inch clearance runs the impeller was removed and 0.010 inch was machined from the vane tip arc. This provided a vane clearance of approximately 0.025 inch on reinstallation. The machining operation removed most of the 0.004 inch eccentricity between vane tips and impeller centerline present in the 0.015 inch tests. The actual installed clearance values are given in the following sketch:

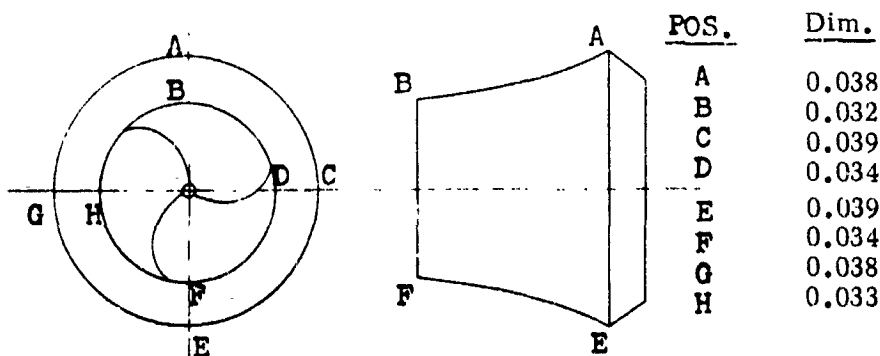
INSTALLED VANE TIP CLEARANCE

The impeller vane tip arc was again machined removing 0.010 inch to provide a constant vane tip clearance of 0.035 inch after completion of testing at the 0.025 inch clearance. The impeller vane tip radius was not machined correctly because of misalignment of the machining template used to cut the arc. The template was located with the center of the radius too far forward in relation to the impeller. This caused too little material to be removed from the vane tips at the rear of the impeller. Corrective machining was done; but, apparently, the same error was repeated in the opposite direction, causing an overcut by approximately 0.005 inch at the rear of the impeller. This resulted in a variable clearance from inlet to discharge of about 0.006 inch. Measured vane tip clearances at installation are given in the following sketch:

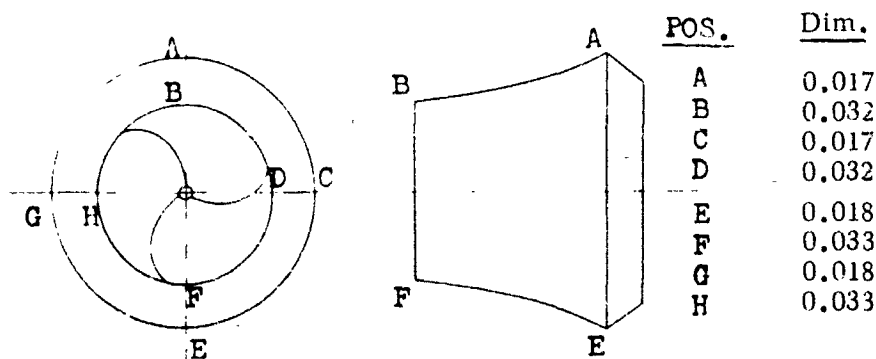
INSTALLED VANE TIP CLEARANCE

Actual installed clearances, as measured, are given in the following sketch for the impeller inlet and discharge only:

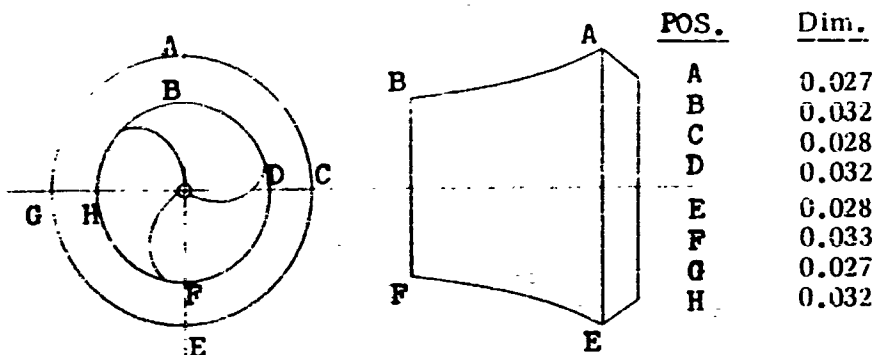
INSTALLED VANE TIP CLEARANCE

The back channel vane tip clearance was increased to approximately 0.027 inch after the tests at 0.017 inch. The increase of back channel clearance was made an even 0.010 inch to correspond to all previous clearance increments. Actual installed vane tip clearance is given in the following sketch:
