NASA CR-225

## OPERATION OF A HAYNES ALLOY NO. 25 FORCED CIRCULATION LOOP TO STUDY THE EFFECTS OF HYDROGEN IN A SIMULATED SUNFLOWER SYSTEM

by *R. C. Schulze and D. B. Cooper*

Prepared under Contract No. NAS 5-462 by  
THOMPSON RAMO WOOLDRIDGE, INC.  
Cleveland, Ohio

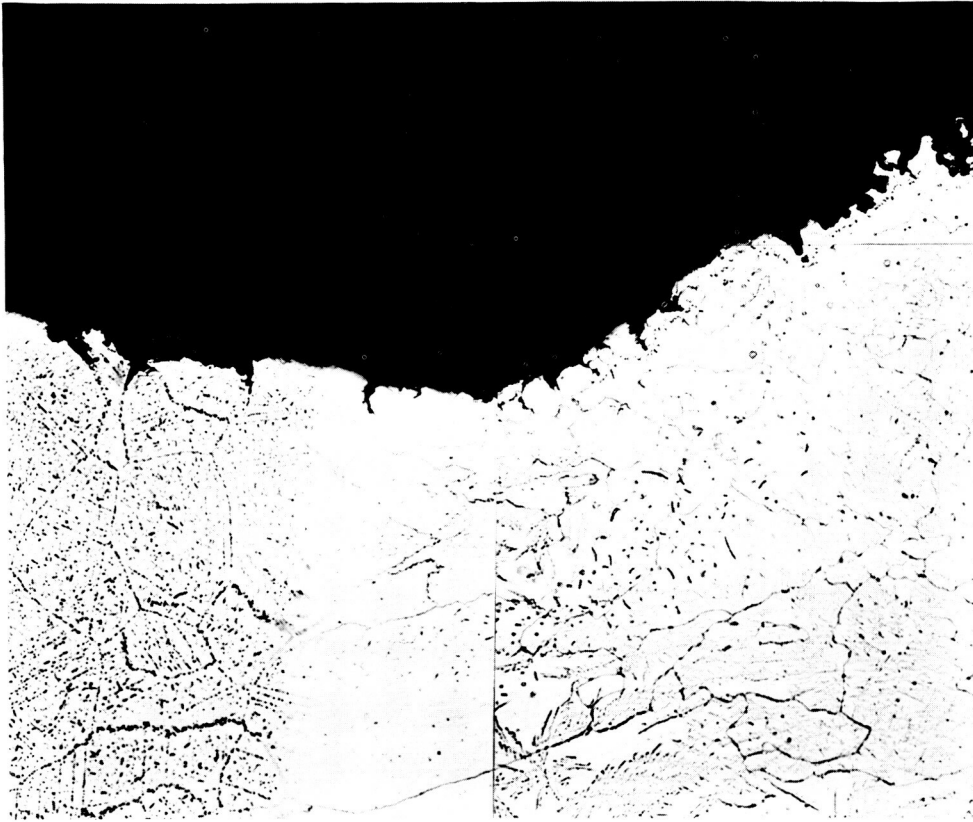
Figure 31. Appearance of Corrosive Attack Found on the I.D. Surface of the Specimen Removed from the Weld in the Lower Part of the Boiler Inlet (Section No. 11, Weld).

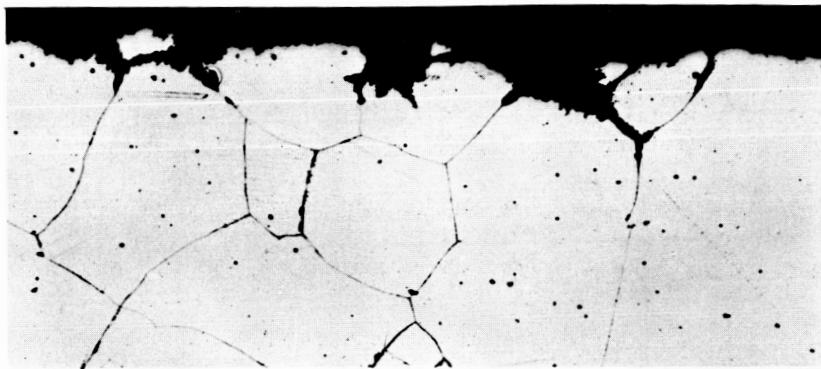
Compared to the boiler, the attack incurred in the superheater was light. The results of the examination of the specimens removed from the superheater are shown in Table 13. Again, the weighted average temperature for Run Nos. 13 and 15 are shown. However, as discussed before, these temperatures are shown just for informative purposes. In general, a light crevice type of attack to a depth of 0.0005 in. was found. Figure 36 (Section 21, thermocouple No. 20) shows the general appearance of the attack. The greatest amount of attack in the superheater was found in the specimens removed from the outlet region of the superheater. The attack again was in the form of a crevice type with a small amount of pitting to a maximum depth of 0.001 in. Figure 37, (Section 26A, TC No. 29) is representative of the maximum attack found.

Along with the attack, deposits of corrosion products were found along the tube wall within the superheater. These deposits were metallic in appearance and appeared to be metallurgically bonded to the inside surface of the tubing. The greatest amount was found in the superheater inlet (Section 20 and 20A). Section 20A was removed after 3833 hours so that the crud separator could be installed in the superheater. Figure 38 (Section 20, thermocouple SH 1) shows the general appearance of the deposit at 100 magnification. In this region, the deposit was rather uniform in nature as shown in Figure 39 (macrograph of a portion of Section 20). The thickness of the deposit varied from 0 to .03 in. in depth.

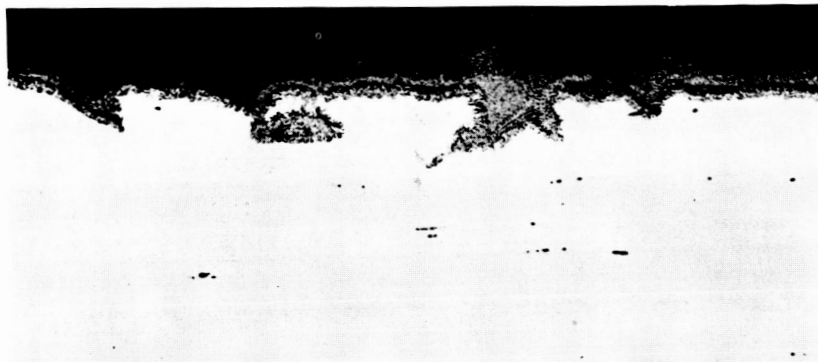
Figure 33. I.D. Surface of Specimen Removed from the Middle Region of the Boiler (Section 12, Thermocouple No. 6).

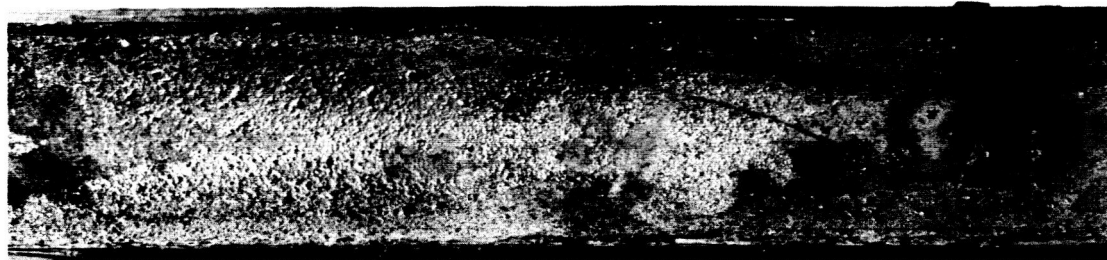
Figure 39. Macrograph of Deposit Found Along the I.D. Surface of the Superheater Inlet (Section No. 20).

A heavy deposit was found along the bottom of the entrance section of the superheater. The deposit was crystalline and metallic in nature. Also, it was quite hard and adherent as if metallurgically bonded. The appearance of this deposit is shown in Figure 39.

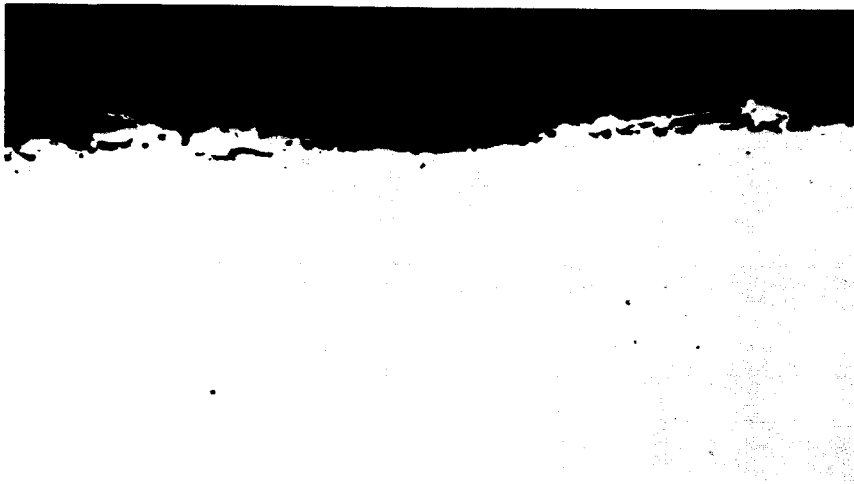
The results of the examination of the specimens removed from the condenser region are shown in Table 13. As shown, the attack found was limited to a light pitting to a maximum depth of 0.0005 in. Figure 43 (Section No. 29, thermocouple No. 35) shows the general appearance of the type of attack found. A weld area in the condenser was also examined for any possible attack. The area examined was in Section No. 27 where the condenser tubing was reduced in size from 5/8" O.D. to 1/2" O.D. tubing. As was the case with the rest of the welds examined, the weld appeared sound.

Figure 43. Appearance of the I.D. Surface of the Specimen Removed From the Condenser (Section No. 29, Thermocouple No. 35).

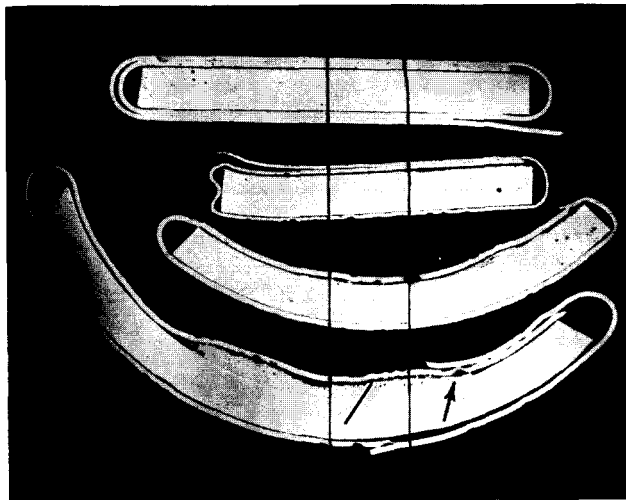
As a further study of the amount of corrosion incurred by the loop, electron beam microprobe analyses were conducted on four of the metallographic specimens. The analytical work was conducted by Advanced Metal Research Corp. Two of the specimens (Section No. 16, thermocouple No. 11; and Section No. 17, thermocouple No. 13) were from the boiler outlet region. The other two (Section 20A, thermocouple No. 18 and Section No. 22, thermocouple No. 21) were from the inlet and middle regions of the superheater, respectively. Two separate areas on the specimen Section No. 20A, thermocouple No. 18 were analyzed. Figure 45 shows the approximate location and scan paths made on the specimens.

Figure 45. Macrograph of Mount Showing the Location of the Microprobe Scan Analyses. Except for the one area marked by the arrow, the rest of the analyses were conducted within the area bounded by the two scratch marks. The line on the bottom specimen indicates the orientation of the scan trace.

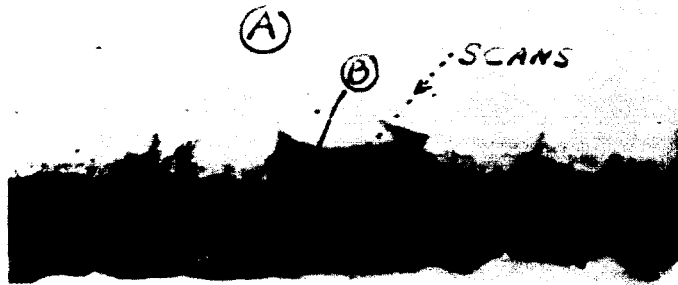
Figure 46. I.D. Surface of Specimen Removed from Section No. 16, Thermocouple No. 11, Showing the Microprobe Scan Path and Areas Analyzed.

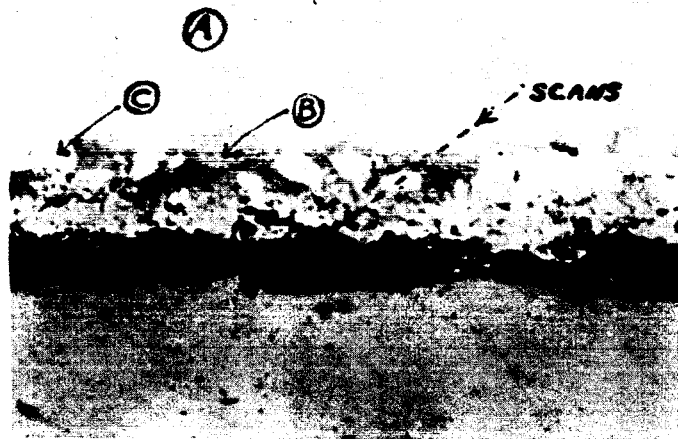
The analyses conducted on the two specimens from the boiler outlet region support the results obtained on wet chemical analysis of the deposits removed from the inside tube wall. However, three different compositional areas were found in the deposit along the surface of specimen Section No. 17, thermocouple No. 13. The grayish appearing phase is similar in composition to the corrosion layer found along the surface of the specimen Section No. 16, thermocouple No. 11 (Figure 46). As shown in Table 18, this phase is high in cobalt and tungsten with only small amounts of chromium and nickel. The white areas (marked C in Figure 47) within the deposit were found to be essentially the base metal depleted of chromium, whereas the edge of the deposit (marked B in Figure 47) was found to be essentially base material depleted in tungsten and nickel.

Figure 47. I.D. Surface of Specimen Removed from Section No. 17, Thermocouple No. 13, Showing the Microprobe Scan Path and Areas Analyzed.

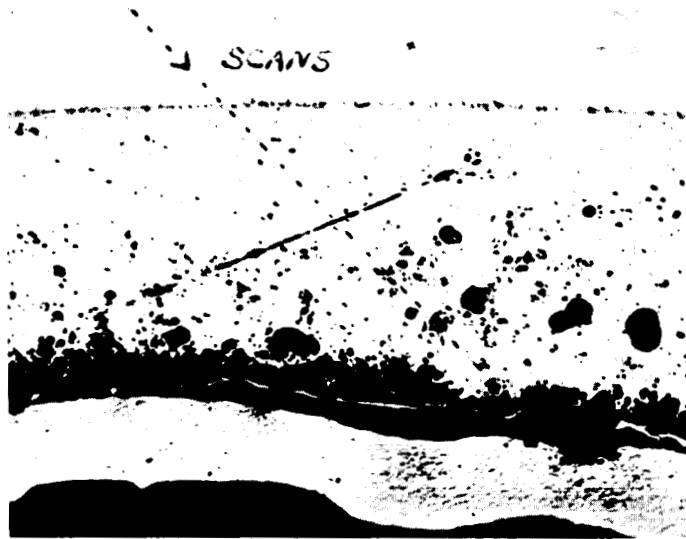
Figure 48. I.D. Surface of Specimen Removed from Section No. 20A, Thermocouple No. 18, Showing the Microprobe Scan Path.

Two areas of different composition were found within the deposit on the specimen Section No. 20A, thermocouple No. 18. As shown in Table 18, the bulk of the deposit (Figure 48 and marked C in Figure 49) was predominantly nickel with about 25 to 27 percent chromium. Only minor amounts of tungsten, iron and cobalt were found. However, another phase, (marked B in Figure 29) was found that was almost pure chromium (98-99 percent). Cobalt, tungsten, iron and nickel were found only in small or trace amounts. The results of the analysis of the specimen Section No. 22, thermocouple No. 21 were approximately the same. However, the chromium-rich phase was present in a greater quantity within the deposit. Also, there was not the same amount of distinction between the phases as was found in the specimen Section No. 20A, thermocouple No. 18.

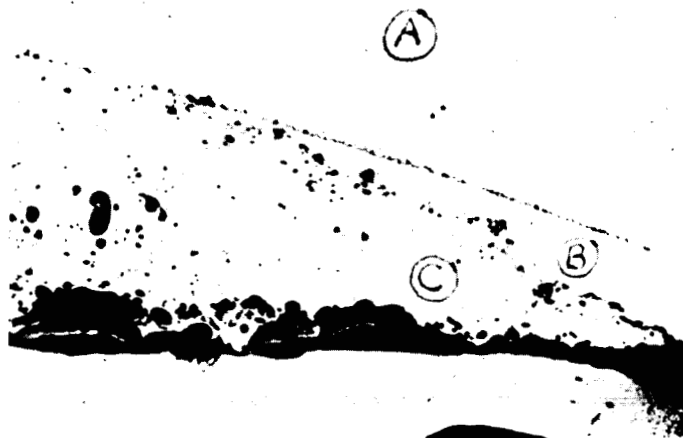
Figure 49. I.D. Surface of the Specimen Removed from Section No. 20A, Thermocouple No. 18, Showing the Areas Analyzed. This area is the area marked by the arrow in Figure 45.

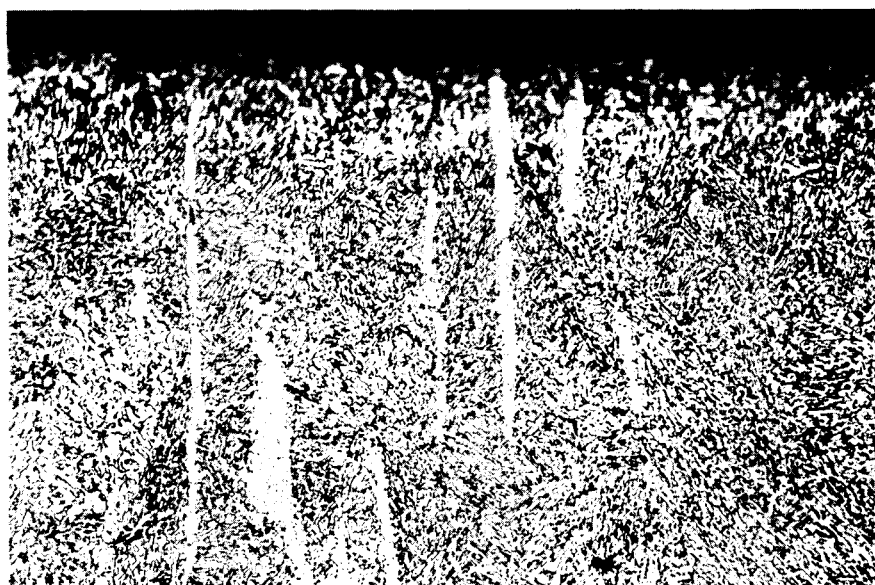
Figure 52 shows before and after test photomicrographs of the PH15-7Mo erosion specimen heat treated to the RH 950 condition. As shown by the photomicrographs, the edge of the specimen was relatively unaffected by the exposure to high velocity mercury vapor. However, as can be seen, the microstructure of the specimen in the after test condition changed from an acicular martensitic structure to that of a tempered martensite. Also as shown, carbon diffused into the ferrite stringers.

Figure 52. Condition of the Edge of the PH15-7Mo Erosion Specimen Heat Treated to the Condition RH 950.

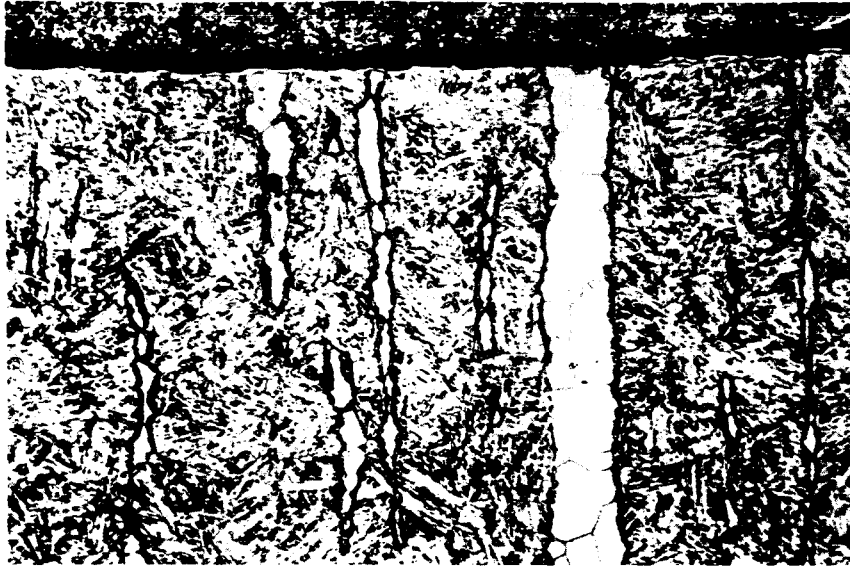
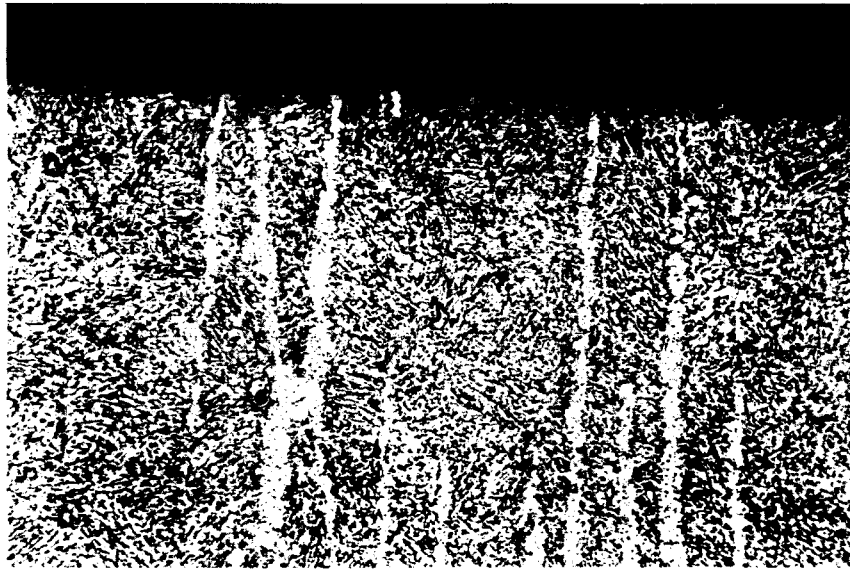
Photomicrographs in the before and after test condition of the PH15-7Mo erosion specimen heat treated to the TH 1050 condition are shown in Figure 53. As shown, the surface of the specimen was relatively unaffected by the exposure conditions. Also, the microstructure of the specimen in the after test condition changed as compared to the structure in the before test condition. The changes which occurred are essentially the same as those discussed for the PH15-7Mo erosion specimen heat treated to the RH 950 condition.

Figure 53. Condition of the Edge of the PH15-7Mo Erosion Specimen Heat Treated to the Condition TH 1050.

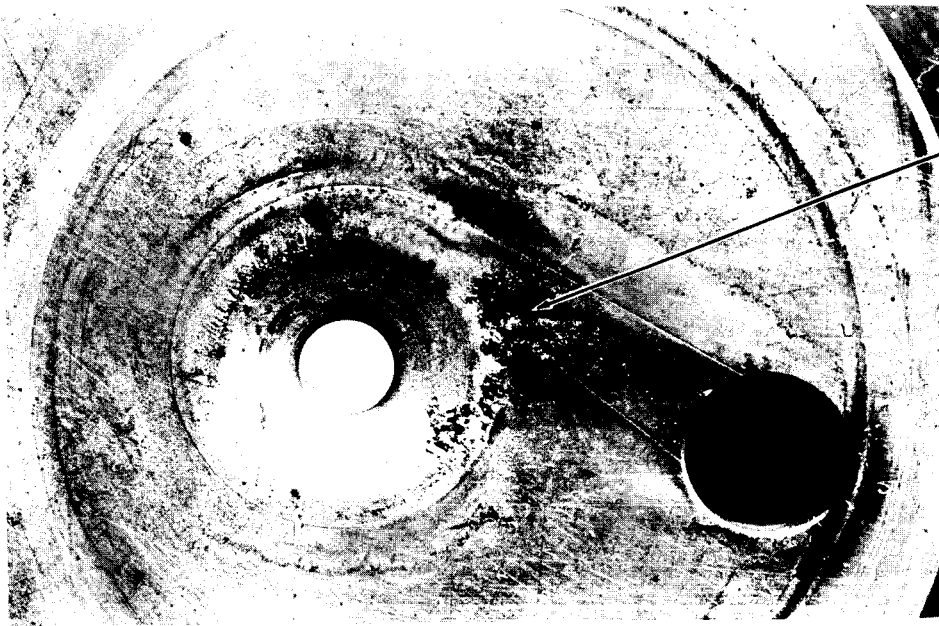
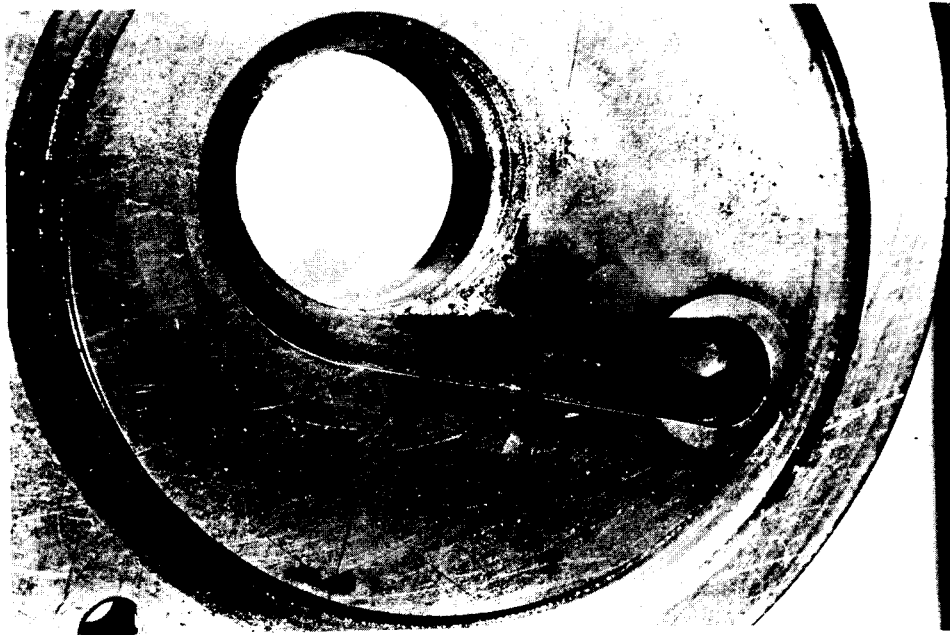
The final loop component to be examined was the centrifugal pump, which was fabricated from Type 316 stainless steel. The pump head was dismantled and examined visually for any possible damage. The pump components examined are shown in Figure 55. Evidence of cavitation damage was found only on the volute tongue. Figure 56 shows macrographs of the tongue and the extent of damage incurred. Sections were removed from the top part of the tongue (Figure 56) at the damaged area. These sections were then mounted and polished for metallographic examination.

Area where metallo-  
graphic specimen  
was removed.

Figure 56. Macrograph of Centrifugal Pump Body Showing the Extent of  
Damage Incurred.

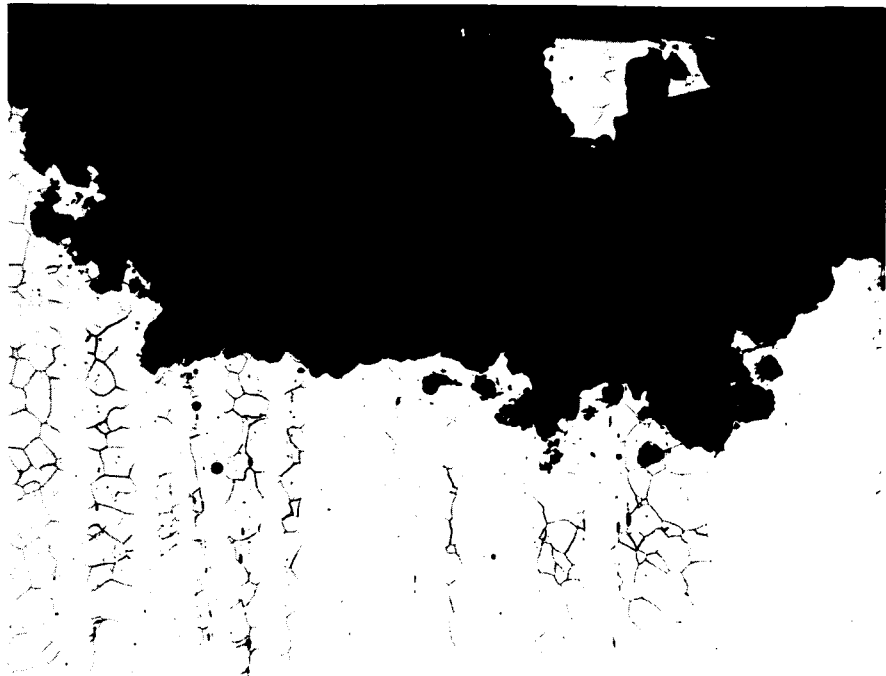
Figure 57 (50X) is a photomicrograph of the damaged area. As shown, material was literally torn away to form the cavity. The maximum depth of the damage was .085 inch.

Figure 57. Appearance of the Damage Incurred Around the Volute Tongue. Specimen removed from the top half of the pump body which was fabricated from Type 316 Stainless Steel.

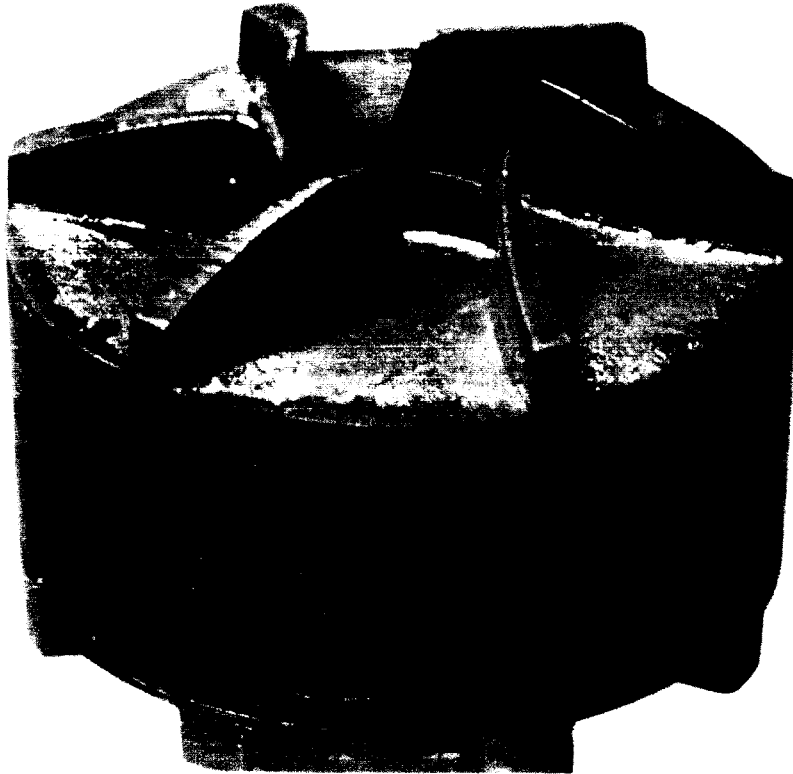
The only other component to be affected was the Type 316 stainless steel impeller. As shown in Figure 58 the side of the impeller was abraded. From the appearance of the markings, the impeller apparently rubbed against the side of the housing during operation. The impeller blades appeared to be completely undamaged as shown in Figure 58.

Figure 58. Macrographs of the Centrifugal Pump Impeller Showing the After Test Condition. Impeller was fabricated of Type 316 Stainless Steel.

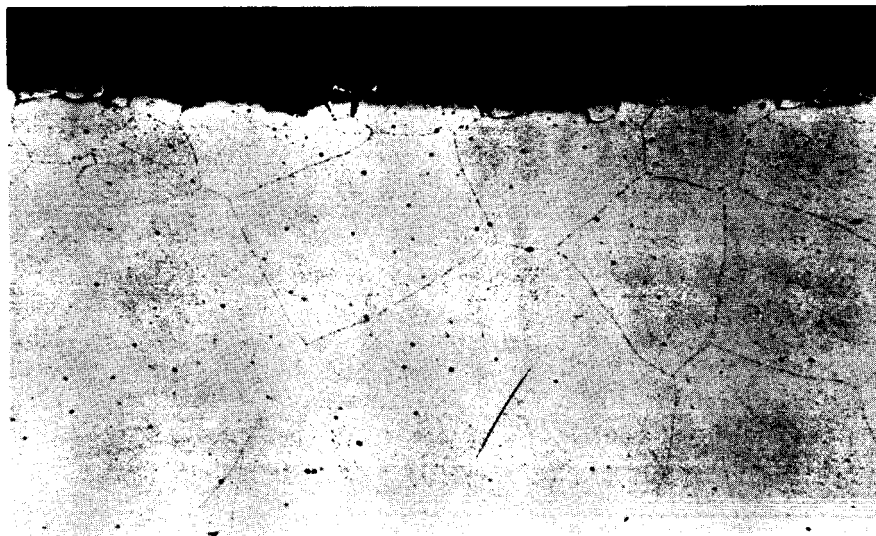
Examination of the I.D. surface near the crack revealed a crevice type of corrosive attack, as shown in Figure 60. The maximum depth of the attack was 0.001 in. A similar type of attack was found on the I.D. surface of the specimens removed on either side of the crack. The depth of penetration was also about the same.

Figure 60. Appearance of the I.D. Surface of the Specimen Removed Near the Crack which Occurred After 262 Hours.

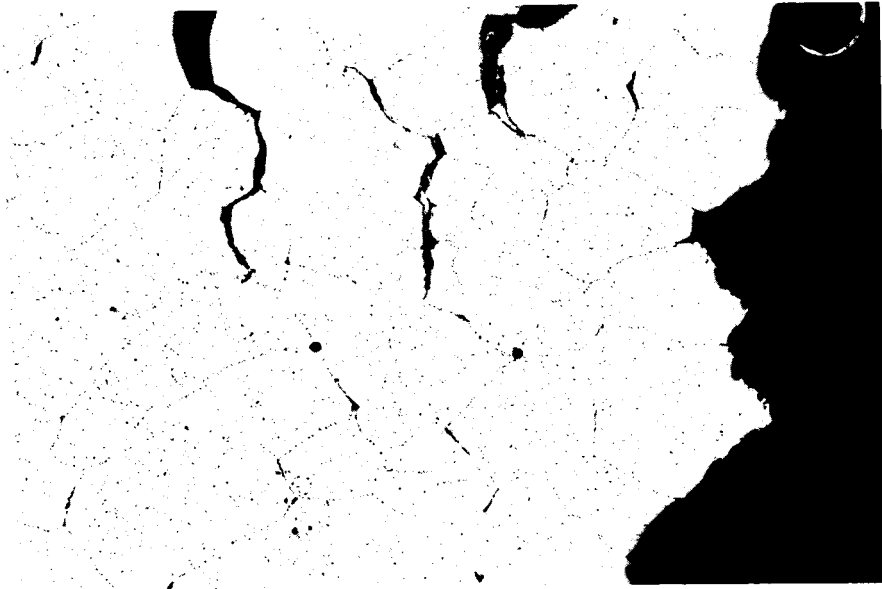
Again, metallographic specimens were removed at the point of failure as well as on either side of the failure. The location of the specimens removed is shown in Figure 11. The crack was again intergranular in nature as shown in Figure 61. However, in this case, the tube wall near the crack was necked down. Also, numerous cracks were found along both the I.D. and O.D. surfaces as well as within the tube wall. The crack density was greatest within the necked down area. The appearance of the tube wall in this case points to a creep rupture type of failure. The appearance and mode of failure indicate that the tube wall was locally overheated and that the rupture may have been the result of a pressure overload at the local thermal condition.

Figure 61. Appearance of the Tube Wall of the Boiler Showing the Failure which Occurred After 3876 Hours.

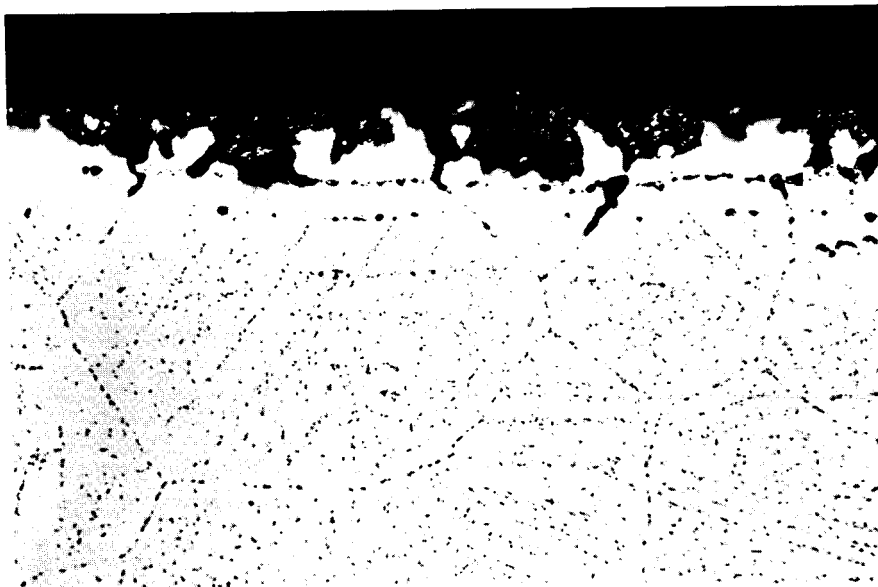
In addition to the cause of failure, the specimens were also examined for the extent of corrosive attack found. In general, the I.D. surface on each specimen was found to have undergone a combination of layer, crevice, and depletion attack to a maximum depth of 0.003 inch. Figure 62 is typical of the corrosive attack found. Examination of the surface of the specimen removed from the inlet end of the section revealed a deposit about 0.015 in. thick. Figure 63 shows the appearance of the deposit. Unfortunately, there was not enough deposit present in the section of tubing to obtain an analyses.

Figure 62. Appearance of the I.D. Surface Near the Failure which Occurred in the Boiler After 3876 Hours.
