**COUPLING CREDIBLE FAILURE MODES AND OWNER OPTIONS TO INTERVENE**

**Stephen R. Locke**  
Principal Consultant, Rotating Machinery  
DuPont  
Old Hickory, TN, USA

In this paper, a user's and an OEM's views are presented of the most common coupling failure modes with examples showing details in the final stages of deterioration and identifies options to enable owners to intervene in sufficient time to prevent catastrophic failure.

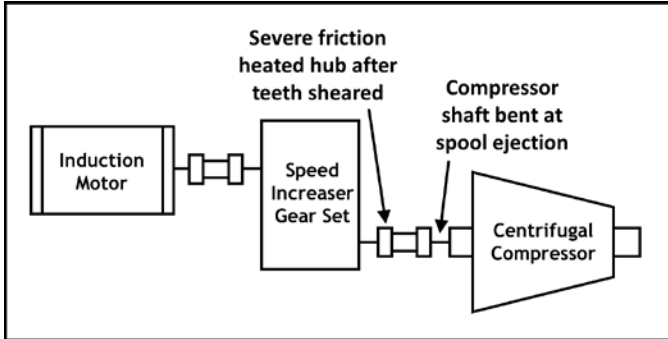
This legacy refrigeration compressor shown in Figure 21 had a size 2-1/2 gear coupling was driven at 6820 RPM by a gearbox and a 1775 rpm, 2500 HP motor and initially had no vibration instrumentation.

Figure 21. Legacy refrigeration compressor initially had no on line vibration measurement for alarm and interlock protection.

Operators had taken readings and inspected the compressor just 90 minutes prior to the failure and did not notice anything unusual, which underscores how quickly the failure occurred. The first indication of trouble was when the control room got out of limits process condition alarms.

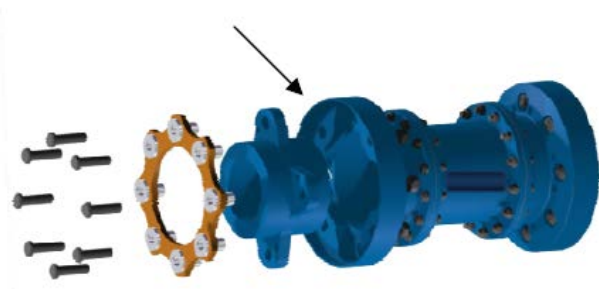
Figure 29. Interlocking Flange Feature

Since the interlock feature (full depiction in Figure 29) worked, serious damage to the equipment train was avoided while the exact cause of the problem – condensate slug, leading to bearing damage, leading to misalignment then coupling failure – was determined.

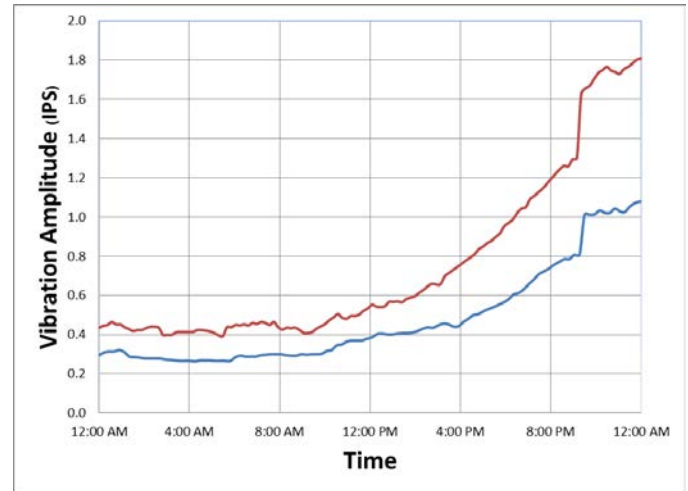
However, since these disc couplings failed gradually and the vibration from unbalance increased gradually, catastrophic failures were averted as, in the 1st failure the high vibration tripped a shutdown, and in the 2nd, the operators shut down the machines for investigation after the vibrations exceeded the Alarm Level (Figure 31).

Figure 31. Vibration Probes Mitigated the Failure

The original couplings were repaired after it was determined that the new turbine mounting structure had undersize bolting to keep the Turbine aligned properly during full load conditions, which led to the excessive misalignment to fail the couplings. This undersize bolting was changed.

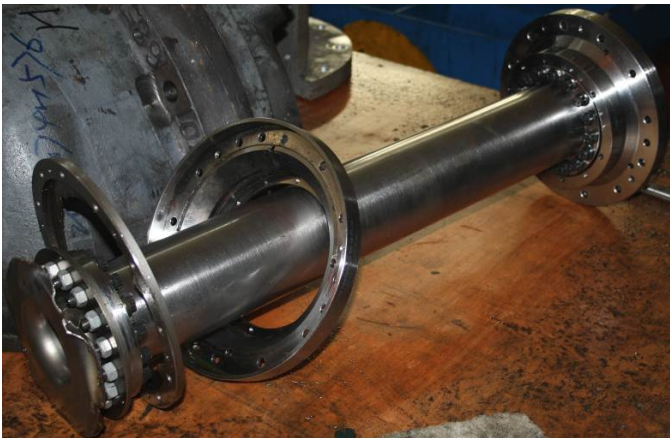
However, due to the anti-flail feature built in to the coupling, the free rotating center section was contained inside the coupling envelope and did not have enough force to be ejected from the coupling guard (Figure 36).

Figure 36. Anti-Flail Worked

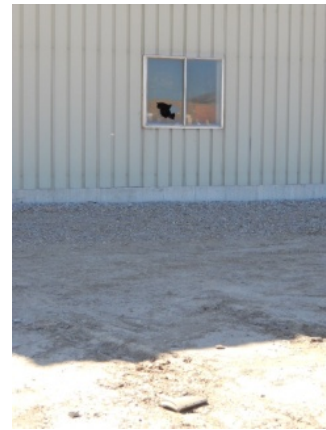
Part of the guard went through a window (Figure 38). This was classified as a Near Miss occurrence and gained much attention from all vendor and operator parties involved.

Figure 38. Ejected Part of Guard

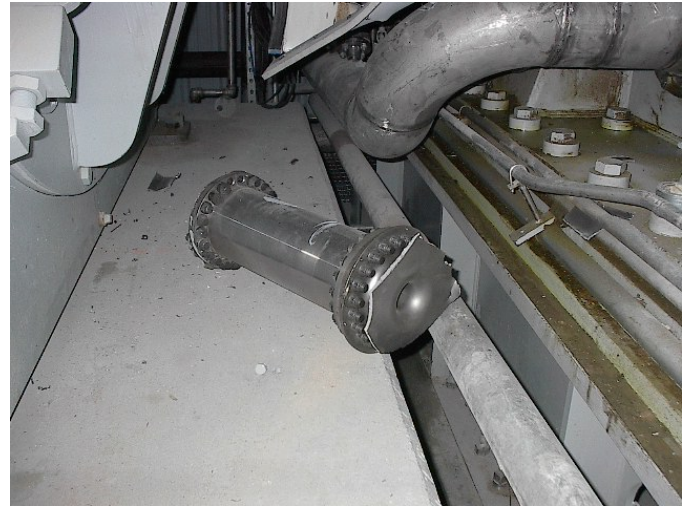
Figure 41. Ejected Diaphragm Spacer

In a Steam Turbine / Generator application, 37221 hp @ 3600 rpm, a 15 inch diameter Diaphragm coupling failed catastrophically on the 1st start up and parts blew right through the coupling anti-flail feature and the coupling guard (Figure 41).

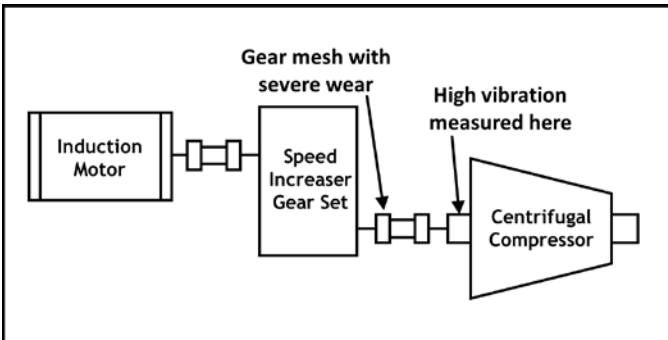
This legacy compressor with a size 2-1/2 gear coupling was driven at 6200 RPM by a gearbox and a 1790 rpm, 1500 HP motor. The coupling was new and had only run for two weeks. The maintenance crew knew shortly after startup that the coupling was leaking grease and hoped to reach a scheduled outage (Figure 44).

Figure 44. High vibration measured at opposite end of coupling from the severe wear.

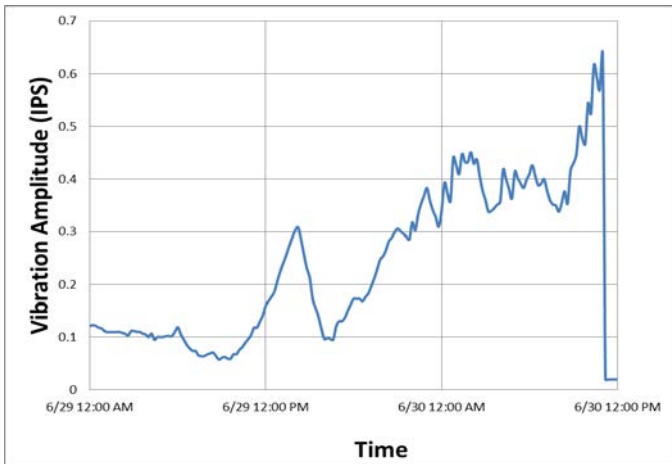
showed constant vibration levels which were flat lines for nearly all of the two week run until the last twelve hours of operation when the vibration levels became very erratic and ramped up quickly as shown here in figure 47.

Figure 47. Vibration ramp rate shows very rapid onset

The rapid vibration ramp and an active grease leak just hours before the shutdown shows most of the tooth wear occurred during the mere twelve hour interval after the gear teeth transitioned from boundary lubrication to dry wear.

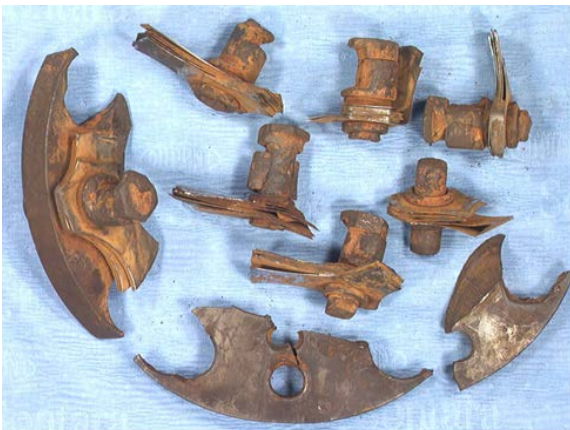
Oblong bolt-hole wear on the compressor hub in Figures 49 and 50 show that after the disc pack failed torque was transmitted through the interlocking bolts until the hub wore too thin and failed into fragments in Figure 51.

Figure 51. Remnants of compressor side disc pack & hardware

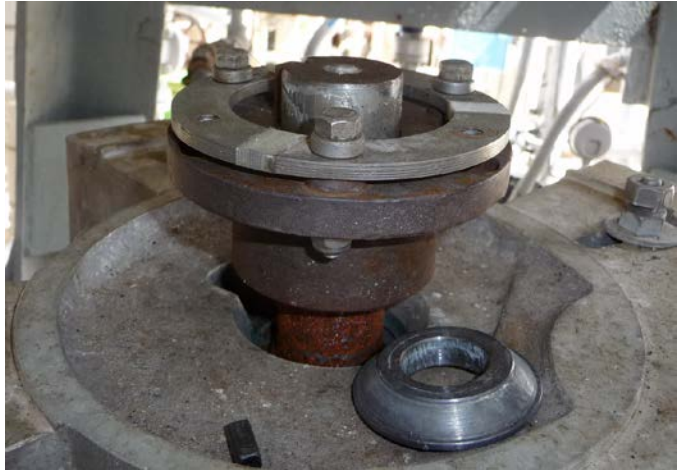
Mechanics had struggled with the alignment methods on this machine, and the shafts were in fact misaligned. Without appreciating the risks or consequences, someone had modified the hub to be a slip fit to simplify installation, as the protrusion of the compressor shaft beyond the hub shows in Figure 56.

*Figure 56. Hub was incorrectly modified to be a slip fit.*

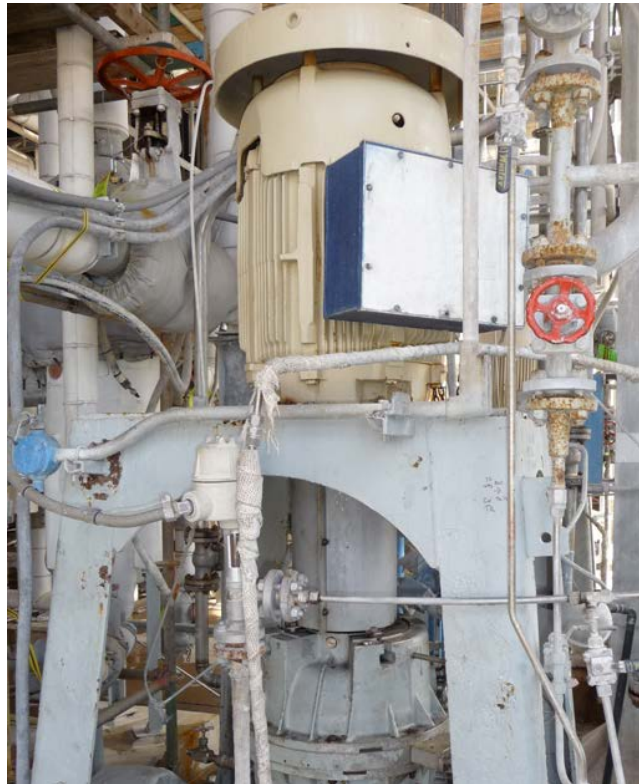
A 100 HP 3600 RPM, vertical motor driven compressor (Figure 54) ejected the coupling spool piece (Figure 55) immediately during start up following maintenance work. The operator was still standing at the start switch, and was very close to the trajectory, but fortunately was not harmed. The compressor had vibration probes on the high speed output shaft, but not on the motor or gearbox input shafts.

*Figure 54. Vertical compressor with 3590 RPM motor.*

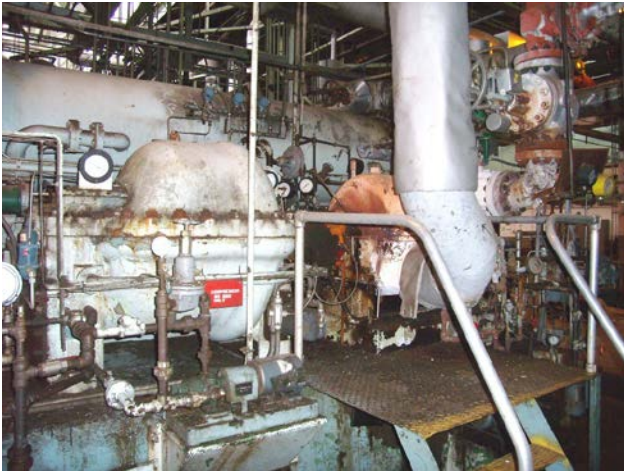
A legacy 1000 HP, 4800 RPM turbine driven refrigeration compressor (Figure 57) with a disc pack coupling but without any installed vibration protection was found to have unusual vibration by a vibration technician, though the amplitude was not excessive. Disassembly and inspection showed the disc packs were failing in fatigue due to excessive offset shaft misalignment and incorrect axial spacing to accommodate the shaft thermal expansion of thrust bearings at the far ends of each rotor (Figure 58).

Figure 57. Turbine direct drive refrigeration machine

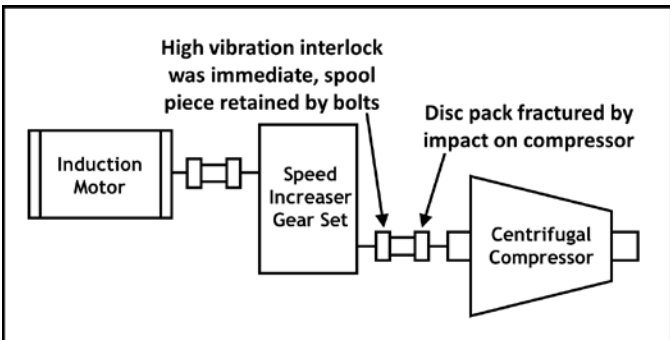
This 900 HP single stage process gas centrifugal compressor was driven by a 1785 RPM motor through a gear speed increaser at 8300 RPM and a 5.5 inch diameter disc pack coupling (Figure 62 and 63).

Impact overload of a coupling can come from multiple sources. In this case the source was a major process upset, resulting in the compressor ingesting a large amount of process solids. The resulting shock load fractured the disc pack of the high speed coupling.

Figure 62. Compressor configuration

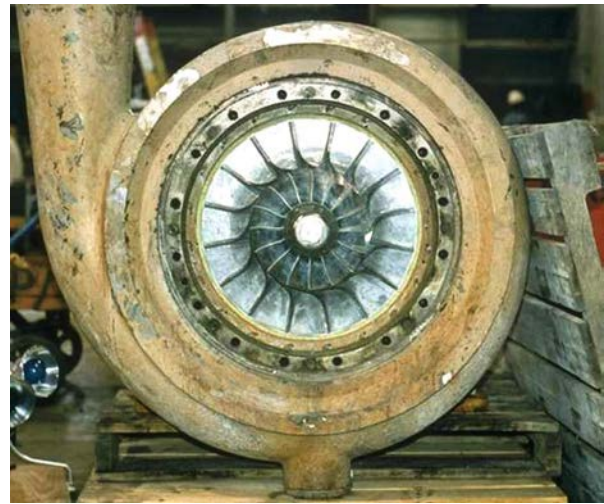
Figure 63. Single stage overhung compressor.

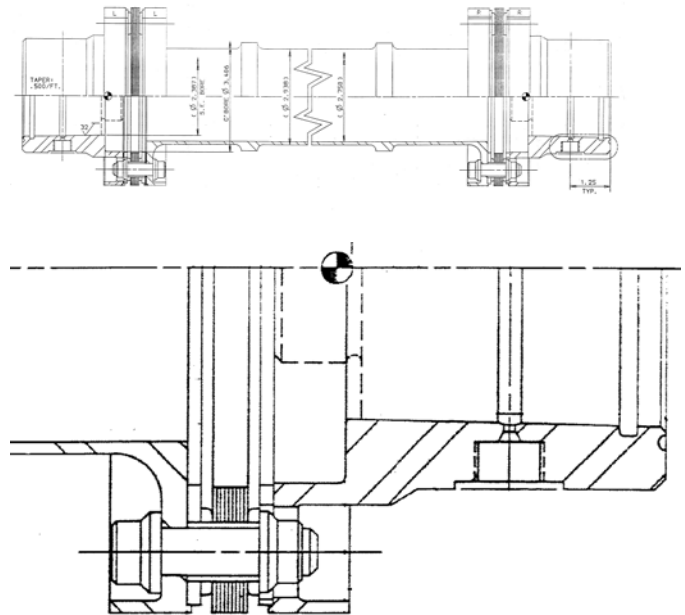
The unbalance force of the off-center spool piece running at 8300 RPM was high enough to immediately shut down the compressor on high vibration. While this older style disc pack coupling did not have the best modern anti-flail features (Figure 64), the compressor and gear box thrust bearings provided enough axial load capability to enable the bolts to retain the spool piece long enough for vibration interlocks to shut the compressor down safely.

Figure 64. Older style disc pack interlocking bolts only.

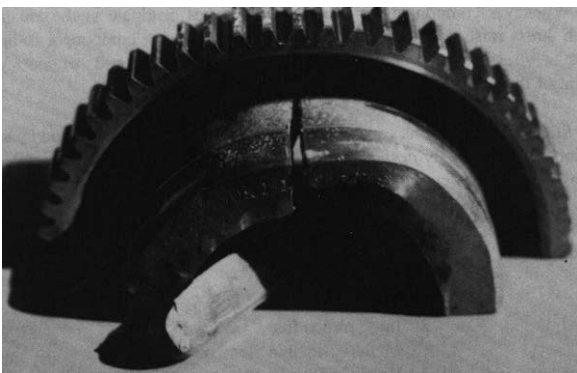
Proper Installation and maintenance of couplings is critical. An improperly fit key can cause a hub failure (Figure 68). Furthermore, an improper hub fit can lead to fretting, hub slippage, yielded hubs, and even shaft failure. See Figures 69 and 70. For information on the proper fitting of keys and information on proper installation of keyless hubs, see ANSI/AGMA 9002-B04 (2005) and ANSI/AGMA 9003-B08 (2008).

Figure 68. Hub Failure Due to Improper Key Height  
Calistrat (Calistrat 1994, Flexible Couplings – Their Design Selection and Use)

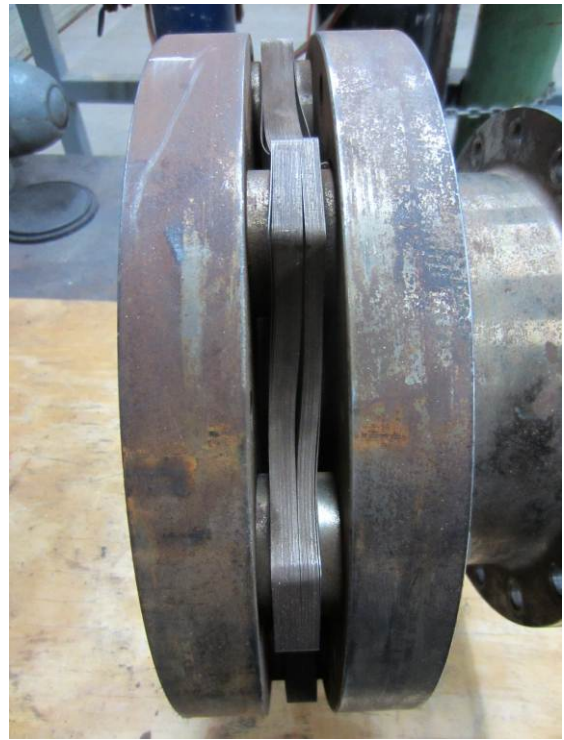
It can be difficult to determine the condition of a disc coupling while in service. Using a strobe adjusted to the disc coupling’s revolution, if the discs are exposed, it’s possible to examine the disc packs for signs of buckling, spreading, or broken discs (Figure 73 and 74).

Figure 73. Spread Discs

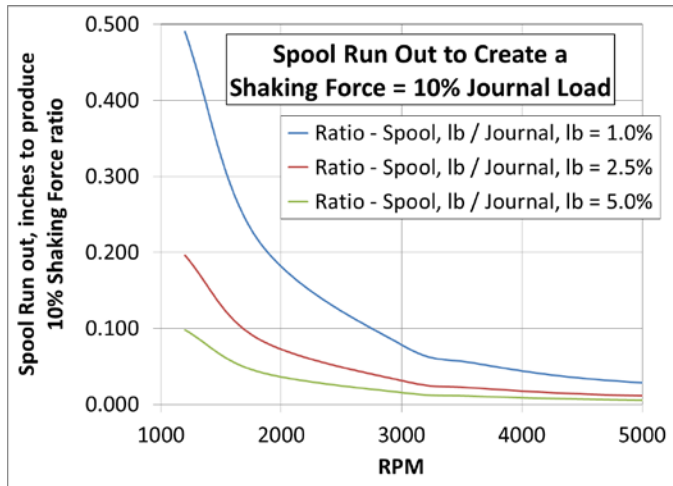
Figure 77: Coupling floating spool run out to produce 10% shaking force on a rotor at low RPMs.

Machines with relatively light coupling spools or slower speed machines could be at greater risk because a larger coupling spool run out is required to generate the 10% shaking force (Figure 77). At least two compressors at DuPont have

been identified where a failing coupling operating at a lower speed did not generate enough unbalance for an automatic trip at normally guide-lined vibration levels.

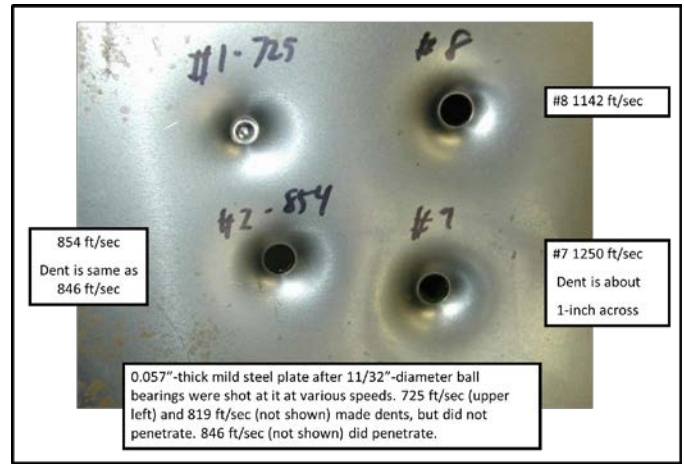
Figure 78. Target plate fragment penetration testing

Through the use of the empirical THOR equations in combination with laboratory testing (Figure 78) it has been shown that coupling guards can be designed to contain a coupling nut and bolt fragment. The analysis method uses the fragment kinetic energy upon release and compares the result to the energy absorbing capability of the guard material to determine if the fragment will be contained by the guard or if it will penetrate the guard. The method also estimates the kinetic energy of the fragment after penetration.

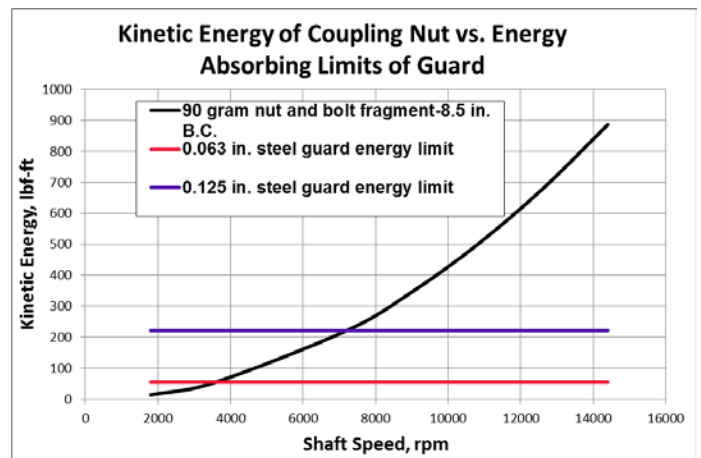
Figure 79. Coupling Guard versus a coupling nut

Figure 79 shows the kinetic energy of a 90 gram nut and bolt fragment versus shaft speed and the energy absorbing limits of two different steel plate guard thickness.

Having the ability to contain a coupling nut and bolt fragment with an appropriately designed coupling guard is beneficial as a means to mitigate a bolt failure because there is no other line of defense for this failure mode. A vibration monitoring system will only sense the resulting unbalance after the failure, and then it is too late.

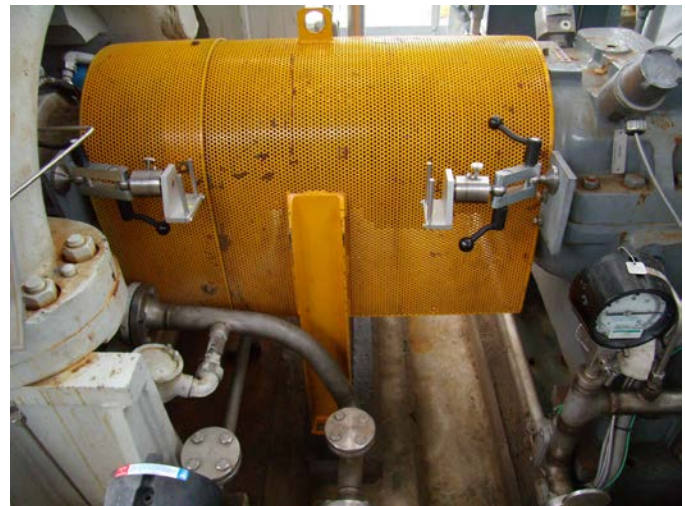
Figure 80. Perforated metal coupling guard

The analysis method has been used for both solid metal and perforated metal guard materials (Figure 80).

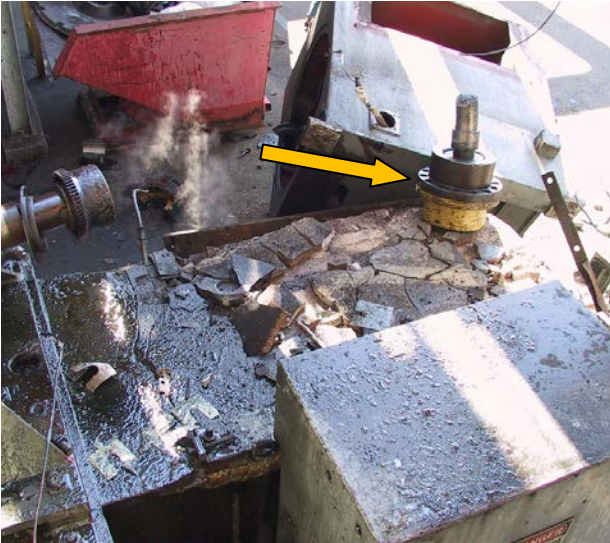
However, containment of a failed coupling component any larger than a nut and bolt fragment is not practical because the kinetic energy of the failed component is too great. Figures 81 and 82 show the results of a coupling separation. Not only did the guard not contain the coupling but the base did not retain the motor.

Figure 81. Coupling Guard versus a flailing coupling
