APPLICATION OF A HEAT BARRIER SLEEVE
TO PREVENT SYNCHRONOUS ROTOR INSTABILITY

Demag Delaval Turbomachinery

ABSTRACT

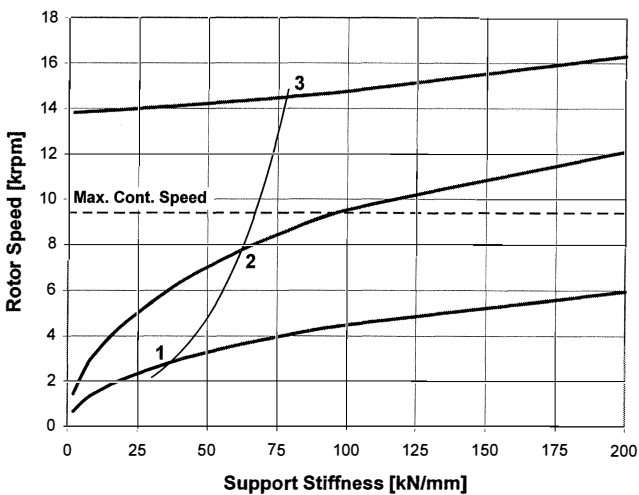
Figure 2. Undamped Critical Speed Map.

Resuming the vibration problem, the compressor had high synchronous rotor vibrations, which could not be predicted by the traditional rotordynamic analyses. The undamped critical speed map in Figure 2 indicates that, to reach maximum continuous speed, two critical speeds have to be passed. As can be seen in Figure 3, these critical speeds have typical conical rigid body modeshapes. Rotor response calculations showed that these modes are both critically damped (AF less than 2.5). The next critical, above the operating speed range, is the first bending mode, which has an amplification factor of around five, and the separation margin to the maximum operating speed is sufficient.

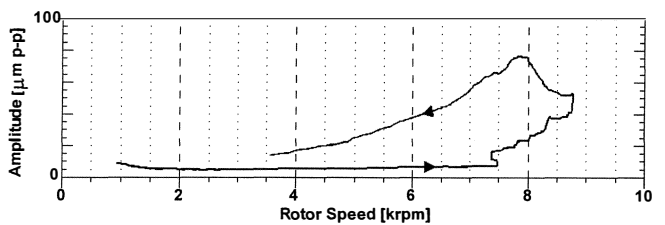
Figure 4. Fundamental Component (1×) of Relative Shaft Vibration, Measured at Impeller-End Bearing.

7,200 rpm (76 percent of maximum continuous speed), were satisfactory with maximum vibration levels of around 12 microns peak-to-peak (0.5 mil). Above 7,200 rpm however, the rotor vibration behavior was unacceptable, and both compressors were tripped several times on high vibration. At these higher speeds, the vibration levels were normal, until a sudden increase in vibration levels tripped the unit at a level of 75 microns peak-to-peak (3 mil). The vibration analysis showed that the predominant frequency of all signals was synchronous with running speed. Figure 4 shows a typical plot of the rotor vibration behavior, measured at the impeller-end bearing. For one of the runups, Figures 5 and 6, respectively, give the rotor speed and the vibration level as a function of time. For this run, above a certain speed the vibrations were varying between a minimum and a maximum value, although the rotor speed was constant. Figure 7 shows a polar plot of this run at a rotor speed of around 8,400 rpm.

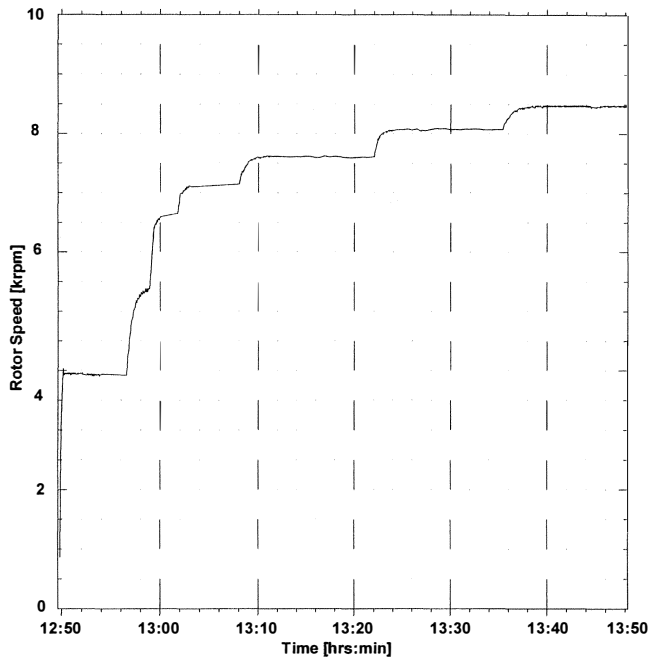
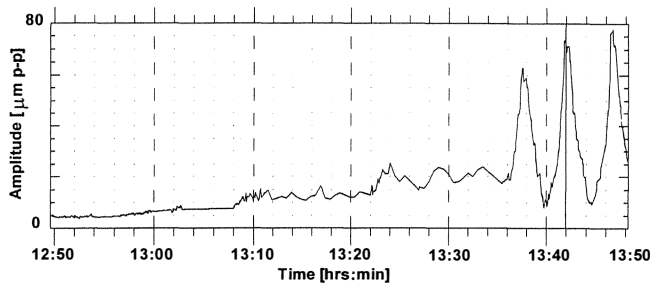
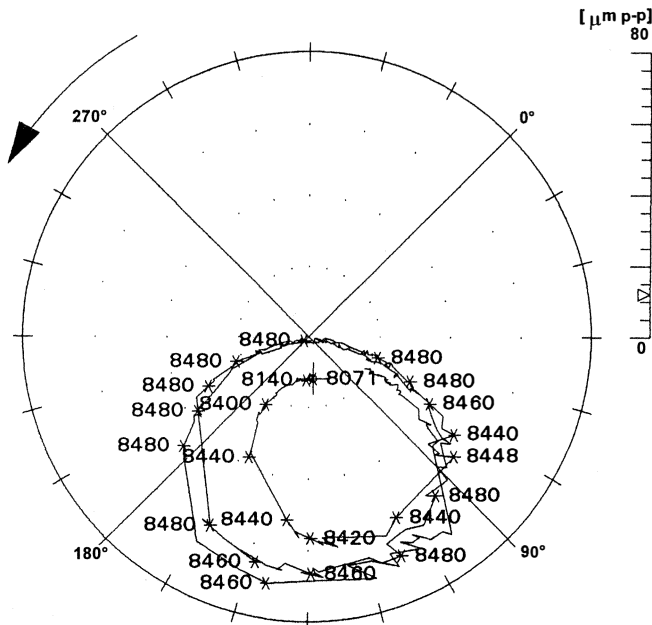
Figure 6. Unfiltered Relative Shaft Vibration Versus Time, Measured at Impeller-End Bearing.

Although the vibrations were synchronous with running speed (1×), it was not possible to field balance the rotor. The phase change in Figure 7 shows a continuously changing unbalance vector. Finally, the compressor suction and discharge piping were removed, and, in this configuration, another test run was conducted. This test run, with open suction and discharge piping (air test), was executed with all other contract equipment in place. During this test, the vibration levels were low over the entire speed range and stayed low, no matter what was done. Quick starting or stopping procedures, changing oil supply temperatures, fast rotor speed changes—nothing changed the low vibrations. In fact, the running behavior was similar as to what was experienced in the manufacturer's workshop.

The rotor vibration behavior was not stable, but was changing in time. The vibrations sometimes were varying between a minimum and a maximum value, although the rotor speed was constant. It was noticed that, during this unstable behavior, the phase angle was also changing continuously. The high vibrations could be suppressed by reducing the rotor speed, but hysteresis was shown in the plots between the runup and coastdown. It can be seen in Figure 4 that during reducing the rotor speed, the vibration level was much higher than during the runup. This hysteresis points into the direction of a thermal phenomenon. However, without the suction and discharge piping connected to the compressor, the machine ran well.

Figures 6 and 7 could also indicate a severe rub between rotor and static parts, such as labyrinths. In that case, the mechanical contact produces a hot spot on the shaft, which results in a thermal bend. The varying vibration levels and corresponding phase changes would be the result of a combined action of the rotor unbalance and the continuously changing unbalance from the thermal bend. This effect is often referred to as the "Newkirk effect" (Newkirk, 1926) or also as "spiral vibrations," due to its nature. That the generation of spiral vibrations can also be caused by stationary elements other than labyrinths, was described by Kellenberger (1979) and also by Schmied (1987).

Figures 6 and 7, in themselves, could be an example of synchronous rotor instability; a phenomenon in which a thermal bend develops at one of the bearing journals, and in combination with a free overhang moment, generates synchronous unstable vibrations. This phenomenon was observed by the authors during the past few years on various types of turbomachinery such as compressors, expanders, gas turbines, and gears. Experimental work at the authors' company on several test rotors confirmed significant differential temperatures across the bearing journals, leading to the assumption that differential heating of bearing journals, in practice, occurs on all rotors supported by fluid-film bearings. Based on these experimental investigations and an analytical model, a calculation program was developed to predict the onset of synchronous rotor

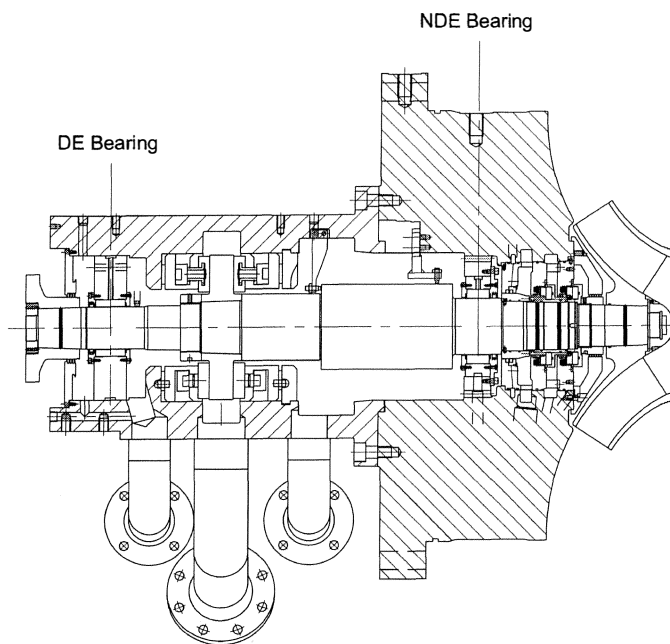
Figure 8. Longitudinal Section of Compressor Cartridge.

For maintenance purposes, all significant parts of the compressor are combined in a "cartridge," as can be seen in Figure 8. This cartridge was sent back to the supplier's works for a detailed inspection of all parts, but nothing unusual was found that could explain the cause of the vibration problem. There were no significant rubbing marks on the shaft, the hydraulic shrink fits of the impeller and the coupling hub were correct, and there was a proper fixture of the rotating seal part to the rotor. The bearings were both in a perfect condition and the diametrical clearances of 0.195 percent at the driven-end (DE) and 0.19 percent at the nondriven-end (NDE) were found within the specifications. The dry gas seal was also in a perfect condition. The only interesting part was the impeller-eye labyrinth where, due to rubbing, the diametrical clearance was increased to about 1.1 mm. However, if this labyrinth is the cause of the problem, then Figures 6 and 7 cannot be explained since this labyrinth is at the very end of the rotor and not even directly positioned on the shaft. The damage to this labyrinth was defined as the result of high rotor vibrations and not as the root cause of the problem.

As can be seen in Figure 8, the cartridge consists of a relatively large steel part around the impeller-end bearing (NDE). On the test bed, during the first start in the morning, the metal is cold with a temperature of around 14°C. During the quick start, the bearing is heated, but restricted in thermal expansion and, as a consequence, the bearing pads will grow inward and the clearance will be slightly reduced. During all other tests of the same day, due to the heat produced by the bearing and the dry gas seal, the temperature of this steel part was increasing to around 45°C and the bearing operating clearance was "normal." As the process gas, being gas from a pipeline with a temperature of around 5°C, has a very high cooling effect on this steel part during compressor operation with process gas, the bearing clearance is expected to stay slightly reduced. A recalculation for synchronous rotor instability, with a reduced NDE bearing clearance, showed a significant reduction for the stability margin. To verify this interim conclusion, it was decided to reduce the bearing clearance of the NDE bearing from 0.19 to 0.16 percent. During the following tests, the rotor vibration behavior was similar as observed at site. Above 8,000 rpm, at randomly selected speeds, the rotor started to become unstable and within one or two minutes the vibration trip levels were reached. The test was repeated without the dry gas seal and without any

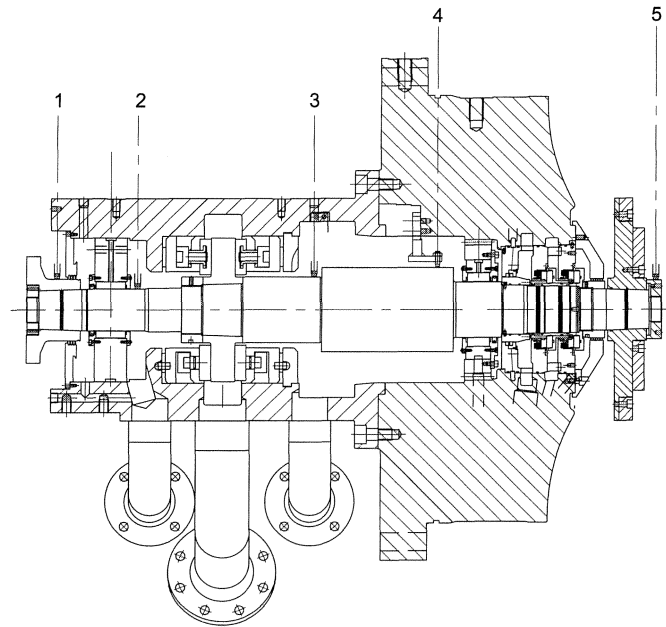
Figure 9. Compressor Cartridge with Dummy Impeller for Testing Purposes.

By then, it was decided to handle the cartridge as a real compressor. It was installed on the test bed floor and driven, via the contract coupling and a shop gear, by a shop variable speed electric motor. As with all other tests carried out with air, the vibrations were low and stable over the full operating speed range. After this test, the impeller was removed and changed out for a "dummy" impeller, a disk with the same shrink fit to the shaft and the same dynamic characteristics and total weight as the actual impeller. However, the dummy impeller weight could be reduced by 10 kg by removing a ring. By adding another ring, a 10 kg heavier impeller could be simulated. Figure 9 shows this test setup. Also, a dummy impeller check nut, suitable for mounting noncontacting vibration probes, was installed at the location of the impeller nose cone. To establish the rotor mode shape during testing, additional pairs of noncontacting vibration probes were installed at the coupling hub, at midspan between the bearings, and on the impeller check nut.

In this configuration, it was relatively easy to change several parameters and test their influence, such as running without the impeller, with various impeller weights, with and without the dry gas seal, with and without unbalance, with the bearing load on pads or between pads. However, whatever we did, the vibrations stayed low and stable in all configurations over the complete operating speed range.

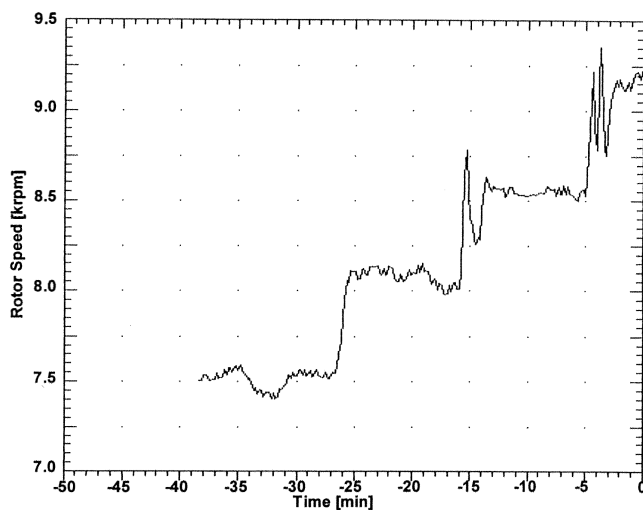
Figure 12. *Filtered Shaft Vibration (1×), Measured at the Dummy Impeller Check Nut.*

labyrinths installed. In this case, the only possible "contact" with the rotor were the bearings. The unstable rotor behavior at site could be reproduced completely, and also during these test runs it was sometimes possible to continue running, if speed changes were made very slowly. But a speed increase of 1,000 rpm within 10 seconds directly triggered the instability. Only small variations in vibration behavior were found when running with a lighter or heavier impeller wheel. One of these test runs is shown in Figures 10, 11, and 12. These plots also show cyclic variation in amplitude and phase, as seen at site (Figures 5, 6, and 7), and also a significant hysteresis was found between runup and coastdown vibration levels as seen in Figure 4. From the rotor modeshapes in Figure 3, it can be seen that for the second mode there is a node between the NDE bearing and the impeller. Rotor response calculations with a single unbalance at the impeller showed that, in the region of this mode, the response at the bearing location was around 180 degrees out-of-phase with the impeller unbalance. For synchronous rotor instability, this condition is necessary for a thermal bow to increase. Depending on the rotor speed, the phase angle will be slightly different from 180 degrees. This means that for each speed, the mentioned phase relationship results in a hot spot that is gradually moving around the journal circumference. This thermal effect results in a continuously changing unbalance vector, or cyclic vibrations in the time domain, which was observed for this machine. It was concluded without any doubt: the observed rotor behavior was synchronous rotor instability.

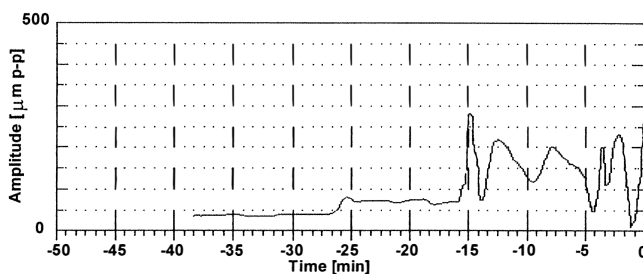
Figure 10. *Rotor Speed Versus Time.*

As starting was becoming a kind of routine, the first start on day four to full speed was executed within two minutes, which was much faster than the days before. At this point, synchronous vibrations started to rise, and around one minute later the unit was tripped on one of the job vibration probes close to the impeller-end bearing, at a vibration level of 75 microns peak-to-peak. Whatever was done during the rest of the day, the vibration levels stayed low and stable over the whole speed range. During the first quick startup the next morning, the unstable rotor behavior was repeated. All other test runs during that day were stable again.

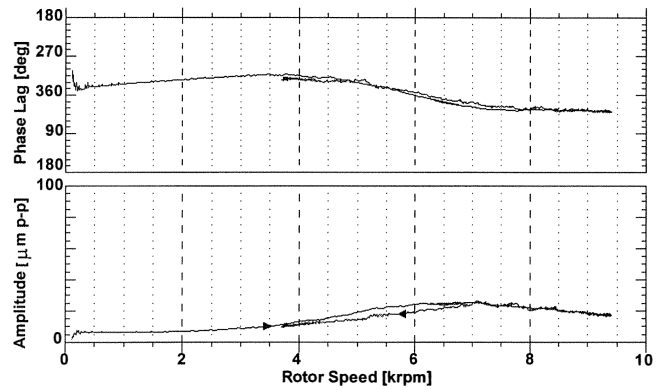
Figure 16. Fundamental Component (1×) of Relative Shaft Vibration, Measured at Impeller-End Bearing (with Heat Barrier Sleeve).

assembled as before, and test runs were started. The compressor rotor behavior was perfect in all aspects, over the entire operating speed range, with low vibrations. No signs of instability were found. Smaller and larger bearing clearances were tested, but the rotor behavior was no longer sensitive to any clearance changes. Tests with different overhung weights were carried out again. Finally, the dummy impeller wheel was replaced by the original impeller and a last check run was executed. To review, the rotor vibrations were low and completely stable. Shortly thereafter, the compressor was shipped to site and was tested over the entire speed range with all kinds of gas flows and pressures, and the vibrations remained low and stable. As can be seen in Figure 16 the vibration level was less than 25 microns peak-to-peak (1 mil). The application of the heat barrier sleeve completely eliminated the vibration problem. A similar heat barrier sleeve was fitted on the rotor of the second compressor, and the running behavior at site was also completely stable.

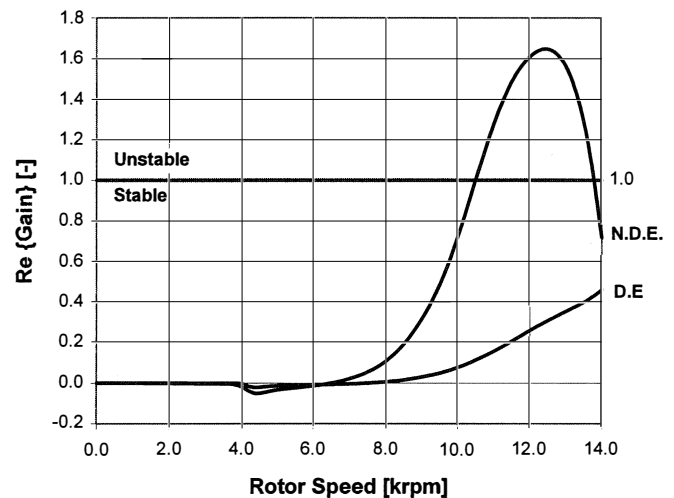
Figure C-1. Real Part of Gain Vector Versus Rotor Speed.

The sequence of the program is as follows. Depending on the overhang geometry, the program first calculates the unbalance for unit bending at the bearing journals, respectively. Then, the rotor response at the bearing locations due to this unbalance, can be calculated using a general rotor response program. This can be done for a defined rotor speed range with small speed increments. From the calculated rotor response, which also includes phase information, the location of the hot spot of the shaft is established. The experimentally obtained data are implemented here to establish the differential temperature across the shaft. From this differential temperature, a resulting output thermal bend, θ_o, including its angular direction is calculated. The complex gain vector, G, results from the ratio between the output and the input bend. Figure C-1 shows a typical output plot of an example analysis that shows the real part of the gain vector, G, versus rotor speed. From this figure, it can be seen that the DE overhung end is not causing any trouble. However, at a speed of around 10,500 rpm, the rotor in this example becomes unstable, because of the NDE overhung end. For this rotor end, the real part of the complex gain vector, G, is exceeding unity. Above 13,800 rpm, the rotor becomes stable again, due to a phase change in the dynamic system.
