# Evaluation of Effects of Fire on the I-465 Mainline Bridges—Volume II

## EVALUATION OF EFFECTS OF FIRE ON THE I-465 MAINLINE BRIDGES—VOLUME II

Report Number: FHWA/IN/JTRP-2012/13

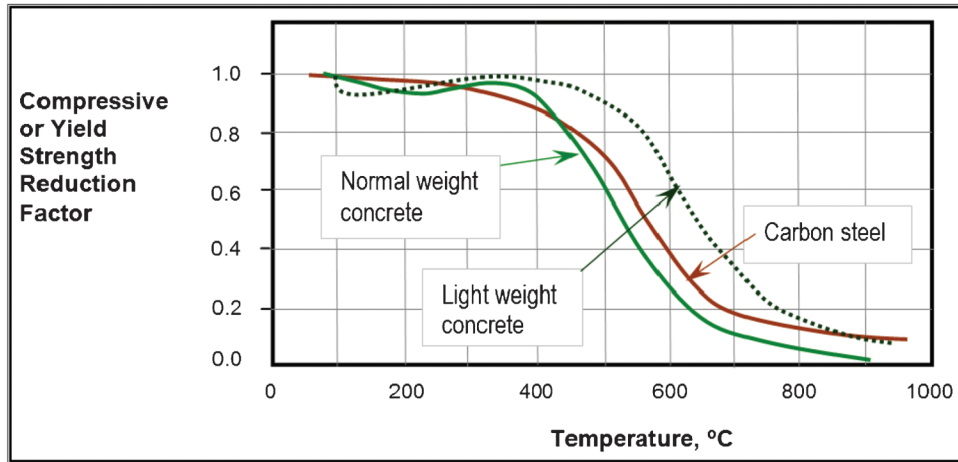
Figure 2.2 Reduction in concrete compressive strength with temperature (4).

Astaneh-Asl et al. (4) also discuss the effects of elevated temperatures due to fire on the material properties of concrete. Concrete undergoes cracking, spalling, and experiences a decrease in stiffness and strength as the temperature increases. Concrete has low thermal conductivity, which allows it to undergo heating for longer durations before the temperature increases significantly and damage occurs. As shown in Figure 2.2, the concrete compressive strength starts decreasing rapidly after its temperature reaches approximately 400°C (750°F). At temperatures of around 500°C (932°F), the concrete compressive strength is reduced to 50% of its nominal strength.

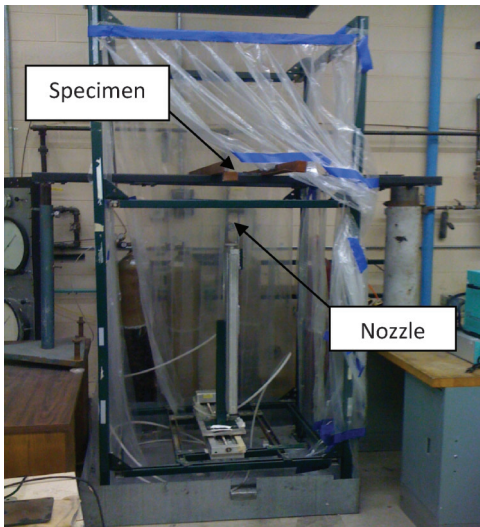
**Figure 4.1** Photograph of jet flame test set up.

Controlled fire exposure tests were conducted at Zukrow Laboratory, which is an indoor fire testing laboratory at Purdue University in West Lafayette, Indiana. A steel frame superstructure with a flame jet setup within the fixture was used to apply controlled fire exposure to the steel bridge elements (plates). A photograph of the flame jet setup in Zukrow laboratory is shown in Figure 4.1. At the top of the setup is an exhaust fan that discharges the soot and smoke from the flame to the outside of the laboratory safely.

The flame jet consists of an 8 mm nozzle connected to an adjustable meter which allows calibrated mass flow rates to be achieved. Ethylene gas (C<sub>2</sub>H<sub>4</sub>) was used to simulate the fire exposure. This is a sooting fuel with adiabatic flame temperature of 2900°C (5252°F). This temperature assumes a pre-mixed flame and no heat loss. However, in the tests there is heat loss to the specimen and cooling from the ambient surroundings.

Ethylene fuel is not mixed with air until it exits the nozzle. Flow rate is initially set at 30 mg/s and adjusted with time depending upon the desired temperature. Steel plate specimens were suspended over the flame jet

using four fixed tabs, one at each corner of the specimen. The nozzle is attached to a screw jack which allows it to traverse along three axes. Steel plate specimens were 10 x 10 in. squares cut from plate stock or out of web and flange materials provided by PennDOT as described in the following sub-section.

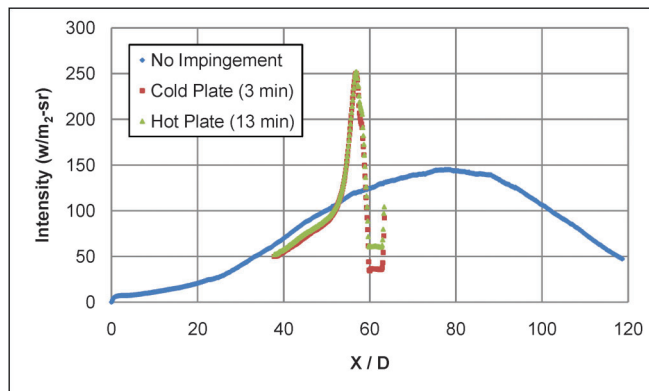
**Figure 4.5** Time-averaged infrared radiation intensity along diametric paths of a turbulent ethylene diffusion flame with and without impingement.

Figure 4.5 reports the time-averaged infrared radiation intensity along diametric paths of the turbulent

ethylene diffusion flame with and without impingement. Peak intensity of the impinging flame occurs approximately 5 diameters upstream of the surface of the plate. Intensity remains approximately constant along the edge of the plate indicating the thickness of the plate is at a nearly uniform temperature consistent with conclusion ascertained from thermocouple measurements on the top and bottom surface of the plate.

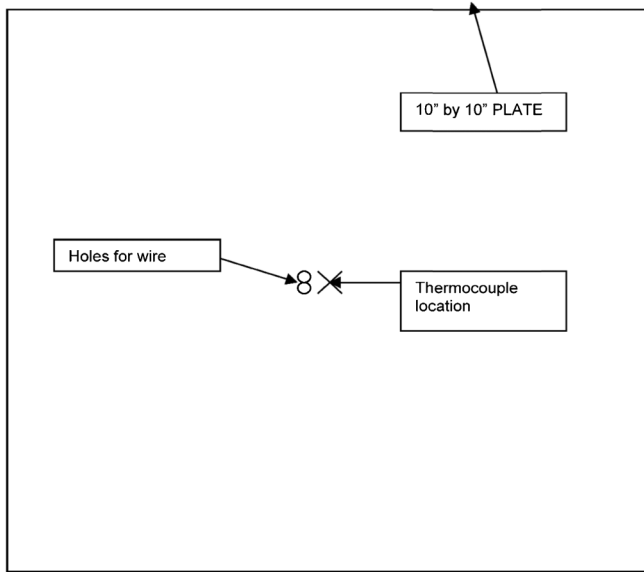
**Figure 4.10** Plate specimen with thermocouples.

As shown in Figure 4.10, each plate specimen is approximately 10 x 10 in., and is instrumented with two thermocouples. Thermocouples are attached to the center of the specimens on both sides, i.e. the flame side or bottom and the non-flame side or top. Two 1/16” holes were drilled just off center in order to allow the thermocouple wires to pass through the plate from the top to minimize flame disturbance on the plate. For the same reason, the holes and the thermocouples are covered with a smooth layer of fiberglass paste.

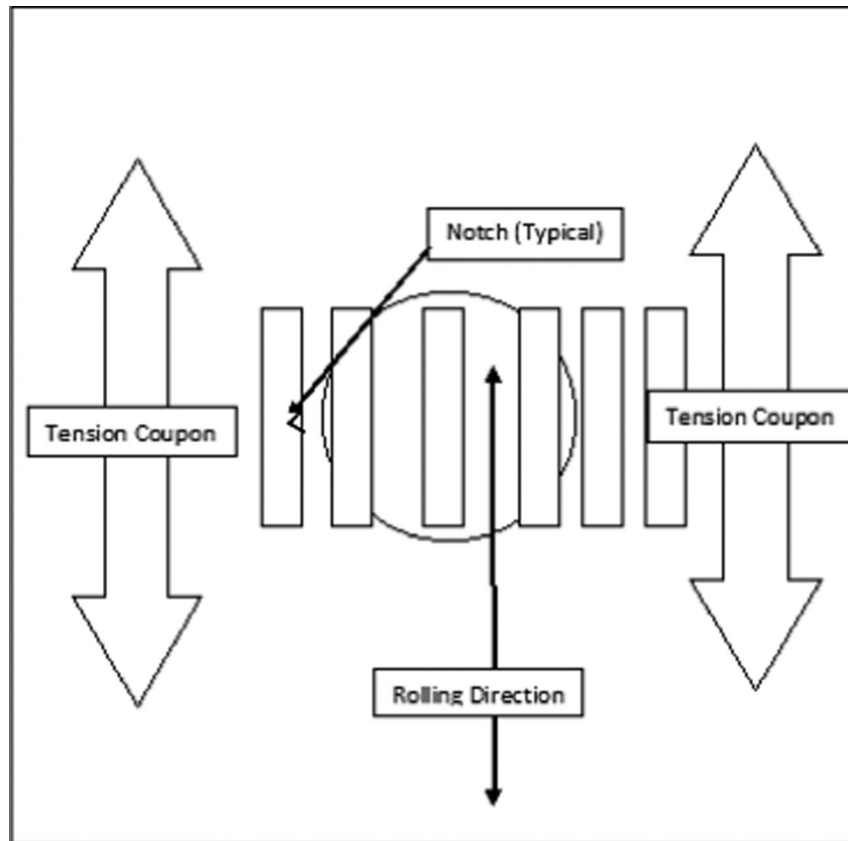
**Figure 4.11** Layout of material coupons taken from plate specimens.

After subjecting the plate specimens to controlled fire exposures, material tests were conducted on coupons fabricated according to applicable ASTM standards. As shown in Figure 4.11, three Charpy V-notch (CVN) coupons (ASTM E23) (9) were fabricated from the central 3 in. of each plate specimen. Another three CVN coupons were fabricated from outside the central 3 in. These six CVN coupons were fabricated parallel to the rolling direction with the CVN notch oriented as shown in the Figure. One tension coupon (ASTM E8) (8) is taken from either end of the specimen parallel to

the rolling direction. Figure 4.11 shows a drawing of the locations of the material coupons as they were taken from the 10 x 10 in. plate specimens.

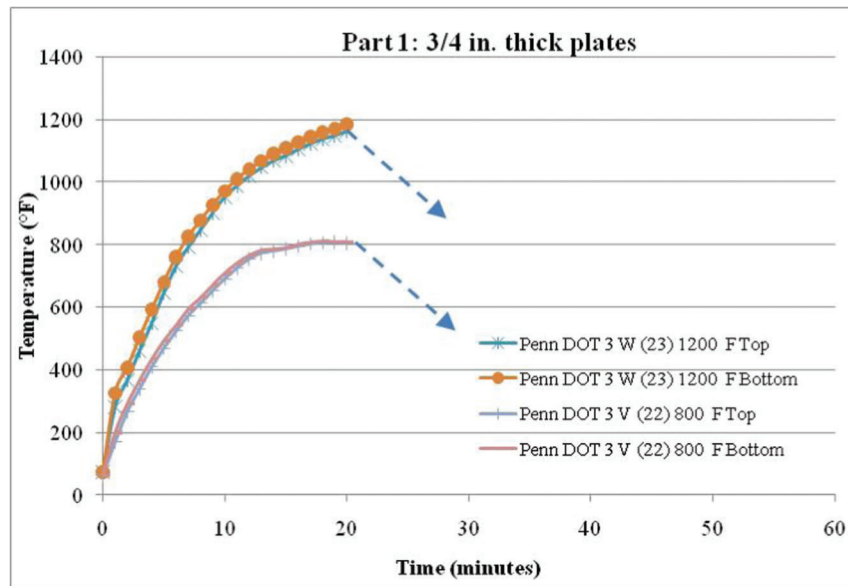
Figure 5.6 Measured temperature-time curves for ¾ in. thick Part 1 plate specimens.

Figures 5.5 and 5.6 show the measured temperature-time (T-t) curves for these plate specimens with ½ in. and ¾ in. thickness, respectively. As shown the target temperatures were achieved and maintained for 20 minutes before cooling. Target time of 20 minutes is representative of the typical fire duration that can cause collapse of a bridge; for example, consider the Oakland, California bridge discussed earlier in Chapter 1.

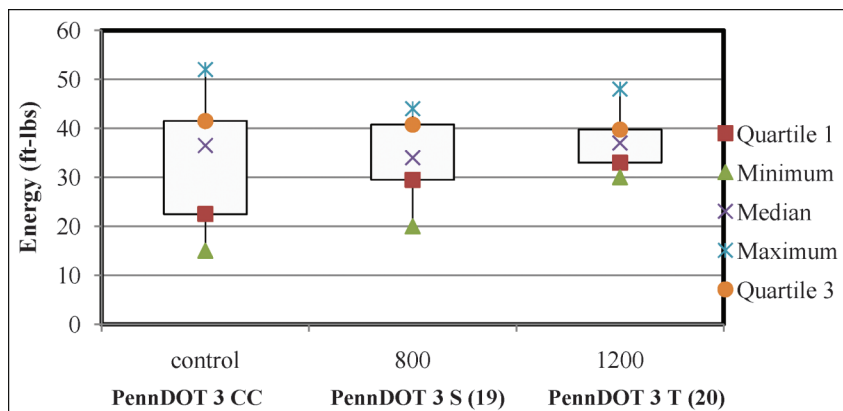
Figure 5.7 Statistical evaluation of CVN fracture toughness values for ½ in. thick plate specimens (Part 1).

Figures 5.7 and 5.8 show box plots that can be used to more comprehensively evaluate the effects of fire exposure on the CVN fracture toughness of steels. These figures focus on ½ in. thick and ¾ in. thick steel plates that had been subjected to controlled fire exposure using the flame jet setup. Box plots included for each plate specimen:

1. Minimum, maximum, and median values of fracture toughness.
2. First and third quartile fracture toughness values. First quartile means that 25% of the values are lower than this value, and third quartile means 75% of the values are lower than this value.

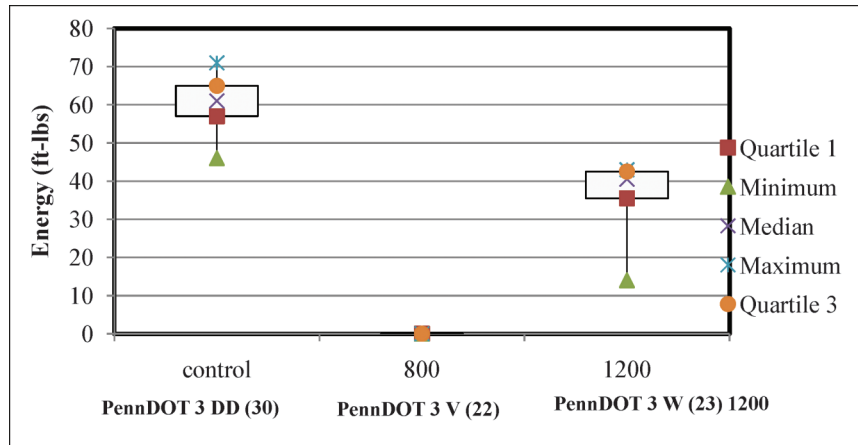
Figure 5.8 Statistical evaluation of CVN fracture toughness values for 3/4 in. thick plate specimens (Part 1).

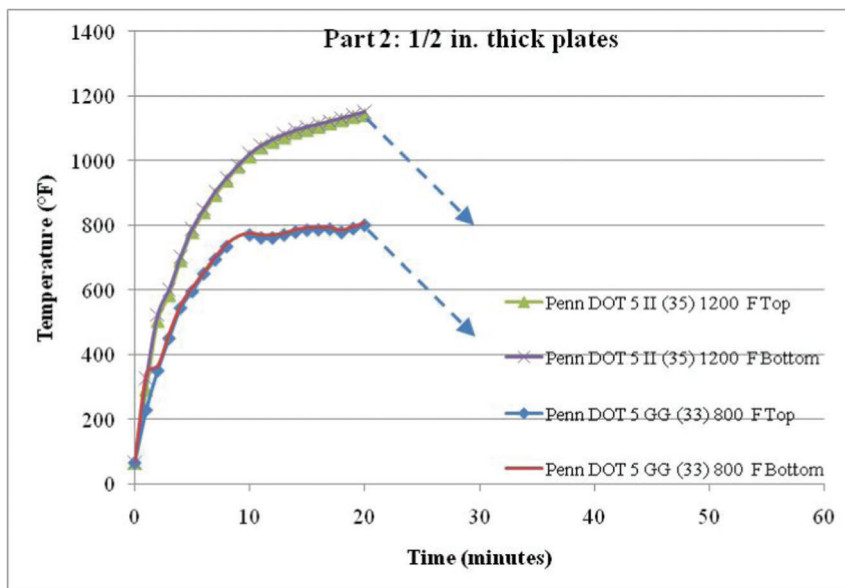
Figure 5.13 Measured temperature-time curves for ½ in. thick Part 2 plate specimens (web).

Figures 5.13 and 5.14 show the measured temperature-time (T-t) curves for these plate specimens with ½ in. thick webs and flanges, respectively. As shown, the target temperatures were achieved and maintained for 20 minutes before cooling.

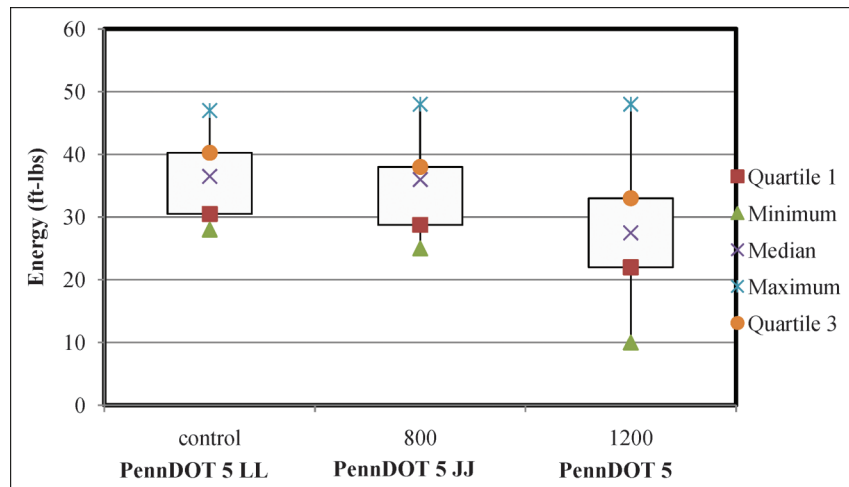
Figure 5.16 Statistical analysis of CVN fracture toughness for Part 2 plate specimens (½ in. thick flanges).

Figures 5.15 and 5.16 show box plots that can be used to more comprehensively evaluate the effects of fire exposure on the CVN fracture toughness of steels. These figures focus on ½ in. thick webs and the ½ in. thick flange steel plates that had been subjected to controlled fire exposure using the flame jet setup. Box plots included for each plate specimen:

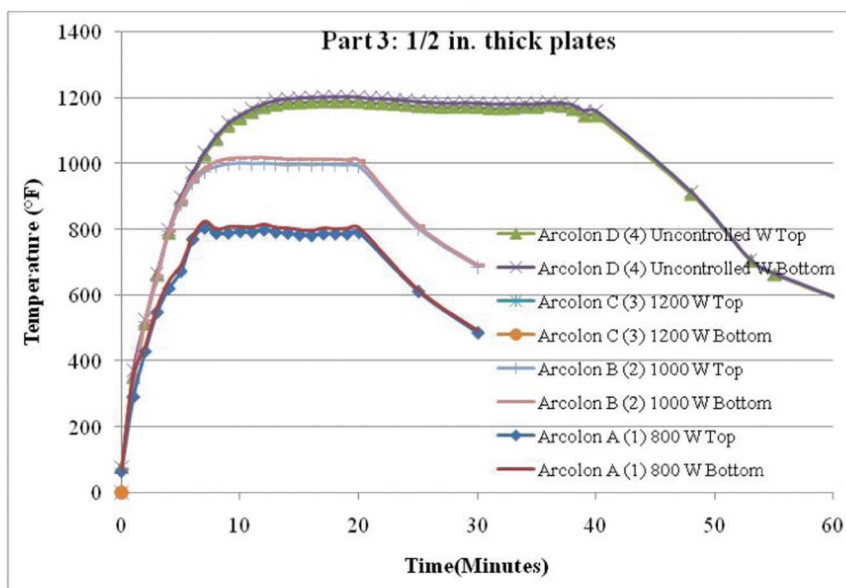
Figure 5.25 Measured temperature-time curves for ½ in. plate specimens with Acrolon coating (Part 3).

Figures 5.25 and 5.26 show the measured temperature-time (T-t) curves for the ½ in. thick and 1 in. thick plate specimens, respectively. As shown, the target temperatures of 800°F, 1000°F, and 1200°F were achieved and maintained for 20 minutes before cooling.

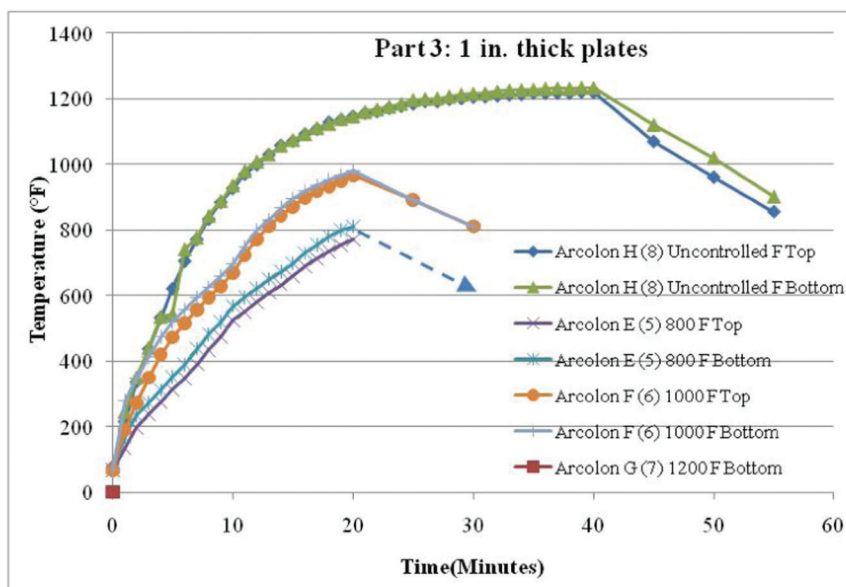
Figure 5.26 Measured temperature-time curves for 1 in. plate specimens with Acrolon coating (Part 3).

The uncontrolled fire test reached a maximum temperature of 1200°F also, and was allowed to continue (burn out) for 40 minutes before cooling.

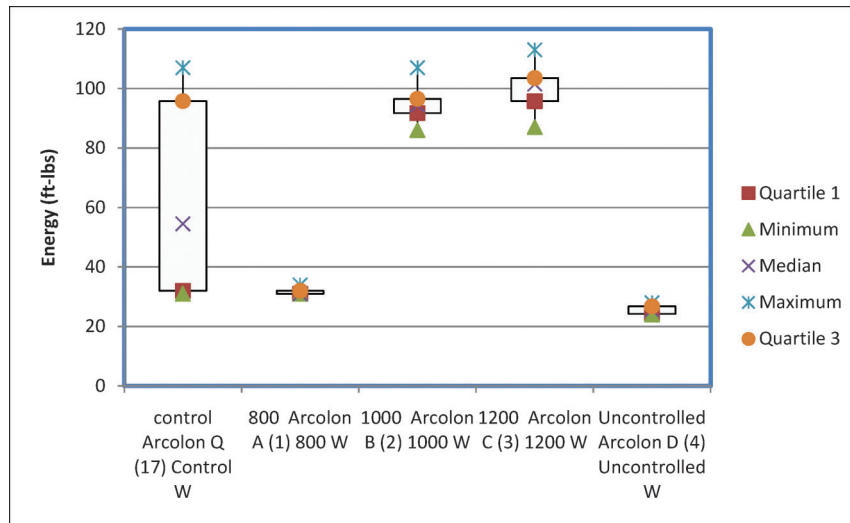
Figure 5.27 Statistical analysis of CVN fracture toughness for Part 3 plate specimens (1/2 in. thick webs).

Figures 5.27 and 5.28 show box plots that can be used to more comprehensively evaluate the effects of fire exposure on the CVN fracture toughness of steels. These figures focus on 1/2 in. thick webs and the 1/2 in. thick flange steel plates that had been subjected to controlled fire exposure using the flame jet setup. Box plots included for each plate specimen:

These figures show that the fire exposures do not have a statistically significant effect on the CVN fracture toughness of steels, which numerically still satisfies the 15 ft-lb limit for Zone 2 (7). The data returned from the material testing shows that all specimens were well within the tolerances set forth by ASTM.

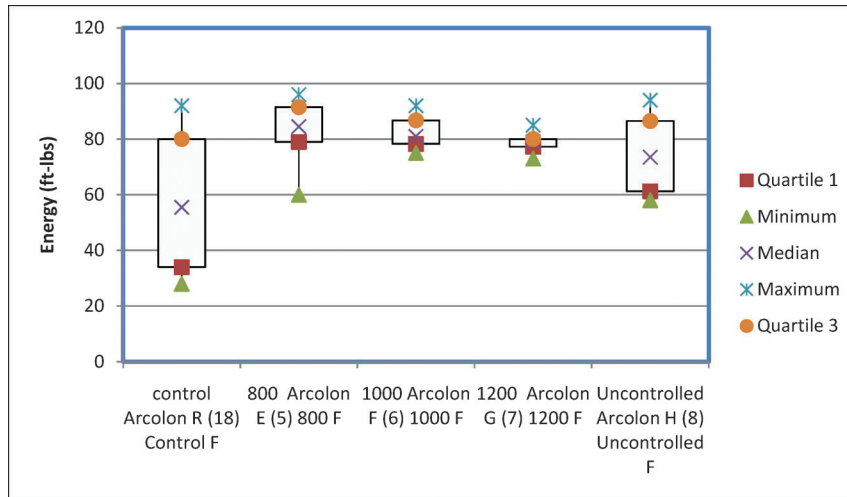
**Figure 5.28** Statistical analysis of CVN fracture toughness for Part 3 plate specimens (1 in. thick flanges).

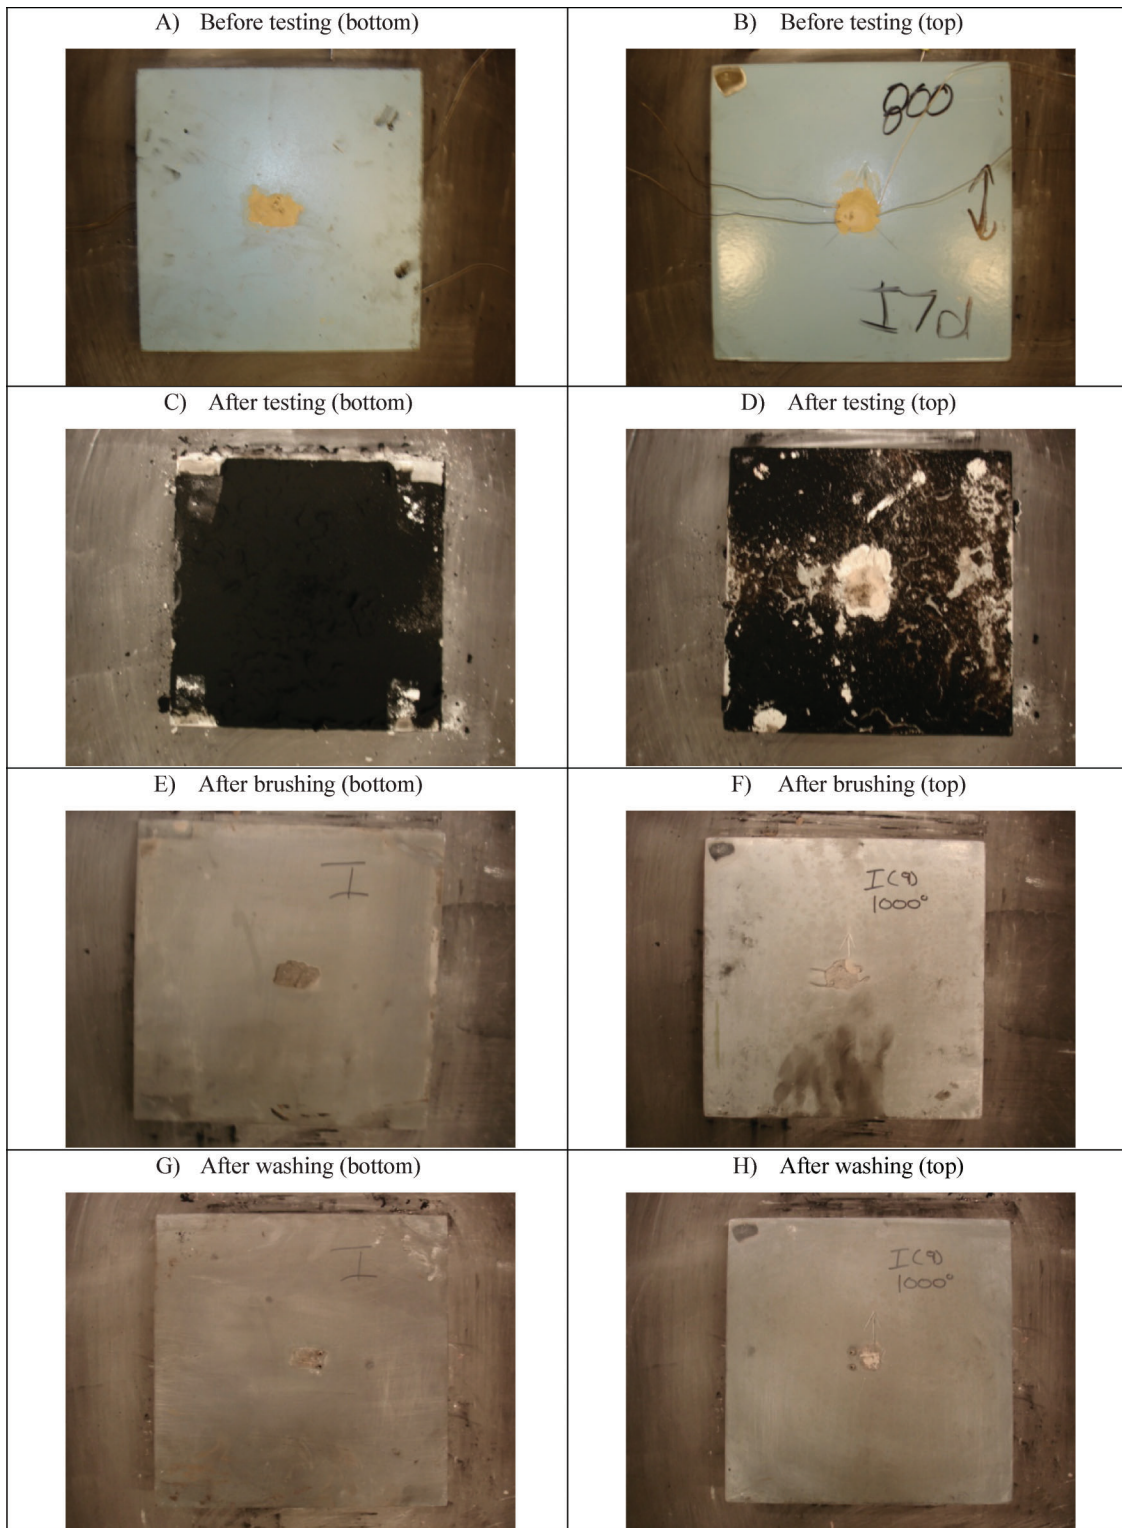
Figure 5.29 Post-fire evaluation of Carbothane I (9) 1000°F.

Figures 5.29 to 5.34 show photographs of the post-fire evaluation of the plate specimens (Part 4) identified in Table 4.1 and again in Table 5.7. These

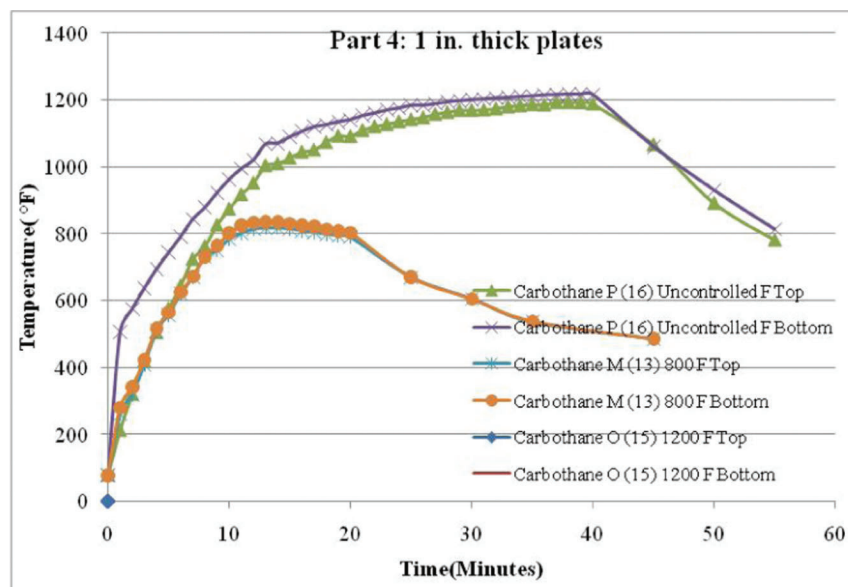
Figure 5.36 Measured temperature-time curves for 1 in. thick Carbothane plates (Part 4).

Figures 5.35 and 5.36 show the measured temperature-time (T-t) curves for the 1/2 in. thick and 1 in. thick plate specimens, respectively. As shown, the target temperatures of 800°F, 1000°F, and 1200°F were achieved and maintained for 20 minutes before cooling. The uncontrolled fire test reached a maximum temperature of 1200°F also, and was allowed to continue (burn out) for 40 minutes before cooling.

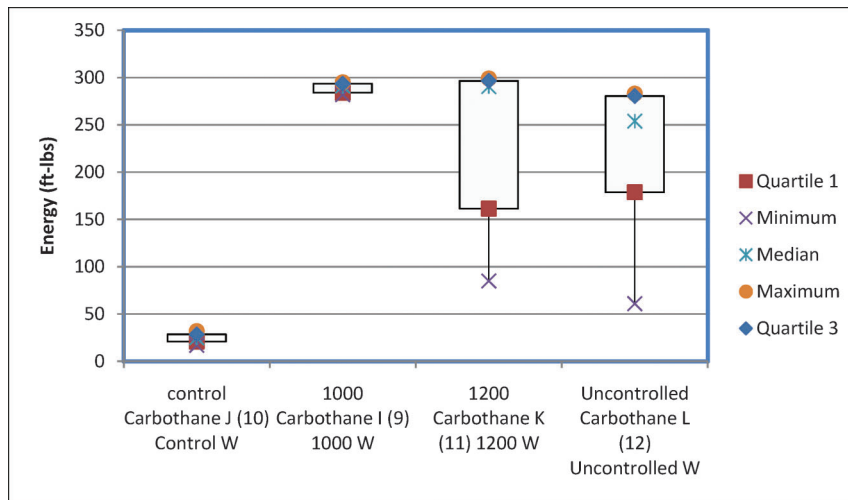
Figure 5.37 Statistical analysis of CVN fracture toughness for Part 4 plate specimens (1/2 in. thick webs).

Figures 5.37 and 5.38 show box plots that can be used to more comprehensively evaluate the effects of fire exposure on the CVN fracture toughness of steels. These figures focus on 1/2 in. thick webs and the 1/2 in. thick flange steel plates that had been subjected to controlled fire exposure using the flame jet setup. Box plots include for each plate specimen:

These Figures show that the fire exposures do not have a statistically significant effect on the CVN fracture toughness of steels, which numerically still satisfies the 15 ft-lb limit for Zone 2 (7). The data

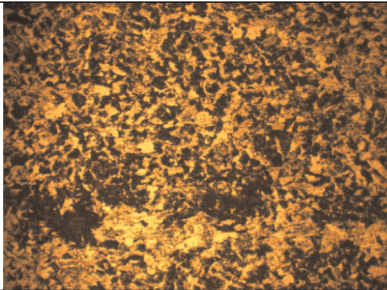
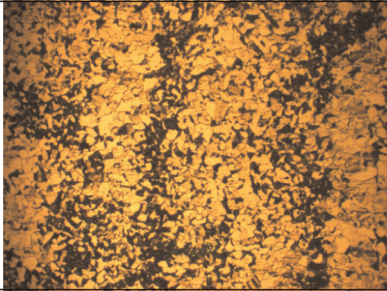
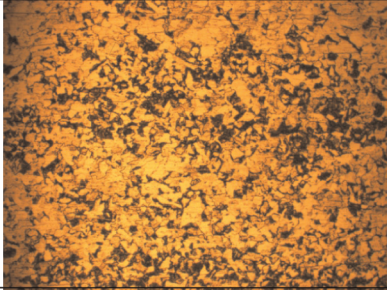
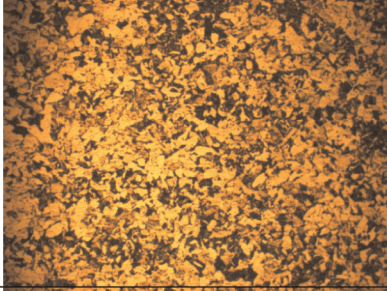
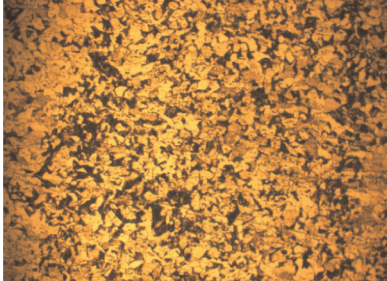
Figure 5.39 300x magnification of Part 3 samples.

<p>Acrolon Q (17) Control W</p>

<p>Acrolon A (1) 800 W</p>

<p>Acrolon B (2) 1000 W</p>

<p>Acrolon C (3) 1200 W</p>

<p>Acrolon D (4) Uncontrolled W</p>

For part 3 web plates, CVN samples were used to determine if the microstructure of the steel changed from control throughout the testing process. Each CVN was polished on the surface of the sample that was directly impinged by testing flames. After polishing, the samples were photographed at 300 times magnification and studied. The photographs are shown in Figure 5.39. Images consist largely of two separate colors. The darker color represents Pearlite, and the lighter yellowish color is Ferrite. As the plates progress in temperature, Ferrite and Pearlite become more evenly scattered and the structure of each particle is more visible although the grain sizes appear to be about the same.
