SOLAR DYNAMICS OBSERVATORY
LAUNCH AND COMMISSIONING

The Solar Dynamics Observatory (SDO) was launched on February 11, 2010. Over the next three months, the spacecraft was raised from its launch orbit into its final geosynchronous orbit and its systems and instruments were tested and calibrated in preparation for its desired ten year science mission studying the Sun. A great deal of activity during this time involved the spacecraft attitude control system (ACS); testing control modes, calibrating sensors and actuators, and using the ACS to help commission the spacecraft instruments and to control the propulsion system as the spacecraft was maneuvered into its final orbit.

This paper will discuss the chronology of the SDO launch and commissioning, showing the ACS analysis work performed to diagnose propellant slosh transient and attitude oscillation anomalies that were seen during commissioning, and to determine how to overcome them. The simulations and tests devised to demonstrate correct operation of all onboard ACS modes and the activities in support of instrument calibration will be discussed and the final maneuver plan performed to bring SDO on station will be shown. In additi

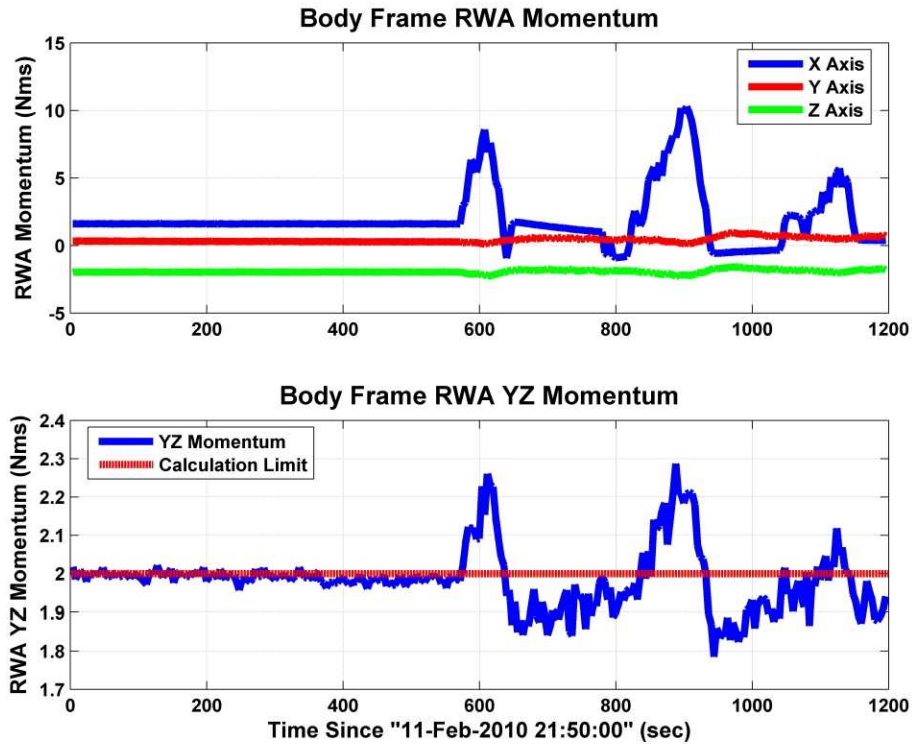
Figure 7: Safehold Checkout RWA Momentum in the Body Frame

During Safehold checkout, the spacecraft saw sunline rates which cycled between high and low values. The spacecraft remained Sun-pointing, but the roll around the sunline alternated be-

tween periods of low roll rates and higher roll rates. This response is evident in the RWA momentum in the body frame plot shown in the upper section of Figure 7.

The lower plot of Figure 7 shows what is happening in this case. When the YZ component of the RWA momentum is below 2 Nms, the sunline error rate fed to the Safehold controller is zeroed. By zeroing out the small rate, the true error in RWA momentum is allowed to build up without being counteracted by the controller. At some point, though, the accumulated momentum in the YZ plane exceeds 2 Nms and the controller begins reacting to it. As the controller reacts to the error and begins to lower it, the total YZ momentum will again go under 2 Nms. This reaction is what causes the alternating periods of lower and higher sunline rates during the Safehold test. Figure 8 shows the corresponding sunline rate signal used by the controller. At a higher overall system momentum, the sunline rate estimation algorithm would behave more consistently and the overall control would be better. At the low system momentum that the checkout test was run, which is more typical of SDO's operations, the Safehold Mode rate estimation and control algorithms are sufficient to safely and stably keep the spacecraft pointed at the Sun, which is power and thermally safe, as designed.

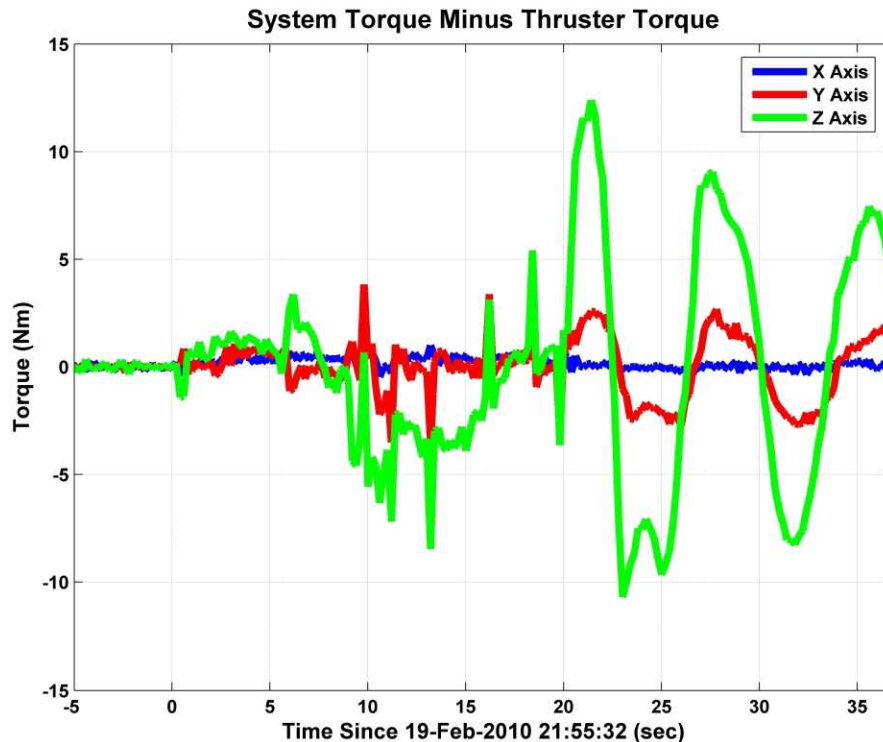
Figure 13: AMF-2 Estimated Propellant slosh Torque

Figure 13 shows one of the data reconstructions performed by the anomaly team. This shows an estimate of the propellant slosh torque acting on the spacecraft. It was derived by calculating a system torque from the system momentum change and subtracting an estimate of the torque imparted by the ACS thrusters and the misalignment of the main engine. Oscillatory propellant slosh dynamics can be seen in both the Y and Z axes of the spacecraft, with the largest effect shown in the Z axis. Note from this plot that it appears that the propellant slosh is damping out, indicating that there may not be an inherent instability to the spacecraft DeltaV Mode because of slosh and that AMF-2 may not have aborted if the FDC limits had been able to be safely set a little higher.

Most of the prelaunch propellant slosh analysis for SDO had been done using a fill fraction of 18–25% and was mainly concerned with the effect of slosh on the jitter seen by the science instruments. The fill fraction at the beginning of AMF-1 was 96% and for AMF-2 was 80%. Based on the pre-launch analysis, we expected propellant slosh effects to increase as the fuel tanks emptied and to reach a maximum around a 60% fill fraction. The anomaly team added a slosh model to the spacecraft high-fidelity simulation (HiFi) and attempted to tune its parameters to match the observed behavior of the spacecraft from the AMF-2 burn (and then the AMF-2B, AMF-3, and AMF-4 burns). Their modeling was not able to completely replicate the observed dynamics, but it did show the correct trends and gave them the confidence to begin developing and testing potential mitigations.

After a lot of time and effort, the anomaly team proposed three simple, easy-to-implement changes to the spacecraft that they felt would solve the problem. First, they suggested increasing the length of the settling burn from 20 seconds to four minutes. That length was selected to encompass the "geyser mode" that can be seen upon initial thruster firing, but did not allow enough time for fuel disturbances to damp out before the main engine firing. Second, the team suggested raising the FDC limit on system momentum to 34 Nms. The 20 Nms limit was chosen based on a two-failure scenario (how much momentum could be placed into the spacecraft by a stuck-on thruster and have the spacecraft successfully recover with one failed wheel); 34 Nms reflected a more realistic failure case. Finally, the team wanted to disable the effect of the structural filter, included in DeltaV Mode to allow it to meet the design requirement for 12 dB modal suppression of all flexible modes, by appropriately setting its parameters to ones and zeros. The increased phase delay caused by the structural filter was affecting DeltaV Mode's ability to react to the slosh dynamics, and the observed flexible modes and damping seen during the appendage deployments (refer back to Figure 4 and Figure 6) indicated that this could be done safely.

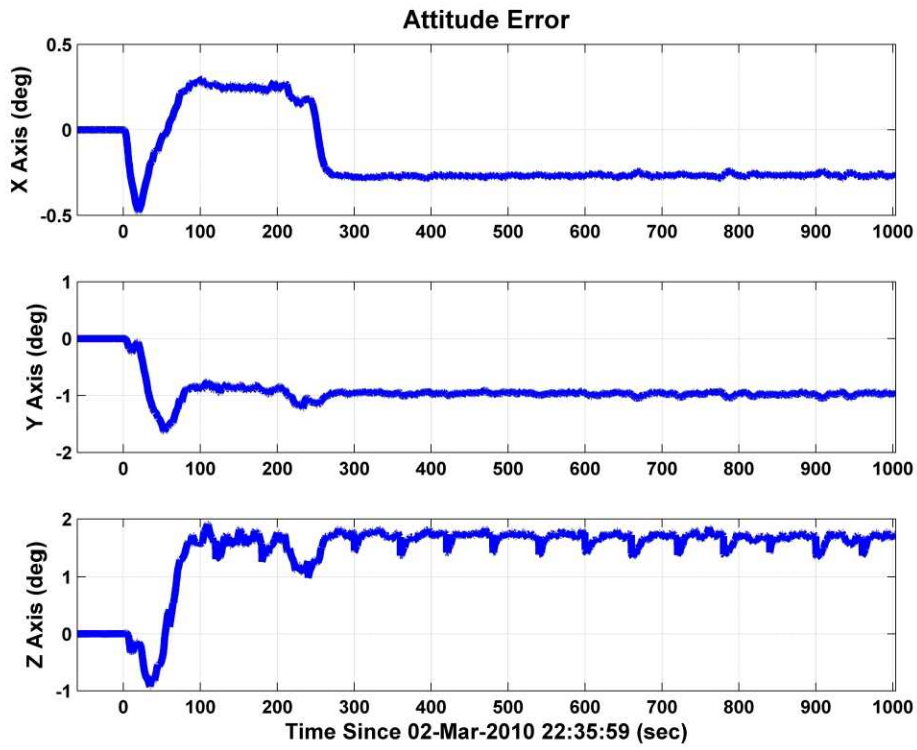
Figure 14: AMF-6 Attitude Error

AMF-5 was the first post-anomaly maneuver to be performed with the main engine. In order to mitigate the operational effects of another failure, this maneuver was done as a "hybrid" maneuver. The 50 minute maneuver was done as a 40-minute, ACS-thruster-only settling burn followed by the final 10 minutes using the main engine. This was done so that if using the main engine caused the maneuver to fail once again, the overall maneuver would still impart a fair amount of ΔV to the spacecraft. To the relief of everyone on the project team, AMF-5 was a success. In fact, the changes made to mitigate the effect of the slosh dynamics—primarily the removal of the structural filter—significantly improved the response of the controller. After the success of AMF-5, three more AMFs were performed. Figure 14 and Figure 15 show the attitude error, phase plane plots, and system momentum magnitude for AMF-6. As can be seen, the removal of the structural filter from the DeltaV Mode controller significantly improved the response of the spacecraft attitude, resulting in a low magnitude one-sided limit cycle. The phase plane plots (plotted using the same scale as that used for Figure 11 for AMF-1) show much smaller limit cycles for all axes, and lower overall system momentum variations.

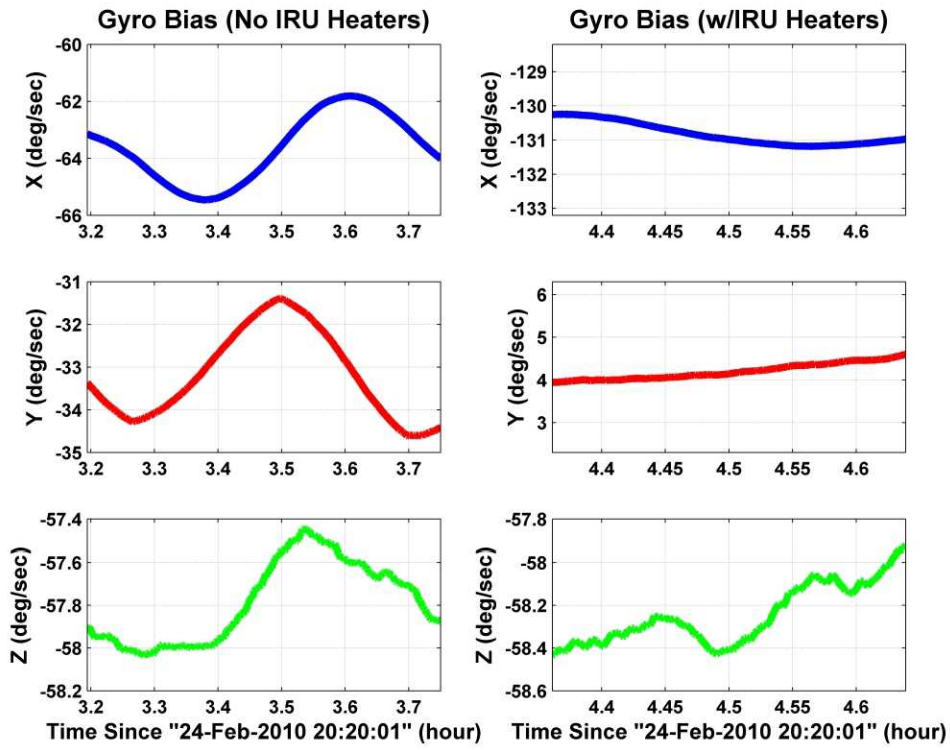
Figure 16: Gyro Biases with and without IRU Heaters

The day after launch, the major activities were the checkout of Inertial Mode, followed by a series of slews using that mode to provide data to calibrate the IRUs. Both of those activities were successful, but small spacecraft oscillations were observed in the IRU bias estimates calculated by the onboard Kalman filter, as shown in the plots on the left hand side of Figure 16. Because the oscillation was at such a low frequency, with a roughly 30 minute period, they were well within the bandwidth of the controller, so the controller followed the oscillating error in the attitude estimate, resulting in actual spacecraft motion. The fact that the spacecraft was actually tracking these oscillations is shown in the guide telescope error signals on the left-hand side of Figure 17. Data from these tests, from subsequent tests of SDO Science Mode, and from all other suitable activities were examined. The oscillations seen on all of the different tests were approximately 10–20 arcsec and would not cause SDO's Science Mode to violate its pointing requirement of [35,70,70] arcsec, but they remained a concern to the science instrument teams. It was determined by looking at this data that the IRUs were the cause, and that the frequency and the amplitude of the oscillations was temperature related.

Because of concerns of the effect of the 87 Hz frequency of the IRU's internal heaters on the spacecraft power bus, the decision had been made not to use them in flight except during a few crucial operations. As a result the IRUs experienced temperature variations that were different from the manufacturer's design and testing profile. That these temperature variations caused the bias oscillations was confirmed by first running a test with the IRU internal heaters turned on; the results of this are shown in the bias estimates and guide telescope signals in the plots on the right hand sides of Figure 16 and Figure 17. Note that because of different average temperatures, the secular component of both the gyro bias estimate and guide telescope error signals are different in the unheated and heated cases, but the scales of each side-by-side plot are the same to show the lower magnitude of the oscillatory component. This test established that the bias oscillation could be reduced through use of the IRU internal heaters, but concerns about the effects on the spacecraft power system remained.

After the first IRU internal heater test, the flight support team ran two tests instead using software-based control of the IRU heaters, first with a setpoint of 40 C and then with a setpoint of 67 C. The software control was relatively coarse, allowing peak-to-peak variations about the setpoint of roughly 2 C. As expected, changing the temperature setpoints resulted in changes to the amplitude and frequency of the observed oscillations. However, they did not significantly decrease the magnitude of the oscillations.

Following the heater tests and the examination of their results, the team decided that the lowest-impact solution to the problem, if possible, would be to adjust the gains of the Kalman filter to make it less sensitive to the low frequency oscillations of the gyro biases caused by the thermal variations. After much analysis and simulation, a new set of gains was available for test.

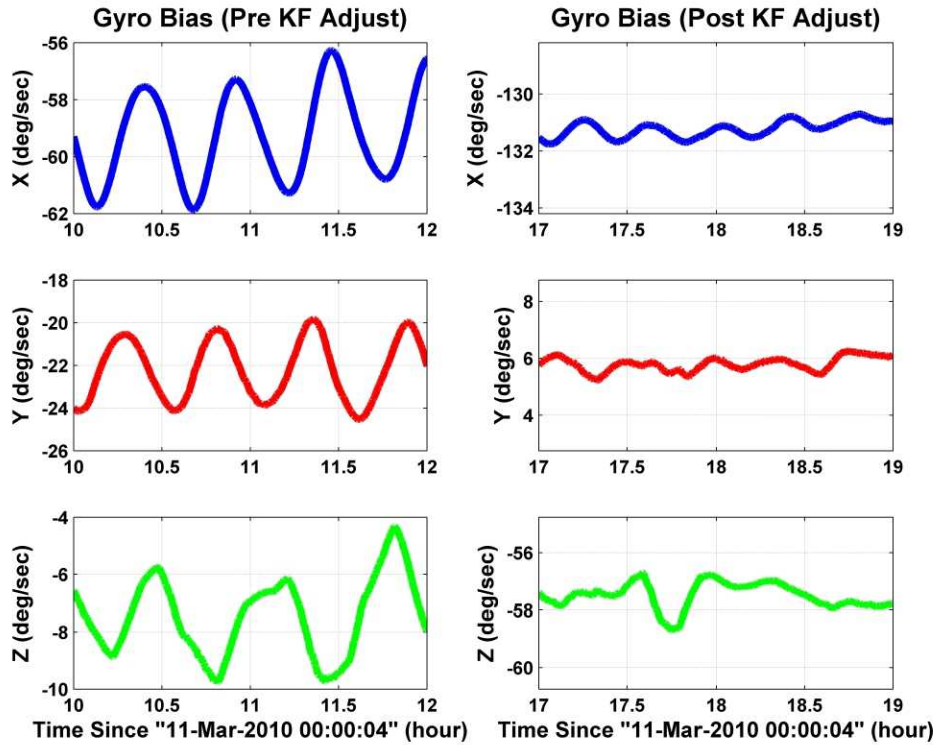
Figure 18: Gyro Biases before and after Adjusting Kalman Filter Gains

Figure 18 shows a plot of the estimated gyro biases before and after the adjustment of the Kalman filter gains. As can be seen, while the retuned filter does not eliminate the oscillations completely—certainly not as much as using the IRU internal heater—it does diminish their magnitude significantly, bringing the actual oscillation of the Observatory down to a level acceptable to the SDO science teams.

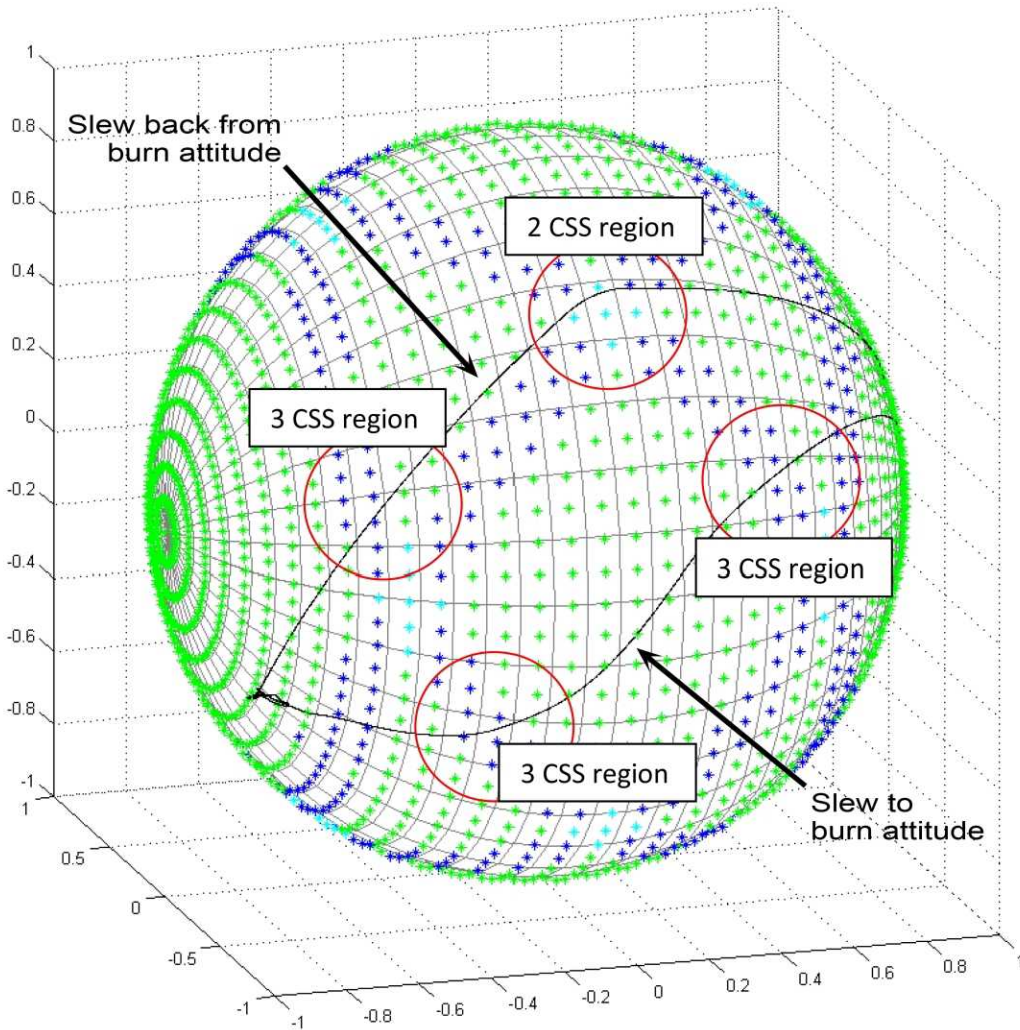
Figure 19: CSS Coverage Map During AMF-1 Slews

As discussed in the previous section, during the engineering burn and AMF-1, the FDC limit for a Sun vector mismatch (a three-way comparison between CSSA, CSSB, and AD calculated vectors) tripped multiple times. Though the persistence of these limit violations were not nearly long enough to trip any autonomous FDC actions, the team was interested in understanding why they were occurring.

Figure 19 shows the unit sphere of possible Sun vectors in the SDO body reference frame. The dark lines superimposed on the sphere represent the attitude path taken by SDO as it slewed out to the burn attitude for AMF-1 and then back to pointing at the Sun afterwards. The colors of the points on the sphere represent how many individual CSSs register sunlight at each point. The green areas are regions of 4-sensor coverage, the blue areas are regions of 3-sensor coverage, and the cyan areas are regions of 2-sensor coverage; different algorithms are used to calculate the Sun vector for the 4-sensor case than the 3- and 2-sensor cases. During nominal science data collection, four CSSs have visibility of the Sun, and it is in this condition where the calculation of the Sun angle is the most accurate. As shown on the figure, there are several locations along the path where only two or three CSSs can see the Sun. It is in these zones that the limit trips occurred. On both ACEs, the times of CSSA vs CSSB mismatches occurred during times of decreased Sun

coverage. In the regions where fewer than four sensors are used, the comparison between CSSA and CSSB is more likely to be different, primarily because the two ACEs may transition between the 4-sensor and 3-sensor algorithms at a slightly different times.

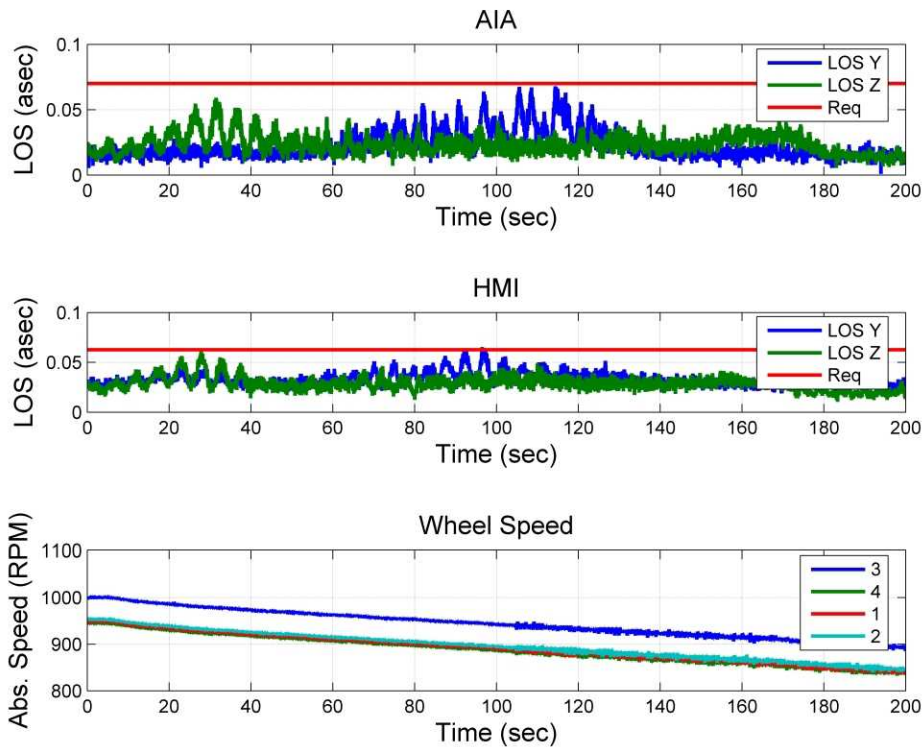
Figure 20: Wheel Jitter Results: AIA/HMI LOS Measurements and Wheel Speeds

During the wheel jitter test, all wheel speeds were driven from a low speed to a maximum speed of about 1000 RPM, and then driven back down to low speed levels. Wheel speed changes were achieved by commanding wheel torques along the null space vector direction to avoid interference with the attitude control torque commands. The primary jitter sensor for this test was the HMI limb sensor measuring LOS errors at 512 Hz. The four AIA guide telescope signals also provided data with sample rates of 256 Hz for telescopes #1 and #3, and 128 Hz for telescopes #2 and #4. Both HMI and AIA instruments can store 3 minutes of data and require 30 minutes to download the data to the ground. To accommodate the instrument data storage and download capabilities, the wheel speeds were accelerated during data collection periods (~3 min) and held constant during data dumping periods (~30 min). Furthermore, during the speed acceleration periods, the acceleration level was small enough (~1 RPM/sec) to ensure that structural modes would be fully excited (e.g. reach maximum amplitude), similar to nominal operating conditions where the wheel speeds change slowly.

The HMI instrument stabilization control system (ISS) was opened while wheel speeds increased to ~1000 RPM and closed while wheel speeds decreased back to low levels. Since HMI nominally functions with a closed-loop instrument control system, jitter data collected during the speed decrement section was compared to the requirement. In Figure 20, the top plot shows the largest AIA LOS measurements from all four telescopes, the middle plot shows the HMI LOS measurement, and the bottom plot shows the corresponding absolute wheel speed levels for four wheels. In the plot legend, LOS Y and LOS Z refer to the tip and tilt motion of the instrument LOS vector.

These jitter measurements demonstrated that the AIA LOS requirement was met for all wheel speeds tested, whereas the HMI LOS requirement was violated when the lowest wheel speed reached ~840 RPM. Based on these results, the SDO team decided to extend the wheel speed limit from ±400 RPM to ±800 RPM, and thereby reduce the number of direction reversals each wheel will experience over its lifetime and prolong the period between thruster momentum unloads.

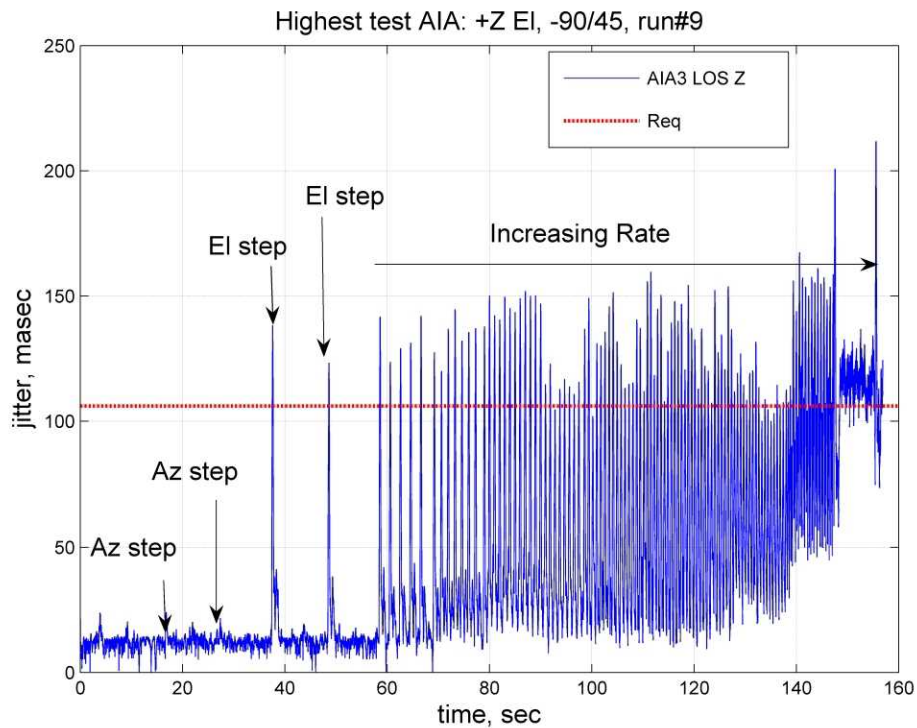
**Figure 21: AIA Telescope #3 LOS Measurements from HGA Jitter Test**

The worst case AIA and HMI LOS jitter measurements are illustrated in Figure 21 and Figure 22, respectively. In these figures, the first four visible jitter peaks are induced by single gimbal steps executed 10 sec apart, with the AZ gimbal stepping twice and then followed by EL gimbal stepping twice. The variable-step rate test results are shown approximately 15 sec after the last EL gimbal step. For the results shown, a single EL gimbal step violates the HGA-induced jitter requirement, and the LOS jitter gets worse as the gimbal step rate increases.

Contrary to the team's expectations, the HGA jitter tests showed flight measurements were higher than pre-flight predictions at various HGA joint configurations, despite several levels of conservatism on assumed damping, and the large margins used in the jitter analysis.[10] As a result, HGA jitter mitigation options (stagger-stepping and NSR flags) were enabled to meet instrument LOS jitter requirements. The mitigation algorithms did work as expected and greatly reduced HGA-induced jitter in science images.
