Analysis of the Signal Outage

Galileo Restores Service after Week's Outage

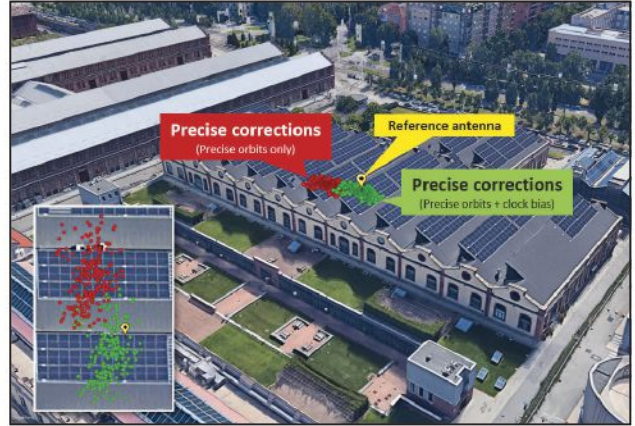
In **FIGURE 3**, the green dots are the navigation solution obtained correcting the satellites positions according to precise orbits data and clock drift provided by the IGS network. The fix is a simple code-based Least Mean Square solution without smoothing of the pseudoranges.

The two results were obtained by processing the same satellites signals, thus proving that their quality was still sufficient to get an acceptable positioning solution during the Galileo service outage period. This brought us to the conclusion that, during the outage, only the ephemerides updates were affected by problems, while the other SIS components appeared sound and usable.

FIGURE 3 Zoom on the Galileo-only positions obtained by using IGS data.
