Mohd. Zamin, Bin Jumaat, [Kabir, Md Humayun](#), & Obaydullah, M (2010) Structural performance of reinforced concrete beams repairing from spalling. *European Journal of Scientific Research*, 45(1), pp. 89-102.

Structural Performance of Reinforced Concrete Beams Repairing from Spalling

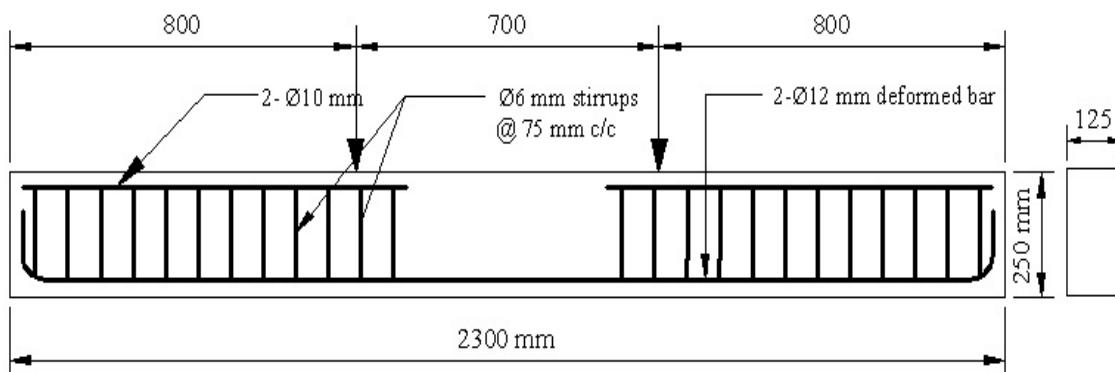
Figure 1: Fabrication of Beam

The test specimens were cast under the same conditions and were crafted using similar workmanship. They were designed in accordance with British code BS 8110 [19] and American concrete institute code ACI 318-99 [20]. More specifically, the flexural reinforcements consisted of two high-yield deformed bars 12 mm in diameter and a characteristic strength of 551 N/mm^2 , two mild steel rebars of 10 mm diameter were used as hangers, while mild steel rebars of 6 mm in diameter and with an average characteristic strength of 520 N/mm^2 were used as stirrups at a spacing of 75 mm c/c as shown in Figure 1. The reinforcements were chosen to ensure a flexural failure mode. The concrete was then placed in steel moulds, compacted by a poker vibrator and demoulded after 7 days. The beams were cured by covering them with wet Hessian cloths for at least two weeks. They were finally air cured at ambient indoor laboratory conditions until the time came to repair them. After the 28th day of curing, specimens of Types II and V were intentionally made to spall in various zones by a process of mechanical chipping up to a depth of 75-80 mm in various zones as shown in Figures 2 and 3.

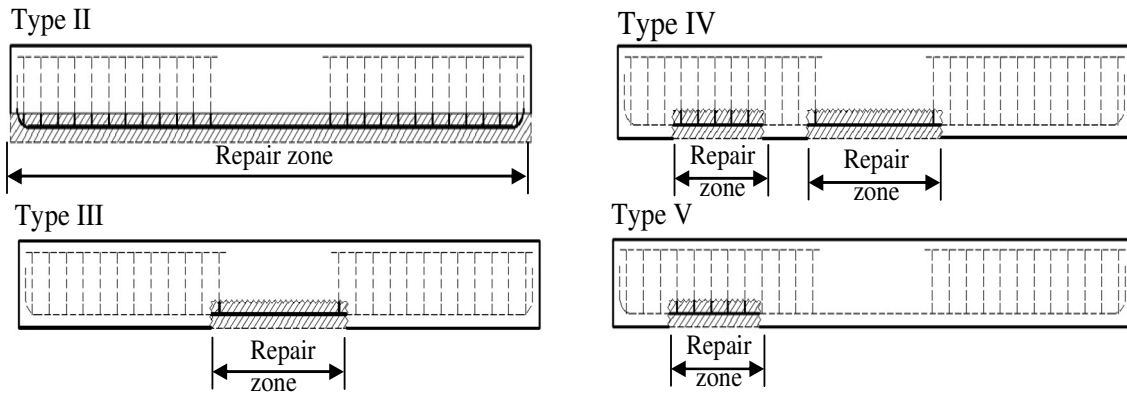
Figure 2: Test Specimens Showing Repair Zones

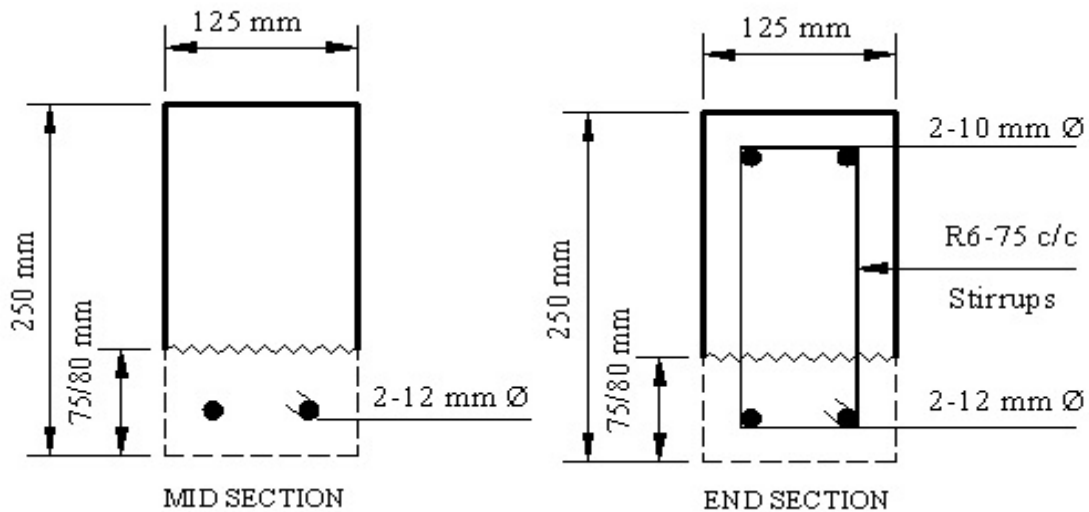
Figure 3: Typical Spalled Sections

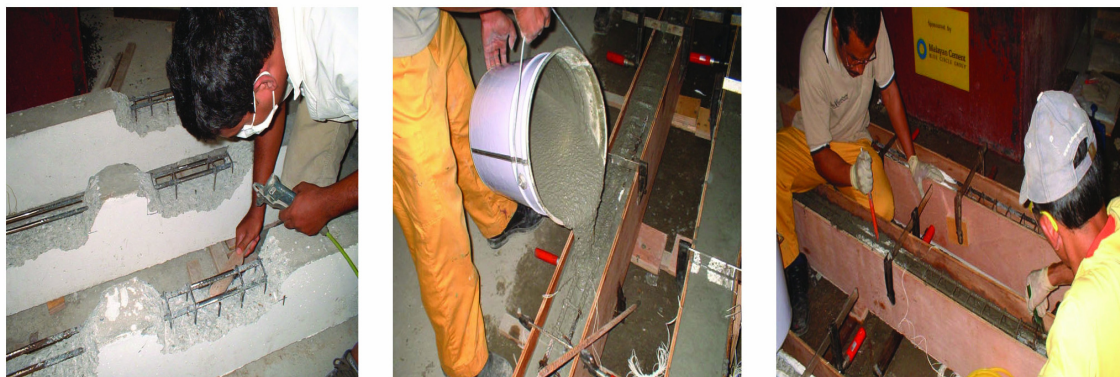
Plate 1: a) Surface Preparation b) Application of Sika Microcrete 2000 to Beam Surface and c) Sika MonoTop R40 on wet surface

Loose and unsound concrete in the various spalling zones along the length of the reinforcement beam were cut away by means of a steel chisel. The resulting grit and dust were removed by means of a wire brush, air blower and water jet as shown in Plate 1(a).

Wooden formworks were used in both repair works to give the repaired areas their desired shape. A few hours prior to the repair work, the substrate was properly saturated by filling the formwork with clean water. The water was then drained just prior to the commencement of the repair work and the formwork was made leak proof by the free-flowing nature of the Sika Microcrete 2000 material. The Sika Microcrete 2000 was mixed with clean water to a trowelable consistency as recommended by the manufacturers. Sika MonoTop 610 was then applied on the surface of steel and parent concrete as a bonding bridge before the repair material was applied. Three layers of micro-concrete, each of maximum thickness 25 mm were applied by pouring, in the method shown in Plate 1(b). Proper compaction was carried out to remove air voids by hammering and shaking sticks in each layer.

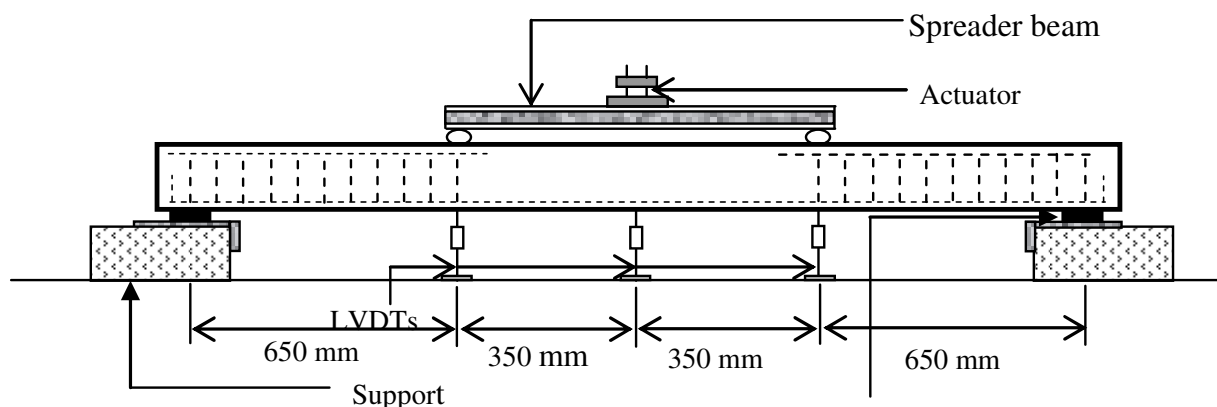
Figure 4: Experimental Setup

Tests were conducted using a 500 kN, servo-controlled Instron Universal Testing Machine. The beam specimens were simply-supported on two rectangular rubber pads (30 mm thick) and loaded in flexure under a two points loading conditions. The position of the loads and the set-up of the machine are shown in Figure 4. The beams were loaded incrementally and the first crack loads, mid-span deflections, strains in steel and concrete, maximum crack widths, total number of cracks and failure modes were recorded accordingly.

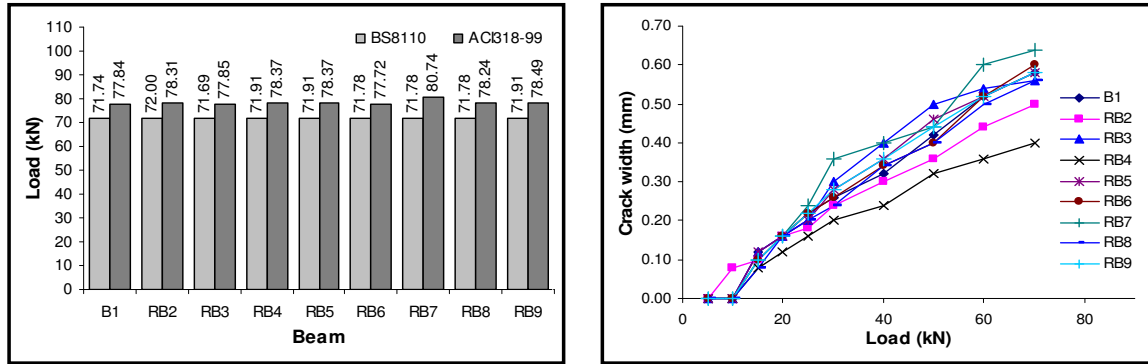
Figure 5: a) Theoretical Values of Ultimate Load and b) Maximum Crack Width-Load Curves for all Beams

Table 3 shows the failure load of all the beams. It can be seen that the ratio of the ultimate load capacity of the beams RB2, RB4, RB6 and RB8 repaired using FFSCM to that of control beam are 1.05, 1.20, 1.00 and 1.05 respectively. While the ratio of the ultimate load capacity of beams RB3, RB5, RB7 and RB9 repaired using PMCM to that of the control beam are 1.00, 1.05, 1.00, 1.03. These results indicate that the repair techniques performed using FFSCM and PMCM repair materials restored the beams to their full capacity compared with the control beam in terms of short-term structural efficiency. The proper surface preparation, unique bonding between the interfaces of concrete substrate and repair materials and the good quality of repair materials attributed to the restoration of full capacity of the defective beams. The level to which the ultimate load capacity was restored for beam specimens RB2 to RB9 is in agreement with the results reported by Nounu [4] and Andrews [8]. The theoretical values of the ultimate load for all beams were well within the satisfactory range, as shown in Figure 5(a).

The cracking behavior of a reinforced concrete (r.c.) beam can be analyzed by considering the maximum crack width, the total number of cracks, relationship of crack width to the increasing load and tensile strain of steel and the pattern of cracks. Table 3 shows the total number of crack of all the beam specimens at failure load and the relationship between maximum crack width and increasing applied load are shown in Figure 5(b). It is seen that the crack widths for all beams increase linearly up to the recorded value of 70 kN load.

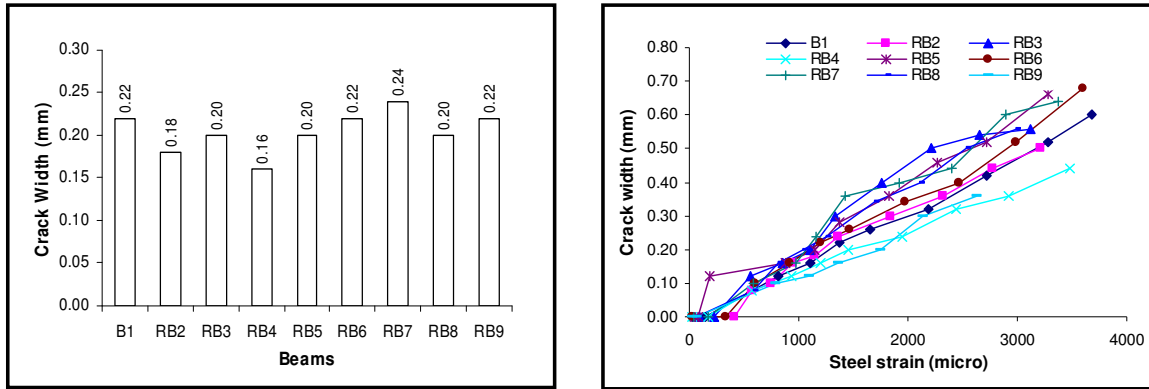
Figure 6: a) Maximum Crack Widths at Service (25 kN) Load and b) Crack Width-Steel Strain Relationship

Fig. 6(a) shows the maximum crack width for all beams at service load and. Compared to the control beam, the beams repaired with FFSCM, namely beams RB2 and RB4, show smaller width of cracks. It can also be seen that the repaired beams RB3, RB5, RB7 and RB8 have the crack width differs by a small extent than that of the control beam, while the crack width of beam RB6 and RB9 are similar to that of the control beam. This small variation in crack width can probably be attributed to the variations in the number of cracks, the position of repair zone, the tensile strain of the steel bars, the thickness of the cover, the bond characteristics of the reinforcement, the distribution of the reinforcements, the diameter of the steel bar used, the distribution of the strain from the steel to the concrete surface, the bonding of the repair materials with steel and concrete and the erroneous reading of crack widths.

Figure 6(b) shows that the crack widths for all beams increase linearly with increasing steel strain, which is in agreement with the assumptions reported by Broms [21]. He mentioned that the average crack width increased linearly with increasing thickness of concrete cover and with increasing steel strain. Beams RB4 and RB9 shows less strain compared with the other beams.

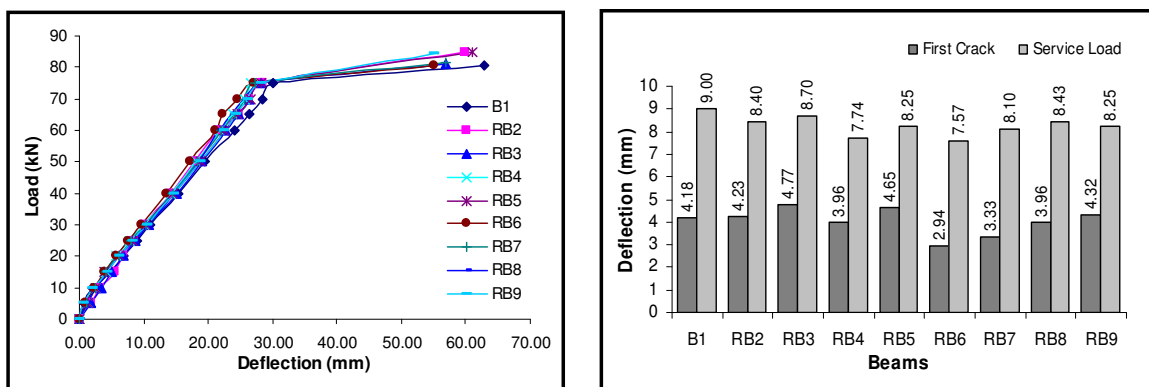
Figure 7: a) Load-Deflection Curves and b) Maximum Deflections at First Crack and Service Load for Beams 1-9

The load-deflection curves for beams repaired with FFSCM and PMCM, as well as for the control beam, are shown in Figure 7(a). The actual maximum deflections at mid-span were measured and plotted against actual loads. The beam specimens repaired using FFSCM and PMCM showed almost similar load-deflection curves to that of the control beam. As stiffness and ductility are directly related to deflection, it appears that all the repaired beams are equally capable of restoring their full stiffness and exhibit similar ductile behavior as the control beam.

Figure 7(b) shows the maximum deflection of all the beams at first crack load and service load. The deflections of all the repaired beams at first crack and service load are similar to that of the control beam, with all showing almost the same deflection trend.

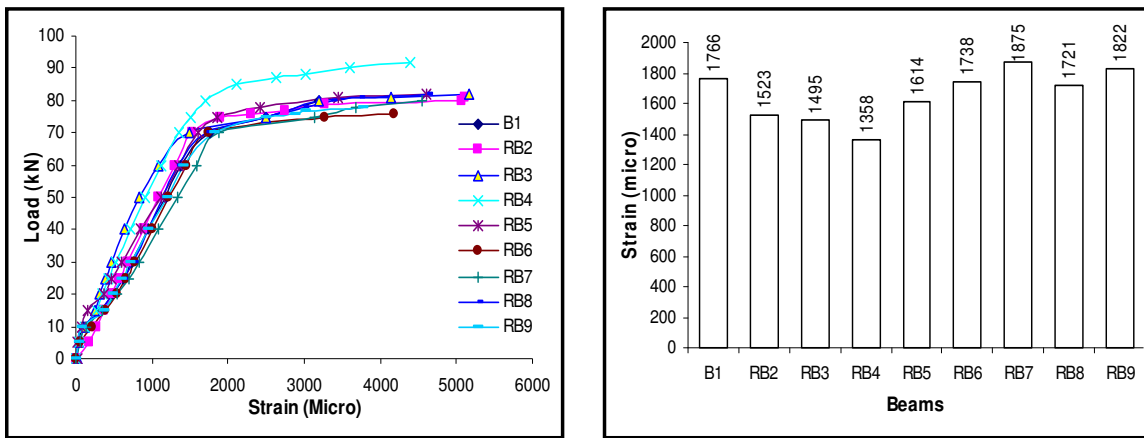
Figure 8: a) Load-Concrete Compressive Strain Curves and b) Concrete Maximum Compressive Strain at 70 kN Load for all Beams

Electrical resistance strain gauges were used to monitor the variation of maximum compressive strains on the top surface with loads as shown in Figure 8(a). The curves of all the beams feature a relatively straight portion, reaching the maximum strain of about 2000 (micro). Compression failures in the concrete were observed to occur when the concrete strains achieved a value between 2500 to 4000 (micro). These findings are in agreement with that of the assumptions provided by ACI 318-99 [20].

Figure 8(b) represents the concrete maximum compressive strain for all beam specimens when the applied load is 70 kN (near the failure load of the control beam). The strains observed on the repaired beams RB2, RB3, RB4, RB5, RB6, RB7, RB8, and RB9 were compared with that of the control beam at a 70 kN load and differences of -13.75%, -15.15%, -23.15%, -8.60%, -1.60%, +6.15%, -2.55% and +3.15% were observed respectively. These results are compatible with the strain in the original beam.

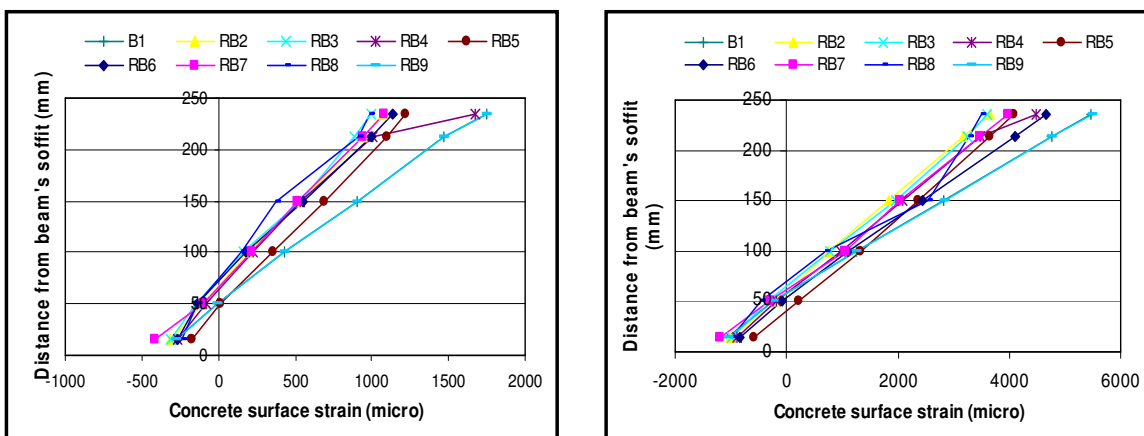
Figure 9: a) Location of Neutral Axis at 20 kN Load and b) Location of Neutral Axis at 70 kN Load

During the test, it was observed that the neutral axis of all the beam specimens were shifting up as the load applied increased. The locations of neutral axis for two specified loads are shown in Figures 9(a) and 9(b). These results were compared with theoretical values calculated using the triangular stress method for measuring cracked sections as shown in Table 4.

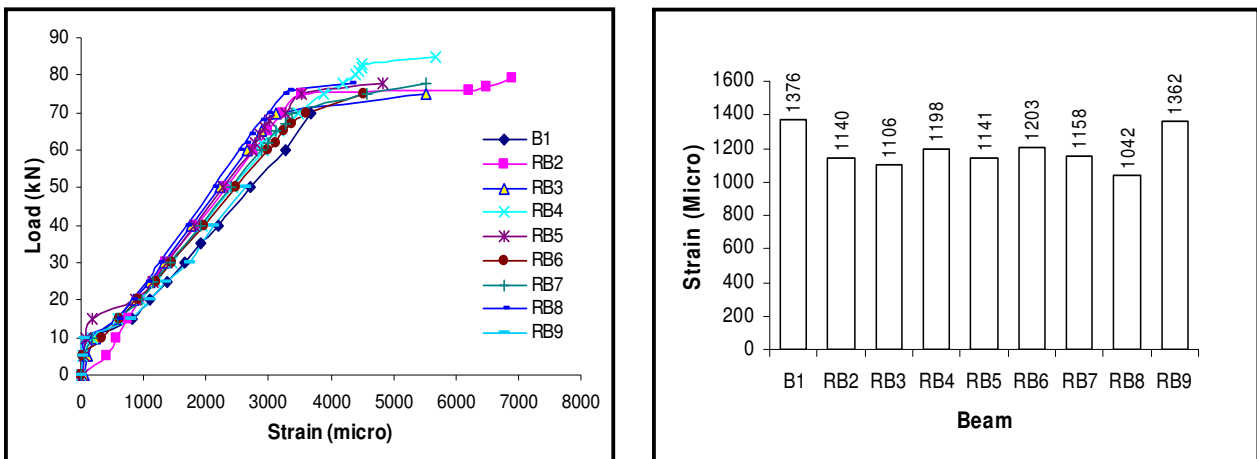
Figure 10: a) Load-Steel Tensile Strain Curves and b) Steel Maximum Tensile Strain at 25 kN Load for all Beams

The strain in the reinforcing bars was monitored using electrical resistance gauges mounted on the longitudinal reinforcements that were placed in the centre of the high moment region. The relationship between the load and the tensile strain of the steel at the mid section of all the repaired and control beams is shown in Figure 10(a). The tension reinforcements of all the repaired beams started to yield at loads ranging between 70 to 80 kN. However, the reinforcements of the control beam and beam RB9 did not show any yield as the strain gauges did not provide any readings after a certain load. Nevertheless, the sudden crushing of concrete in the compression zone and the faster widening of central cracks just before failure were evidence of failure due to the yielding of reinforcements of the control beam and the repaired beam RB9. It was observed that the tensile strain of the steel increased with the increasing load, rising abruptly just before the beams failed.

Figure 10(b) shows the tensile maximum strains measured at service (25 kN) load for all repaired and control beams. The strain of the repaired beams RB2, RB3, RB4, RB5, RB6, RB7, RB8, and RB9 were found to differ from the control beam by -17%, -20%, -13%, -17%, -13%, -16%, -24% and -1% respectively. Thus, it can be said that the tensile strain registered at service load in the repaired beams is lower to that of the original beam.
