University of Southern Queensland

**The Effect of Vandalism on Fibre Composite
Structures**

Bachelor of Engineering (Civil)

Submitted: October, 2009

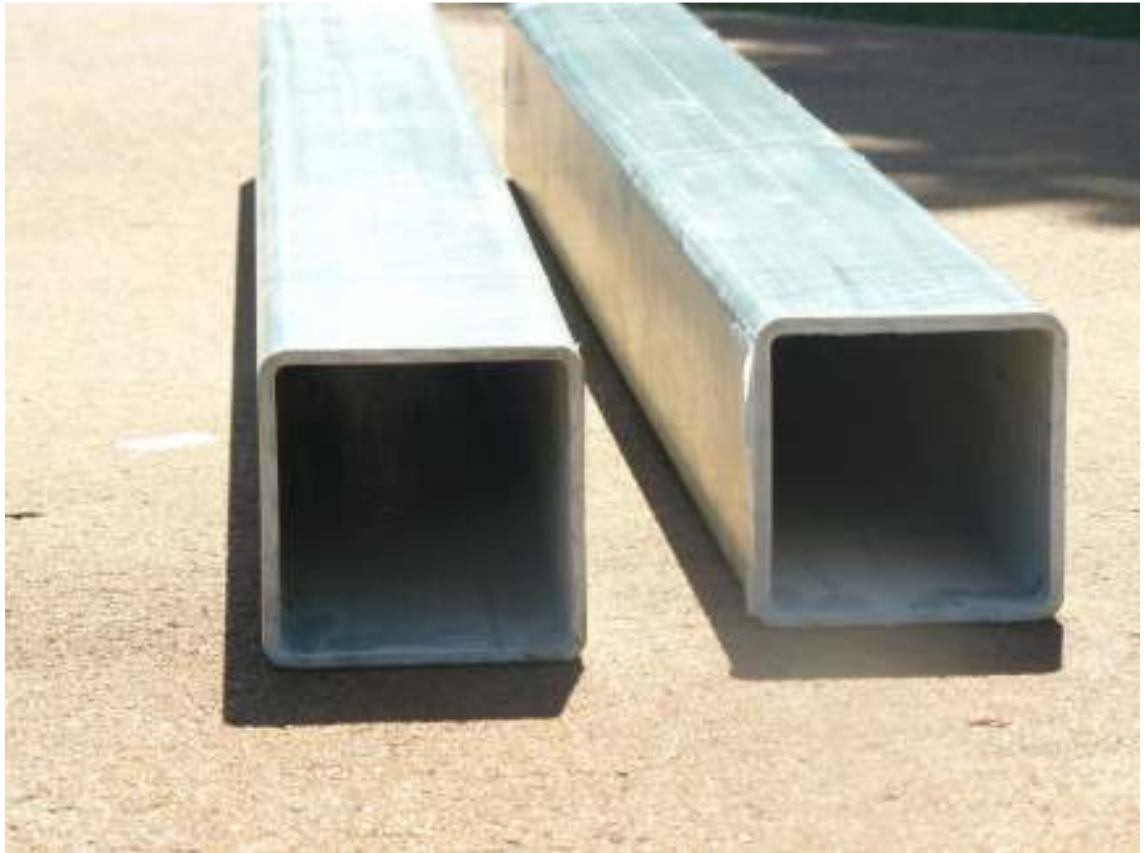
Figure 2.2 Pultruded Section

A pultruded sections differs from sandwich panels as it comes from a fibre composite manufacturing process producing continuous lengths of fibre reinforced polymer in a range of structural shapes. The pultrusion is made from a liquid resin and the reinforcing fibres (Van Herk, H., Rosselli, F. 2008). The liquid resin that is used

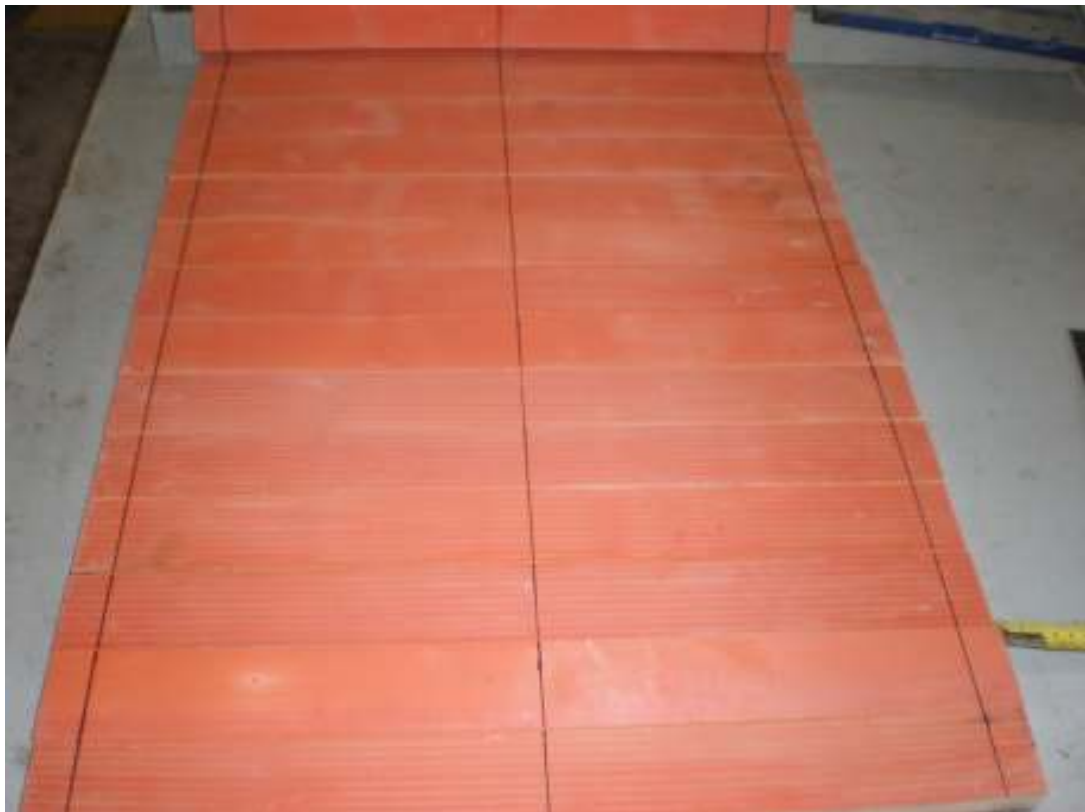
Figure 3.1 Prepared LOC Sandwich Panel

The sandwich panels used in this project are a commercially available material and manufactured by LOC composites. They are produced in large panels. The panels that were used have been surface treated with an asphalt top. These were also compared to unsurfaced samples. The samples were cut from both panels. The covered samples were cut to 500 mm x 50 mm. Some prepared samples can be seen in figure 3.1.

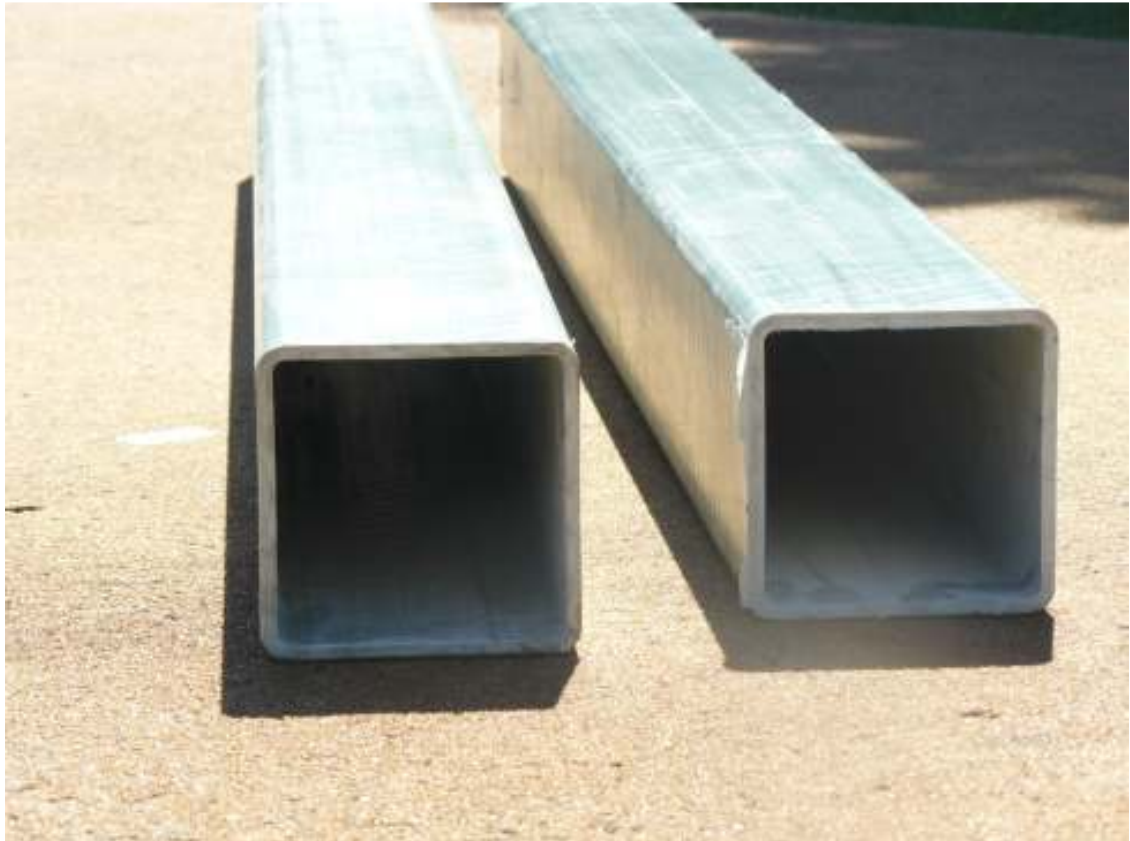
Figure 3.2 Prepared Wagners Pultrusion

The first glass fibre pultrusions that were used in this study are also commercially available and these sections are manufactured by Wagners Composites. These pultrusions come in many standard structural sections. The sections used for this project were a commonly used standard section of 100mm x 100mm. This had a thickness of 5mm. The Wagners composite is made using a poly ester resin and uses glass reinforcing fibres in 0°, 90° and 45° directions.

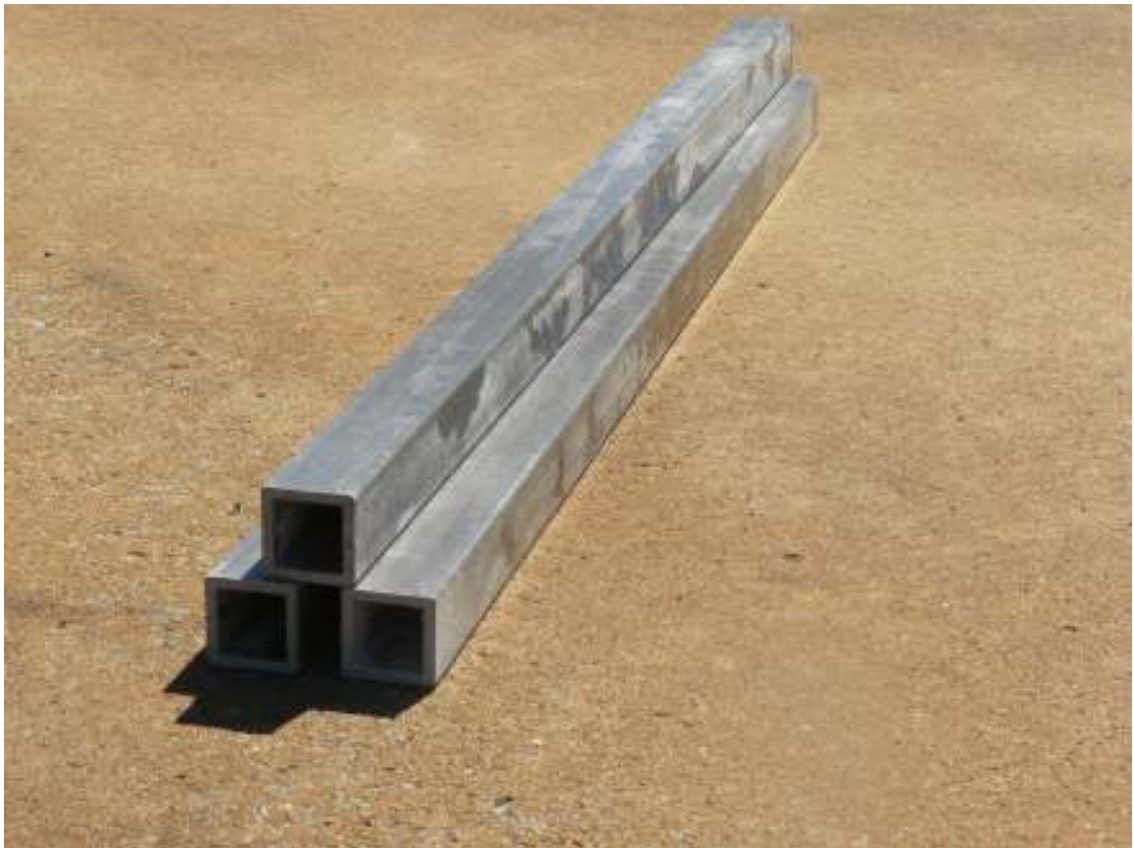
Figure 3.3 Exel Composites Square Pultrusion

The second glass fibre pultrusion that were used were also commercially available and these sections were manufactured by Exel Composites. There were two different types of pultrusion by Exel Composites used in the project. The first product was a 50mm x 50mm section with a 6mm thickness.

These pultrusions differed to the Wagners one in multiple facets. The Exel composite uses a poly ester resin and glass fibres in both the 0° and 90° directions. The pultrusion instead of using 45° fibres as well 0° and 90° direction fibres uses a continuous filament mat to provide the shear strength and rigidness needed.

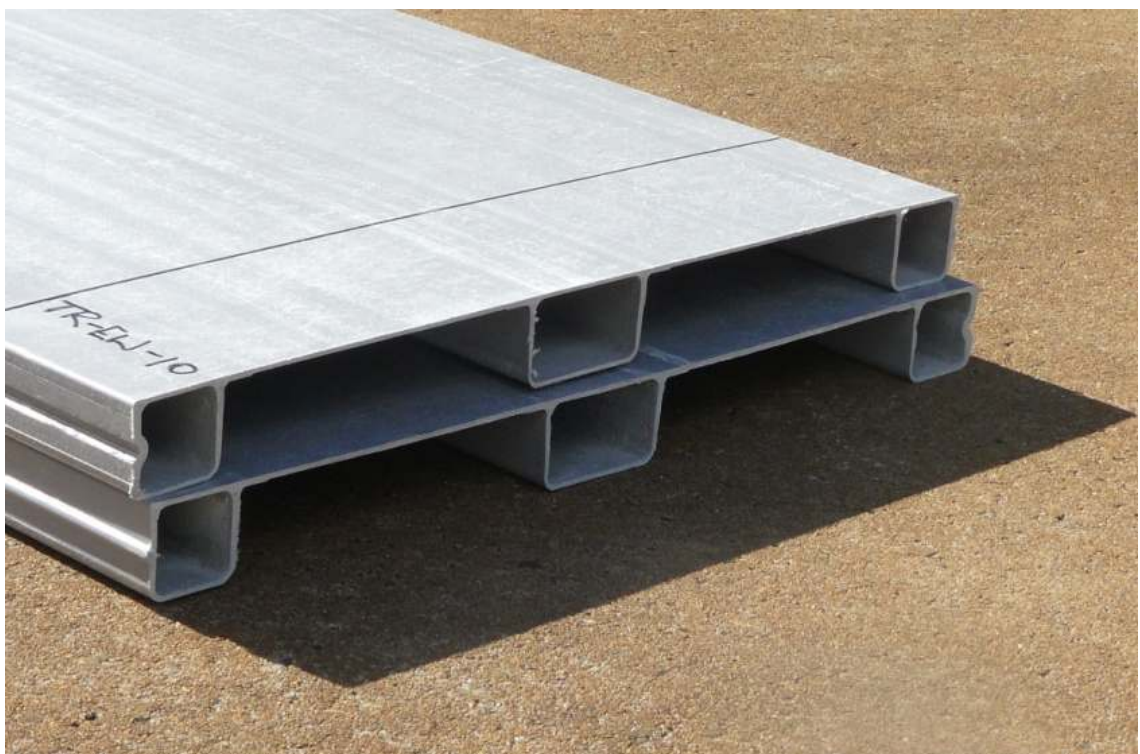
Figure 3.4 Exel Composite Wall Pultrusion

The second is a wall panel of three square section connected by a thin flat section of pultrusions, these can be seen in Figure 3.4. The wall panel is made using a poly ester resin and uses loose unidirectional fibres to create the stiffness in all directions.

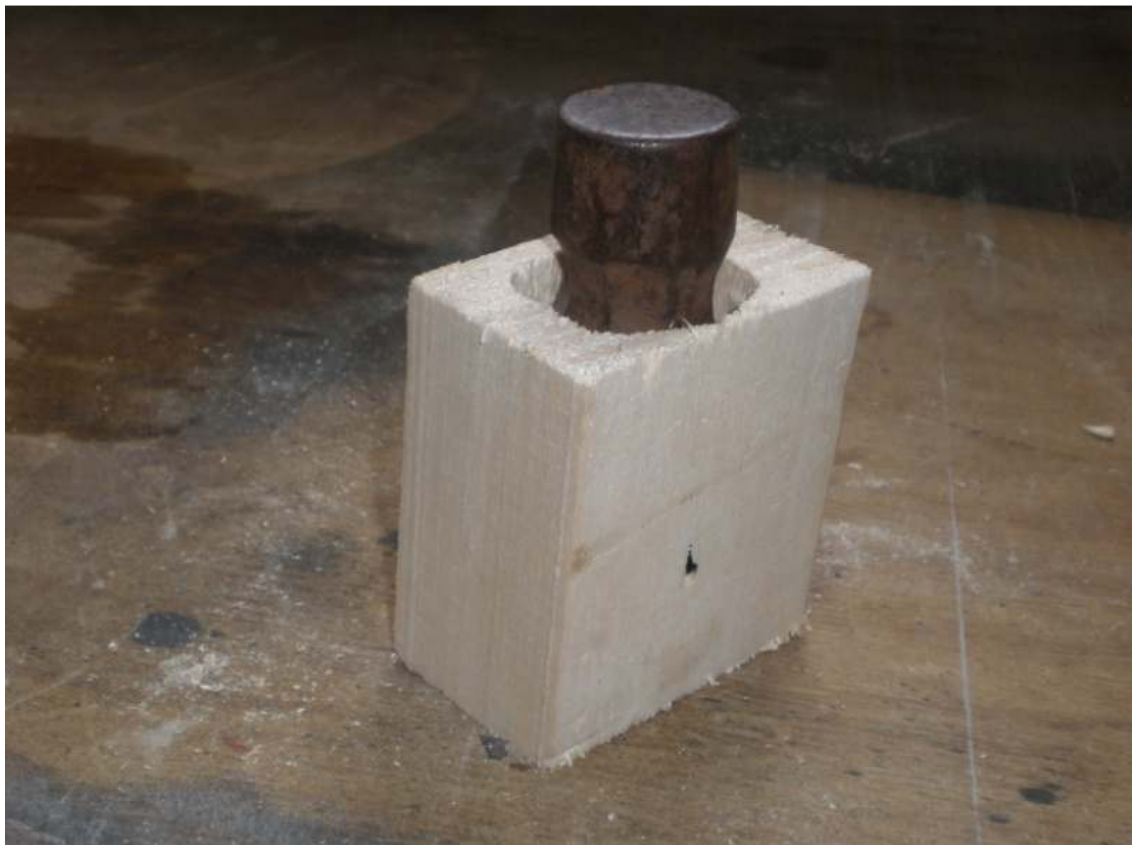
Figure 3.5 Blunt Impactor

These were subjected to a drop mass situation which has been used in the literature. This drop weight used the impactor as the head of a hammer as the possible vandal weapon, as the literature suggested impactor size was a major influence to damage response. The impact was into the centre of the specimen. The impactor can be seen in figure 3.5.

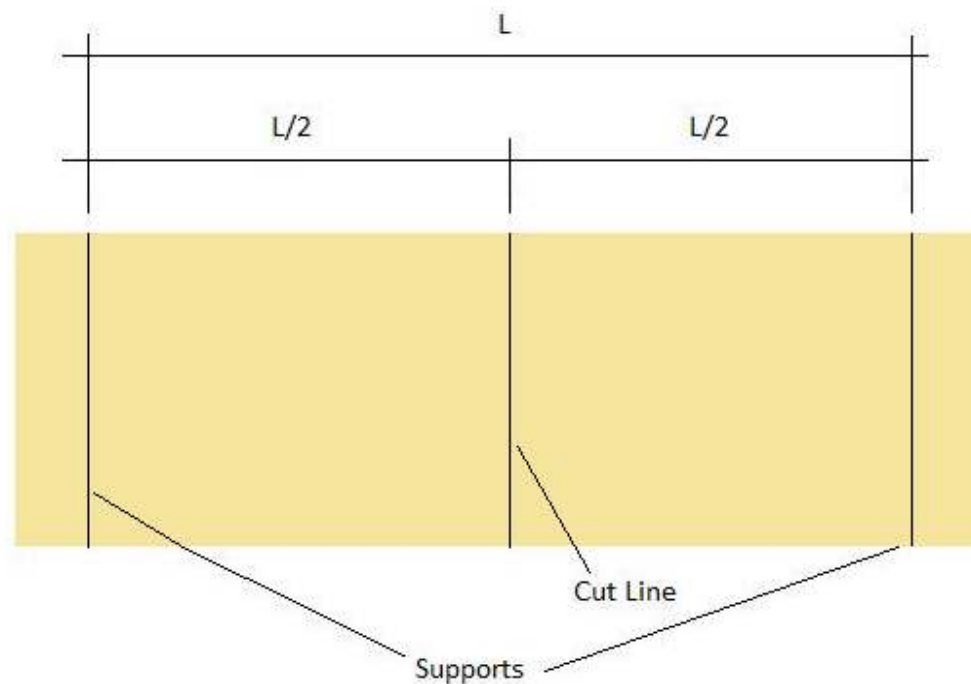
Figure 3.7 Layout of cut specimen both sandwich and glass fibre composite

Three samples were prepared of both sandwich panel and glass fibre reinforced composite. The layout of the cut can be seen below in figure 3.7.

The damage was made by placing a spare sample on scales and a range of pressures was applied. This was repeated till damage was obvious and this same pressure was repeated on each of the three samples. This procedure was used for the sandwich panel only.

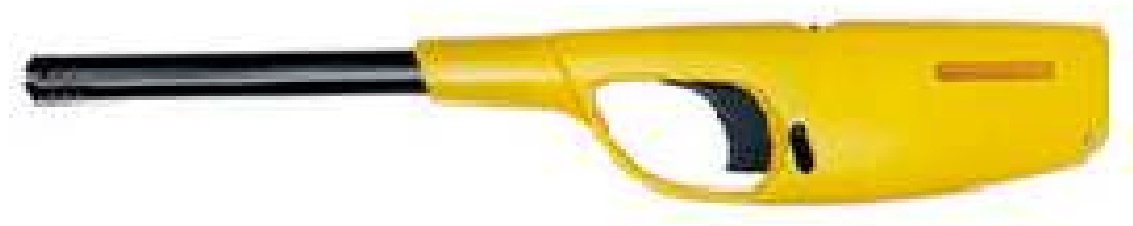
Figure 3.9 BBQ Lighter

This test was similar to that of the literature but on a much smaller scale. The literature was aimed at bush fire and extreme heats. The tests completed were of both sandwich composites and glass fibre composites. Three samples were again used to follow the literature. The lighter can be seen in figure 3.9.

The fire damage tests were conducted using over the counter bbq lighters. These small bbq lighters were used on sample pieces to determine the length of flame required to cause damage this was then repeated for the similar time on the test specimens. The fire damage was done to the centre of the test specimens.

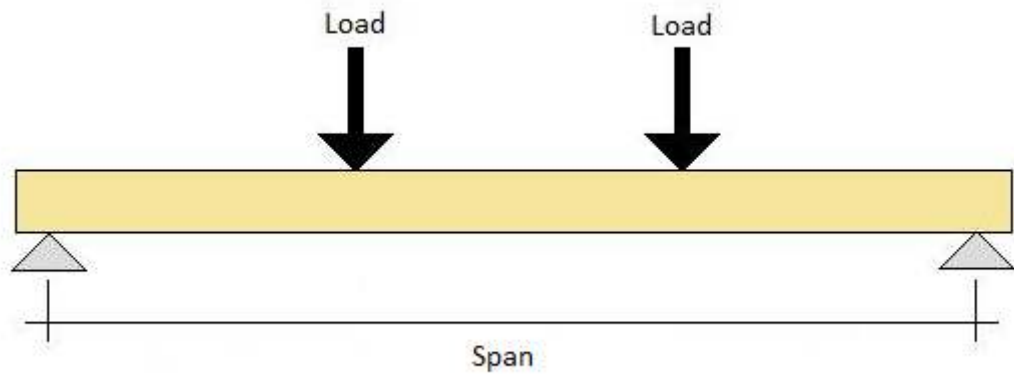
Figure 3.10 Four Point Bending Test

The flexural tests were completed on the MTS Alliance RT/10 testing machine. The purpose of the test is to determine the flexural strength of the material before and after damage. The tests involved failing the specimens using a 4-point bending test. This can be seen below in figure 3.10.

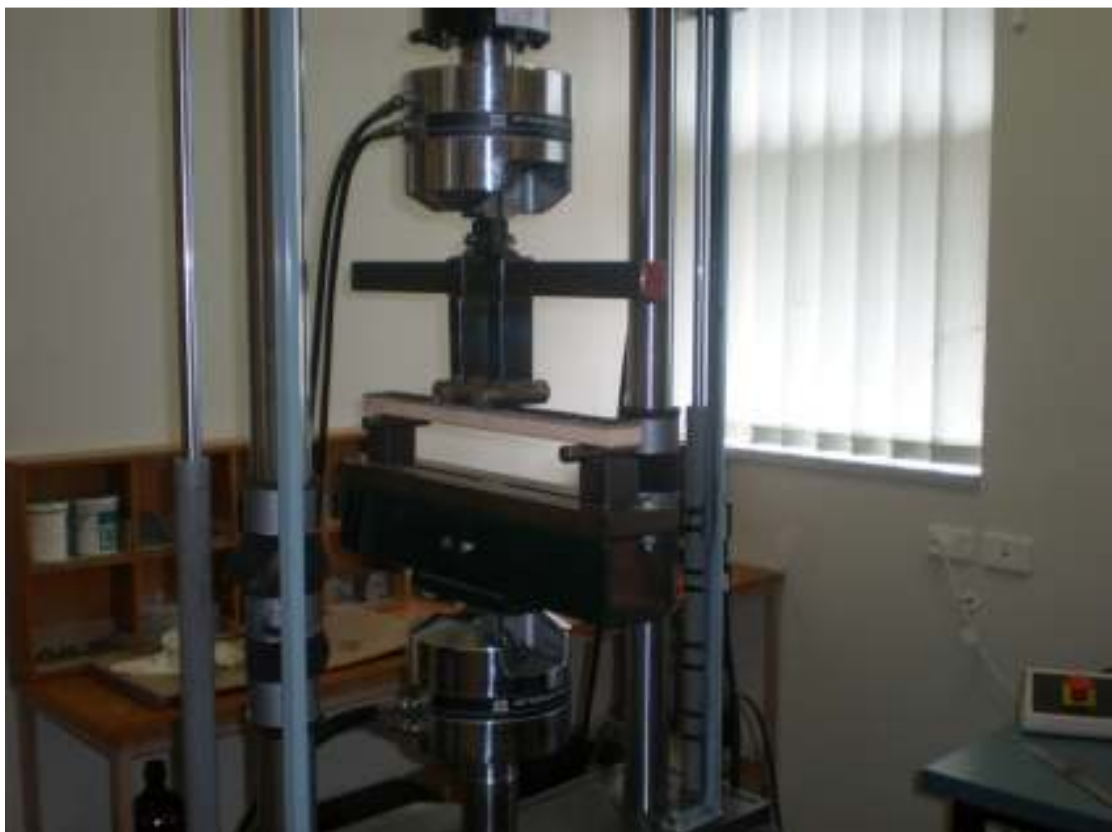
Figure 3.11 MTS testing machine used on the Sandwich Panels

The test machine records the data during the test and displays many of the properties in real time. The program also records load and deflection, this can be seen in figure 3.11.

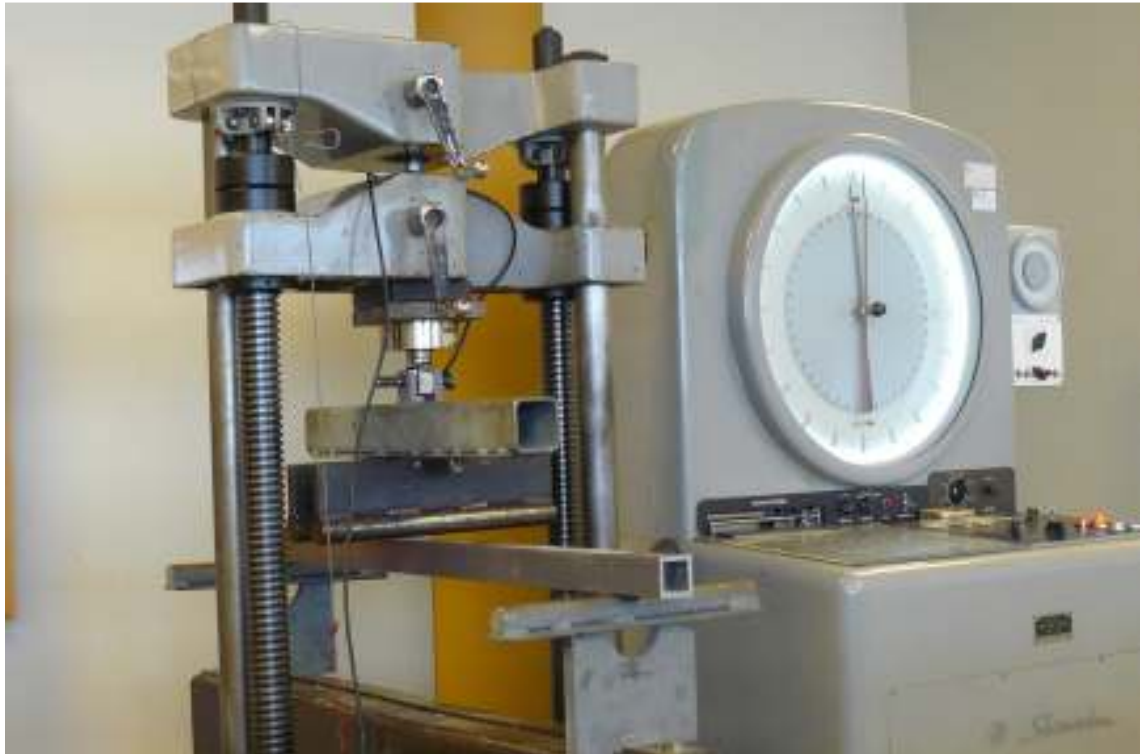
Figure 3.12 MTS testing machine used on the Pultrusions

The larger full sized samples were tested using a larger capacity machine, this can be seen below in figure 3.12.

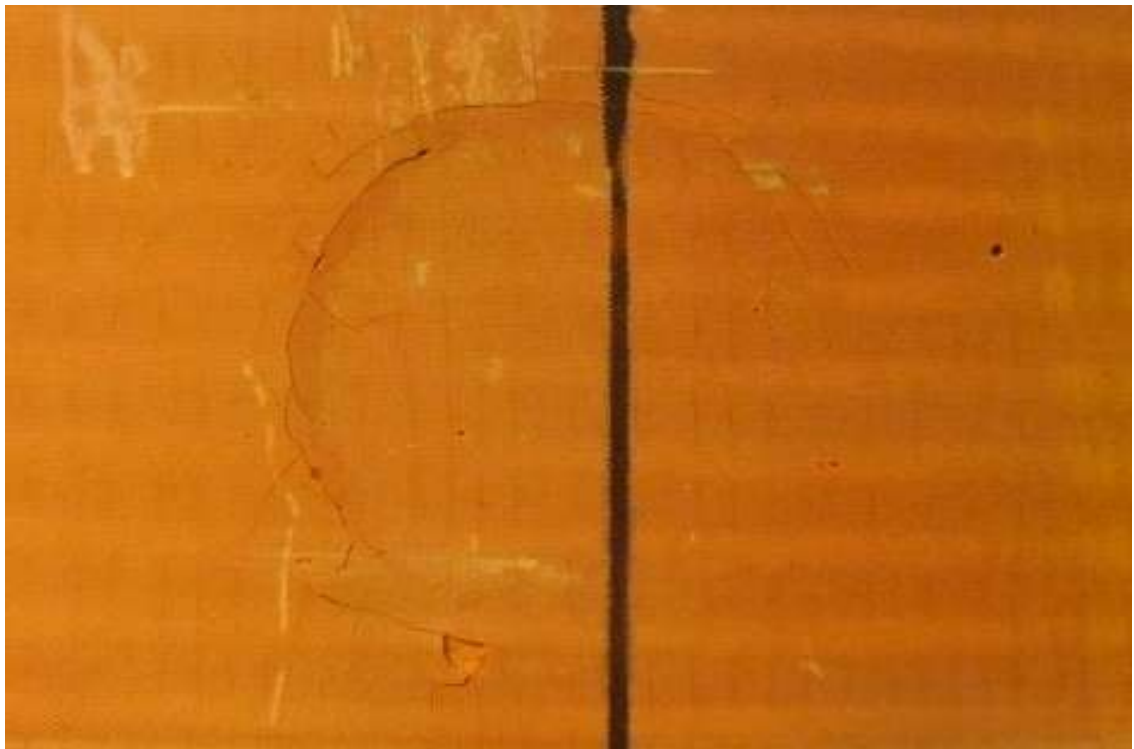
Figure 4.2 Blunt Impact Damage

The damage from the impact left a circle the size of the hammer into the skin of the specimen for both the asphalt cover and the no cover. The indent was not deep but provided internal core crushing to some extent and skin ripples where it had impacted. This can be seen in figure 4.2. This correlated with the previous research done as the wide impactor was said to achieve this visible damage.

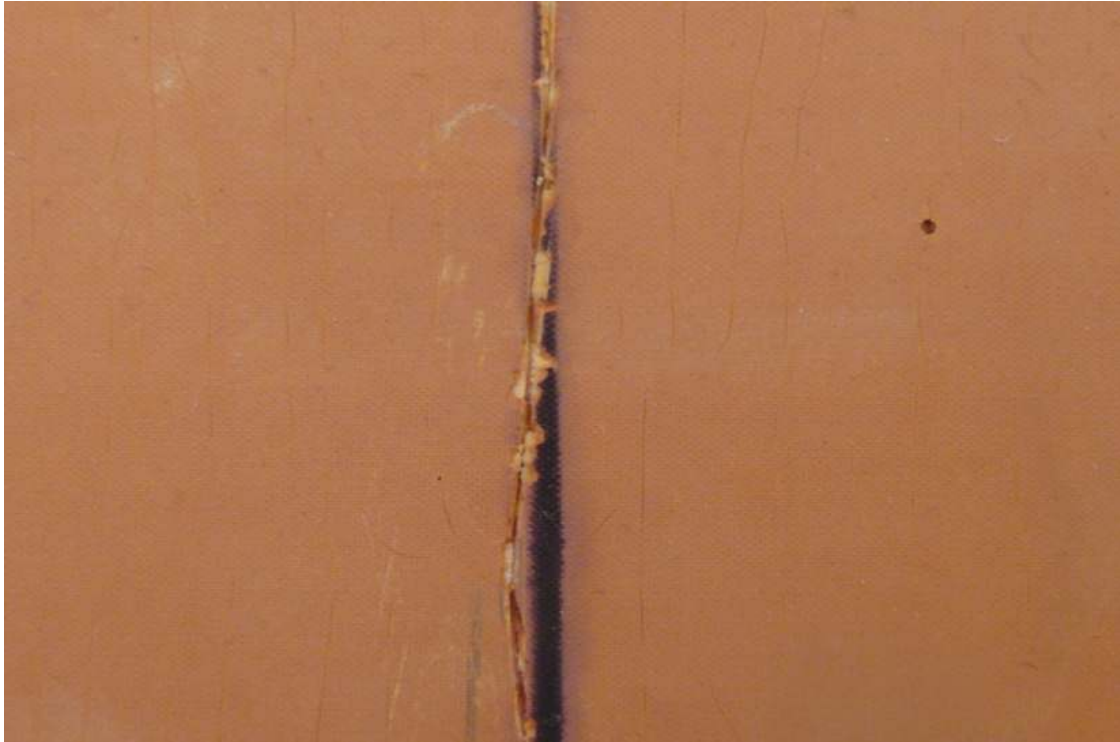
Figure 4.5 Cut Damage

The cut damage was produced by placing the sample on a set of scales and applying approximately 4kg down and cutting across the centre line of the sample. The specimens were only cut once per specimen. With approximately 4kg of pressure the cut was approximately 1mm deep. The damage can be seen below in figure 4.5.

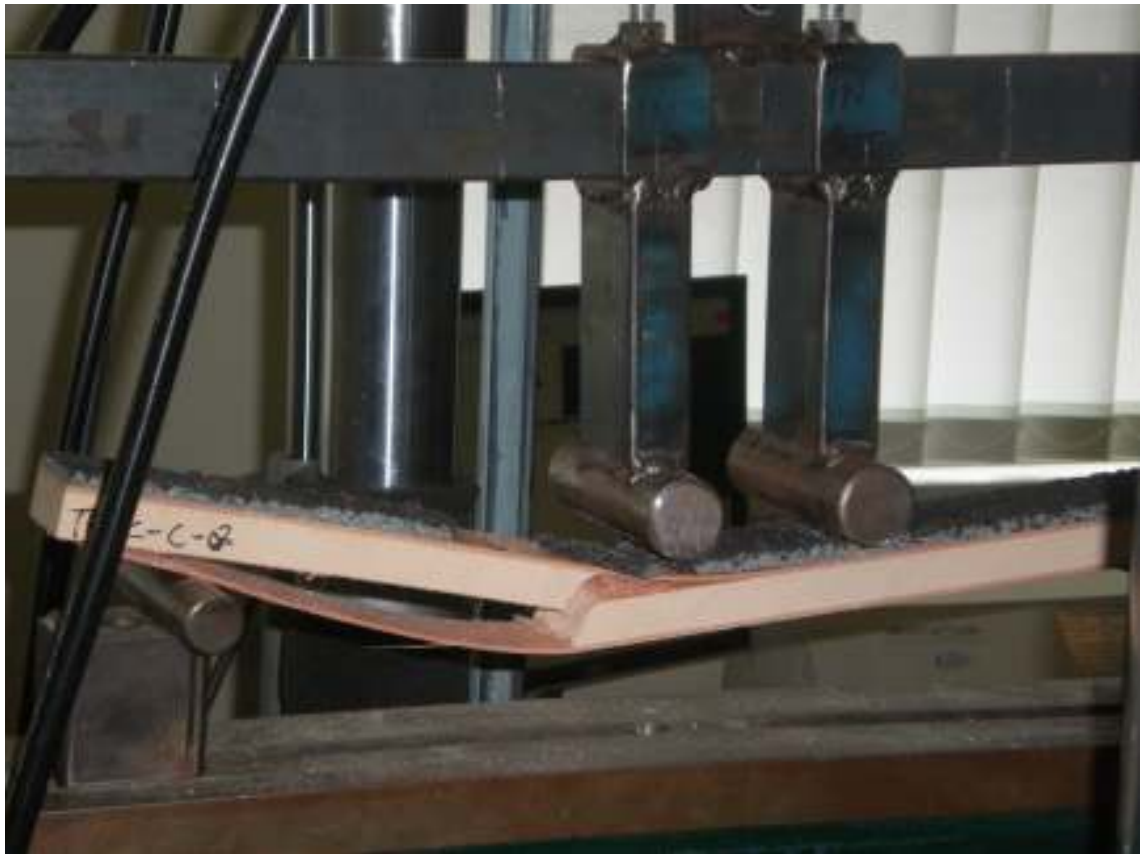
Figure 4.8 Failure of Sandwich Panel with Cover

The differences that can be seen between the results on the tests could be explained by the asphalt cover that was present on the specimen. The asphalt cover was not a perfect thickness and in some cases was not as compact as in other places. This can also be somewhat contributed to the longer failure time of Control (SP-C) specimen, the drops and reloading is due to large sections of the asphalt began to crack and lift off the sample. This can be seen in figure 4.8 where the asphalt cover has fallen from the section after failure.

This can be best seen in figure 4.8 where the samples would fail and re-load as the cracks or tears would dissipate to the side. One side would typically go as the impacts were not directly centre and the shortest distance from the impact site to the edge would fail. It would continue to load until the other side would fail.

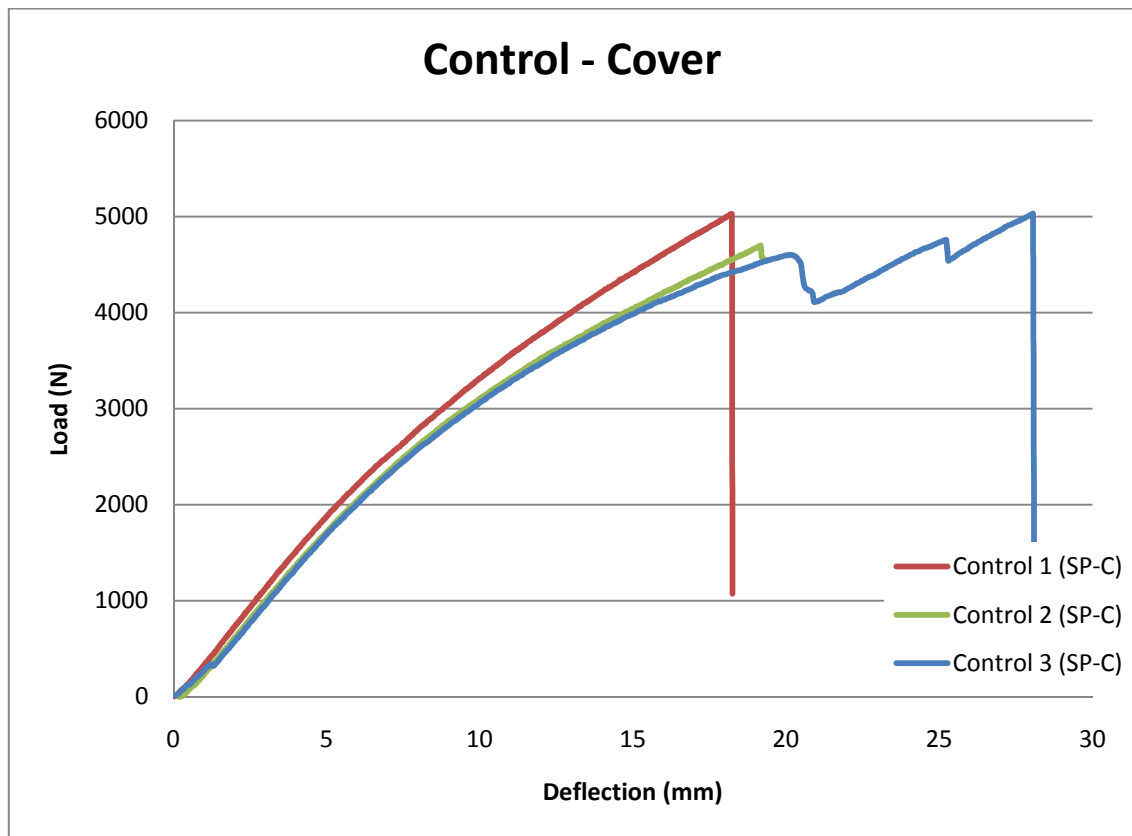
Figure 4.9 Control Specimen with Cover

The average ultimate load of the control with cover was 4917N, where the average ultimate load of the control specimen without cover was 4591N. The asphalt cover provided an increase of 6.6% in average ultimate load. The flexural stiffness an indicator of the flexural modulus of the covered specimen was 363N/mm and the non covered specimen had a flexural stiffness of 210N/mm an indicator of the flexural modulus, the cover providing an increase of 42%.

The graphs of the control samples can be seen in figure 4.9 and 4.10. The flexural modulus of the control samples with no cover 7681.01MPa and the flexural modulus of the control samples with cover was 8703.08MPa, the cover providing an increase of 11.7%.

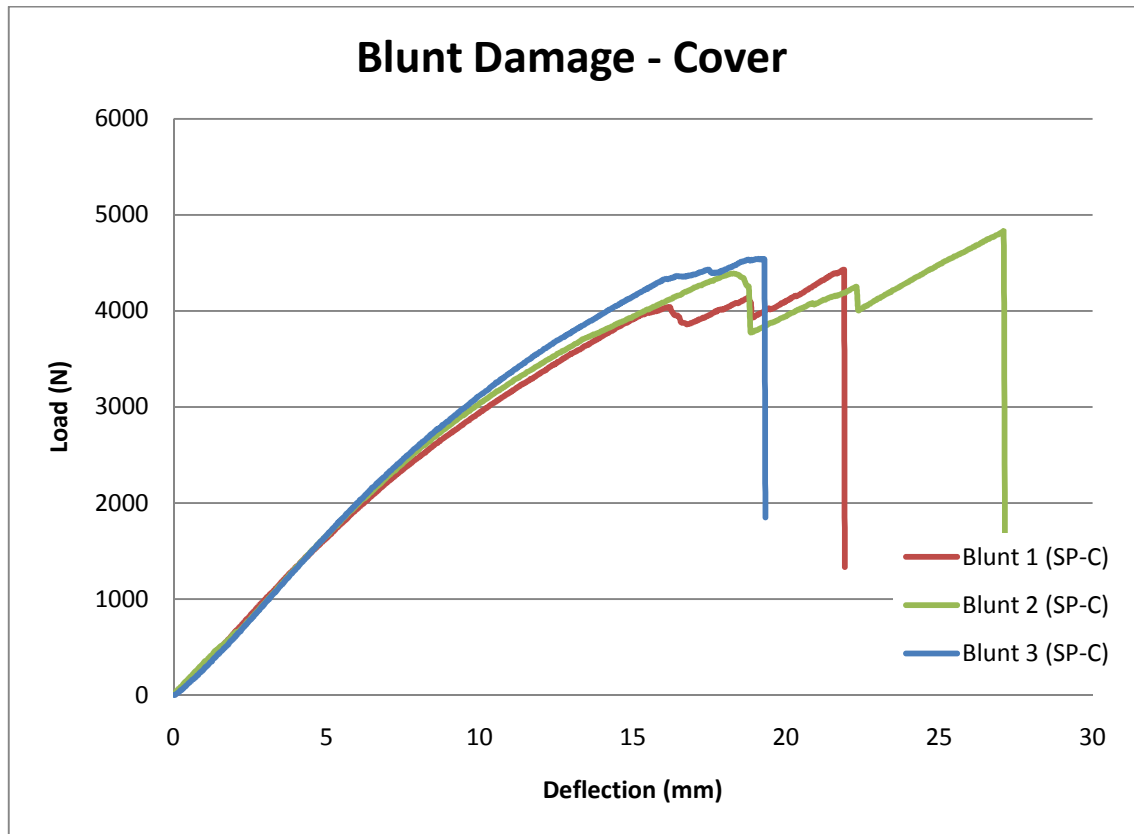
Figure 4.11 Blunt Damage with Cover

The blunt impacted covered samples had an ultimate strength of 4599N, in comparison to the control the blunt impact damage decreased average ultimate load by 6.5%. The covered samples had a flexural stiffness of 323N/mm an indicator of the flexural modulus, in comparison to the control the blunt impacted stiffness was reduced by 11%.

The blunt impact sample had a flexural modulus of 7602.75MPa, in comparison the flexural modulus was reduced by 12.6%.

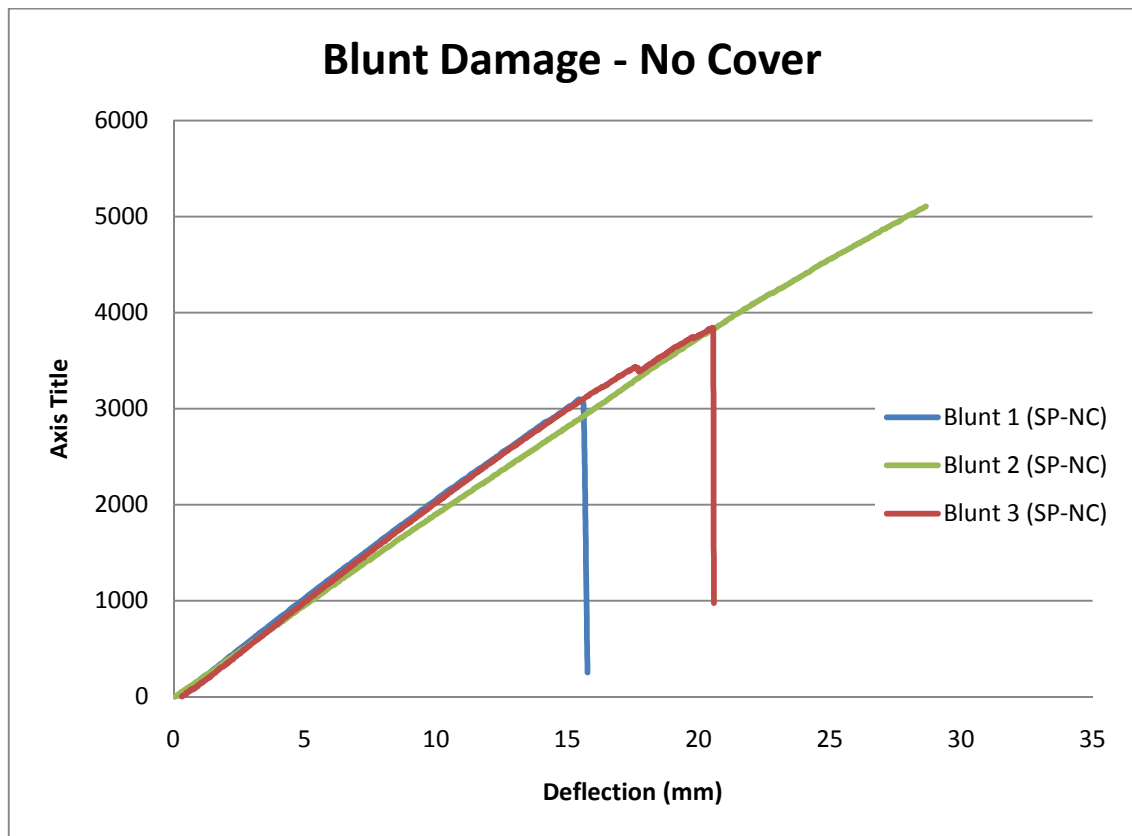
Figure 4.12 Blunt Damage without Cover

For the non covered blunt impact the amount of damage seemed too high for intended results. The asphalt had taken much of the effect out of the hammer and for the non covered samples the core actually took damage and in one case had quite extensive damage.

This is an explanation for the early failures of the samples as the failures were in the core and do not effectively show the effect of the damage had on the specimen, thus the ultimate load was neglected. The flexural modulus of the blunt impacted samples without asphalt cover was 7354.78MPa; this was a reduction of 4.2%.

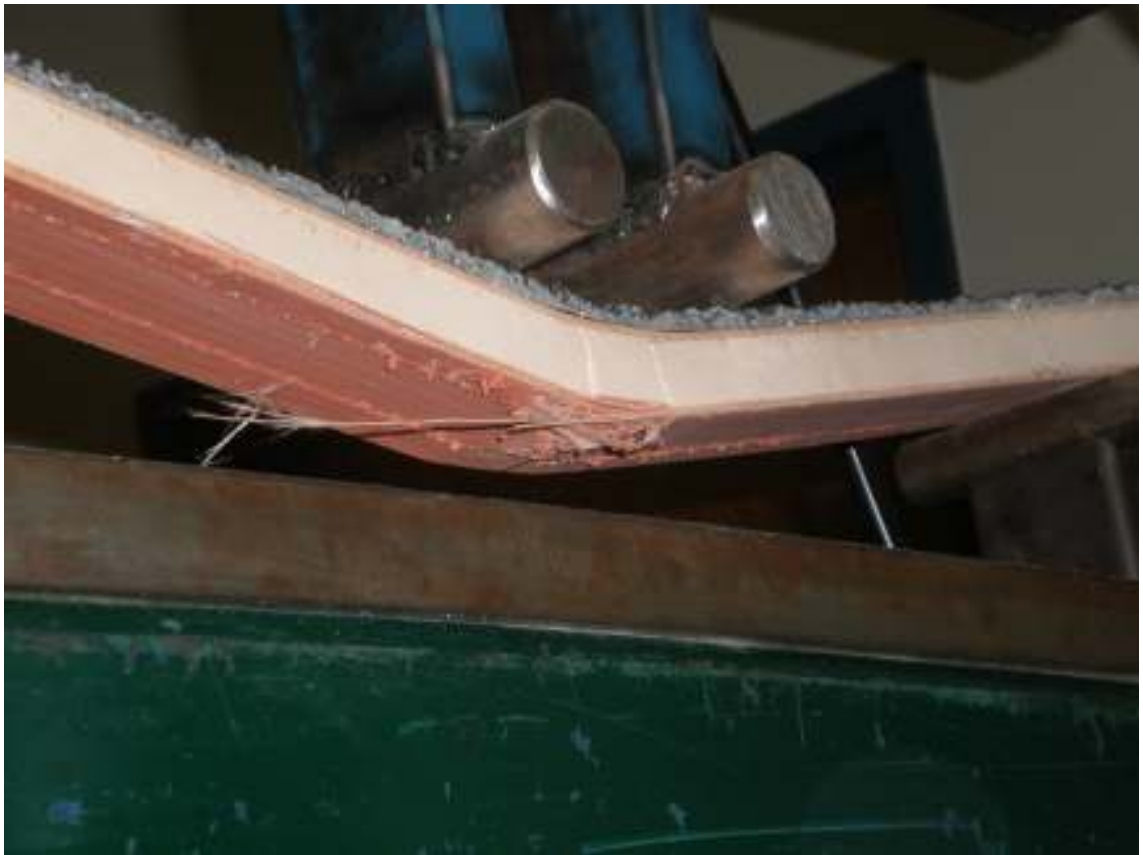
Figure 4.13 Failure of Sandwich Composite with Cover Sharp Impact Damage

This ductile like failure can be best seen in figure 4.14 where the samples would fail and re-load as the cracks or tears would dissipate up the specimen. The literature reported that small strips would tear longitudinally up the specimen from the impact site; this can be seen in figure 4.13. This was what was found to be the case. As the load increased impact size strips would tear up the specimen which is seen in the multiple failure reloading spikes in the specimen.

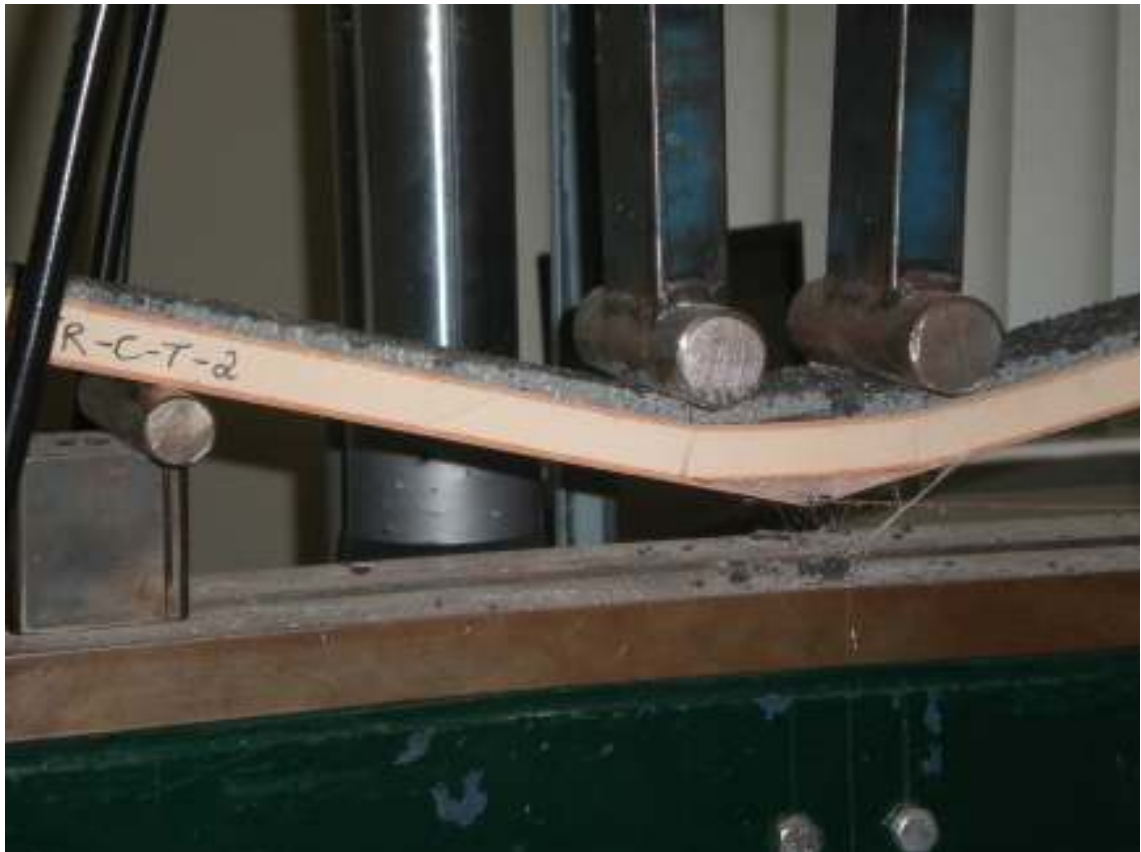
Figure 4.16 Sandwich Panel With Cover Cut damage

Where the specimen had more depth in the cut and more fibres severed the effect was more noticeable. The cut had much the same effect as the blunt impact. Visible cracks were not observed as the crack was already started in the damage and this would be increased with more fibres breaking with increased load. This can be seen in figure 4.16 with the amount of broken fibres underneath the failed sample.

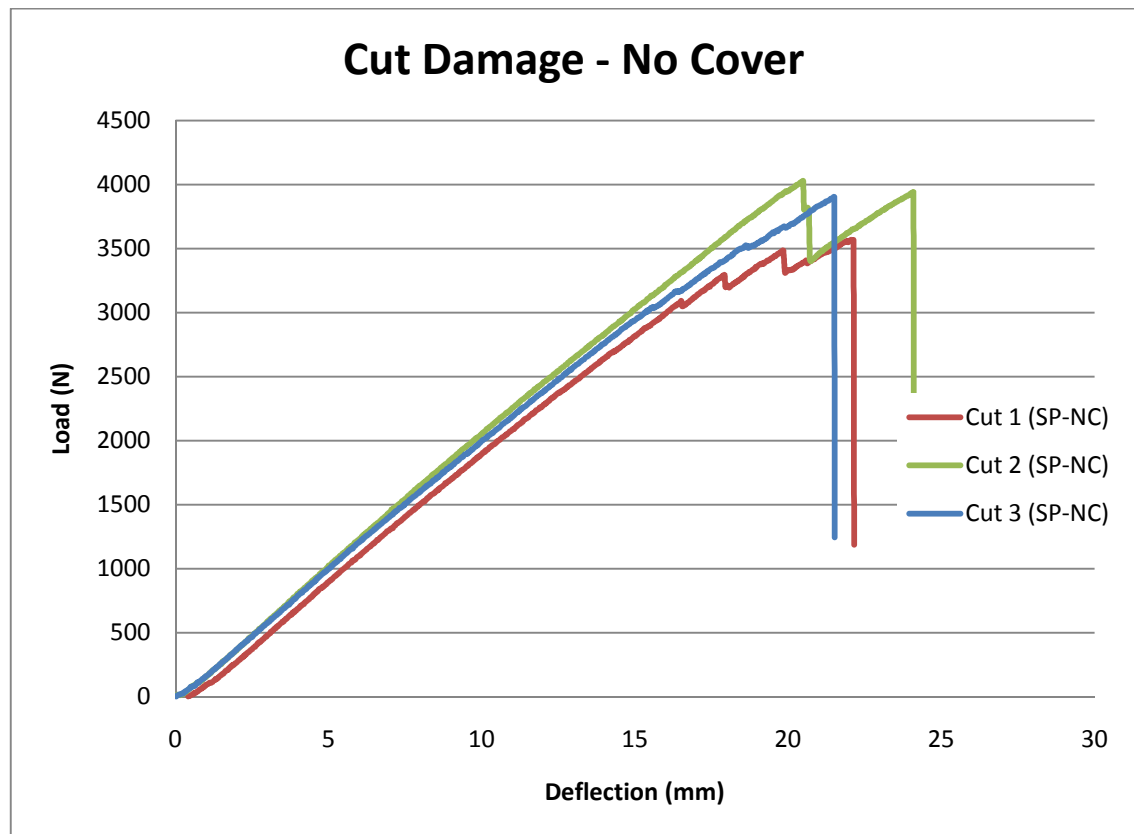
Figure 4.18 Cut Damage without Cover

The non covered samples had an ultimate load of 3833N, a 16.5% drop. The flexural stiffness an indicator of the flexural modulus is 205N/mm, a 2.2% drop. So this shows that the damage again has no effect until ultimate load. The non covered sandwich panel had a flexural modulus of 7160.28MPa which was a reduction of 6.8%.

The failure in Cut 1 (SP-NC) in figure 4.18 resembles that of the sharp impact samples as well. This was to a much smaller extent but small sections would strip away but not extend to far up the specimen.

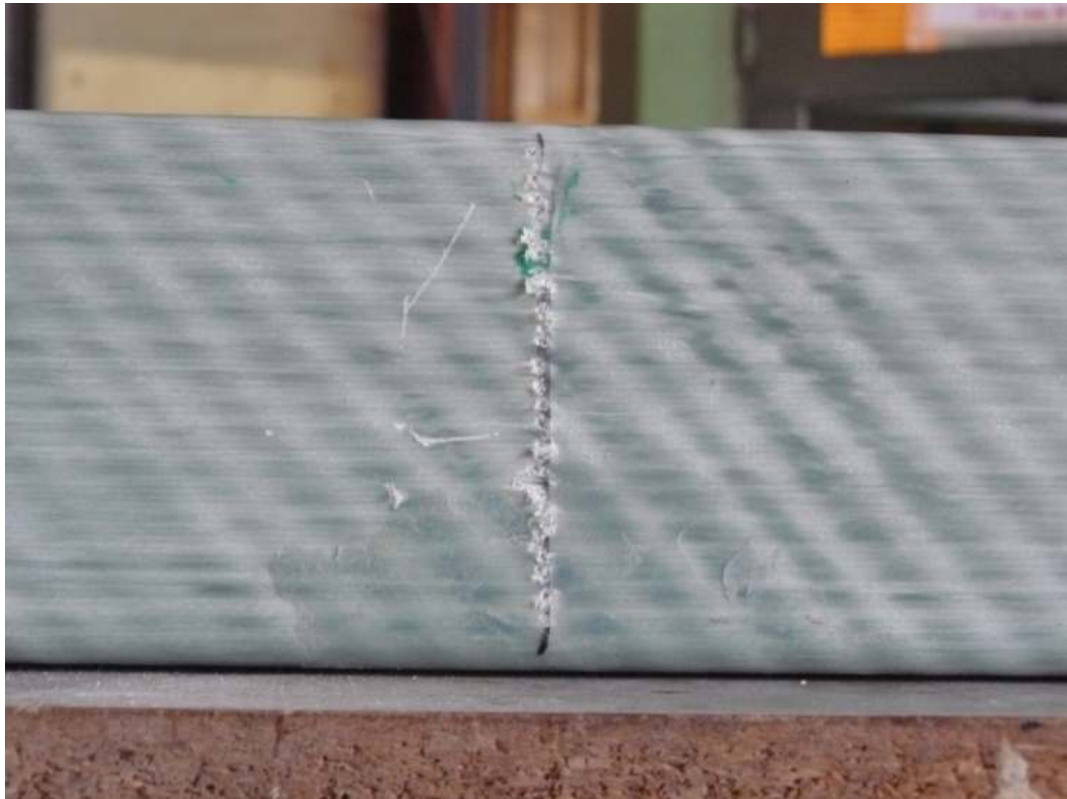
Figure 5.1 Sharp Impact on 100x100mm section

This time the sharp impact was done using both a screw driver and a hammer. The hammer was used to impact the screw driver in the sample to a 1-2mm depth. This was done along the centre line of the sample; this can be seen in figure 5.1.

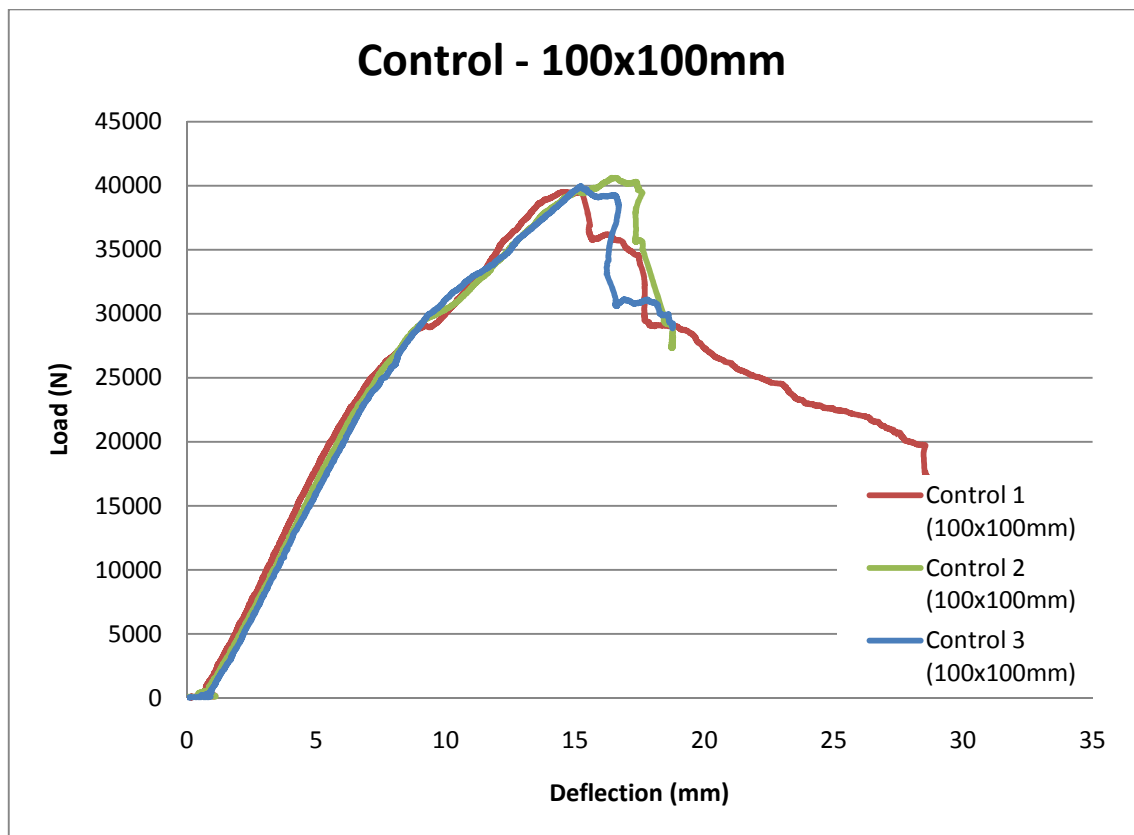
Figure 5.4 Control Results of 100x100mm section

Three control samples were tested as explained earlier to provide a control or standard to measure the effect the damage had on the specimen. The failures of the specimen were of a buckling type failure in the compression side of the sample. This buckled and caused the sides of the samples to also buckle. The points under the loads buckled and had a crushing failure.

At approximately 8mm of deflection the samples began to buckle and crush around the load points. This continued as the side walls buckled which led to ultimate failure. The control samples had an ultimate load of 40 068N. The samples also had a flexural stiffness of 3 896N/mm; an indicator of the flexural modulus. The control samples had a flexural modulus of 19 731.07MPa.

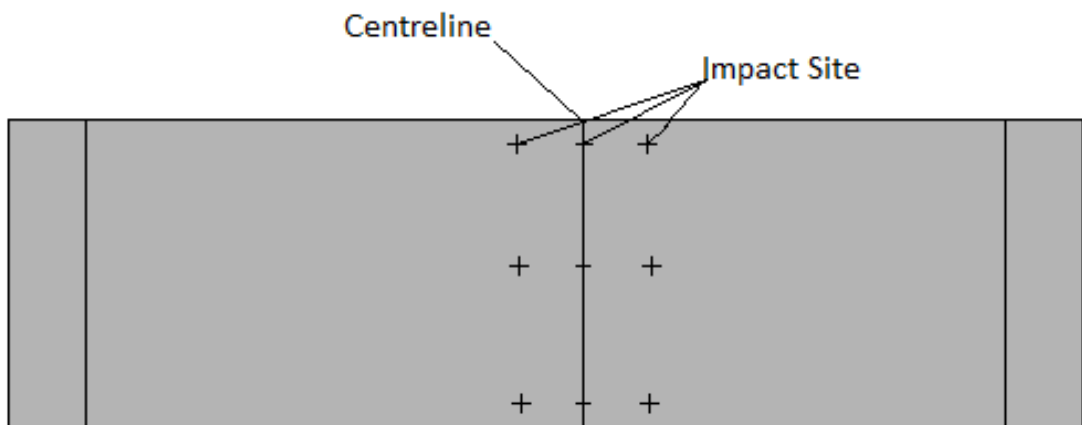
Figure 6.2 Blunt Impact Schematic (Wall Panel)

The wall panel was impacted 9 times, three impacts on each of the stiffeners, on and around the centre line. This left the same indent as on the 50x50mm section. The area between the impact sites was unable to be damaged as the section was too flexible for the hammer to damage. This meant 68% of the specimen was immune to the blunt impact. The impact on the wall panel can be seen in figure 6.3.
