FINAL REPORT

EVALUATION OF FEASIBILITY OF MEASURING EHD
FILM THICKNESS ASSOCIATED WITH CRYOGENIC FLUIDS

NATIONAL AERONAUTICS AND SPACE ADMINISTRATION
GEORGE C. MARSHALL SPACE FLIGHT CENTER

August 26, 1983

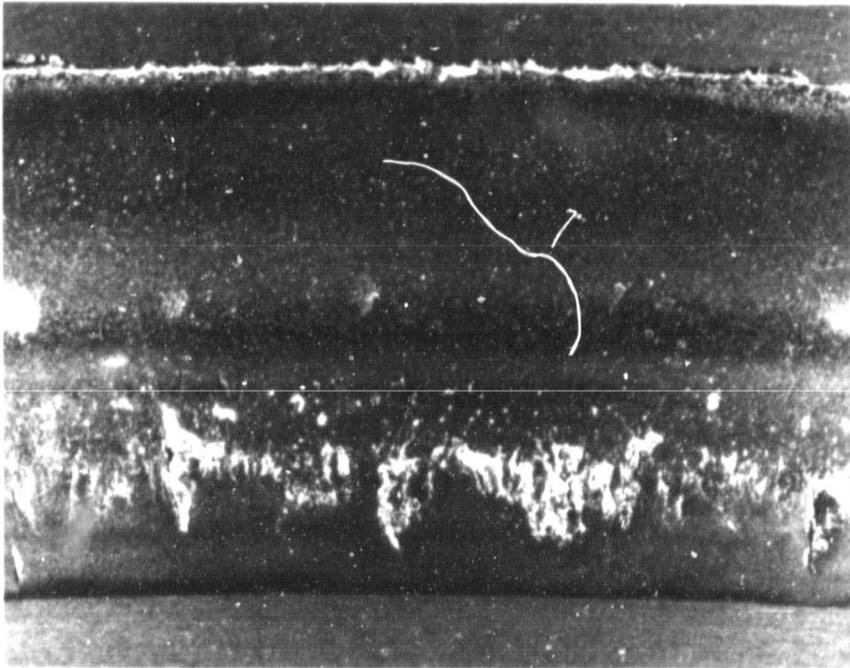
2L404   10x

Examination of the 120-degree segments of the races and four balls from the No. 3 turbine bearing of unit 2209R1 showed evidence of high loads in both the axial and radial direction. As shown in Figure 7, the axial load caused the ball track on the inner race to reach the shoulder and roll a burr

FIGURE 7. ROLLED-OVER SHOULDER (AT TOP OF PHOTO) AND
           BAND OF SPALLS ON INNER RACE OF TURBINE

at the corner. This portion of the race conformed with the ball radius, which confirmed that the plastic deformation (possibly combined with wear) was a result of a high axial load. The inner race also had a track of fatigue spalls at the radial load (zero contact angle) position, which was slightly skewed in location but otherwise uniform over the 120 degree segment. The band reportedly was continuous around the entire inner race, which is indicative of a high continuous radial load (non synchronous). The balls were uniformly darkened in color and had a nominal diameter of 12.62 mm (0.497 inch), which is 0.08 mm (0.003 inch) under the typical standard diameter. The outer race had a clearly defined dark contact track with a continuous band of spalls near one edge, Figure 8. The location of the spalls was consistent with an axial load on the bearing.

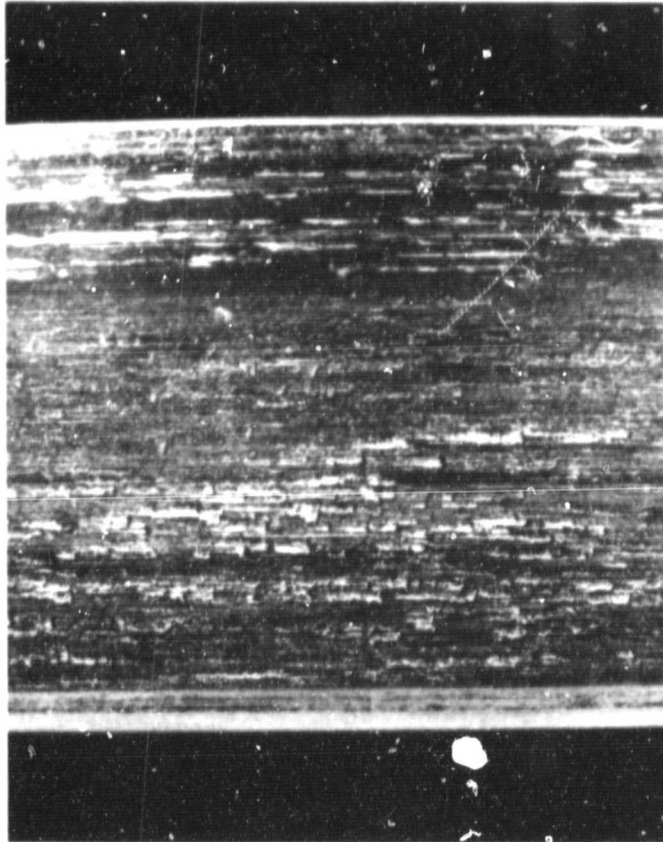
2L403   5x

The balls and race segments from the No. 2 preburner bearing from unit 2209R1 had evidence of very high continuous radial loads, but an absence of high axial loads. The inner race had a continuous band of spalls located at the pure radial load (zero contact angle) position. It was reportedly present around the entire circumference. The balls were worn to 11.0 mm (0.434 inch), which was 0.08 to 0.10 mm (0.003 to 0.004 inch) less than the original nominal diameter. The outer race ball track was wide, centrally located, and had a unusal uniform scalloped pattern on one edge, Figure 9. The outer-diameter mounting surface showed evidence of spinning in its housing, Figure 10. This bearing apparantly was damaged from a repetitive load (such as high frequency vibration), which scalloped the outer race and caused it to spin in its housing.

FIGURE 9.   SCALLOPED WEAR PATTERNS ON OUTER RACE OF NO. 2
             PREBURNER BEARING FROM UNIT NO. 2209R1

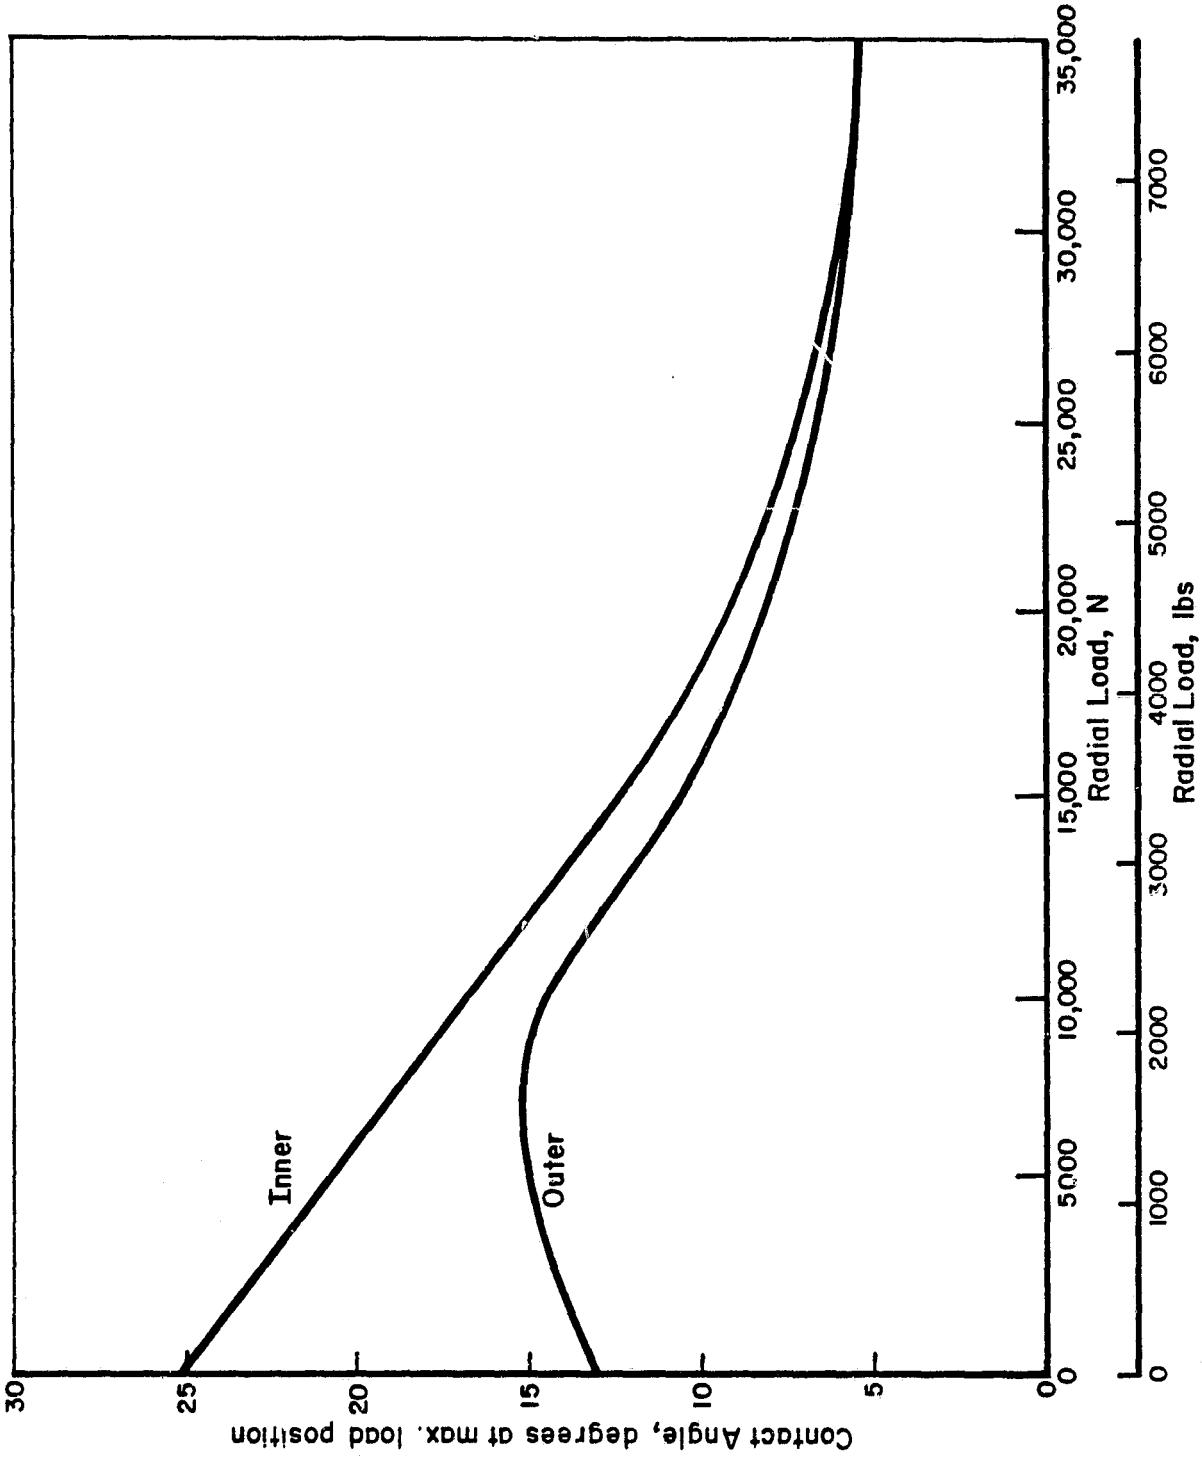
As an externally applied radial load is increased for a given axial preload of 3780 N (850 lb), as shown in Figure 13, the contact angle decreases at the maximum load position. However, the contact angle does not approach

FIGURE 13. CONTACT ANGLE VARIATION WITH RADIAL LOAD AT MAXIMUM LOAD POSITION SSME HPOTP BEARING (7955) AT 30,000 rpm AND 3780 N (850 lb) AXIAL LOAD

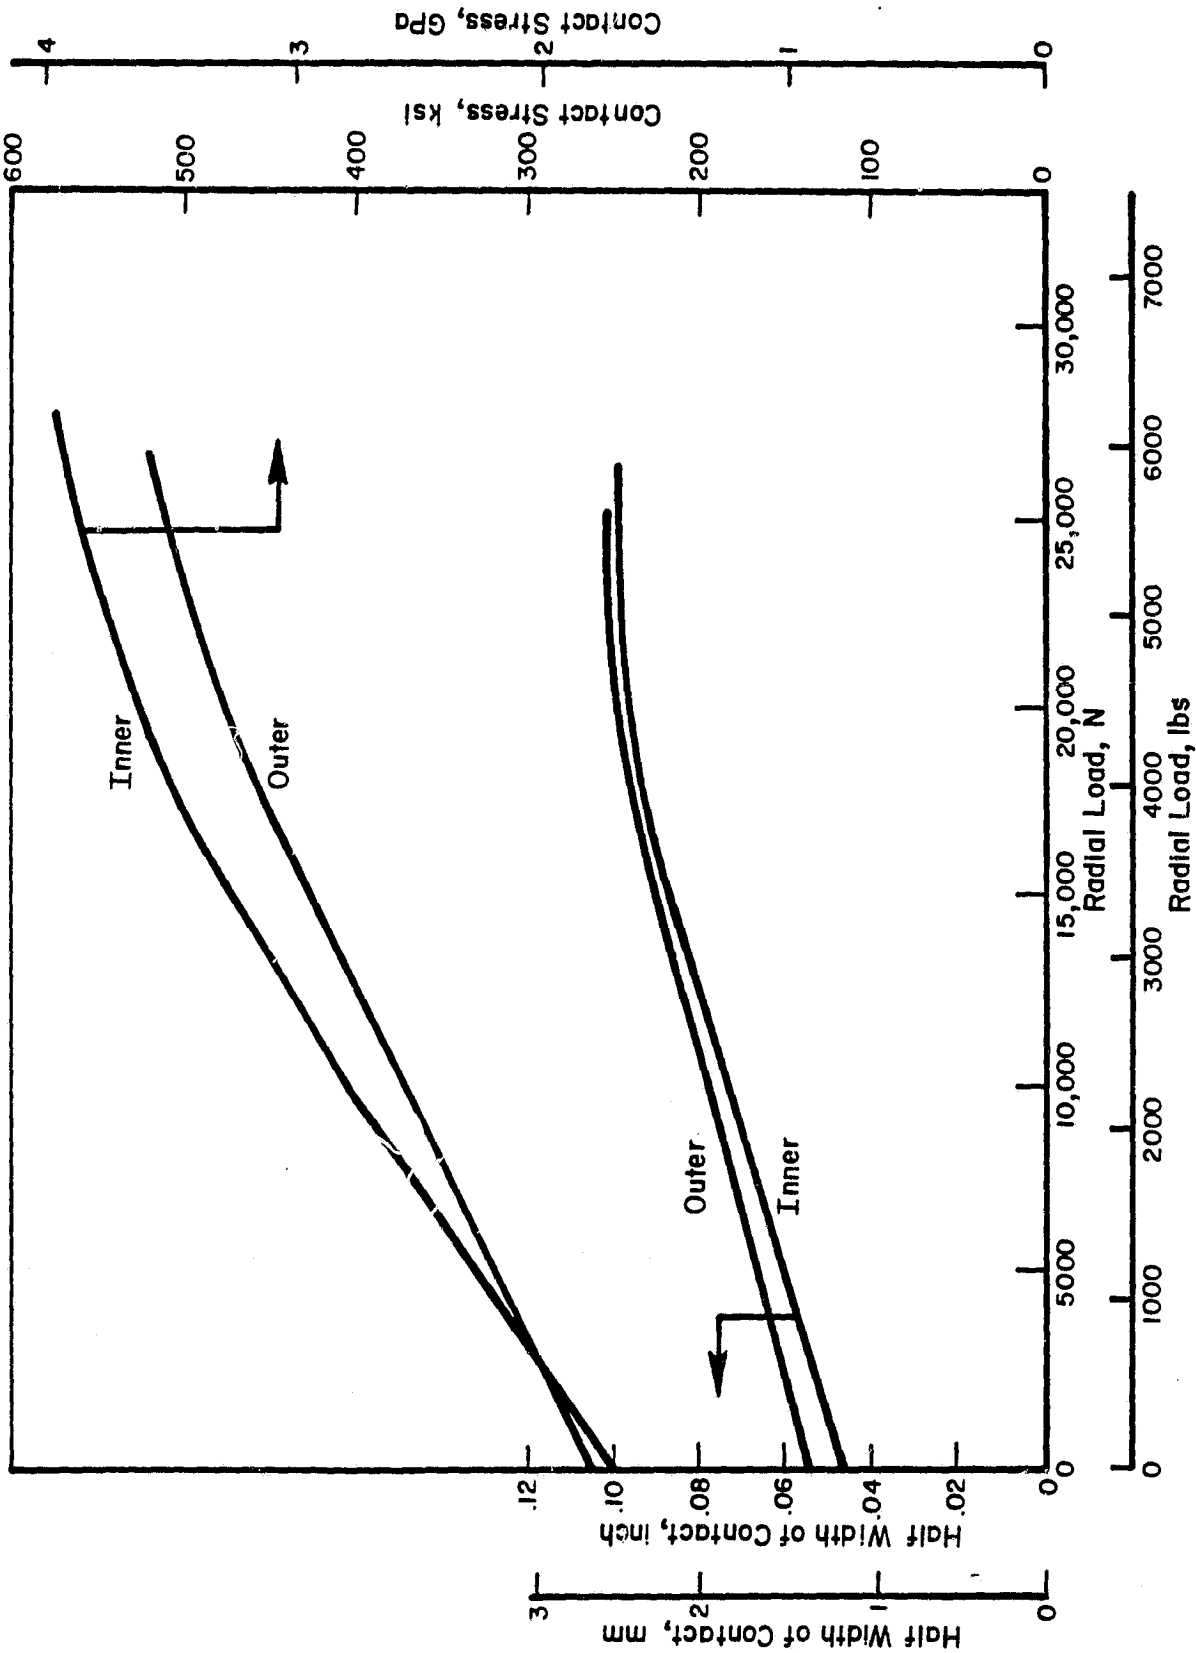
FIGURE 14. CONTACT STRESS AND HALF-WIDTH VARIATION WITH RADIAL LOAD AT MAXIMUM LOAD
POSITION FOR SSME HPOTP TURBOPUMP BEARING (7955) AT 30,000 rpm AND
3780 N (850 lb) AXIAL LOAD

zero even at loads as high as 35,000 N (8,000 lb). The corresponding contact stresses and contact half widths are shown in Figure 14. The contact stresses rise to a very high value as the radial load is increased to 35,000 N (8,000 lb). The calculations also showed that on the outer race at the minimum load position the contact angle tends to zero with radial loads greater than 4,400 N (1,000 lb). This is the result of centrifugal loading of the balls when the combination of axial and radial loads relieve the ball load in the minimum load position. The contact stress due to centrifugal loading is 1.42 GPa (207 ksi) and the half width is 1.1 mm (0.042 inch).

Applying these calculated results of the effect of inner race growth and radial loads on resulting stresses and contact angles to the two HPOTP turbine bearings, the low contact angles and high continuous radial loads are best explained by inner race growth. Since the wear patterns on the inner race were continuous, the loads could not have been synchronous (out of balance) loads. Since the outer race wear paths were also continuous, the radial load could not have been externally applied (there is also no logical source of a continuous radial load exceeding 35,000 N (8,000 lb)). Therefore, a run-away thermal growth of the inner race is the likely source of the very high internal loads experienced. A diametral growth of .025 to 0.3 mm (0.010 to 0.012 inch) would be required to reach the zero contact angle observed on the races. However, such growth causes intolerably high contact stresses exceeding 3.5 GPa (500,000 ksi). Therefore, the bearing races experienced spalling and the balls wore to relieve the internal loads.
