ARC MELTING AND PROPERTIES OF TWO CHROMIUM-BASE ALLOYS

WESTINGHOUSE ASTRONUCLEAR LABORATORY

FINAL REPORT

December 22, 1968

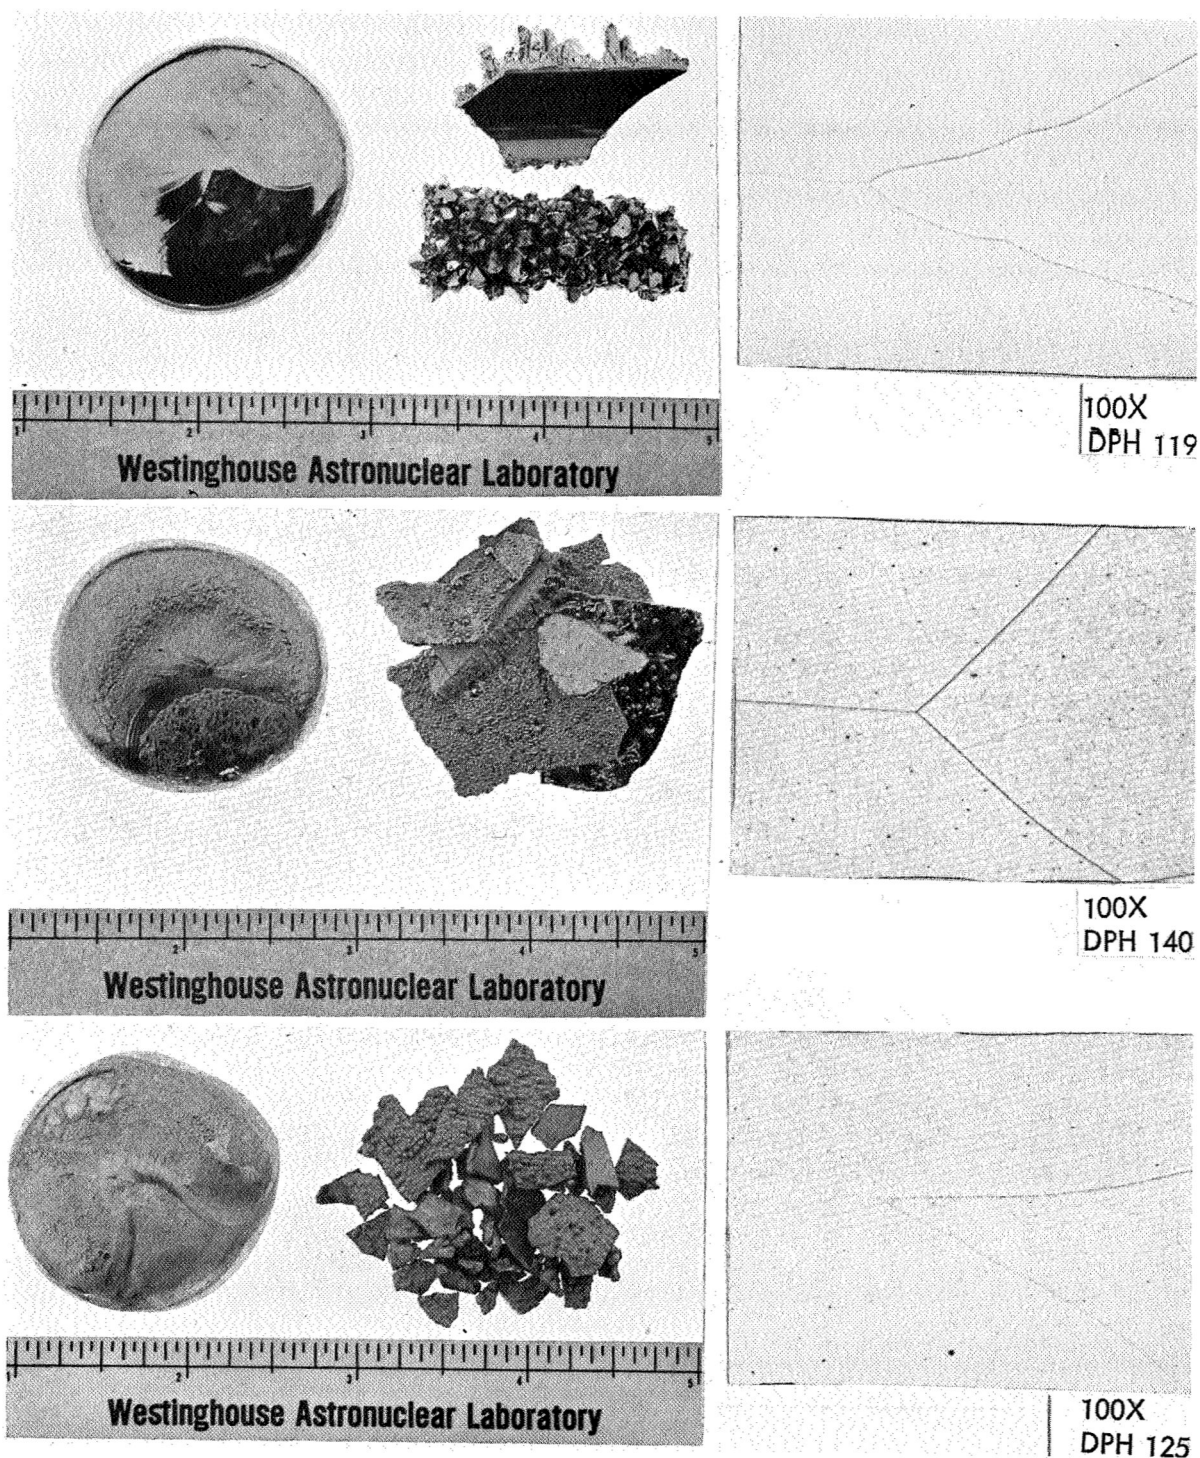
To further characterize these materials, each was consolidated by tungsten-inert-gas arc melting in a water cooled copper mold. Photographs of these buttons are shown in Figure 1 along with the starting materials, and as-cast microstructures and hardness. The surface appearance and microstructure of the iodide material is consistent with its high purity. The appearance of the buttons produced from the electrolytic chromium paralleled that of the starting materials, with the "powdery deposit" Australian chromium yielding a duller as-cast surface. On the other hand, the Australian chromium produced a cleaner microstructure in comparison to the Union Carbide material. Hardness of the as-cast buttons followed microstructural cleanliness.

FIGURE 1 – Non-Consumable Arc Melted Buttons, Starting Materials, and
As-Cast Microstructures of Chromium Sources.
Top: Iodide Chromium from Materials Research Corp.
Middle: Electrolytic Chromium from Union Carbide Corp.
Bottom: Electrolytic Chromium produced in Australia

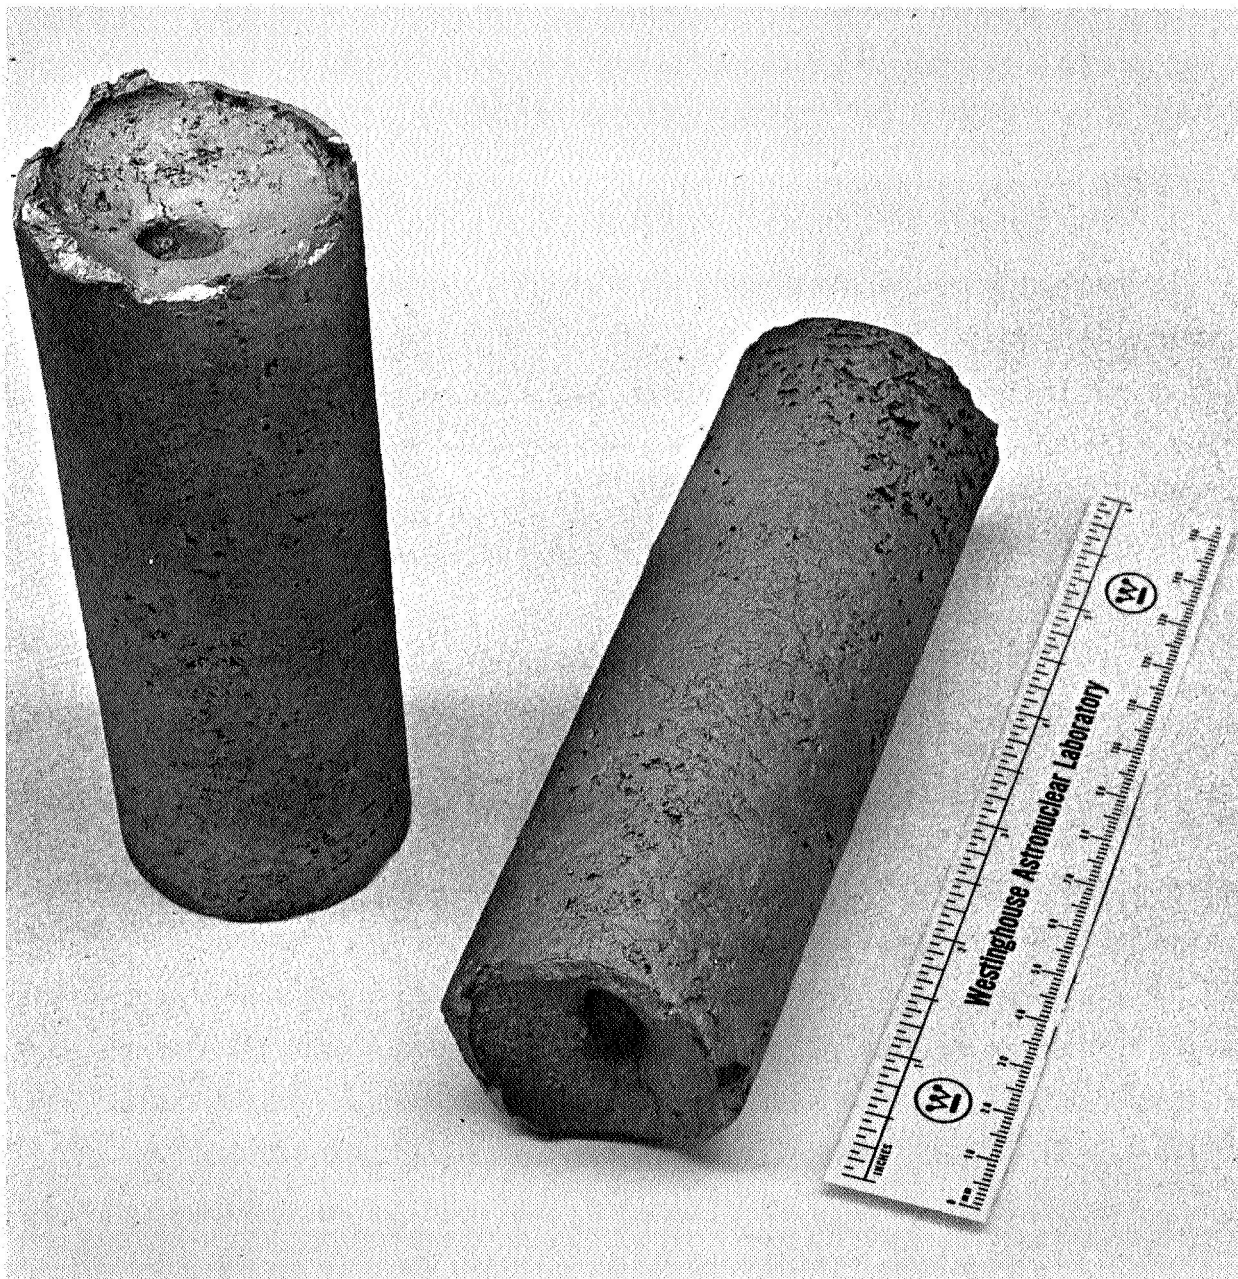
Each electrode was melted to 2 inch diameter ingot using AC current. Typical melting parameters were 18-25 volts, 35-45 KW, and 1.1 pound/minute melt rate. A photograph showing two of these ingots is displayed in Figure 6. Cracking was noted in the vicinity of the shrinkage pipe on each of the five ingots, some of which can be seen on those shown in Figure 6.

FIGURE 6 – Two First Melt Ingots

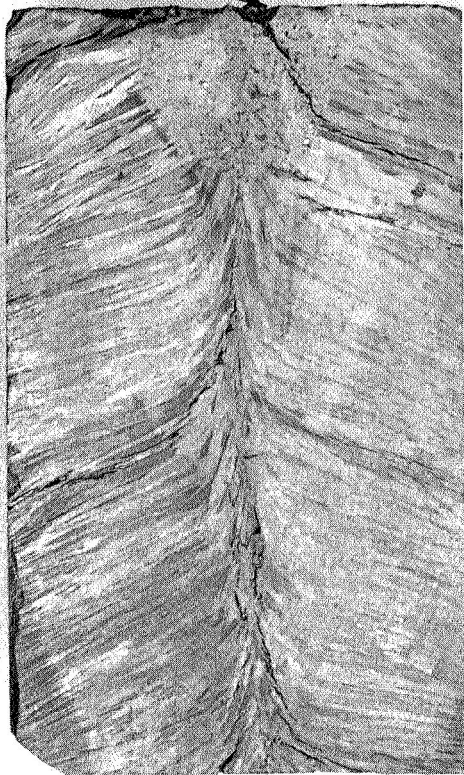
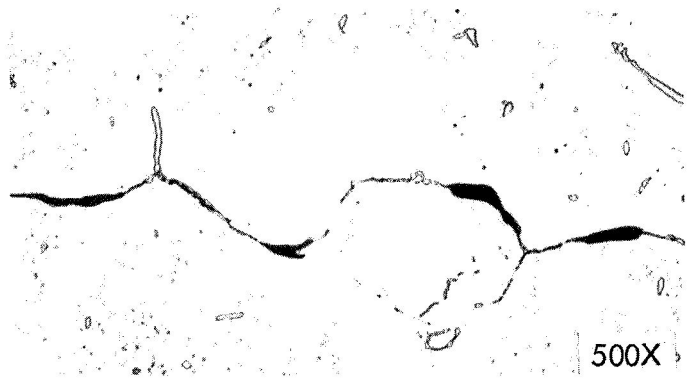
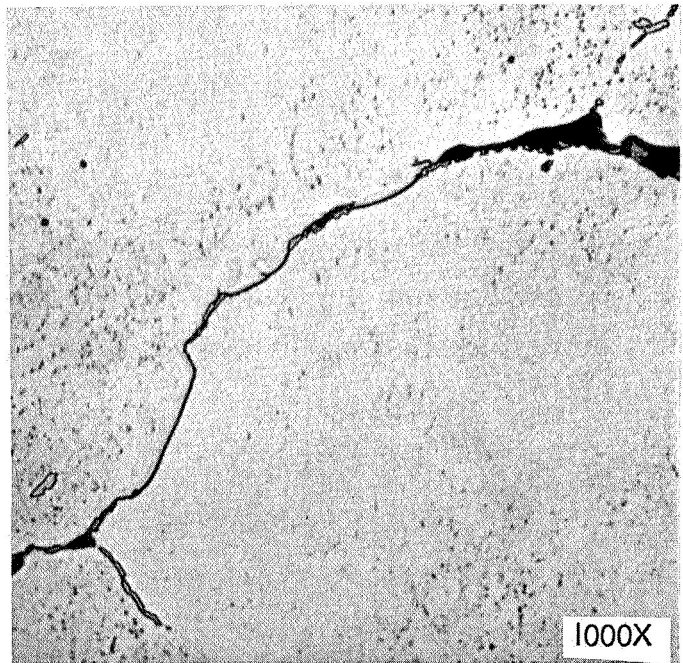
Examination was made of the cracked condition in ingot CAM-297. Photographs of the structure observed are displayed in Figure 7. Cracking was found to be generally associated with grain boundaries, with wide cracks developing along the radial columnar grain boundaries, and the centerline casting defect formed by impingement of these grains. Some crack branches observed in the macroetched axial ingot section shown in Figure 7 extend through to the ingot side, as well as its top and bottom. Actually, cracking was not obvious on the as-cast surface of either ingots CAM-297 or CAM-298. Ingot CAM-297 had been machined on the diameter about 1/4 inch below the as-cast size exposing these cracks, prior to sectioning axially.

FIGURE 7 - Cracked Condition of Ingot CAM-297

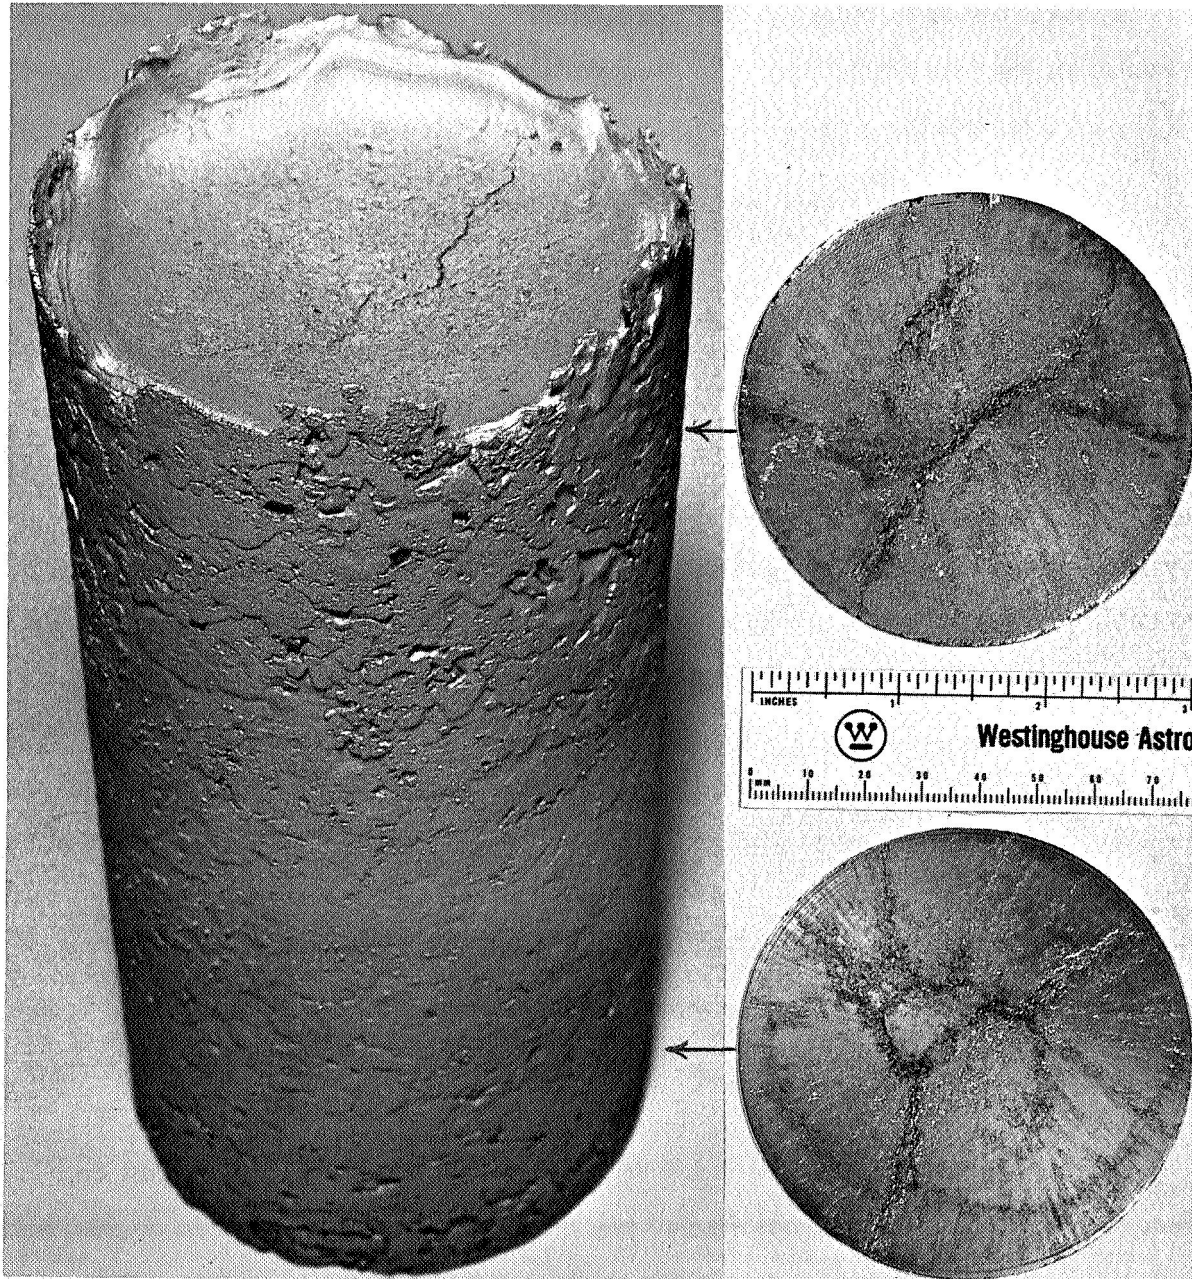
The 3 inch diameter castings of both program compositions (CAM-425 and CAM-426) cracked badly, in spite of the introduction of the melting procedures outlined above. Of the two compositions, ingot cracking appeared most pronounced in the Cr-7Mo-1.75Ta-0.095C-0.085Y alloy (CAM-426). A photograph showing this ingot, and the cracked condition observed at top and bottom positions, is given in Figure 8. One observation made during this melt, which proved important in latter analysis of the cracking problem, was that the crack at the ingot top formed shortly after termination of melting, before the ingot had cooled below "red heat".

FIGURE 8 – Condition at Top and Bottom of CAM–426

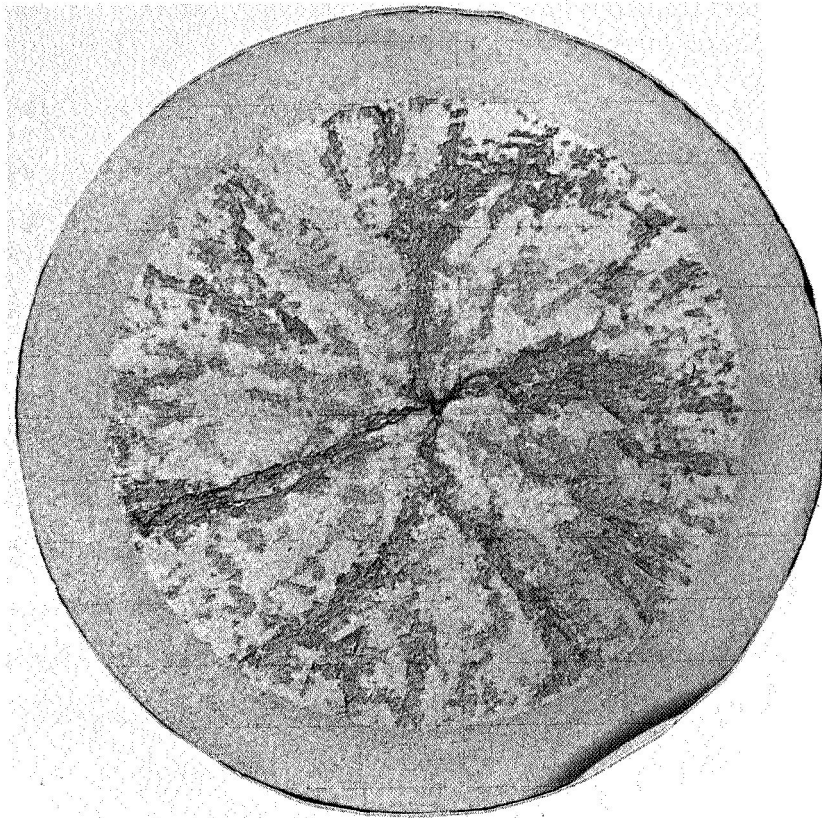
Casting of this ingot, CAM-452, was smoothly accomplished into the molybdenum heat sink, and for at least a minute after its completion, molten liquid was noted to be shimmering in the crucible. By comparison, total solidification is observed immediately at the end of a melt of this size when arc cast into a conventional water cooled copper mold. The ability of the molybdenum crucible to slow the cooling rate was further noted by the time during which the ingot remained above "black heat", ten minutes, compared to about two minutes for similar size chromium heats cold mold consumable arc cast. In spite of this, gross cracking occurred in this casting, as can be seen in Figure 9, where the condition at the ingot top just below the solidification pipe is displayed.

Hardness of this ingot was noted to be higher than that observed on the similar composition heat CAM-425, and compared closer to CAM-426, the Cr-7Mo-1.75Ta-0.095C-0.085Y alloy. It follows, therefore, that some molybdenum pick-up occurred from the crucible. As previously noted in discussion of CAM-425 and CAM-426, ingot cracking is most pronounced in the alloy containing 7% molybdenum, thus, contamination from the heat sink may have contributed to cracking of CAM-452.

FIGURE 9 – Condition at the Top of CAM–452

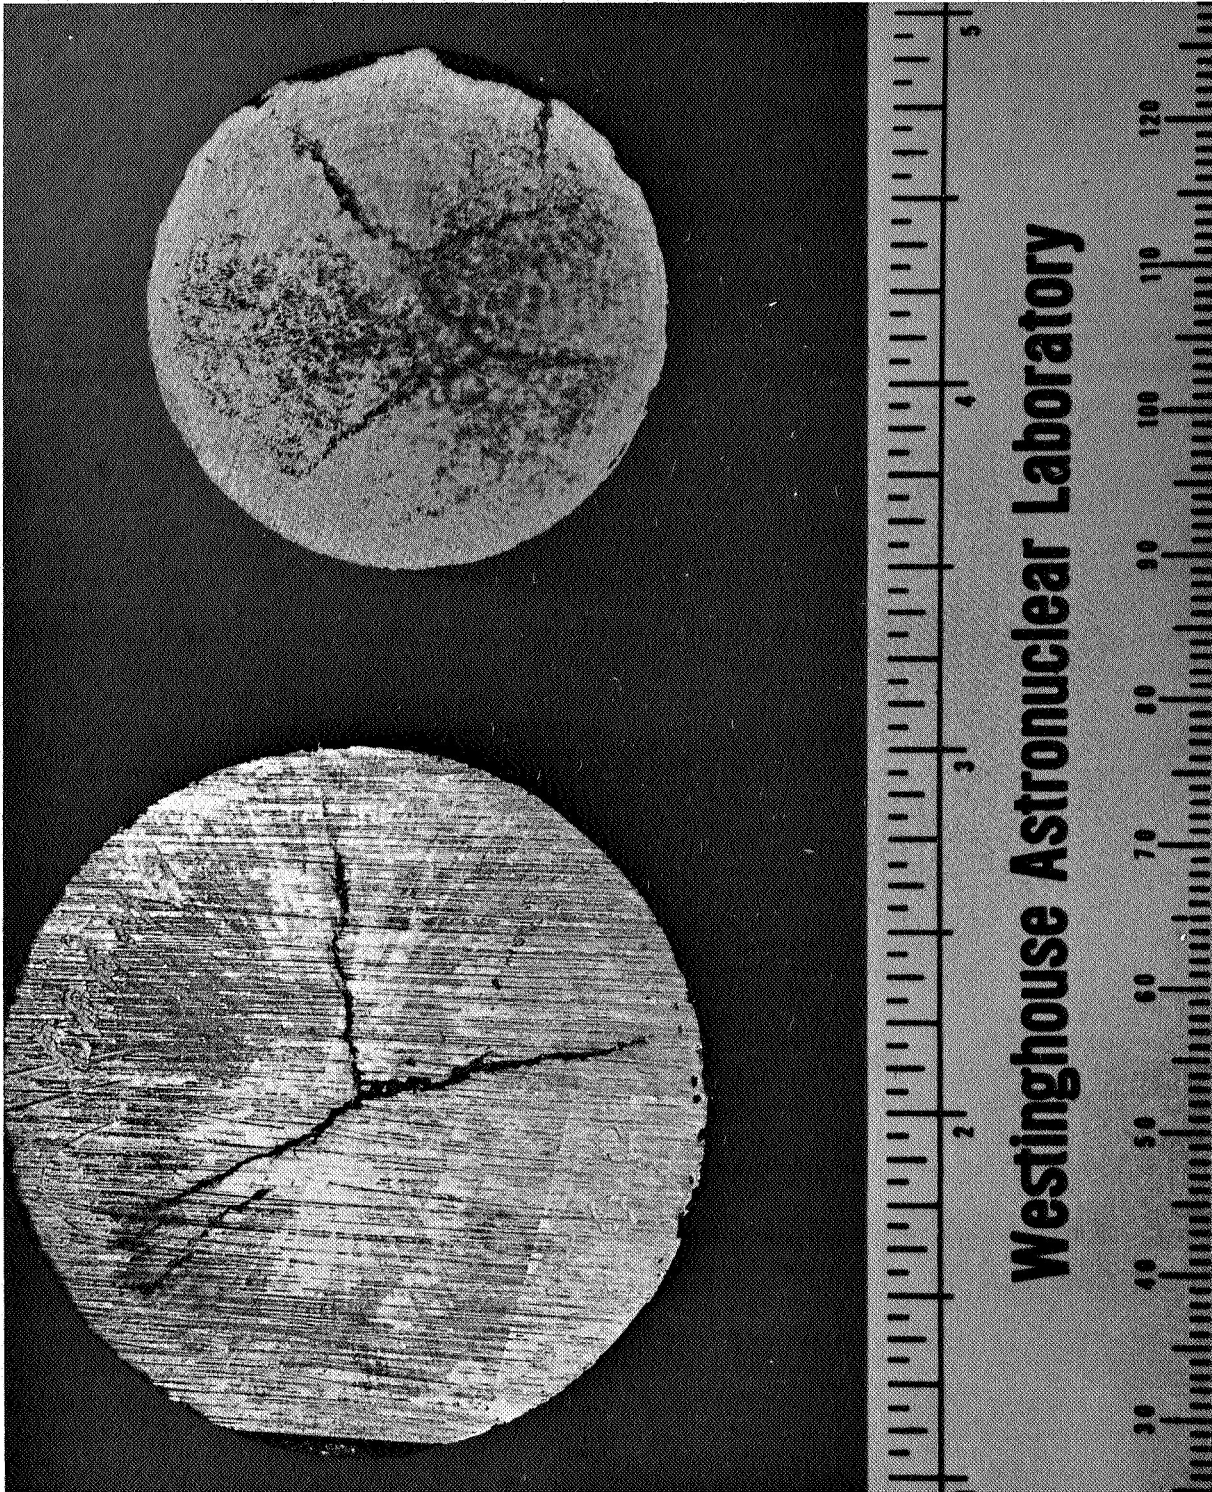
Each of these ingots (CAM-447, 448, 449, and 451) cracked severely, and no relationship between the degree of cracking and ingot size was observed. The cracked condition typically observed at the ends of ingots of each of these sizes, is shown in Figure 10.

FIGURE 10 – Condition at the Ends of 1.4" and 2" Diameter Ingots

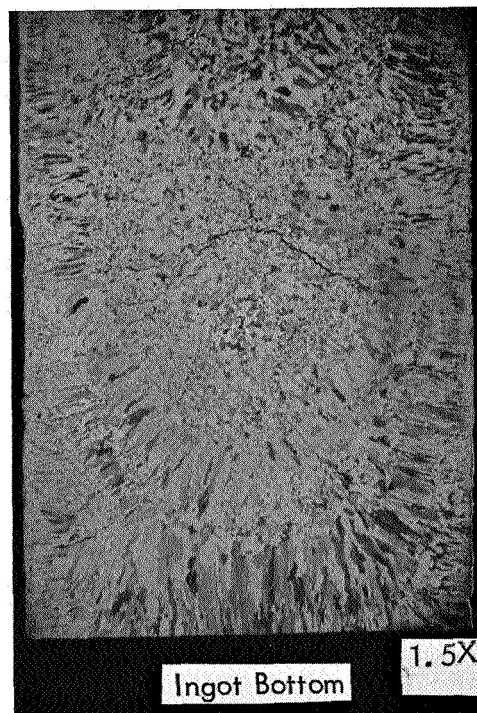
The ingot cast under these conditions, CAM-459, was sectioned on an axial plane, and prepared metallographically for macro-examination. A photograph showing the structure of this section is given in Figure 11. Grain refinement was certainly induced at the core of the casting, eliminating the centerline defect and associated cracking. Grain boundary cracking did occur, however, both in the fine central structure and the columnar grain case, as can be seen in Figure 11.

FIGURE 11 – Macroetched Structure of Axial Plane on CAM-459

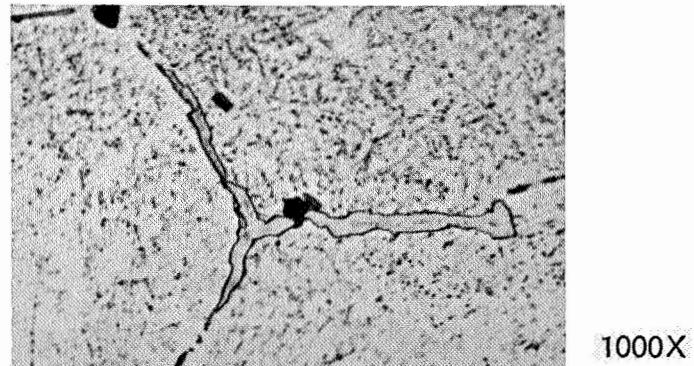
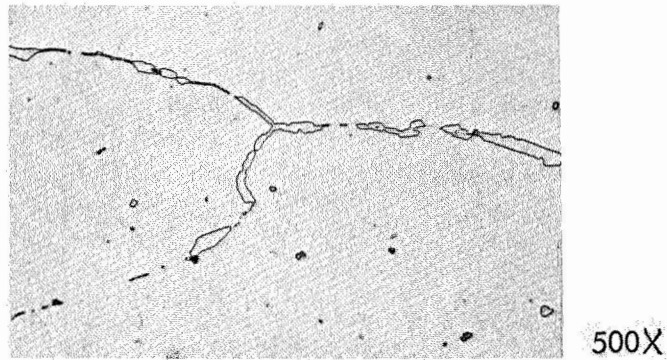
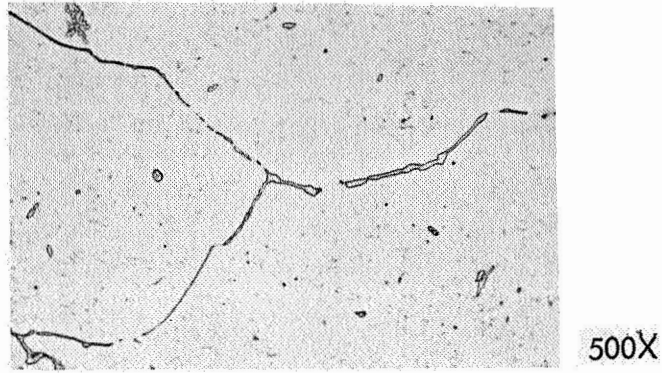
Metallographic examination made on both program alloys revealed a large amount of semi-continuous grain boundary phase, and finer matrix precipitate, in the as-cast structure. Photomicrographs of typical as-cast structures are displayed in Figure 12.

FIGURE 12 - Typical As-Cast Microstructure of the Program Alloys
Top: CAM-425
Middle & Bottom: CAM-426

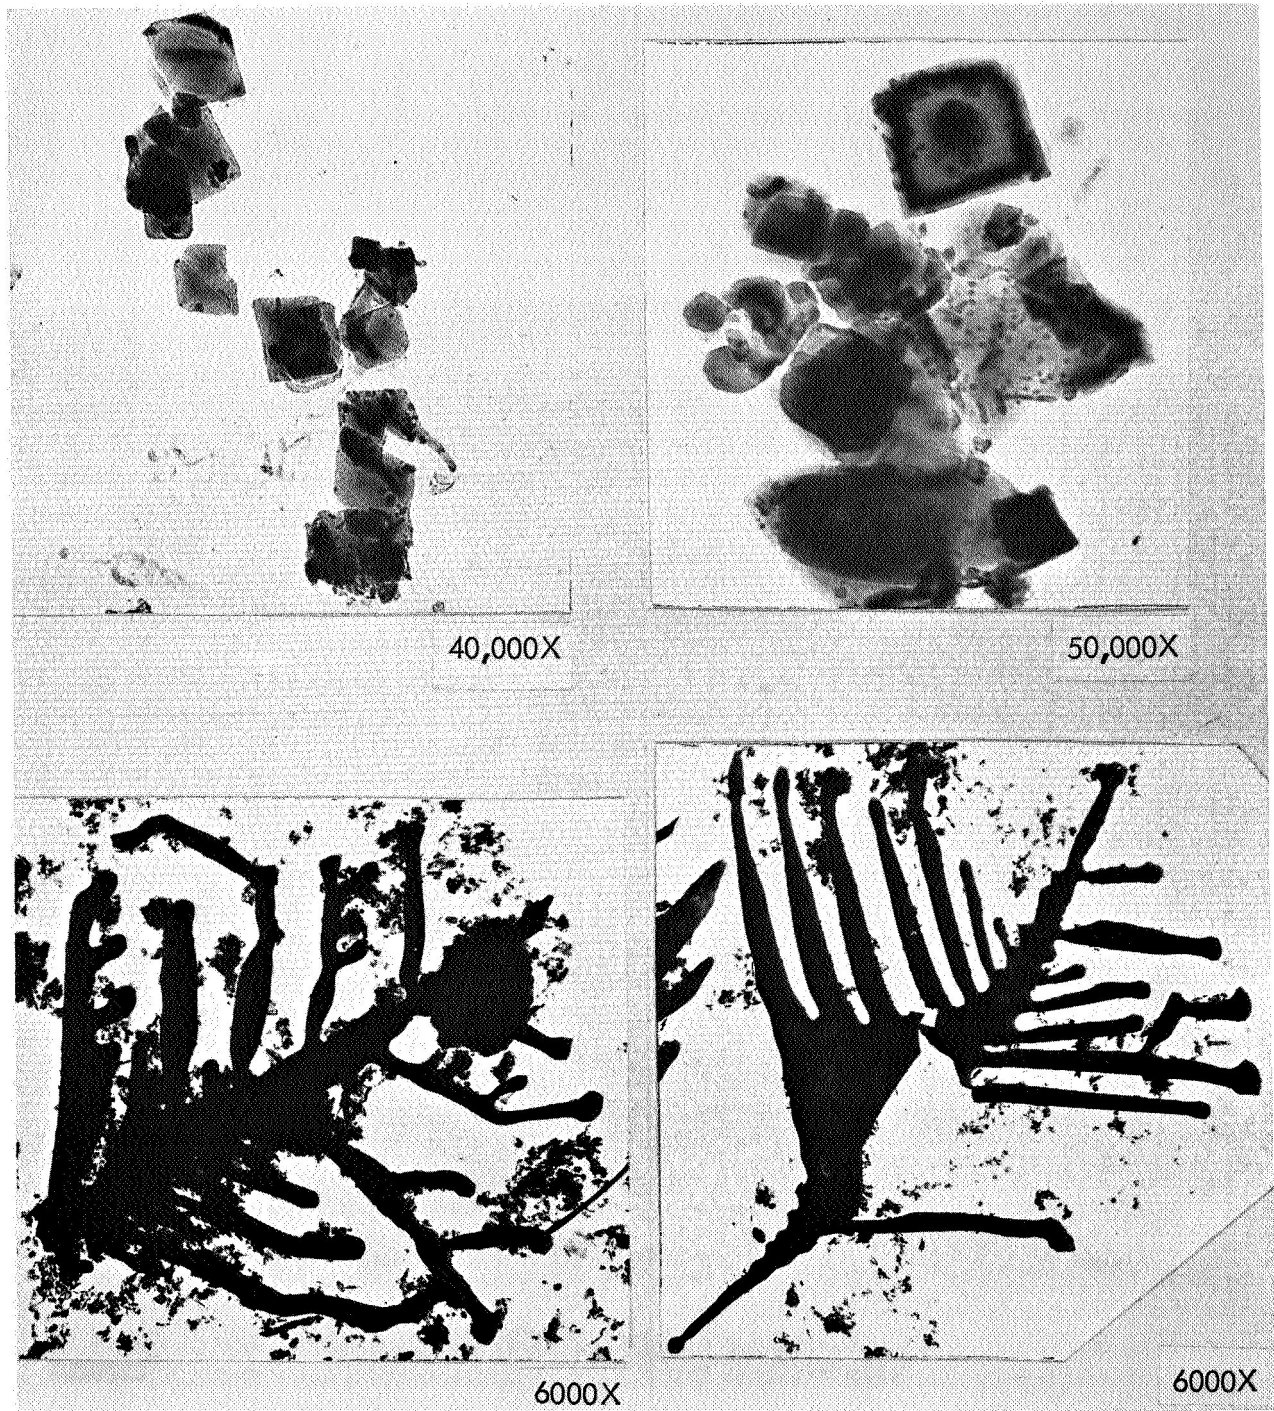
Electron diffraction patterns could not be obtained from any of the large precipitate particles since none displayed areas thin enough for penetration by the beam. A diffraction pattern was obtained, however, from a cluster of the thin platelet particles, the results of which compared well to the ASTM standard for the monocarbide of tantalum. This data is summarized in Table 6. Photographs of the two precipitate phases are displayed in Figure 13. It is deduced from identification of the platelet phase as TaC that the large irregular particles are the $Cr_{23}C_6$ phase. The appearance of each phase suggests that the TaC particles were formed by solid state reaction, and the $Cr_{23}C_6$ particles directly from the melt.

FIGURE 13 – Morphology Typical of Precipitate Phases in As-Cast
Alloys. Top: TaC. Bottom: $Cr_{23}C_6$

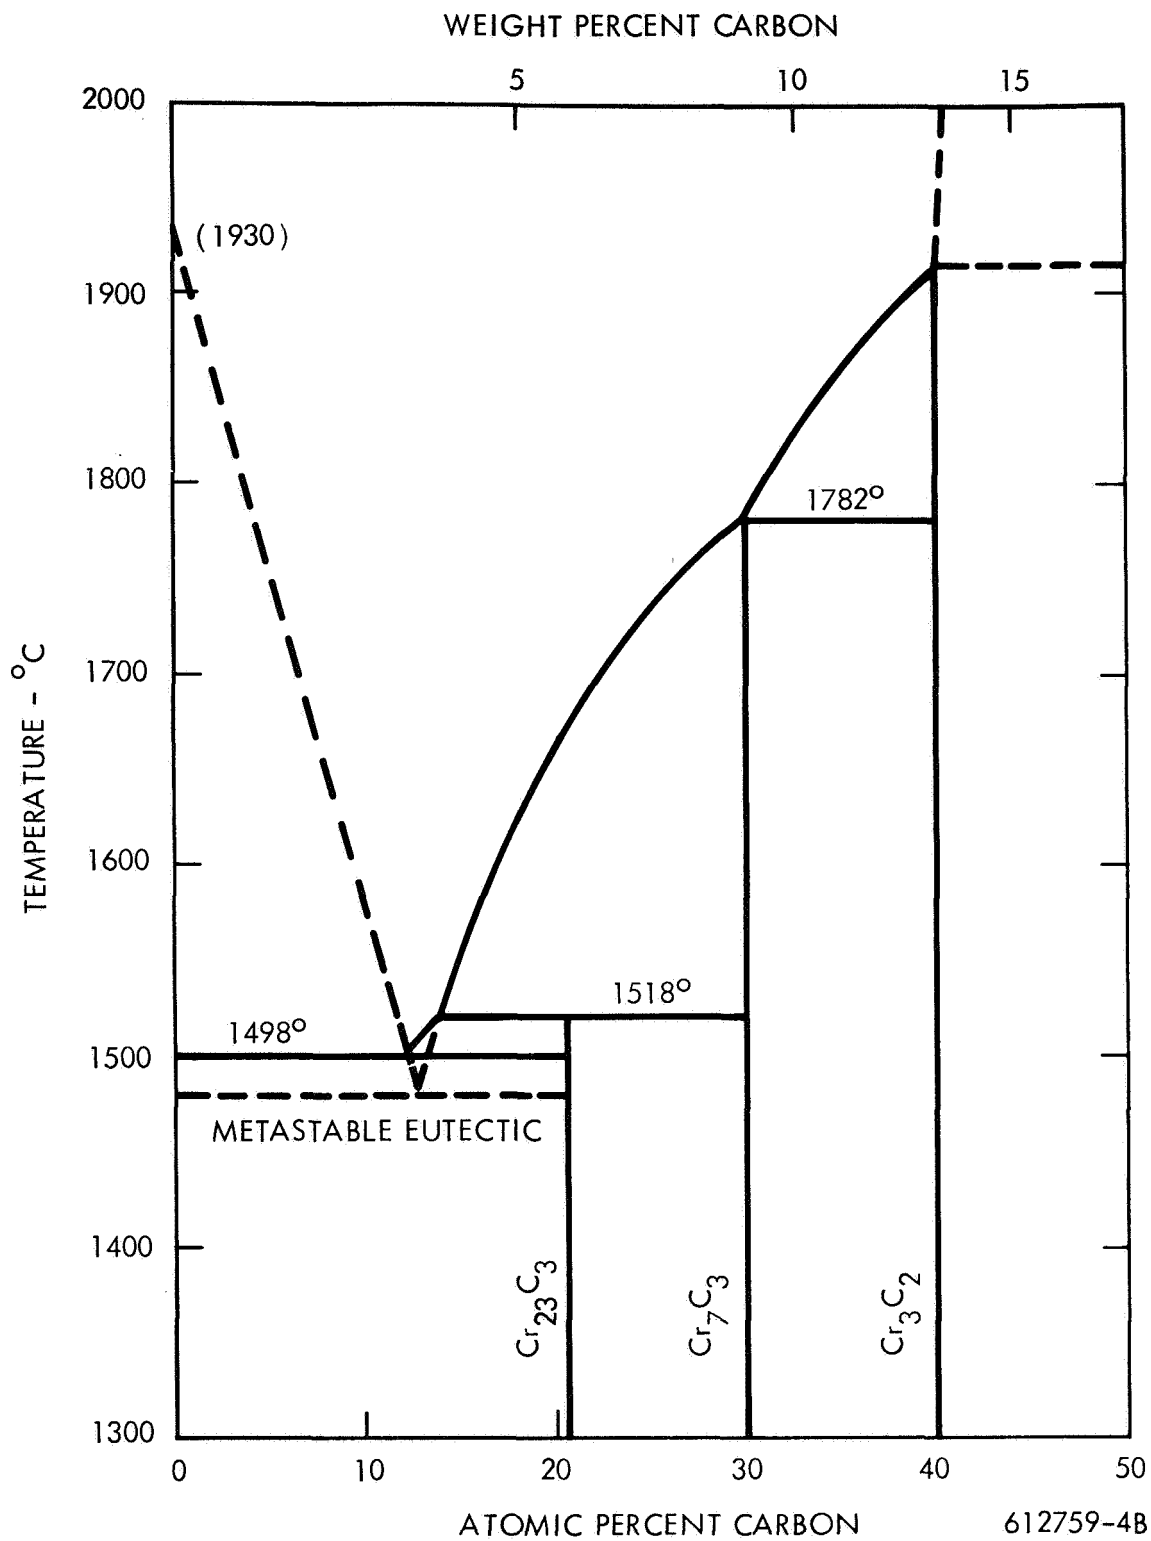
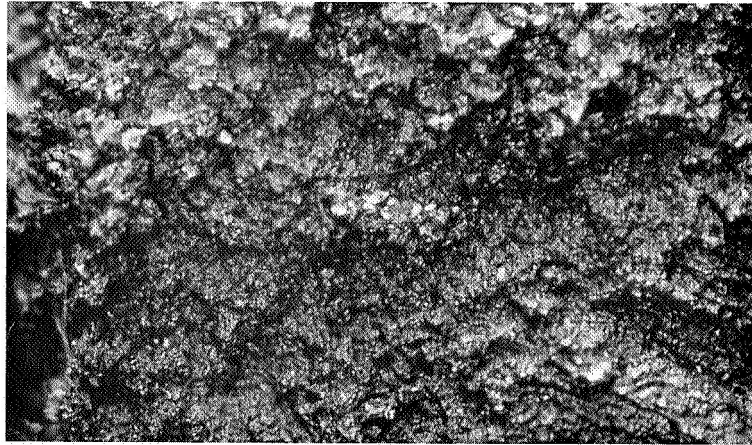
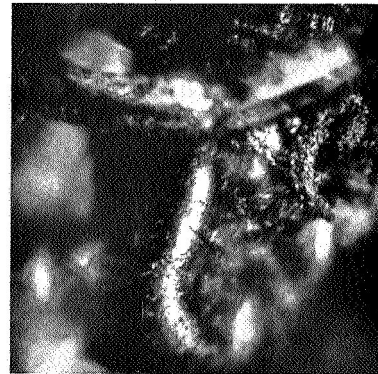
Carbon enrichment of interdendritic liquid would cause a wide separation of liquidus
and solidus temperatures, and is considered a major factor contributing to the formation of inter-
granular casting cracks in the consumable electrode melted ingots. An approximate idea of
the solidification range which would result, can be obtained by reference to the Cr-C binary
system, reproduced in Figure 14[18]. Freezing over a range of about 700°F is characteristic
of a composition containing carbon at the 0.1 w/o level. It is felt that this wide solidification
temperature range favors development of a "hot tearing" condition in the study alloys, in
which ingot stress resulting from thermal gradients and shrinkage, is relieved by separation at
a few remaining liquid grain boundaries.

The observation of cracking at the top of ingot CAM-426 prior to its cooling below
"red heat", lends support to hot tearing as the failure mechanism. Furthermore, microscopic
inspection of the surface of cracks formed in the ingots, revealed a contour suggestive of
interdendritic separation. Photographs showing ingot crack surface features are displayed in
Figure 15. The low magnification photograph, 20X, shown in the figure is typical of the
macroscopic fracture appearance, and reveals the absence of signs of cleavage, or plastic
deformation. At higher magnification the fracture detail observed reveals a surface con-
taining closely spaced smooth rounded features. The rounded surface features are believed
to be dendrite branches, their smooth appearance suggesting failure by separation through

interdendritic liquid.

FIGURE 15 - Ingot Crack Surface Fractography. Top: Macroscopic
Fracture Appearance. Left: Typical Fracture Surface
Detail. Right: Individual Smooth Fracture Surface Features.

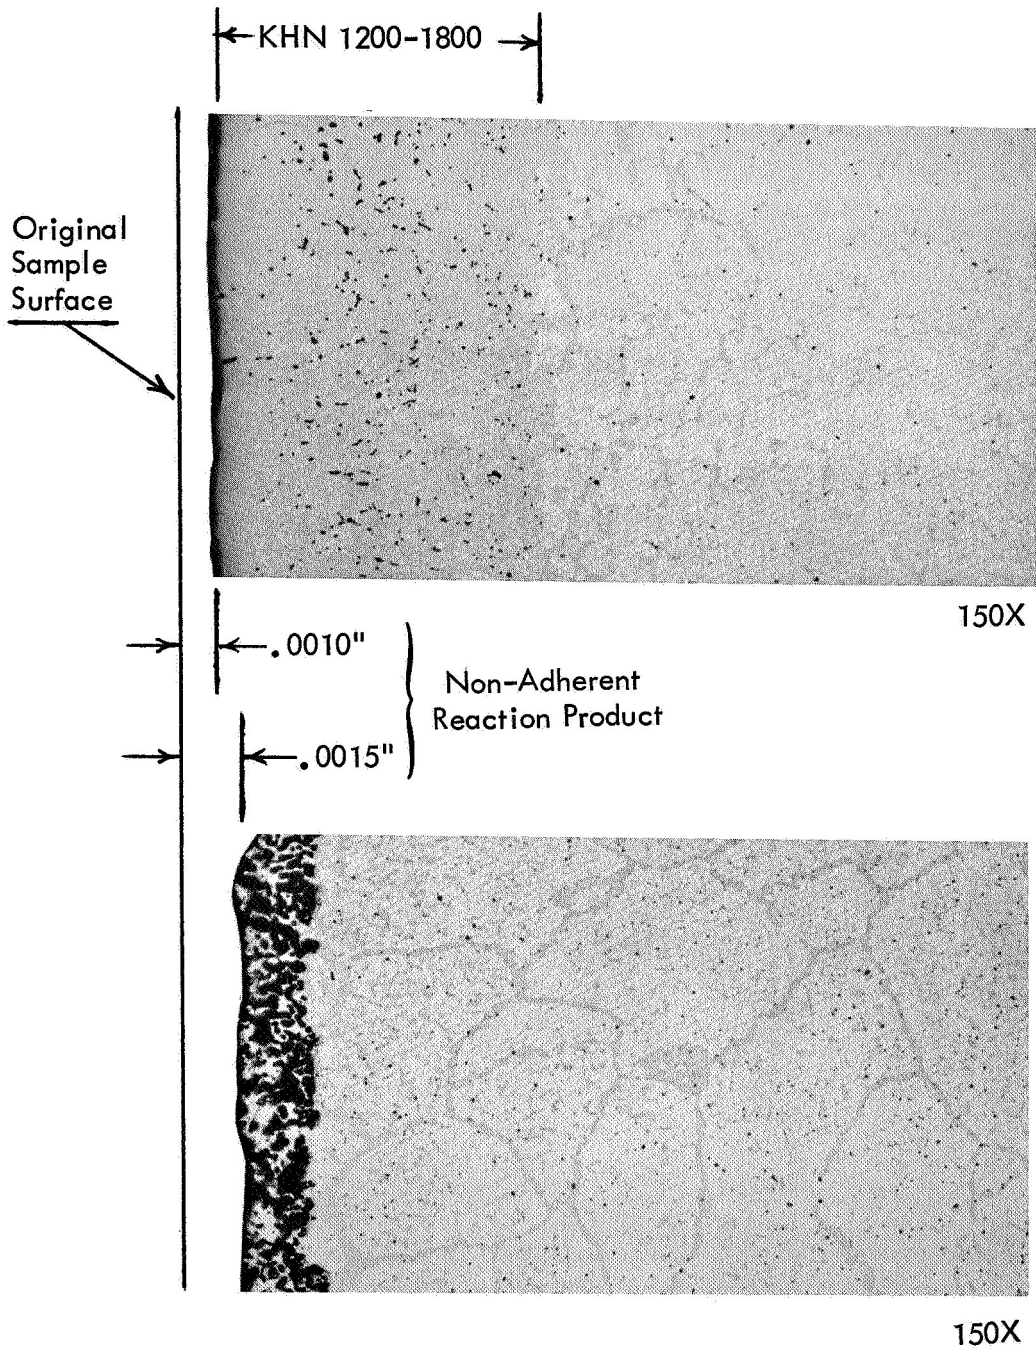
Surface recession and weight gain appeared similar for both alloys exposed in air at 2400°F for 24 hours with a weight increase of 20-25 mg/cm^2, and a surface recession of 0.001 inch to 0.0015 inch, being typical. The Cr-2Ta-0.1C-0.05Zr composition exhibited a 1900°F yield strength of 37 ksi*, and a 3-4 hour rupture life at 2100°F and 15 ksi. The Cr-7Mo-1.75Ta-0.095C-0.085Y alloy had a 60 ksi yield strength and a 10-25 hour rupture life under equivalent conditions. An impact DBTT of about 600°F and tensile DBTT of room temperature were observed for the Cr-2Ta-0.1C-0.05Zr alloy in the wrought plus stress relieved condition.

Non-Adherent

Reaction Product

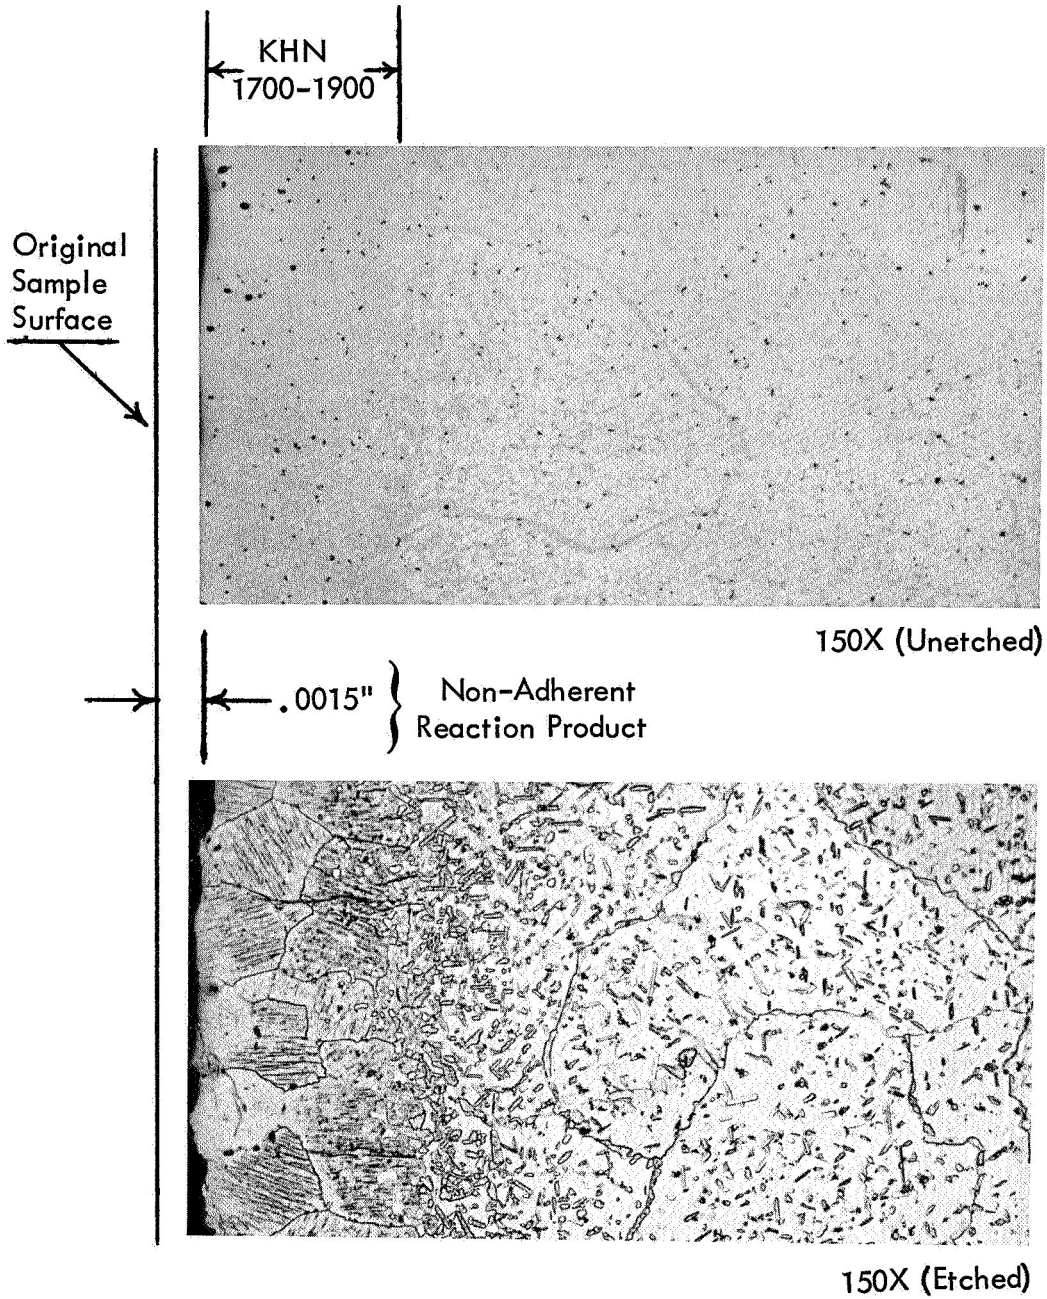
Surface recession of 0.0015 inch was measured on this sample by removing the soft non-adherent surface reaction product. Microstructural examination revealed that a hard adherent layer, 6 to 7 mils in thickness, had formed beneath the soft surface product. Some penetration of the hard reaction product along grain boundary paths, was also noted. Photomicrographs are given in Figure A-4.

KHN
1700–1900
