University of Southern Queensland

**The Effect of Vandalism on Fibre Composite
Structures**

Bachelor of Engineering (Civil)

Submitted: October, 2009

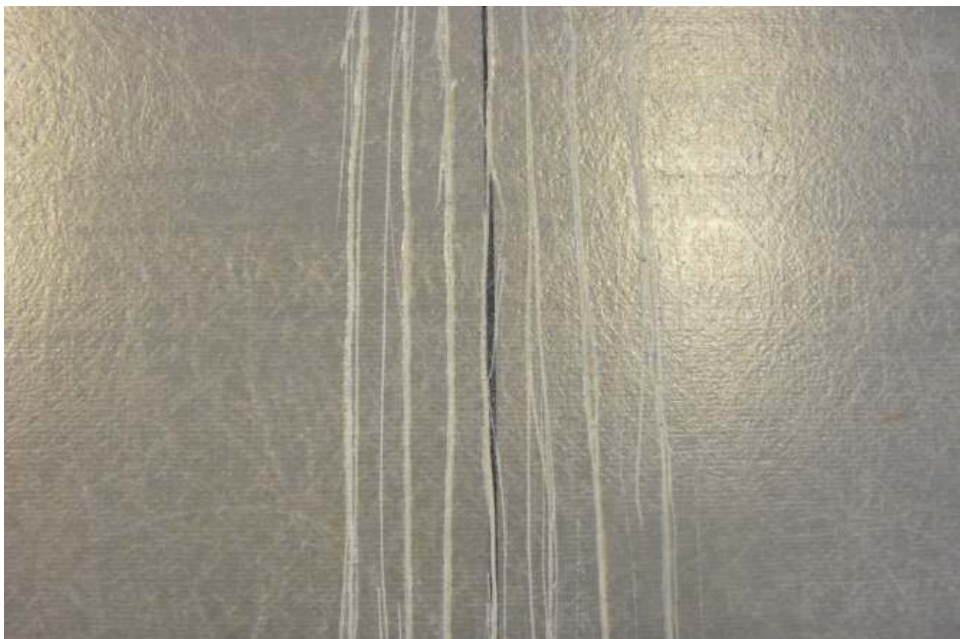
Figure 6.6 Cut Damage to Exel Composite

The cut damage was also done using a Stanley knife. The cut was three 1-2mm cuts along and beside the centre line for the 50x50mm section. The wall panel was cut the same but only to a depth of 1mm, it was also cut 7 times around the centre line, this can be seen in figure 6.6. The cut damage was very easy to achieve using the Stanley knife, especially when the outer skin of the pultrusion has been cut away in inner white material is easy to get through.

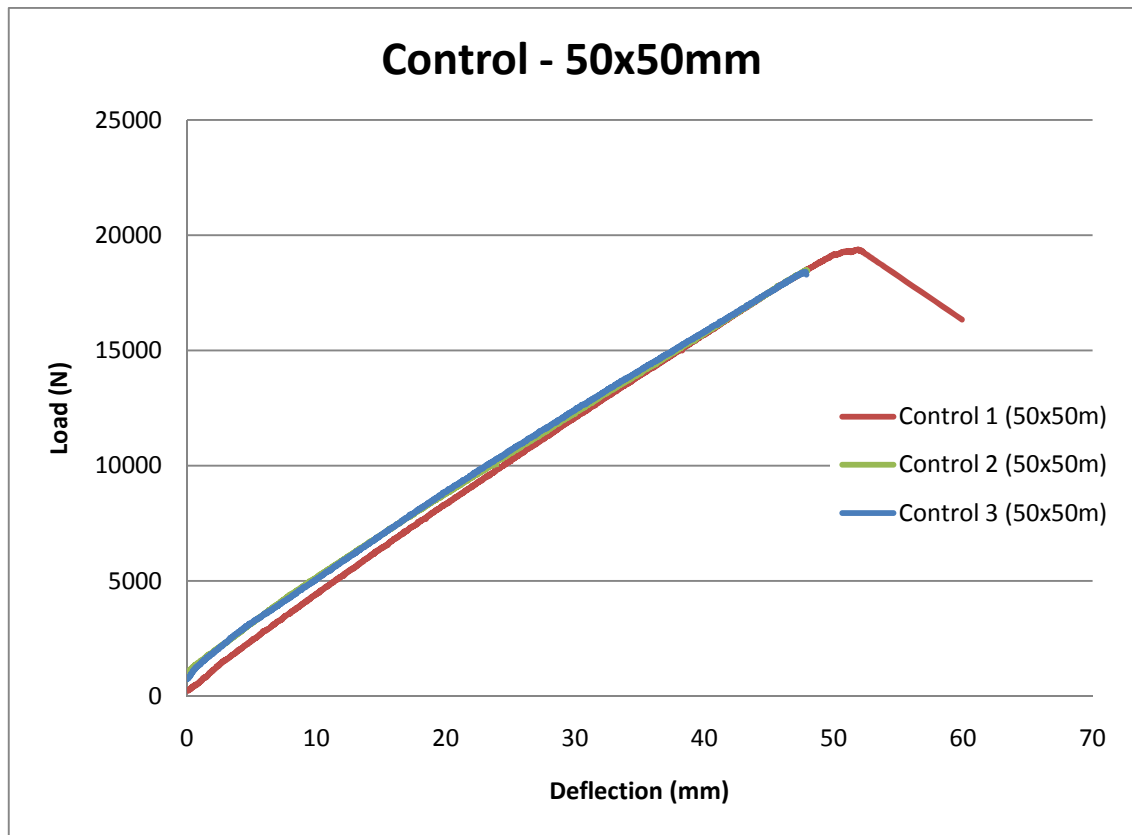
Figure 6.8 Control Results of 50x50mm Samples

The 50x50mm section failed due to a tear in the tension side followed by shear cracks or tears up the side walls of the section. Complete failure when the side tears reached the top compression section which had a crushing type failure.

The 50x50mm sections had an ultimate load of 18 758N and a flexural stiffness an indicator of the flexural modulus of 432N/mm. The control samples also had a flexural modulus of 19 731.07MPa. The failure of the sample was very sudden as can be seen in figure 6.8 by the very sudden decrease in load capacity. There were no signs of failure before ultimate failure for the control samples.

For the 50x50mm section three samples were tested and two wall panels were tested without damage to provide the standard. Both the 50x50mm section and the wall panel had a very sudden failure as can be seen from figure 6.8 and figure 6.9 with the sudden drop in load capacity.

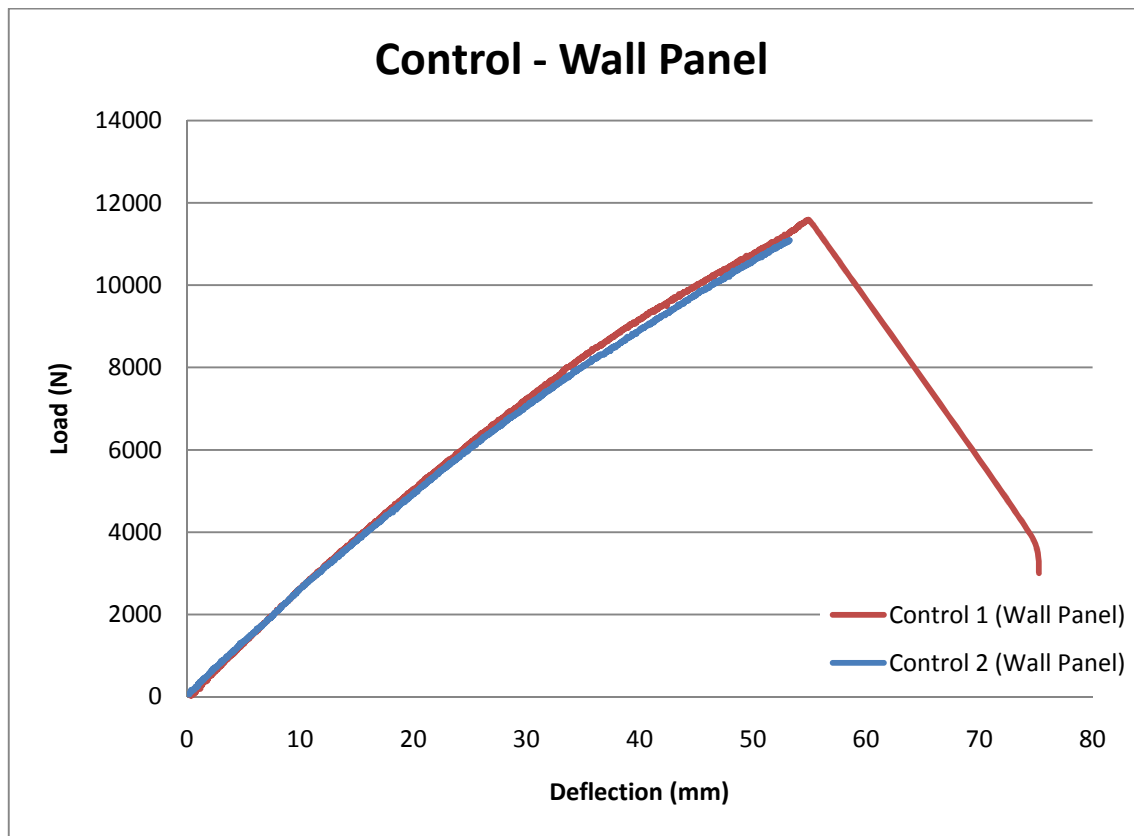
Figure 6.9 Control Results of Wall Panels

The wall panels had an ultimate load of 11 532N, with a flexural stiffness an indicator of the flexural modulus of 255N/mm. The control wall panels had a flexural modulus of 5706.9MPa. The failure was a sudden failure much like that of the 50x50mm sections. There is a change in flexural stiffness and this is when the stiffening sections begin showing tears and cracks forming.

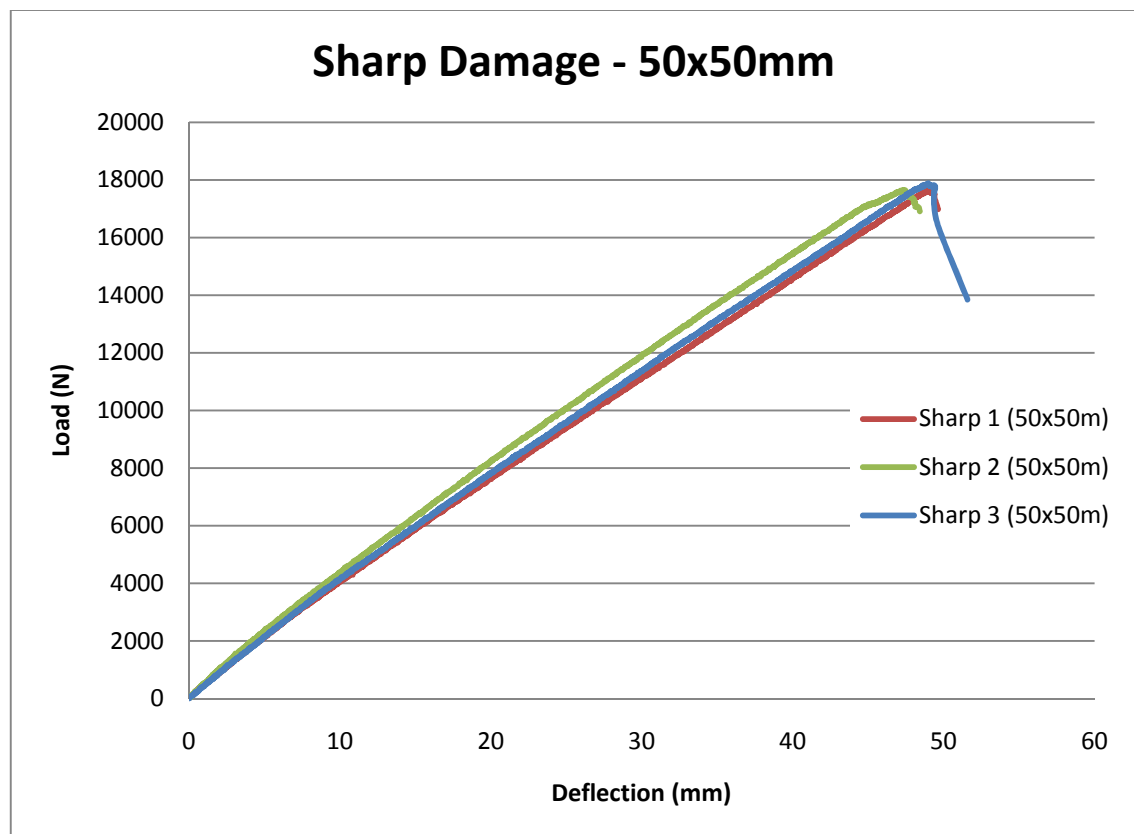
Figure 6.13 Sharp Impact Results of 50x50mm Samples

The 50x50mm sections had an ultimate load of 17 723N, a 5.5% decrease from the undamaged control samples. The section also had a flexural stiffness an indicator of the flexural modulus of 434N/mm, which is not decreased. The 50x50mm section had a flexural modulus of 20 442.27MPa, which is not decreased from the control samples.

Therefore the 50x50mm section had a 5.5% reduction in ultimate load but the initial stiffness of the material and flexural modulus is not affected by the sharp damage. The failure can be seen in figure 6.13.

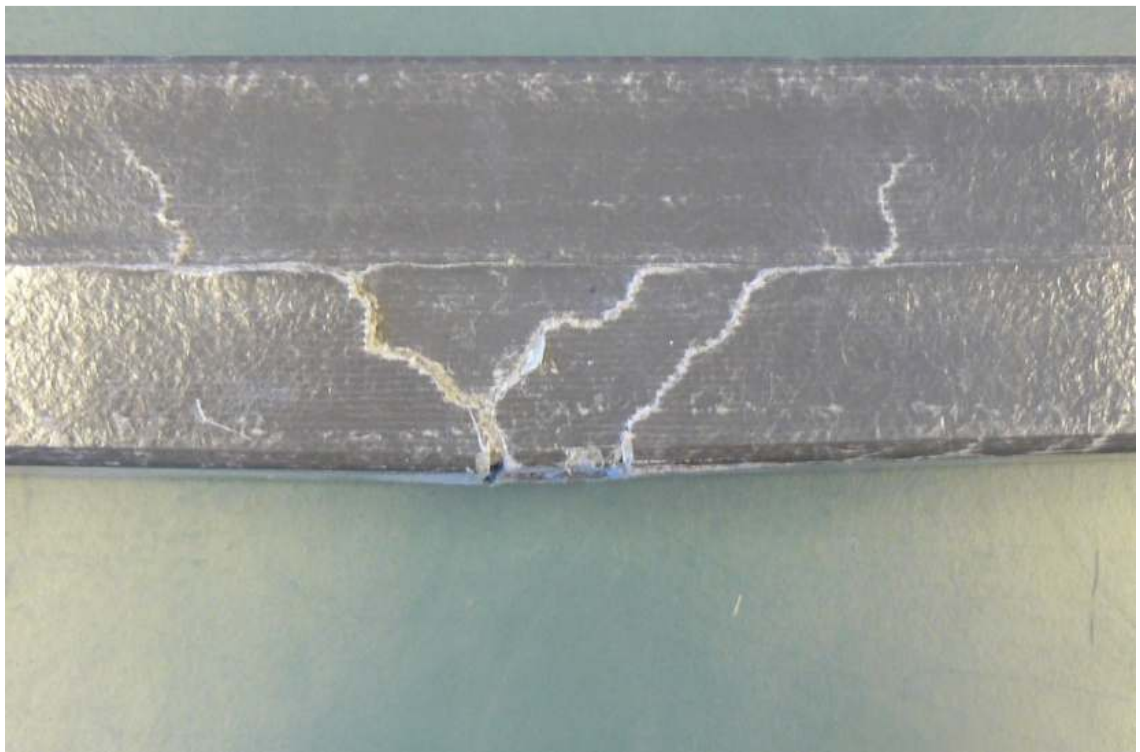
Figure 6.16 Cut Failure in 50x50mm section

For the 50x50mm section the failure originated at the tension side and the tear would be a continuation of one of the damage cuts, this would then shear up the side wall of the section in multiple directions. This can be seen in figure 6.12.

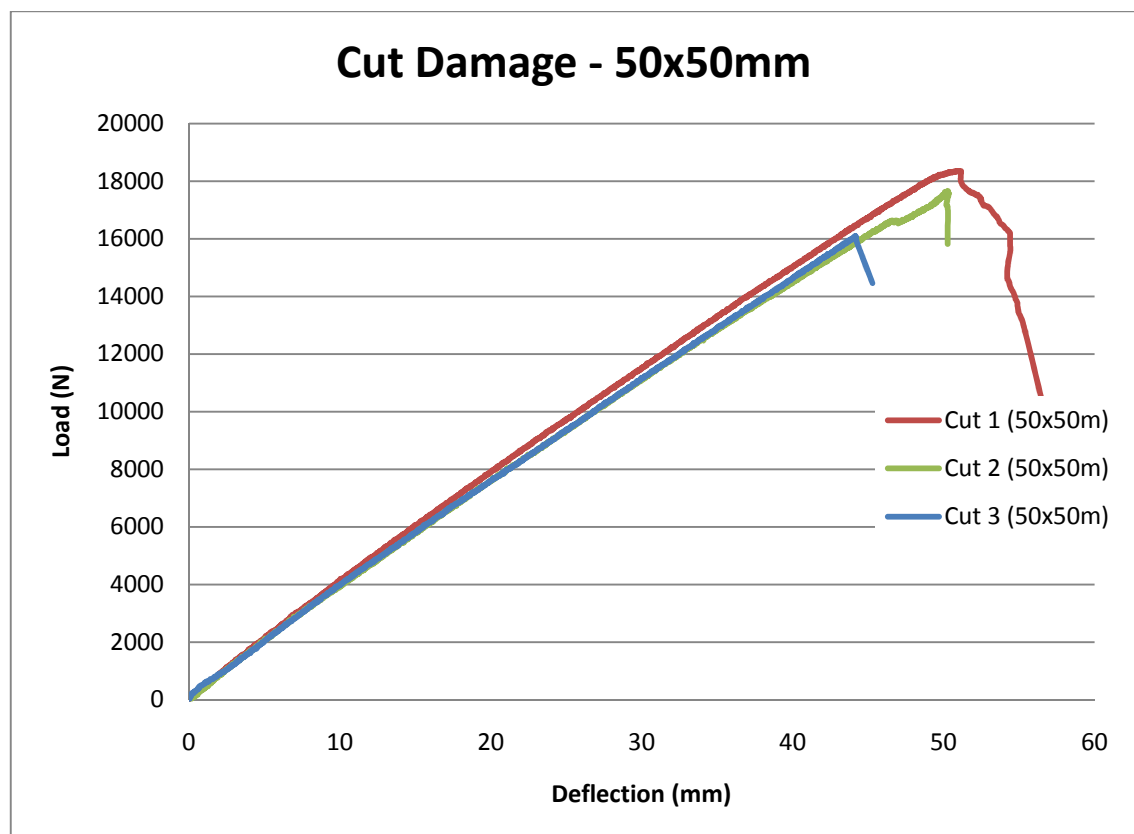
Figure 6.17 Cut Damage Results of 50x50mm Samples

The 50x50mm section had an ultimate load of 17 366N, a 7.4% reduction in average ultimate load. The section also had a flexural stiffness of 419N/mm, a reduction of 2.8% which is an indicator of the flexural modulus. The wall panel also had a flexural modulus of 19 044.44MPa, a reduction of 3.5 %. The cut damage has had the largest effect to both ultimate load, flexural stiffness and the flexural modulus of the material.

As the cut has penetrated the outer coating or layer of the sample the inner material begins to fail earlier in comparison to damage to the inner section like the blunt impact where the inner material has been damaged but the outer layer still holds the tension forces. The cut removes this ability with the cuts opening up and causing multiple shear tears in side walls in comparison to the other types of damage which a single shear tear is present, this is the cause of the reduction in stiffness and flexural modulus.
