# Crack detection in “as-cast” steel using laser triangulation and machine learning

**Abstract**—We describe a high-accuracy inspection system designed to automatically detect cracks in “as-cast” steel slabs. Real-time slab inspection requires instrumentation capable of withstanding high temperatures above the steel surface as well as coping with the dirty and dusty environment present in a steel mill. Crack detection is also challenging due to the presence of oxidation scale on the slab surface. A bespoke laser triangulation system has been developed, providing images at 250 fps with a calibrated surface resolution of 97  $\mu\text{m}$  from a 1m standoff distance. Cracks are detected using a combination of morphological detection and SVM classifier. Results are reported from laboratory testing and from extended trials at a production steel mill.

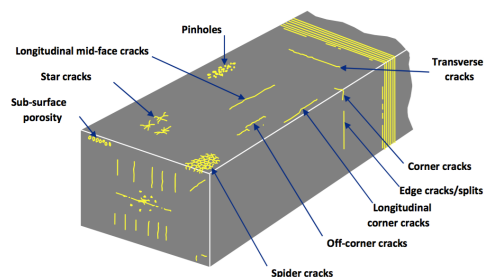
Figure 1. Major defect types found on “as-cast” semi-processed steel slab.

Figure 1, adapted from [1], shows a range of defects that can occur in continuously cast steel.

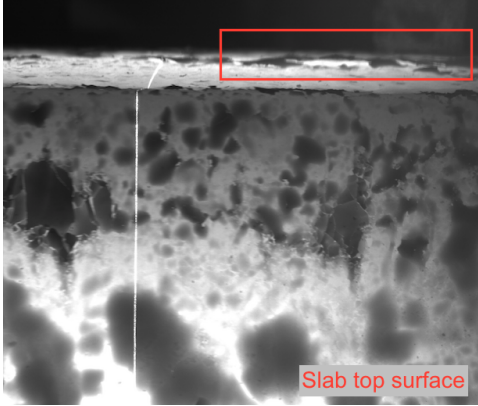
Figure 2. Continuously cast steel slab, imaged using the HTP-C instrument. The red box highlights scale blisters forming on the side of the slab. The laser stripe is visible in the left half of the image.

detection systems should be able to differentiate between scale features and slab defects [5]. Figure 2 shows a top-down view of a continuously cast steel slab, captured using the HTP-C instrument. The presence of scale is clearly visible as discolouration and 3D scale structures are visible on the side of the slab, such as the region marked by the red box.

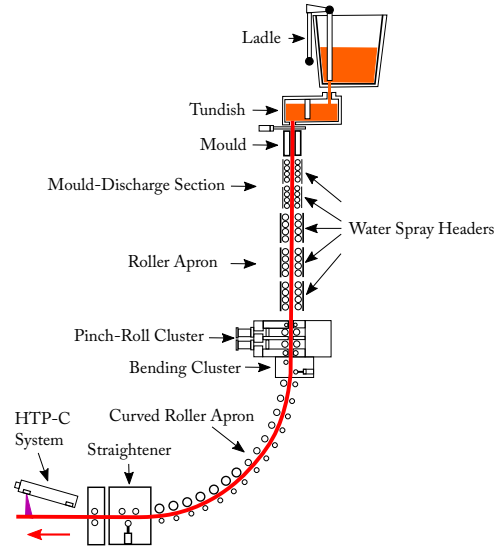
Figure 3. Typical horizontal-output continuous caster (not to scale). The HTP-C system was installed at the exit of the straightening rollers.

The location for the instrument was chosen to be at the straightener exit as shown in Figure 3. This site allowed access to the instrument during plant downtimes and allowed imaging of the steel with as little scale as possible. Initial thermal measurements, suggested an air temperature in excess of 200 °C at a height of 1m above the slab surface.

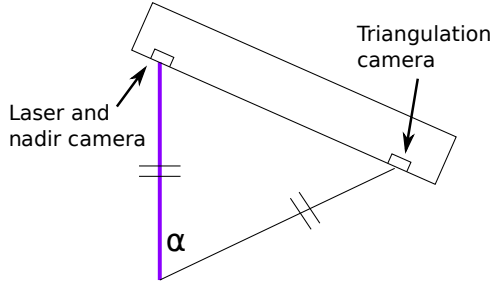
Figure 4. HTP-C system geometry. The system is angled such that the path length from the surface to each camera is the same.

The HTP-C system consisted of a blue/violet (405 nm) laser stripe projector and associated triangulation camera. The system geometry is shown in Figure 4. Unlike a conventional laser triangulation system, HTP-C included an additional overhead (nadir) camera positioned at the laser beam exit, approximately coaxial with the beam. The triangulation camera is positioned along a baseline and angled towards the laser line. The nadir camera recorded full-resolution images with minimal perspective distortion.

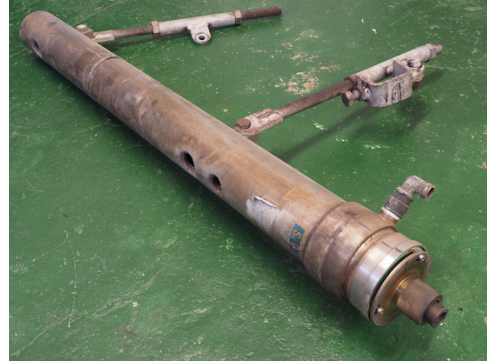
Figure 5. HTP-C cooled housing with apertures for two cameras and a laser stripe projector. The exterior shows extensive marking after being suspended above the caster for a period of several weeks.

Due to the harsh environment, a custom cooled enclosure (Figure 5) was used to house the optical components. The housing was a modified furnace probe, commissioned from SVA Industrie Fernseh GmbH (Hilden, Germany)<sup>8</sup>, and featured a water-cooled outer sheath and internal air purging to prevent dust build-up. Three apertures were placed into the probe for the laser line generator and two cameras.

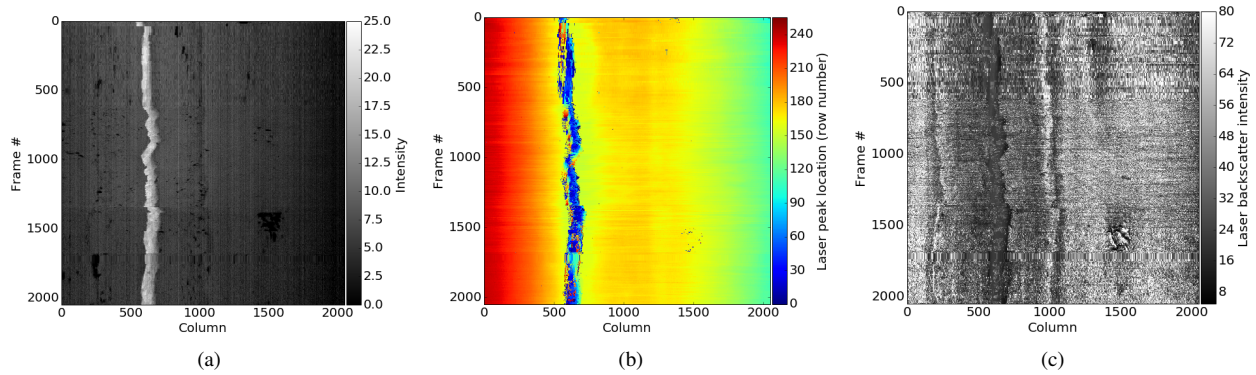
Figure 6. HTP-C data product example (a) Raw "linescan" image. (b) Uncalibrated laser peak location (c) Laser backscatter intensity. The frame contains a large longitudinal crack.

Examples of each stack of data products are shown in Figure 6. The steel image shown is a partial top surface view of a 300 mm wide mini-slab with a large centreline crack clearly present. The data were acquired at the Materials Processing Institute (MPI) on a 7 tonne pilot caster, primarily used for research.

The raw image data, Figure 6a, is formed from the first row in each image stacked over time to produce an image like that of a linescan camera. In this image, the crack

appears brighter than the slab surface due to the exposed, hotter, slab interior. Figure 6b shows the laser line location, a 2D representation of the topology of the surface. Note that there are a wide variety of surface features visible in the raw image which might be mistaken for defects. However, these regions are shown by the laser to be homogenous and mostly flat. Where the laser line falls on the crack, recovery of the peak is challenging and this is observed as missing data in the crack region. Finally the backscatter intensity image, Figure 6c provides insight into the reflectivity of the surface and allows monitoring for saturation of the laser line.

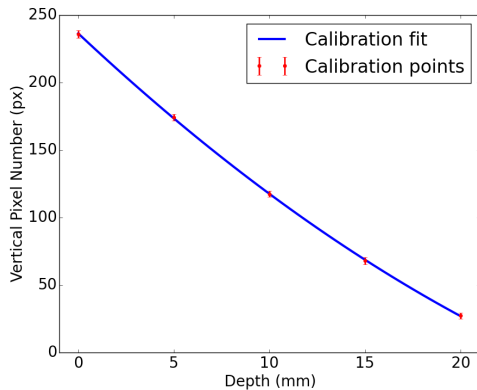
Figure 8. HTP-C calibration

The target was placed at the focus of the laser line and positioned so that 5 steps, corresponding to 25mm of depth variation, were visible. A stack of 1280 frames of data was captured. The mean laser line location for each step was used as the calibration value. The data were fitted using a 2nd order polynomial. The intercept of the curve was not important as the point of zero-depth can be chosen arbitrarily. A plot of the calibration curve is shown in Figure 8.

The fit equation was  $P = 0.14Z^2 - 13.29Z + 229.1$ . Taking the derivative with respect to  $Z$  and setting  $Z = 1$  m gave a value of  $\Delta Z/\Delta P = 77 \mu\text{m}/\text{px}$ . Considering the peak

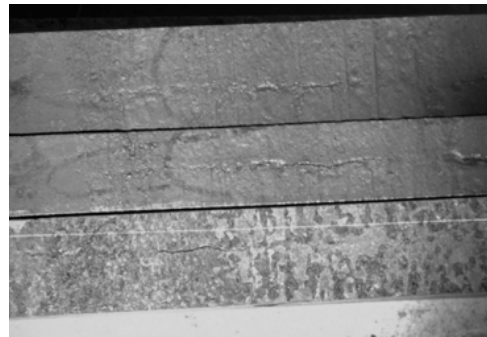
Figure 9. Defective steel samples placed on a carriage for imaging with the HTP-C instrument.

A series of initial trials were performed at MSSL to evaluate the acquisition and crack detection software. Three samples of defective steel were provided by TATA Steel, shown in Figure 9.

The samples contained a variety of defects including longitudinal and semi-spider cracks. The instrument was positioned similarly to the expected configuration in the production steel plant. The samples were moved in a linear motion under the HTP-C instrument at a speed of 15 mm/s.

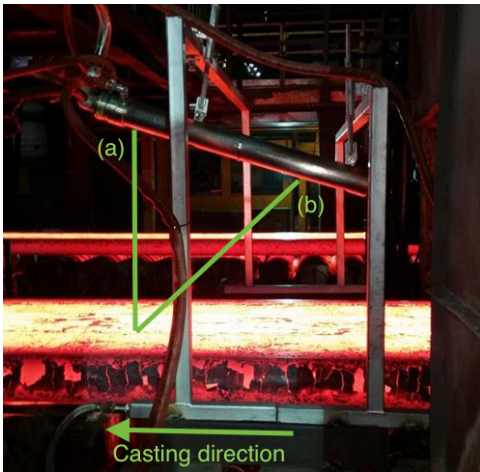
Figure 11. HTP-C system installed on a slab caster at the Concast facility at TATA Steel, Scunthorpe. (a) Nadir camera and laser. (b) Triangulation camera. Casting direction is from right to left as shown.

The HTP-C system was installed at the continuous casting (Concast) facility at TATA Steel, Scunthorpe, UK. The instrument was attached to a water-cooled metal frame which was spot-welded to a site near the first set of rollers. The acquisition PC was situated nearby behind a heat-resistant screen. Data and power cables were housed in an air-purged insulated sheath. Figure 11 shows the system in operation.

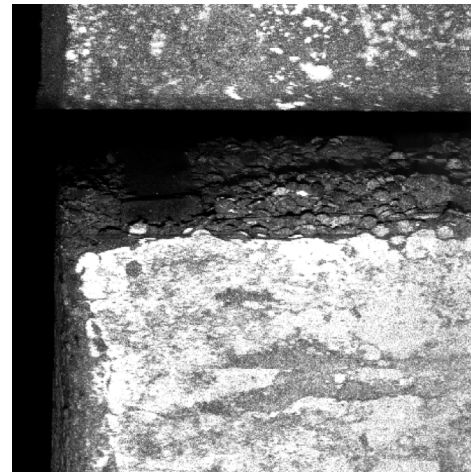
Figure 12. Laser backscatter image of the leading edge of a slab, acquired at the start of a cast. The dummy bar is visible at the top of the image with the slab below.

The system was focused at a distance of 1 m, coincident with the expected surface height of the slabs. The depth of focus is shown in Figure 12. The backscatter intensity image shows the leading edge of a new slab. The object at the top of the image is the dummy bar, a piece of steel used to draw the new slab down from the mould. Below the

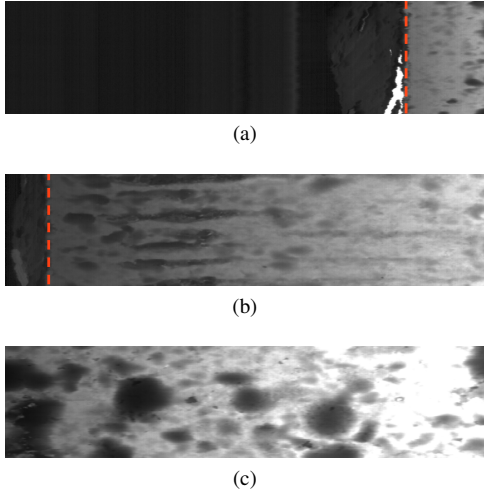
Figure 13. HTP-C instrument field of view for three slab widths at the Concast facility. (a) 1610 mm (b) 1830 mm (c) 1970 mm. For (a) and (b), the slab edge is marked with a dashed line.

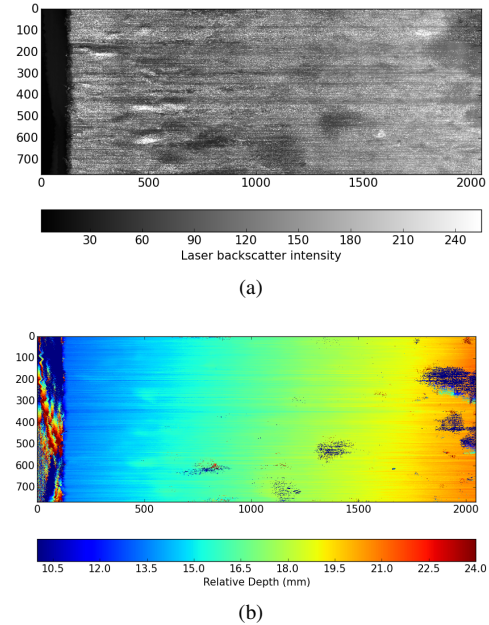
Figure 14. Effects of scale on (a) laser backscatter and (b) corresponding depth image.

In almost all images, scale was visible. The effect on the data varied. In some cases it was possible to discern the scale topology. Figure 14 shows an example of this.

Close to the slab edge (left of image) the scale topology was captured, visible as intensity variations in the depth image. Towards the slab centre (right of image), the laser line is either not detectable by the system or is spuriously detected. This is a similar response to that expected of a crack, i.e. the laser line not being visible, so any classification result should also consider the shape of the feature.

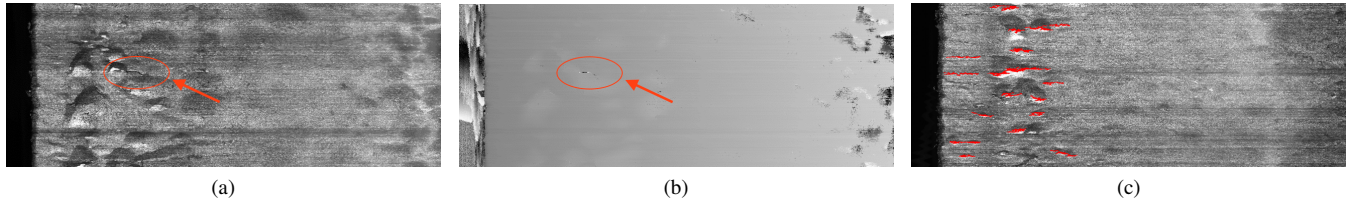
Figure 15. Manually identified potential crack (a) laser backscatter image (b) depth image. (c) Potential L0 cracks located using the crack detection algorithm before being filtered with the SVM classifier.

Potential cracks were identified both by software and through manual analysis of the data. Figure 15 shows one example found via manual search (highlighted). There are prominent scale bubbles visible near the slab edge. Each bubble appears as if it is illuminated from one side. This effect is due to specular reflection of the laser beam rather than actual shadowing. The depth image clarifies that these features are raised compared to the surrounding surface, and hence confirmed as scale. However, further processing with the crack detection algorithm did not yield positive results. A typical example of L0 potential cracks detected in a different data stack is shown in Figure 15c.

The L0 cracks are found in locations with strong edges, mostly around the edge of scale. The SVM classifier is able to correctly filter these as false positives.
