EVALUATION PROGRAM
for
SECONDARY SPACECRAFT CELLS

SEVENTH ANNUAL REPORT
OF
CYCLE LIFE TEST

SEVENTH ANNUAL REPORT OF CYCLE LIFE TEST

QE/C 71-1 29 JANUARY 1971

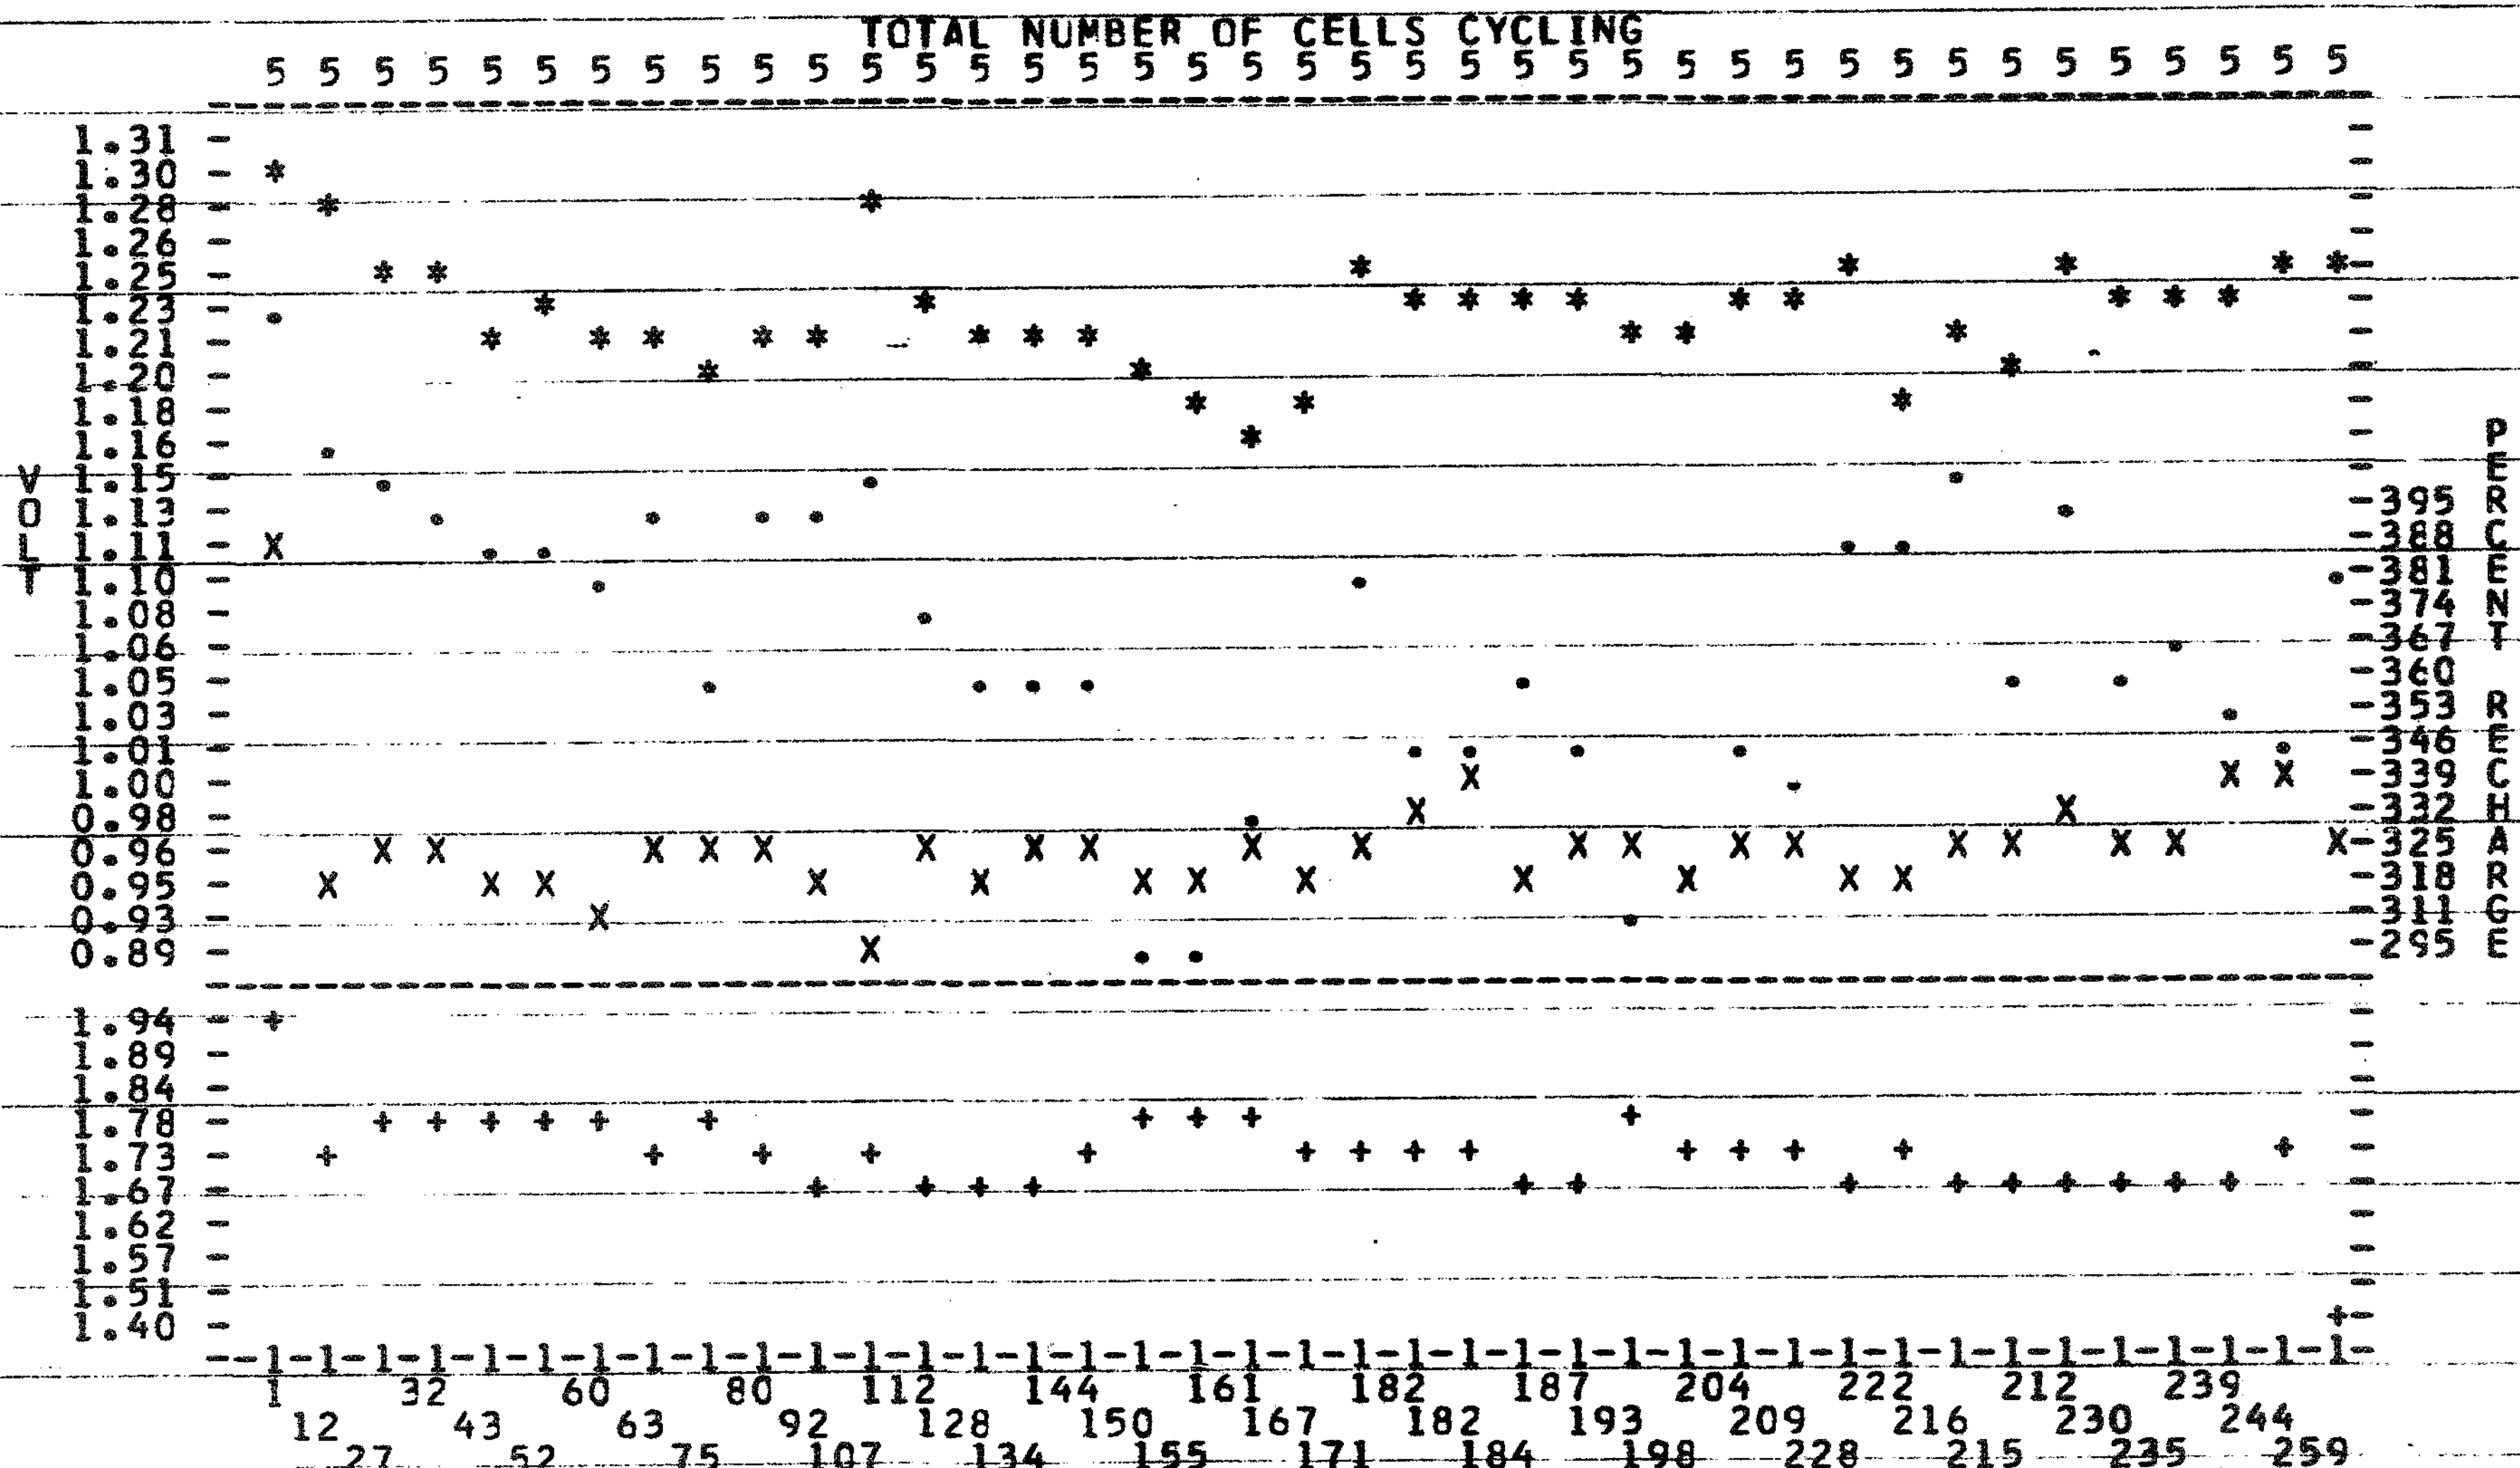
CYCLES ARE IN MULTIPLES OF 100
FIGURE 43

(1) Performance on Cycling: (Figures 43 through 45) Cycling was started in March 1966. Packs 74B, 88D and 108B have completed 26,337, 25,575 and 25,630 cycles, respectively with one cell failure each in packs 74B and 88D. Pack 98B failed on cycle 12,247. All four packs have experienced high pressure (some

(2) Failure Analysis: Analysis of the five failed cells shows severe migration of negative material, blistering of the positive plates and high internal pressure.

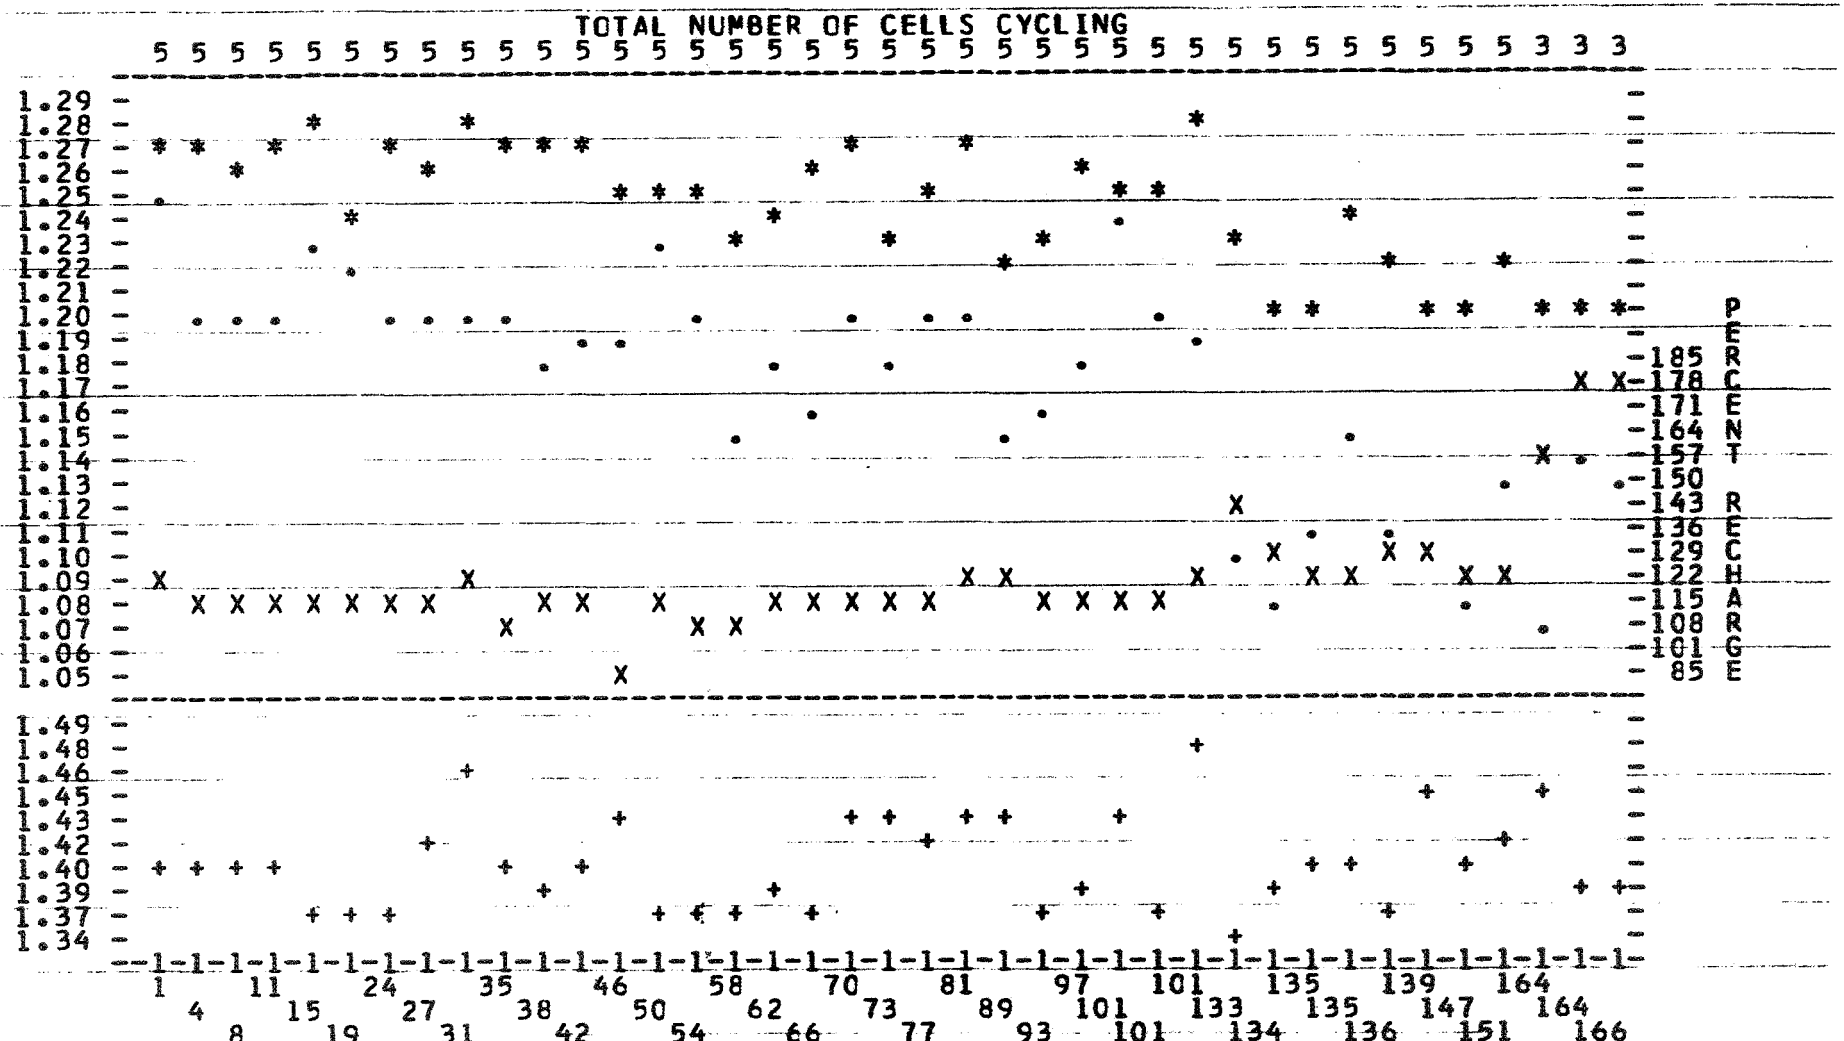
FIGURE 46

(1) Performance on Cycling: (Figures 46 and 47) Cycling was started in April 1967. Packs 48B and 24C failed on cycles 6156 and 17,328, respectively. Pack 60B has completed 21,068 cycles with no cell failures.

(2) Failure Analysis: Analysis of the six failed cells showed the major causes of failure to be shorting between the positive and auxiliary electrodes due to insufficient separator material between the edge of the positive plates and the auxiliary electrode. Separator deterioration, migration of negative material and blistered positive plates also were major reasons for failure. Other conditions found were high pressure, electrolyte leakage, weak weld between the auxiliary electrode and the bracket on the inside wall of the cell, and shorting between plates within the cell stack. This latter shorting is due to separator deterioration. The weak welds may result from failure to remove active material from the grid of the auxiliary electrode prior to welding to the bracket.

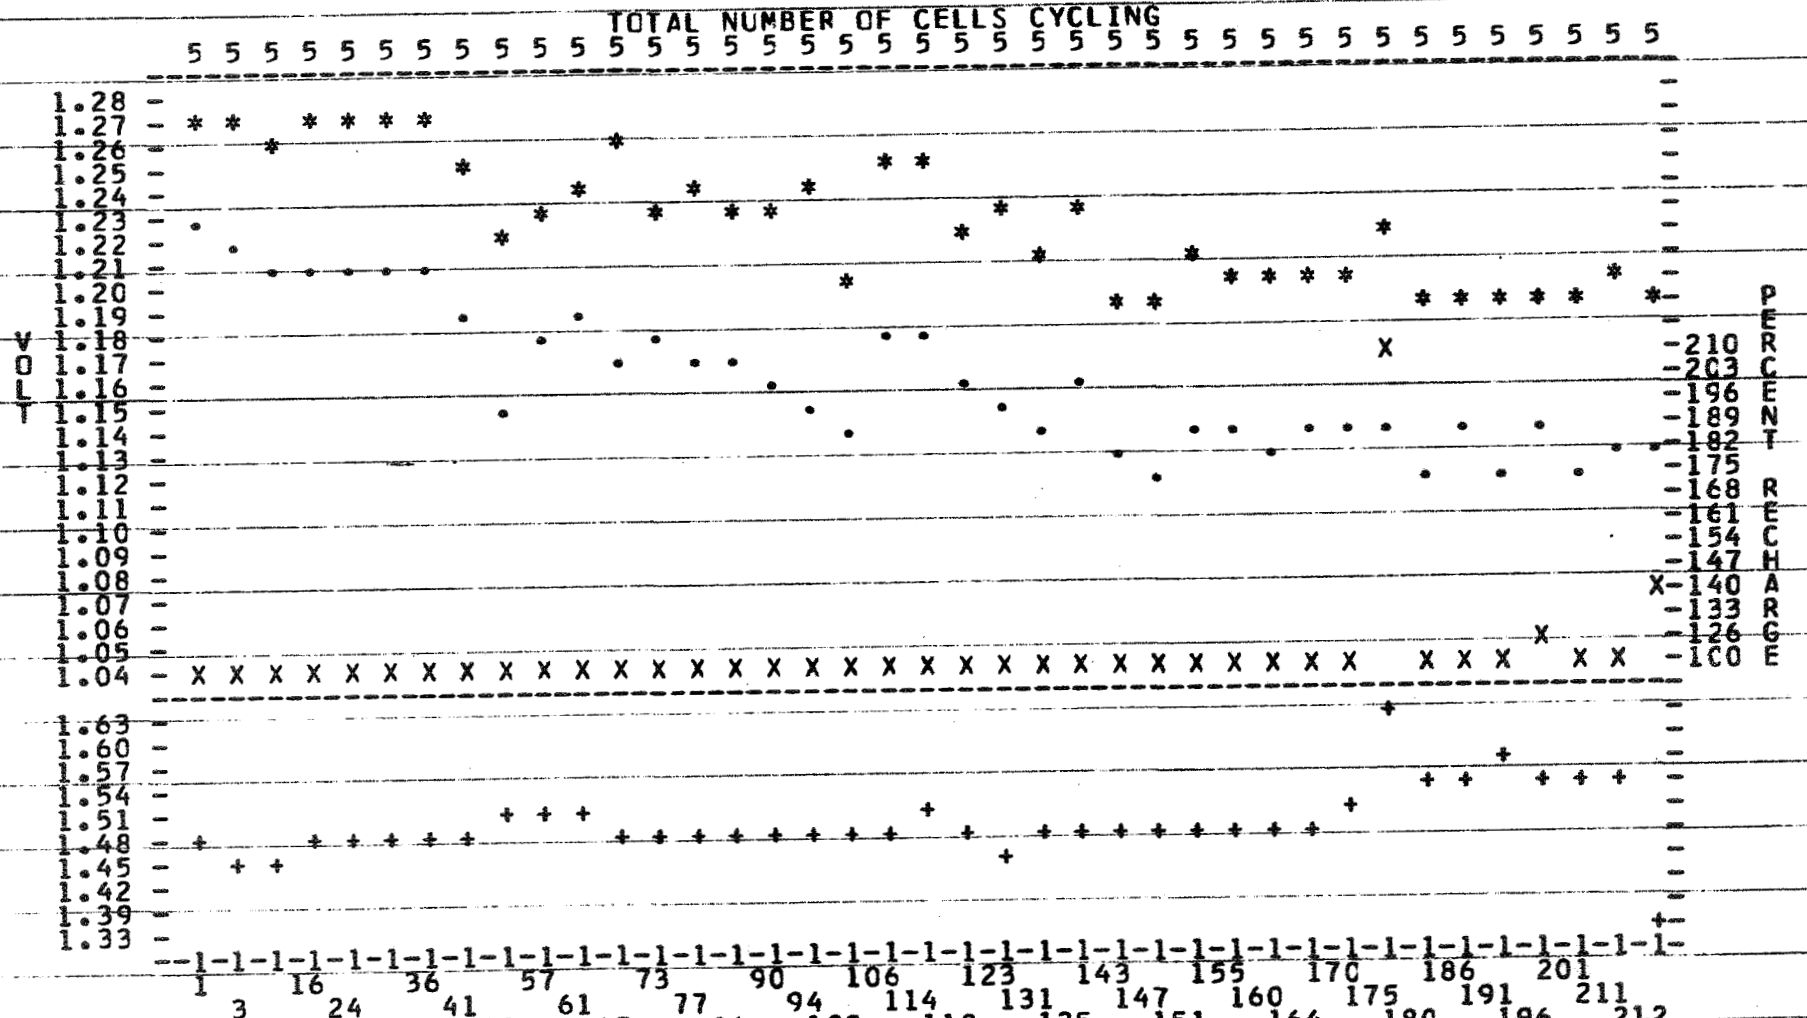
FIGURE 53

(1) Performance on Cycling: (Figure 53) Cycling was started on Pack 11B in October 1966, on packs 47B and 71B in January 1967 and on pack 70A in February 1967. Pack 70A has completed 21,792 cycles to date with no failures. Packs 71B, 11B and 47B failed on cycles 15,275, 11,933 and 6537, respectively.

(2) Failure Analysis: Analysis of the nine failed cells showed that the failure was due to separator deterioration and migration of the negative plate material. Other conditions found in these cells were high internal pressure and electrolyte leakage.

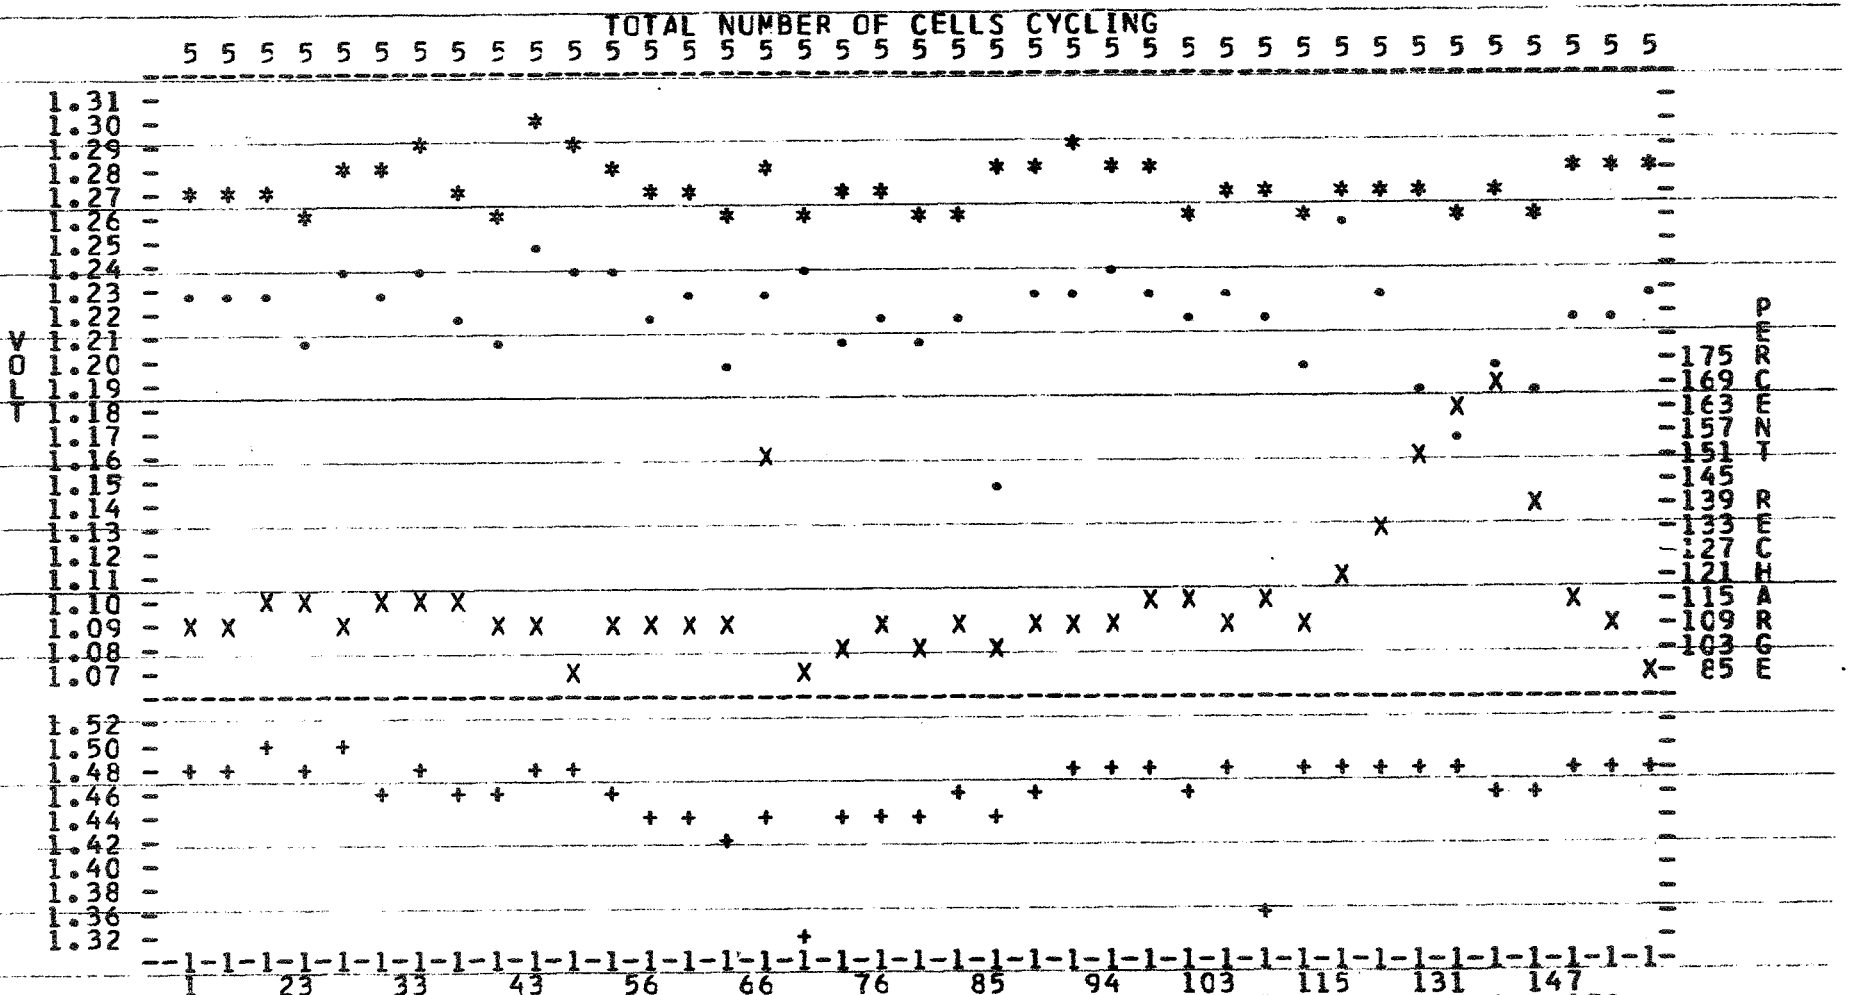
FIGURE 54

(1) Performance on Cycling: (Figures 54 and 55) Cycling was started in March 1968. Packs 54B and 19B have completed 15,882 and 15,907 cycles, respectively, with no cell failures. Pack 38E failed after 4943 cycles due to loss of capacity at high temperature.

(2) Failure Analysis: Analysis of the three failed cells showed that failure was due largely to separator deterioration. Migration was not as extensive as that seen in most failed cells. Other conditions included blistering and high pressure as evidenced by gas escaping from the punctured cell.

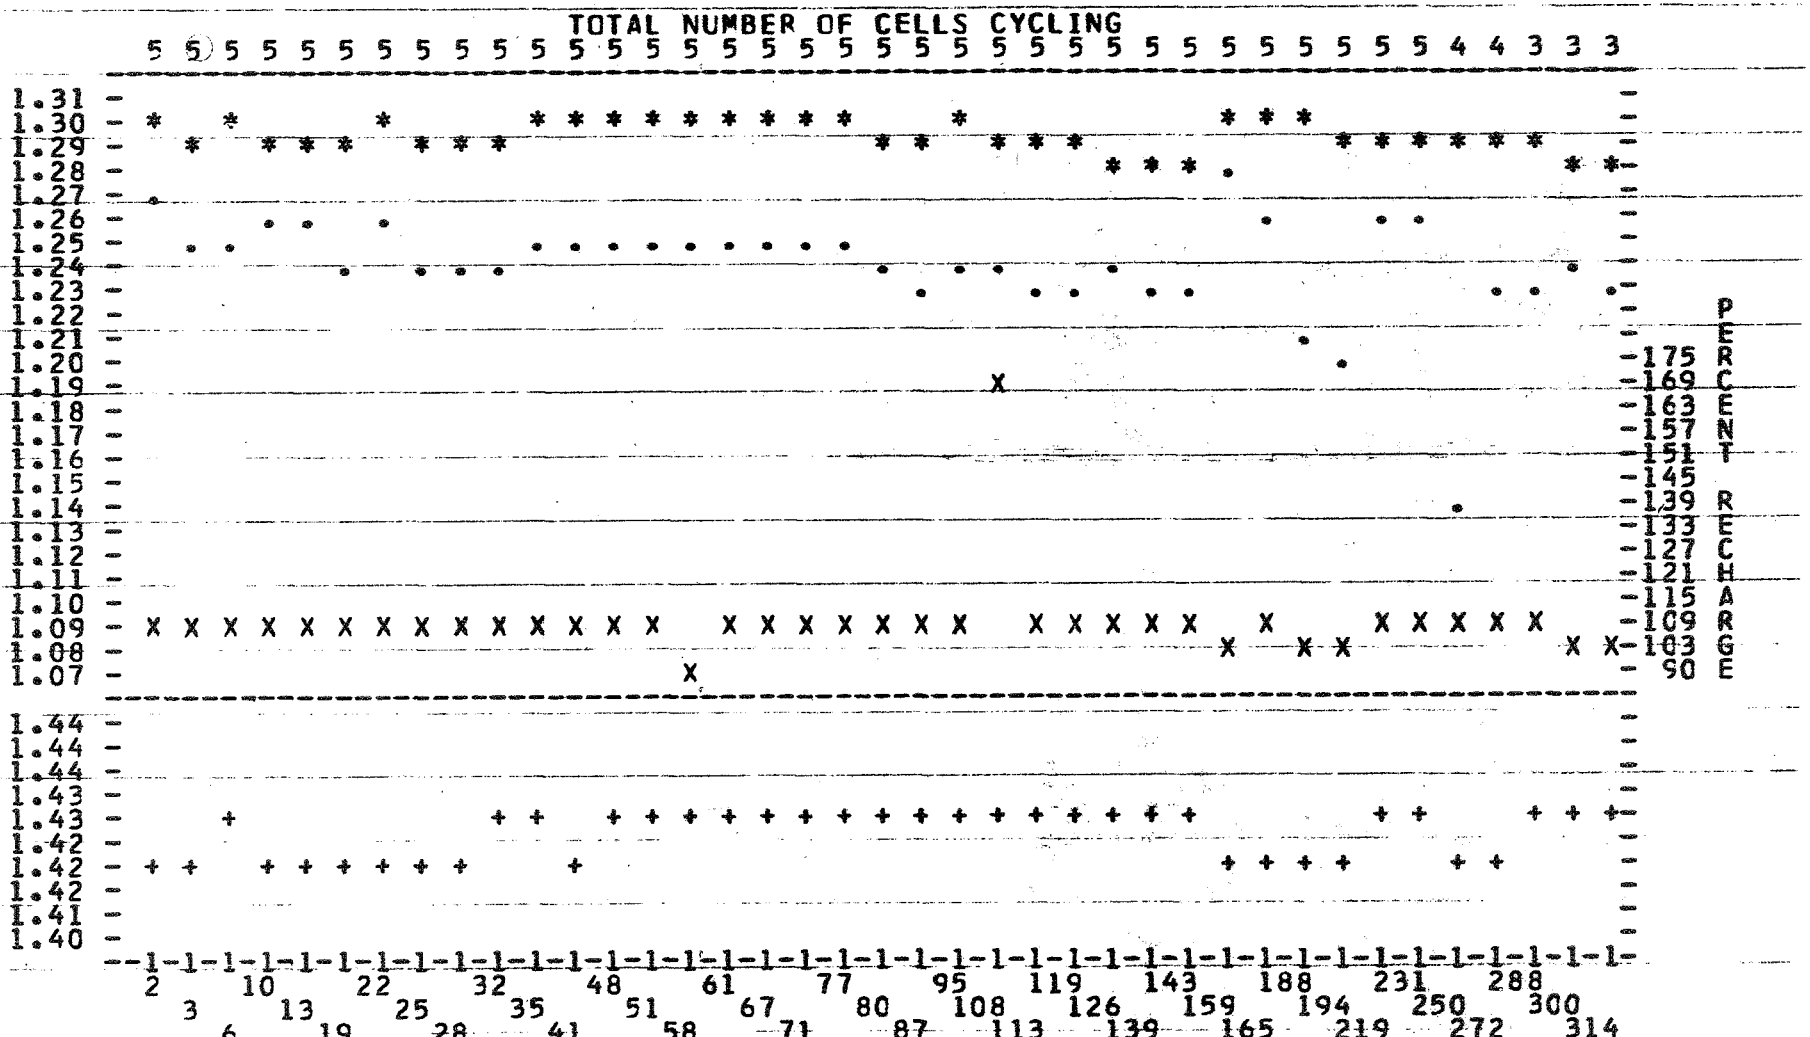
FIGURE 57

(1) Performance on Cycling: (Figure 57) Cycling started in May 1970. Pack 12E has completed 3284 cycles with two cells removed.

(2) Analysis: After 2522 cycles, the cells showed a large amount of imbalance at the end of charge. The cell showing the highest end-of-charge voltage was removed at the request of Goddard Space Flight Center. Analysis showed excessive migration and moderate separator deterioration. Samples of positive and negative (adjacent) plates were removed, and individual plate capacities were measured. The positive capacity exceeded the negative capacity in each case by as much as 13 percent. This leads to high voltage (usually high pressure also, though not noted in this case, during charge. The second cell was removed after 2729 cycles and sent to Goddard Space Flight Center.

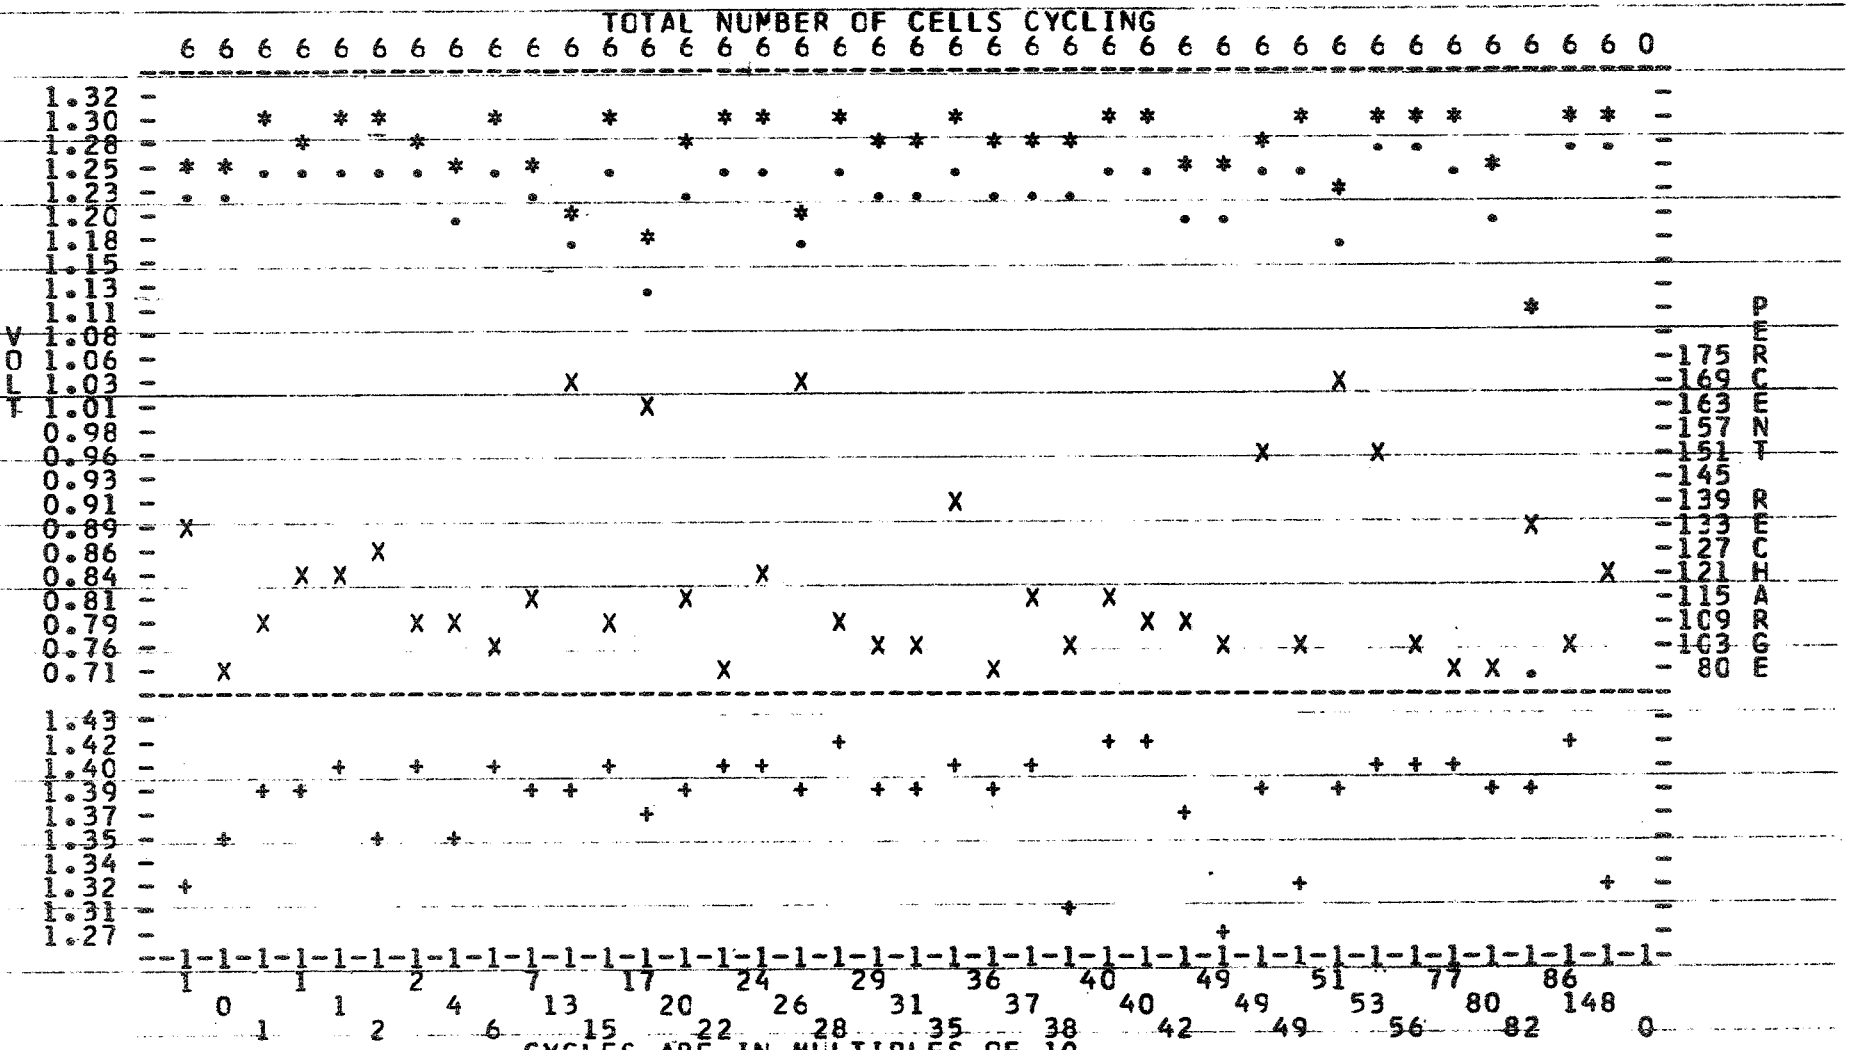
FIGURE 59

(1) Performance on Cycling: (Figure 59) Cycling started in May 1969. Pack 48C was terminated after completing 1984 cycles. On cycles 586 and 627 cell number 1 (8.0 ah of precharged cadmium) developed high internal pressure. In both cases the gas pressure was allowed to decrease while the cells were on open circuit. On cycle 627, four ampere-hours of precharged cadmium were removed and the cell returned to cycling. No further difficulties with high pressure were encountered with this cell. Cell number 5 failed after 1733 cycles, and cell 2 failed after 1984 cycles. The pack was removed after 1984 cycles.

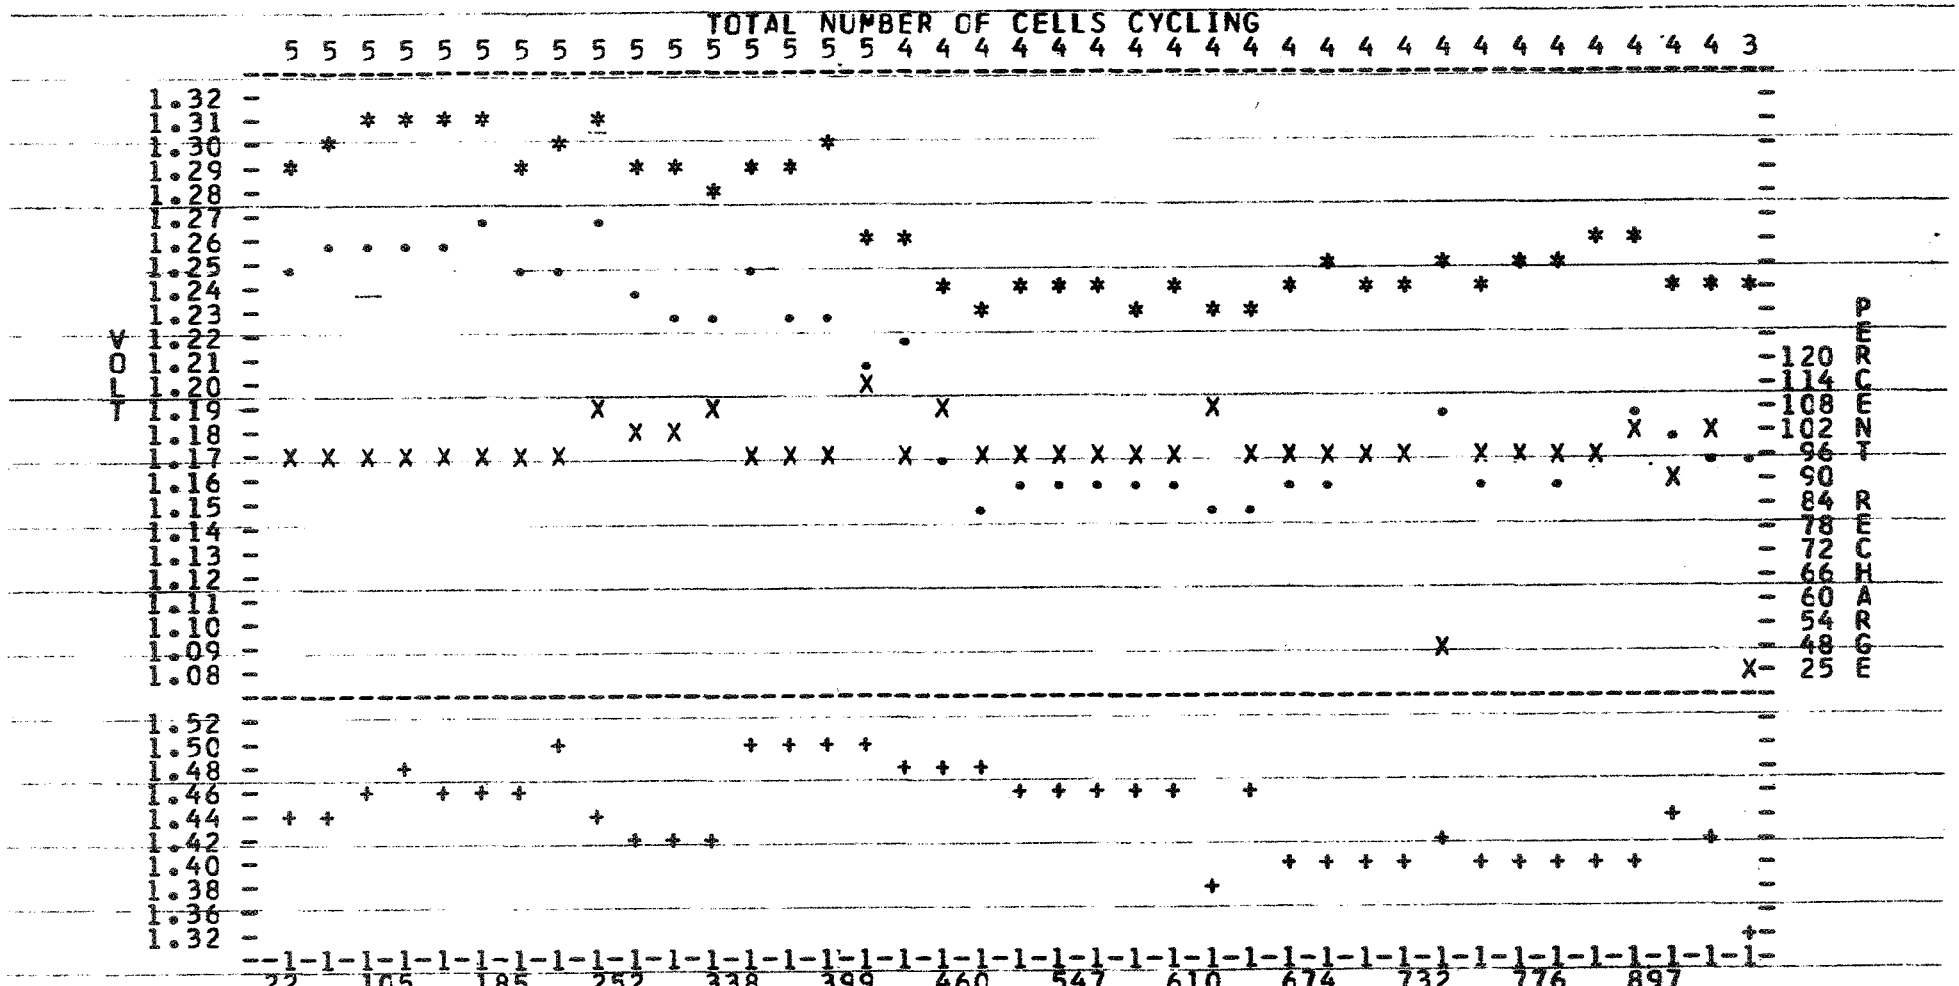
FIGURE 66

(1) Performance on Cycling: (Figures 66 and 67) Cycling was started in July 1968. Packs 53B and 28C failed on cycles 9230 and 9987, respectively. Pack 47C was discontinued on cycle 5842. One cell was removed from each pack and returned to the manufacturer for analysis. These cell removals occurred on cycle 4039 for 53B, on cycle 4095 for 28C and on cycle 4063 for 47C. Two additional cells (one failed and one nonfailed) from 47C were returned to the manufacturer for analysis as outlined in the NASA contract.

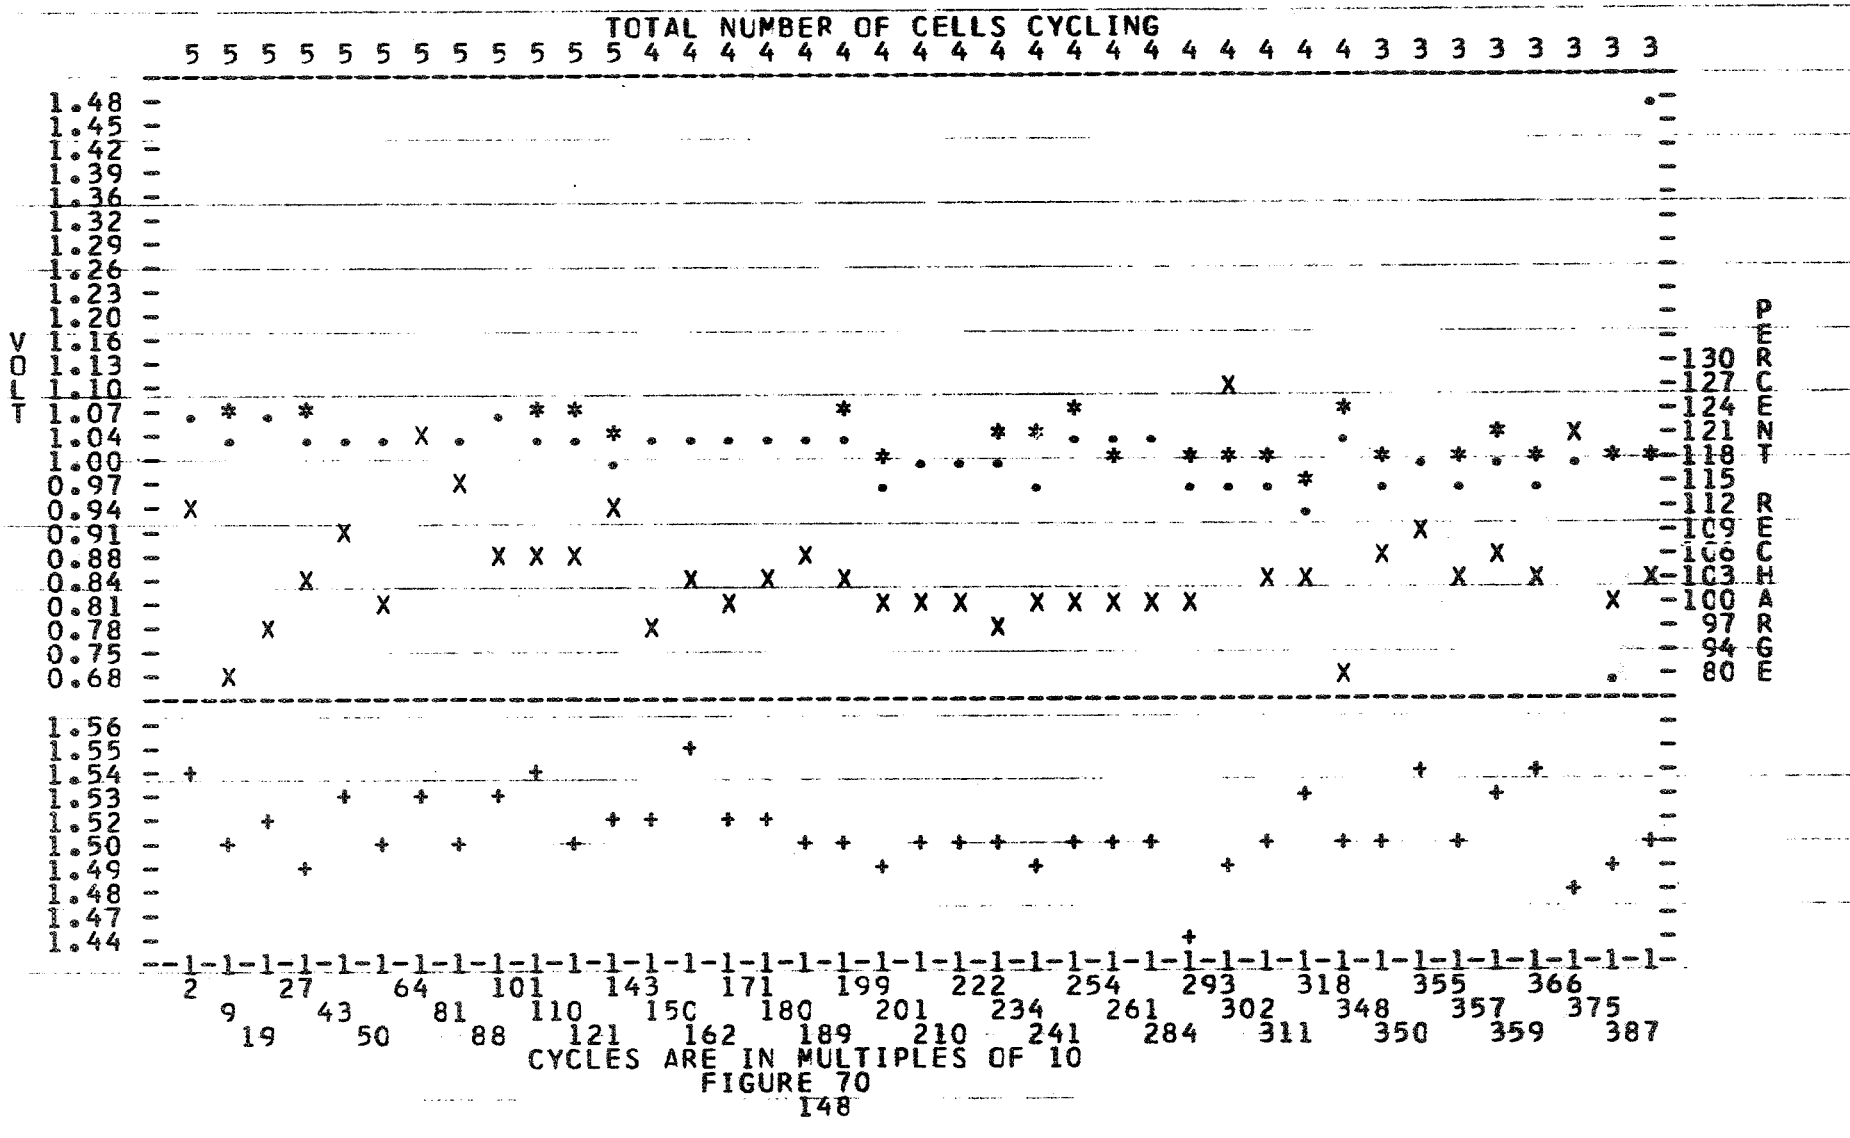
FIGURE 70

(1) Performance on Cycling: (Figure 70) Cycling was started in September 1966. This pack failed in June 1970 after completing 3875 cycles.

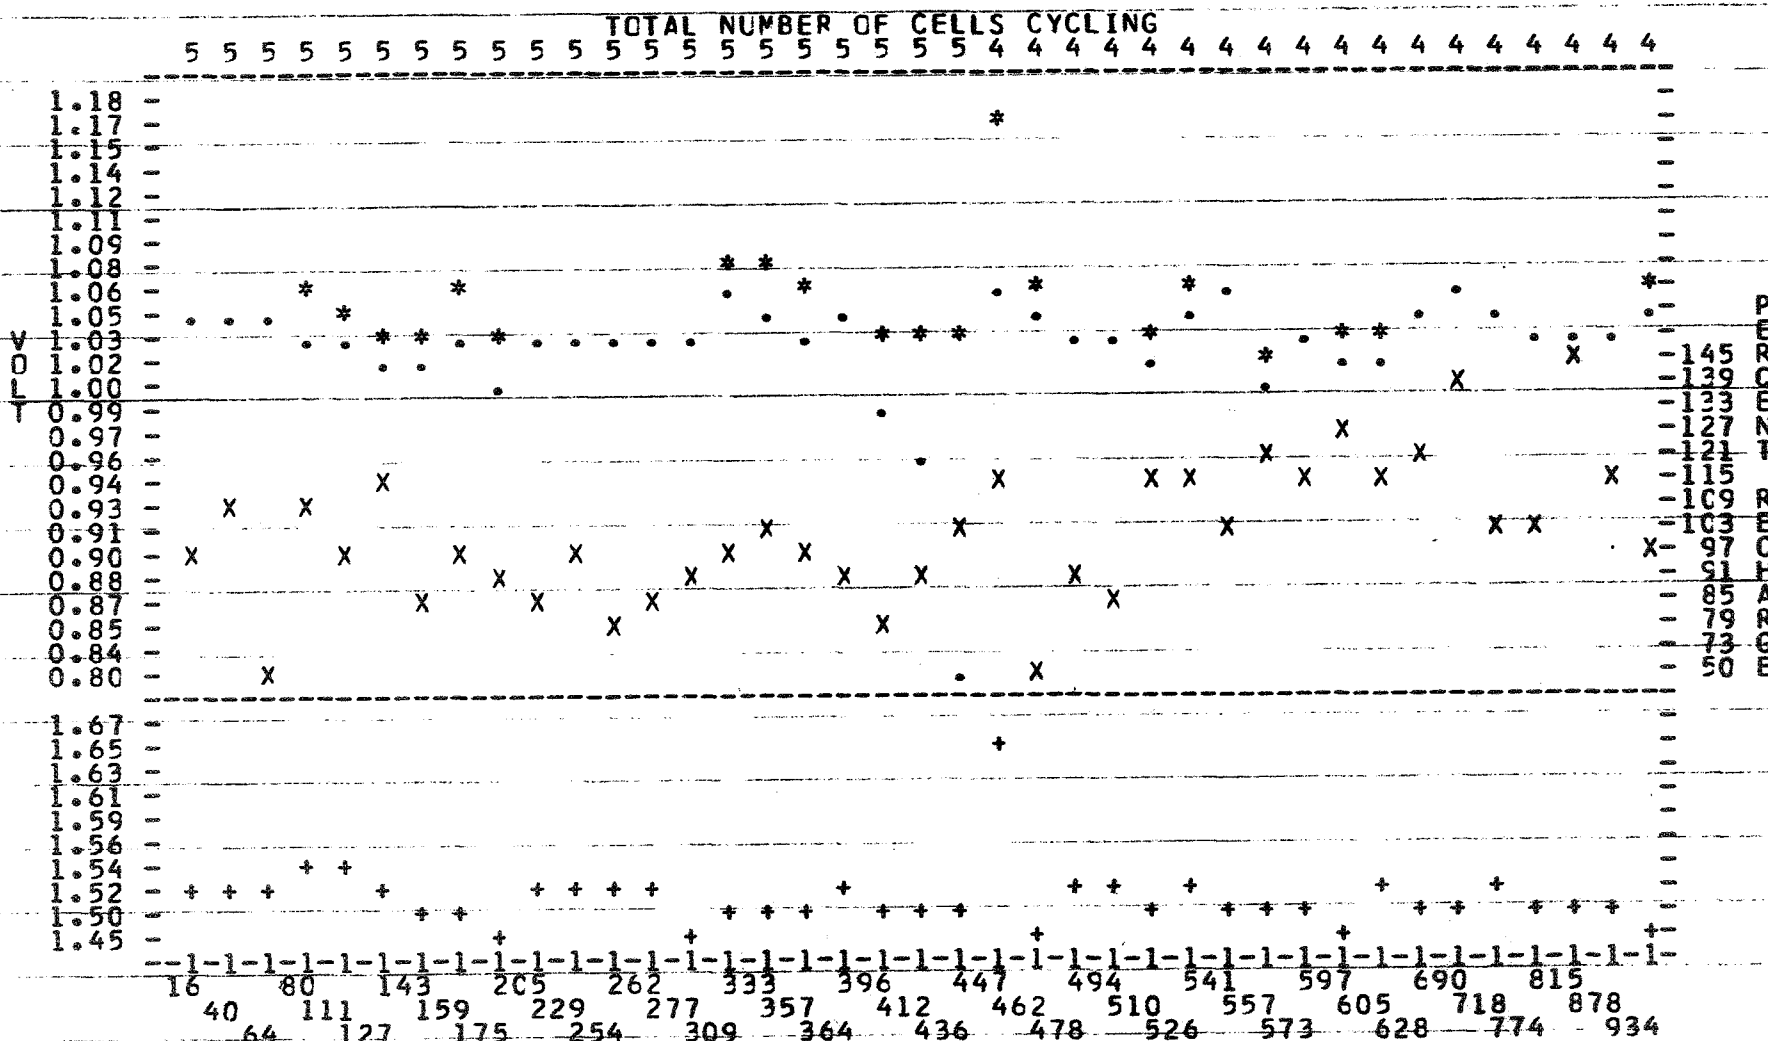
FIGURE 71

(1) Performance on Cycling: (Figure 71) Cycling was started in February 1968. Pack 57D has completed 1006 cycles to date with one cell failure. Packs 69B and 33C failed on cycles 507 and 447 respectively

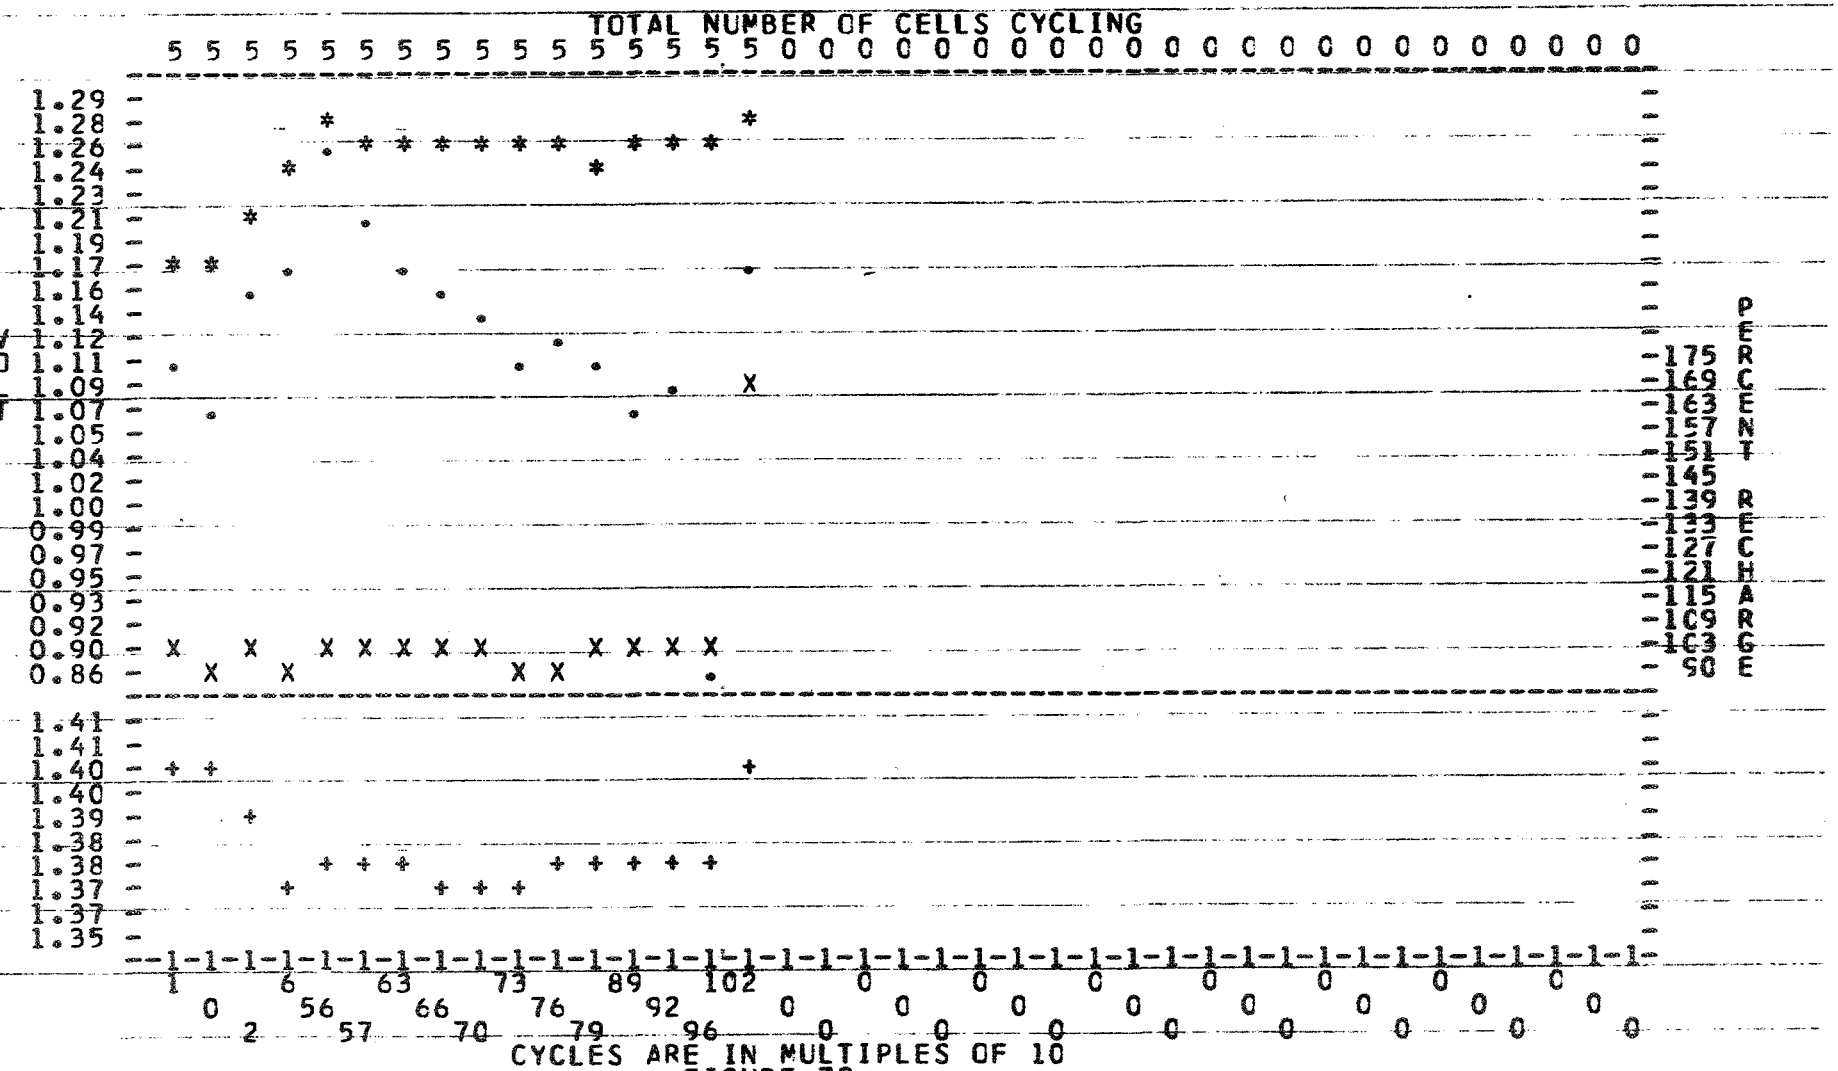
FIGURE 72

(1) Performance on Cycling: (Figures 72 through 75) Cycling was started in September 1970. Packs 39D, 63B, 3C and 27D have completed 1089, 2310, 1342 and 1224 cycles, respectively. No cell failures have occurred, but a coulometer was replaced in pack 39D after 115 cycles.
