Philosophical Transactions of the Royal Society A: Mathematical, Physical and Engineering Sciences

Arora, H., Kelly, M., Worley, A., Del Linz, P., Fergusson, A., Hooper, P. & Dear, J. (2014). Compressive strength after blast of sandwich composite materials. *Philosophical Transactions of the Royal Society A: Mathematical, Physical and Engineering Sciences*, 372, 20130212-20130212.

One contribution of 12 to a Theme Issue ‘Shock and blast: celebrating the centenary of Bertram Hopkinson’s seminal paper of 1914 (Part 1)’.

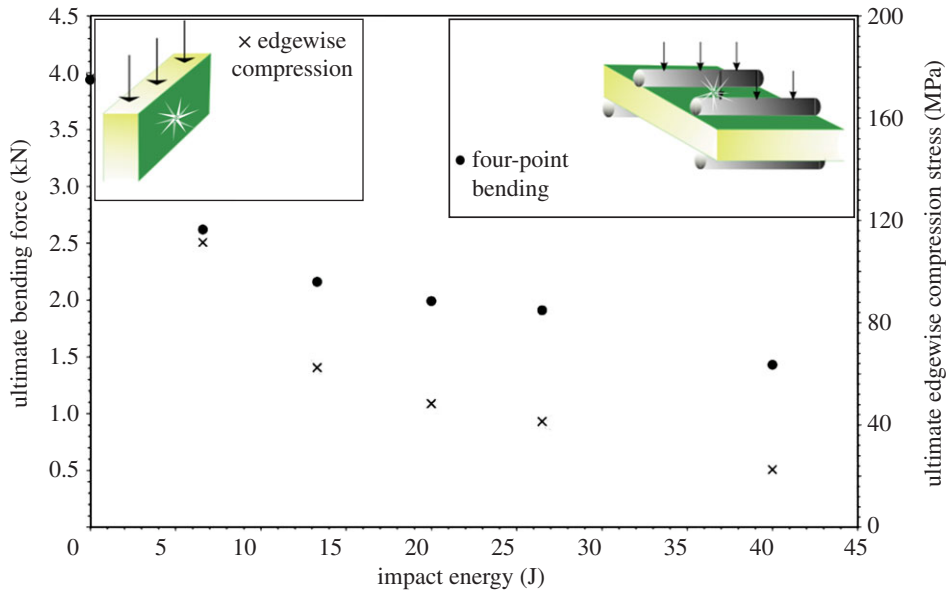
Figure 1. Impact energy to cause inherent damage versus stress to cause failure in edgewise compression, and force to cause failure in four-point bending. Adapted from reference [28]. (Online version in colour.)

Xie *et al.* [27] also performed tests on carbon-fibre facesheets with an aluminium honeycomb core, this time looking only at barely visible damage. A drop tower was used to create mild indentation with ply delamination and core crushing, and then FEA models were created with damage present, to be validated using edgewise compression testing. The delamination of the skin and core was already present in the model, and this was achieved using point-to-surface contact elements. The FEA incorporated routines to simulate in more detail core crushing and the nonlinear effect of the core stiffness during displacement. Very good correlation was found with experimental results and modes of failure with core crushing present, whereas there was high deviation at higher strains without core crushing present. Shipsha *et al.* [28] investigated the effect of impact on a panel by a spherical indenter, and on a beam by a cylindrical impactor. It was found that, in both cases, a cavity formed underneath the skin in the core where the two had completely separated, and core crushing occurred around this zone. The materials used were polymethacrylimide foam cores and glass-fibre skins. In these tests, drop tower energies were used that would cause negligible damage in the front facesheet. This was found to produce a reduction in stiffness of less than 5%. Post-impact testing of these sandwich panels was in the form of edgewise compression and four-point bending. In the bending tests, it was found that failure took place suddenly at the periphery of the local core damage, with no steady crack propagation beforehand. The variation of force to cause failure in the four-point bending tests, and stress to failure in edgewise compression tests, versus the impact energy used to create initial damage are shown in figure 1.

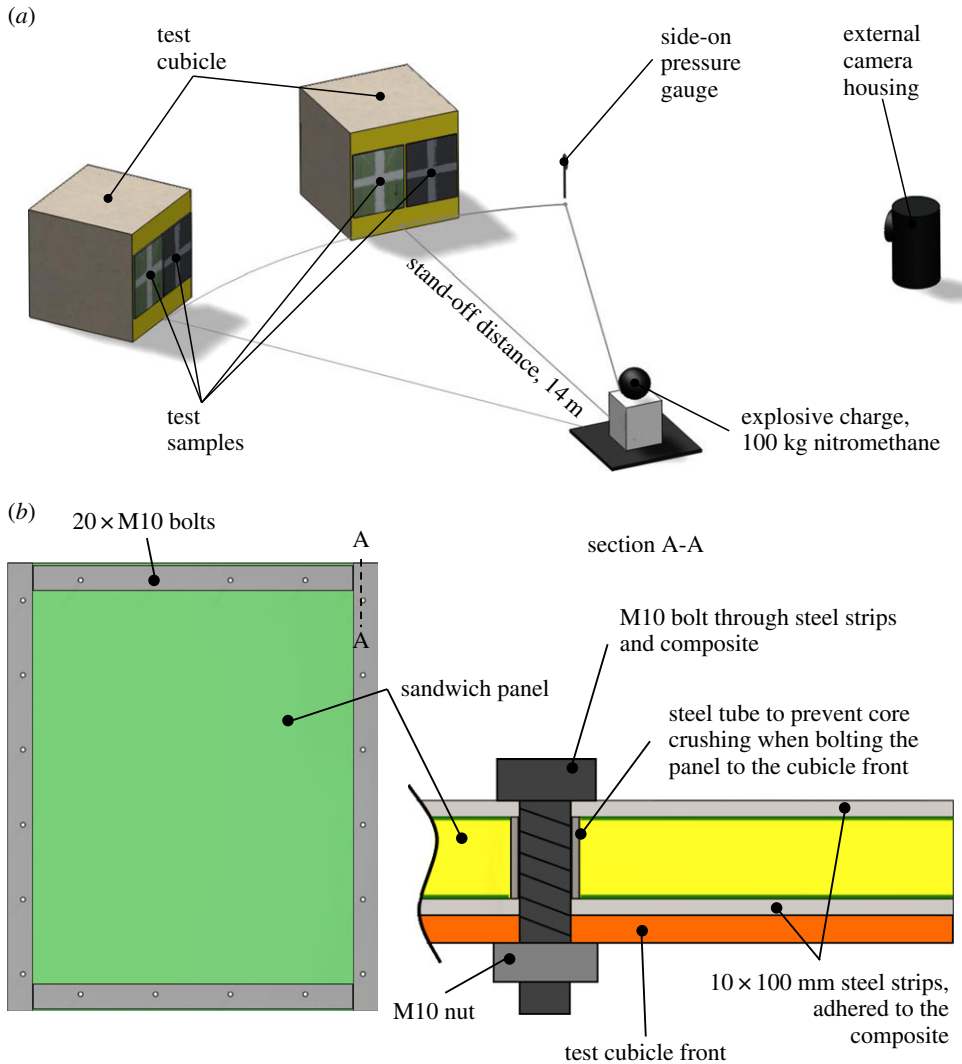
Figure 2. (a) Schematic of the experimental layout on the test pad at RAF Spadeadam, Cumbria, UK, and (b) the clamping arrangement of the sandwich panels onto the test cubicle. (Online version in colour.)

panels as shown in figure 2*b*. This clamping approximates the loading as a ‘built-in’ boundary condition. Full modelling should also consider the response of the cubicle front.

An additional high-speed camera was positioned outside of the cubicle to observe the effects of the blast on the front face of the panel and moreover to allow the user to confirm that the test conditions remained as desired throughout. An arbitrary cross shape was painted onto the front of the panels to aid in the visualization of the deflection during blast, but not intended as a quantitative measurement of the front face. The displacements were taken from the rear face using DIC. Overpressure due to the blast was measured with a pressure gauge positioned next to the cubicle at the same stand-off distance (figure 2*a*).

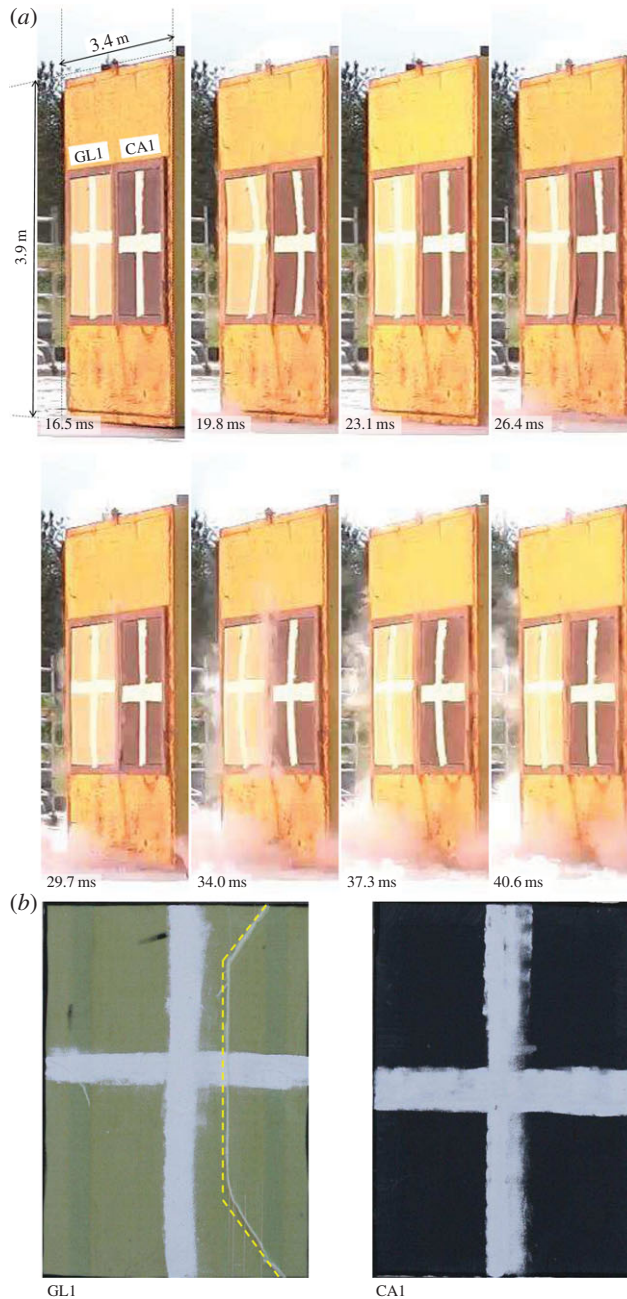
Figure 3. (a) Images taken at regular intervals with the shockwave impinging on test samples GL1 and CA1 after 16.5 ms. (b) Final visible front-face damage. Time stamps are relative to detonation time at 0.0 ms. (online version in colour.)

Figures 3 and 4 show sample front-view images taken from the high-speed video cameras positioned on the test pad during the 100 kg nitromethane charge explosion. The shockwave is seen to arrive at the target after 16.5 ms post-detonation. This blast experiment was designed to take the panels beyond their elastic limit and inflict a significant proportion of damage on each target. The test samples have an arbitrary cross painted on their front face for ease of tracking the front face deformation.

Figure 3 shows the effect of the blast on test samples GL1 and CA1. Front-face damage is seen to initiate in the top right corner of GL1 at 19.8 ms and propagate down the right-hand edge. The final front-face damage is shown at the bottom of figure 3, highlighting the relative visible damage sustained by each target. There was no visible skin damage in CA1.

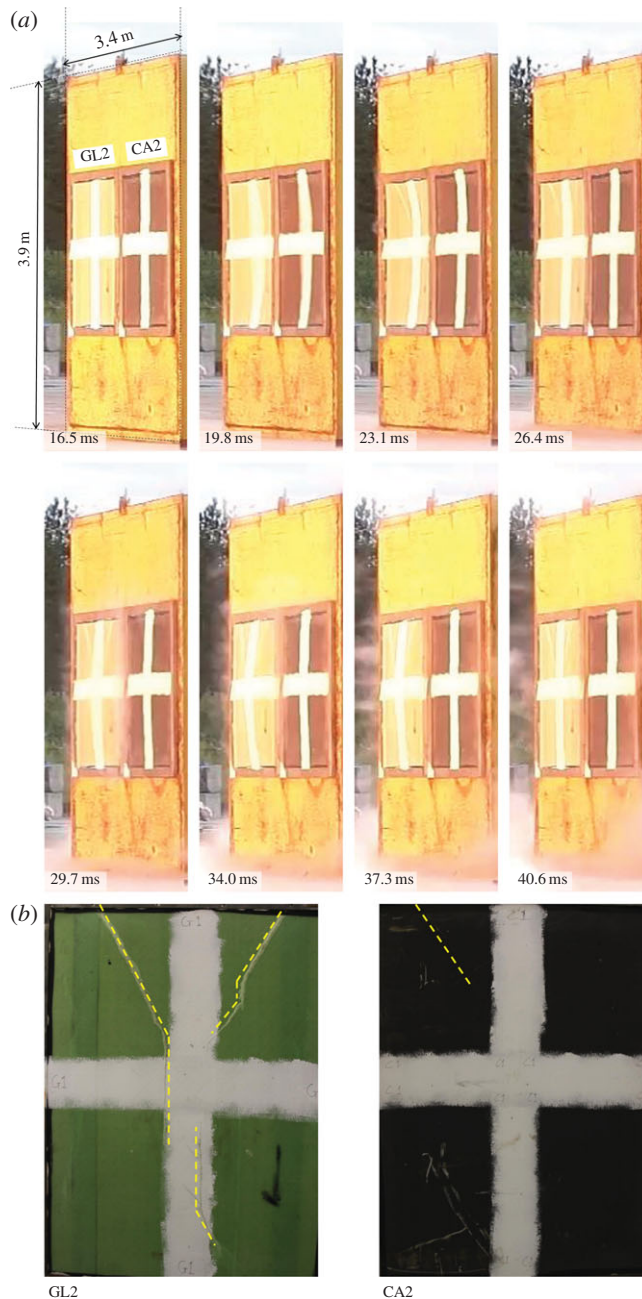
Figure 4. (a) Images taken at regular intervals with the shockwave impinging on test samples GL2 and CA2 after 16.5 ms. (b) Final visible front-face damage of targets 1.6×1.3 m area. (Online version in colour.)

For the second pair of samples subjected to blast, figure 4 shows the external view of samples GL2 and CA2 for the duration of the loading cycle. Front-face damage is seen to initiate in the top left and right corners of GL2 between 19.8 and 23.1 ms. These cracks propagate down the sides of GL2. This time, in the CFRP panel, there is a small amount of skin failure visible, highlighted in the final front-face damage image at the bottom of figure 4.

as shown previously in figure 4. The damage to the panel also led to a reduced stiffness, which caused an increase in the time for the return response. This was seen in the carbon-fibre panel as an elongated return from maximum displacement in figure 5 and the relatively flat-looking contour plot in figure 8. It took 1 ms longer for the carbon-fibre panel to return to its original position than the glass-fibre panel owing to the difference in core crack distribution observed in the carbon-fibre-skinned panels compared with the glass-fibre-skinned panels and other effects.

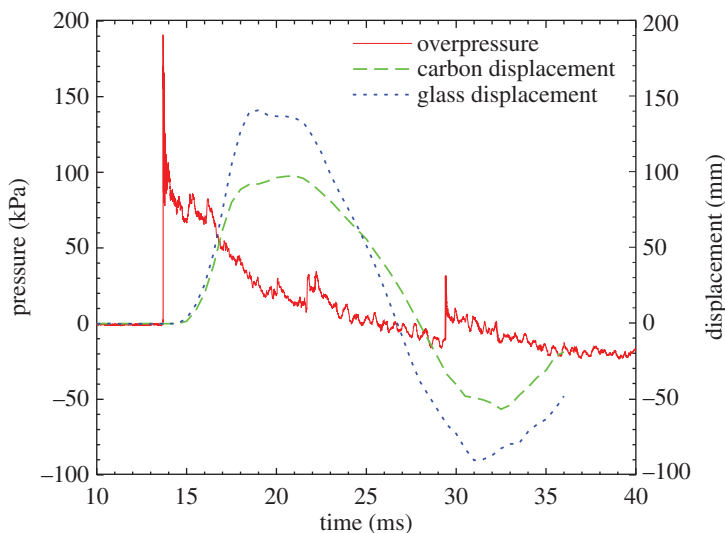
Figure 5. Graph showing the out-of-plane displacement of both CA1 and GL1 alongside the synchronized overpressure measurement. (Online version in colour.)

At the 14 m stand-off from the 100 kg charge, an impulse of 420 kPa ms was recorded, and the initial positive pressure wave lasted for 12.0 ms. This is shown alongside the transient central out-of-plane displacement plots for CA1 and GL1 in figure 5.

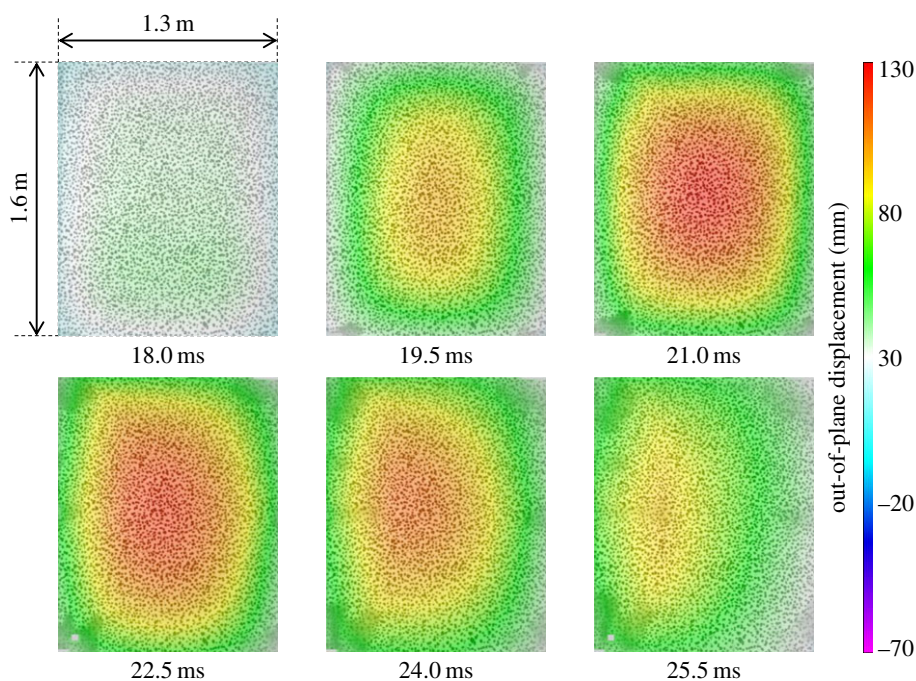
Figure 6. DIC analysis of blast on GL1 featuring contour plots of out-of-plane displacement. (Online version in colour.)

The glass-fibre-skinned panel, GL1, deformed symmetrically until the point of maximum *z*-displacement. By this point, front-face and core damage had already occurred and affected the return response of the panel, causing a non-uniform rebound response at 20 ms about the peak out-of-plane displacement (see graphic in figure 5). This asymmetry caused by the damaged core is highlighted in the out-of-plane displacement contour plots in figure 6.

see the greatest initial loading. This is evident from the U_z plots during each blast for the targets in figures 6 and 8. However, composite structures exhibit compliance; therefore the pressures do not build up necessarily to their theoretical maxima based on geometry alone. GL1 was seen to suffer the most damage at the bottom corner closest to the centre of the fixture (4R), whereas CA1 was seen to suffer most damage in the opposite corner (1R). When the blast wave hits the targets, there are a series of transmitted waves and reflected waves. The transmitted waves are either through-thickness surface waves or a combination of shear waves. Upon impact, the bottom-most central corner (GL1-4R and CA1-4L) will be loaded first and see the initial peak loading

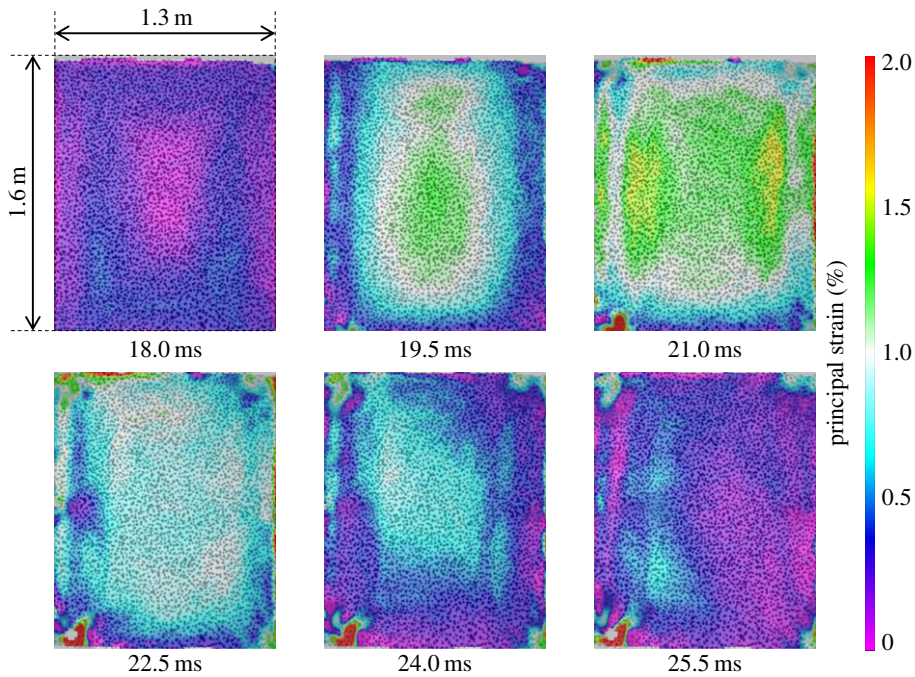
Figure 7. DIC analysis of blast on GL1 featuring contour plots of maximum principal strain. (Online version in colour.)

The maximum z -displacement, U_z^{\max} , was 140 mm and the maximum principal strain, ε^{\max} , peaked at 1.6% towards the right- and left-hand edges of the panel (figure 7). The carbon-fibre-skinned panel, CA1, deflected to a U_z^{\max} of only 107 mm, owing to a higher stiffness than that of the glass-fibre-skinned panel. Core shear failure was still observed. There was no skin damage visible in CA1, although a fine crack on one of the panel edges of CA2 was observed to occur,

CA1 was seen to have strain concentrating around the edges of the panel in figure 9, with the central region relatively unstrained, complementing the displacement observations in figure 8. Similarly, the edges of the GL1 were relatively highly strained between 18.0 and 21.0 ms; however, this strain progressed to concentrate around a region that suffered complete failure along an edge (figure 7). This coincided with the time at which a front-face failure was observed in figure 3.

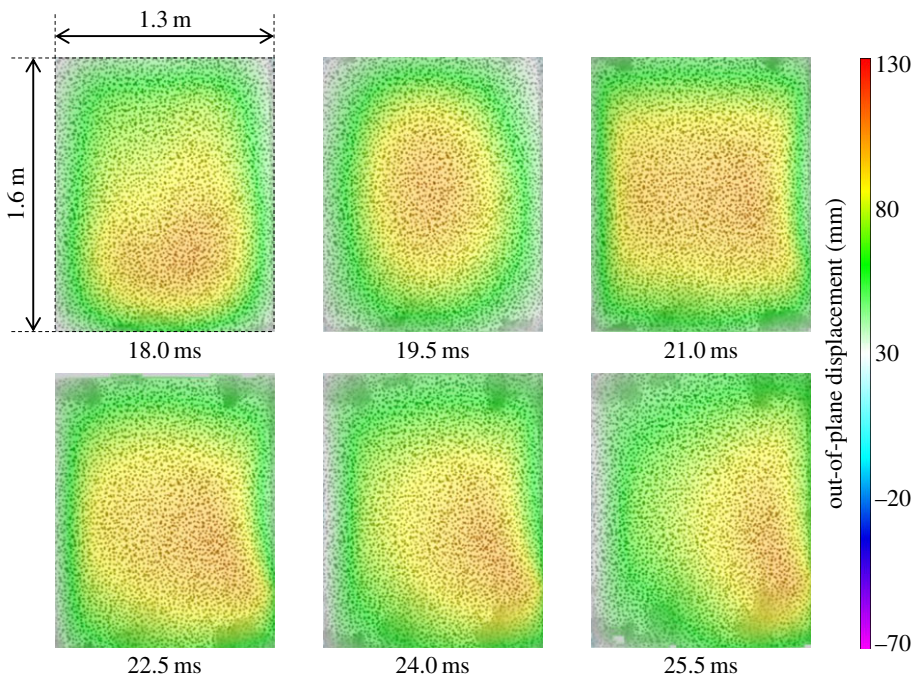
Figure 8. DIC analysis of blast on CA1 featuring contour plots of out-of-plane displacement. (Online version in colour.)

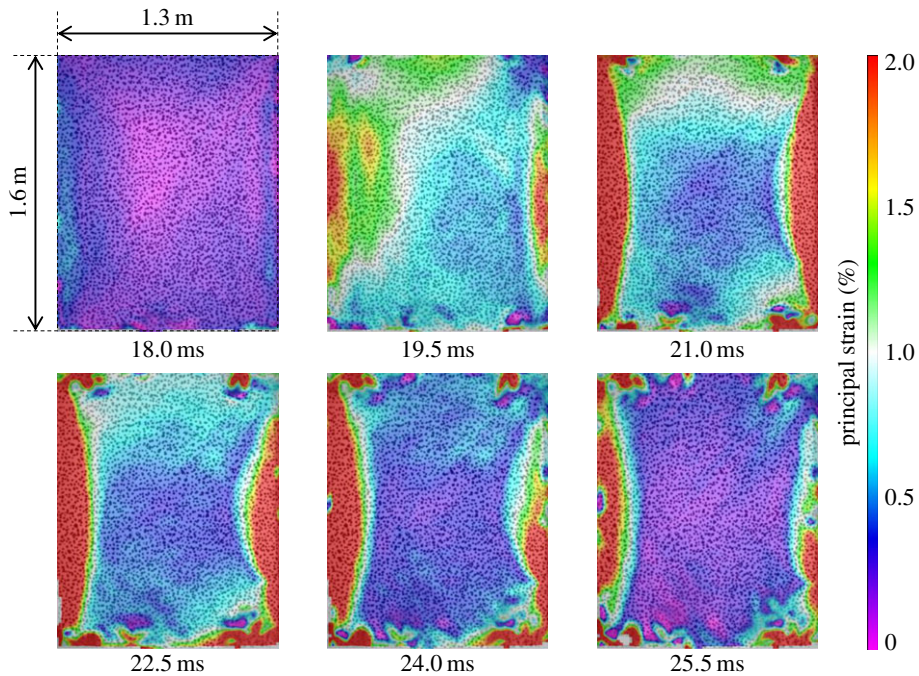
Figure 9. DIC analysis of blast on CA1 featuring contour plots of maximum principal strain. (Online version in colour.)

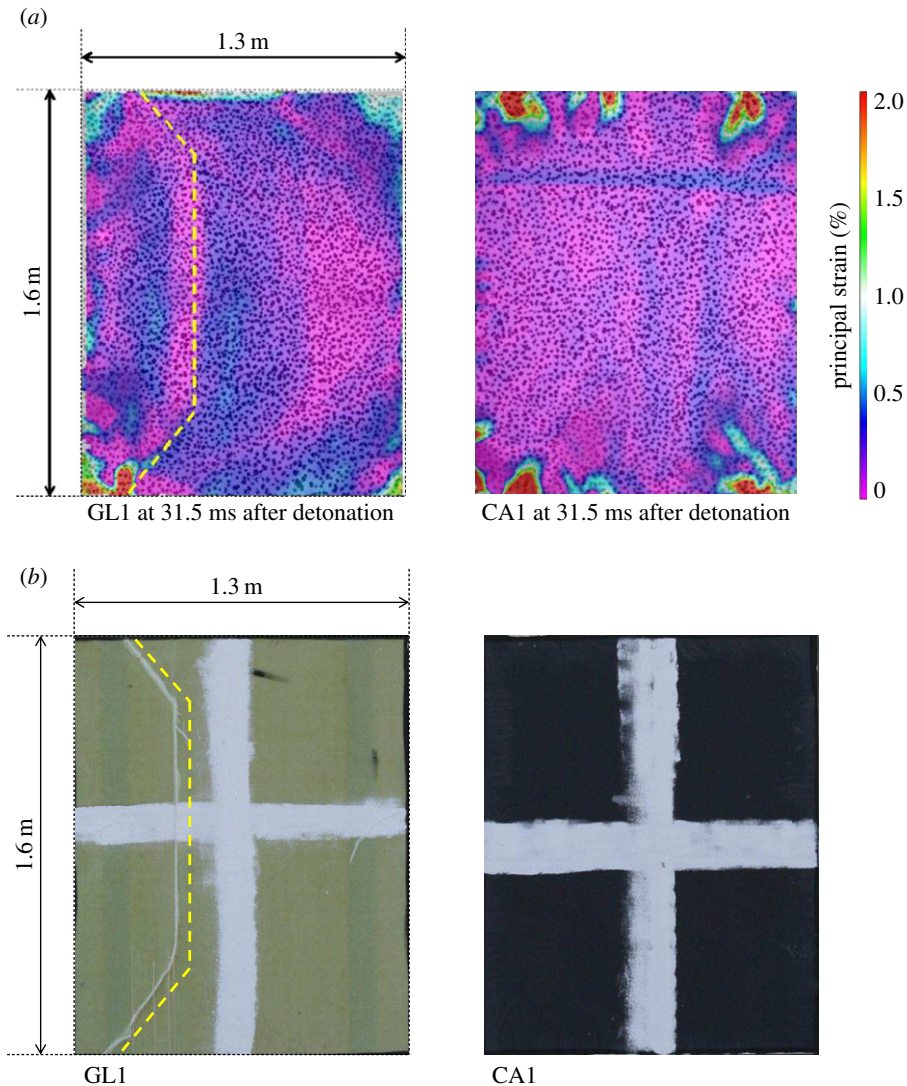
Figure 10. DIC analysis of both GL1 and CA1 showing (a) the maximum principal strains and (b) the mirrored images of the damaged front faces of each target. (Online version in colour.)

Clear indications of damage induced are shown in the DIC images. Sample snapshots of the maximum principal strain are given in figure 10*a*. For GL1, there is a region of material in compression of approximately -1% when GL1 is at its peak rebound displacement (out towards the origin of the charge). This region builds in strain owing to the lack of support

provided by the core. This lack of support due to core cracking can also be observed in CA1, along the top of the panel, but, in this case, front facesheet damage is not observed owing to the higher strength of the carbon fibre. A core shear failure propagated through the panel, resulting in a front-skin failure as well shown in figure 10*b*. The front-face image of the damaged sample in figure 10*b* has been mirrored for ease of comparison with the rear-face DIC result in figure 10*a*. In both carbon panels, there was no visible skin damage apart from a few hairline cracks on the front-most fibres. The higher-stiffness fibres resisted the blast better in terms of a lower out-of-plane deflection. However, by deflecting less, more energy was retained in the sandwich panel and, rather than being dissipated in momentum, it was dissipated in internal reflections within the sandwich material. This led to a greater coverage of core shear failure within the carbon-fibre-skinned panels than the glass-fibre-skinned ones. Evidence in figure 10*a* shows a typical flicker of subsurface damage in CA1. During the deformation and rebound phases, the core cracks are individually highlighted with bands of strain concentration, i.e. the dark (blue online) streaks in the plot of 0.5% strain across the relatively unstrained surface (light (purple online)). Areas where wider bands of strain relief are observed also suffered propagation of the shear cracks into interfacial failures as well, again showing that the strain contour plots available through DIC analysis can be used as an indication of subsurface damage in the sandwich composites (to be discussed further in §3c).

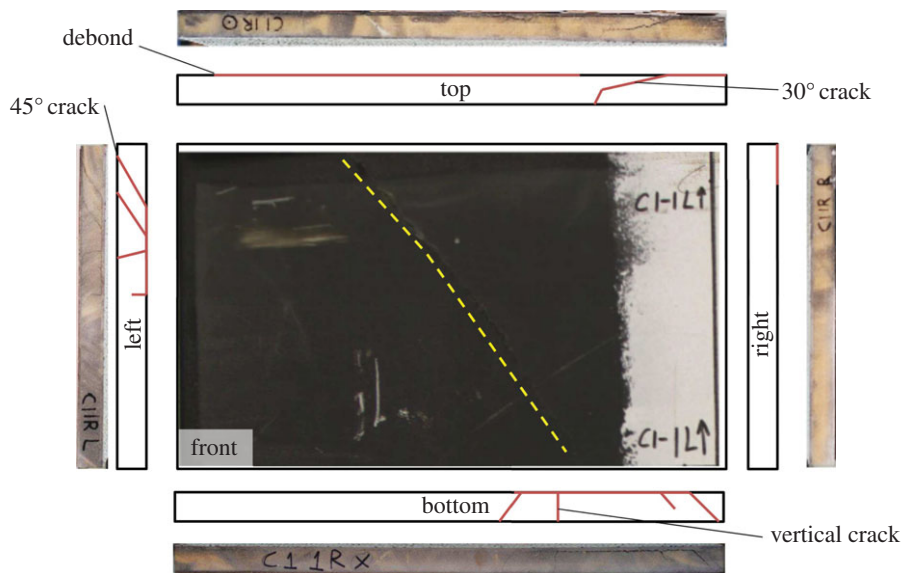
Figure 11. An example of the documentation process for visual inspection post-blast on CA1 subpanel 1R (650 × 400 mm in area), showing images and schematics of damage noted. Subpanel 1R is top right when viewed from the rear. (Online version in colour.)

After the blast experiments, the samples were recovered and sectioned into eight equally sized subpanels, 635 × 400 mm in area. The global panels of CA1, CA2, GL1 and GL2 were cut down their vertical into halves and then cut into a further four sections down each side. Each subpanel was then visually inspected for damage. An example of a 1R subpanel (top right when viewed from rear) for CFRP is presented in figure 11 and a 1R subpanel for GFRP is presented in

figure 12. Core cracks are identified and recorded in terms of orientation. Debonded surfaces are also recorded in terms of percentage propagation along a length. Sample records are shown for CA1 and GL1 for subpanel location 1R, presented in table 2. Such visual inspection records were collected for all subpanels, to be used later in the discussion to analyse how post-blast damage influences residual strength. The estimates are based on debonds as a percentage of the length of the edge, from edge inspections. This can be further verified with the use of three-dimensional CT scanning to determine the extent of subsurface damage.

vertically, and then into four smaller panels horizontally. Damage was observed along the edges of each panel, and recorded in a series of images. Examples of such images are shown in figures 11 and 12. These images were used to estimate the degree of damage within each panel to correlate such measures of damage, as presented previously in table 2, with residual strength.

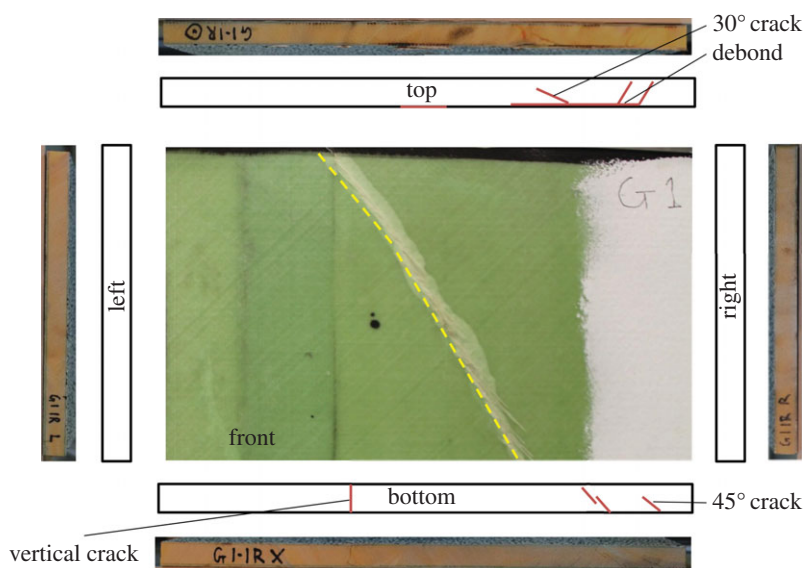
Figure 12. An example of the documentation process for visual inspection post-blast on GL1 subpanel 1R (650 × 400 mm in area), showing images and schematics of damage noted. Subpanel 1R is top right when viewed from the rear. (Online version in colour.)

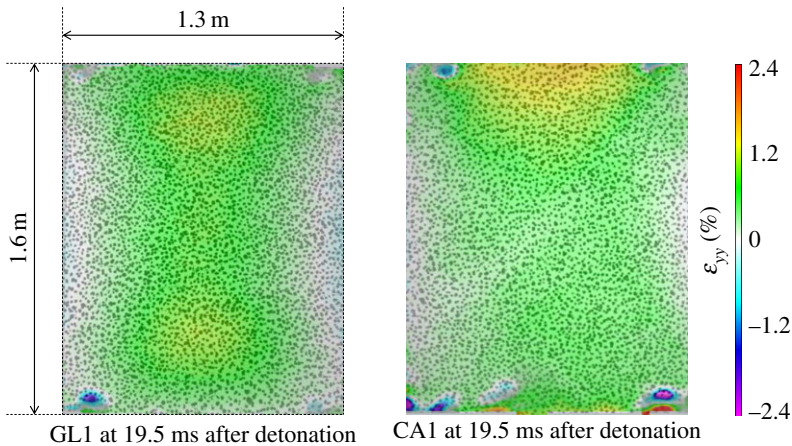
Figure 13. DIC analysis showing strain in the y -direction in GL1 and CA1 recorded during the blast taken at 19.5 ms after detonation. (Online version in colour.)

Signs of where the most damaged areas of each global panel occur were available in the DIC analysis. Figure 13 shows the strain in the y -direction in the image, denoted ε_{yy} , for GL1 and CA1. It is shown that the propensity for horizontal cracking along the shorter length (x -direction) is fairly uniform in GL1, whereas in CA1, ε_{yy} is much higher towards the top edge of the target. This goes some way to highlight why visual inspections show that the GFRP panels were more uniformly damaged throughout the target compared with the CFRP sandwich panels. Evidence

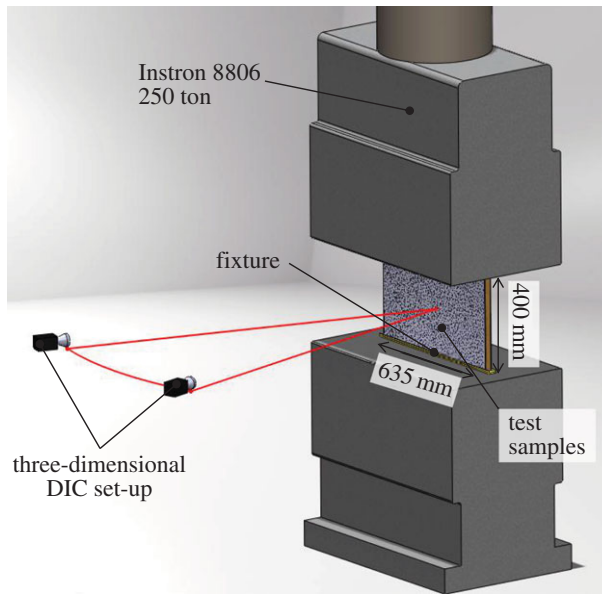
Figure 14. Schematic of the experimental test set-up for edgewise compression of sandwich materials. (Online version in colour.)

Two 5 MP digital cameras were set up and calibrated for three-dimensional DIC on one side of the panel, which now had a finer speckle pattern applied owing to the higher resolution of the recording apparatus and the smaller size of the samples, as per standard image correlation practices [33]. In all cases, the imaged face was the skin, which was originally facing the explosive charge. A schematic of the experimental test set-up is shown in figure 14.

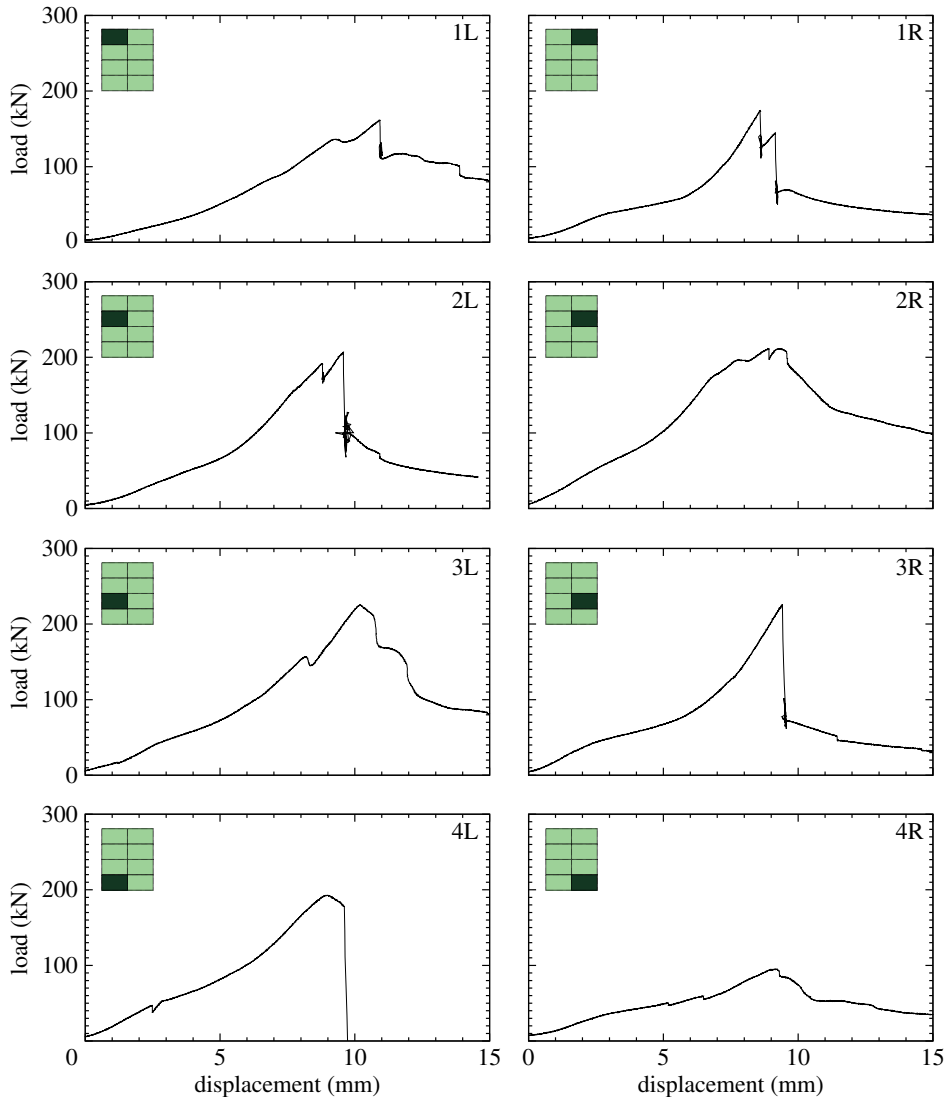
Figure 15. Force–time data for each sample in GL1. Data for each subpanel are shown in the position of where it lay in the global blast panel as viewed from rear of panel. The inset shows the location of the subpanel within the GFRP panel. (Online version in colour.)

Figure 15 shows a summary of all the load–displacement plots taken for each subpanel of GL1 tested, with each location of the subpanel within the global blasted panel labelled. It was observed in the glass specimens that the ultimate compressive load was greater for those panels which were situated in positions 2 and 3. The damage here was observed to be less severe than the bottom of the panels. The damage in the centre panels was also noted to be predominantly at the top and bottom, and the DIC data from the blast test (figures 16 and 17) suggested that core cracks travelled vertically, in line with the direction of the compressive load. It can be seen in figure 18 that higher ultimate loads were withstood by the panels in positions 2 and 3, and that, particularly in position 4R, a much lower load was attained before ultimate failure. These panels demonstrated

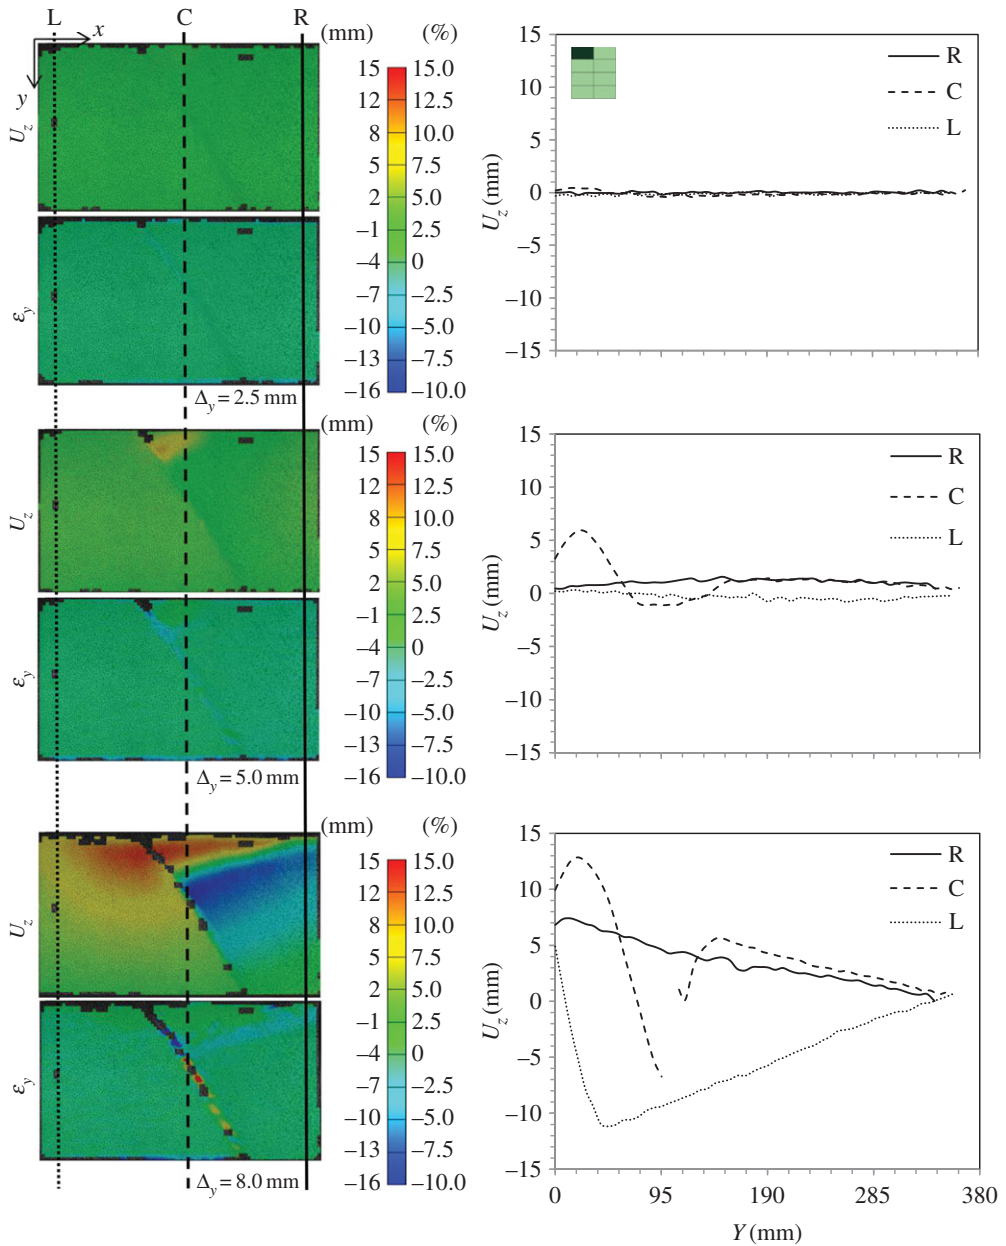
Figure 16. DIC analysis for subpanel 1L (top left when viewed from rear) in global blast panel GL1: out-of-plane displacement, U_z , and strain in the y -direction, ε_y ; and section plots showing the variation of U_z along the height of the panel at three locations along the length—right (R), centre (C) and left (L). Note the subpanel dimensions were 635×400 mm; however, a window height of 360 mm was imaged. (Online version in colour.)

Figure 16 shows DIC images, which have been extracted to illustrate out-of-plane displacement, U_z , of the front GFRP skin, as well as strain in the vertical direction, ε_y , on the front face. The idea here is that, during the early stages of the loading of the subpanels, the DIC contours can tell the user what kind of subsurface damage is present. A simple concept

figure 16 and 3L in figure 17 for various compressive loading stages labelled with reference to the full load–displacement plots given in figure 14.

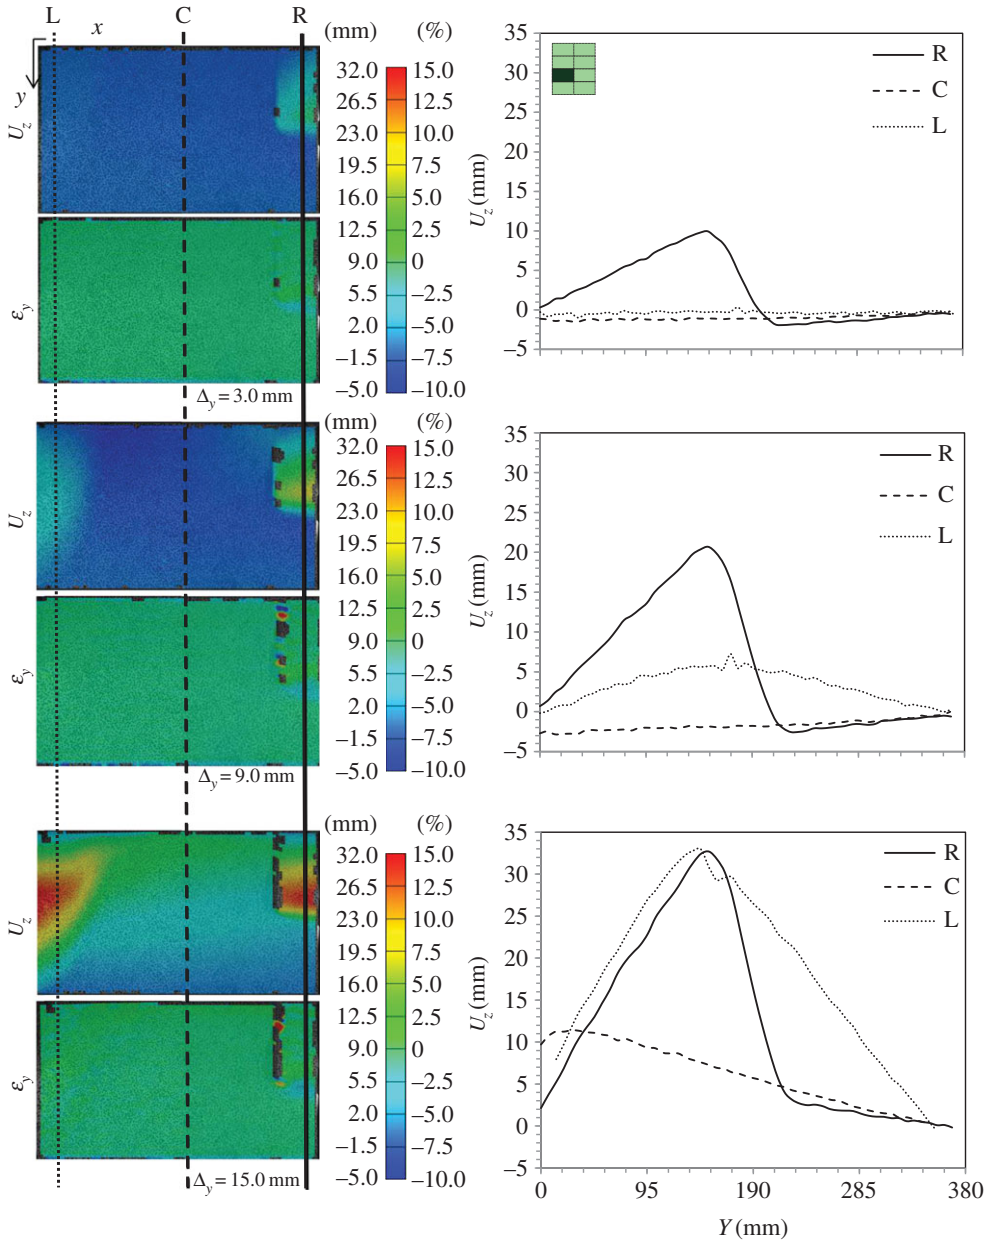
Figure 17. DIC analysis for subpanel 3L in global blast panel GL1: out-of-plane displacement, U_z , and strain in the y -direction, ϵ_y , and section plots showing the variation of U_z along the height of the panel at three locations along the length—right (R), centre (C) and left (L). (Online version in colour.)

Clearly visible from these images are residual cracks that were in place in the front glass sheet from blast testing. Also visible in these DIC images is the fact that wrinkling has taken place in the front skin, mainly due to discontinuity across the facesheet as a result of the skin cracking. This is an interesting feature, as it shows that the two facesheets still maintain some connection through the foam, so not all out-of-plane displacement is away from the centreline.

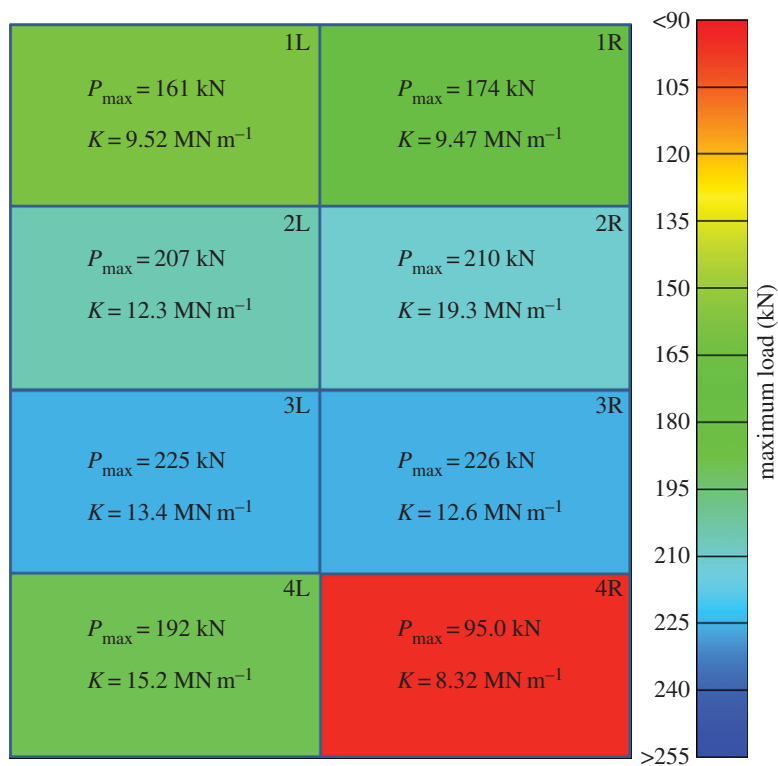
Figure 18. Graphic showing, as a greyscale (colour) plot, how ultimate load-bearing capacity varied with location of subpanel on the global GFRP blast panel as viewed from rear. (Online version in colour.)

relative to the whole target, which is also being loaded by the blast. There is a period of build-up during the loading phase, particularly on a non-infinitely rigid surface. The surface waves travelling along the panel are transmitted along the lengths towards other regions of the target, i.e. opposite corners. The faster wave speed in the CFRP targets allows the waves to propagate to the other boundaries quicker than in the GFRP targets. Therefore, damage builds up greatly in the CFRP targets away from the centre. However, in the GFRP targets, the magnitude of the blast wave is sufficient to breach the failure strain of the fibres (especially once support from the core is lost due to shear failures), and so energy dissipation to remote areas from peak-loaded ones is minimized. Energy is lost due to other failure mechanisms in the GFRP sandwich panels such as gross skin failure, rather than simply core damage. Therefore, the more significantly damaged area is focused in the GFRP targets to where the most force is expected to be applied and not necessarily focused in the CFRP targets. This concept is shown in figures 18 and 22.

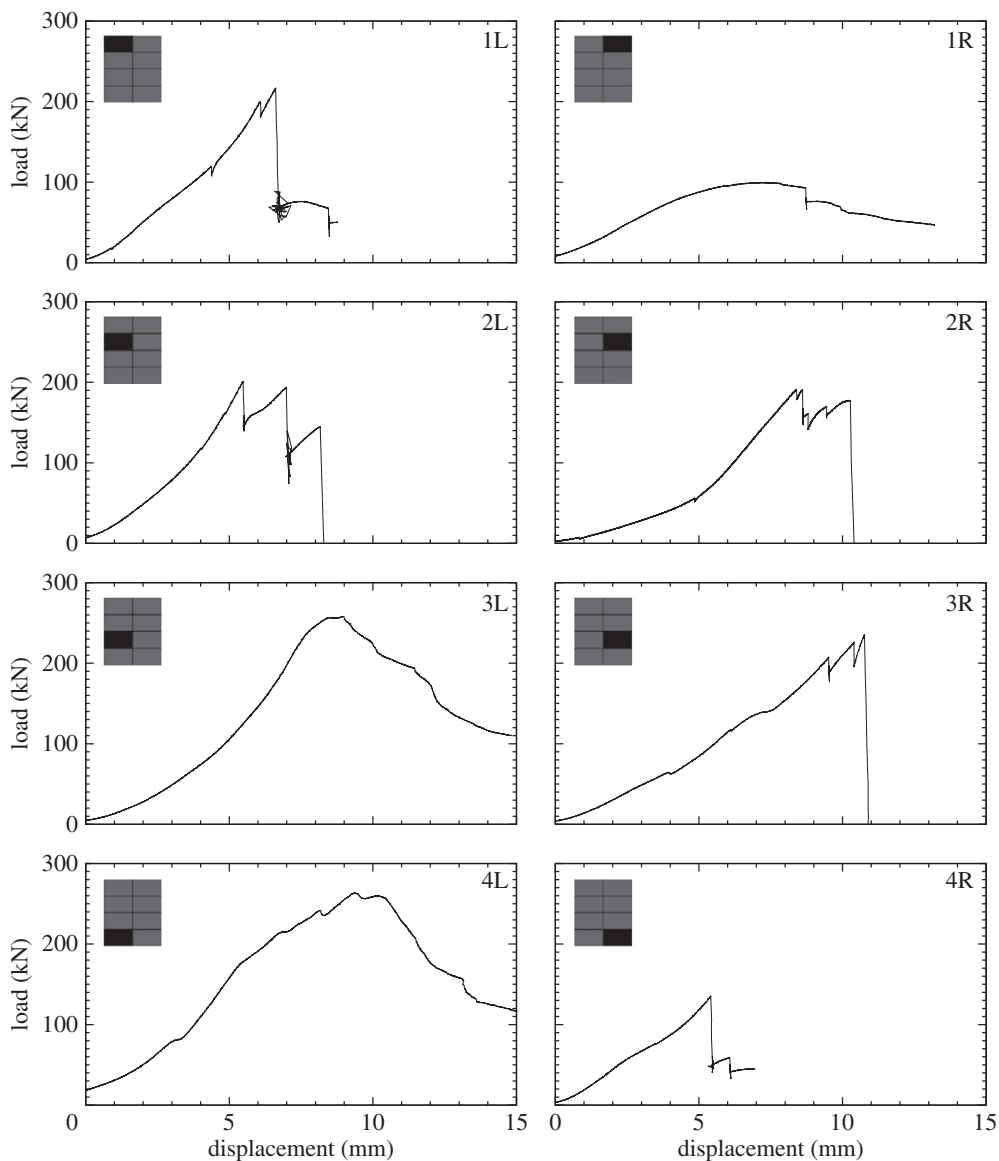
Figure 19. Force–time data for each sample in CA1. Data for each subpanel are shown in the position of where it lay in the global blast panel as viewed from rear. The inset shows the location of the subpanel within the CFRP panel.

Figure 19 shows a summary of the load–displacement plots for the subpanels of CA1 tested. Figures 20 and 21 show the DIC for out-of-plane displacement in the CA1 subpanels 1R and 4R, respectively. The point during each test where the plots have been extracted are marked in terms of compressive displacement relating to the plots in figure 19. Similar to those figures produced for the GFRP subpanels, each compressive stage shows DIC images to illustrate the variation of out-of-plane motion and ε_y along the height of the panel front. The carbon skins suffered minimal damage during blast testing, which can be seen from the even displacements in the DIC images. However, core cracking and debonding were present in these test samples. In CA1-4R, this can be seen by the high out-of-plane deflection and relatively uniform strain plots on the right-hand edge, which corresponds to the core cracking damage.

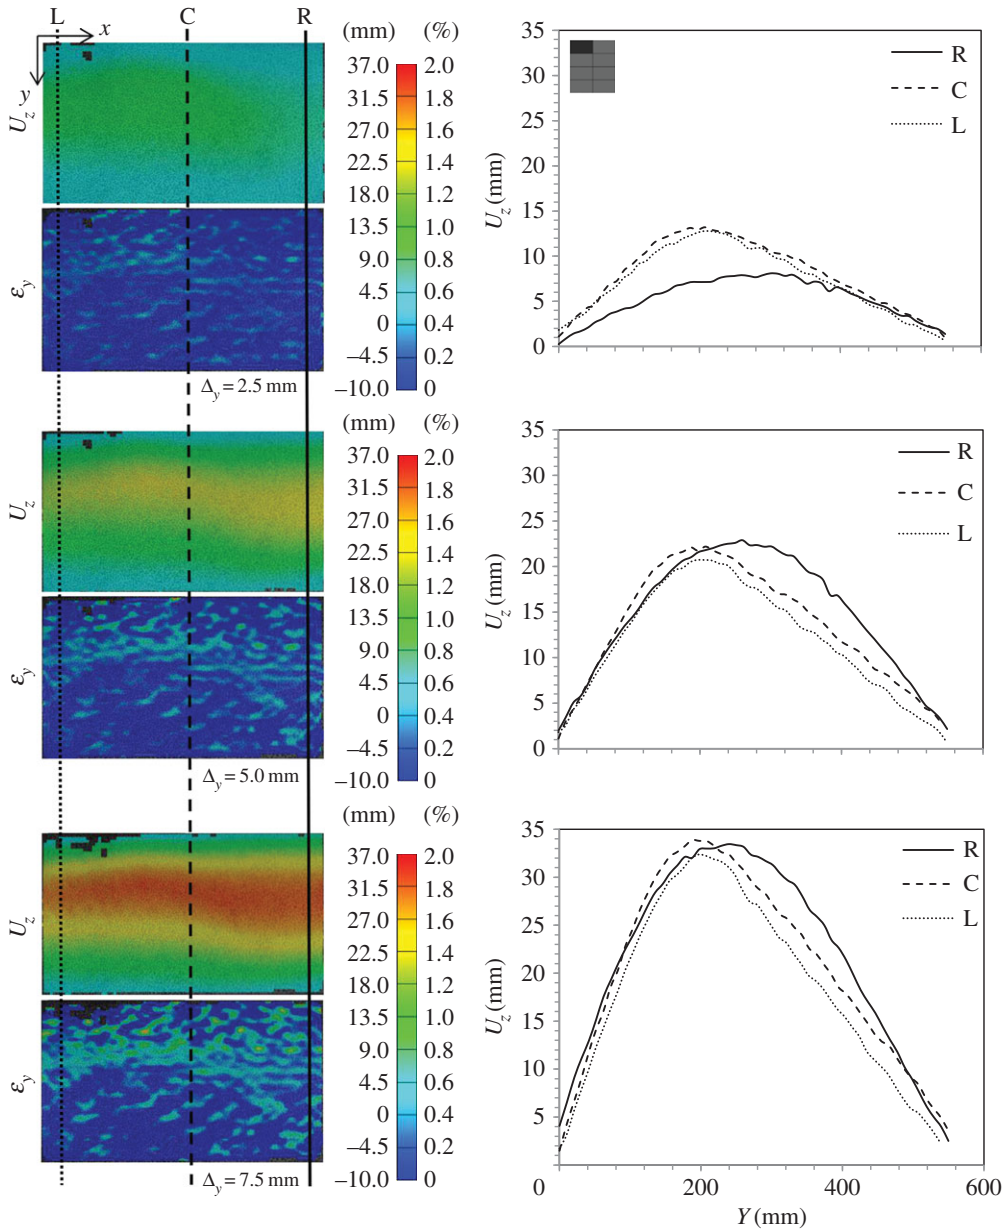
Figure 20. DIC analysis for subpanel 1L in global blast panel CA1: out-of-plane displacement, U_z , and strain in the y -direction, ε_y ; and section plots showing the variation of U_z along the height of the panel at three locations along the length—right (R), centre (C) and left (L). (Online version in colour.)

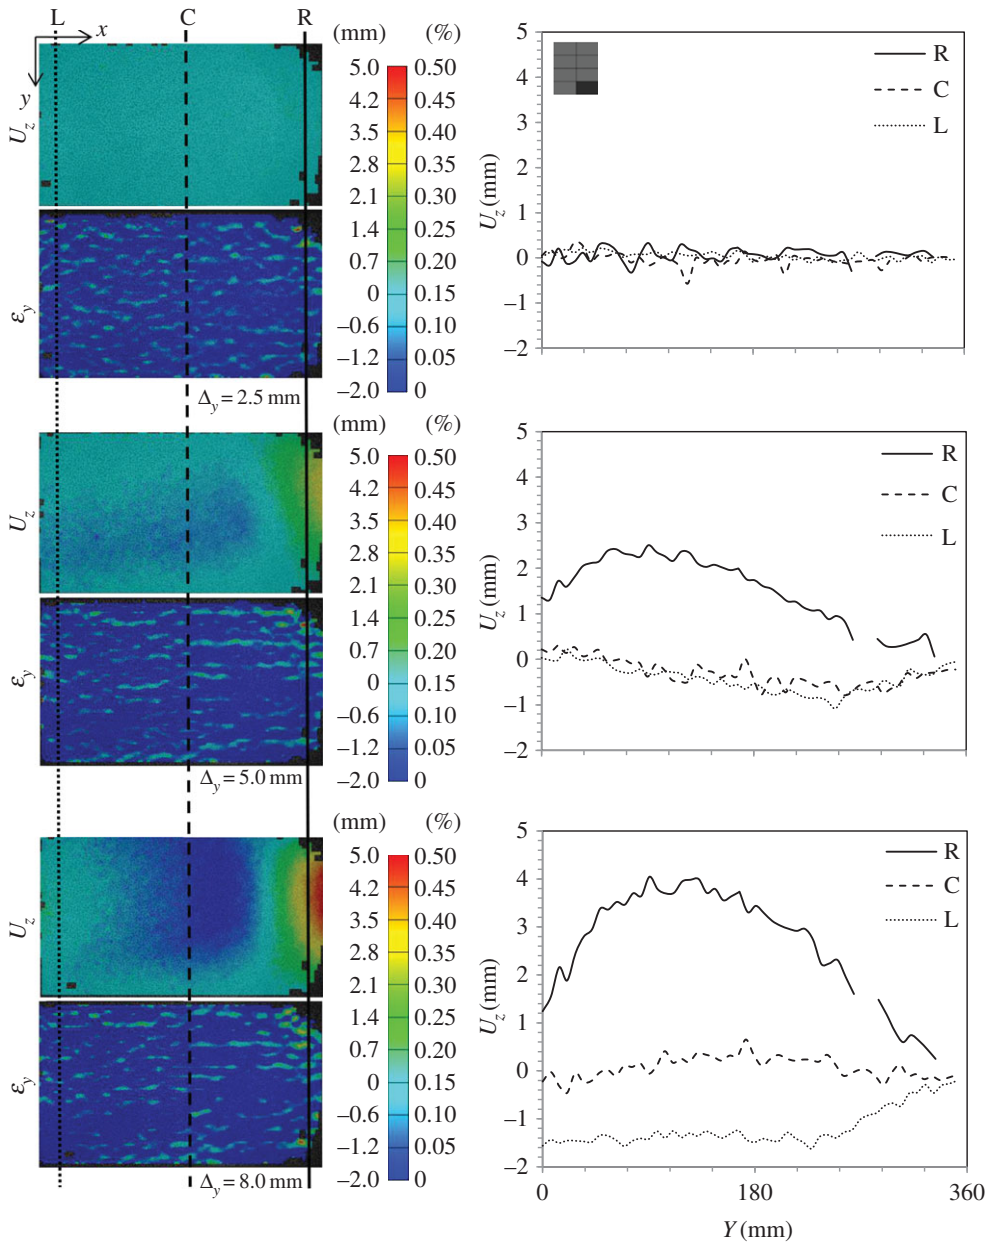
Figure 21. DIC analysis for subpanel 4R in global blast panel CA1: out-of-plane displacement, U_z , and strain in the y -direction, ϵ_y ; and section plots showing the variation of U_z along the height of the panel at three locations along the length—right (R), centre (C) and left (L). (Online version in colour.)
