EVALUATION PROGRAM
for
SECONDARY SPACECRAFT CELLS

SEVENTH ANNUAL REPORT
OF
CYCLE LIFE TEST

SEVENTH ANNUAL REPORT OF CYCLE LIFE TEST

QE/C 71-1 29 JANUARY 1971

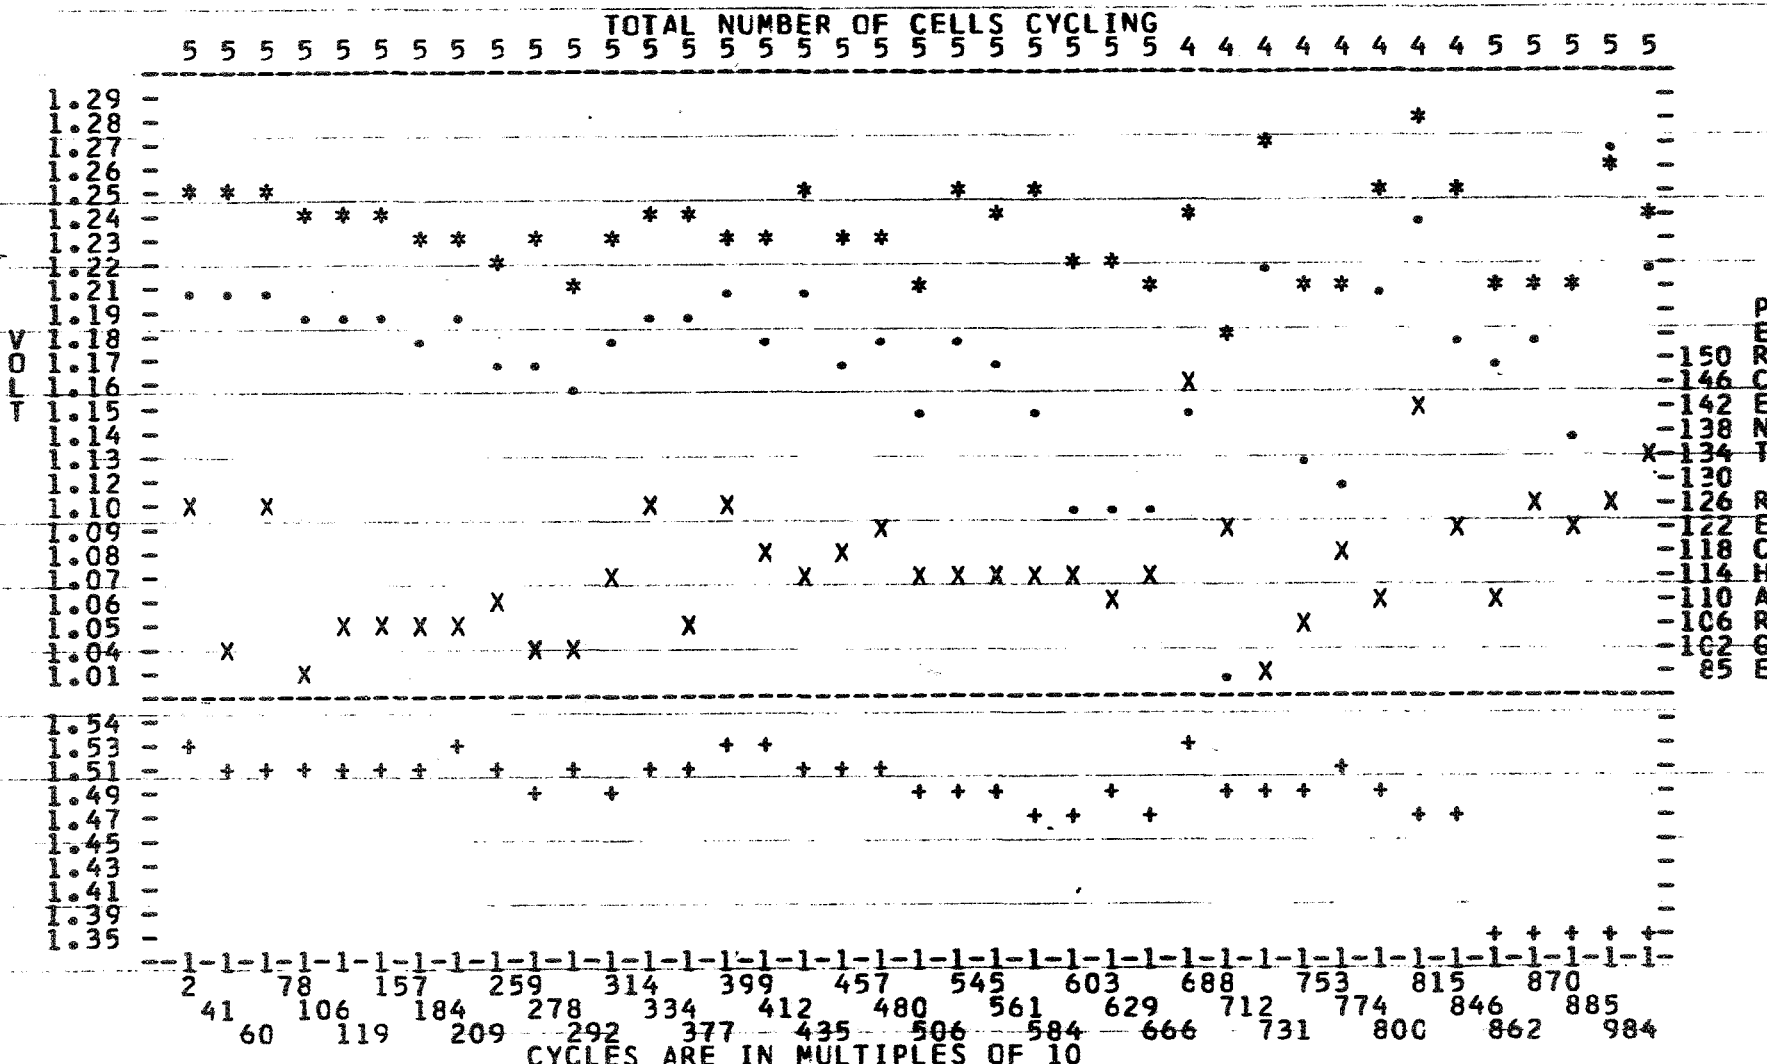
FIGURE 76

(1) Performance on Cycling: (Figures 76 through 78) Cycling was started in November 1966. Packs 41B and 66B have completed 10,396 and 11,602 cycles, respectively, to date with one cell failure in pack 41B. Packs 29B and 18C failed after 7941 and 9633 cycles, respectively.

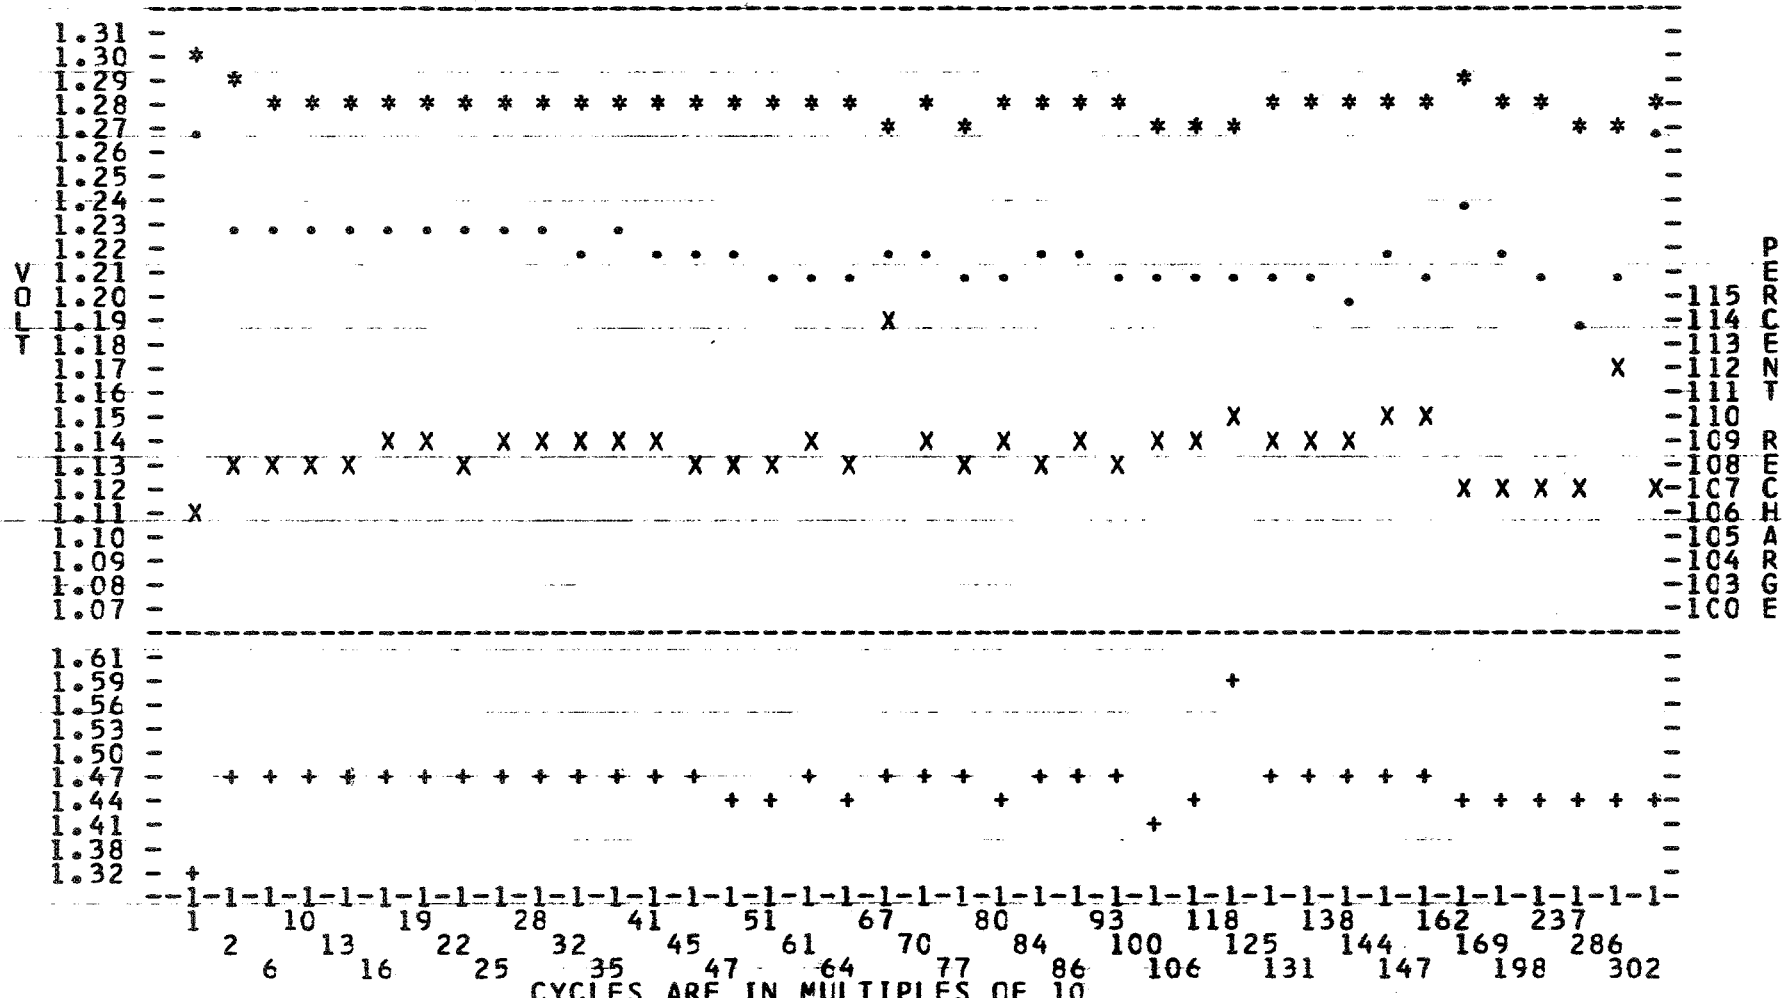
FIGURE 79

(1) Performance on Cycling: (Figures 79 through 83) Cycling was started in May 1970. Packs 22B and 46B were discontinued after 3419 and 1686 cycles, respectively with two failures in pack 46B. Packs 10B, 34C and 72C completed 3419, 3404 and 3384 cycles, respectively to date with two failures in pack 72C.

PACK 010B, MANUFACTURE SONOTONE20.0 AH
ORBIT PERIOD IN HOURS 01.5
TEMPERATURE IN DEGREES C. 20
CHARGE RATE IN AMPS 7.00
DEPTH OF DISCHARGE IN % 25

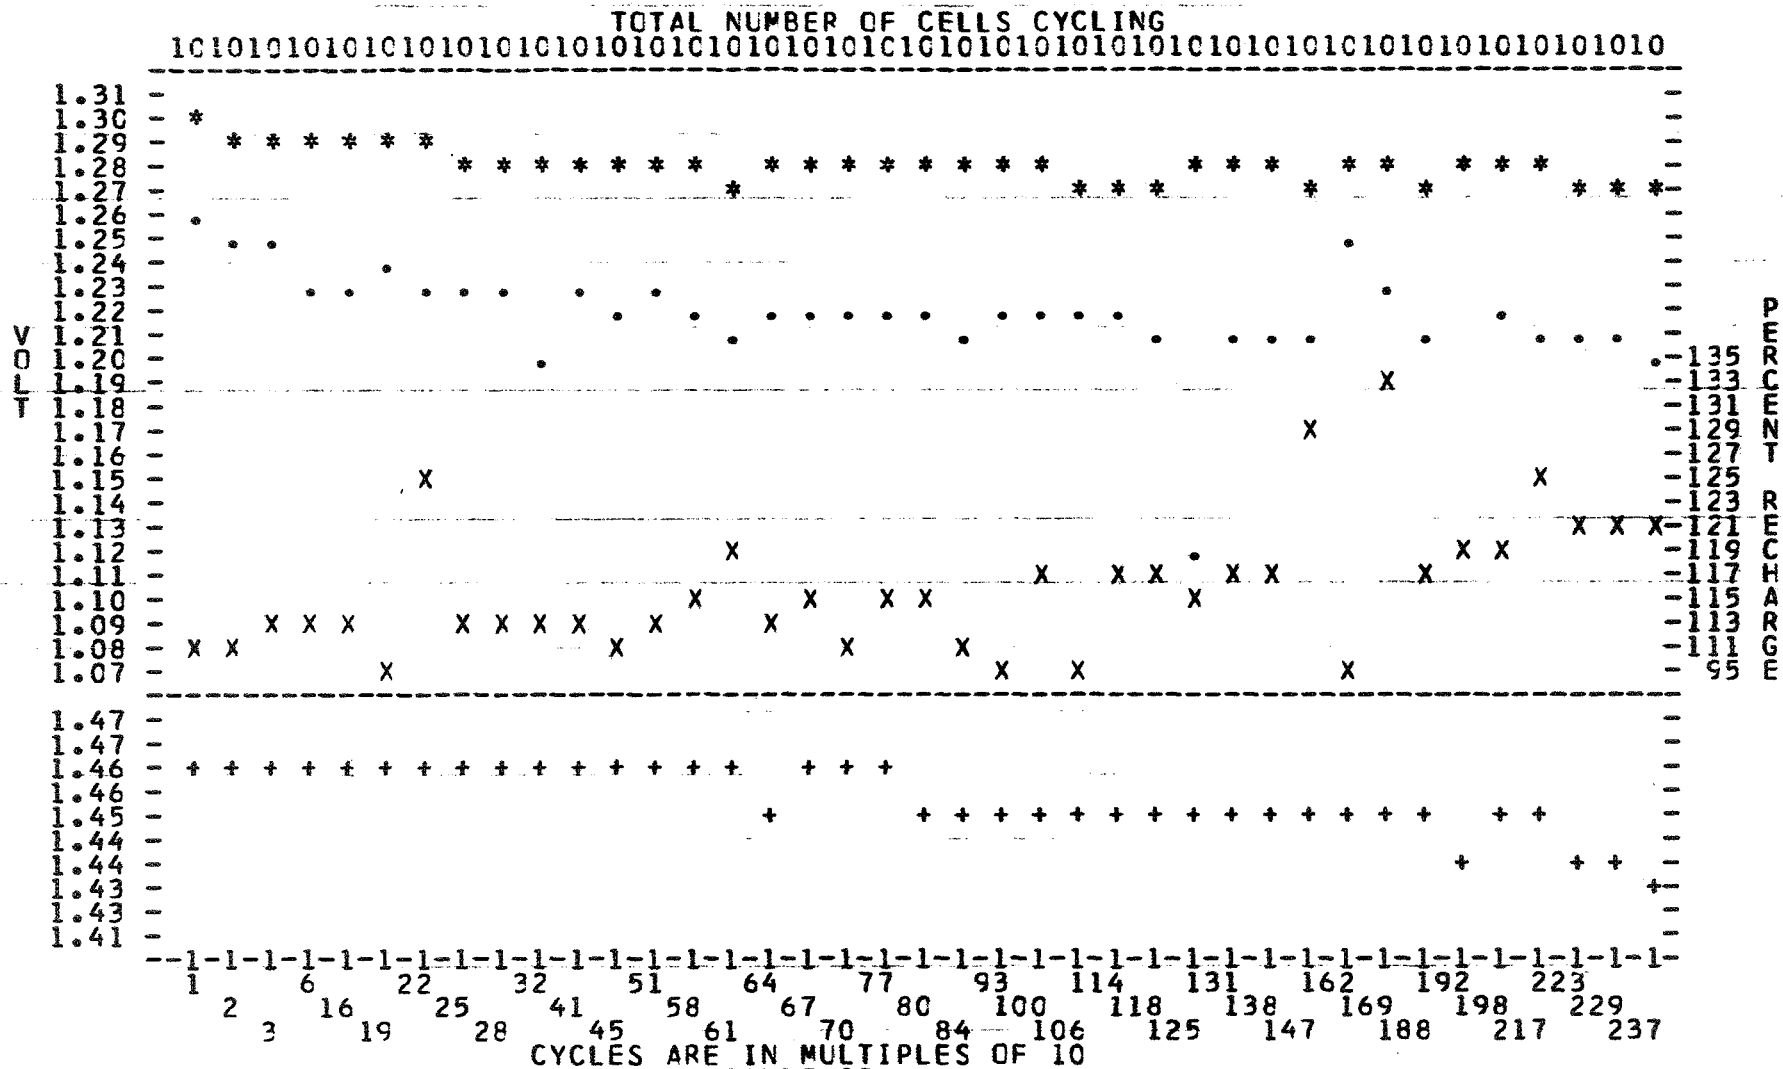
FIGURE 80

(2) Failure Analysis: Analysis of four failed cells revealed that separator deterioration and migration of the negative material were the major causes of failure. High pressure,

weak tab-to-plate welds, extraneous active material, and blistering on the positive plates were also in evidence. Packs 22B and 46B were discontinued when they failed to reach the voltage limit on cycling thereby receiving a recharge in excess of 200 percent which was causing the cell cases to become exceedingly hot. These packs were sent to NASA, Lewis Research Center, for further testing and/or failure analysis.

PACK C22B, MANUFACTURE SONGTONE20.0 AH
ORBIT PERIOD IN HOURS 01.5
TEMPERATURE IN DEGREES C. 20
CHARGE RATE IN AMPS 15.00
DEPTH OF DISCHARGE IN % 25

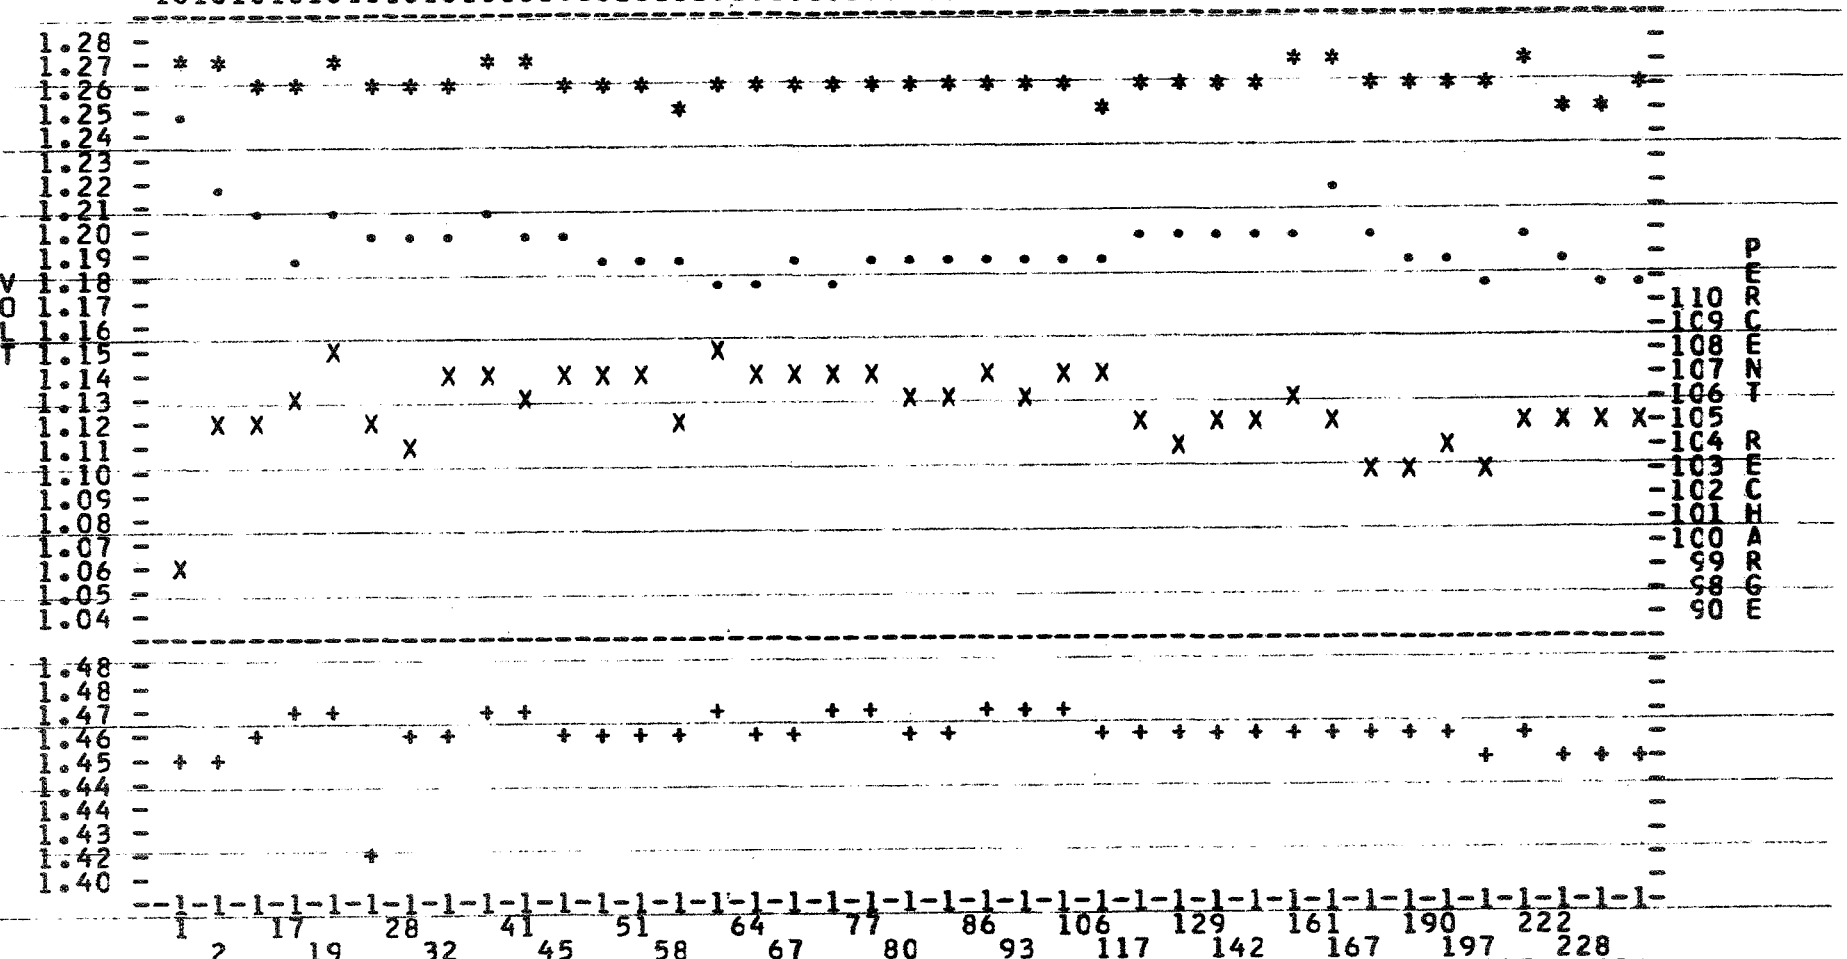
FIGURE 81

PACK 034C, MANUFACTURE SONOTONE20.0 AH
ORBIT PERIOD IN HOURS 01.5
TEMPERATURE IN DEGREES C. 20
CHARGE RATE IN AMPS 15.00
DEPTH OF DISCHARGE IN % 40

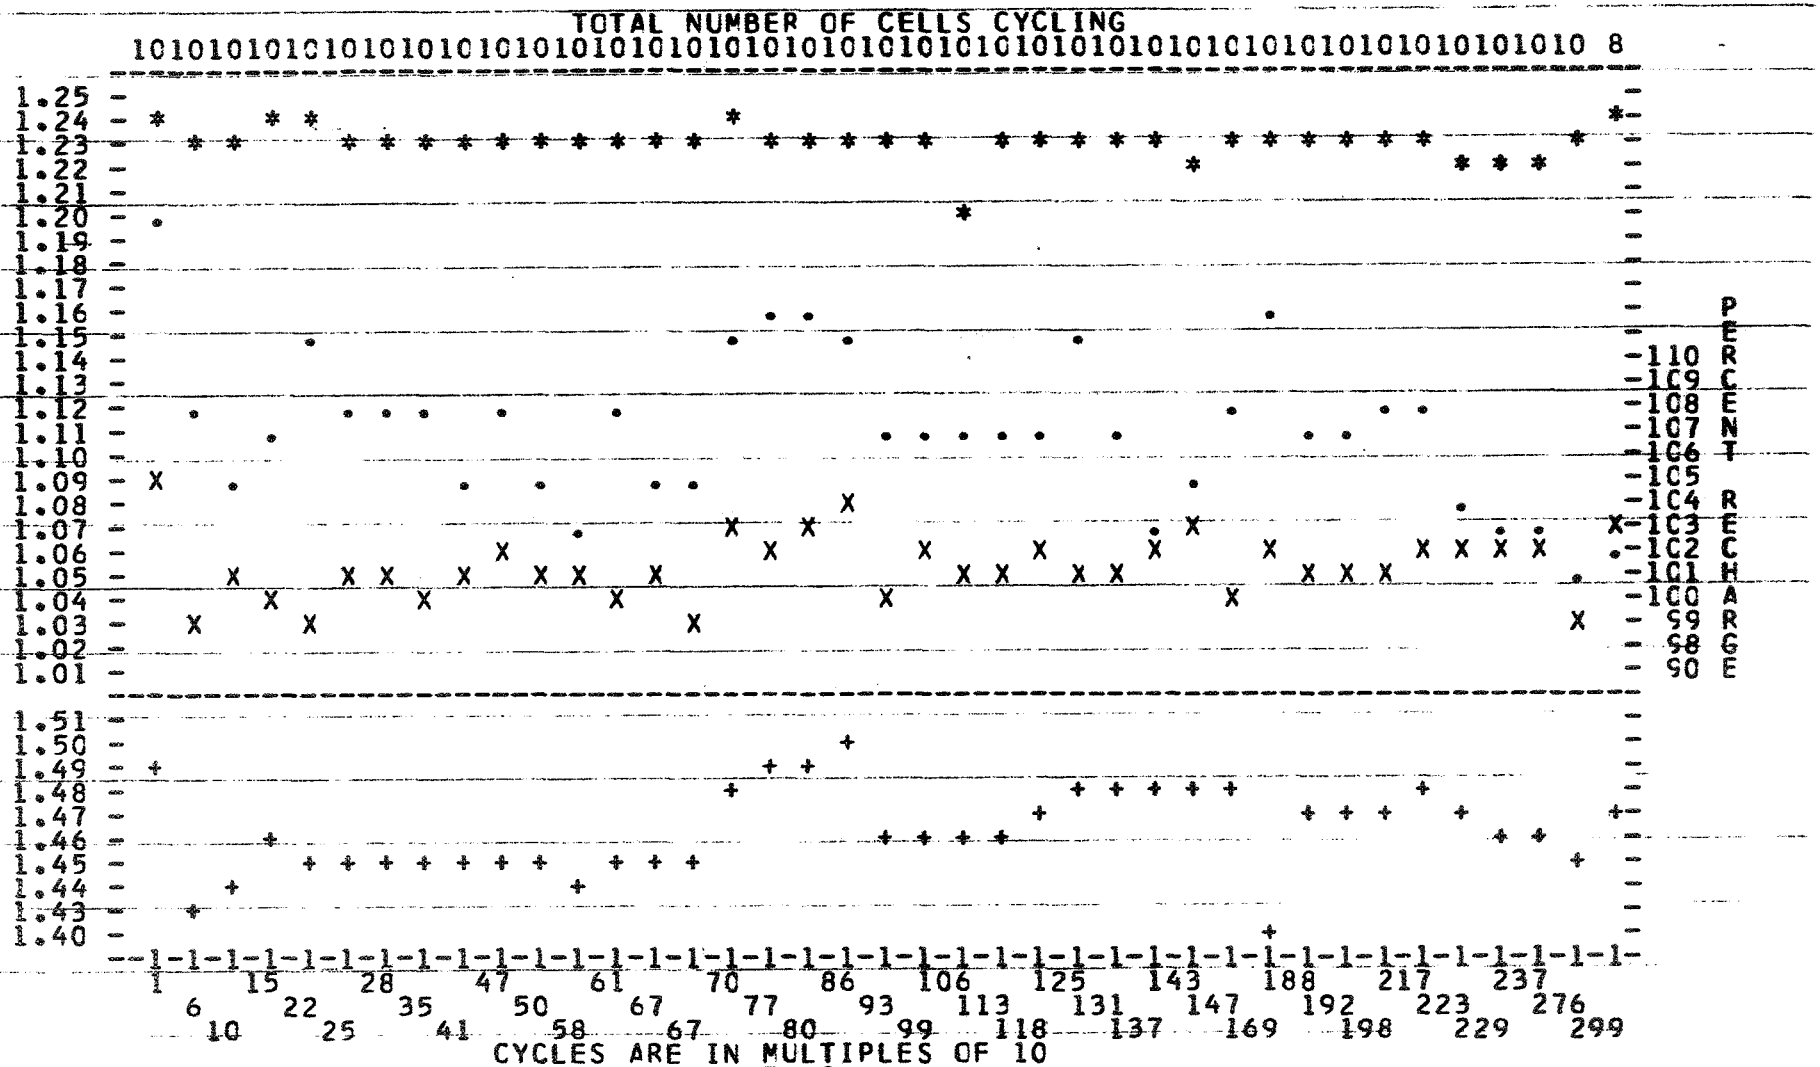
FIGURE 82

PACK C72C, MANUFACTURE SONOTONE20.0 AH
ORBIT PERIOD IN HOURS 01.5
TEMPERATURE IN DEGREES C. 20
CHARGE RATE IN AMPS 20.00
DEPTH OF DISCHARGE IN % 75

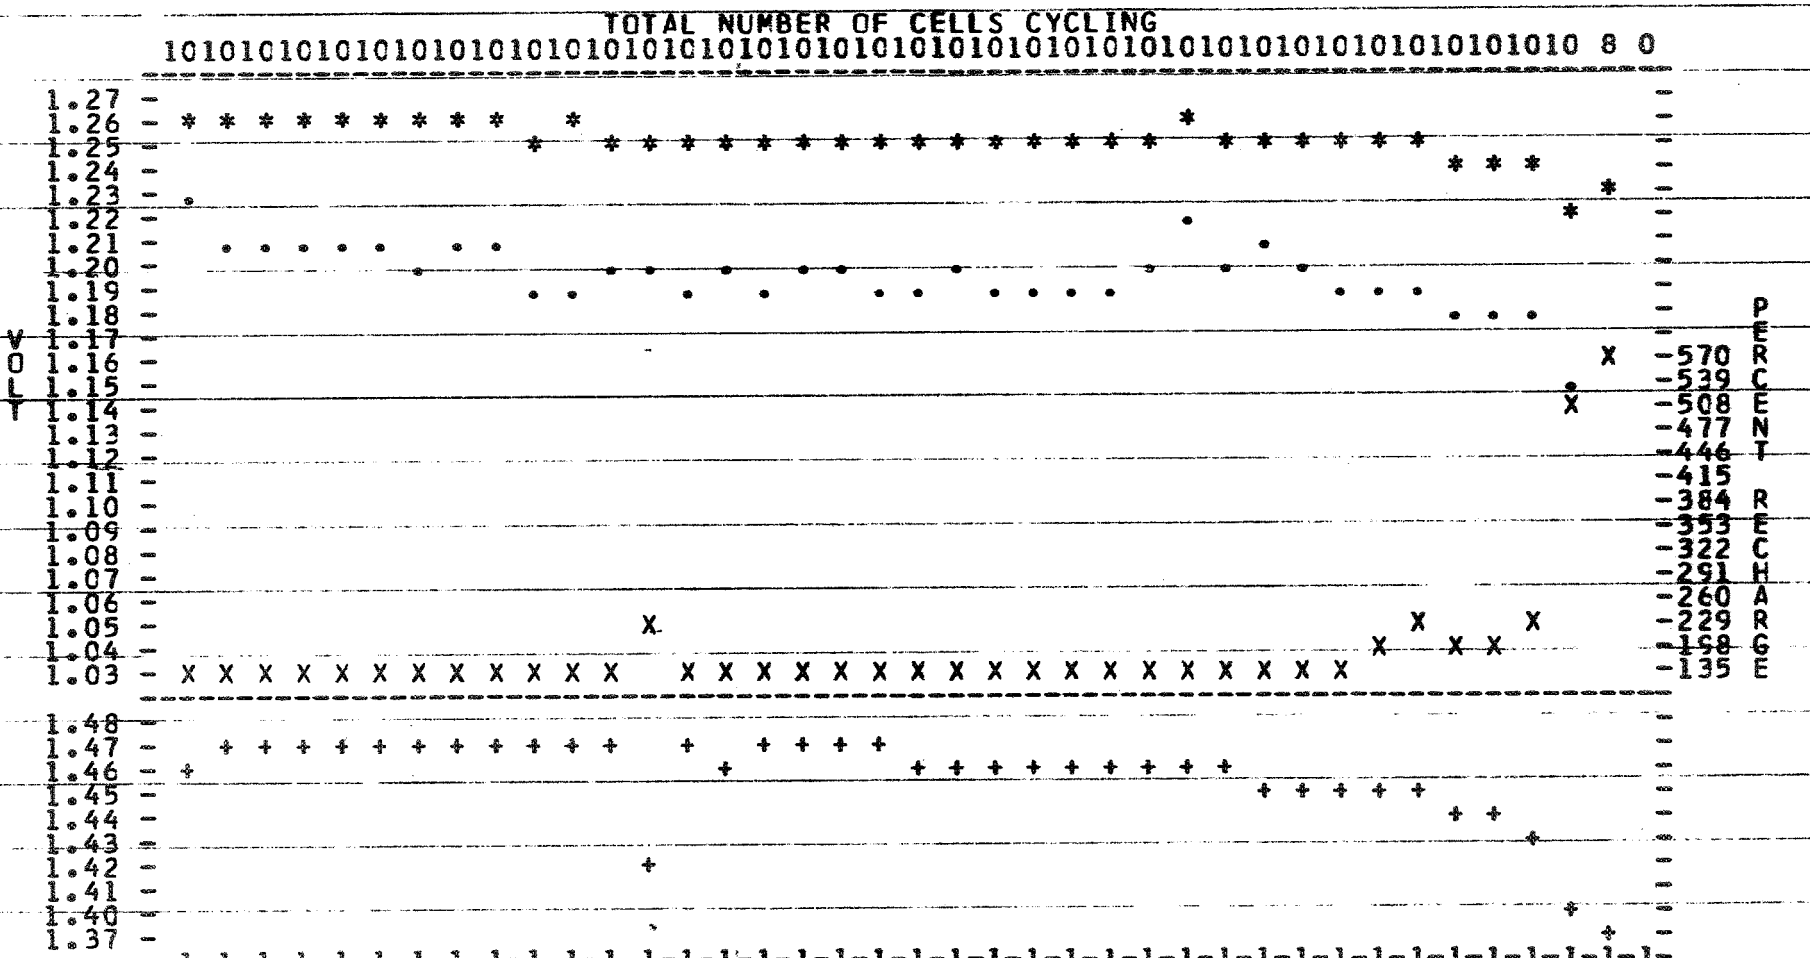
FIGURE 83

PACK 046B, MANUFACTURE SONOTONE20.0 AH
ORBIT PERIOD IN HOURS 03.0
TEMPERATURE IN DEGREES C. 20
CHARGE RATE IN AMPS 15.00
DEPTH OF DISCHARGE IN % 40

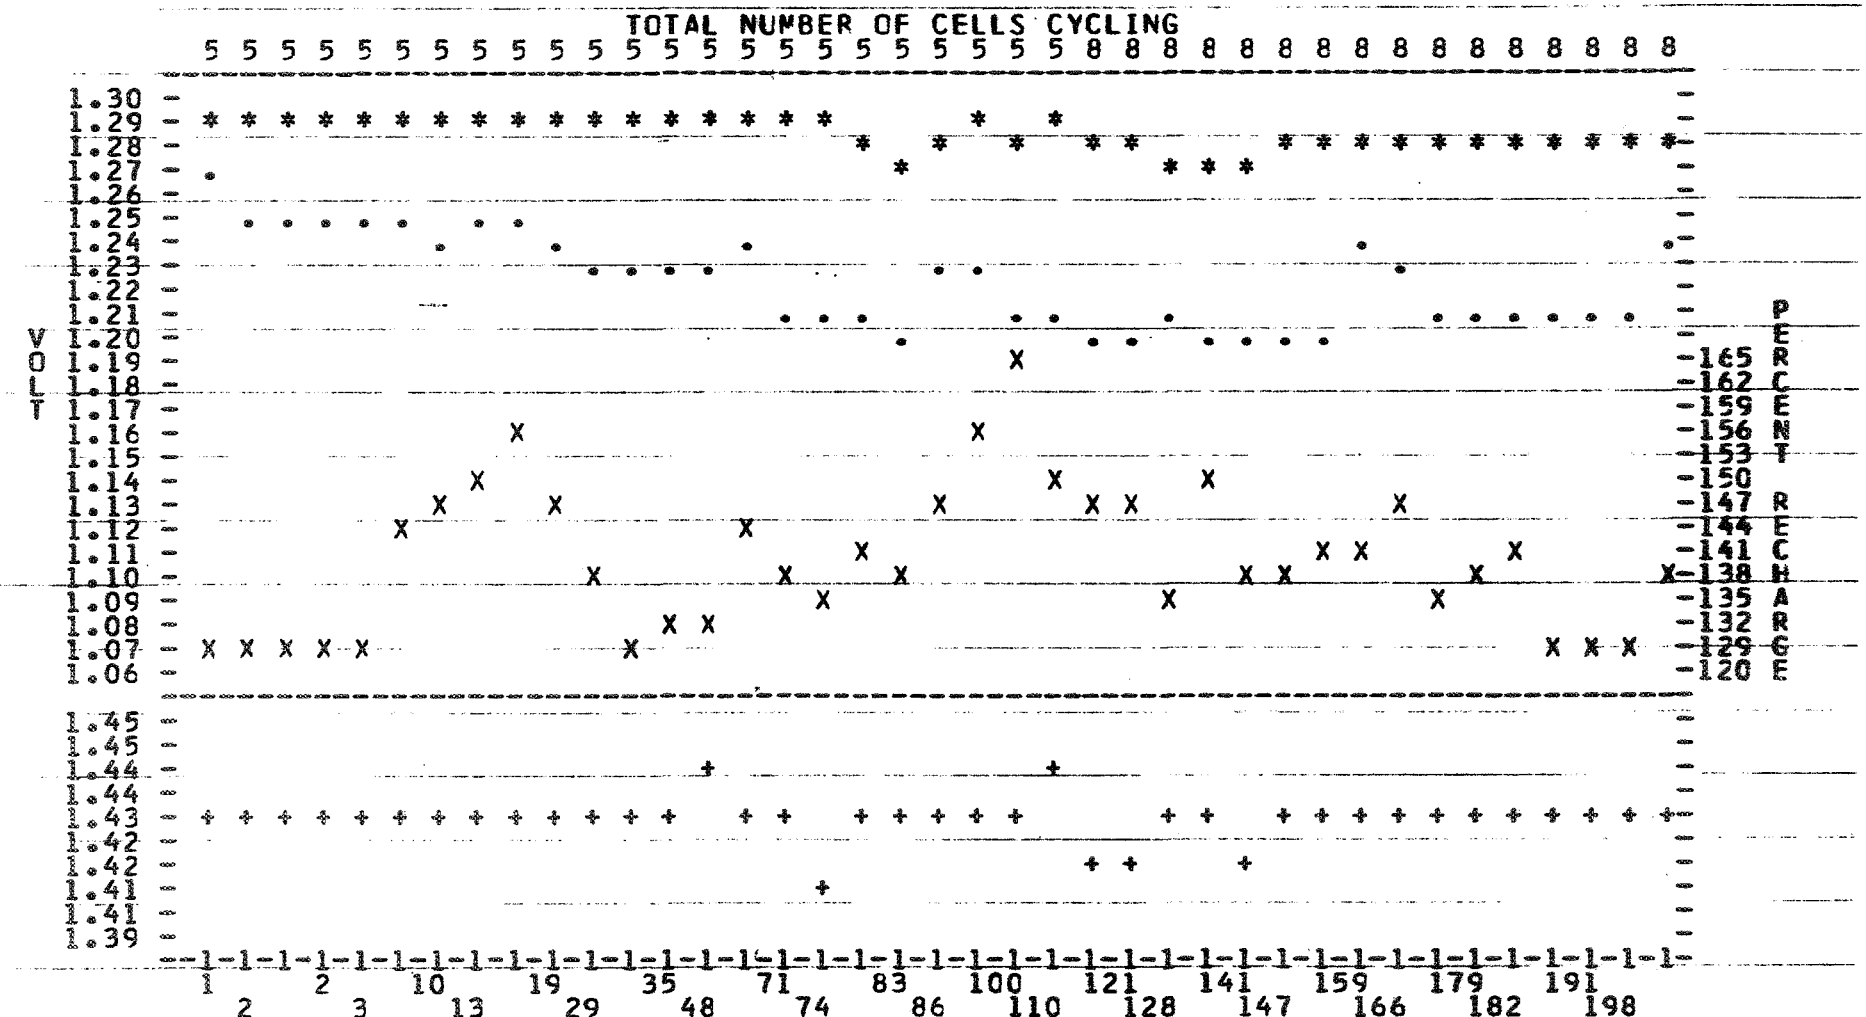
FIGURE 84

(1) Performance on Cycling: (Figure 84) Cycling started in July 1970. This pack has completed 2335 cycles.

PACK 018D, MANUFACTURE GULTON 06.0 AH
ORBIT PERIOD IN HOURS 01.5
TEMPERATURE IN DEGREES C. 25
CHARGE RATE IN AMPS 3.50
DEPTH OF DISCHARGE IN % 25

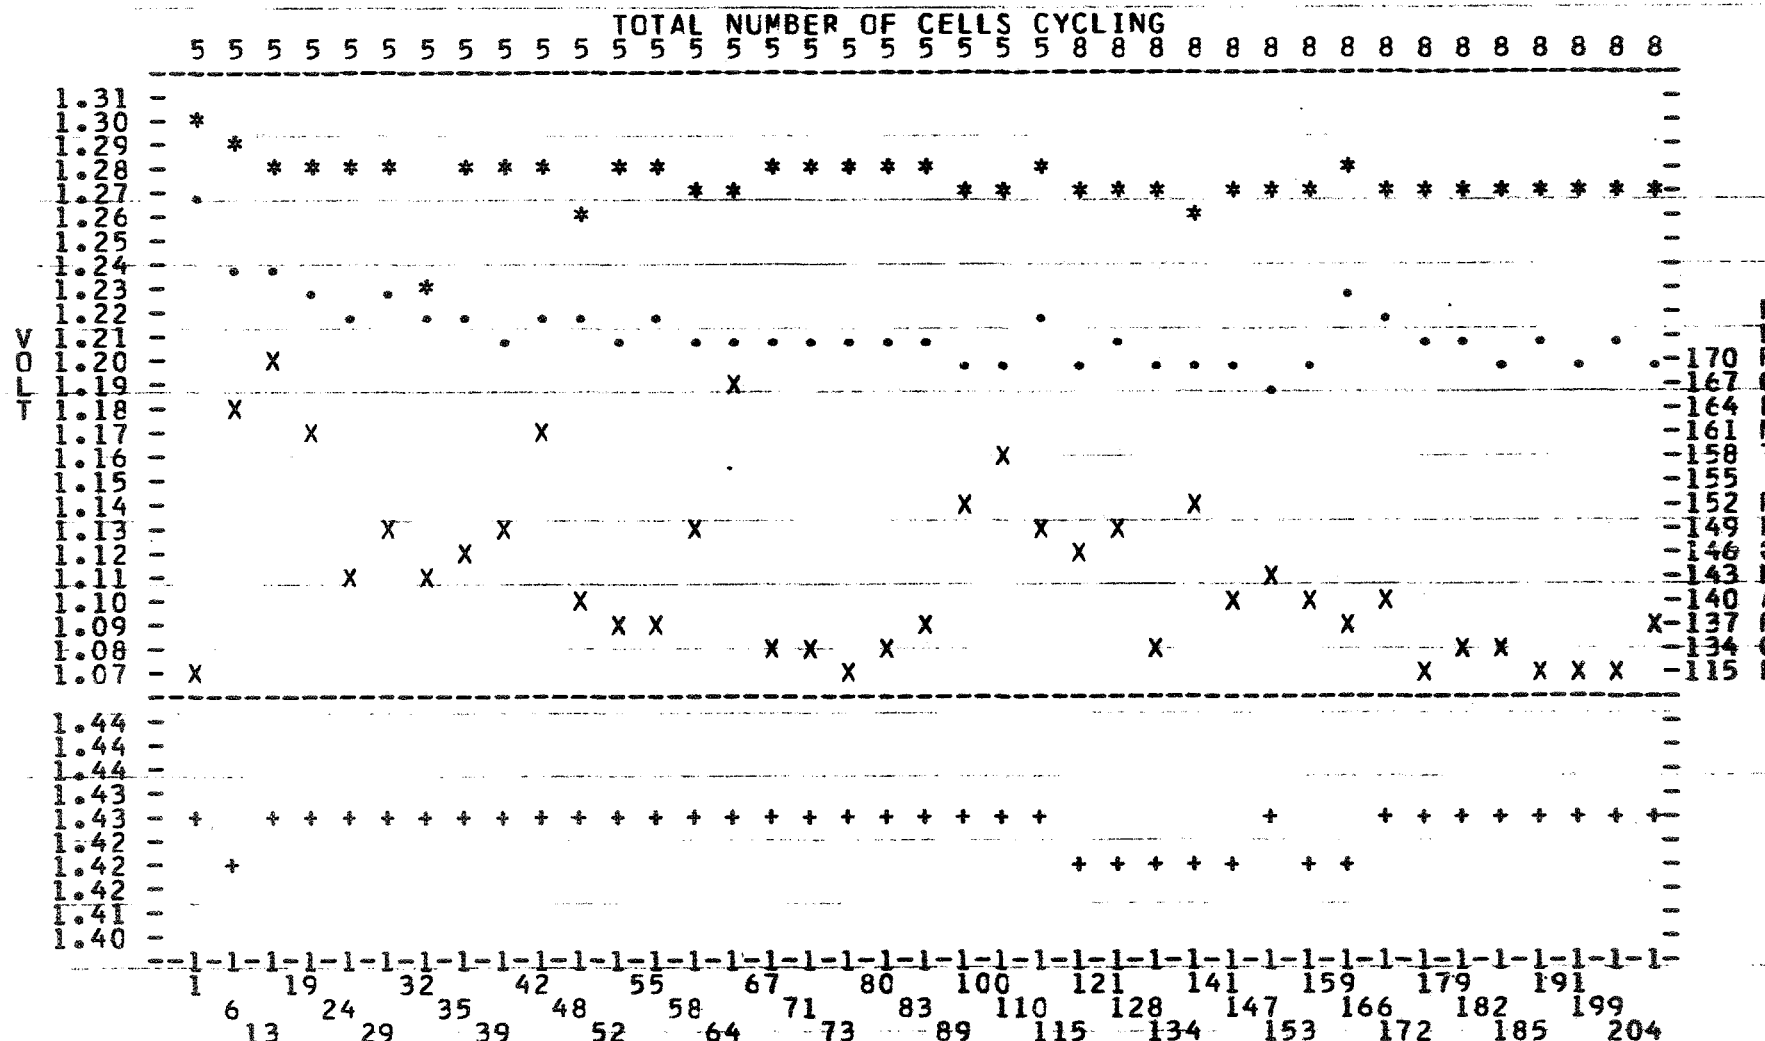
FIGURE 85

(1) Performance on Cycling: (Figure 85) Cycling started in July 1970. This pack has completed 2335 cycles.

PACK 001C, MANUFACTURE GE 06. AH
ORBIT PERIOD IN HOURS 01.5
TEMPERATURE IN DEGREES C. 25
CHARGE RATE IN AMPS 3.50
DEPTH OF DISCHARGE IN % 25
