DEVELOPMENT OF A THERMAL BARRIER COATING FOR USE ON A WATER-COOLED NOZZLE OF A SOLID PROPELLANT ROCKET MOTOR

AEROJET-GENERAL CORPORATION

FINAL REPORT

3 May 1969

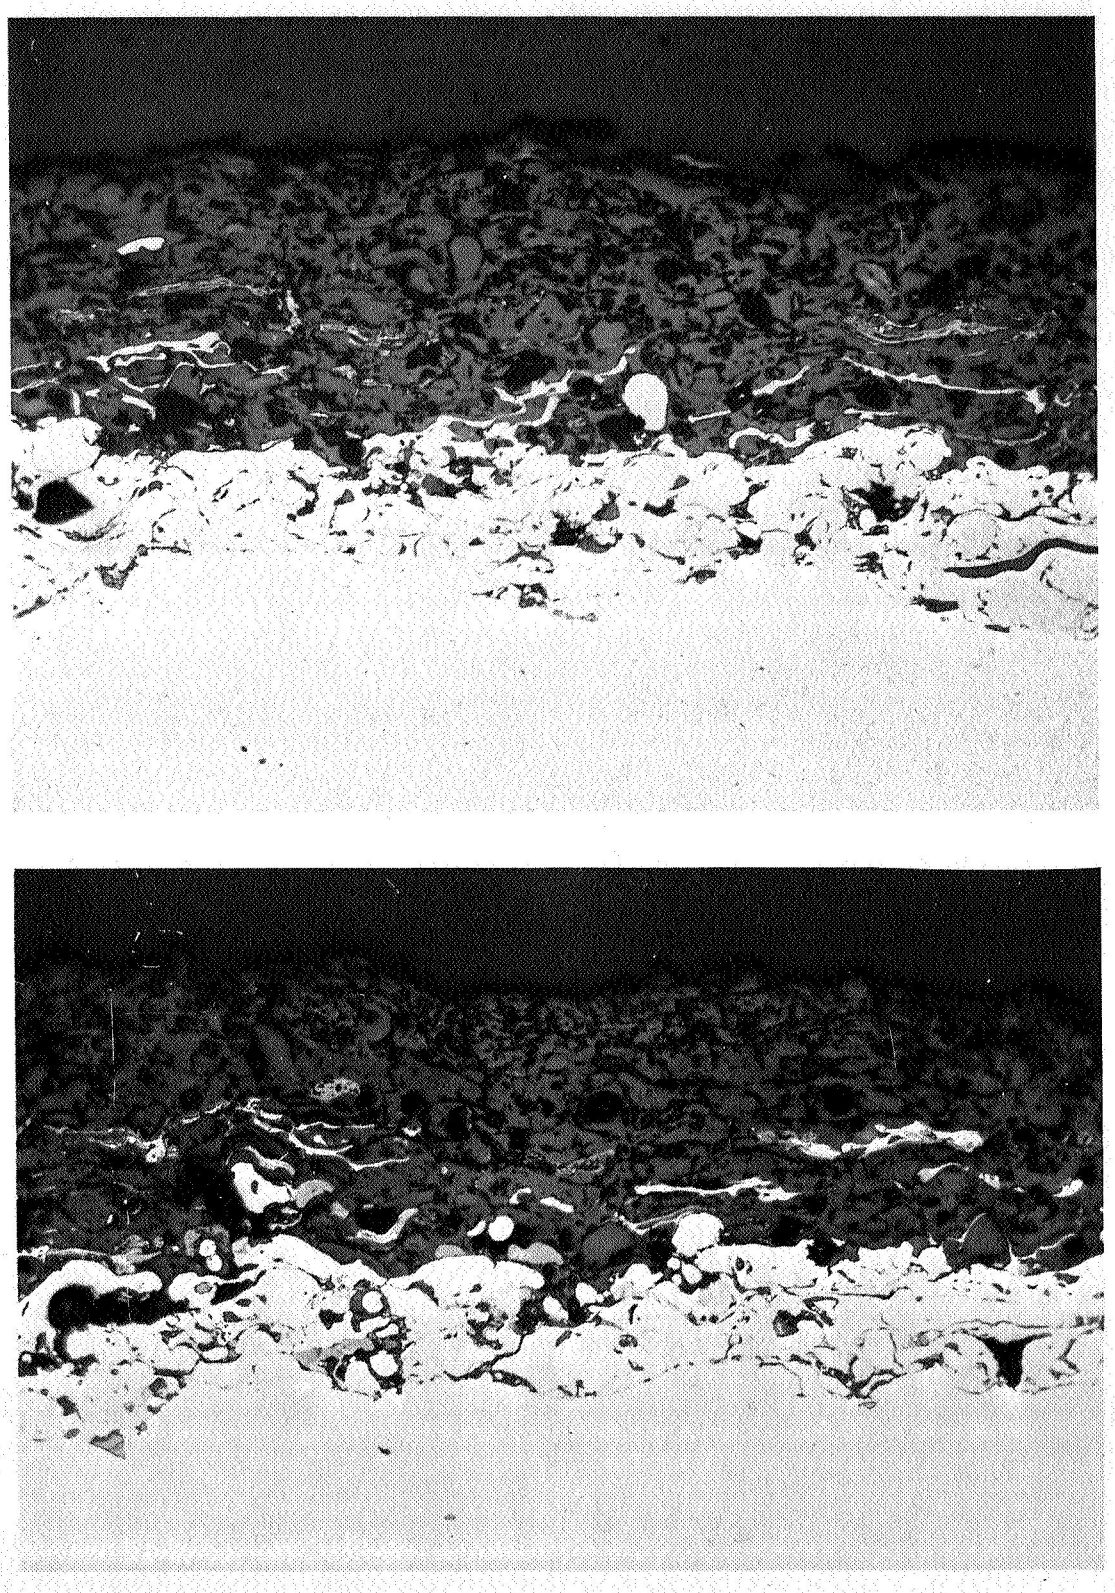
Figure 5

Specimen X18 (Table VIII) was sectioned and examined for comparison of microstructure as sprayed to after 150 sec exposure. The before and after photomicrographs are shown in Figure 5. Note the refinement of the microstructure along the top surface of the exposed area.

Specimen X18 Before (upper) and After Testing (lower)

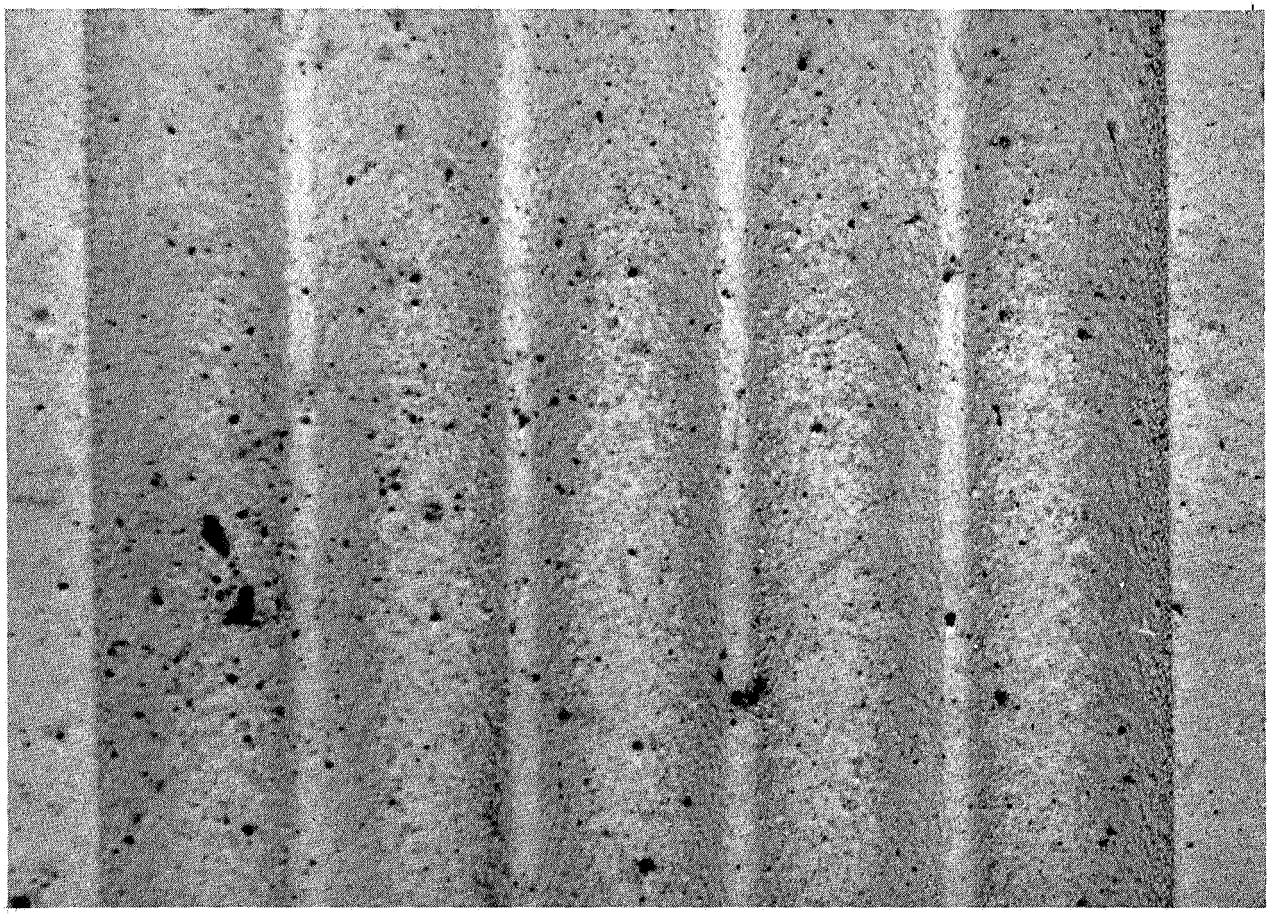
Figure 7

The second series of tests, Table XI, were with 5-tube specimens and included thick coatings of the compositions previously tested as thin coatings in the early part of the program. The Mo wire coatings appeared rougher and contained voids in some cases around the wires. The results insofar as wire deposition and dispersement are concerned were disappointing. Deposition rate was observed to be poor during plasma spraying. This was confirmed by examination at 40X magnification.

5-Tube Specimen, Mo Wire/Al_2O_3 After Testing

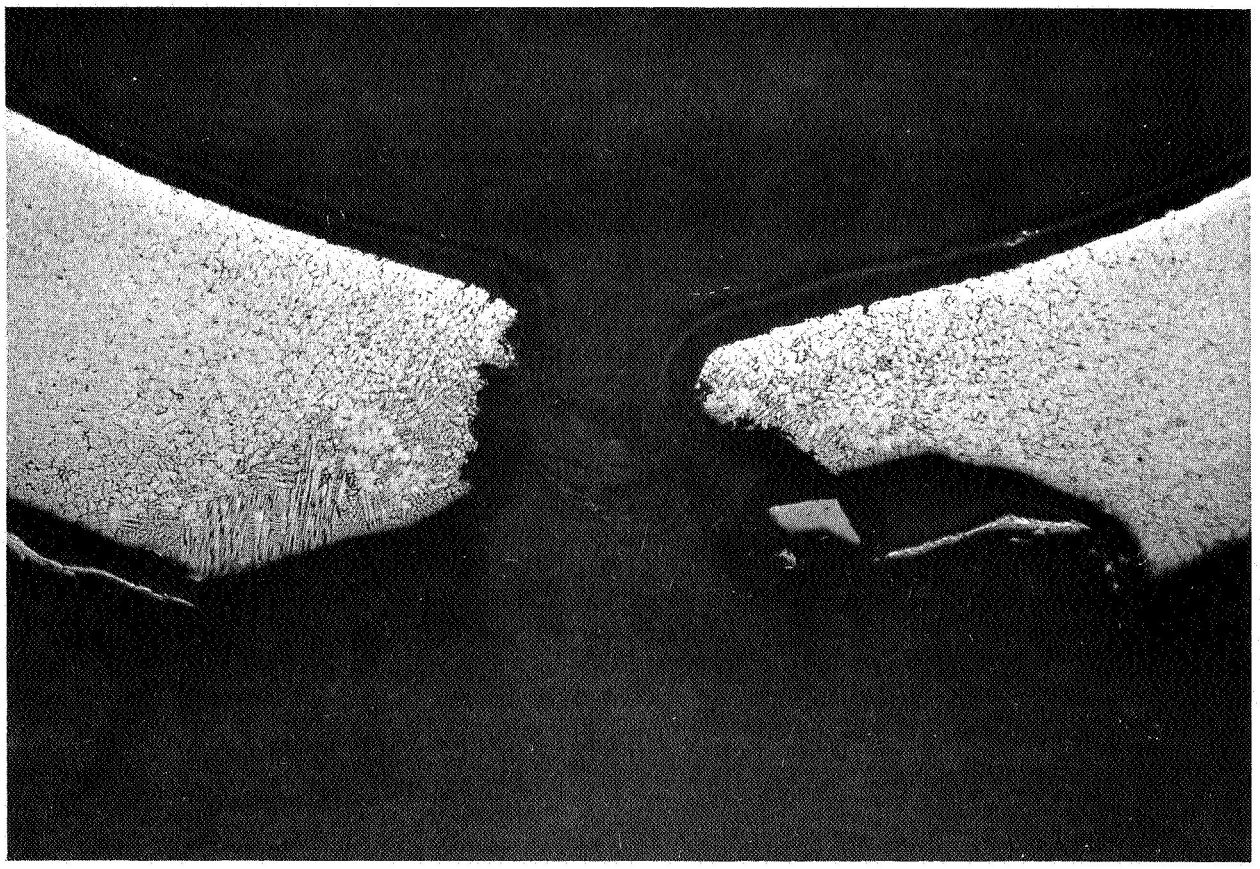
A complete failure analysis was performed on the fired nozzle. The metallographic examination revealed no other possible cause of failure other than inadequate cooling resulting in burnout. Figure 13 is presented to illustrate the appearance of the typical burned through tube.

(1) Tube ruptures in the throat regions were heat transfer burnout in nature.

A count of burned-out tubes was made and oriented to the propellant grain pattern. Fifty-one tubes were burned through. Of these, 10 were downtubes or 1st pass and 41 were uptubes or return pass. Twenty tubes showed slight surface melting and the balance (77) were intact. The majority of the burned-out tubes were opposite the peak of the propellant grain pattern. Based on these data, the assumption was made that the downtubes had burned out at a burnout heat flux ratio of 1.0. To determine what gas-side heat transfer coefficient was necessary to satisfy this assumption a post-test heat transfer analysis was made with the actual test conditions, coolant water flow rate (117 lb/sec) inlet pressure ($\sim$ 750 psia) and temperature of coolant (71°F). The results shown in Figure 14 indicate that a heat transfer coefficient that is 2.4 times the original design value would satisfy the downtube burnout assumption. It is felt that the heat transfer coefficient used in the original study may have been correct, however, it is evident from the burnout pattern that the local heat fluxes due to mass flow effects were considerably higher than average.

Burned Tube at Throat

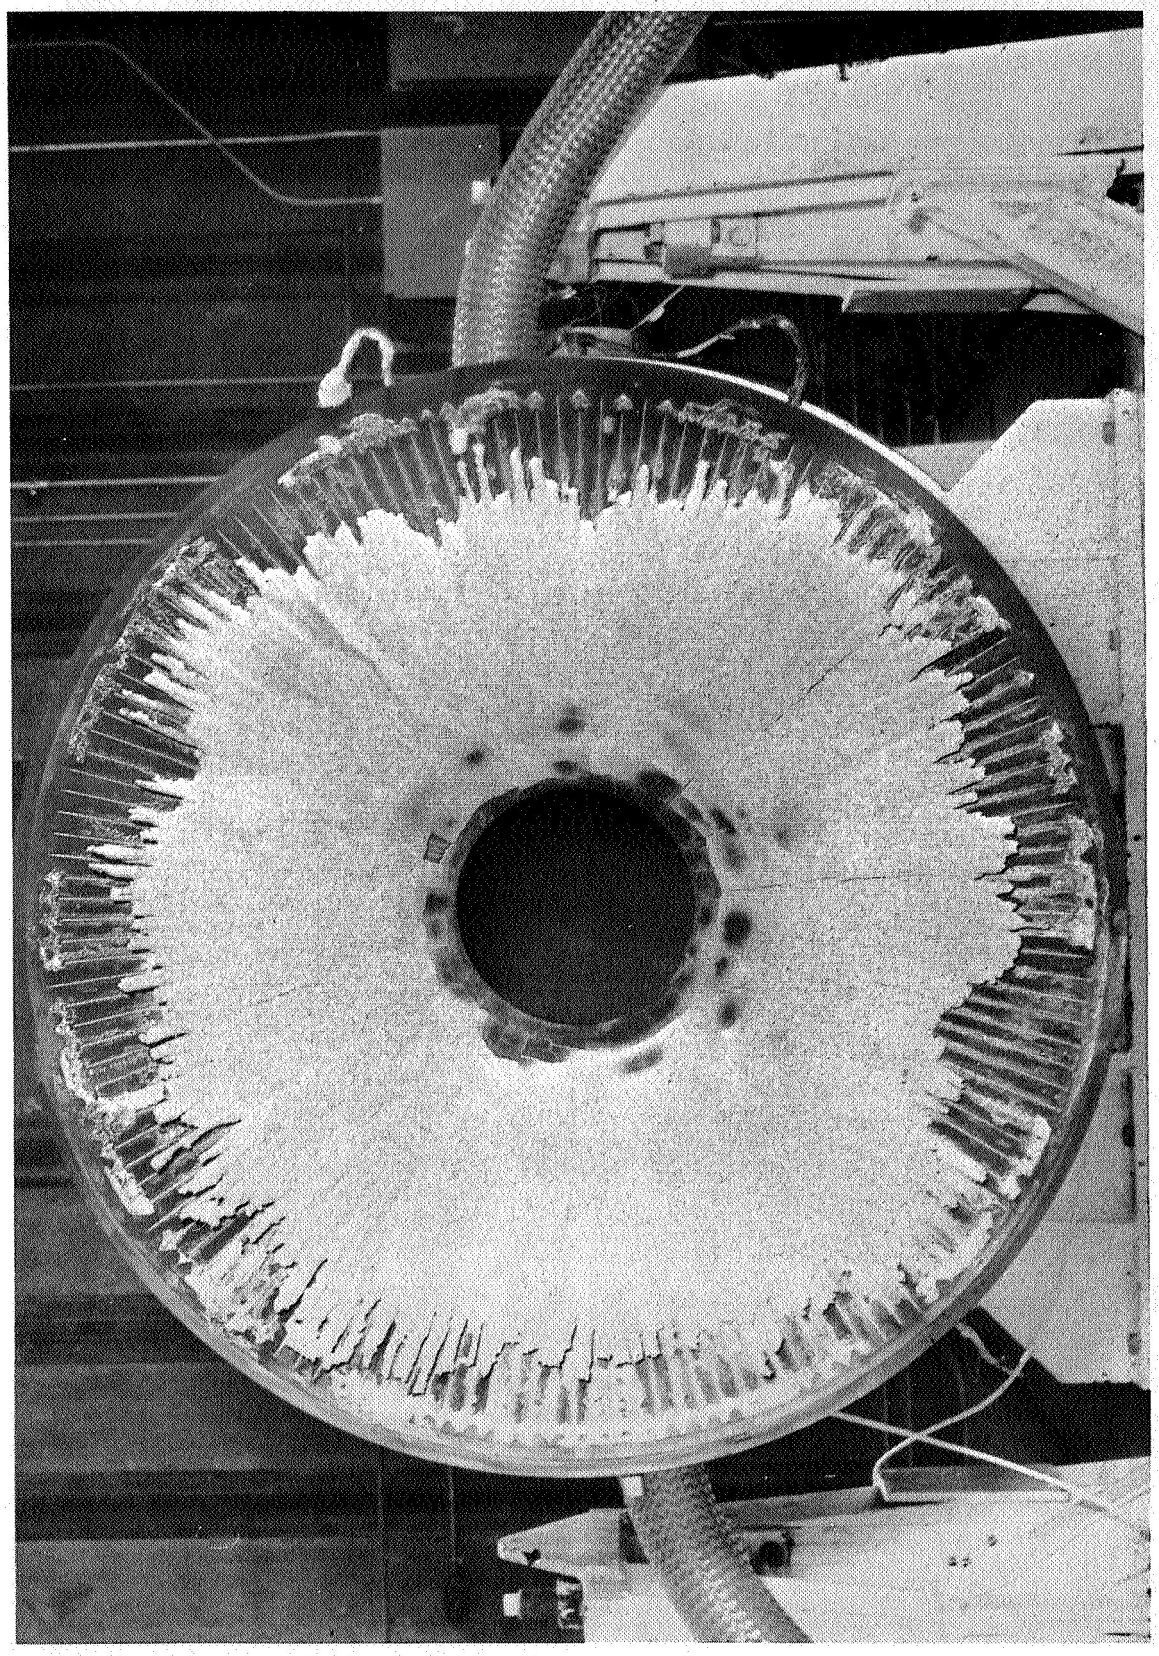
The second test firing (Nozzle SN 02) was accomplished at AFRPL on 20 September 1968. The firing was of full duration with no observed abnormality. Visual inspection of the nozzle after firing showed no tube rupture or leakage. A layer of Al_2O_3 had plated out over the entire nozzle. This layer was approximately 1/16 in. thick over the tube crowns in the throat area and 3/8 in. thick in the exit area. The alumina had shrunk away from the nozzle at cooldown and had a network of cracks. Figure 18 shows the coated nozzle. Figure 19 shows the condition of the nozzle immediately after firing.

Nozzle SN 02 After Test

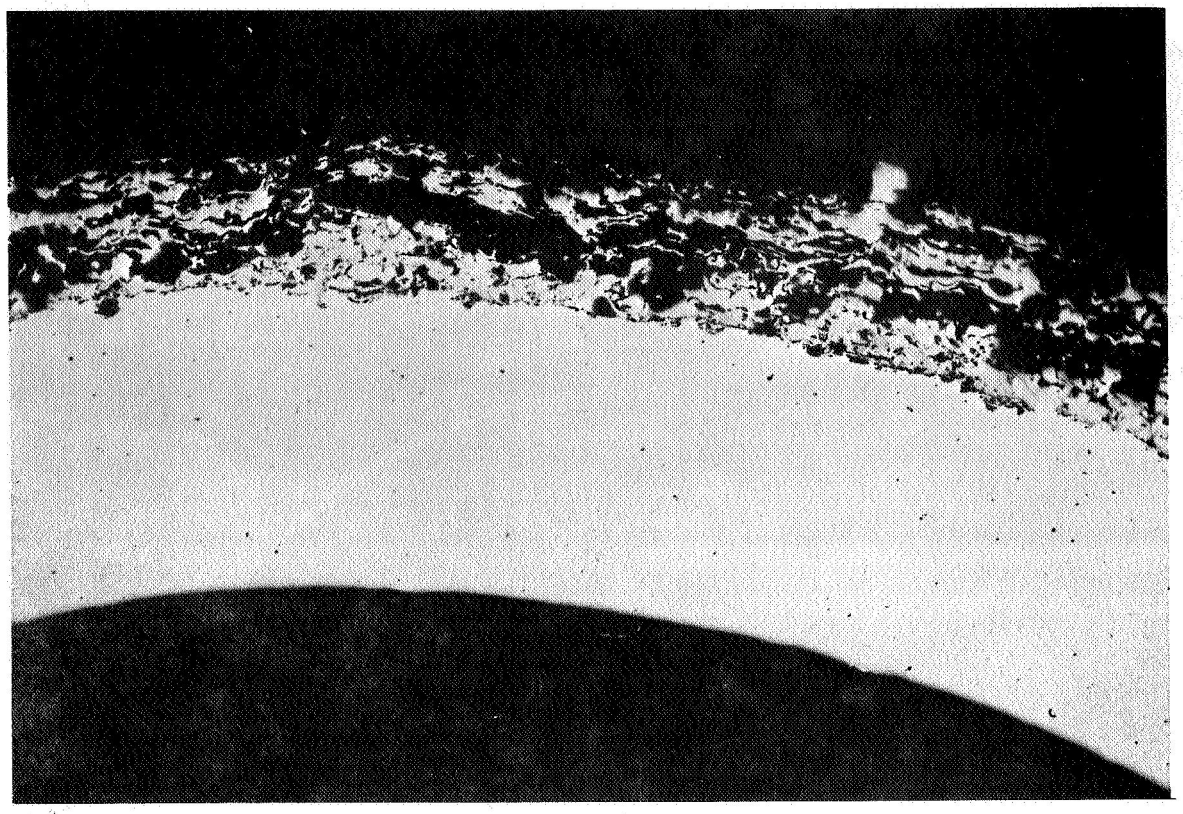
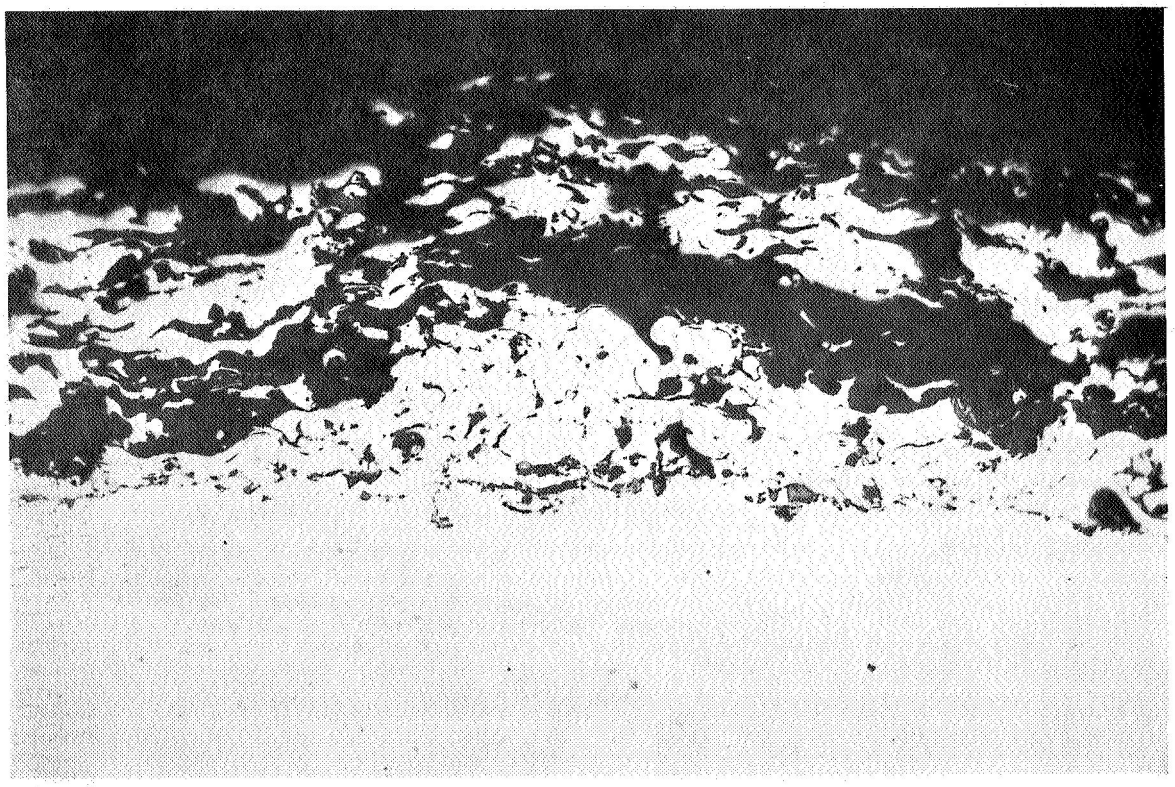
Figure 20

The coating in the forward section and throat (Figures 20 and 21) appears to have a void between the nickel aluminide primer and the topcoat. This occurred either in the sectioning and polishing process or when the propellant Al_2O_3 cracked and fell off due to shrinking while cooling. Pieces of the Al_2O_3 have been examined by X-ray diffraction for the existence of either Mo or Ni on the underside. The results of the analysis are that only alpha Al_2O_3 was observed. The conclusion was made that the plasma-arc-sprayed coating was still in place and did not come off with the propellant deposited Al_2O_3 on cooldown.

Forward Section - 250X

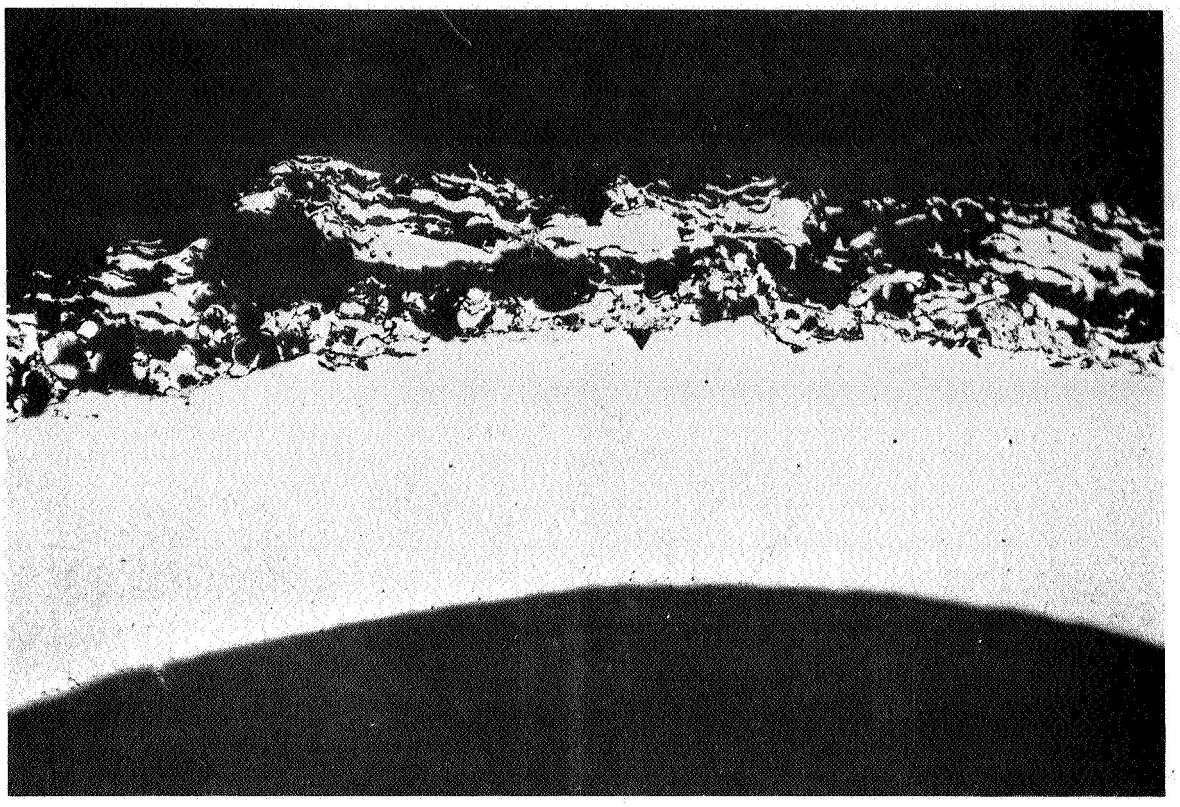
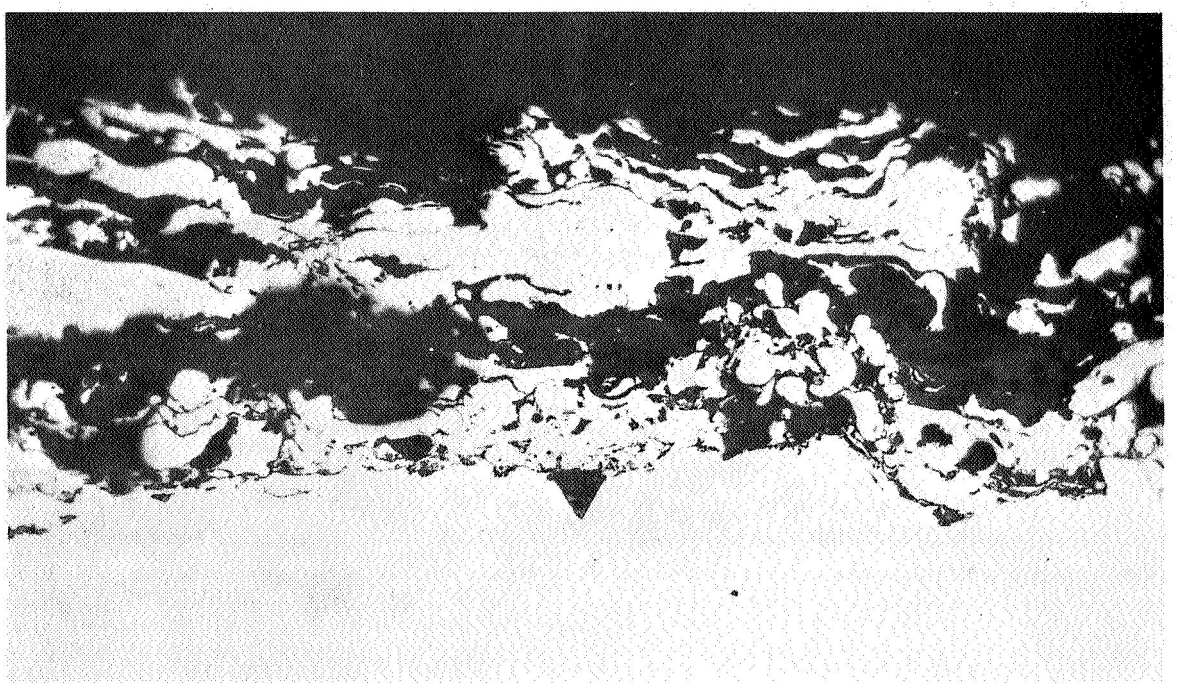
Figure 21

Throat - 250X
