Philosophical Transactions of the Royal Society A: Mathematical, Physical and Engineering Sciences

Arora, H., Kelly, M., Worley, A., Del Linz, P., Fergusson, A., Hooper, P. & Dear, J. (2014). Compressive strength after blast of sandwich composite materials. *Philosophical Transactions of the Royal Society A: Mathematical, Physical and Engineering Sciences*, 372, 20130212-20130212.

One contribution of 12 to a Theme Issue ‘Shock and blast: celebrating the centenary of Bertram Hopkinson’s seminal paper of 1914 (Part 1)’.

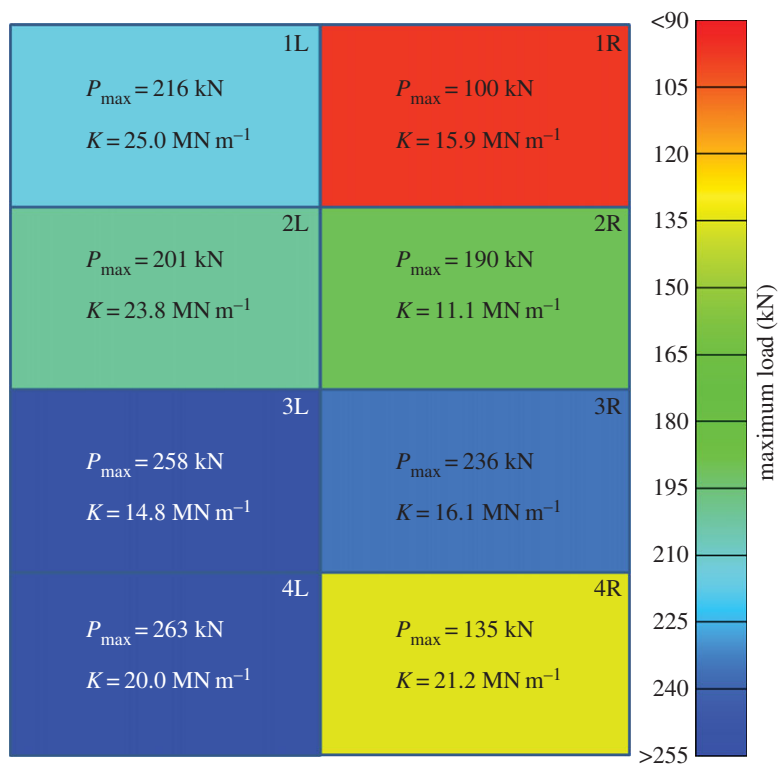
Figure 22. Graphic showing, as a greyscale (colour) plot, how ultimate load-bearing capacity varied with location of subpanel on the global GFRP blast panel as viewed from rear. (Online version in colour.)

Ultimate load-bearing capacity data are presented for the CFRP panels in figure 22. It can be seen again that the residual strength of the panels corresponds to the damage severity and orientation observed from the edges of the panels and interpreted from the DIC blast data. In this case, it can be noted that panel 4L demonstrates a very high ultimate compressive strength, and that the corresponding corner, 1R, demonstrates a very low compressive strength. This

relative to the whole target, which is also being loaded by the blast. There is a period of build-up during the loading phase, particularly on a non-infinitely rigid surface. The surface waves travelling along the panel are transmitted along the lengths towards other regions of the target, i.e. opposite corners. The faster wave speed in the CFRP targets allows the waves to propagate to the other boundaries quicker than in the GFRP targets. Therefore, damage builds up greatly in the CFRP targets away from the centre. However, in the GFRP targets, the magnitude of the blast wave is sufficient to breach the failure strain of the fibres (especially once support from the core is lost due to shear failures), and so energy dissipation to remote areas from peak-loaded ones is minimized. Energy is lost due to other failure mechanisms in the GFRP sandwich panels such as gross skin failure, rather than simply core damage. Therefore, the more significantly damaged area is focused in the GFRP targets to where the most force is expected to be applied and not necessarily focused in the CFRP targets. This concept is shown in figures 18 and 22.

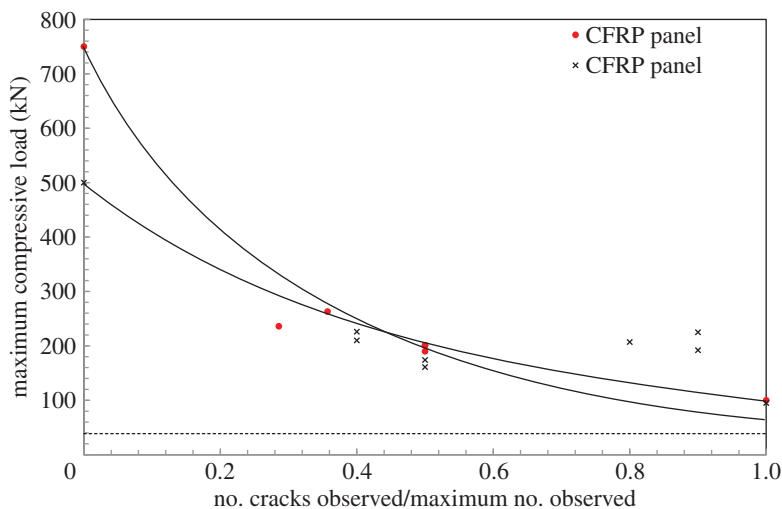
Figure 23. Plot showing compressive load against normalized number of cracks recorded prior to compression testing. Dashed line represents the theoretical minimum compressive load to crush the core and buckle the skins. (Online version in colour.)

A number of trends and hypotheses can be drawn from the raw data. However, the importance of core cracking, particularly those normal to the loading direction, can lead to significant reduction in stiffness and load-bearing capacity. The graph shown in figure 23 plots the normalized number of cracks, i.e. the total number of cracks observed visually from each edge of the subpanel divided by the greatest number observed, all plotted against the peak compressive load. The peak values of compressive load were obtained from testing non-blasted materials.

Referring to figure 23, it is seen that the CFRP targets have a much higher initial maximum load-bearing capacity (which is taken to be the buckling load) than the GFRP targets. However, based on the stiffer fibres in CFRP and the improved blast resistance, resulting in greater degree of blast energy absorption, the relative reduction in load-bearing capacity was greater for the CFRP targets compared with the GFRP targets. Furthermore, a stiffer material experiences a higher load (or resistance to impact); therefore the apparent damage induced in the core and interfaces is understandable compared with a more compliant material such as GFRP.

Both targets seem to reach a similar lower level of strength once some small amount of damage is incurred. The graph, however, goes beyond the x -axis plotted, i.e. the panels can damage further than shown in this paper, to a theoretical maximum damage where the panels are loaded purely to compress the foam core and buckle the skins. This minimum compressive load is shown as the dotted asymptote at the bottom of the graph in figure 23.
