This is a repository copy of *Repair and reinforcement of timber columns and shear walls – A review*.

Chang, W-S. [orcid.org/0000-0002-2218-001X](http://orcid.org/0000-0002-2218-001X) (2015) Repair and reinforcement of timber columns and shear walls – A review. *Construction and Building Materials*, 97. pp. 14-24. ISSN 0950-0618

# 1 **Repair and reinforcement of timber columns and shear walls – A** 2 **review**

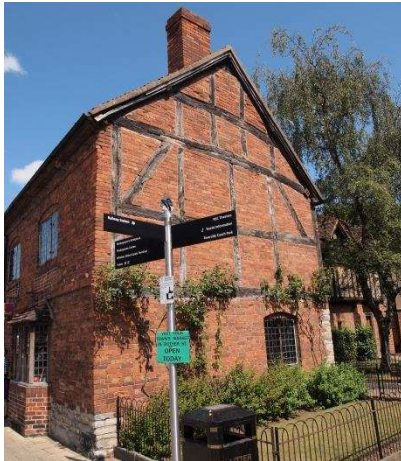
Figure 1 Half-timber frame with brick infill

1 dissipation capacity. Note that in this paper only shear walls made of timber will be discussed.  
2 For example, in some half-timber framed structures, stones, bricks (Figure 1) and wattle and  
3 daub (Figure 2) are often used as in-fill elements and therefore are outside the scope of this  
4 paper.  
5

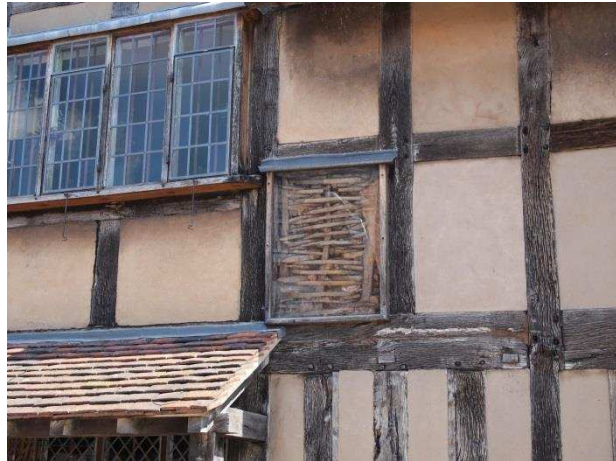
Figure 2 Half-timber frame with wattle and daub infill

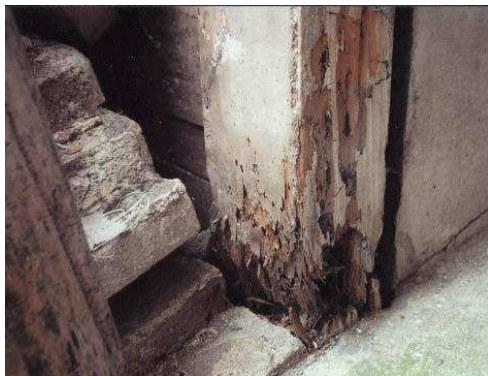
Figure 3 Bio-deterioration in a column that has contact with the ground      Figure 4 Timber strut attacked by termites

12 Columns, when touching the ground without any measure to isolate them from damp, are  
13 prone to elevated moisture content levels which will lead to bio-deterioration due to insects  
14 (such as termites) and fungal attacks. This is a common form of decay that can be found  
15 where the column touches the ground (Figure 3). Although it is advisable when designing a  
16 timber column to select the timber carefully as the most common form of deterioration is  
17 from attack of the sapwood by insects while the heartwood remains untouched [1], the rise of

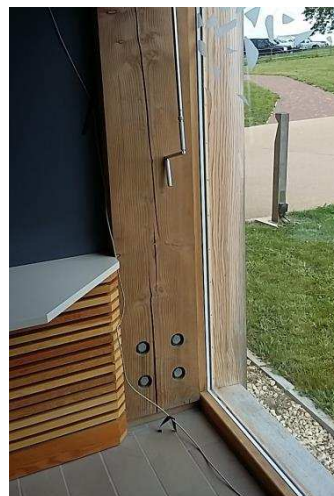
Figure 6 Vertical cracks occur in a column

12 Cracks occurring in timber members often result from the differences between the drying  
13 speed in interior layers and outer ones. The drying stresses will build up if the outer layers are  
14 dried to a level that is much lower than the fibre saturation point while the interior is still  
15 saturated [3]. Rupture in timber occurs and, in consequence, cracks occur if the drying stress  
16 exceeds the strength perpendicular to the grain, as shown in Figure 6.

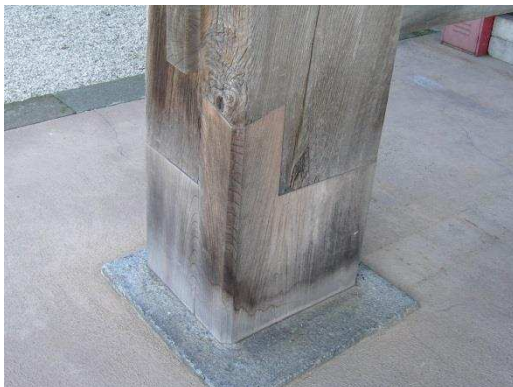
Figure 7 A new timber component was used to partially replace a rotten column with traditional carpentry

20   When dealing with historic buildings, engineers and architects need to balance authenticity of  
21   the structures after renovation/repair with assurance of the strength of the structure to carry  
22   the load needed. To minimise the amount of timber being replaced, prosthesisation has  
23   become common practice when the timber members are bio-deteriorated due to termites or  
24   insects. It is a method that replaces only the decayed or failed part with a new portion.

1 Timber used for prosthesis, in particular for the conservation of historic buildings, must  
2 be carefully selected so that the nature of the new timber will match that of the old. The  
3 moisture content of the timber being used should be close to that of the existing members so  
4 that moisture movement can be avoided. Figure 7 shows an example of a column being  
5 prothesised after it was partially damaged. When a new prosthesis is adopted to replace the  
6 damaged portion in a timber member, two methods exist to connect the old and new members:  
7 (a) local and traditional carpentry as shown in Figure 8; and (b) glued-in members for the  
8 connection. For both cases, modern adhesives are often used to ensure the continuity of the  
9 new column. Although prosthesis is common practice nowadays in historic building  
10 conservation in many countries [4], there is a lack of research work on this method.

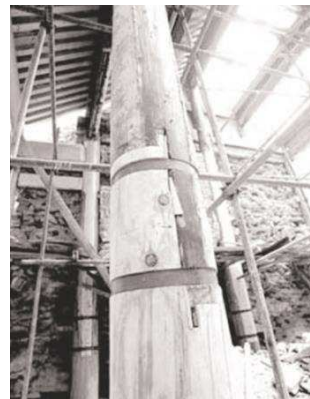
Figure 8 Partial replacement repair in Daibei Temple (1550), China [4]

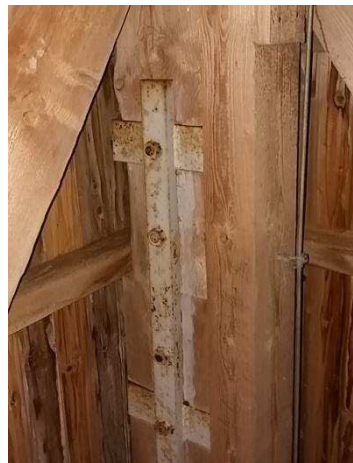
7  
 8 Figure 11 Steel members are used to connect two columns to transfer load  
 9

1 (Figure 11); and (b) to prevent crack to split. The common forms of steel reinforcement  
 2 include: (a) steel plate with nails or screws; (b) punched metal plates; and (c) steel glued-in  
 3 rods. However, the focus was mainly on beam elements and connections; efforts being  
 4 devoted to the reinforcement of columns were relatively scarce. Tanaka et al. compared the  
 5 effect of a column reinforced by steel plate with that of one reinforced by carbon fibre sheets  
 6 [6].

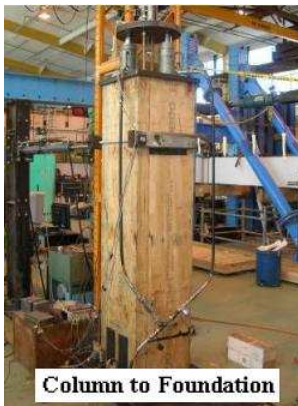
Figure 17 Column to foundation specimen with post-tensioned reinforcement and external energy dissipater [18]

8 Figure 17 and Figure 18 show the specimens and experimental setup, respectively.

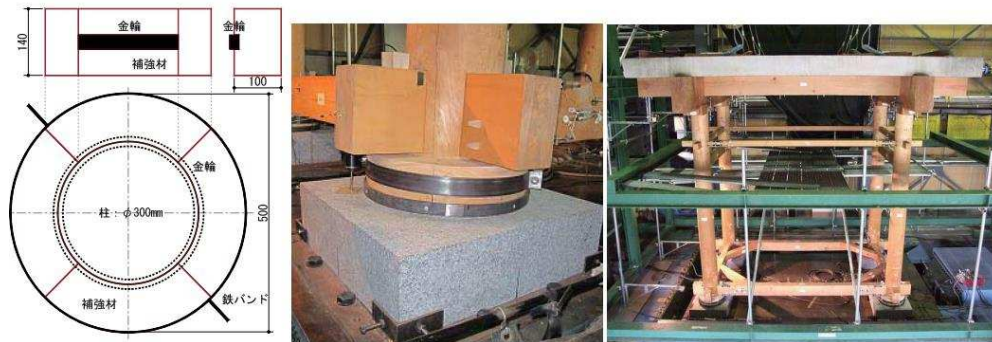
Figure 20 Enlargement of column base proposed by Suda, Tasiro and Suzuki [20]

Enlargement of the cross section of a column will help to reduce stress within the column so as to reduce the potential for buckling and material yield in compression. In some structures, such as those found in Japanese temples, large section columns will contribute to resisting lateral load by providing restoring forces [19]. Suda, Tasiro and Suzuki [20] proposed to enlarge the column base of existing structures (Figure 20) to increase the restoring force, which helps the column to return back its original position from its movement, so as to enhance the aseismic behaviour of traditional temples.

Shaking table tests were carried out to investigate the effectiveness of the proposed reinforcement method. The reinforced column shows higher restoring force at the same deformation. A column with diameter of 300mm was used, and the column base was increased to 400 and 500mm as reinforcement. It showed, respectively, 200 and 300%
