OŠTEĆENJA BOKOVA ZUBA ZUPČANIKA UZROKOVANA KOTRLJAJNO-KLIZNO-KONTAKTNIM ZAMOROM MATERIJALA ROLLING-SLIDING-CONTACT FATIGUE DAMAGE OF THE GEAR TOOTH FLANKS

Robert BASAN – Marina FRANULović – Markus LENGAUER – Božidar KRIŽAN

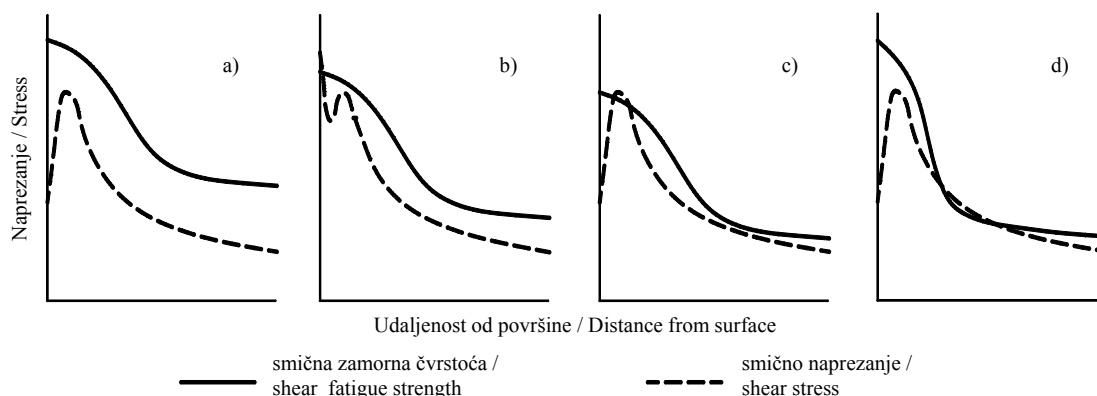
Hyde [3] and Pederson and Rice [12] have given simplified relations between the shear fatigue strength profiles of surface-hardened materials and the distribution of shear stresses caused by rolling-sliding-contact loading as possible causes of fatigue damage (Figure 2). Locations at which the shear stresses exceed the shear fatigue strength are the most likely sites for damage initiation.

Slika 2. Mogući odnosi smične zamorne čvrstoće i smičnog napreznja i najvjerojatnije mjesto i oblik oštećenja: a) bez oštećenja, b) površinsko oštećenje (jamičenje), c) oštećenje neposredno ispod površine (flake pitting, spalling), d) oštećenje duboko ispod površine (case crushing) (prema [3])

Figure 2. Possible relations between shear fatigue strength and shear stress and the most likely location and form of damage: a) no damage, b) surface damage (pitting), c) damage immediately below surface (flake pitting, spalling), d) damage in deep subsurface layers (case crushing) (according to [3])

Hyde [3] te Pederson i Rice [12] su kao moguće uzroke nastanka određenih vrsta oštećenja dali različite odnose profila smične zamorne čvrstoće površinski otvrdnutog materijala i raspodjele smičnog napreznja izazvanog kotrljajno-klizno-kontaktim opterećenjem (slika 2). Mjesta na kojima smično napreznje prelazi smičnu zamornu čvrstoću materijala vjerojatna su mjesta nastanka zamornih oštećenja.

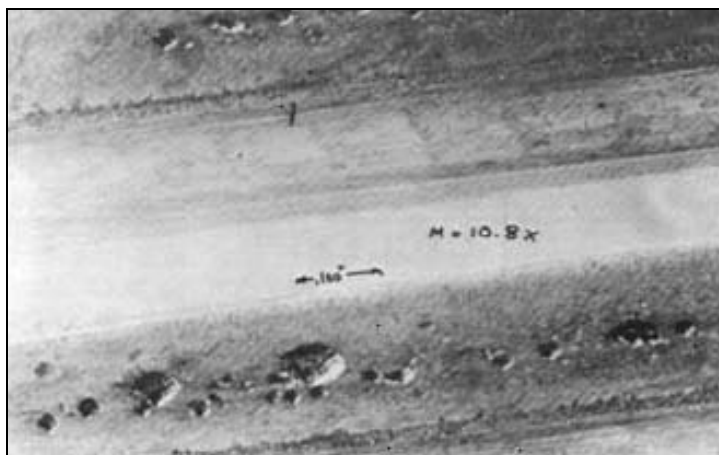
Pitting is a general term that denotes crack-like damage of gear teeth flanks in the form of small pits whose diameter can range from a couple of tenths of a millimeter in smaller gears, up to several millimeters in gears with large modules (Figure 3). Regardless of gearing type, pinion teeth are more susceptible to this type of damage as they enter the mesh more often than the teeth of the wheel. Part of the tooth flank immediately below the pitch line is particularly at risk due to an adverse combination of loading magnitude and rolling/sliding conditions.

Slika 3. Jamičenje na bokovima zuba [13]
Figure 3. Pitting on gears teeth flanks [13]

Jamičenje (engl. *pitting*) je općeniti naziv za oštećenje površine bokova zuba u vidu pukotina odnosno jamica, čiji promjer može iznositi od nekoliko desetinki milimetra do nekoliko milimetara, a u slučaju velikih ozubljenja i više (slika 3). Neovisno o vrsti, jamičenju su izloženi zubi pogonskog zupčanika zbog češćeg ulaženja u zahvat i to posebice njihovi dijelovi oko i ispod kinematskog kruga zbog ukupno nepovoljnije kombinacije visine i načina djelovanja opterećenja na tom dijelu bokova zuba.

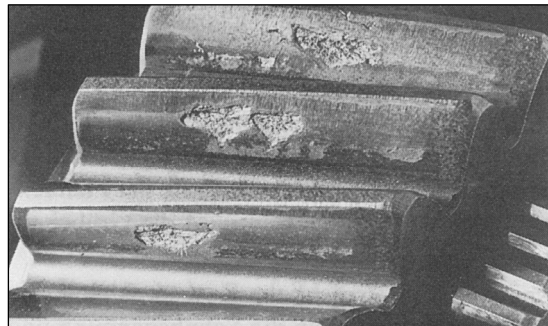
Spalling is the name for subsurface initiated fatigue damage, which is rather similar to the already mentioned flake pitting. It also usually stretches over larger portions of the tooth flank, but with spalls being generally of greater thickness (Figure 7). Initiated cracks grow and advance parallel to the surface and after reaching a critical size, deviate toward the flank's surface. At gears with surface hardened teeth flanks, very often larger pieces of the material fall off, leaving significant damage in the form of a shallow pit. The bottom of the pit is usually located at the transition layer between the harder surface material and the softer core. When this type of

damage occurs on through-hardened or non-hardened gears, in more advanced stages it typically manifests itself in the form of a large number of shallow, overlapping pits, similar to those encountered in pitting, but of greater dimensions.

Slika 7. Spalling [13], [15]
Figure 7. Spalling [13], [15]

mekše jezgre. Kod prokaljenih ili neotvrdnutih zupčanika riječ je o masovnim nakupinama povezanih i međusobno preklapajućih plitkih jamica sličnih onima kod jamičenja, ali većih izmjera.
