Traffic in the Cities

Preliminary Communication

ANALYSIS OF VEHICLE VIBRATIONS – NEW APPROACH TO RATING PAVEMENT CONDITION OF URBAN ROADS

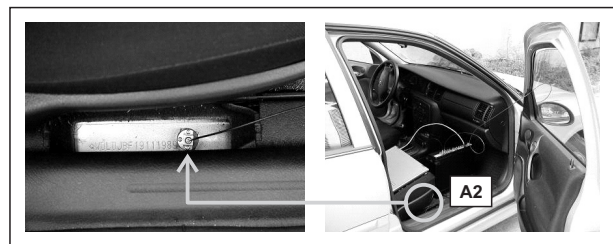
Figure 2 - Accelerometer A2 on the vehicle chassis

The two accelerometers for vibration measurement were installed at an authorized dealer in Zagreb (Opel AutoWill). The first accelerometer (A1) was mounted on the front right wheel holder (*Figure 1*) and the second accelerometer (A2) was mounted to the chassis immediately next to the passenger seat (*Figure 2*). Vibrations in the vertical direction (perpendicular to the

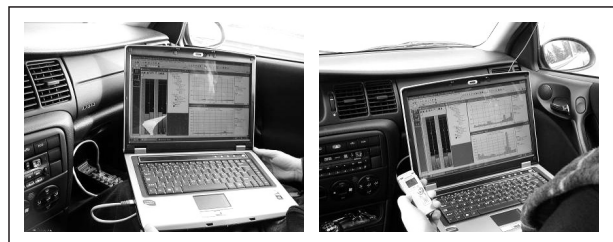
Figure 3 - Measuring equipment in the vehicle

road surface) were recorded using a battery-powered multi-channel Brüel & Kjær PULSE analyzer and the Time Data Recorder program (*Figure 3*). Information regarding some specific qualities during the measurement were recorded by means of a 'voice dictaphone' and a video camera.

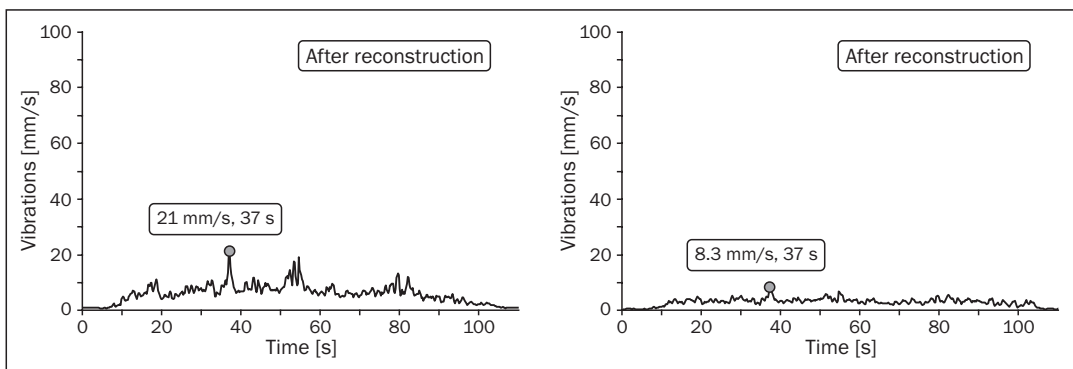
Graph 3 - Car wheel holder and car frame vibrations after reconstruction (Zagreb Avenue)

As mentioned, the vehicle vibrations and road surface roughness were measured before and after the reconstruction of the Zagreb Avenue. The measurement of the vibrations of the car wheel holder (Graph 1) and the car chassis was carried out continuously at a constant speed of 80km/h. Graphs 2 and 3 present, in the same scale (0-100mm/s), the time profiles of the car wheel holder and the car frame (chassis) vibrations before and after reconstruction. The measured maximum values of wheel holder vibrations before reconstruction were 78mm/s on the 1st section (IRI: 3.28m/km) and 45mm/s on the 2nd section (IRI: 2.08m/km). After the reconstruction, wheel vibrations decreased to 21mm/s parameter (IRI: 1.28m/km). The maximum measured car frame vibrations before reconstruction were 15.3mm/s on the 1st section and 11.2mm/s on the 2nd section. After reconstruction, they decreased to 8.3mm/s. As can be seen in graph 3, the average value of wheel vibrations after reconstruction were not higher than 10mm/s, and the vibrations of the car frame were therefore not higher than 3mm/s.

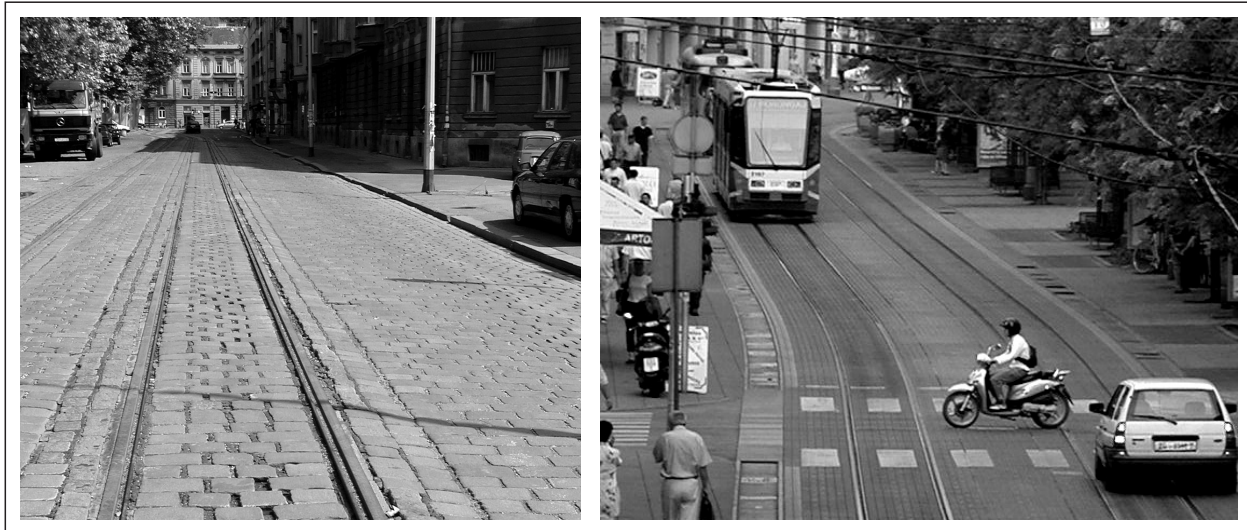
Figure 5 - Survey of tram track embedded in road surface

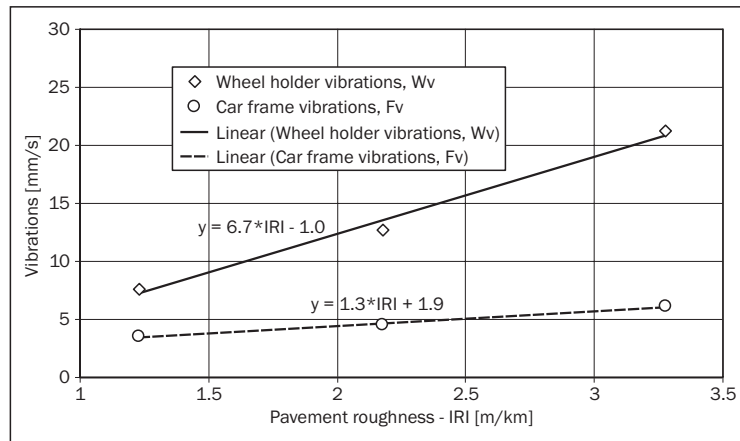
Graph 12 - Pavement roughness - vehicle vibration correlation (vehicle speed: 80 km/h)

Based on the previously measured evenness of the pavement driving surface, the graph estimates the vehicle vibrations quantity. As mentioned in the Introduction, vehicle vibrations are closely connected to the roughness of the road driving surface. If we consider the relative increase in vibrations at the moment of vehicle contact with the humps then it is obvious from

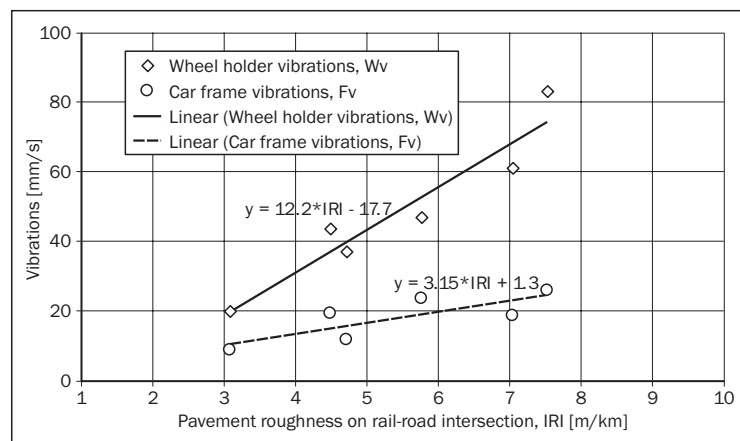
Graph 13 - Pavement roughness on rail-road intersection - vehicle vibration correlation (vehicle speed: 40km/h)

If the road-railway crossings are observed, vibrations are noticeably higher. For crossings observed in this research it can be observed that the maximum
