# The Shallow Groundwater Level Fluctuations and Soil Salinity Problems in the Lower Seyhan Plain

Sevgi DONMA<sup>1</sup>, Takanori NAGANO<sup>2</sup>, Takashi KUME<sup>2</sup>, Selim KAPUR<sup>3</sup>, Erhan AKÇA<sup>3</sup>  
and Tsugihiko WATANABE<sup>2</sup>

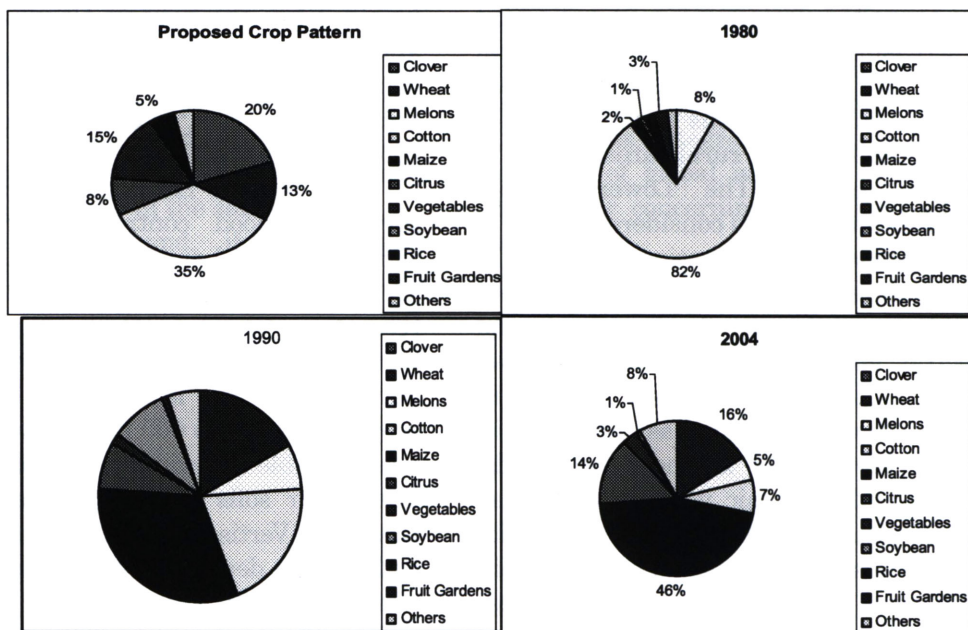
**Fig.2** Historical change of cropping pattern in the LSIP

Figure 2 illustrates the change of cropping patterns in the years 1980, 1990 and 2004. Because of socio-economical reasons (increase of labor cost and instability in the prices of agricultural products), there

were significant differences between the proposed cropping pattern and the materialized at the three different periods.

The diversified cropping patterns were the cause of the increase in the water demand, especially of maize consuming more water than cotton.

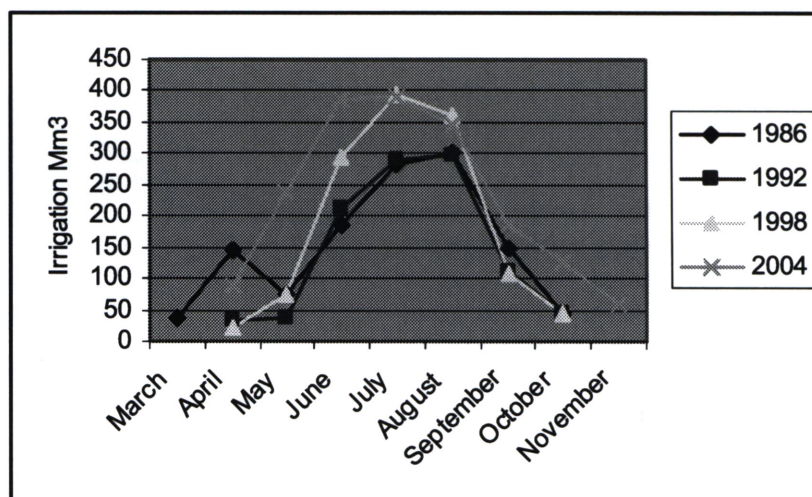
**Fig.3** Seasonal irrigation water use in the LSIP

An increasing trend, in the gross irrigation depth, in the recent years was detected in the study area as shown in Fig.3. The gross irrigation depth of the LSIP (irrigation intake at the Seyhan Regulator divided by the total irrigated area) was exceeding 1000 mm and irrigation efficiency was below 50%. There are many possible causes for this such as, a) the leakage from canals, b) the bad design of the canals causing the high loss of the tail water, c) the diversified cropping pattern, and e) the over-use of the water in the farm land.

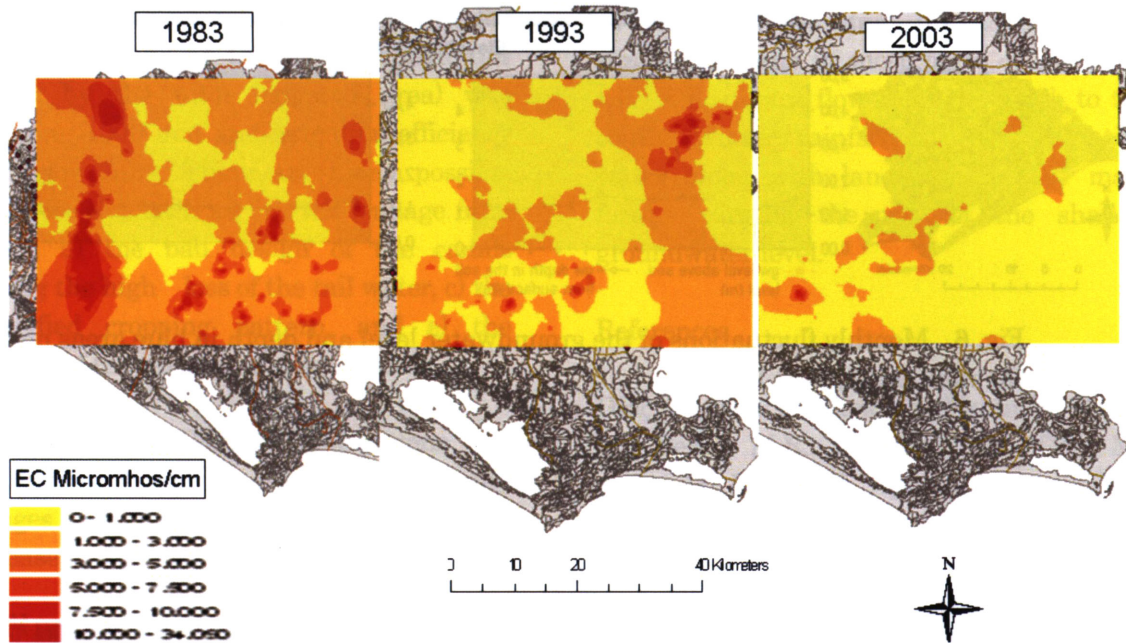
Fig.4 Change in groundwater salinity on the left bank of the LSIP.

Figures 4 and 5 visualize the salinity changes in 10-year intervals with the decrease in the high saline areas.

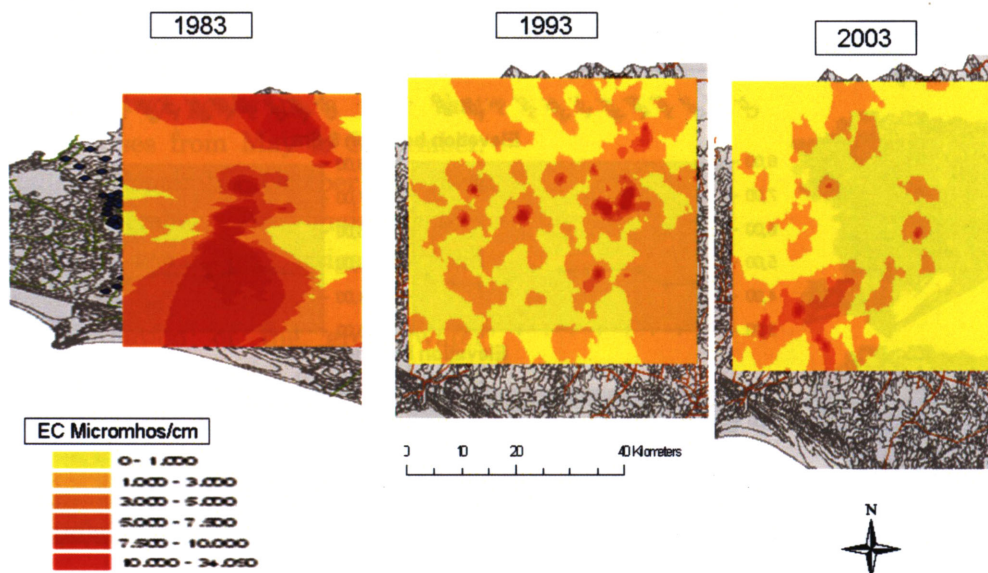
Fig.5 Change in groundwater salinity on the right bank of the LSIP.

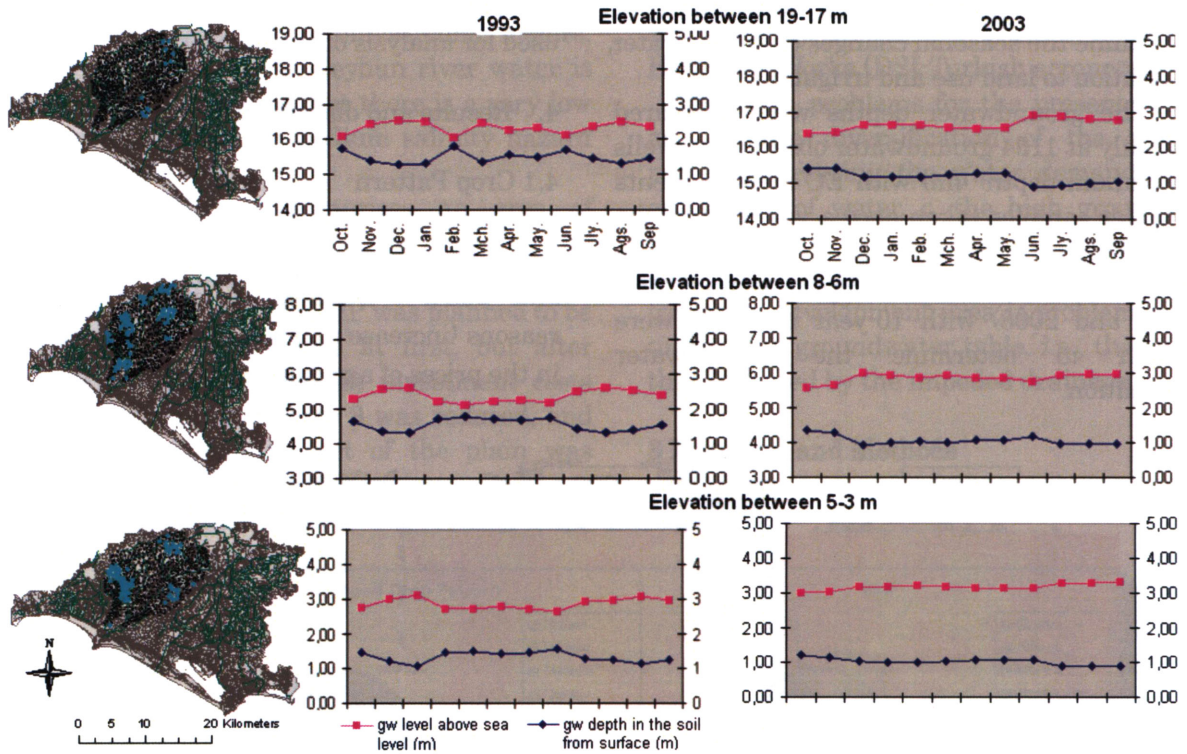
Fig. 6 Monthly fluctuations of the groundwater level and depth in blue areas on the right bank of the LSIP.

Figure 6 and 7 show the monthly groundwater fluctuations with similar patterns in all different elevations and a flow direction from the north to the south. The trends reveal two peaks in a year that groundwater rises from May to September, and it falls in September, October and rises again in November. The main factors affecting this trend are irrigation and rainfall.

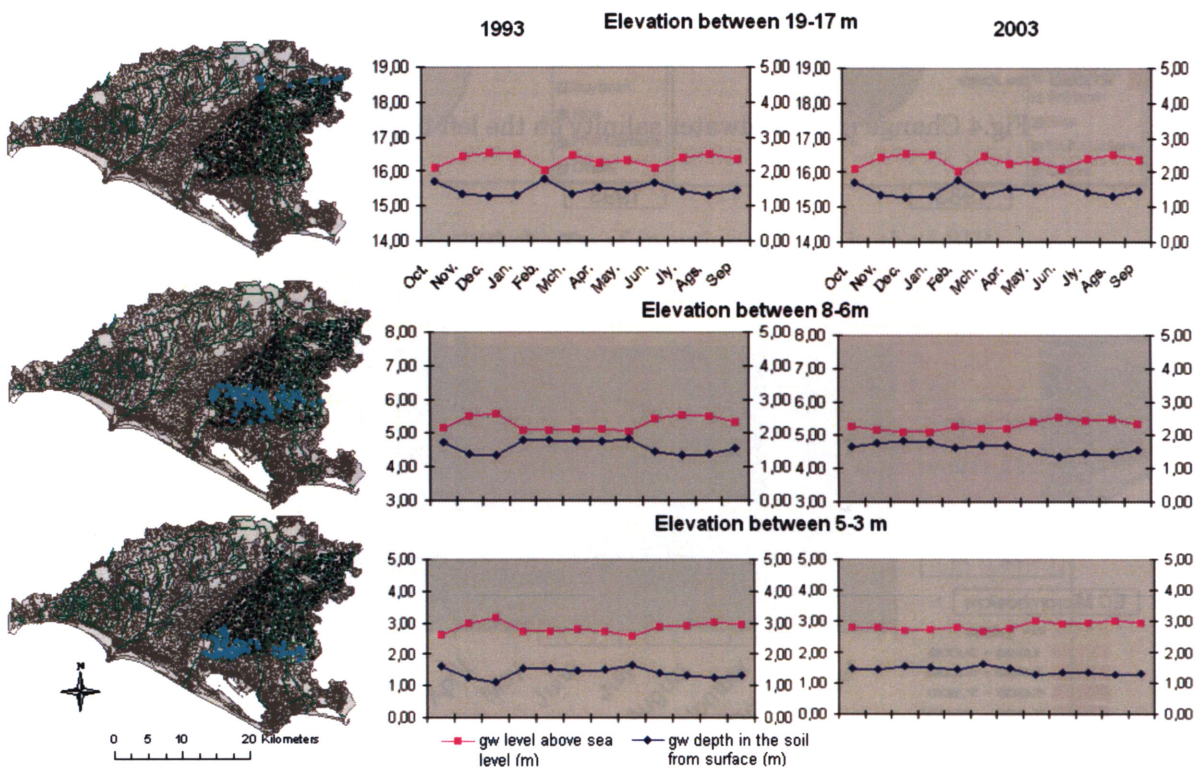
Fig. 7 Monthly fluctuations of the groundwater level and depth in blue areas on the left bank of the LSIP.
