# Effect of Glass Fiber Hybridization on the Behavior Under Impact of Woven Carbon Fiber/Epoxy Laminates

**ABSTRACT:** The low-velocity impact behavior was studied in hybrid laminates manufactured by RTM with woven carbon and glass (S2) fabrics. Specimens with different thicknesses and glass fiber content (from 0 to 21 vol.%) were tested with impact energies in the range 30–245 J and the resulting deformation and fracture micromechanisms were studied using X-ray microtomography. The results of these analyses, together with those of the impact tests (maximum load and energy absorbed), were used to elucidate the role played by glass fiber hybridization on the fracture micromechanisms and on the overall laminate performance under low-velocity impact.

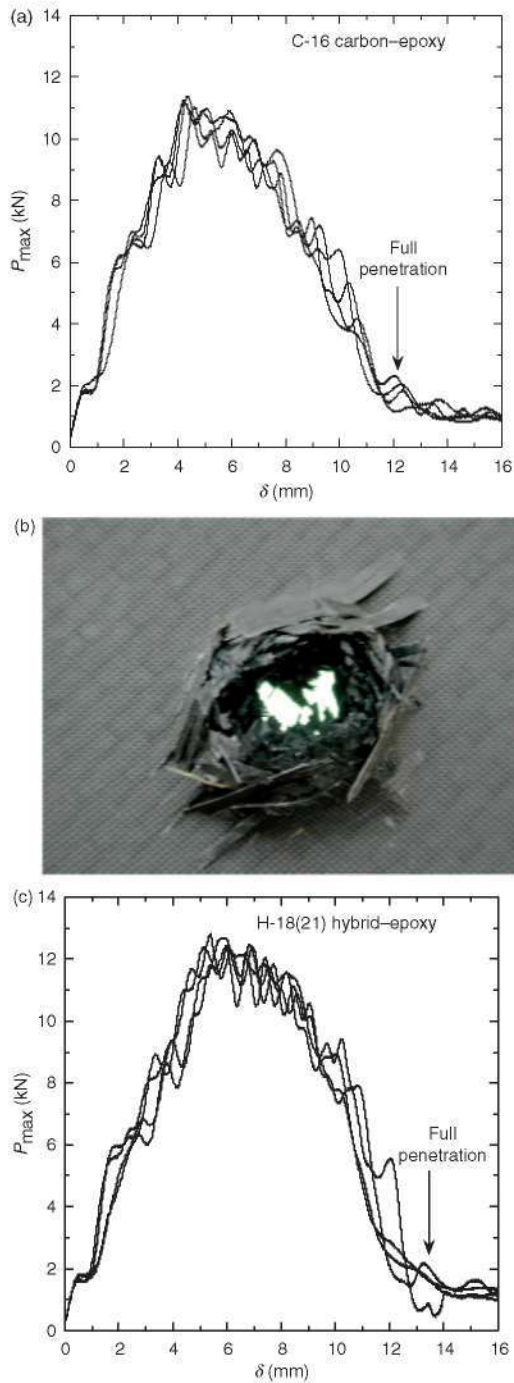
**Figure 1.** Load–displacement ( $P$ – $\delta$ ) curves of laminates subjected to out-of-plane low-velocity impact: (a) C-16 carbon–epoxy laminate with 5.7 mm nominal thickness. The arrows indicate the point of full penetration; (b) optical micrograph of the bottom layer a C-16 carbon–epoxy laminate after an impact test with full penetration; and (c) H-18 (21) hybrid carbon/S2 glass–epoxy laminate with 5.5 mm nominal thickness. The arrows indicate the point of full penetration.

Between four and six impact tests were carried out on each type of laminate. Impact energies were selected in such a way that full penetration was achieved in at least three specimens of each laminate. In addition, the impact energy was selected in several tests; therefore, the tup was stopped after reaching the maximum load to determine the fractions of the total kinetic energy dissipated by damage and stored as elastic energy at this point. Load–displacement ( $P$ – $\delta$ ) curves corresponding to full penetration tests in the C-16 laminate are plotted in Figure 1(a). The energy dissipated was computed as the area within the load–displacement curve. The different tests showed consistent results. The mechanical response was fairly linear up to the maximum load ( $\approx 11$ – $12 \text{ kN}$ ),\*\* which was attained when the tup displacement had reached 5 mm and the laminate had undergone extensive damage. After the maximum, the load carried by the composite decreased rapidly while extensive damage developed under the tup. The final part of the  $P$ – $\delta$  curve showed a marked change in curvature (marked with an arrow in Figure 1(a)), which stands for the instant at which full penetration was achieved. The residual load carried by the tup after this point corresponds to friction of the lateral tup surfaces with the laminate, as the laminate is completely perforated (Figure 1(b)).

The corresponding load–displacement curves for the full penetration impact tests of the H-18(21) laminate are plotted in Figure 1(c). The experimental scatter was very limited, once again. The curves presented the same features observed for the carbon–epoxy laminates, indicating that the deformation and damage mechanisms are equivalent. However, the maximum load and, particularly, the tup displacement at maximum load and at full penetration were consistently higher in the hybrid materials, although the H-18(21) laminate was slightly thinner than the C-16 plate (5.5 mm vs. 5.7 mm).

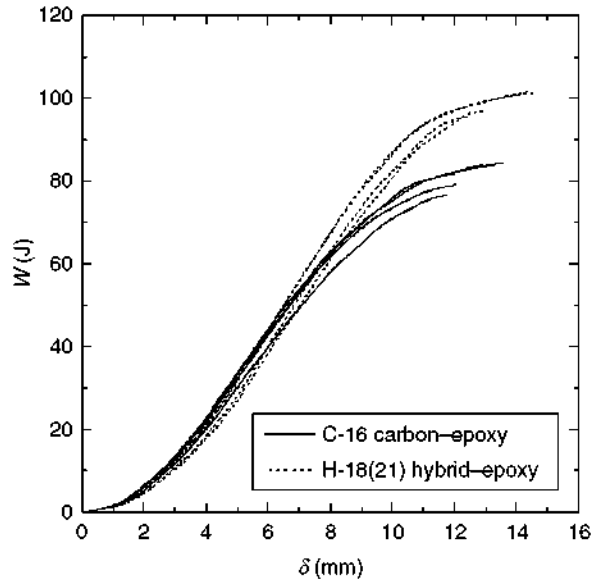
**Figure 2.** Energy–displacement ( $W$ – $\delta$ ) curves of C-16 and H-18(21) laminates subjected to out-of-plane low-velocity impact.

The energy absorbed by the laminates upon impact is given by the area under the  $P$ – $\delta$  curves in the test with full penetration and is plotted as a function of the tup displacement in Figure 2 for the C-16 and H-18(21) laminates. The curves are stopped at full penetration

because further energy dissipation was due to friction between the tup and the perforated sample. The curves for both materials showed a sigmoidal shape, which accounts for the two main deformation mechanisms: the elastic deformation of the plate and the nonlinear deformation associated with the damage processes. The former is dominant at the beginning of the impact whereas fracture and damage control post-peak behavior. This hypothesis is supported by the results of tests with lower energy, in which the tup did

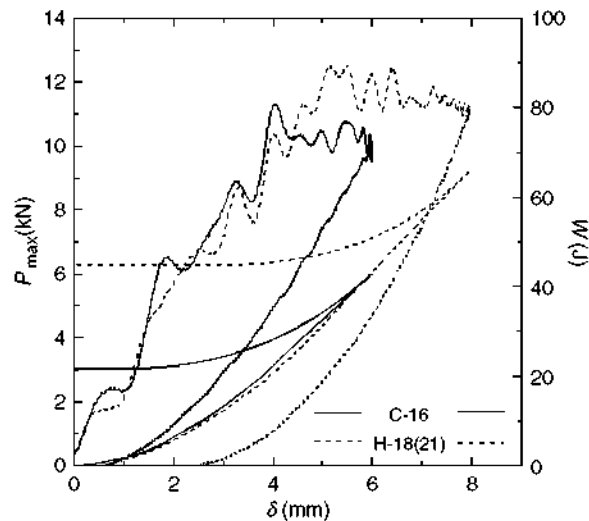
**Figure 3.** Load–displacement ( $P$ – $\delta$ ) and energy–displacement ( $W$ – $\delta$ ) curves corresponding to C-16 and H-18 (21) specimens impacted with 42 and 63 J, respectively, in which full penetration was not achieved.

not penetrate the laminate but rebounded. The corresponding  $P-\delta$  and  $W-\delta$  curves are plotted in Figure 3 for two representative tests on the C-16 and H-18(21) laminates. The maximum displacement of the tup was  $\approx 6-7$  mm and the rebound of the tup started just beyond the peak load. The  $W-\delta$  curves showed that between 30% and 50% of the energy absorbed by the laminate at this point was elastic and was returned to the tup during rebound, while the remaining energy was dissipated. The behavior of the carbon and hybrid laminates is also consistent with this picture. The energy absorbed by the carbon laminates was slightly higher than that of the hybrid laminates in the elastic region due to their greater stiffness (Figure 2). Nevertheless, hybrid laminates dissipated much more energy during fracture and the total energy dissipated by the hybrid laminates during impact was higher.

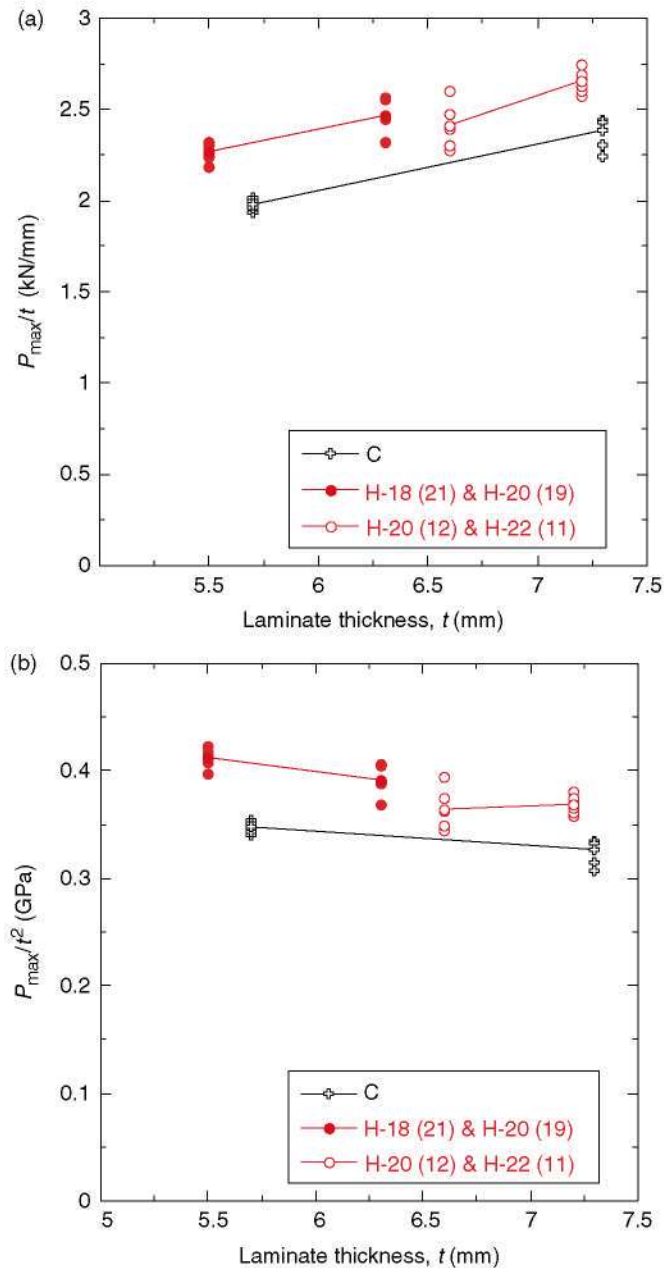
**Figure 4.** Maximum load supported by the laminates subjected to out-of-plane low-velocity impact as a function of the laminate thickness,  $t$ : (a)  $P_{max}/t$  and (b)  $P_{max}/t^2$ .

Similar curves were obtained for all the other materials, and the main results of the impact tests are summarized in Figures 4 and 5. They show, respectively, the maximum load,  $P_{\max}$ , and the energy dissipated during impact,  $W$ , as function of the laminate thickness  $t$  for all the materials. These figures demonstrate that thicker laminates carried higher loads and absorbed more energy during impact and that hybrid laminates performed better than carbon laminates. Thus, the hybridization with S2 glass was clearly beneficial from the viewpoint of impact behavior. In addition, the results in Figure 4 are useful for understanding the dominant failure mode. Depending on the stiffness of the laminate panel, failure by out-of-plane impact may be due to two mechanisms. If the plate is extremely rigid, fracture has to occur by formation of a cylindrical plug under the tup and the load-bearing capability of the plate depends on the out-of-plane shear strength of the laminate and is proportional to the thickness  $t$ . Conversely, if the laminate plate is very flexible, the maximum load supported by the composite is controlled by the tensile fracture of the bottom ply due to the bending stresses. In this case,  $P_{\max}$  depends on the ply tensile strength and is proportional to  $t^2$ . The variation of  $P_{\max}/t$  and  $P_{\max}/t^2$  with the laminate thickness is plotted for all the materials in Figure 4(a) and (b), respectively. These curves show that  $P_{\max}/t$  increases with the laminate thickness in all the materials and precludes fracture by the formation of a cylindrical plug. The curves in Figure 4(b) show that  $P_{\max}/t^2$  was constant (within the experimental scatter) for all the laminates and these results seem to indicate that fracture of the bottom ply was the mechanism controlling the maximum load upon impact. In addition, the results in Figure 5 show that the energy dissipated during impact was approximately proportional to the square of the laminate thickness for each material. This behavior is compatible with the development of conical damage behind the tup, as was postulated in previous investigations [1-3], whose volume is proportional to  $t^2$ .

Finally, results were presented for two sets of laminates containing 11-12 and  $\approx 20$  vol.% of S2 glass fiber plies. Although all the laminates had different thicknesses, and it was not possible to make direct comparisons; it may be concluded from Figures 4

and 5 that laminates with 20 vol.% of S2 glass fibers performed slightly better than those with only 11–12%. These differences disappeared when the laminates were compared in terms of the areal density, as is shown in Figure 6. Thus, increasing the glass fiber content does not monotonously improve the impact performance of hybrid composites in terms of specific properties (impact strength/weight and energy dissipated/weight).

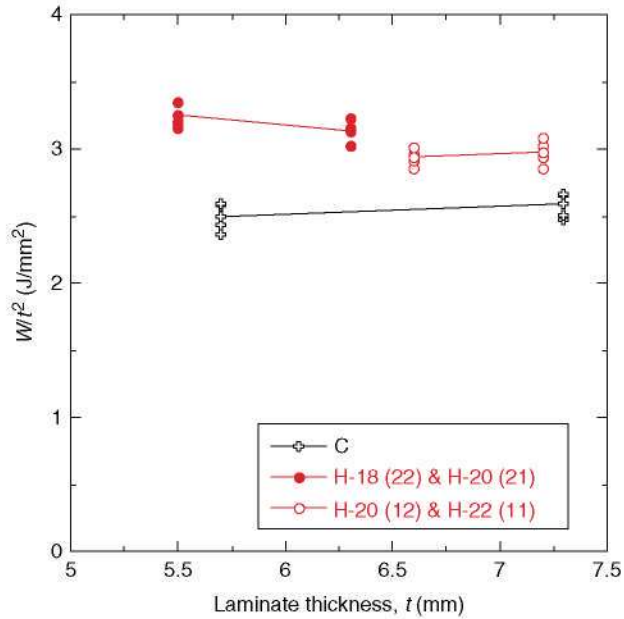
**Figure 5.** Energy dissipated,  $W$ , normalized by  $e^2$ , under low-velocity, out-of-plane impact as a function of the laminate thickness.

Variations in the laminate thickness did not change the dominant deformation failure and micromechanisms, although the volume of the conical damage zone increased with  $t^2$  (Figure 10) and the corresponding energy dissipated increased accordingly (Figure 5). Regarding the effect of the volume fraction of glass fibers in the laminate, they can be analyzed from the sections in Figure 8 (21% of S2 glass fibers) and in Figure 11 (11% of S2 glass fibers). Although these sections correspond to two laminates with different thicknesses (5.5 and 7.2 mm, respectively) impacted with different energies (63 and 92 J, respectively), the damage state in both cases was comparable because both correspond to tests in which the tup was stopped right after attaining maximum load. The specimen with 11 vol.% of S2 glass fibers (Figure 11(a)) showed the beneficial effect of the two glass fiber plies near the top and bottom surfaces, which impeded the propagation into the laminate of the intraply cracks formed on the surfaces. Differences with the laminate reinforced with higher volume fraction of S2 glass fibers appeared in the inner carbon plies, which underwent damage by delamination and intraply cracking (Figure 11(b)). Carbon plies of laminates with a higher S2 glass fiber content subjected to similar deformation (Figure 8(b)) only showed damage by delamination, indicating that

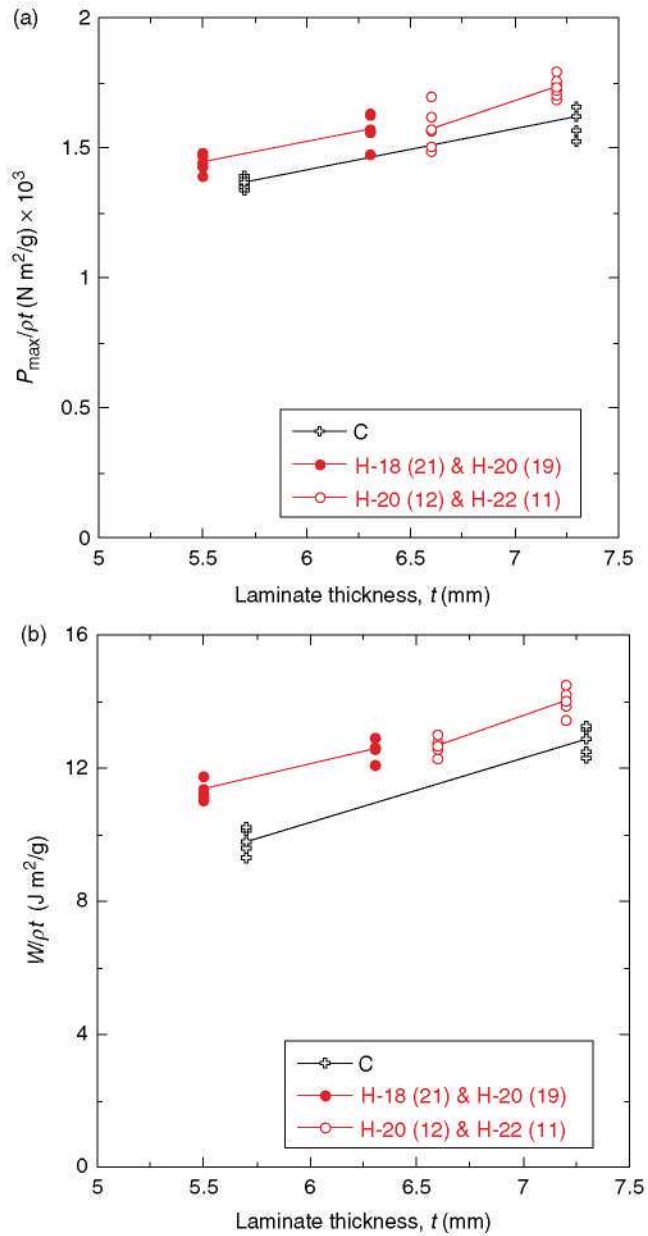
**Figure 6.** (a) Maximum load, normalized by the areal density  $\rho t$ , as a function of the laminate thickness,  $t$ ; and (b) energy dissipated, normalized by the areal density  $\rho t$ , as a function of the laminate thickness,  $t$ .

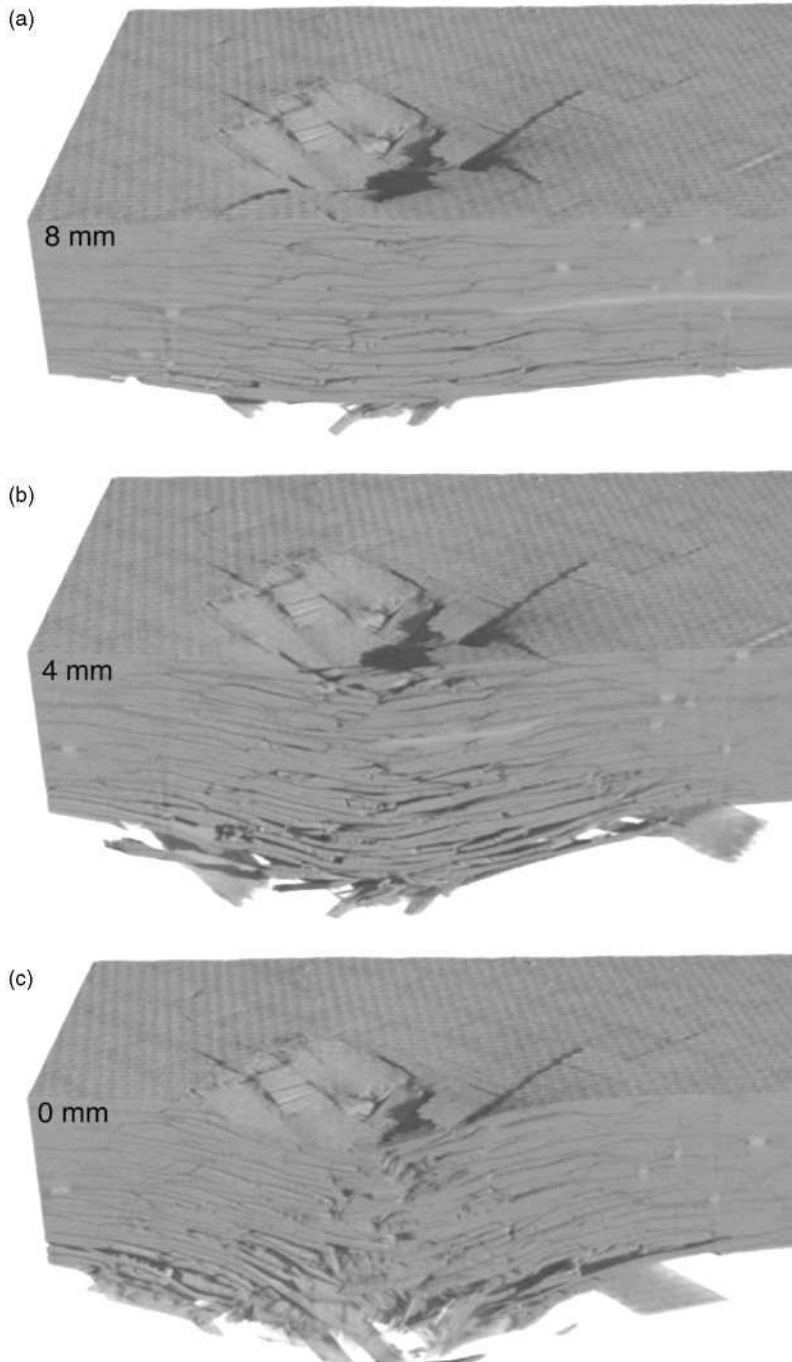
**Figure 7.** X-ray tomography sections of a C-16 composite laminate subjected to out-of-plane low-velocity impact with 63 J: (a) 8 mm from the impact axis; (b) 4 mm from the impact axis; and (c) under the impact axis. The laminate thickness was 5.7 mm.

Specimens, which underwent full penetration, showed extensive damage and it was very difficult to determine the sequence of fracture events. Therefore, analysis by X-ray microtomography focused on specimens which did not undergo full penetration. Sections perpendicular to the plies of the C-16 laminate with a thickness of 5.7 mm impacted with 63 J are shown in Figure 7. They were obtained at various distances from the impact axis, and provided very useful information about the fracture processes when the laminate was

subjected to different deformation levels. Further away (i.e., 8 mm) from the impact axis, damage was observed in the form of tensile fracture of the bottom plies (Figure 7(a)). Intraply cracks formed at the bottom plies, propagated through the lamina until they were deflected at the interply interface and delamination progressed until interply cracks were deflected by matrix cracking into upper plies. This process was visible throughout the whole section although the damaged zone was larger near the bottom plies. The laminate section at 4 mm from the impact axis (Figure 7(b)) showed extensive damage near the bottom plies by delamination and intraply fracture because the stiff carbon plies were not able to withstand the large strains induced by the impact of the hemispherical tup. In addition, failure by crushing was seen in the top plies. The intraply cracks generated by crushing were deflected at the interfaces and led to the development of the interface cracks between the upper plies observed in Figure 7(a). Damage was, however, more localized near the top plies and the overall damaged zone presented a conical shape. The section located just below the impactor (Figure 7(c)) showed the formation of an incipient crack through the laminate thickness formed by the coalescence of the interply cracks created in the bottom and top plies. The conical shape of the damaged region was also evident in the section.

The effect of glass fiber hybridization is readily observed when Figure 7 is compared with the sections shown in Figure 8, which correspond to the H-18 (21) laminate with a thickness of 5.5 mm impacted with 63 J. The dominant damage processes were equivalent to those found in the carbon–epoxy laminates, namely tensile fracture of the bottom plies and crushing of the top plies under the tup. The intraply cracks in the bottom and top plies grew upwards and downwards, respectively, leading to the development of delamination cracks, and final fracture took place by the formation of a crack through the laminate thickness (Figure 8(c)). Comparison of Figures 7(c) and 8(c) demonstrates, however, that the amount of damage in the carbon–epoxy laminate was far higher than in the hybrid–epoxy composite for equivalent impact conditions. At 6 mm from the impact axis (Figure 8(a)), damage in the hybrid composite was limited to tensile fracture of the bottom carbon ply and to delamination between carbon plies (marked with arrows in Figure 8(a)). The S2 glass plies were intact and impeded the propagation of interply cracks from the bottom ply toward the center of the laminate. The reason for this behavior is more obvious in Figure 8(b), which shows that the S2 glass plies were able to accommodate the deformations imposed by the hemispherical impactor without fracture due to the higher strain-to-fracture of the glass fibers. Thus, damage by intraply fracture and delamination was localized in the carbon plies, but the S2 glass plies were able to hold the laminate together. Fracture of the laminate only began when the S2 glass plies were finally broken by shear (Figure 8(c)). The higher strain-to-failure of the S2 glass plies thus helped to sustain higher deformations before laminate fracture by the percolation of a through-thickness crack and increased the maximum load-bearing capability of the composite. In addition, the S2 plies failed at higher strains than the carbon plies and absorbed more energy, significantly improving the energy dissipated under impact.

Extensive delamination between C plies did not enhance the overall energy dissipation and this is in agreement with recent numerical simulations [24], which found that the contribution of intraply failure to the total energy dissipated was far higher than that provided by interply delamination. In this respect, the location of the glass fiber plies (near to but not on the top and bottom laminate surface) helped to increase the laminate performance upon impact. The maximum load was controlled by the fracture of the carbon ply at the bottom though the intraply cracks did not propagate into the laminate but were stopped at the S2 glass ply, and a similar process occurred with cracks formed by crushing on the top ply (Figure 8(a)). In addition to stopping the intraply cracks, the glass fiber plies accommodated the impact deformation, and the inner carbon plies in the hybrid composite did not fail at low strains although they experienced extensive delaminations to accommodate the deformation of the glass fiber plies. This behavior is in contrast with the brittle behavior of the composites without glass fiber plies in which extensive ply cracking was observed away from the impact axis (Figure 7(a)).

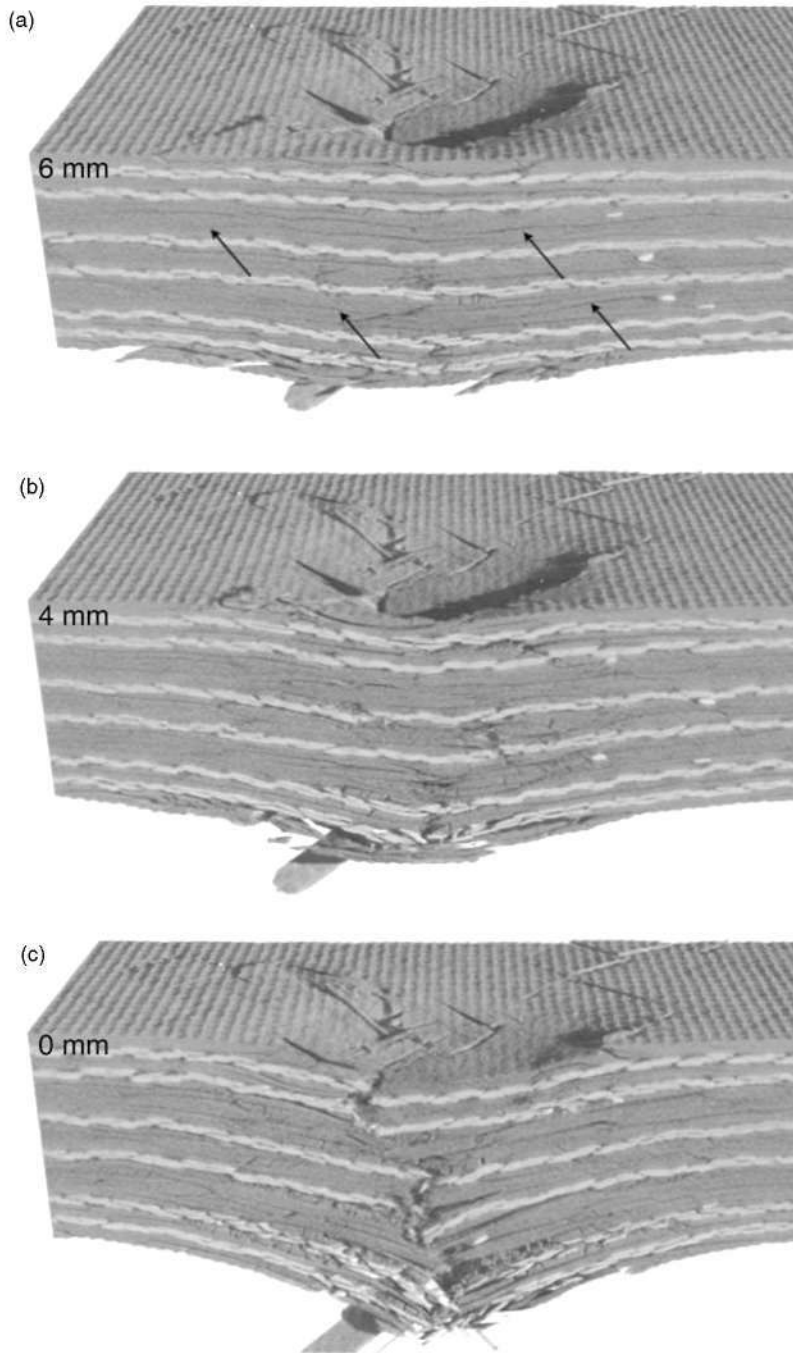
**Figure 8.** X-ray tomography sections of a H-18 (21) composite laminate subjected to out-of-plane low-velocity impact with 63 J: (a) 6 mm from the impact axis; (b) 4 mm from the impact axis; and (c) under the impact axis. The laminate thickness was 5.5 mm.

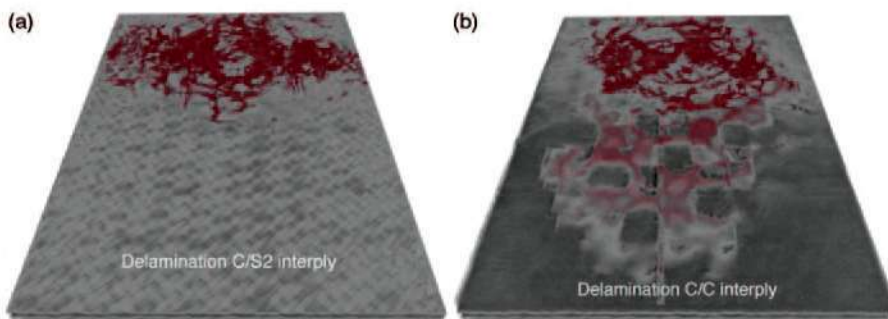
**Figure 9.** Delamination between plies located near the bottom of the H-18 (21) composite laminate subjected to out-of-plane low-velocity impact with 63 J: (a) delamination at C/S2 glass interply and (b) delamination at C/C interply. Contrast was enhanced with a ZnI solution and delaminated regions appeared in red. The laminate thickness was 5.5 mm.

It should be noted that the higher deformability of the S2 glass plies also inhibited the propagation of interface cracks. To quantify the differences more accurately, samples were immersed in a solution containing ZnI prior to X-ray microtomography. The extent of interply delamination near the bottom of the laminate between C/S2 and C/C plies is shown in Figure 9(a) and (b), respectively. These differences were not caused by changes in the interply toughness (which was mainly controlled by the epoxy properties) but they were also a consequence of the higher deformability of the S2 glass fiber plies. In the absence

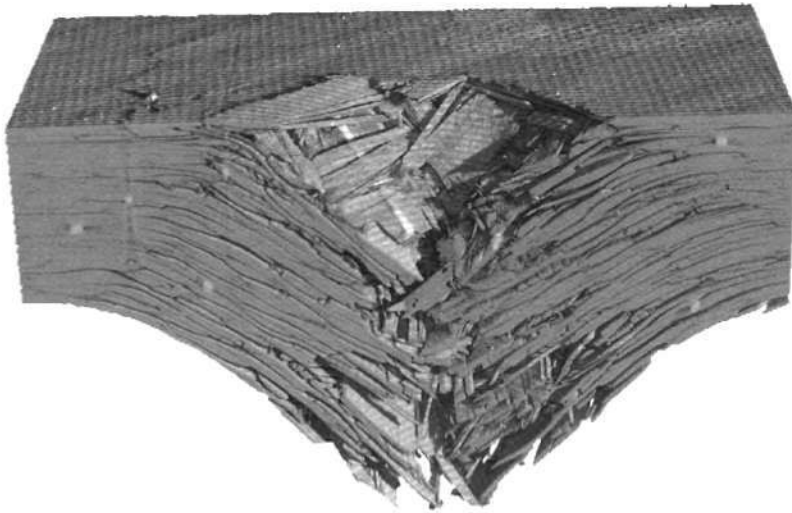
**Figure 10.** X-ray tomography sections of the C-20 carbon-epoxy laminate subjected to out-of-plane low-velocity impact with 92 J. The laminate thickness was 6.3 mm.

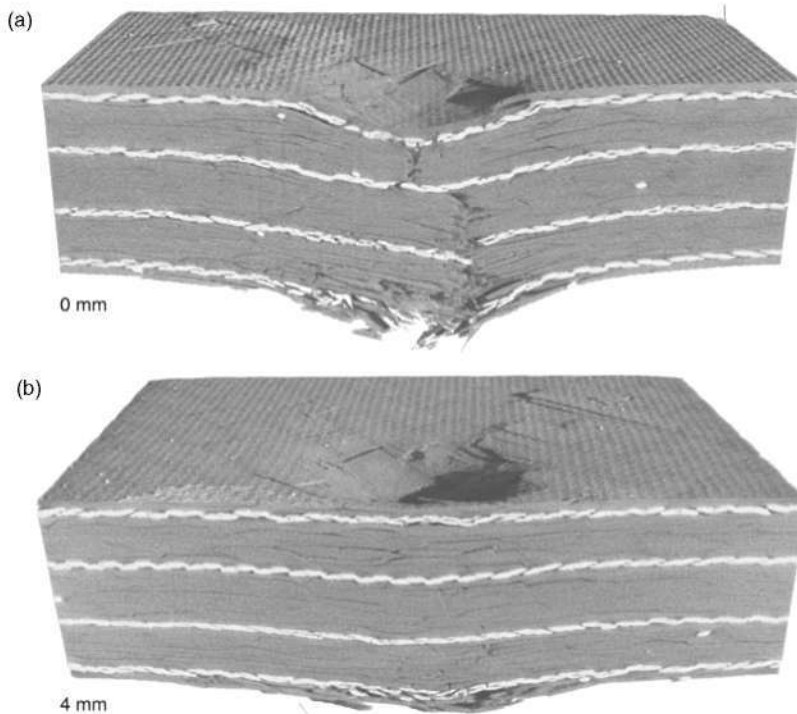
**Figure 11.** X-ray tomography sections of the H-22 (11) hybrid-epoxy laminate subjected to out-of-plane low-velocity impact with 92 J: (a) under the impact axis and (b) 4 mm from the impact axis. The laminate thickness was 7.2 mm.

the presence of more glass fiber layers has helped to accumulate the nonlinear deformations without leading to intraply cracking. Nevertheless, it should be noted that these differences only led to marginal improvements in the maximum load and energy dissipated by the laminate.
