Procedia Engineering 167 (2016) 252 – 264

# THE EFFECT OF SLAMMING IMPACT ON OUT-OF-AUTOCLAVE CURED PREPREGS OF GFRP COMPOSITE PANELS FOR HULLS

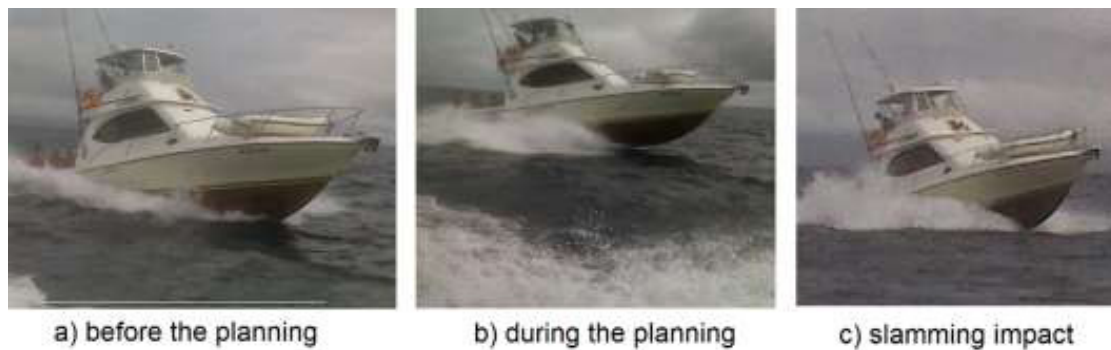
Figure 1. Navigation of the boat "Bite Me"

In Figure 3, three moments of navigation of the SB "Bite Me" are shown [3]; these were observed during a sea trial to determine its behavior in the slamming impact produced by the planing condition of the vessel. The phenomenon of slamming consists of three clearly identified moments: in a), the vessel is gaining hydrodynamic lift; then, in b), it reaches the critical point at which the bow rises. Breaking the equilibrium, it falls, hitting the sea with the bottom of the hull, over times equivalent to microseconds, thereby generating a high pressure of slamming [4-5].

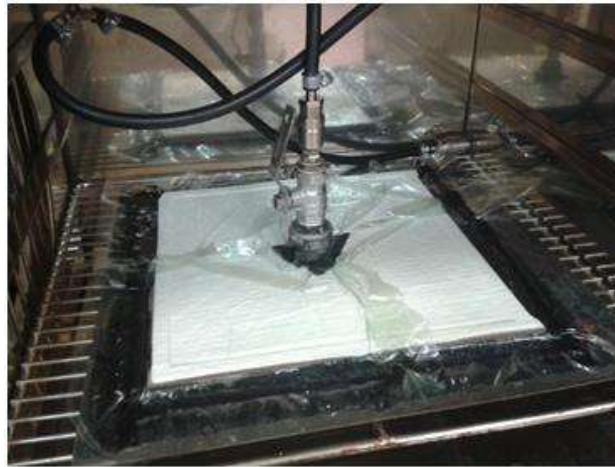
For the slamming test, OoA prepreg GFRP panels were prepared and stored at  $-18^{\circ}\text{C}$ . Before use, they should be kept in a plastic bag that does not absorb humidity for 24 hours. The laminate was cut with fabrics of  $270 \times 270$  mm, corresponding to dimensions of the frame of the slamming test apparatus. This included peel ply at the ends, a breathing fabric at the top, an impermeable sheet so that the resin flows to the sides and the vacuum valve is not covered, and cork bars on all four edges, with all of this tucked inside a vacuum bag. It was necessary to prove that the vacuum was maintained without leaks to ensure that during oven curing, there is a good vacuum.

The furnace employed made it possible to introduce a vacuum hose and keep the vacuum pump turned on during the curing process. The applied temperature ramp consisted of a temperature rise at  $6^{\circ}\text{C}$  per minute to  $120^{\circ}\text{C}$ , which was maintained for 90 minutes and then allowed to cool to room temperature. Figure 3 shows a panel ready for curing. After demolding, the strain gauge was placed on one side for the purpose of controlling the  $\varepsilon$  that was applied in the tests. This gauge was located at a distance of 40 mm from the center of the panel to avoid being hit by the cam.

Figure 3. Panel ready for curing

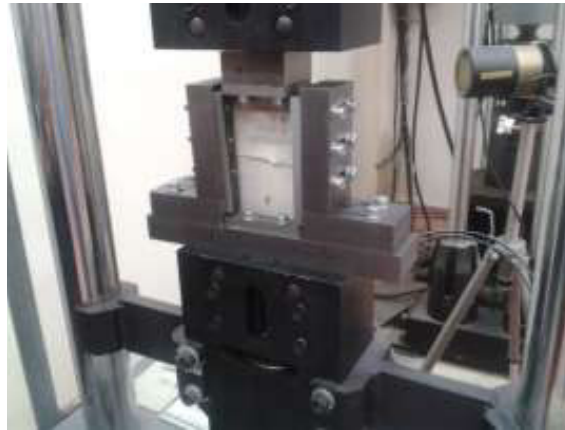
The methodology required, for the analysis of results, the residual strength of the damaged panels to be determined, for which the Airbus AITM-0010 tool was built, as presented in Figure 4. The panels

impacted by dropping weight by gravity at different  $\epsilon$  values were tested with the tool. It is noteworthy that during the tests, the samples remained embedded on four sides to prevent the panel from tilting and erroneous data being obtained.

Figure 4. Airbus AITM-0010 compression tool after impact

Compression tests were performed after impact for five test pieces that had been impacted to different  $\varepsilon$  values: 0 (non-impacted), 1921, 3394, 3750, and 4336  $\mu\text{m/m}$ . The flexibility of the material, which had changed from 7000  $\text{mm/N}$  to 12,300  $\text{mm/N}$ , was calculated.

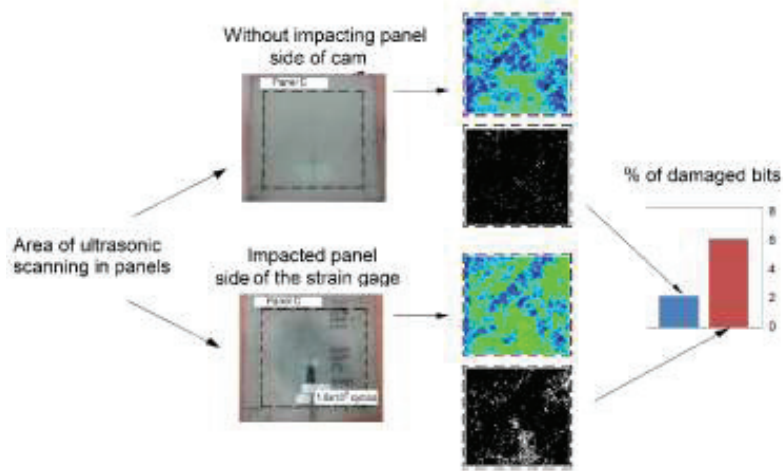
Ultrasound analysis on each panel between impact blocks was performed on an equivalent 150 x 150 mm surface, taking the impact zone as the center. A comparison of the percentage of damaged parts from panel C without impacting and impacted at a pressure of  $633 \text{ kN/m}^2$  is shown in Figure 9. Ultrasound analysis was conducted on the panel without impacting, and a color image, which was then converted into black and white, was

obtained. The percentage of damage obtained was 2.05%. At the end of the test, the same procedure was applied to the end of the impact cycle block with  $1.8 \times 10^5$  accumulated cycles, which resulted in 5.80% damaged parts in the panel.

Figure 9. Ultrasound comparison of panel C without impacting and after  $1.8 \times 10^5$  cycles of impact at  $P = 633 \text{ kN/m}^2$

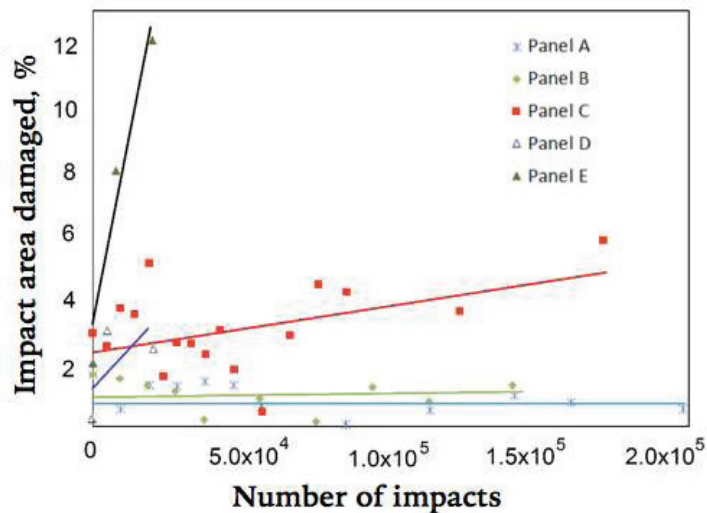
Figure 10 shows the level of damage of the panels impacted by slamming versus the number of impacts received for each of the ultrasound tests. It is noted that panels A, B, and C in the regimen of progressive damage at high numbers of cycles do not exceed 6% damaged parts. For panel D, although it is part of the regime of low-cycle progression, the ultrasound testing is not representative for the point damage received in the area in contact with the cam in relation to the total swept area, as is the case with panel E.

Figure 10. Comparison of percentage of damaged area

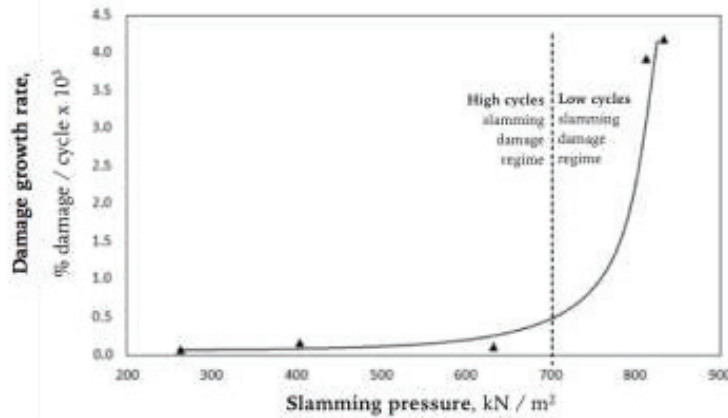
According to the damage-percentage ratio for the total cycles per panel tested at different pressures, Figure 11 shows the trend in damage obtained with the slamming apparatus. For pressures greater than  $700 \text{ kN/mm}^2$  damage per cycle imposed on the material, there is a low-cycle damage progression regime, on the order of  $10^4$  slamming impact strokes. For pressures less than this value, the tests are in the low-cycle damage progression regime, or on the order of  $10^5$  strokes.

Figure 11. Percentage of damage/cycle with the pressures applied on the panels
