VINGT-CINQUIEME CONGRES  
DES GRANDS BARRAGES

Stavanger, juin 2015

**CONCRETE LINING OF THE CORE-FOUNDATION INTERFACE TO PREVENT  
INTERNAL EROSION: AN EFFICIENCY ASSESSMENT<sup>(\*)</sup>**

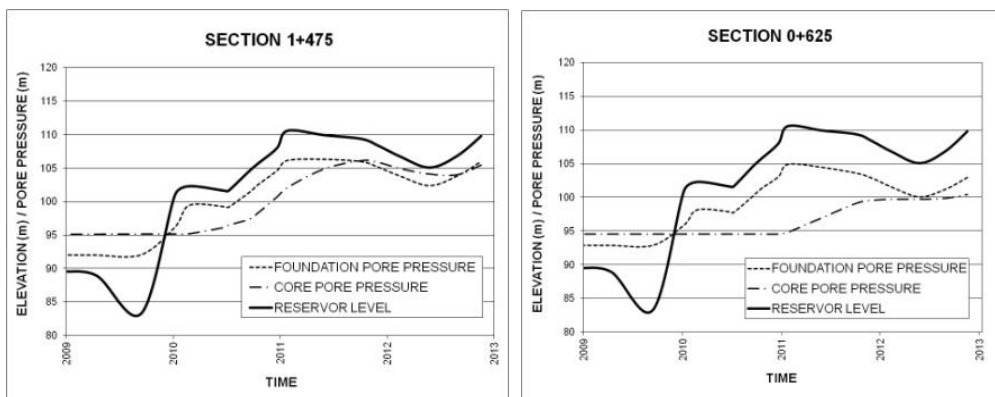
Fig. 5

Although pore pressure measurements are related to specific points of the dam and leakage may be located elsewhere, the extensive monitoring system for controlling this variable gives an accurate idea on how the lining performs. Figure

5 shows the evolution of the pore pressures in two sections, for the pair of piezometers located at the dam axis. It can be observed how the pore pressure follows the evolution of the reservoir level, with slight differences depending on the location of each apparatus. The general trend that is observed for most of the piezometers pairs is that pressures on the foundation have a faster response to changes in the reservoir level than those on the core-base. This effect suggests that the foundation permeability on the rock foundation is larger than that of the core-base.

Pore pressure evolution above and beneath the concrete slab.

Pore pressure on the core-slab line has a slower response to changes in reservoir level than the one on the foundation-slab interface. This behaviour, in which the pore pressure evolution of clay shows a significant inertia when following the reservoir level, is not that clear in the foundation. This is due to the different permeability of each one. This fact was expected for the site geology and clay characteristics of Andévalo dam.
