Review article

Reinforcement and repair of small sawn *Pinus Sylvestris* beams with carbon fiber

E.P. Gómez ^{a,*}, A. Cobo ^a, M.N. González ^b

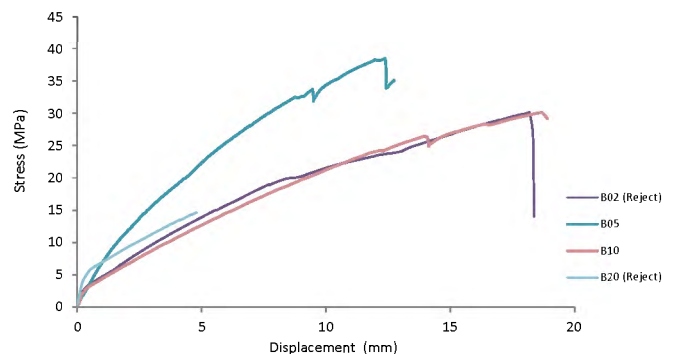
Fig. 5. Stress–displacement of beams without reinforcement tested to flexural strength at 3 points.

Figs. 4 and 5 and Table 4 show the results obtained in the tests. The first column indicates the beam number; the second column shows the strength class (C-22 or rejection); in the third and fourth column, the maximum flexural strength value reached can be checked, as well as the displacement obtained for that strength value. Fifth and sixth columns indicate the type of fracture and the constraints of it. The ultimate stress value reached by the beam (ultimate fracture stress) has been obtained assuming that the material has a linear elastic behavior, as stated in the Eurocode 5 [36], based on the expression [1].

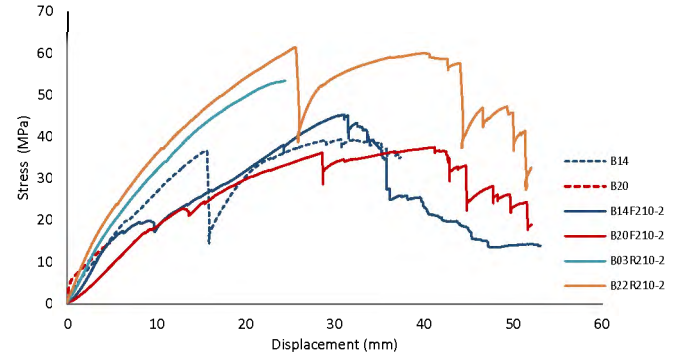
Fig. 10. Stress –displacement of the beams reinforced and repaired with 2 layers of CFRP of 210 gr/m² tested in 3 and 4 point bending.

Figs. 6 and 8–10 show the results obtained during the bending tests of beams reinforced and repaired with 1 and 2 layers of bidirectional CFRP of 160 gr/m² and 210 gr/m².
