CHANSON, H., and WHITMORE, R.L. (1998). "Gold Creek Dam and its Unusual Waste Waterway (1890-1997) : Design, Operation, Maintenance." *Can. JI of Civil Eng.*, Vol. 25, No. 4, Aug., pp. 755-768 & Front Cover (ISSN 0315-1468).

Gold Creek Dam and its Unusual Waste Waterway (1890-1997) : Design, Operation, Maintenance

Keywords : spillway design, engineering heritage, concrete construction, stepped weir, spillway operation, spillway refurbishment, 19th century structure.

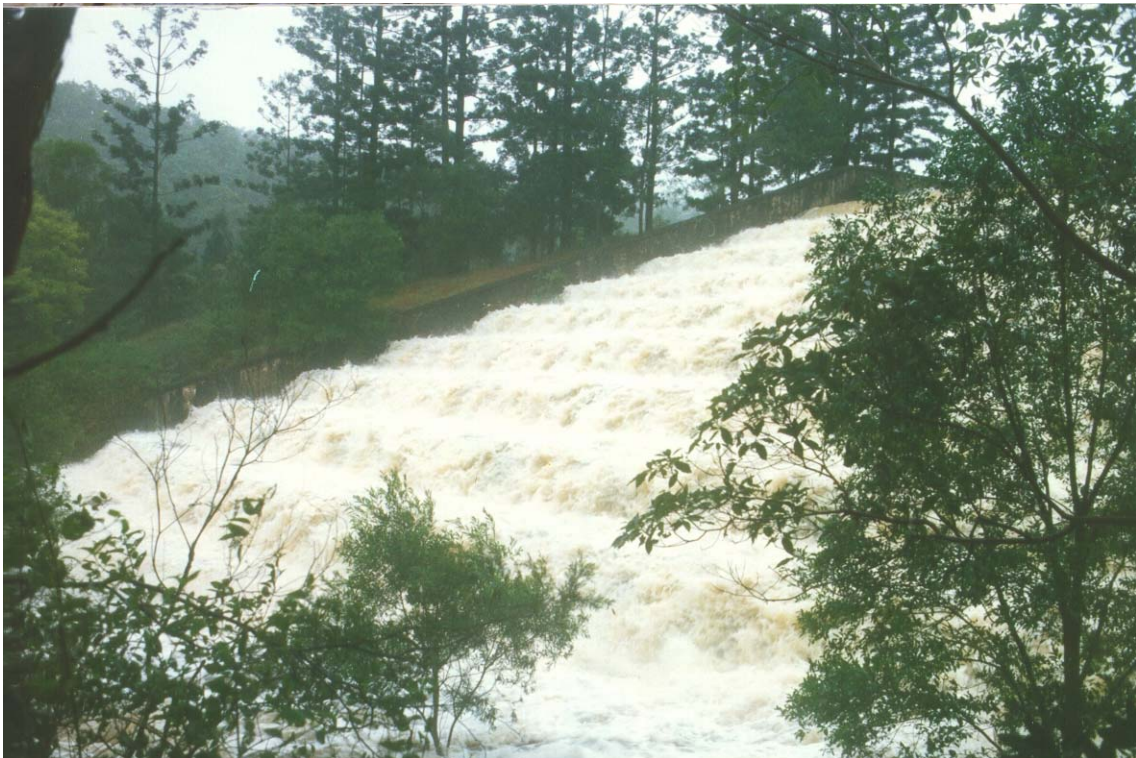
Fig. 4. Photographs of the Gold Creek dam spillway in operation (taken on 2 May 1996)
(a) View from the left bank and downstream

In 1975, the crest elevation of the spillway was lowered by 1.2-m (4 feet) to increase the maximum discharge capacity⁷ but the steep channel was unmodified. Today the stepped chute is still in use (fig. 4).

Figure 4 presents photographs of the spillway in operation early May 1996. The photographs show the cascading waters at low overflow (i.e. nappe flow regime).

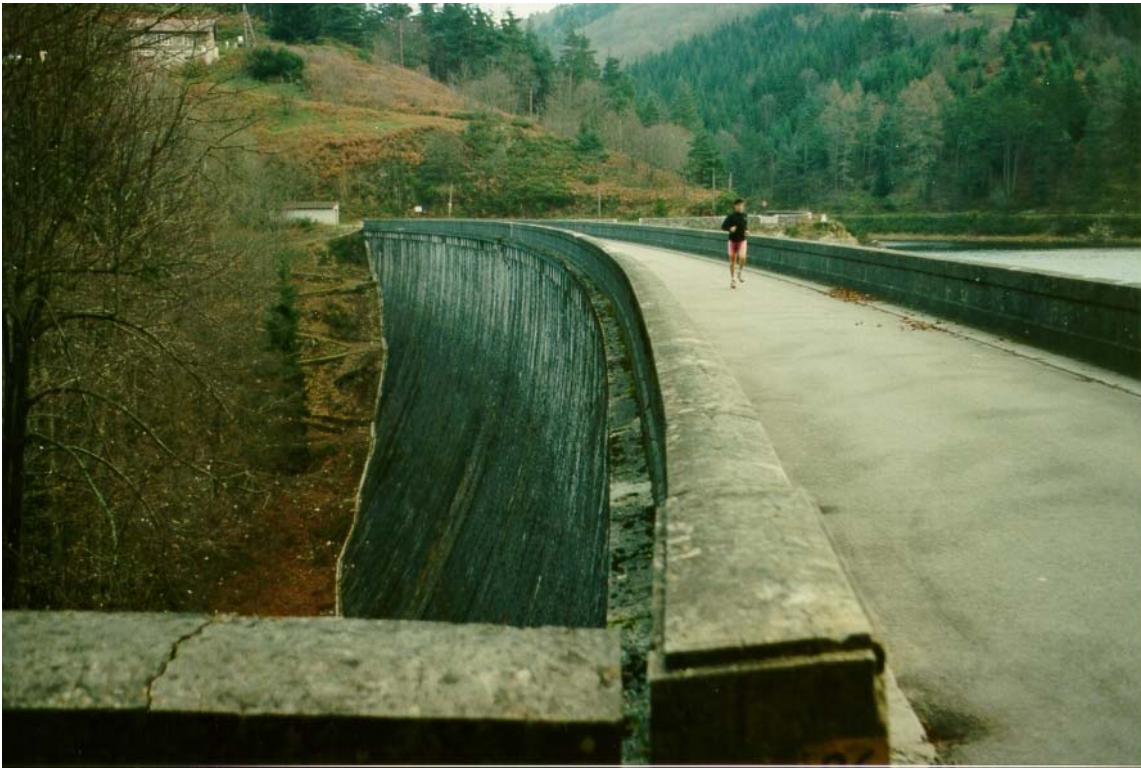
Fig. 7. Photograph of the Pas du Riot dam (taken on 3 December 1994)

Masonry dam completed in 1873 : H = 36 m, L = 154 m - Maximum discharge capacity : 65 m³/s

(a) View of the downstream dam face from the left bank.

Another influence might have been the French experience in stepped spillway design. Between 1850 and 1900 several masonry dams were constructed with a lateral stepped spillway : e.g., the Gouffre d'Enfer dam (fig. 6), the Ternay dam, the Pas du Riot dam (fig. 7), the La Rive dam and the La Tâche dam¹⁴. The first of these structures was designed by the French engineer Delocre (1828-1908) while the next three structures were built as replicas of the Gouffre d'Enfer dam (Wegmann 1911, Smith 1971). In his book, Humber (1876) mentioned the work of Delocre and the construction of the Gouffre d'Enfer dam built in 1858 (Humber, p. 123) (see App. 1). It is likely that Australian engineers knew these references.

Three masonry dams were built subsequently as replicas of the Gouffre d'Enfer dam : the Ternay dam, completed in 1867, to supply water to the city of Annonay, France¹⁸; the La Rive dam (also called the Ban dam), completed in 1870, to supply water to the city of Saint-Chamond, France¹⁹; the Pas du Riot dam, completed in 1873, and located few kilometres upstream of the Gouffre d'Enfer dam, to supply water to the city of Saint-Etienne (fig. 7)²⁰.

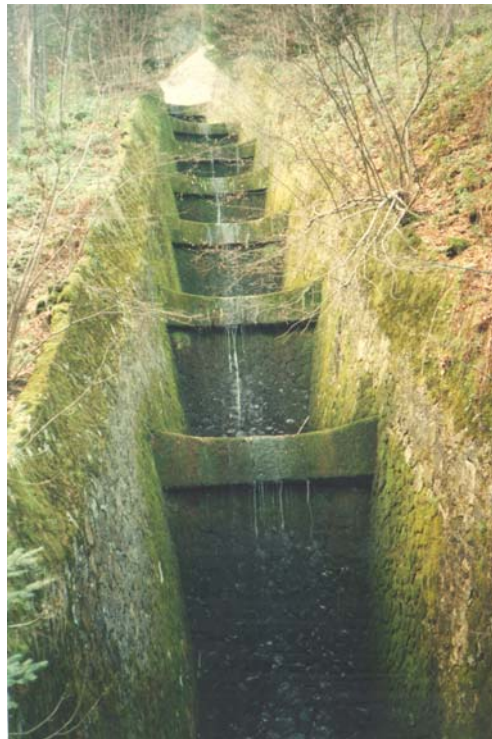
(b) View from downstream of the masonry stepped spillway located on the left bank.
