5th Australasian Congress on Applied Mechanics, ACAM 2007
10-12 December 2007, Brisbane, Australia

Composite Repairs To Cracked Metallic Components- Experiment and Theory

R. Jones, D. Peng, K. Cairns, and S. Pitt

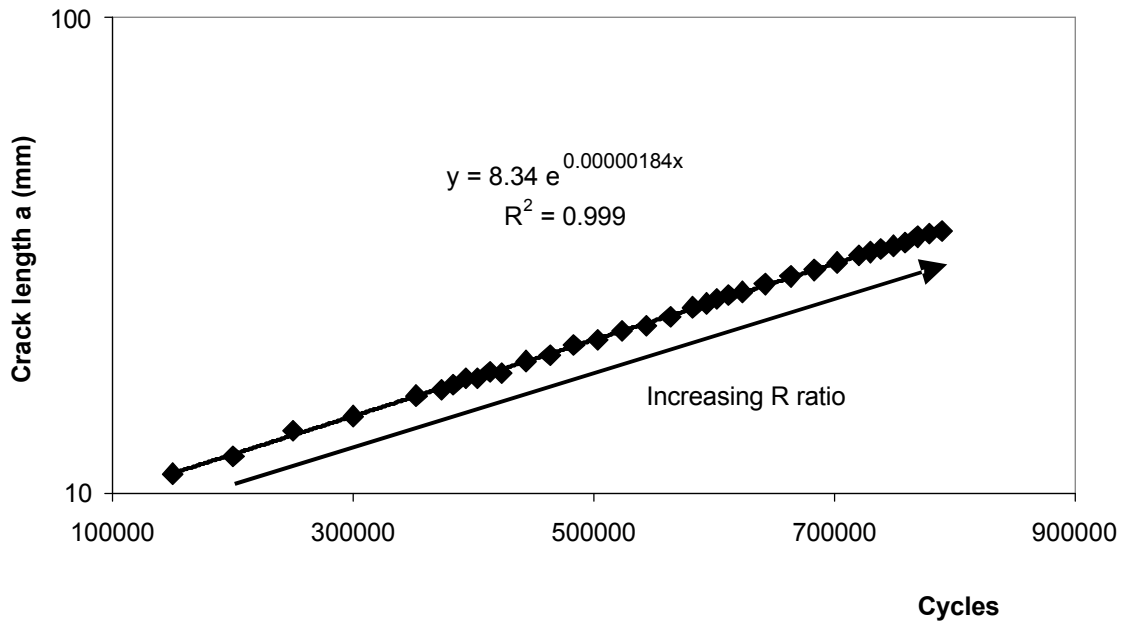
Case 2: Baker [13] also presented the test results, in Figure 13.7 on page 385, for the seven ply boron epoxy repair described in Case (1), with the exception that the initial flaw size was 10mm, subjected to constant amplitude loading with $\Delta\sigma$ of 76 MPa, but with the R values that were successively increased from 0.1 to 0.55, 0.64 and finally 0.75 as the test continued. The resultant crack growth data is plotted in Figure 2, where it can be seen that as postulated in [13] crack growth was relatively insensitive to the R ratio and that the data is essentially log-linear, i.e. there was a near linear relationship between the log of the crack length and the number of cycles.

Figure 2 Crack length versus number of cycles for the edge cracked 2024 T3 aluminium plate, repaired with a seven ply boron epoxy patch, under variable R ratio from Baker [13].

For small cracks it is accepted that the dominant effect of the patch is due to the reduction in the net section stress. The log-linear relationship shown in Figures 1-3, over the range $5 \text{ mm} < a < 40 \text{ mm}$, which corresponds to a (near) linear relationship between da/dN and the crack length (a), reveals that over this range of crack lengths the dominant mechanism is essentially unchanged. This in turn means that the dominant mechanism is essentially that seen for a composite repair to a small crack, i.e. it is (essentially) due to the reduction in the net section stress beneath the patch. This finding when taken together with the results presented in [10, 11], the experimental results presented above and in [7-9, 14, 15] reveals crack bridging effects to be a secondary effect over this range of crack lengths and hence invalidate the theoretical model presented by Rose and co-workers [5, 6].

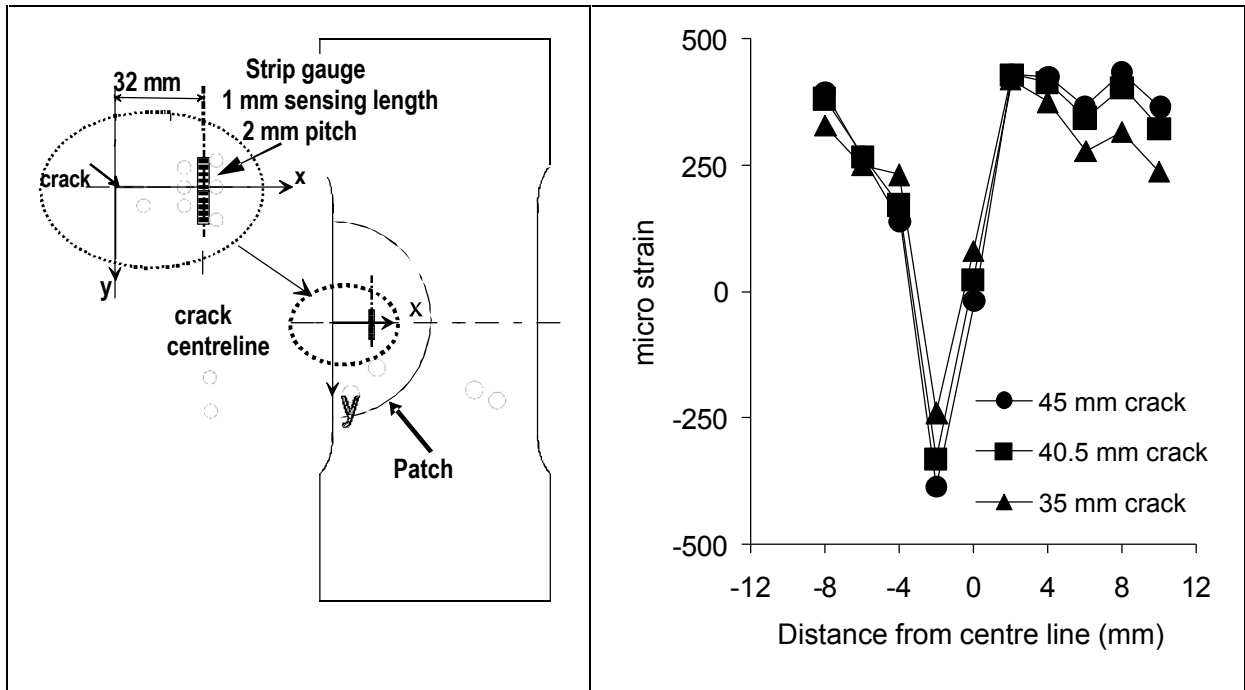
Figure 4 Patch surface strains for a 35, 40.5 and 45 mm long crack, from Galea [19].

When developing this model Rose and co-workers [5, 6] assumed over the crack the stresses in the patch were constant through the thickness of the patch, and that the maximum stresses in the patch occurred over the crack. The experimental and numerical results presented in [16-19] invalidates these assumptions. In [16, 17, 18] it was found that over the crack the stress field in the patch is highly three dimensional, i.e. the maximum principal stress varies through the thickness, and that there is a dramatic reduction in the (surface) stresses in the patch directly over the crack. This conclusion, i.e. that the stress field over the crack in the patched structure is highly three dimensional and that there is a dramatic reduction in the (surface) stresses in the patch directly over the crack, has been confirmed via three dimensional finite element analysis [17, 18] and by strain gauge measurements [19]. In [19] a series of strain gauges were located along a line on the surface of the patch that lay at a distance of 32 mm from the edge of the specimen, see Figure 4, which in this study was as described in Case (1). The gauges, which as mentioned above lay on a line that was perpendicular to the line of the crack, were located at distances of $0, \pm 2, \pm 4, \pm 6, \pm 8$ and 10 mm from the centre line of the specimen. (As shown in Figure 4 the line of the crack was nominally along the centre line of the specimen.) In this study it was found that the surface fibre strain directly over the crack dropped dramatically as the crack grew underneath the central gauge and that the surface fibre strain in the patch directly above the crack was significantly lower than that on either side of the crack, see Figure 4. As such the assumption adopted in [5, 6] that the stress distribution in the patch resembles the 2D lap joint solution is invalid. Furthermore, the assumption adopted in [5, 6] that over the crack the stress in the patch is constant through the thickness of the patch is also invalid.

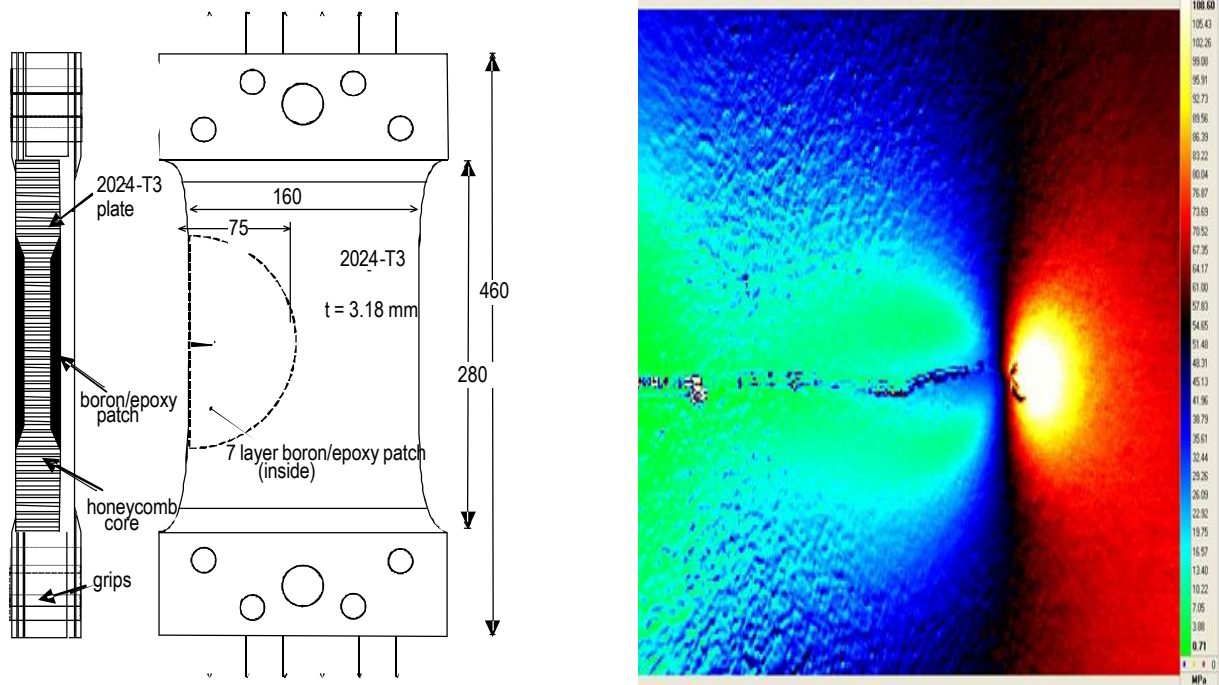
To further evaluate that the hypothesis that the stresses in the central region looked like that associated with a lap joint tests were performed on the specimen geometry tested in [11] which contained a 32 mm long edge crack repaired with a seven ply uni-directional boron epoxy patch. This specimen geometry is identical to the edge cracked specimen outlined in Case (1) above except that the (seven ply) uni-directional boron epoxy patch was on the inner surface so that the cracked panel could be monitored during testing. A picture of the bulk stress field in the plate, obtained using lock-in infra-red thermography, for a cyclic remote stress $\Delta\sigma = 100 \text{ MPa}$ and $R = 0.1$, near the crack is shown in Figure 5. Here we see that the stress field does not resemble that of a lap joint, i.e. the iso-stress lines are not parallel to the crack. Hence the Rose assumption that the region behaves like a lap joint is invalid.

Figure 5 Geometry of the test specimen and the stress field around the crack

where A and B are constants and r is the distance from the crack tip, it is possible to use the bulk stress data to determine the stress intensity factor. Analyzing the data at an angle $\theta = 0^\circ$, i.e. directly ahead of the crack, we obtained a value of $\Delta K_1 = 17.9 \text{ MPa} \sqrt{\text{m}}$, whilst a value of $\Delta K_1 = 16.0 \text{ MPa} \sqrt{\text{m}}$ was obtained when analyzing the data along the line perpendicular to the crack plane, i.e. $\theta = 90^\circ$. These values compare reasonably well with the corresponding solution of $\Delta K_1 = 21.2 \text{ MPa} \sqrt{\text{m}}$ obtained assuming that the reduction in the stress intensity factor was only due to the reduction in the net section stress. In contrast Aktepe and Baker [12] reported that for this repair configuration to a 30 mm long crack subjected to a remote stress amplitude of 78.6 MPa the Rose solution for this test is approximately $\Delta K_1 = 6.8 \text{ MPa} \sqrt{\text{m}}$ so that for a stress amplitude of 100 MPa the Rose solution yields a

value of $8.6 \text{ MPa} \sqrt{\text{m}}$. Even if we allow for the fact that the crack in this test was approximately 32 mm long we see that the measured values are significantly greater than the value of approximately $8.6 \text{ MPa} \sqrt{\text{m}}$ obtained using the Rose theory. This is due to the fact that the stress field in the patch over the crack is very three dimensional, i.e. it varies through the thickness of the patch, and the two dimensional approximation used by Rose, which assumes that all of the plies over the crack are equally effective in restraining the opening of the crack, is invalid.
