**INFRARED THERMOGRAPHY ENHANCEMENTS FOR  
CONCRETE BRIDGE EVALUATION**

Khatereh Vaghefi

A DISSERTATION

In Civil Engineering

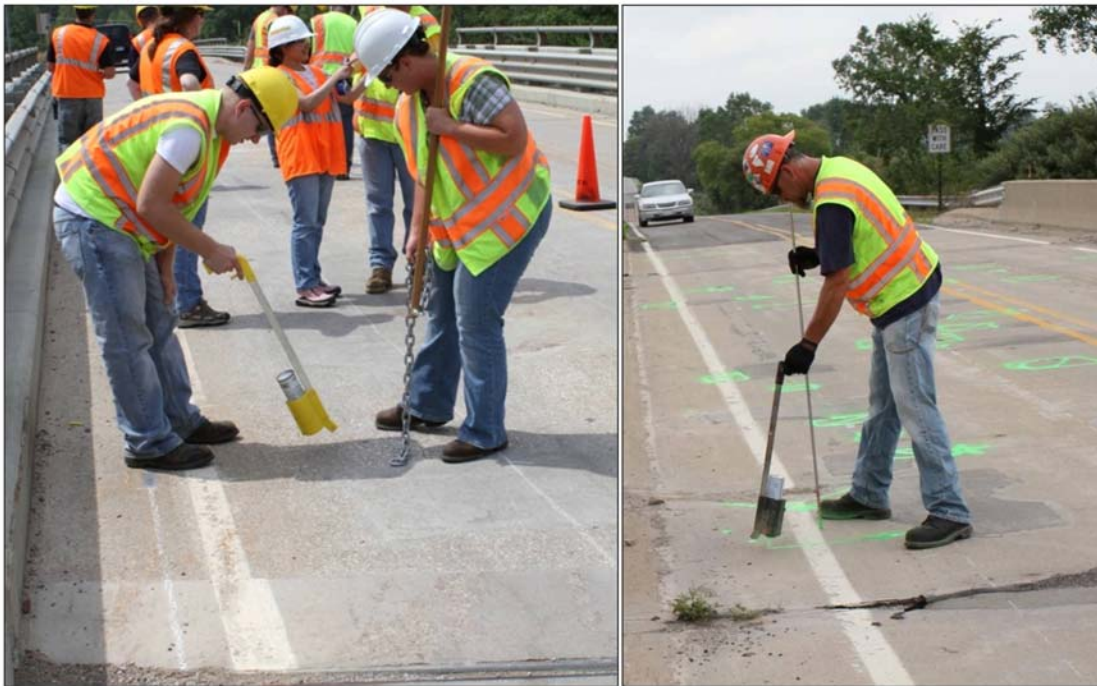
Hammer sounding a concrete bridge element is the most common practice method to detect delaminations. Delaminated areas sound hollow when tapped with a hammer, compared to a sharp tone of intact concrete, and the sound difference can indicate a defective area. Hammer sounding is mainly used under the bridge and for accessible areas. This technique can also be used to detect delaminations on the entire bridge deck

by tapping the deck with a metal rod. Another more time efficient sounding method for detecting delaminations on a concrete bridge deck is the chain drag testing technique. The chain drag technique is also based on the generated sound from the deck surface. This testing method involves dragging a heavy chain across the bridge deck and marking the hollow sounding areas with a spray paint, similar to the hammer sound technique (Ryan et al. 2006; Jana 2007). Figure 2.2 shows hammer sounding and chain dragging surveys being conducted on a concrete bridge deck. The main disadvantages of these data collection methods are that they are time consuming and labor intensive. Also, results of these surveys are subjective and are based on inspector's interpretation of different sounds.

**Figure 2.2 Chain drag and hammer sound techniques.**

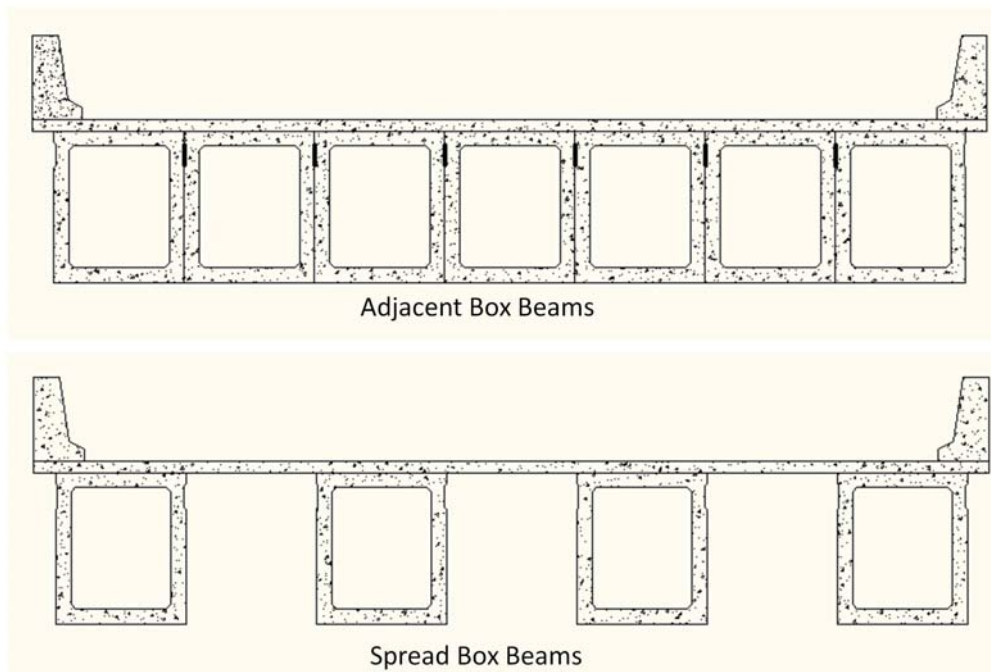
Construction of prestressed box beam concrete bridges in the United States began in the early 1950s and gained popularity due to fast and economic construction (Russell 2009; Naito et al. 2010). The majority of prestressed concrete box beam bridges were constructed using hollow rectangular girders as the main superstructure, and placing a concrete or asphalt surfacing on the top. In box beam bridge construction, box beams can be placed in two different arrangements, adjacent or spread. In constructing adjacent box beam bridges, box beams are typically placed side by side to each other. The box beams are post tensioned transversely and shear keys are grouted to ensure the interactive performance of the bridge box beams. Another application of box beams is in the construction of spread box beam bridges in which box-beams are placed at a certain distance (typically between 2 to 6 feet) with a cast-in-place concrete deck on the top (Ryan et al. 2006). Figure 2.5 shows the application of prestressed concrete box beams in bridge construction.

**Figure 2.5 Prestressed concrete box beam configurations used in bridge construction.**

Box beam bridges are typically built for a span length of 20 to 90 ft. The typical width of the AASHTO precast prestressed type girders is either 36 or 48 in., with the height range between 27 to 42 in. (PCI 1997). Box beams in bridges can have a composite action with the cast-in-place deck on the top. In composite construction, stirrups are extended out on the top of the girders and are cast in the concrete deck to assure composite action between the deck and girders. Non-composite construction is another option, in which stirrups are not extended out and bridge girders do not achieve the composite action but rather act as independent elements (Ryan et al. 2006).

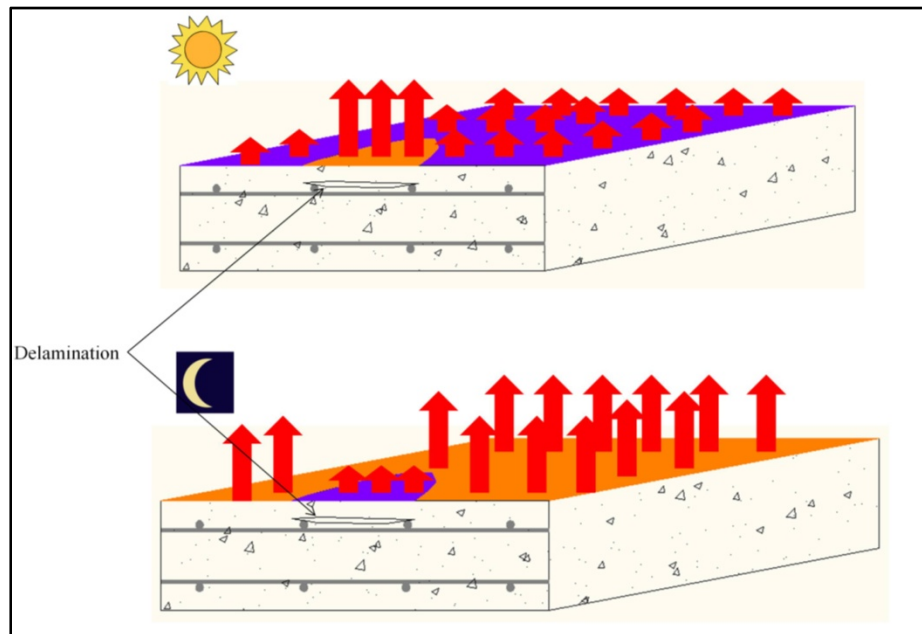
technique is also called thermal infrared imagery in the remote sensing field. The concept behind the application of this technology in concrete bridge evaluation is that anomalies and subsurface delaminations interrupt the heat transfer through the concrete and appear with different temperatures on the thermal IR image compared to the area of surrounding sound concrete (see Figure 3.1). During the day, as the ambient temperature increases, concrete absorbs heat and starts emitting radiant energy. Delaminations and air voids within the concrete will resist the heat transfer and warm up at a faster rate compared to the area of the surrounding sound concrete, thus delaminations will appear as hot areas on the thermal IR image. However, during the night, as the ambient temperature decreases, the area of the sound concrete around delaminations loses heat at a lower rate compared to the delaminations, thus delaminations appear as cold areas on the thermal IR images (Washer et al. 2009a).

**Figure 3.1** Emitted thermal infrared energy from a concrete deck during the day and night.

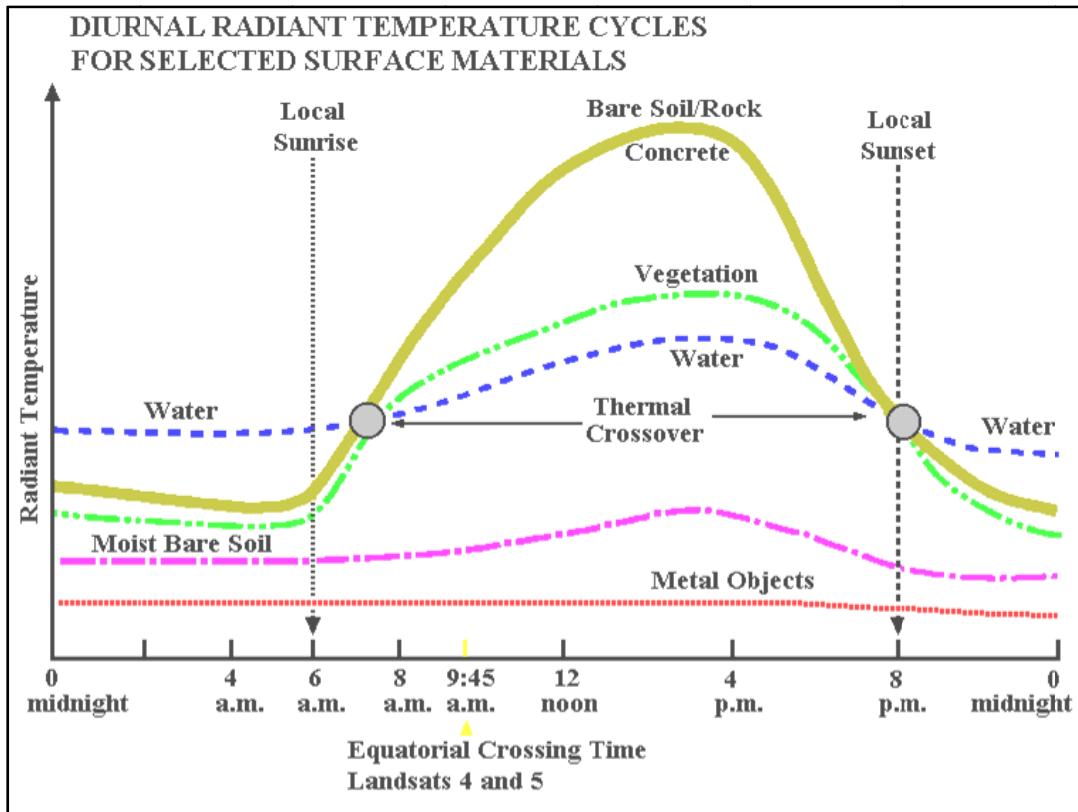
where  $K$  is thermal conductivity,  $C$  is thermal capacity (specific heat) and  $P$  is thermal inertia. Figure 3.2 shows the diurnal radiant temperature of selected materials in the environment. Two thermal crossover times can be identified in the diurnal graphs of radiant temperature of materials. These two times are roughly the local sunrise and local sunset; when the radiant temperatures of the materials are the same and appear with the same temperature on the thermal IR image.

**Figure 3.2** The diurnal radiant temperature graph of selected materials (Jenson 2007), reprinted by permission of Pearson Education, Inc.

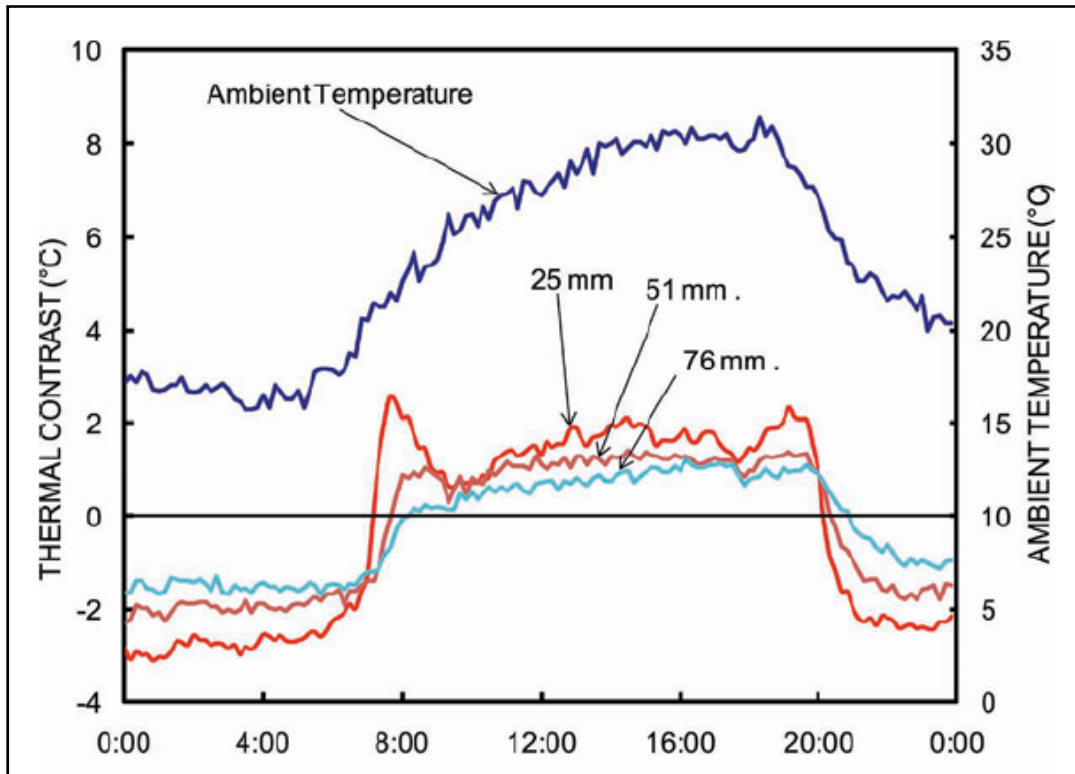
Concrete materials and delaminated areas on a bridge have similar behavior with respect to ambient temperature changes. The most contrast between a delaminated area and the surrounding sound concrete area appears a few hours after each cross over time (Figure 3.3). In a study conducted by Washer et al. on developing the infrared thermography inspection technology for bridges, it was found that the effective time to perform a passive infrared thermography survey depends on the depth of the delamination. The

most contrast appears on the thermal IR images approximately 4 hours after sunrise for a 2 in. deep delamination and 7 hours after sunrise for a 3 in. deep delamination. Also, it has been noted in this study that deeper delaminations appear with lower temperatures on the thermal IR image (Washer et al. 2009a).

**Figure 3.3** The diurnal temperature graph for delaminations at different depths (Washer 2010), used with permission from the American Society for Nondestructive Testing.

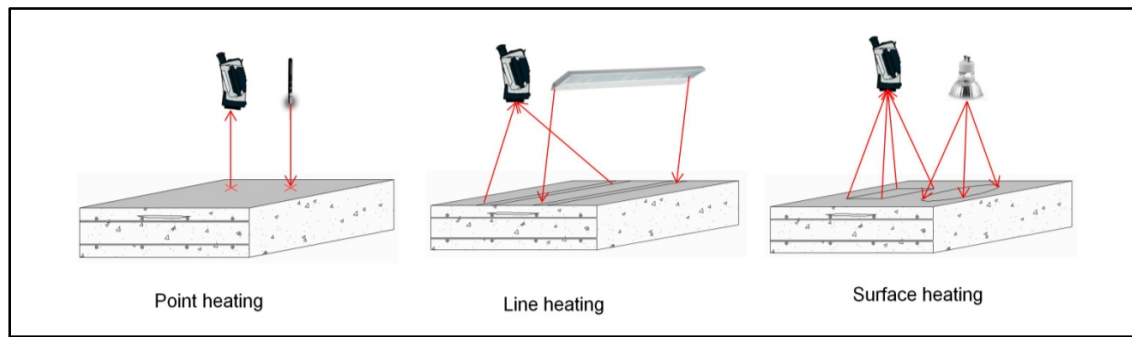
Three methods of heating configuration using pulsed infrared thermography include: point, line and surface methods (Maldague and Moore 2001). In the point method, electromagnetic energy is transmitted to the surface with a laser point and reflection from the surface is recorded by a thermal IR camera. Uniform heating and repeatability can be achievable using this technique; however, inspecting a surface with this method is time consuming due to the point by point inspection moving along the specimen. The line method involves heating the specimen surface by moving line lamps, heated wires, a scanning laser or an air jet. Fast inspection and uniform thermal gradient are advantages of using this method. Complete analysis of the phenomena can be obtained using the

surface method. Heating systems in the surface method test includes lamps, flash lamps or a scanning laser. Not all the points on the surface of the specimen are at the same distance to the heating source; therefore, it is hard to achieve uniformity on the specimen surface. Figure 3.5 illustrates these three heating methods.

**Figure 3.5 Different heating methods for infrared thermography inspection.**

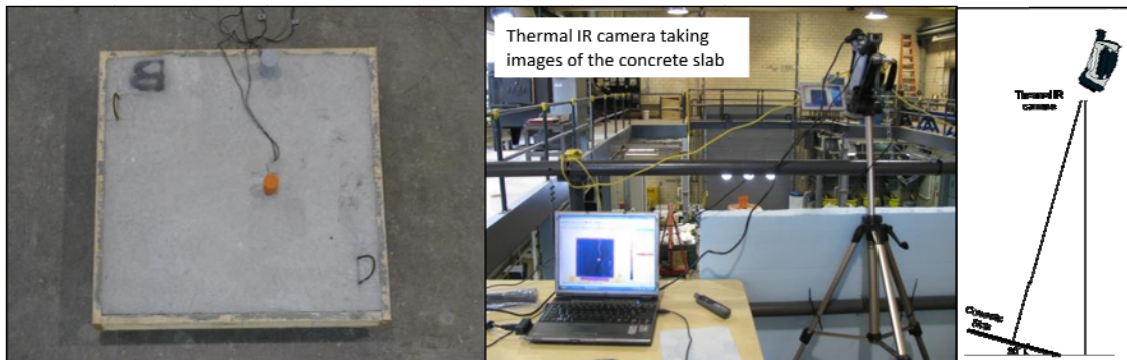
The slab was placed outside during winter (around 10 to 20°F) for over 24 hours and then brought into the lab, which was at a significantly higher temperature than outside (72.3°F). Thermal IR images were taken inside as the specimen was warming up. Figure 4.2 shows the set-up of this test.

**Figure 4.2** Laboratory set-up for passive infrared thermography testing.

The thermal IR camera was set up at a distance of 16.67 ft above the slab to take images every 10 minutes during a seven hour period (9:28 am to 4:30 pm). The indoor lab temperature was 72.3°F and the relative humidity was 13%. The emissivity value of 0.95 was inputted in the data acquisition and analysis software. Figure 4.3 shows the thermal IR image of the test specimen and the graphs of the temperature change during the seven hour period. Areas 3 and 4 on the thermal IR image correspond to the F1 and F2 delaminations.

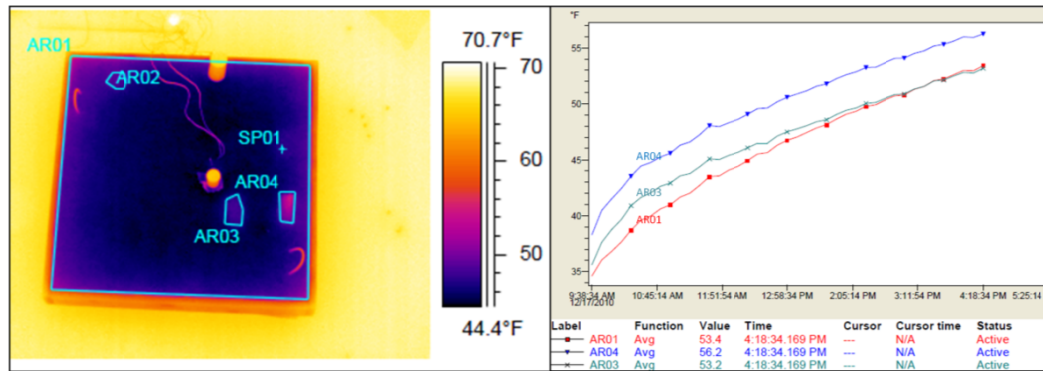
**Figure 4.3 Thermal IR image and graphs showing the temperature change of each defect compared to the average temperature of the slab.**

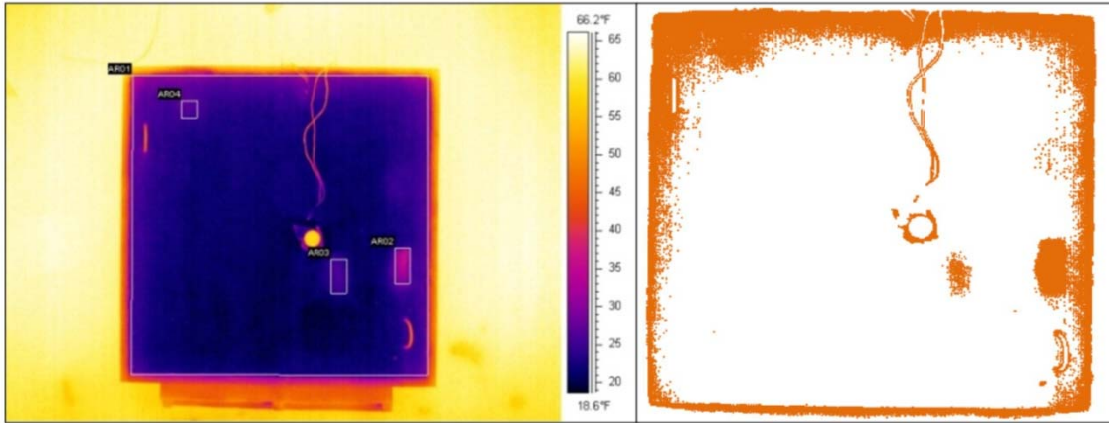
The second method involved saving the data in a comma separated format (.csv) and using a spreadsheet to count the number of pixels. In this test, the MS Excel spreadsheet was set up to highlight the number of pixels within a specific temperature range that best fit the shape of the delamination apparent on the thermal infrared image and to count the number of pixels.

One of the errors that appeared in this test was the effect of the thermal gradient from the edge of the slab which made it difficult to assign pixels to delaminated areas close to the edges. The percentage of delaminated areas was calculated by Equation 12. A sample thermal IR image and the associated highlighted MS Excel spreadsheet are presented in Figure 4.4. Because delaminations appear with higher temperature, pixels with higher temperatures than a threshold value can be highlighted in a way to match the bright area on the associated thermal IR image. This threshold value is different for each image due to the various temperature ranges between thermal IR images taken at different time and environmental conditions. Matching the area between the spreadsheet and thermal IR image is subjective and based on the user interpretation of the thermal IR image. For comparison purposes, the actual percentage of delamination was 1.78%. The proprietary software computed 1.61% and the simplified post-processing using a spreadsheet computed 1.84% of the concrete slab area was delaminated.

**Figure 4.4 Thermal IR image and the associated Excel spreadsheet.**

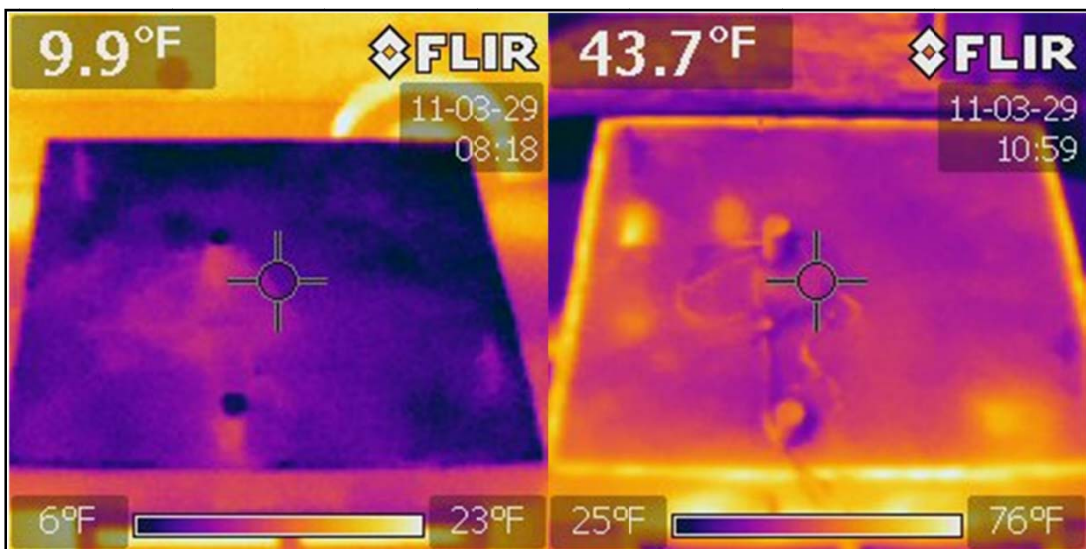
To study the effect of time of day in data collection, the same concrete specimen that was used for phase 1 was put outside and thermal IR images were taken at two different times. Figure 4.5 shows these thermal IR images that were taken at 8:18 am and close to 10:59 am to highlight the time of day factor in thermal IR imaging (sunrise time was at 6:40 am). A FLIR i7 handheld thermal IR camera was used for this phase of the experiment.

**Figure 4.5 Comparison of thermal IR images of the concrete slab with simulated delaminations at 8:18 am and 10:59 am.**

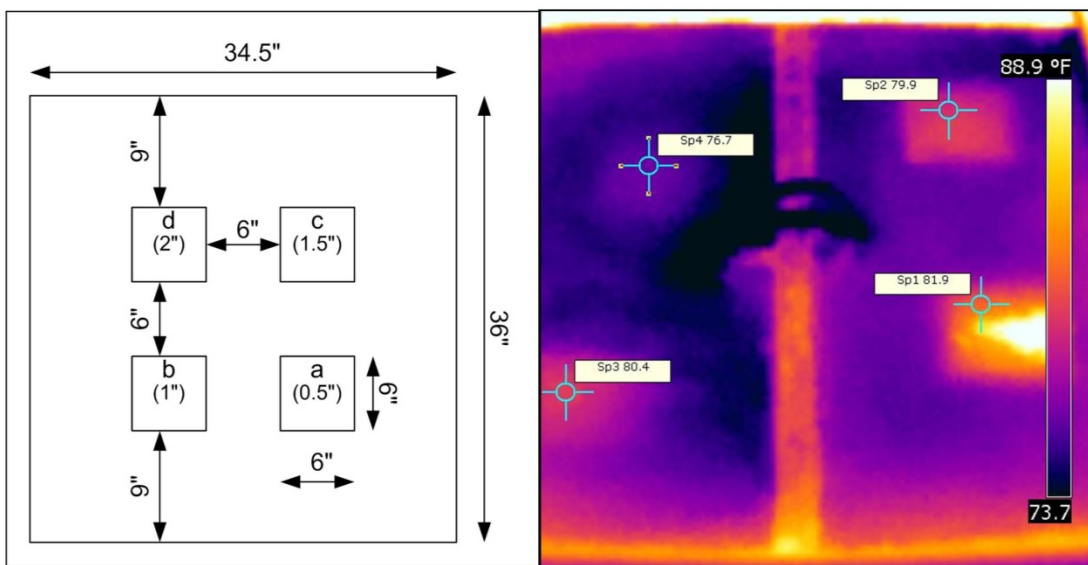
Determining the depth of delamination was the next step of this phase. To achieve this objective, a concrete slab was built with simulated delaminations (6 in. x 6 in. x 1/8 in. cardboard squares placed at different depths; 0.5 in., 1 in., 1.5 in. and 2 in.) and a thermal IR image was taken around noon to have the maximum contrast on the image. Figure 4.6 demonstrates the plan layout of the concrete slab with the simulated delaminations and spot temperature readings on the thermal IR image. It has been noted that deeper delaminations manifest themselves with lower temperature measures compared to the shallower delaminations.

**Figure 4.6 Plan layout of the concrete slab with simulated delaminations and the thermal IR image showing the temperature data of delaminations placed at different depths (0.5 in., 1 in., 1.5 in., 2 in.).**

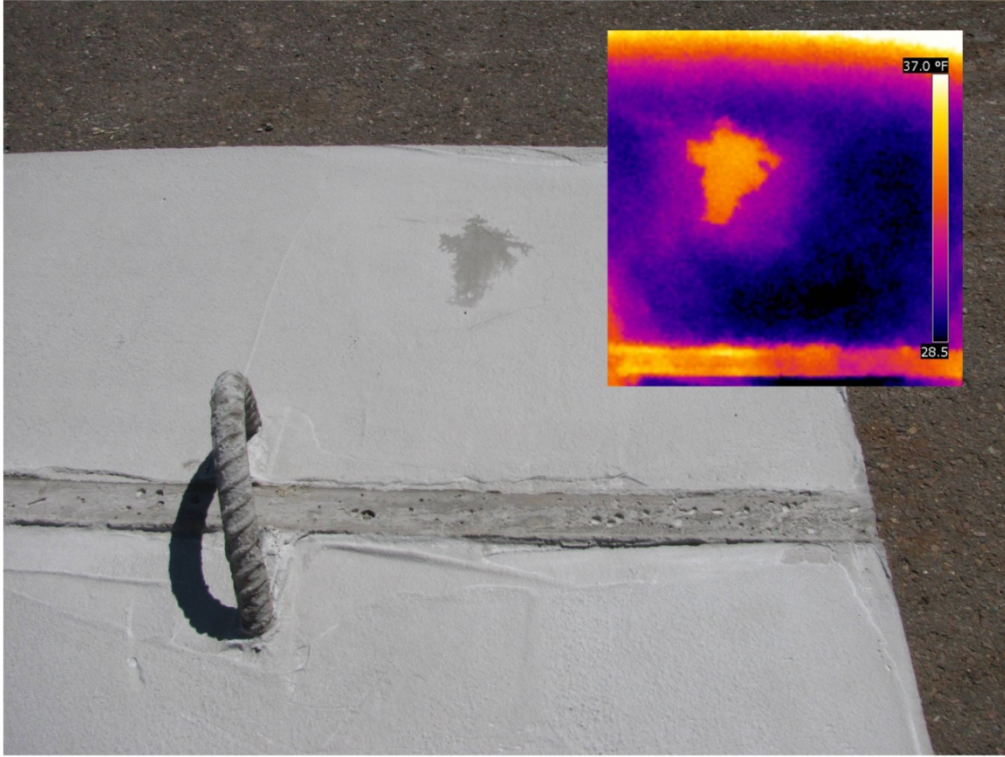
Figure 4.7 highlights the importance of distinguishing actual delaminations from soil, moisture, oil spills, and staining. This figure shows how a surface concrete stain (a residual chemical released from a cardboard square) on the concrete surface can affect the results by appearing as a higher temperature on the thermal IR image.

**Figure 4.7 Thermal IR image of the chemical staining on the concrete specimen.**

delaminations and appear on the thermal IR image due to different emissivity values such as an oil stain.

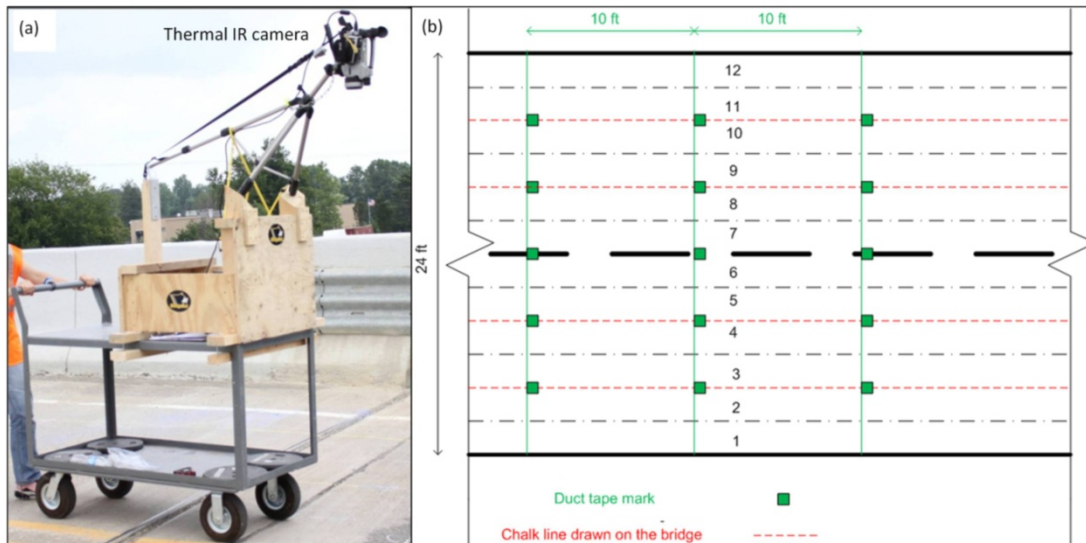
A grid pattern was laid on each bridge deck before testing. Duct tape was used on the bridge deck every 10 ft longitudinally and every 4 ft transversely to provide reference points on the bridge deck. Duct tape has a reflective surface and low emissivity compared to concrete; therefore, it appears on the thermal IR image as a lower temperature. The use of duct tape enabled the merging of individual images for creation of a full bridge deck. Figure 4.8 shows a sample grid pattern for field deployment and a working mobile configuration for the camera system on a cart. The proposed data collection method was specific to the camera model and lens that were used in this study. Wider-angle lenses can be used to achieve a more ideal data collection scenario.

**Figure 4.8 (a) Thermal IR camera acquisition cart and (b) sample grid pattern on the bridge deck.**

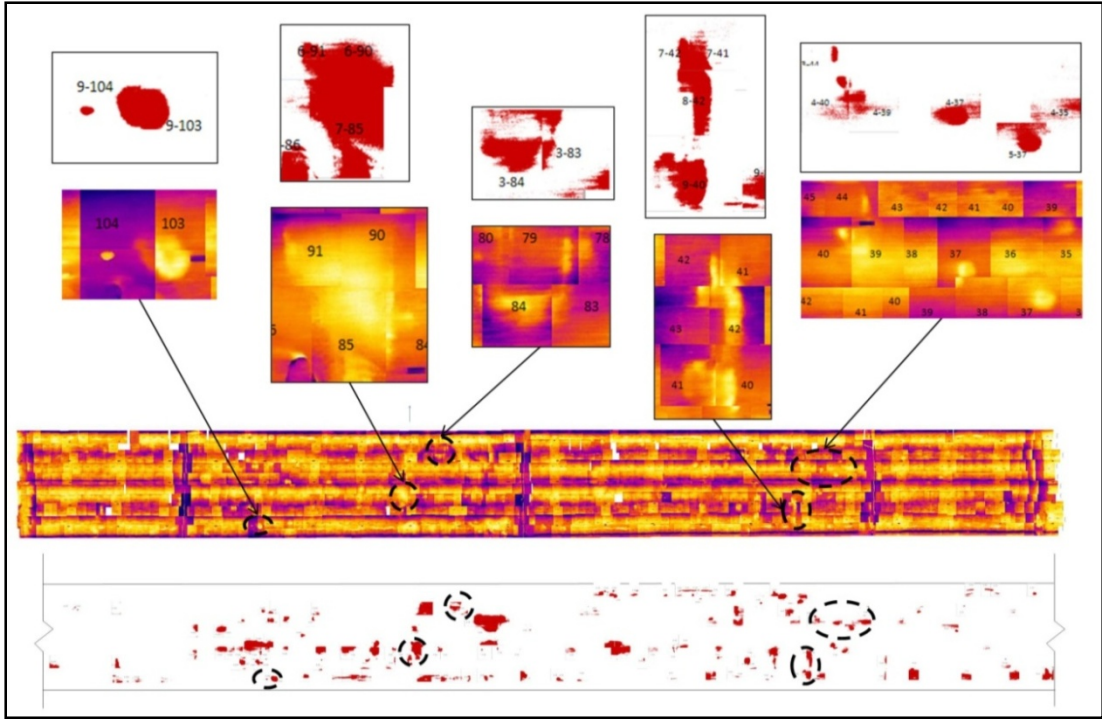
**Figure 4.10 Deck delamination map of Willow Rd. bridge, using Thermal IR and post-processed output data results for a typical spreadsheet analysis.**

map for the Freer Rd. bridge, the Willow Rd. bridge, and the Mannsiding Rd. bridge are shown in Figure 4.9, Figure 4.10, and Figure 4.11, respectively. Although having duct tape on some of the thermal IR images was helpful to create a thermal IR map of the bridge deck, delaminations on these images were not as apparent as the rest of the thermal IR images. Also, the rubber expansion joints on the bridge appeared with higher temperature on the thermal IR image due to the higher emissivity factor of rubber and it induced some difficulties in detecting delaminations within these areas.

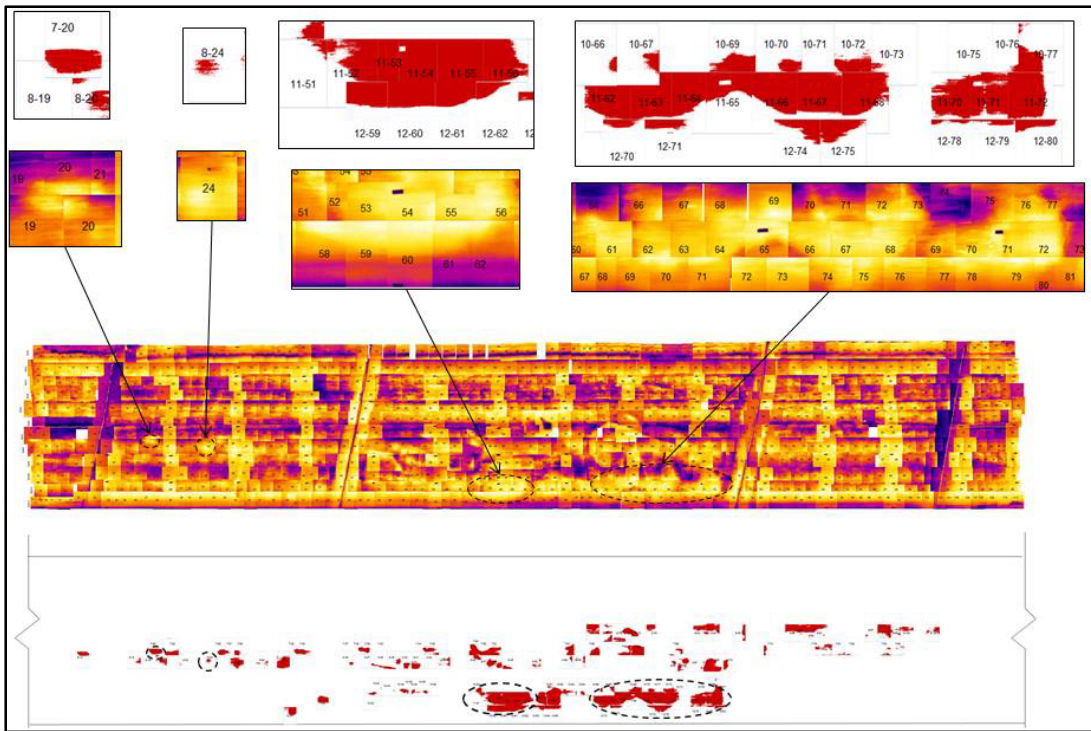
**Figure 4.11 Deck delamination map of Mannsiding Rd. bridge, using Thermal IR and post-processed output data results for a typical spreadsheet analysis.**

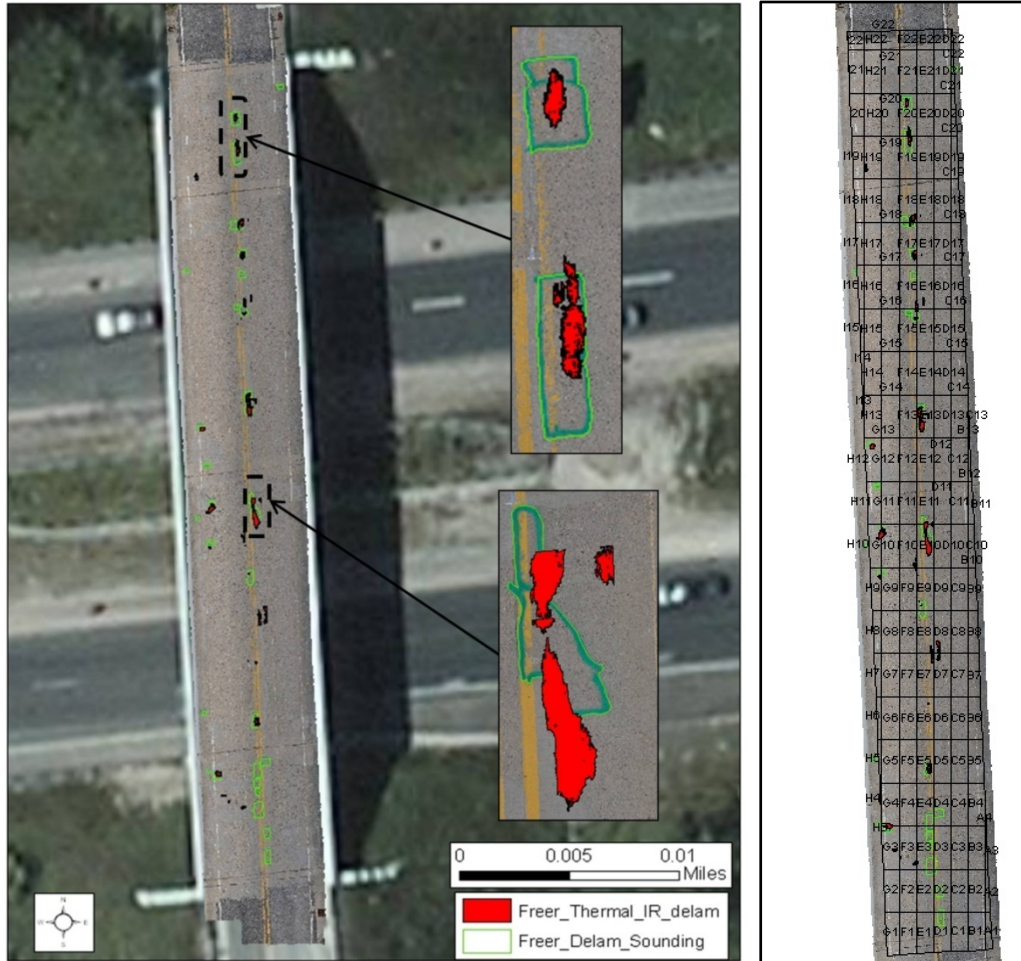
Figure 4.12 shows the thermal IR and hammer sound delamination maps for Freer Rd. bridge displayed as two layers in ArcGIS. The main cause of variation between the results of the MDOT and thermal IR surveys on the Freer Rd. bridge is that most of the delaminations on this bridge were around the construction joint and overlapped with the painted centerline on the bridge deck. Reflective paint on the bridge deck has lower emissivity than concrete; therefore, it will appear on the thermal infrared image with lower temperature and cause some difficulties to detect delaminations in those areas. Also, delaminations are most likely to occur around spalled or patched areas, which can help to detect the exact location of delaminations based on the thermal IR and optical images.

To compare the variations between hammer sound and thermal IR inspections, a virtual grid pattern (4 ft x 10 ft) was created over the bridge deck in ArcGIS (Figure 4.12). Delaminated areas within each cell that could be detected by either hammer sound or thermal IR camera or both was calculated in ArcGIS and presented in Appendix A. While the total correspondence between thermal IR and sounding technique is 12.1%, higher correspondence was observed for some sub-section areas such as cell E13 which shows 40.3% correspondence between thermal IR and sounding within the total union

**Figure 4.12 Thermal IR and sounding delamination map and the virtual grid pattern over the Freer Rd. bridge displayed on ArcGIS.**

delaminated areas. Correspondence of this overlapped area with the area detected with thermal IR and sounding surveys are 72.7% and 47.5%, respectively. This shows that the sounding survey in this specific location detected more delaminations than what was obtained from the thermal IR survey. On the other hand, for cell H10, total correspondence between thermal IR and delamination survey is 9.81%. The overlapped area has the correspondence of 14.4% and 23.5% with the area detected with thermal IR and sounding techniques, respectively. In cell E13, contrary to cell H10, more area of delamination was detected with thermal IR survey as opposed to sounding.

Larger correspondence was observed for delaminated areas detected by the thermal IR survey within most grid cells on this bridge due to overestimating the delaminated area by the sounding survey. However, these results must be interpreted with caution due to the effect of the painted centerline on influencing the thermal IR images obtained on site. In-depth inspection data (ground truth obtained by coring) is required to make the decision on the potential areas of delamination that were detected by only one of the two surveys.

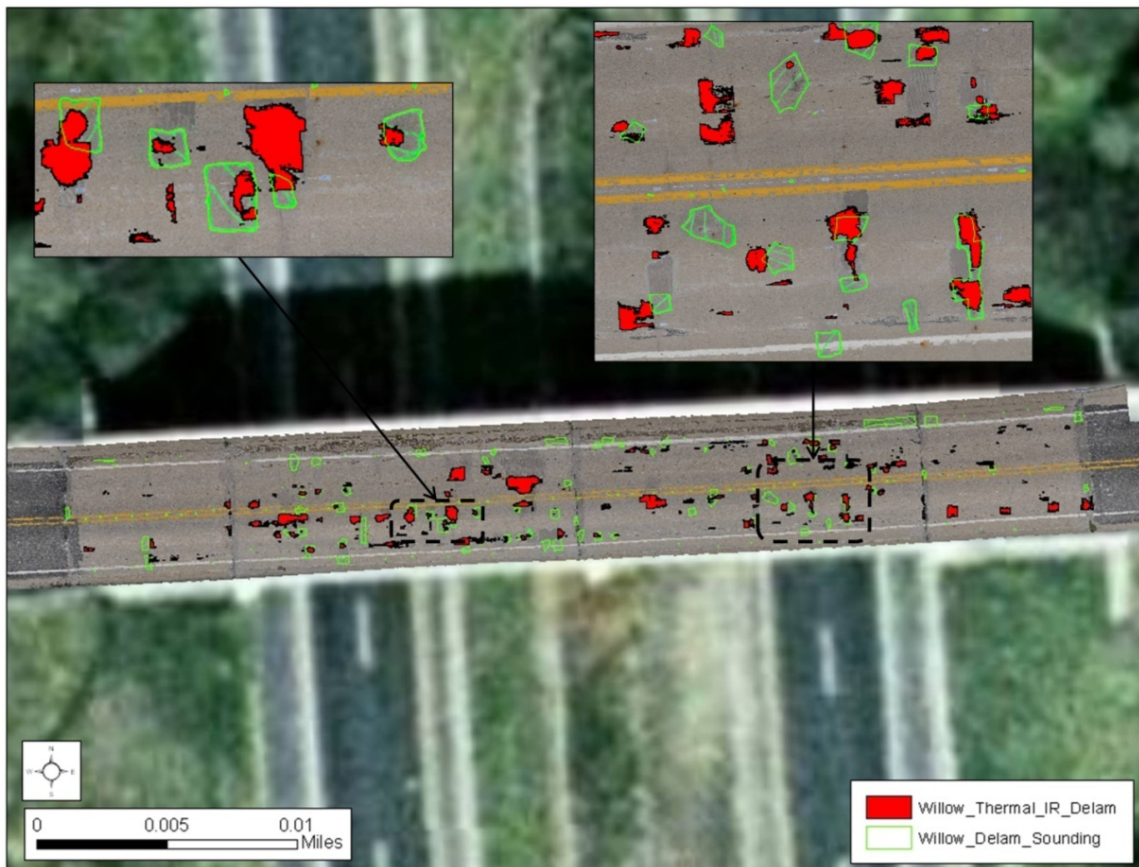
Delamination and hammer sound maps for the Willow Rd. bridge are demonstrated in Figure 4.13. To compare the variations between hammer sound and thermal IR inspections, the same virtual grid pattern (4 ft x 10 ft) as Freer Rd. bridge was created over the bridge deck on ArcGIS (Figure 4.14). Delaminated areas were calculated within each cell and results from both methods were compared. Appendix A of this document provides a summary of this analysis. Total delaminated area for cell G4 calculated from thermal IR and hammer sound methods are 4.43 and 5.72 square feet, respectively. The overlapped delaminated area between these two methods in this cell is 3.24 square feet.

**Figure 4.13 Thermal IR delamination map and sounding delamination map of Willow Rd. bridge displayed on ArcGIS.**

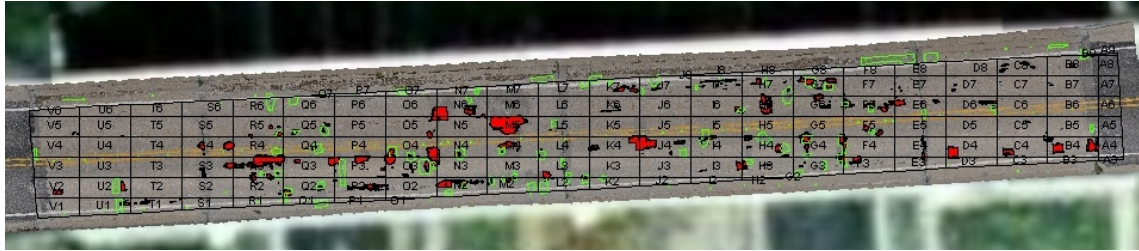
**Figure 4.14 Virtual grid pattern over the Willow Rd. bridge deck.**

Results for this specific cell show 56.7% and 73.12% correspondence with MDOT and thermal IR survey. However, the correspondence of the overlapped area with the total delaminated areas that can be detected by either one of the techniques is 46.93%. Values for percentage of correspondence vary between the specified cells and this fairly high correspondence may not be achievable for other areas. Therefore, the total correspondence between thermal IR and hammer sound survey for this bridge was calculated as 10.96 and 11.08 percent for MDOT and thermal IR surveys, respectively. This variation was anticipated due to the variations in hammer sound results and not having the ideal environmental condition for thermal IR survey on the inspection day.

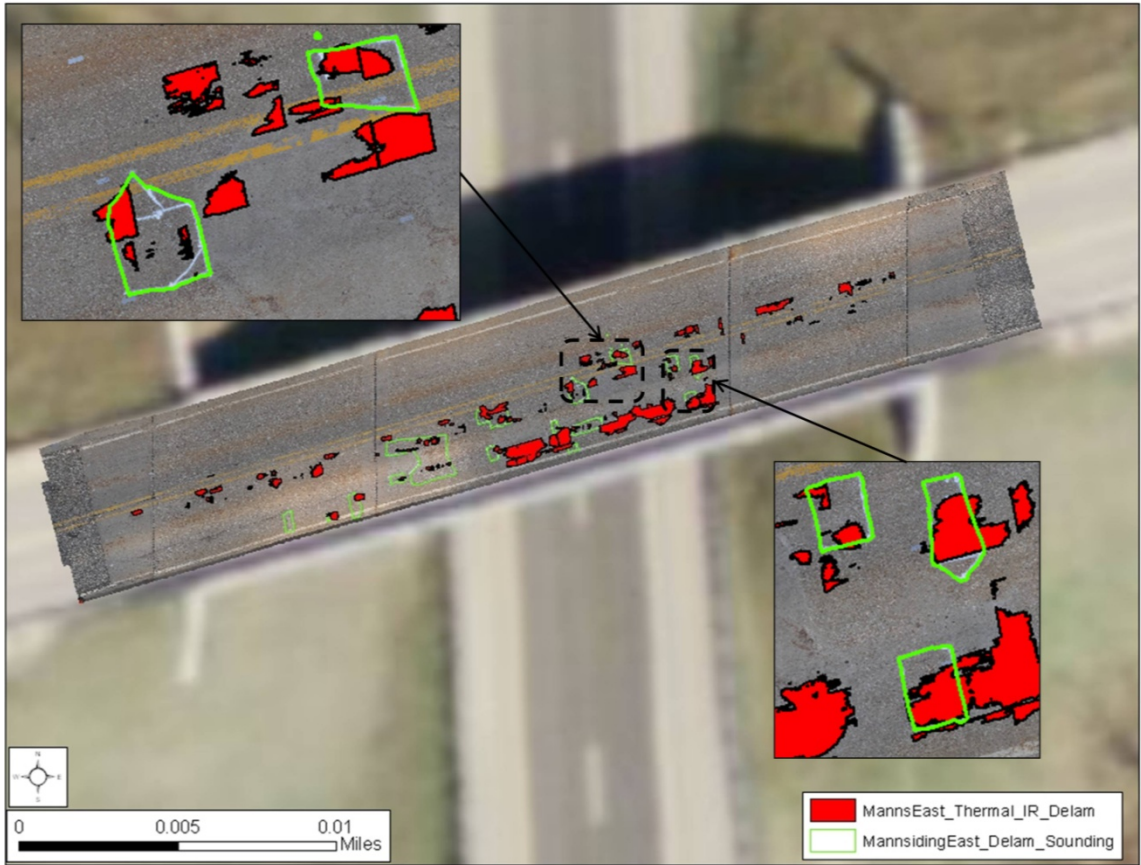
Figure 4.15 shows thermal IR and chain drag delamination maps for Mannsiding Rd.-NB on ArcGIS. Similar to the other two bridges, there are some variances between the results of these two techniques that are demonstrated in this figure. A virtual grid pattern, similar to the aforementioned bridges, was created on ArcGIS to compare the results of the two inspection methods considered in this study (Figure 4.16).

**Figure 4.15 Thermal IR delamination map and sounding delamination map of Mannsiding Rd. bridge displayed on ArcGIS.**

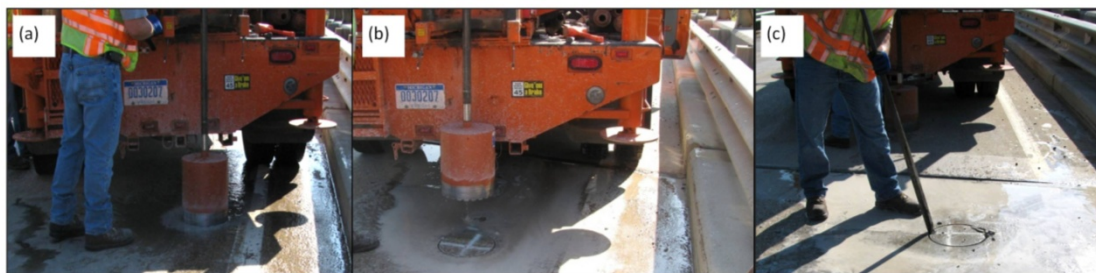
Figure 4.18 showed the MDOT coring extraction procedure that was performed on Mannsiding Rd. bridge in July 2012. This procedure include: (a) drill the concrete deck up to 4 in., (b) bringing out the drill and (c) use a metal rod to take out the 12 in. diameter

core. Cores with no delaminations (C4, C9, C10) did not come out easily and were left in place.

**Figure 4.18 Core extraction procedure on Mannsiding Rd. bridge deck.**

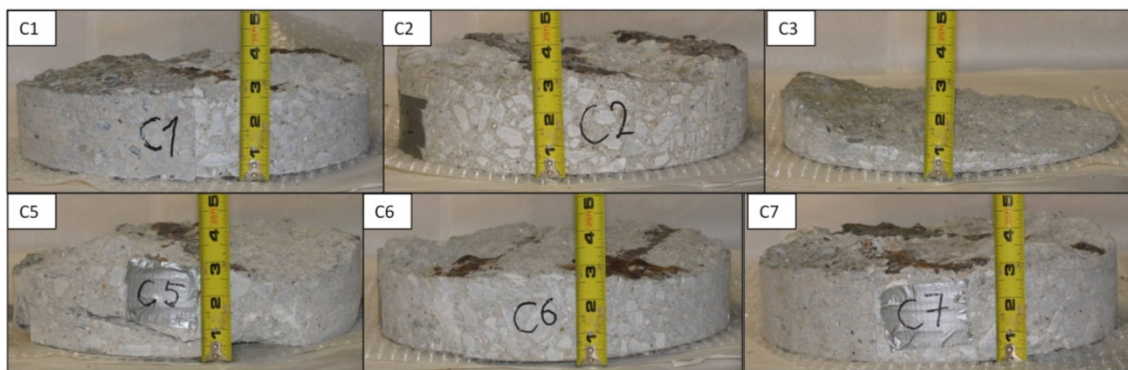
Figure 4.19 shows the cores that were extracted from Mannsiding Rd. Bridge deck. The depth of the delamination for each core is summarized in Table 4.4. Seven out of the ten cores showed visible damage. Four out of seven delaminated cores were evident in

thermal IR imagery results. Core C2 and C5 were 3 inches or deeper (3.125 in.), thus no delaminations were detected with thermal IR imagery. This result may be due to the long period of data collection (approximately one hour), which causes the variation in temperature gradient on the bridge deck, or overcast condition. Delaminations on cores C6 and 8 were only detected by thermal IR imagery. These delaminations were closer to the surface. Cores C4, 9 and 10 were intact (therefore not included in Figure 4.19) and no delaminations were found within 3.5 in. of the top surface for these locations. The reasons for not properly distinguishing between the delaminated and solid areas in these locations (C4, 9 and 10) can be due to delaminated areas smaller than the 12 in. diameter core or patched areas with different concrete properties that influence the emissivity factor, core C4 was placed on the patched area of the deck.

**Figure 4.19 Cores that were extracted from Mannsiding Rd. bridge deck.**

Locations of delaminated areas for five cores out of seven were properly detected using chain drag. However, it was noted that the delamination (C8) that was very close to the surface (<1 in.) could be detected only in thermal infrared images, and delamination (C2) that is deeper than 3 in. could only be detected by chain drag method. Results from this study suggest that passive infrared thermography is more effective for detecting delaminations closer to the concrete surface, and not located within the patched areas. Overall, further investigation is required to determine whether the passive infrared thermography is can detect delaminations within patched areas or deeper than 3 in.

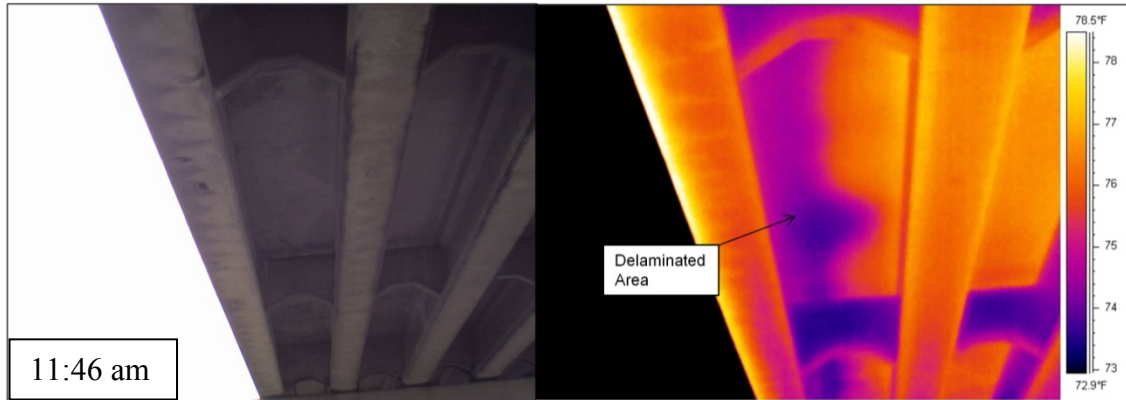
**Figure 4.20 Digital and thermal IR image of Willow Rd. bridge soffit.**

It has been suggested in the literature that thermal IR imagery can also be used for bridge soffits and girders (Washer 2010). The possibility of using thermal IR imagery has been investigated on the three case studies of the research conducted herein. Because all these three bridges were prestressed I-beam bridges, the main challenge was end-beam cracking. No delaminations were found on the girders using either thermal IR or hammer sound inspection. The bridge soffit was another element that was investigated in the study herein. Figure 4.20 and Figure 4.21 were taken from the Willow Rd. and Mannsiding Rd. bridges. Delaminated areas on these images appeared as cold (darker) areas as opposed to the warm (brighter) areas. This is possibly prominent due to the rainy weather conditions the day before testing and mostly cloudy conditions for both bridges during thermal IR inspection. Times at which images were taken are indicated on each image.

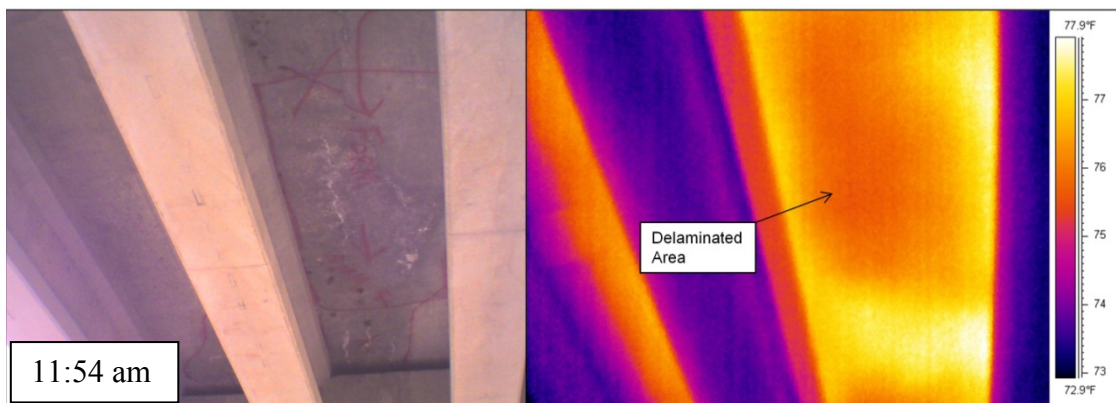
**Figure 4.21 Digital and thermal IR image of Mannsiding Rd. bridge soffit.**

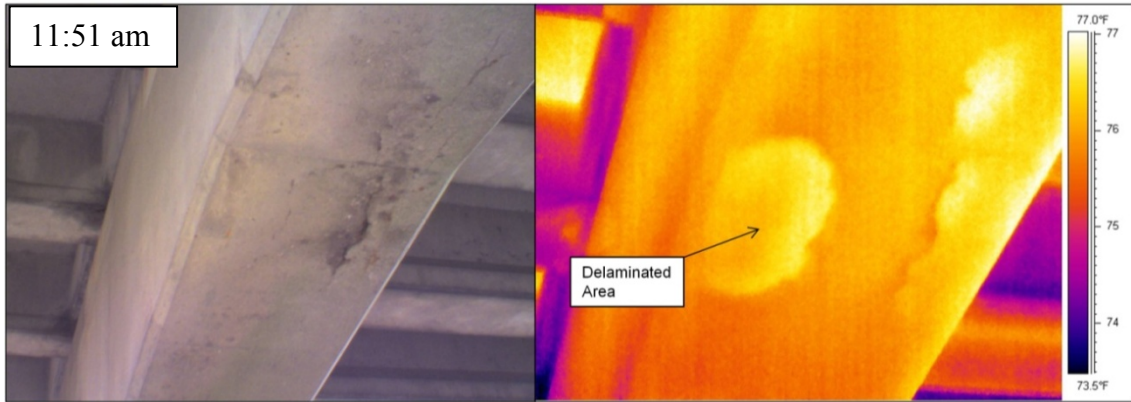
Figure 4.22 and Figure 4.23 show digital and thermal IR images taken from the bridge piers under Willow Rd. and Mannsiding Rd. bridges. Potentially delaminated areas were shown as bright areas (higher temperature) on the thermal IR image.

**Figure 4.22 Digital and thermal IR image of bridge pier under Willow Rd. bridge.**

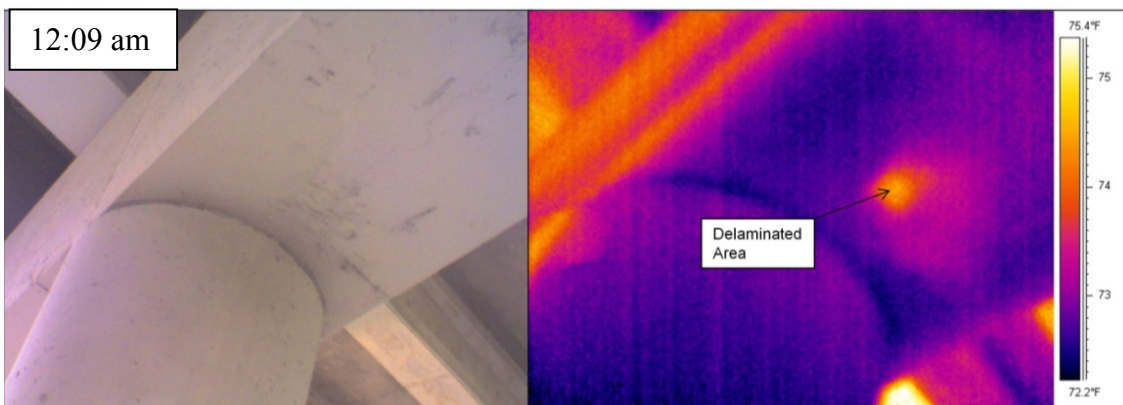
**Figure 4.23 Digital and thermal IR image of bridge pier under Mannsiding Rd. bridge.**

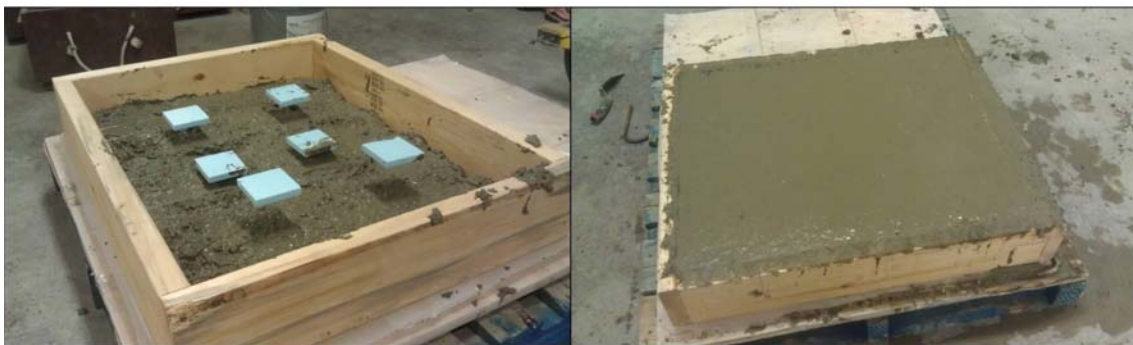
Figure 5.2 shows the construction sequence of this concrete slab with built-in Styrofoam. The Styrofoam pieces were placed at various depths in the slab and held in place with fishing lines. Then concrete was cast around and above the blocks. Care was taken to ensure that the blocks remained level and at the right height as the rest of the concrete was placed. The slab was cured at ambient laboratory conditions.

**Figure 5.2 Construction sequence of the concrete slab with Styrofoam blocks used as simulated delaminations.**
