**INFRARED THERMOGRAPHY ENHANCEMENTS FOR  
CONCRETE BRIDGE EVALUATION**

Khatereh Vaghefi

A DISSERTATION

In Civil Engineering

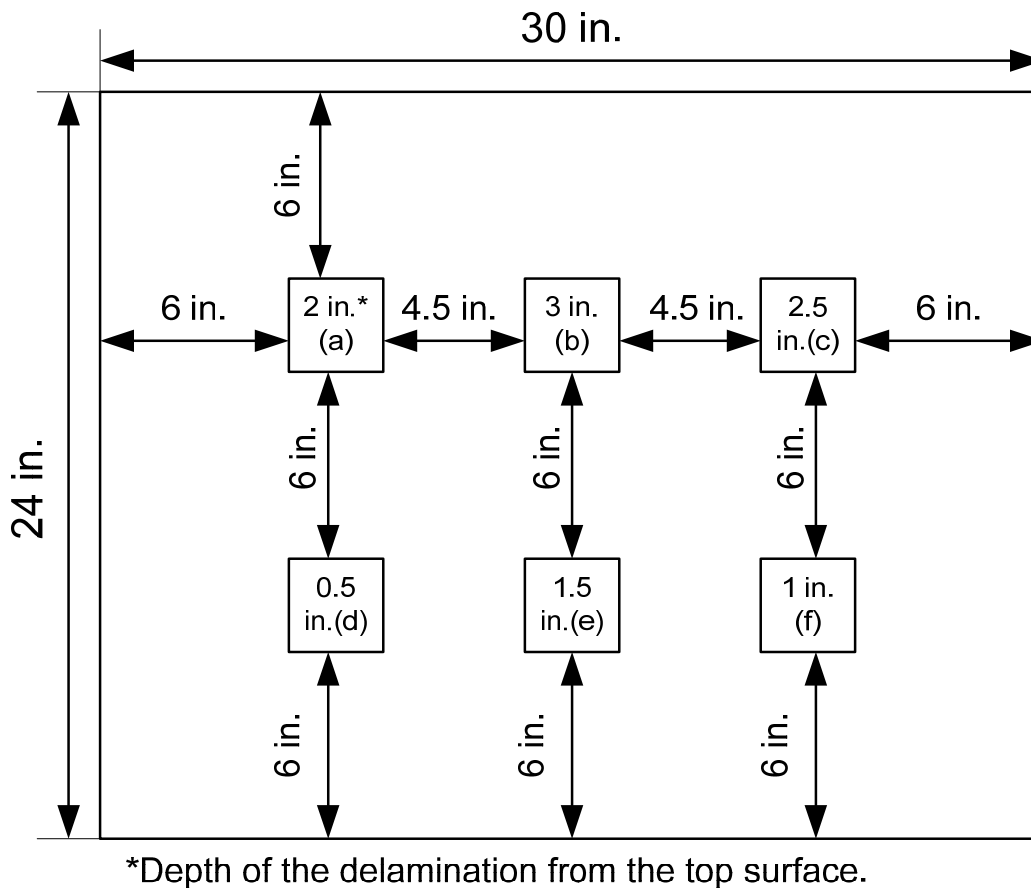
Concrete Slab II was constructed with simulated delaminations similar to Slab I using square shaped Styrofoam blocks (3 in. x 3 in. x 3/8 in.). A plan layout of Slab II is demonstrated in Figure 5.7. In this slab, depth of the defects varies with ½ in. increments, to enable for more precise estimation of the depth based on the temperature and observation time.

**Figure 5.3 Layout of concrete test specimen “Slab II” with simulated delaminations.**

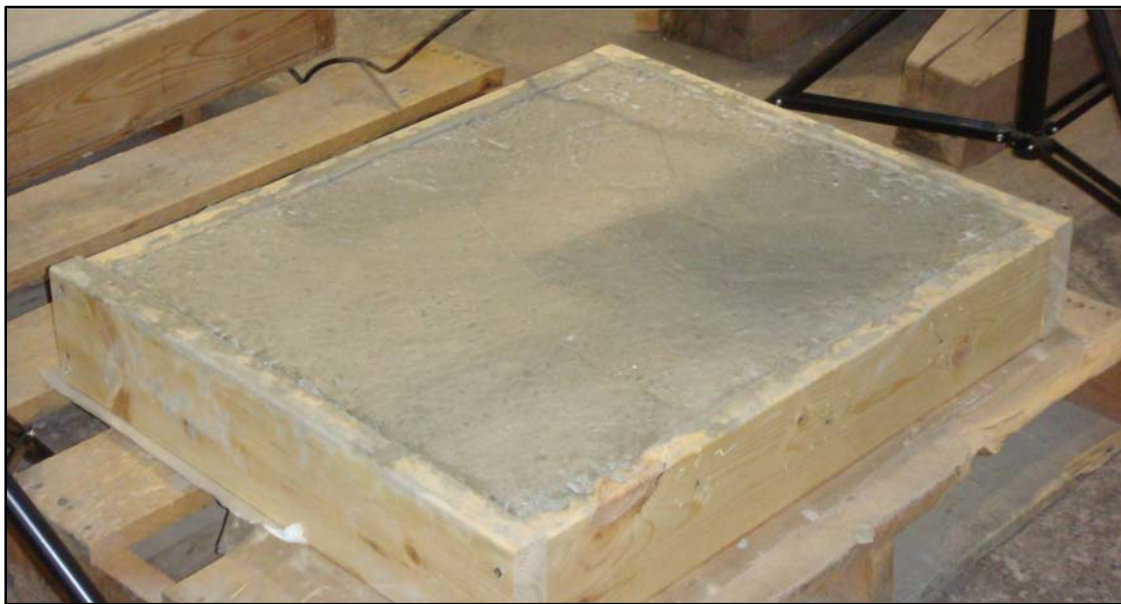
**Figure 5.4 Concrete Slab II after it was cured.**

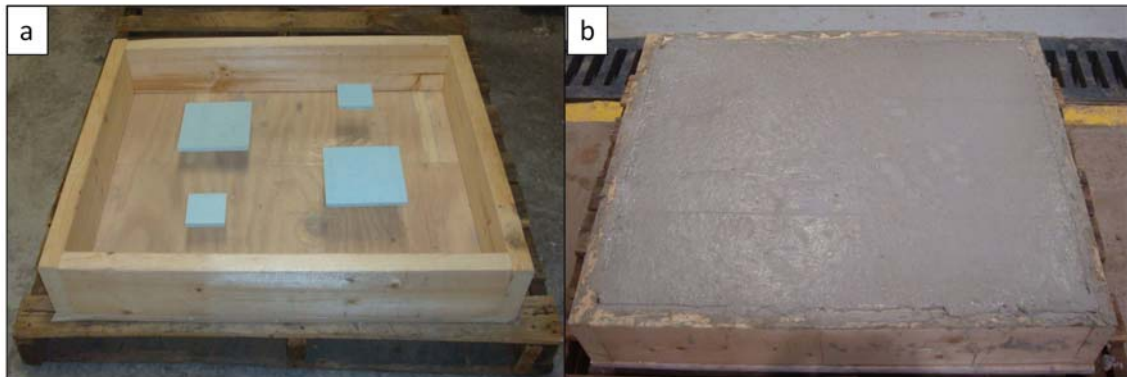
Similar mix design to Slab I was used to build Slab III. Mix proportions for Slab III are summarized in Table 5.4. This concrete mix had a slump of 2.5 in. and air content of 3.3%. Figure 5.6 shows the mold for concrete Slab III before placing the concrete mix inside and the concrete slab after it was built and cured for about a month. Similar to the construction of Slab I, Styrofoam blocks were put in place and restrained by fishing line to ensure that the blocks remained level and at the right depths.

**Figure 5.6 (a) Mold that was built for slab III before pouring concrete and (b) concrete slab III after it was built and cured.**

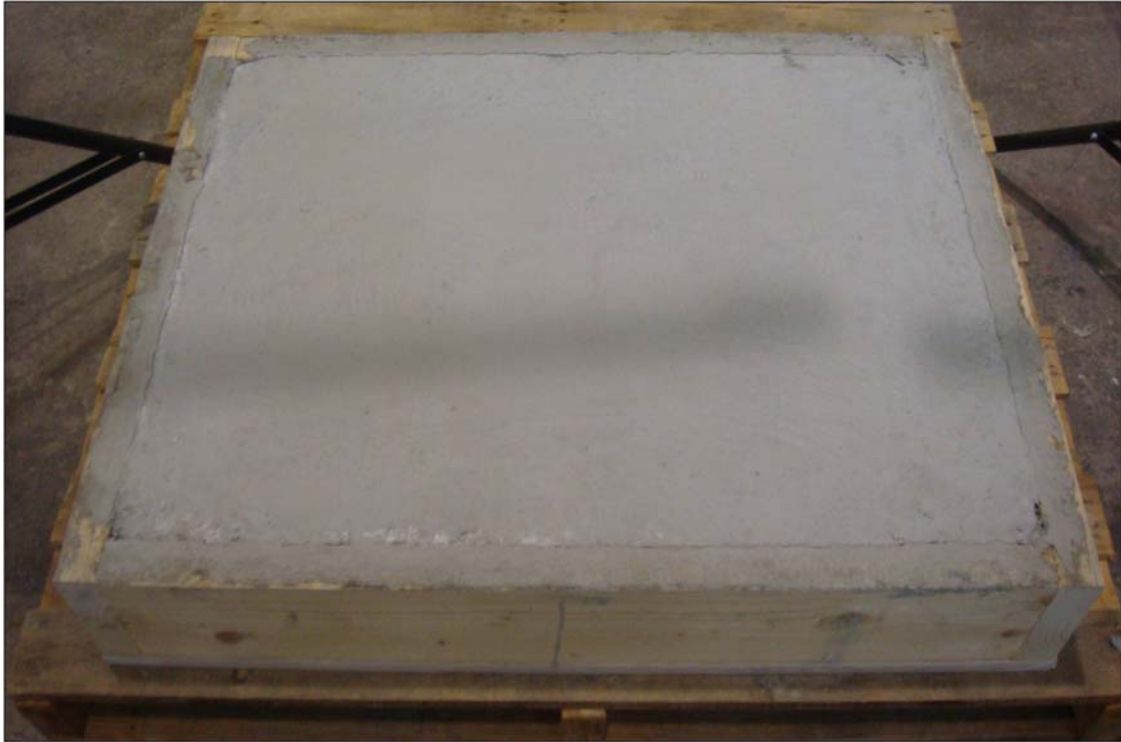
Figure 5.8 shows the concrete Slab IV at the time of data collection after it was built and cured at ambient conditions.

**Figure 5.8 Concrete Slab IV after it was built and cured.**

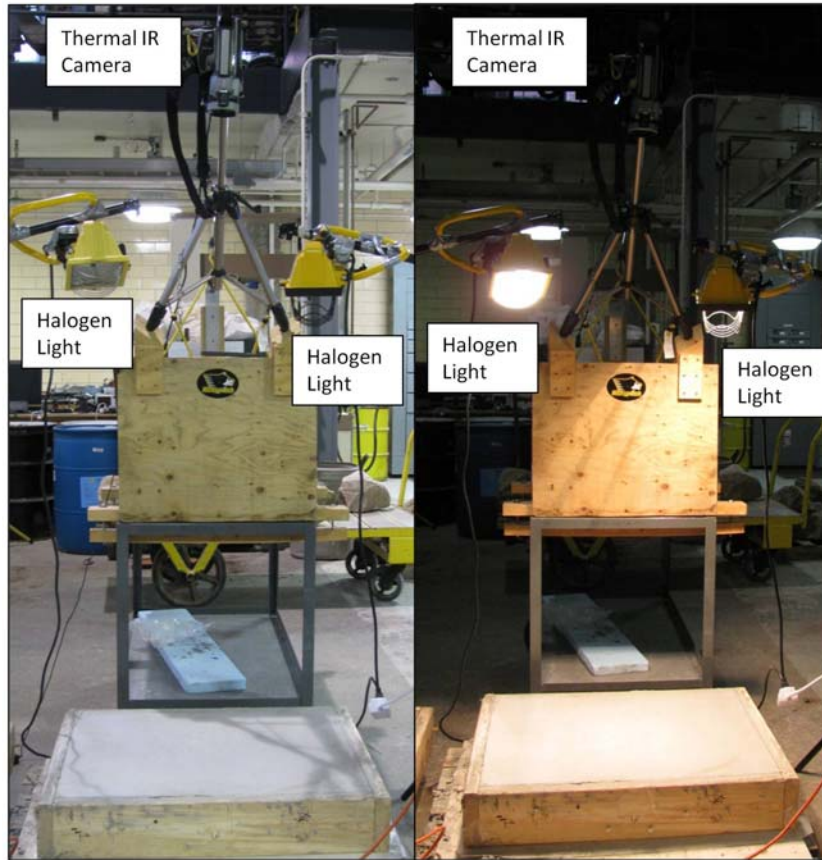
Data collection was conducted on Slab I 10 weeks after construction. In the first stage of the investigation, two halogen lights (500W each) were placed at a distance of 3.5 ft from the test specimen at a normal angle, and the camera was placed at a distance of 5.5 ft from the specimen (see Figure 5.9). The halogen lights and the camera were installed such that lights were not in the field-of-view of the camera and did not affect the thermal image collection. The thermal IR camera was set up to collect images at 30 second intervals throughout the test. Intervals of 30 seconds were selected to assure the constant monitoring and to avoid interruptions due to the auto-focus set-up of the camera. The halogen lights were turned on and heated the slab for 15 minutes. Data collection continued for about 35 minutes after the halogen lights were turned off. The ambient temperature was 69.9°F and ambient humidity was 11.7% in the laboratory at the time of data collection.

**Figure 5.9 Active infrared thermography test set-up using halogen lights as an external heat source, shown with the lights off (left) and on (right).**

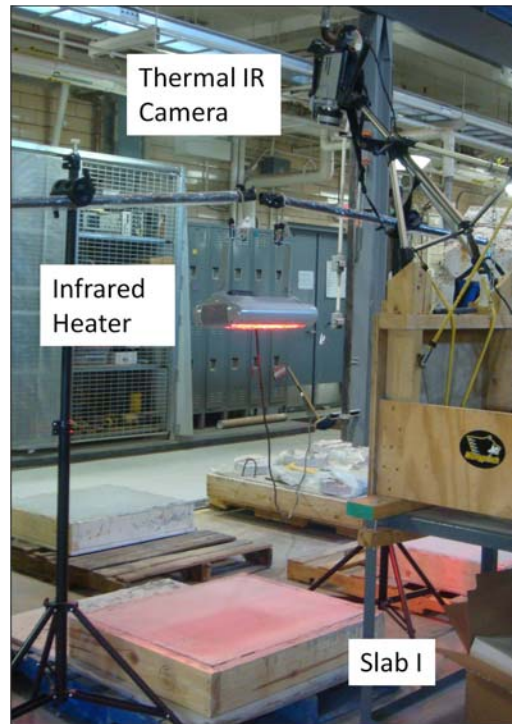
The second stage of this experimental series involved repeating the test using a 1500W infrared heater. In this stage, the heater was placed at a distance of 3.5 ft from the concrete slab and the camera was located at a distance of 5.5 ft from the concrete slab. The camera was slightly tilted ( $<10^\circ$ ) from the normal orientation to prevent having the heater in the field of view of the thermal infrared camera. Similar to the previous stage of Phase I of testing, the thermal IR camera was set up to collect images at 30 second intervals throughout the test. The infrared heater heated the slab for 15 minutes. Data collection continued for about 30 minutes after the heater was turned off. The ambient temperature in the laboratory was 72.3°F and the ambient humidity was 14.1% during the data collection.

**Figure 5.10 Active infrared thermography test set-up using infrared heater.**

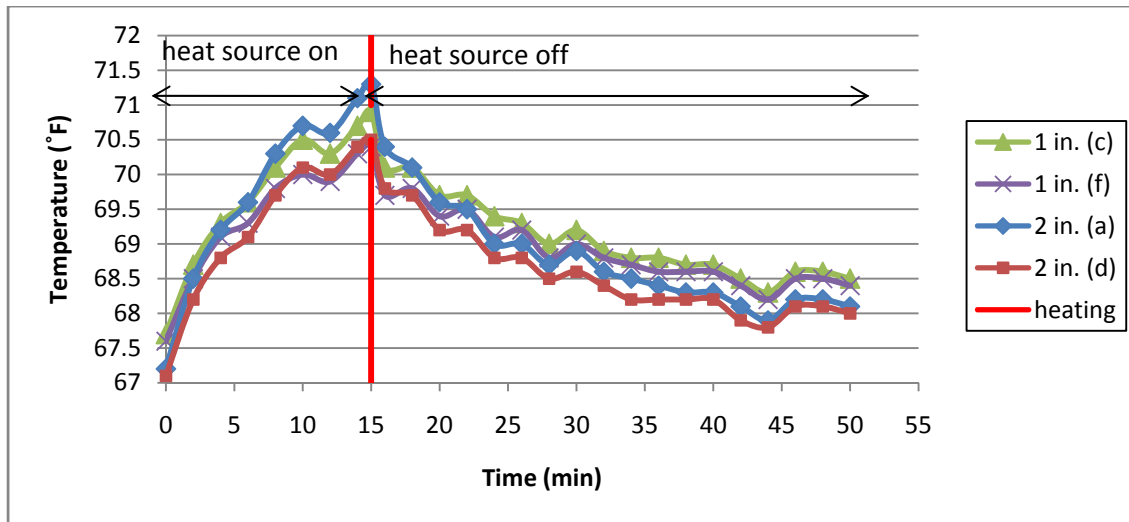
Figure 5.11 shows the variation of temperature for each simulated delaminated area when using two 500W halogen lights. This figure shows the temperature variations during the heating period and for about 35 minutes after heating was terminated. It can be seen from this graph that 10 minutes after the heat source was turned off, delaminations placed at 1 in. deep appeared with a higher temperature compared to delaminations placed at 2 in. deep. Figure 5.12 shows the thermal IR image that was taken when heating stopped (15 minutes after data collection was started) and 5 minutes after the heat source was turned off (20 minutes after data collection was started). Reference background areas (Ref) were selected to be close to each delamination and were used in calculating the absolute

**Figure 5.11 Plot of the temperature variation in an active infrared thermography test using two 500W halogen lights as a heat source, Slab I.**

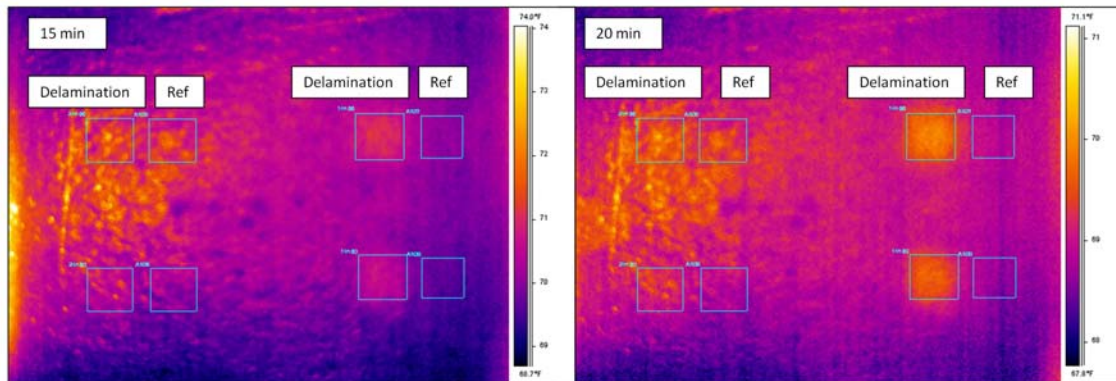
contrast for each delamination. Comparing these images with the plan layout of Slab I in Figure 5.1 indicates that delaminations placed at 3 in. deep did not appear during an active infrared thermography testing on this slab. “Ref” on these images indicates the area at the background and close to the delamination that was considered in determining the temperature of the background and the absolute contrast of each delamination.

**Figure 5.12 Thermal infrared images obtained from an active infrared thermography test using halogen lights on Slab I, shown 15 minutes after data collection began (left) and 20 minutes after data collection began (5 minutes after the heat source was turned off) (right).**

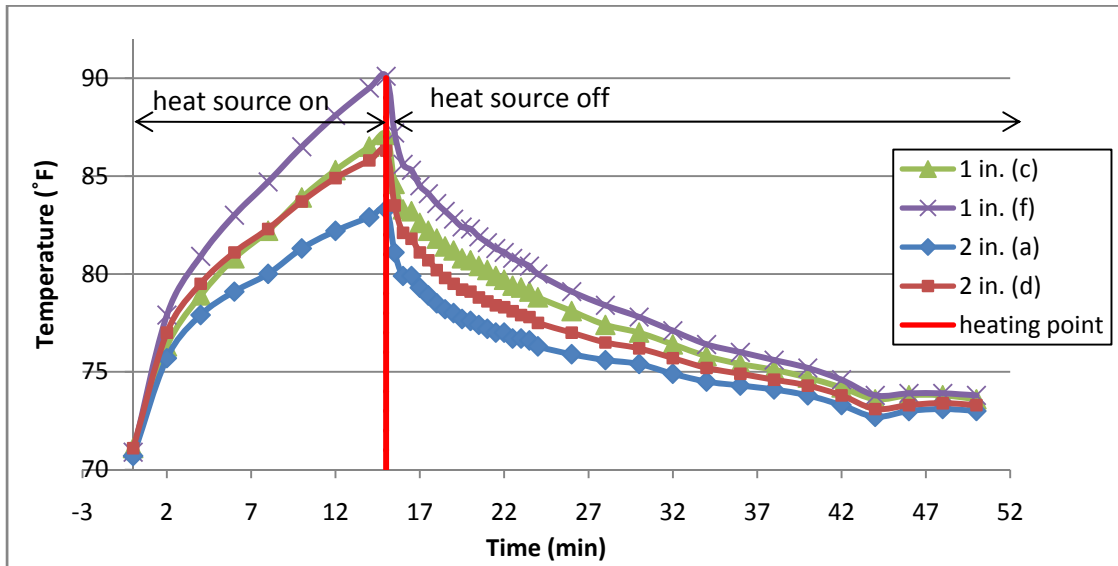
The variation of average temperature values for each delamination, collected in the second stage of this experiment using heater B, are presented in Figure 5.13. These

**Figure 5.13 Plot of the temperature variation in an active infrared thermography test using a 1500W infrared heater as a heat source, Slab I.**

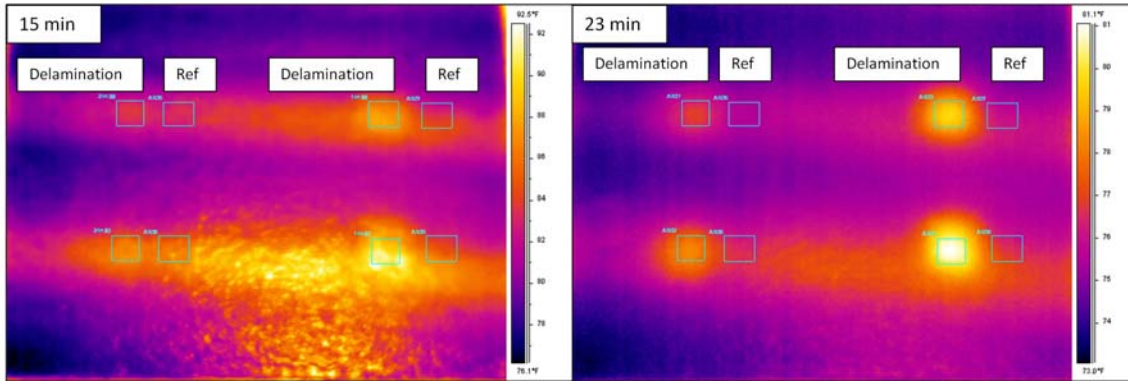
Figure 5.14 shows the thermal IR images at 15 minutes and 23 minutes after starting the data collection. 15 minutes is when the heating was stopped, and 23 minutes is when the maximum contrast appeared on the thermal infrared images for delaminations located at 2 in. deep. As it can be seen from these images, both delaminations at 23 minutes are more apparent than 15 minutes. This indicates that a reflection on the surface is prominent due to the surface heating method.

**Figure 5.14 Thermal infrared images of active infrared thermography test using 1500W infrared heater, shown 15 minutes after data collection began (left) and 23 minutes after data collection began (8 minutes after the heat was turned off) (right), Slab I.**

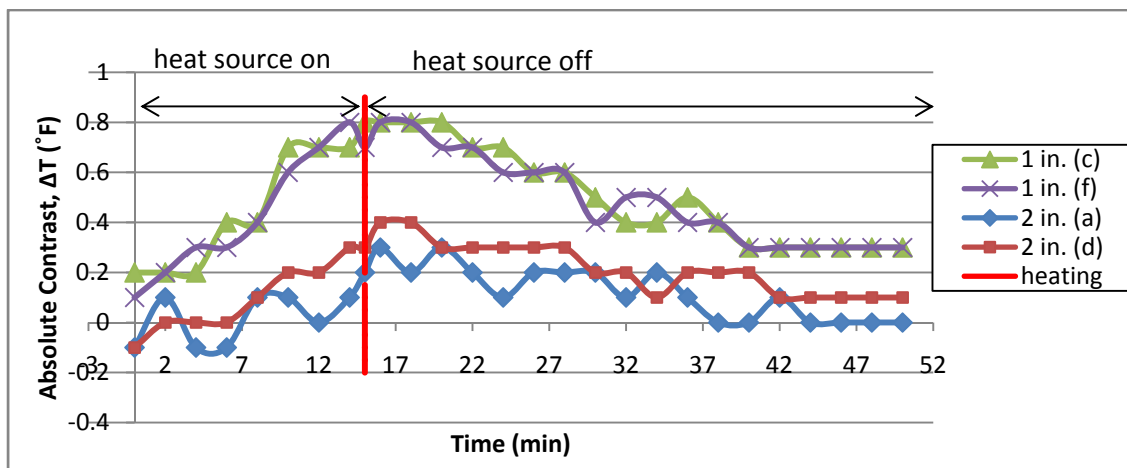
Figure 5.15 provides a plot of the absolute contrast ( $\Delta T$ ) versus time for delaminated areas at depths 1 in. and 2 in., when heated using heat source A.  $\Delta T$  was calculated by subtracting the average temperature above the area of delamination and the average temperature of a similar area adjacent to the delaminated area. Delaminations 3 in. deep were not detectable in this test. Although data were collected at 30 seconds intervals, the data used for this plot is presented at 2 minutes intervals as it shows the same trend. Data were collected at 30 seconds intervals to avoid missing any points in the data set.

**Figure 5.15 Absolute contrast plot for an infrared thermography test using two halogen lights (500W each), Slab I.**

Phase I investigated the effect of type of heat source on conducting an active infrared thermography test of existing concrete elements. Halogen lights (500W) and an infrared heater (1500W) were compared in this study. Comparing the plots in Figure 5.15 and Figure 5.16 showed that the 1500W infrared heater is a more efficient heat source in active infrared thermography testing of concrete elements; better contrast can be achieved on the thermogram results using a heat source with higher output power. Previous studies showed that halogen lights are a good source of heat for identifying areas of debonding and flaws in fiber reinforced polymer (FRP) overlays on the concrete surface. However, the depth of most flaws in FRP overlays is less than 5 mm (0.16 in.) (Starnes and Carino 2005; Brown and Hamilton 2007), while the delaminations in concrete bridge elements mostly occurred at the depth of the first layer of reinforcement or within the rebar's cover, which is less than 3 in. (AASHTO 2007). Therefore, the larger heat source is needed to heat the concrete deeper in the slab, to the level of the delaminations.

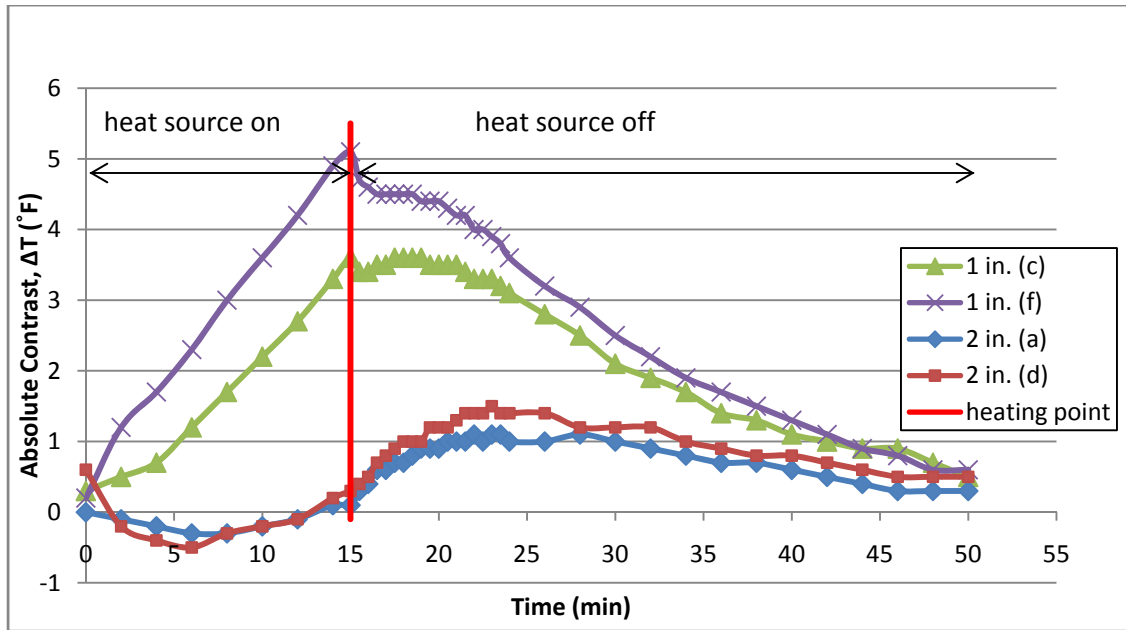
Figure 5.16 shows the plot of the absolute contrast between delaminated areas and background temperature versus time when heated using heat source B. This plot can be compared with the plot in Figure 5.15 which shows that using the 1500W infrared heater increases the absolute contrast significantly and results in better contrast between delaminated areas and sound concrete area on the thermal infrared image. Furthermore, this plot indicates that the delaminated areas located at 2 in. deep from the top surface appeared on the thermal infrared images after the heating was stopped (in this case seven minutes). The time at which the maximum contrast will be observed between the delamination and background area is called observation time (t).

Data points for the absolute contrast variation plot presented in Figure 5.16 were input in the spreadsheet at 2 minute intervals. However, to monitor the temperature changes more precisely after the heating was terminated, data points were plotted at 30 second intervals between the time when the heater was turned off (15 minutes after data collection began) and 9 minutes after the heat was turned off (24 minutes after data collection began). It was noted that after the heat source B was turned on over the concrete slab the absolute contrast for delaminations located at 2 in. depth decreased for about 6 minutes before it increased to the maximum absolute contrast. This reduction in absolute contrast to negative values means that the background temperature was higher than the temperature of the delaminated area. Non-uniform heating of the concrete surface due to the selected heating method is possibly the cause of this drop in absolute contrast to negative values at the beginning of the test.

**Figure 5.16 Absolute contrast above delaminations at 1 in. and 2 in. depth in infrared thermography test using an infrared heater (1500W).**

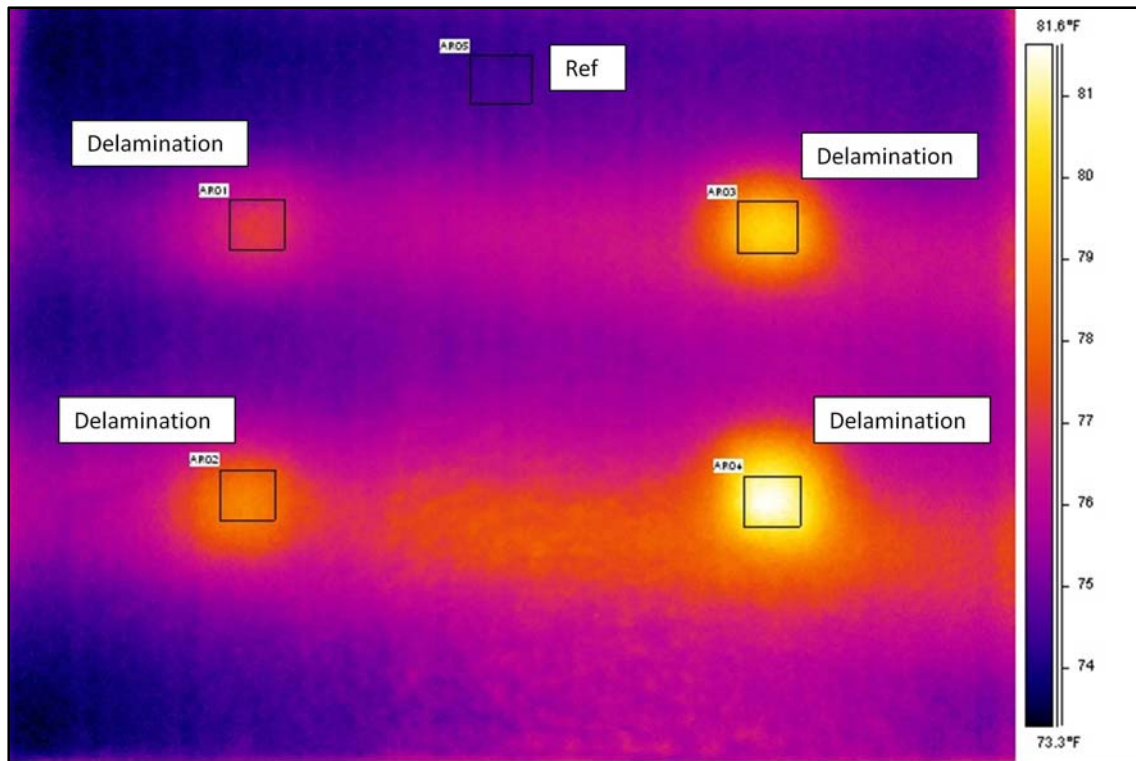
To further study this concept, an analysis was performed on the data collected in Phase I using heat source B. In this analysis, a single background area was selected instead of multiple background areas and the contrast for each delamination was calculated relative to that single background area. Figure 5.17 shows the relative location of the delaminated areas to the single background point on the thermal infrared image of Slab I taken at 22 minutes after starting of the test.

**Figure 5.17 Relative locations of delaminated areas and a single background area selected for analysis (7 minutes after the heat was turned off), Slab I.**

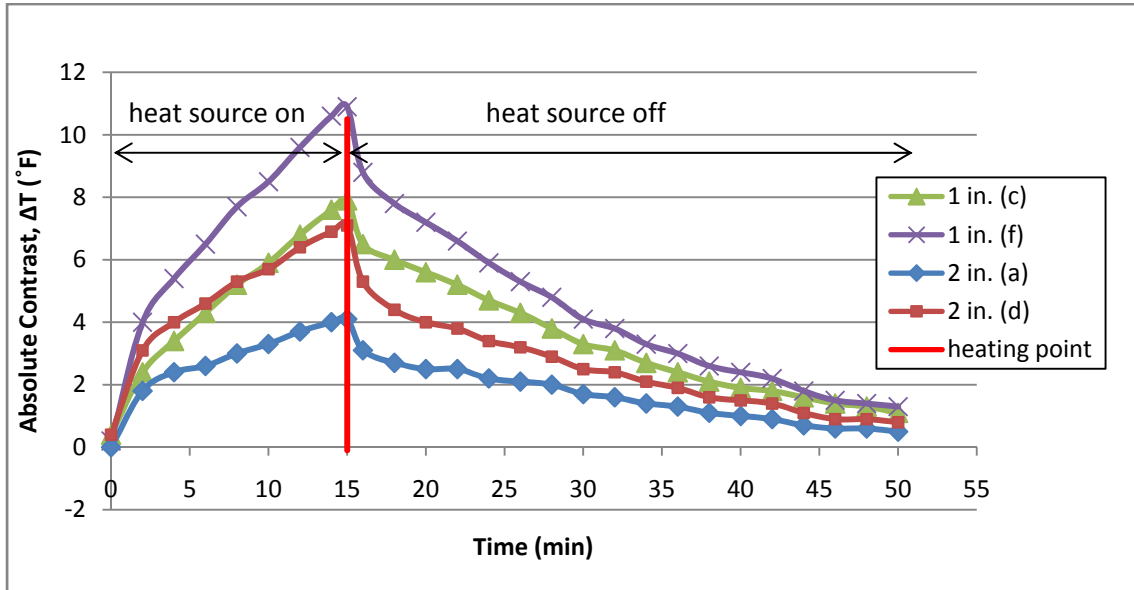
A plot of the variation of the absolute contrast for each delamination versus time is given in Figure 5.18. In this plot, the absolute contrast was computed by subtracting the average temperature within the area above each delamination and the average temperature within a single area selected as background. Comparing this plot (Figure 5.18) with the plot, obtained using multiple background areas for analysis (Figure 5.16), shows that the observation time and associated maximum contrast, which can help in estimating the depth of the delamination, are not obtainable using only one single background area for all four delaminations. The maximum absolute contrast for 1 in. deep delamination is 5.1°F when using a background area close to the delamination and 10.9°F when using a background area further away from the delamination. The maximum absolute contrast for 2 in. deep delamination is 1.4°F and appeared 7 minutes after turning off the heater. The maximum absolute contrast and the observation time values are evident on the absolute contrast plot in Figure 5.16, in which the analysis was based on selecting multiple background areas. The maximum contrast, obtained from the analysis using a single

background area, is 7.1°F and appeared at the same time when the heater was turned off (15 minutes after data collection was started). This contrast does not necessarily correspond to the time and absolute contrast in which 2 in. deep delaminations are evident.

**Figure 5.18 Absolute contrast above delaminations at 1 in. and 2 in. depth using a single background area for analysis.**

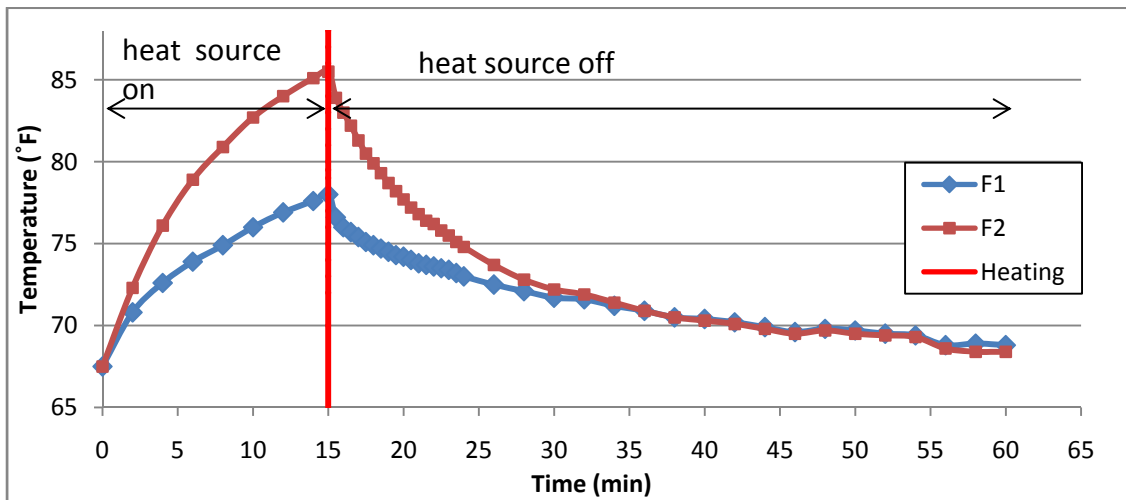
Figure 5.19 shows the temperature variation for the simulated delaminated areas F1 and F2 during the 15 minute heating period and 45 minutes after the heat source was turned off.

**Figure 5.19 Temperature variation within the delaminated areas F1 and F2 in concrete slab A during an active infrared thermography test.**

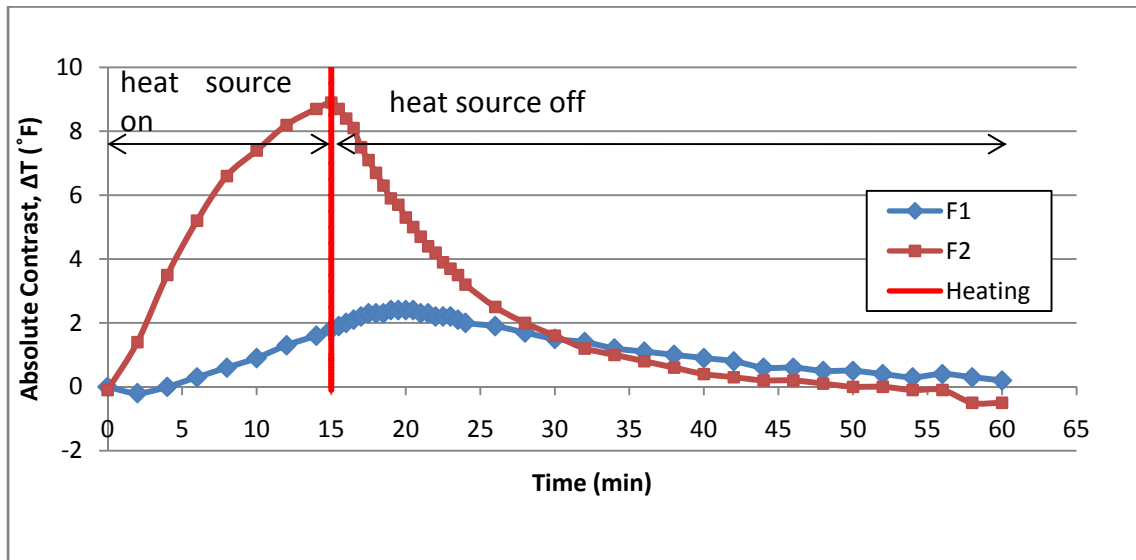
Figure 5.20 shows a plot of the variation of the absolute contrast ( $\Delta T$ ) versus time for delaminated areas F1 and F2 during the 15 minute heating period and 45 minutes after the heat source was turned off. Computation of the absolute contrast was similar to Phase

I and was based on subtracting the average surface temperature of the area above the delamination and the average surface temperature in the background area close to the delaminated area. Based on this figure, the maximum absolute contrast was observed at 15 minutes for defect F2 and at 20 minutes for defect F1. That makes the observation time for defect F2 to be close to 0 and observation time for defect F2 is 5 minutes. Observation time was determined based on the time at which the maximum absolute contrast occurred for each delamination.

**Figure 5.20 Absolute contrast above delaminations F1 and F2 during the 15 minutes heating period and 45 minutes after the heat source was turned off.**

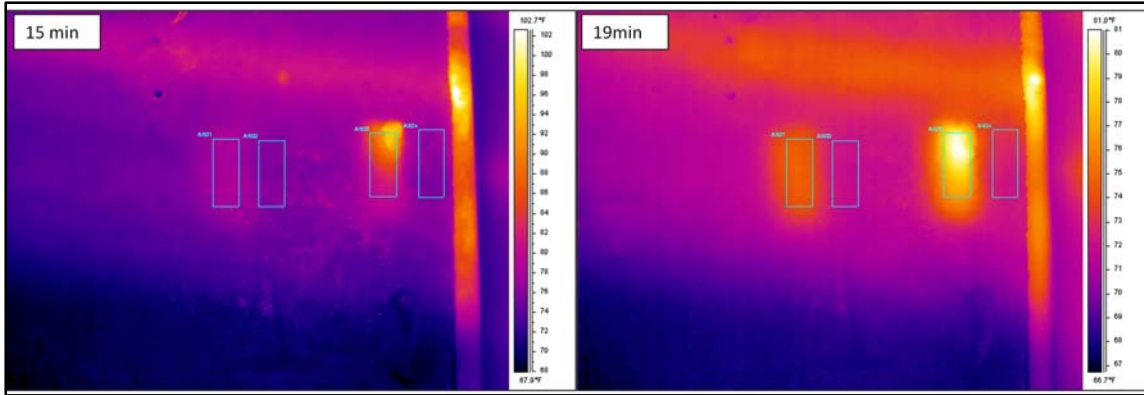
Figure 5.21 shows thermal IR images 15 minutes after the start of the data collection (when the heat source was turned off) and 20 minutes after the start of the data collection (when the defect F2 appeared on the thermal infrared image with the highest contrast).

**Figure 5.21 Thermal infrared images for the active thermography test on slab A, shown at 15 minutes after data collection began and 19 minutes after data collection began (4 minutes after heat source was turned off).**

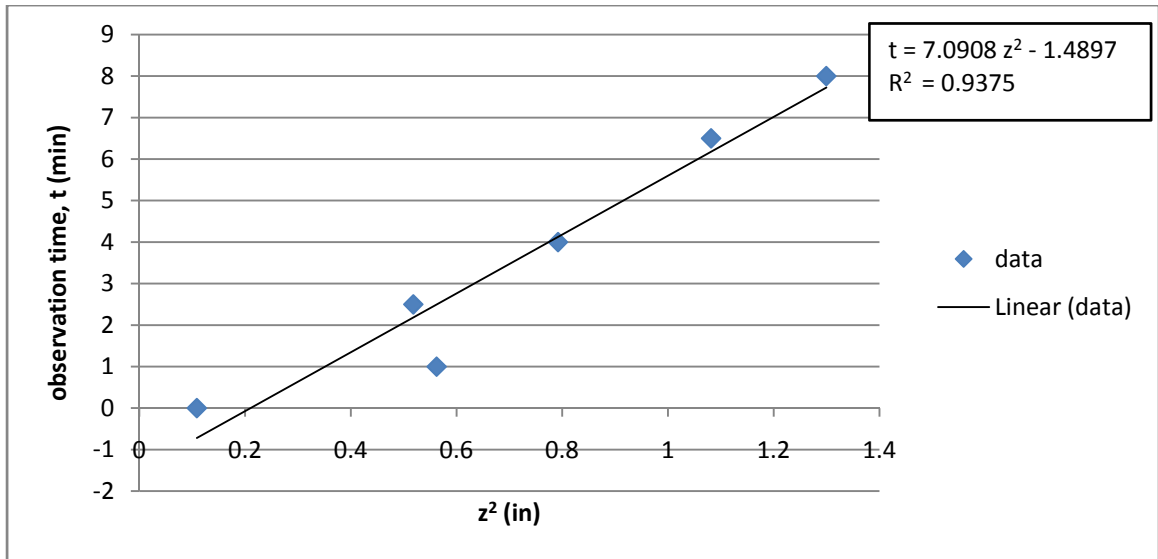
The relationship between the depth of each delamination and the observation time was discussed in section 3.3.3.1. From this discussion and the literature review, the time of observation has a linear relationship to the depth square ( $z^2$ ) (Equation 5). Figure 5.22 shows the plot and relationship between the observation time and the square depth of the delaminations in Slabs I and A ( $n = 6$ ). Depths presented on this graph are the actual depth for each delamination obtained from cores. The linear regression line was drawn for these data points to confirm the linear relationship between  $t$  and  $z^2$ . The square of the correlation coefficient ( $R^2$ ) is determined to be 0.94 for the data set. An  $R^2$  value gives a measure for reliability of linear relationship for this data set. The  $R^2$  value of 1 implies that all data points are perfectly fit on the straight line. It can be seen from the graph and the equation in Figure 5.22 that the correlation coefficient for this data set is very close to 1 which confirms the linear relationship between  $t$  and  $z^2$ .

**Figure 5.22 Observation time versus the depth squared of each delamination.**

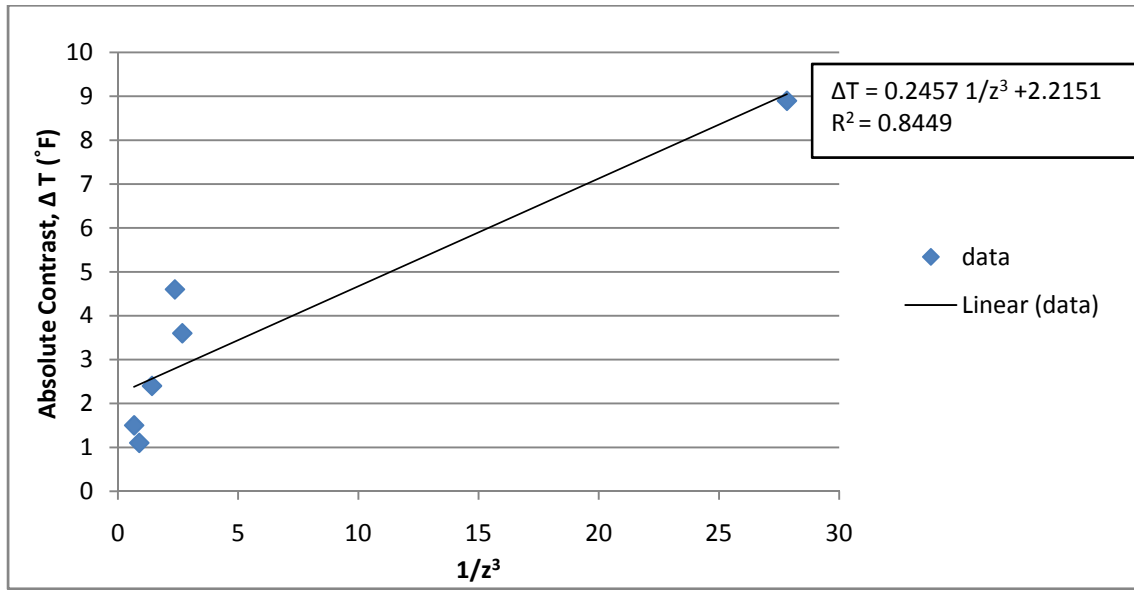
The relationship between the contrast and the depth of the flaws was discussed previously in Section 3.3.3.1. For the six data points obtained from Slabs A and I, the absolute contrast ( $\Delta T$ ) is plotted versus the inverse of the cubic depth of each delamination (Equation 5). This plot and the associated linear regression equation are shown in Figure 5.23. The relationship between the running contrast values and the inverse of the cubic depth of each delamination was also plotted in Figure 5.24. Definitions of absolute contrast and running contrast values were discussed previously in Section 3.3.3.1.2 of this document (Equations 8 and 9). The square of the correlation coefficient ( $R^2$ ) is determined to be 0.84 and 0.83 for the linear regression lines in Figure 5.23 and Figure 5.24, which confirms the almost perfect linear relationship. However, more data points between the  $1/z^3$  value of 2.4 and 8 will give a better estimation of these linear regression equations. Based on these two graphs and relationship between the contrast and the inverse of the cubic depth ( $1/z^3$ ), the depth of each delaminated area can be estimated.

**Figure 5.23 Absolute contrast versus the inverse of the cubic depth for Slabs I and A.**

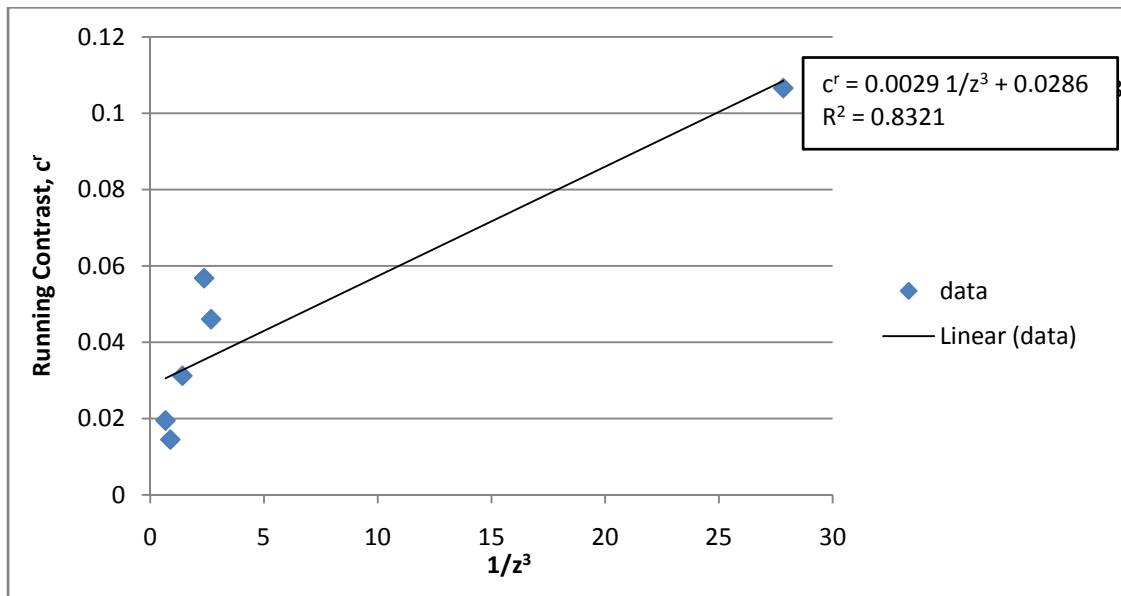
**Figure 5.24 Running contrast versus the inverse of the cubic depth for Slabs I and A.**

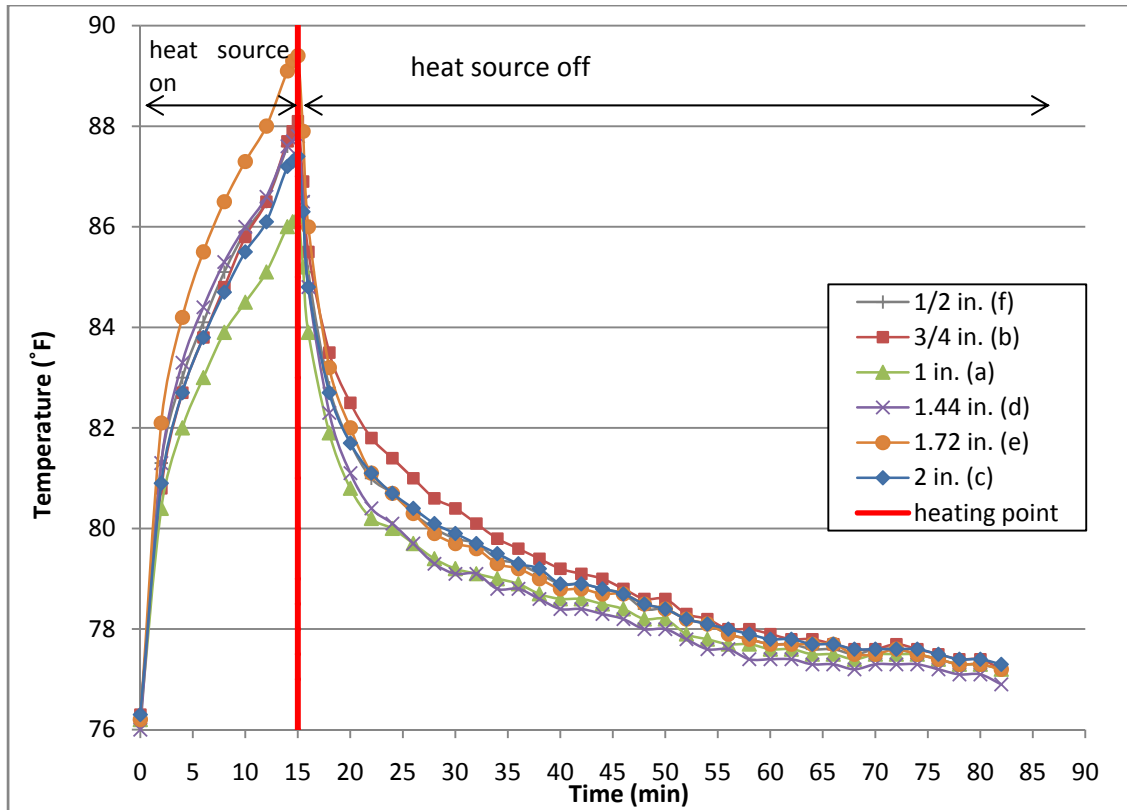
The temperature variation above each simulated delamination (Styrofoam blocks of 3 in. x 3 in. x 3/8 in.) is presented in Figure 5.25. Similar to the results obtained in Phase I, the surface temperature above each delamination increased during the heating period and it decreased after heat source was turned off (15 minutes after the beginning of the data collection). In general, it was expected to observe higher temperatures above shallower delaminations compared to the deeper delaminations. However, the results presented in the temperature variation plot of concrete Slab IV showed that the surface temperature above the delamination located at the depth of 1.72 in. had the highest temperature after heating up the slab for 15 minutes, while delamination located at 1 in. had the lowest temperature after the 15 minutes heating period. The reason for this unexpected temperature values was a combination of non-uniform heating of the concrete slab surface and the reflection of heat off the concrete slab surface.

**Figure 5.25 Temperature variation above each delamination in an active thermography test on the concrete slab IV.**

After turning off the heat source, the surface temperature above the delamination, placed at 1.72 in. depth, decreased at a faster rate compared to the surface temperature above the delamination located at  $\frac{3}{4}$  in. depth. Comparing the surface temperature change above the delamination located at 1 in. and 1.44 in. depth showed a similar trend. The surface temperature above both 1 in. and 1.44 in. deep delaminations decreased after the heat source was turned off, however it can be seen from the graph that the surface temperature above the delamination located at 1.44 in. under the surface decreased a little bit more after about 34 minutes from the start of data collection (19 minutes after the heat source was turned off).

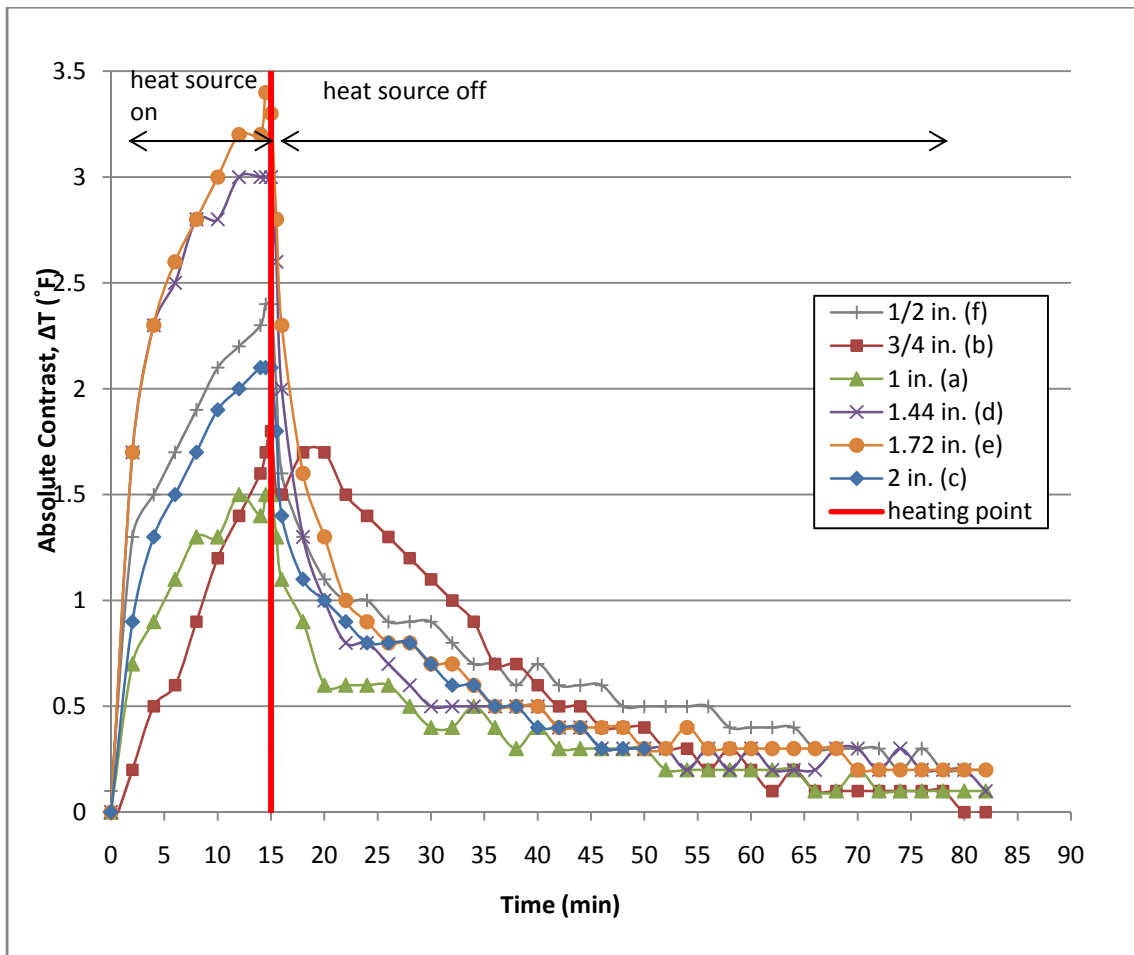
The absolute contrast variation plot for the six delaminations placed in concrete slab IV is shown in Figure 5.26. It can be seen from this graph that the absolute contrast decreases with a near vertical slope for a few minutes, then it stays constant and decreases at a

much lower rate. The linear slope observed on these graphs can be considered as a false signal due to the non-uniform heating and the observation time determined to be the time at which the absolute contrast remained constant after the rapid decrease. This value is more evident in the graph of the absolute contrast change for the delamination located at  $\frac{3}{4}$  in. (Figure 5.26). The absolute contrast above the delamination placed at  $\frac{3}{4}$  in. depth decreased from  $1.7^{\circ}\text{F}$  to  $1.5^{\circ}\text{F}$ , during the minute after the heat source was turned off (16 minutes after data collection began) and increased to back to  $1.7^{\circ}\text{F}$ , three minutes after the heat source was turned off (18 minutes after data collection began). It can be seen that the time of observation for delamination placed at  $\frac{3}{4}$  in. depth is about 3 minutes after the heating was stopped.

**Figure 5.26 Absolute contrast variations above simulated delaminations in concrete slab IV during an active infrared thermography test.**

The absolute contrast variation for other delaminations located deeper inside Slab IV is slightly different. The absolute contrast value for delaminations placed at  $\frac{1}{2}$ , 1, 1.44, 1.72 and 2 in. under the concrete surface decreased after the heat source was turned off, then the absolute contrast remained constant before decreasing again and did not increase to a higher value. Therefore, the observation time for delaminations placed at  $\frac{1}{2}$ , 1, 1.44, 1.72 and 2 in. were not evident from results obtained from Slab IV.

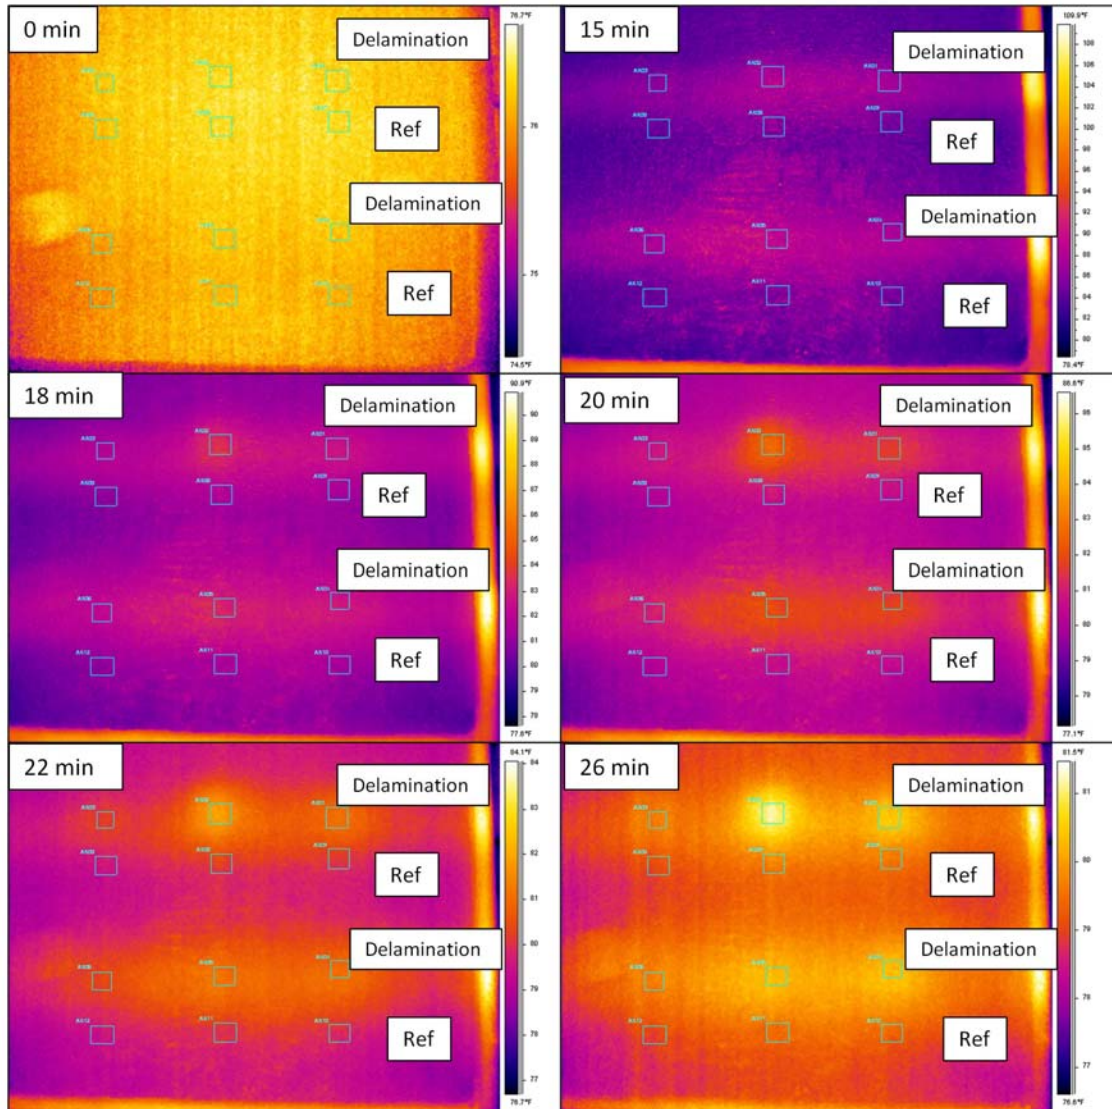
Thermal infrared images taken at the beginning of the data collection (0 minutes), at the time when the heat source was turned off (15 minutes) and at the times when defects appeared on the thermal infrared images (18, 20, 22 and 26 minutes), are shown in Figure 5.27. Although obtaining the observation time was not possible based on the results of the active infrared thermography testing on Slab IV, it is evident that all delaminations are apparent on thermal infrared images taken between 5 to 15 minutes after the heat source was turned off (20 to 30 minutes after data collection began). Absolute contrast for all delaminations is greater than  $0.5^{\circ}\text{F}$  between 5 to 15 minutes after the heat source was turned off.

**Figure 5.27 Thermal infrared images of concrete slab IV, shown at 0, 15, 18, 20, 22 and 26 minutes after data collection began.**
