**INFRARED THERMOGRAPHY ENHANCEMENTS FOR  
CONCRETE BRIDGE EVALUATION**

Khatereh Vaghefi

A DISSERTATION

In Civil Engineering

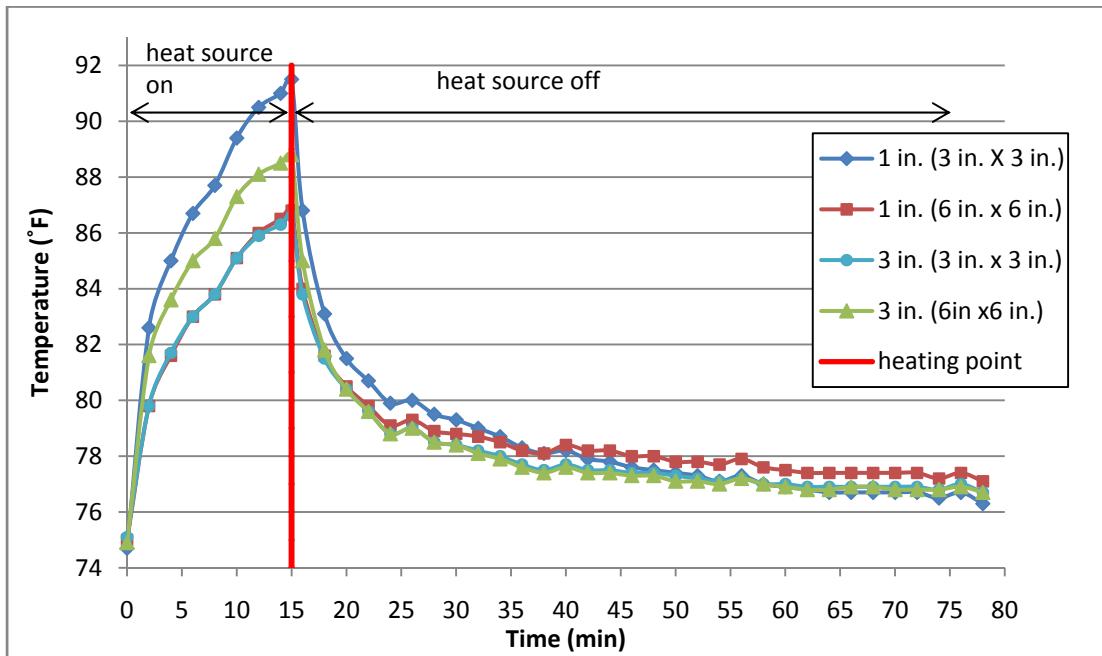
period was obtained based on the average temperature above each delaminated area. The plot of the surface temperature variation for the four delaminated areas in concrete Slab III is shown in Figure 5.29. Comparing the average surface temperature change for the two delaminations located at 1 in. depth shows that the average surface temperature above the larger delamination (6 in. x 6 in. x 3/8 in.) is higher than the average temperature above the smaller delamination (3 in. x 3 in. x 3/8 in.) after 40 minutes from the beginning of the data collection (35 minutes after the heater was turned off).

**Figure 5.29 Temperature variation in an active infrared thermography test on Slab III.**

The average temperature values and absolute contrast values, in Figure 5.29 and Figure 5.30, are presented at 2 minutes intervals, while data was collected from the concrete slab at 30 seconds intervals. Collecting thermal infrared images with 30 seconds intervals prevents having missing data points in the data set due to the auto focus setting of the thermal IR camera.

Another interesting remark that can be observed from Figure 5.29 and Figure 5.30 is that larger delaminations hold the heat for a longer period of time than smaller size delaminations. The maximum absolute contrast for the 6 in. x 6 in. delamination placed at a 1 in. depth occurred 32 minutes after the beginning of data collection and remained approximately the same for about 24 minutes before it dropped to a lower value 56 minutes after the beginning of data collection. This indicates that the size of the delamination is an important factor to be considered in establishing a time window for the concrete bridge element inspection after turning off the heat source.

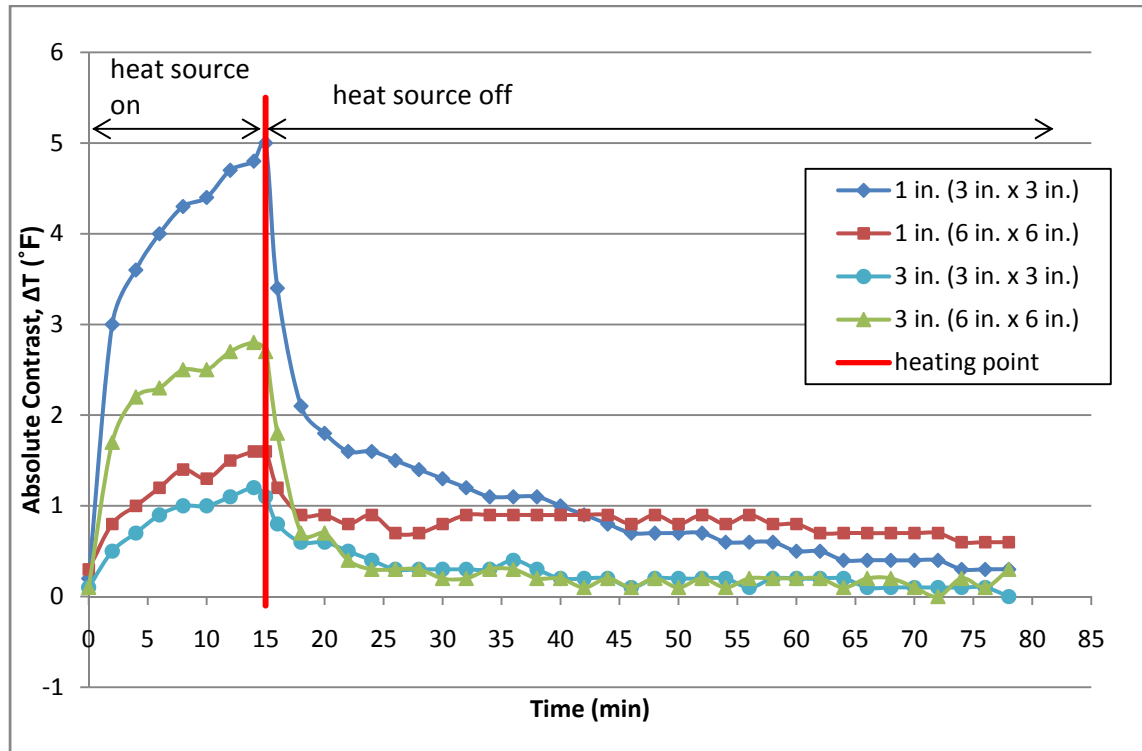
The absolute contrast variation plot for the four delaminations in Slab III is shown in Figure 5.30. It can be seen from this graph that delaminations located 3 in. deep did not have enough contrast after the heater was turned off to appear on the thermal infrared images. The high contrast values of the 6 in. x 6 in. delamination placed at 3 in. deep during the 15 minutes heating period are likely due to the reflection from the concrete slab and do not reveal information regarding the location and size of the delamination inside the concrete slab. Moreover, it has been noted from comparing the graphs of absolute contrast change for the two delaminations located at 1 in. from the concrete

surface that the delamination with the smaller area lost contrast much faster than the larger delamination. In fact, 27 minutes from the time at which heating was stopped (42 minutes after the data collection began), the larger delamination at 1 in. depth appeared on the thermal infrared image with higher contrast compared to the smaller delamination.

**Figure 5.30 Absolute contrast variations above simulated delaminations in slab III during an active infrared thermography testing.**

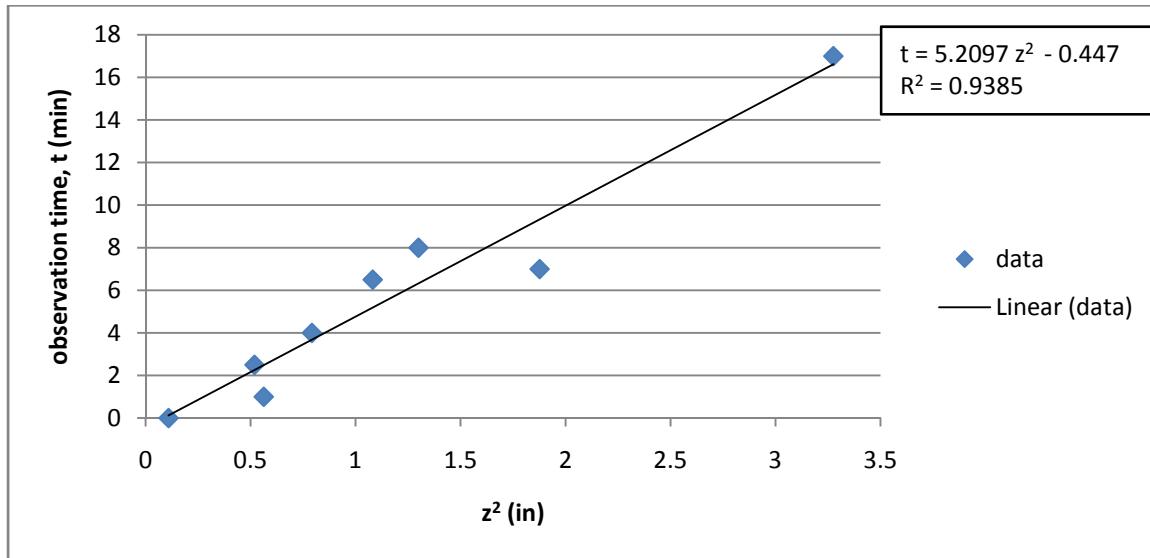
The linear regression line obtained from the combined results of observed delaminations in Slabs A, I and III is shown in Figure 5.32. It can be seen that the square of the coefficient of correlation is 0.94, which still confirms the given linear relationship is a good fit between the observation time and the depth of the delaminations.

**Figure 5.32 Observation time versus the depth squared of each observed delamination in Slab A, I and III.**

Based on the results presented in Chapter 5, the depth of the delamination is predictable using active infrared thermography. Results in Chapter 6 showed that this conclusion is valid and the depth of the delamination was correctly predicted for location W1 to be less than 1 in. Using the equation shown in Figure 5.32 and the observation time of 2.5 minutes for location W1-B, the depth was determined to be 0.75 in. The actual depth of 0.5 in. was determined by coring at this location. In other locations on the beam, because no observation time could be observed in the absolute contrast variation plot, no prediction of depth can be made using the linear relationship equation obtained from Figure 5.32.

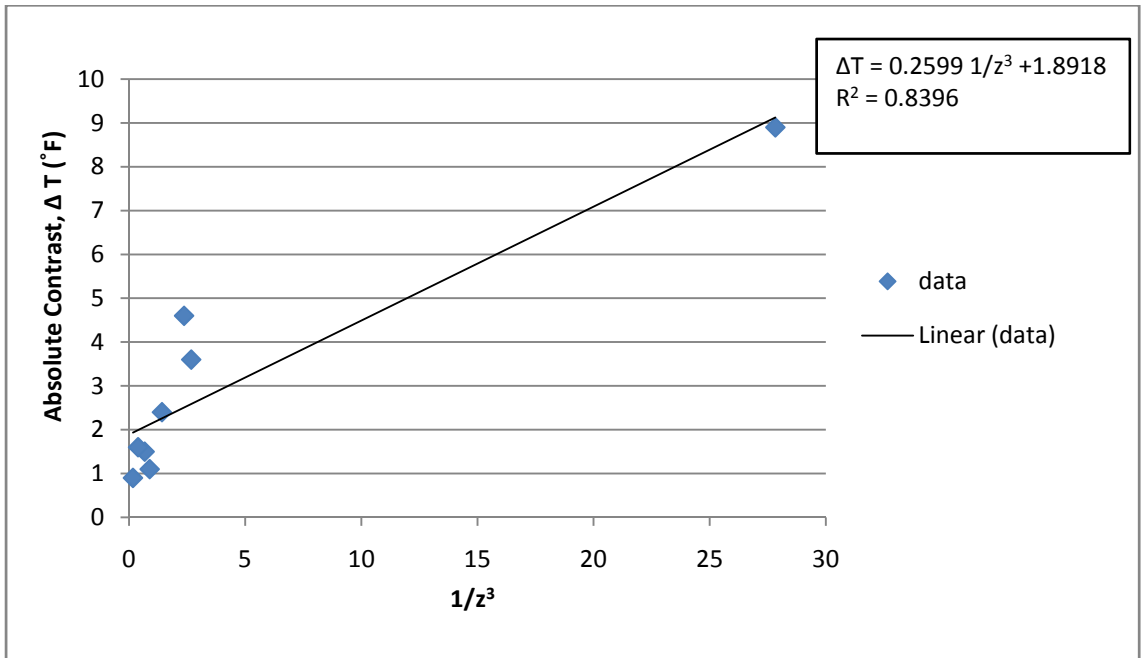
The absolute contrast and the running contrast for the two observed delaminations in Slab III was also added to the linear regression relationship between the contrast and the inverse of the cubic depth discussed in 5.3.2.1. It can be seen from the two graphs presented in Figure 5.33 and Figure 5.34 that the  $R^2$  values were remained close to 0.84 and 0.83 which confirms the linear relationship. However, there exists the lack of data points for the values of  $1/z^3$  between 2.4 and 8, representing depths between  $\frac{3}{4}$  in. and  $\frac{1}{2}$  in.

**Figure 5.33 Absolute contrast versus the inverse of the depth cubed for Slabs A, I and III.**

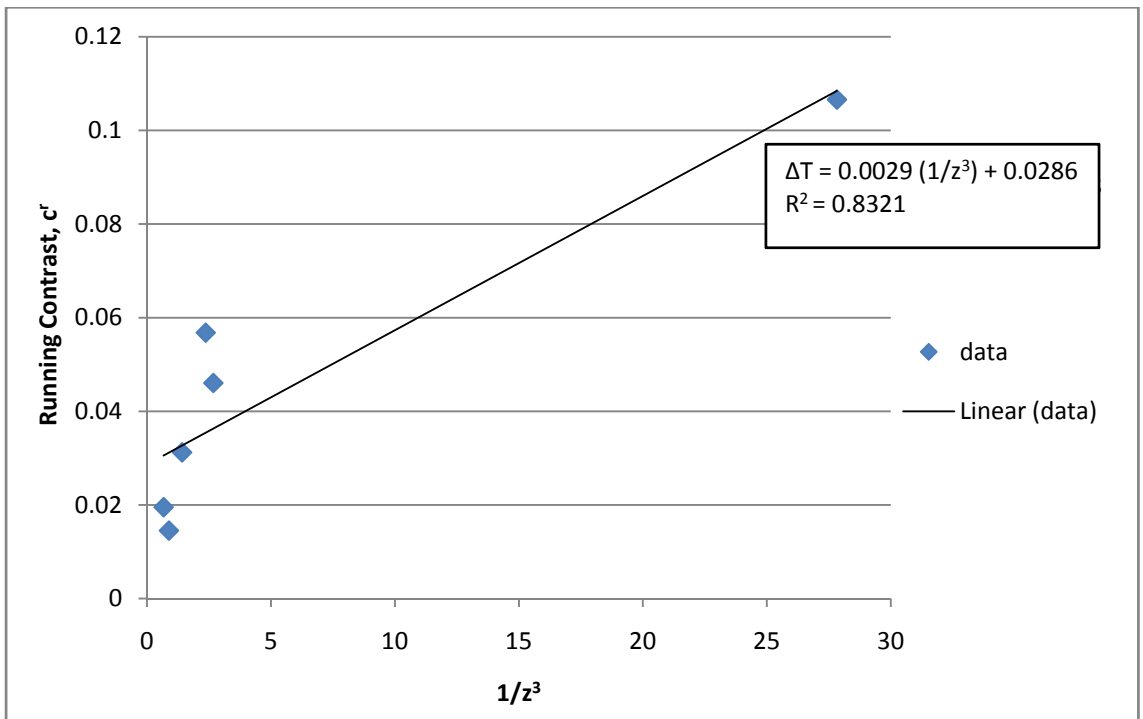
**Figure 5.34 Running contrast versus the inverse of the depth cubed for Slabs A, I and III.**

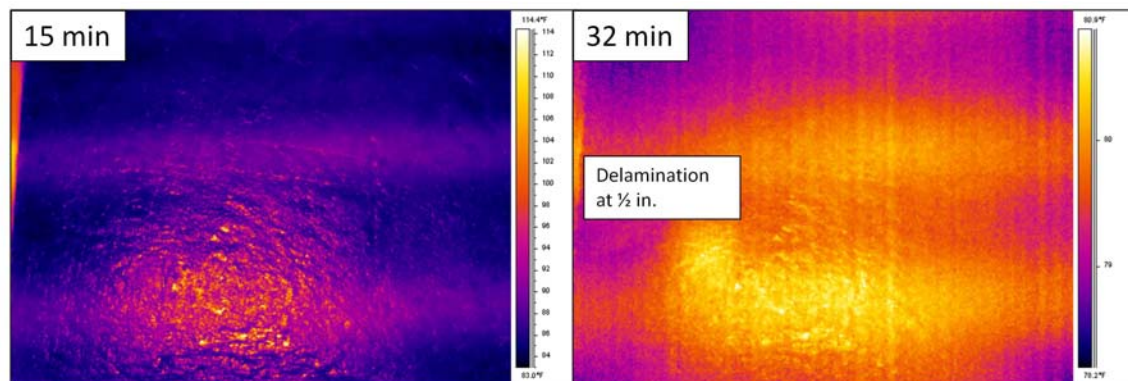
The results obtained from an active infrared thermography test on Slab II illustrate one of the reasons for hesitation yet in declaring active infrared thermography as a practice-ready NDT tool for bridge inspection. Active infrared thermography was deployed on this concrete slab using the same method to what was presented previously in phase II for slabs I and IV. Slab II was heated for 15 minutes using an infrared heater and thermal infrared images of the concrete slab were collected at 30 seconds intervals. The only delamination that was detected was the ½ in. deep delamination. Although it was expected that the other delaminations located at 1, 1.5, 2 and 2.5 in. depths in this concrete slab would be detectable, there were no indication of any other delaminations in this concrete slab. Figure 5.35 shows the thermal infrared images in an active infrared thermography test on concrete slab II which was conducted 45 days after the slab was constructed.

**Figure 5.35 Thermal infrared images obtained from an active infrared thermography test, shown 15 minutes after data collection began (when the heat source was turned off) and 32 minutes after data collection began.**

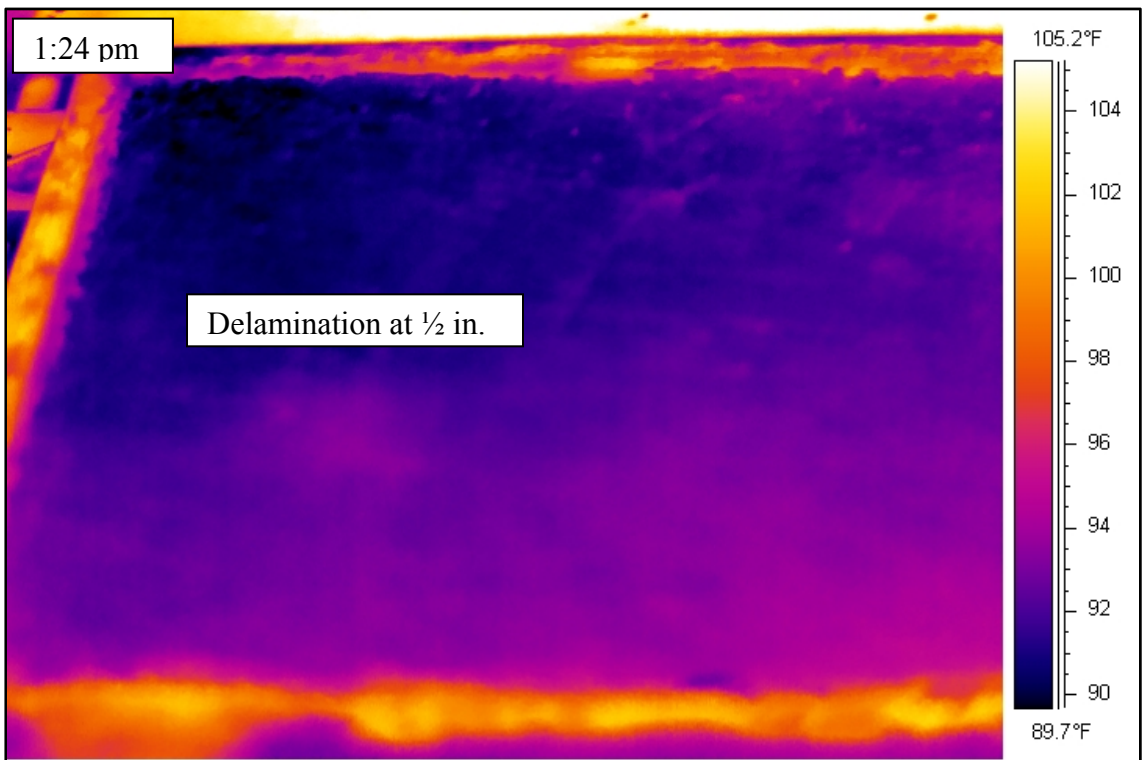
To further investigate the infrared thermography test on Slab II, passive infrared thermography was conducted on this specimen. Slab II was placed outside overnight and remained outside to be exposed to sunlight and the ambient temperature change. Thermal infrared image was taken from slab at 1:24 pm (see Figure 5.36), when it was expected to see the delaminations that were placed in the slab. Ambient temperature at the time of

data collection was 91.2°F and humidity was 51%. The lowest temperature at night was recorded as 61°F. The result from passive infrared thermography was similar to the active infrared thermography testing. The only delamination that showed some indications on the thermal infrared image was the delamination located at ½ in. depth from the concrete surface.

**Figure 5.36 Thermal infrared image obtained from a passive infrared thermography test on Slab II.**

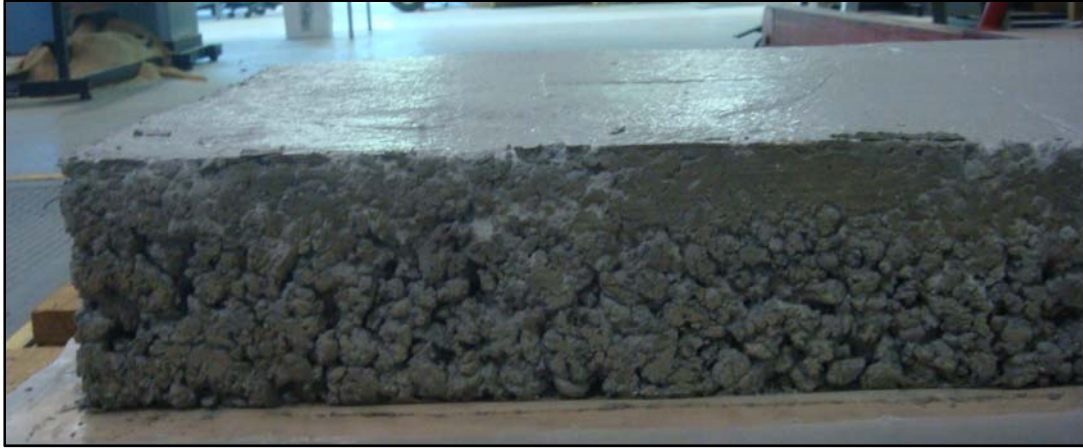
After infrared thermography was conducted on Slab II, the timber forms were removed from the sides of the slab. As it can be seen in Figure 5.37, poor consolidation was observed at the edges of this slab.

**Figure 5.37 Slab II after the timber form was removed.**

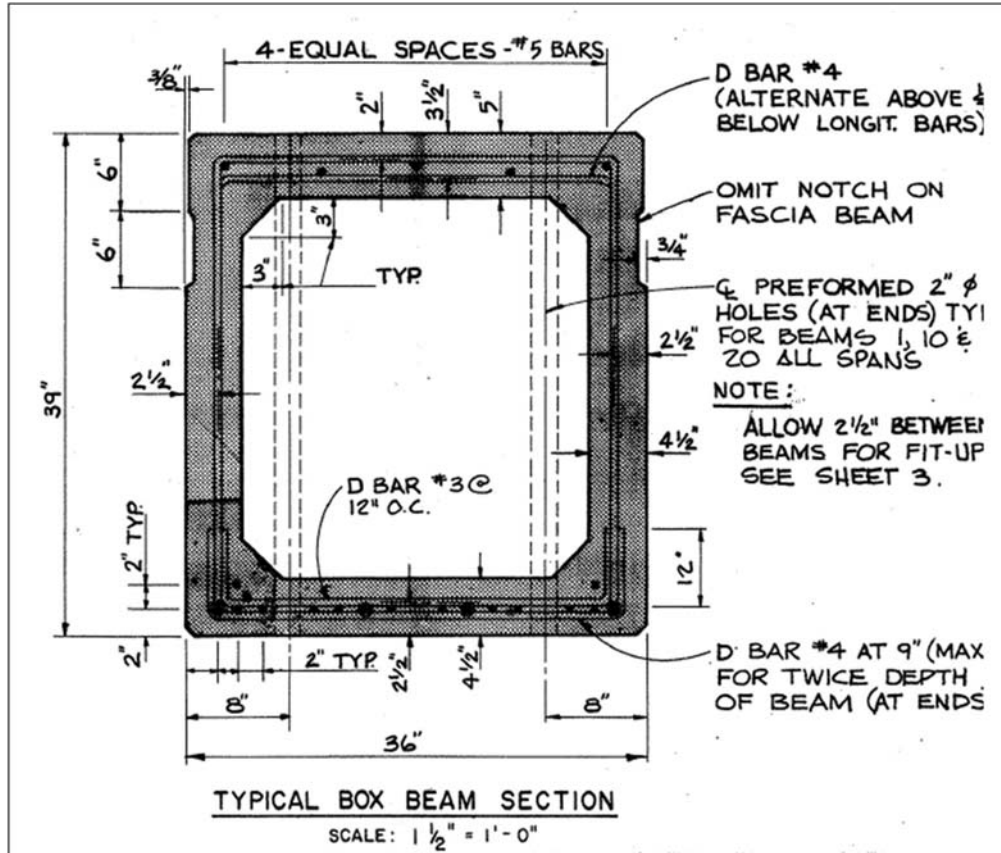
(ADT) on this bridge in 2006 was 13,320. The bridge consisted of three spans with beams lengths of 73 ft-2¾ in. Each span was comprised of 20 adjacent prestressed box beams 36 in. wide and 39 in. deep (AASHTO BIII-36). These beams were post-tensioned in the transverse direction with three post-tensioning tendons in the middle of each span and two tendons at each end. The riding surface consisted of a 3 in. latex modified concrete overlay with no water proofing membrane between the concrete overlay and box beams. Only the reinforcement, used in the sidewalks and parapets, were epoxy coated. The bridge had a skew of 42°. Silverbell Bridge was demolished and replaced in February of 2011 due to the severe deterioration of the prestressed box beams. Figure 6.1 shows the location and orientation of this bridge before it was demolished. Figure 6.2 and Figure 6.3 show the prestressed concrete box beam cross section and Figure 6.4 shows the relative location of the bridge beams and post-tensioning tendons. Clear concrete cover over the stirrups to the sides of the box-beam was 2¼ in. and clear cover of the stirrup to the bottom surface of the box beam was around 1¾ in.

Figure 6.2 Silverbell Bridge box beam cross section.

4¼ in. for all cores extracted from W2-A, W2-B, W3-A, and W4 (Note that Figure 6.2 shows the web wall thickness was designed to be 4½ in. Location W1-B was drilled up to 13.5 in. inside concrete but proved to be a solid section and did not reach the Styrofoam filling inside the box beam. Figure 6.43 shows the coring procedure and the way the drilling was carried out on the beam.

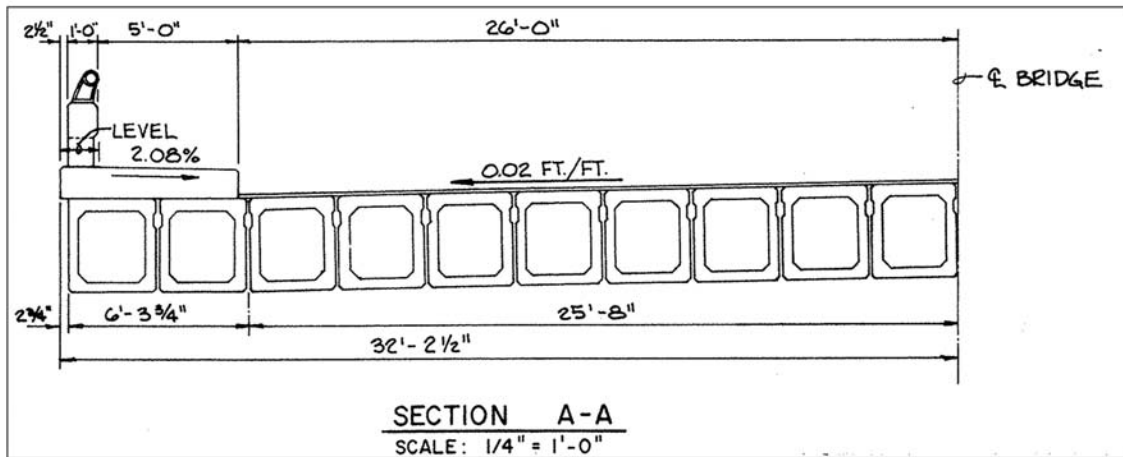
Figure 6.3 Cross section of Silverbell Bridge box beams.

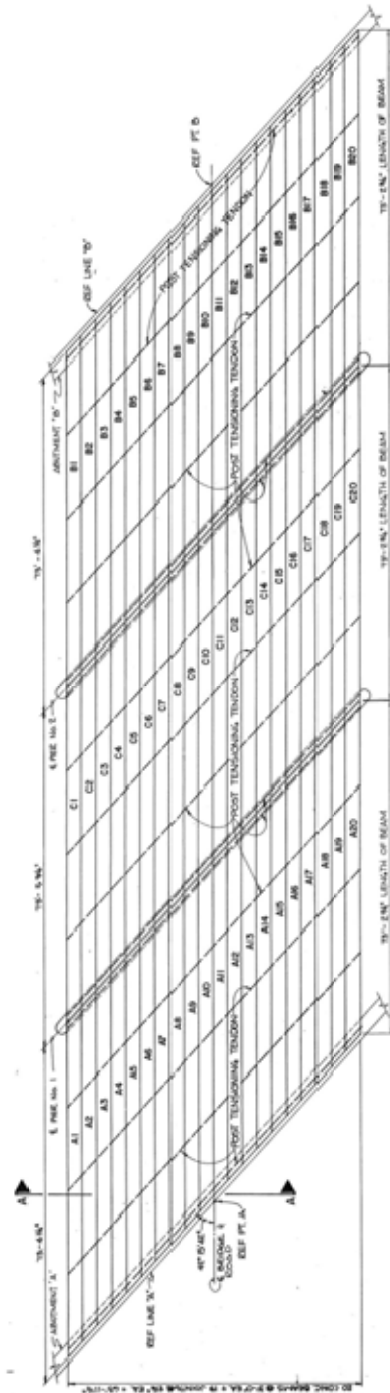
Figure 6.4 Silverbell Bridge box beam plan.

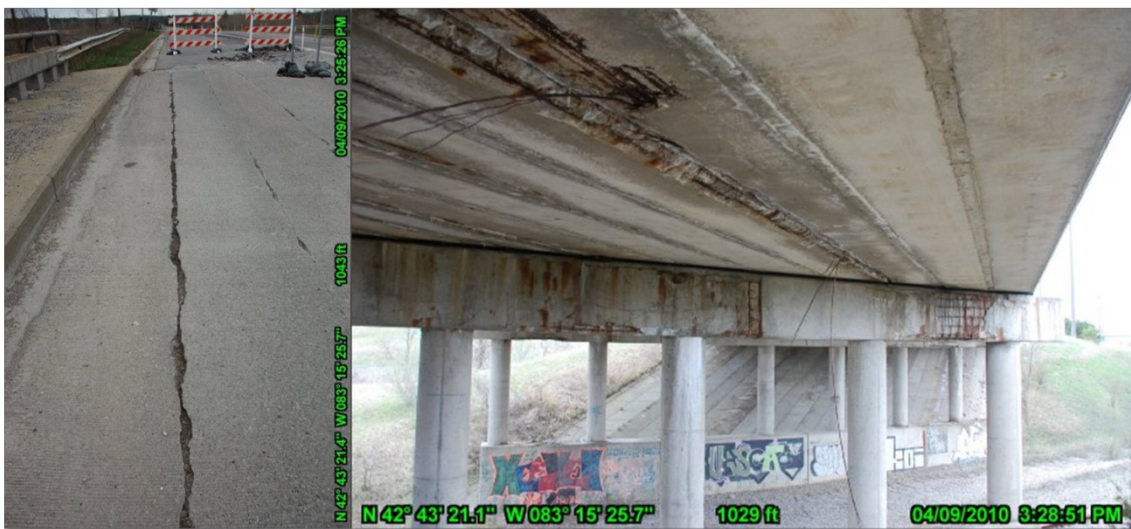
A bridge inspection conducted in March 2010 rated the bridge deck surface as 4 on the NBI scale (Bridge inspection reports are included in Appendix B). Severe longitudinal reflective cracks were observed on the bridge deck (up to 5 in. wide) and in some locations cracks had turned to deep spalls with surrounding delaminations. Adjacent box beams prevented inspection of the underside of the bridge deck. Leaching from the joints was also observed at some locations. The overall superstructure of this bridge was rated as a 2 on the NBI scale, which indicates a very poor condition bridge. Broken strands, exposed rebar, and severe spalls and delaminations on several box beams were observed during the inspection. Two lanes on this bridge were closed due to the severe deterioration of superstructure and pier caps. Figure 6.5 shows the condition of the Silverbell Bridge in April 2010.

**Figure 6.5 Silverbell Bridge deck and superstructure in April 2010.**

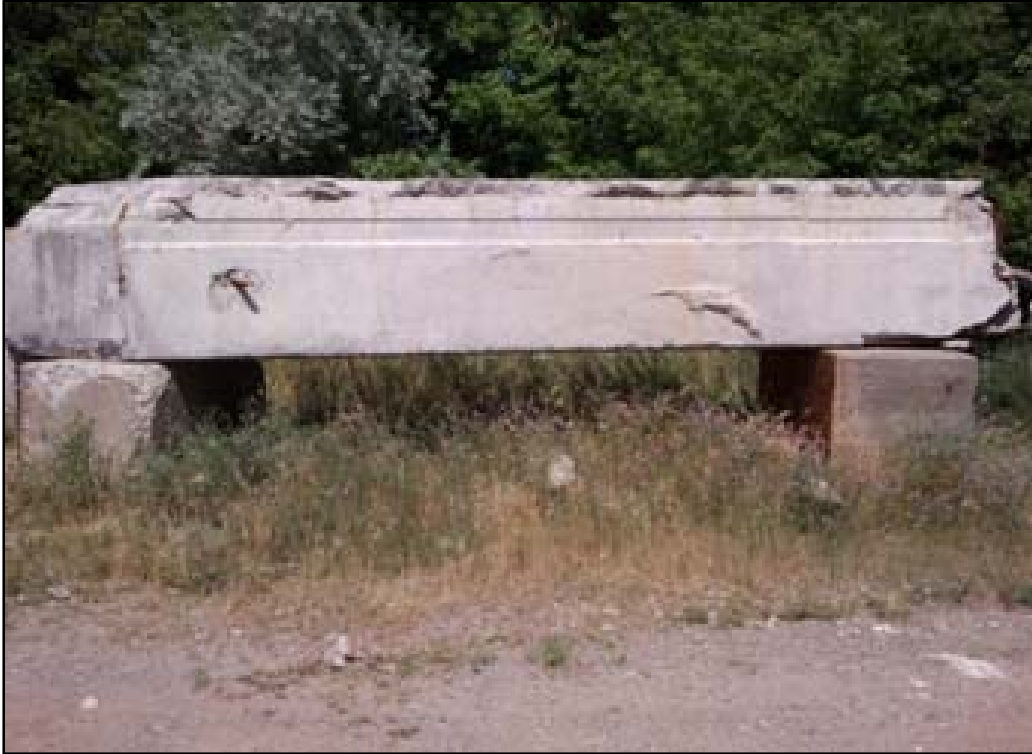
A 23 ft segment of this bridge was saved after demolition for future nondestructive testing study. This segment is shown in Figure 6.6 as it was stored in RCOC facility and before being transferred to Michigan Tech in October 2012. Figure 6.7 showed the placement of this bridge segment in the laboratory.

**Figure 6.6 Silverbell Bridge beam in Road Commission Oakland County facility (west face shown).**

This segment of the beam contains two post-tensioned tendons and has moderate delamination and spalling along the edges and on the sides. Hammer sound testing was conducted on the beam to determine the delaminated areas prior to active infrared thermography testing. Delaminated areas were detected on the sides but not at the bottom surface. No delamination was detected on the top side of the beam using the hammer sounding method. However, there was narrow transverse cracking noted on the concrete overlay on the top of the box beam toward the south side (direction is based on the placement of the beam in the laboratory.), and a wide longitudinal crack on the top side of the beam.

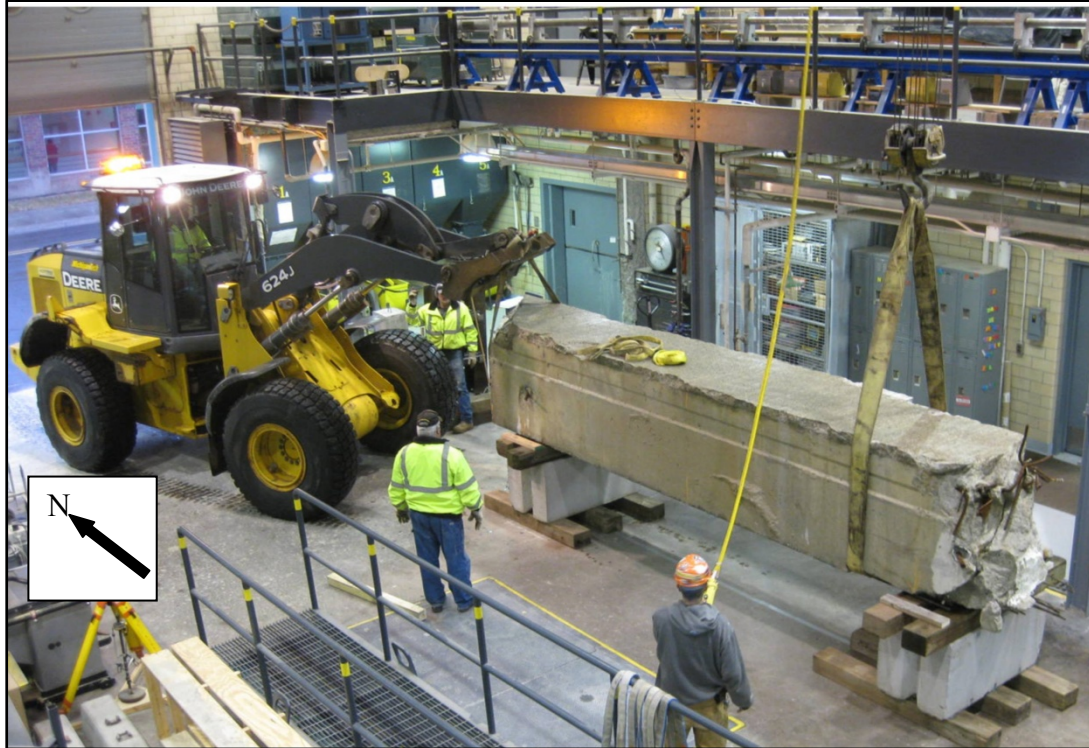
**Figure 6.7 Placement of Silverbell Bridge in the Michigan Tech laboratory.**

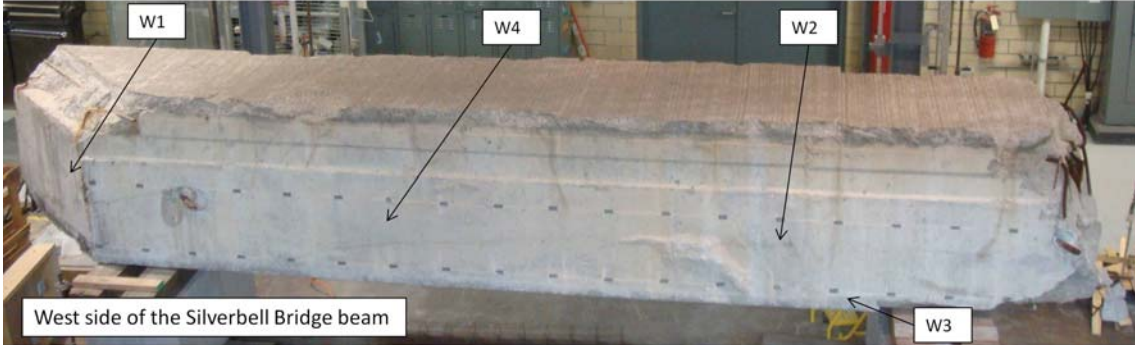
Active infrared thermography testing was carried out on seven locations of the box beam. These locations were selected based on the results of both the hammer sounding and visual inspection of the beam, and are shown in Figure 6.8 and Figure 6.9. In some locations, more than one delaminated area was detected. Directions on these figures are based on the orientation and placement of the beam in the laboratory, with the skewed end pointing north.

**Figure 6.8 West side of the Silverbell bridge beam.**

Three locations on the west side of the Silverbell Bridge beam were identified as areas with possible delaminations using the hammer sounding technique. These three locations (W1, W2 and W3) were shown in Figure 6.8.

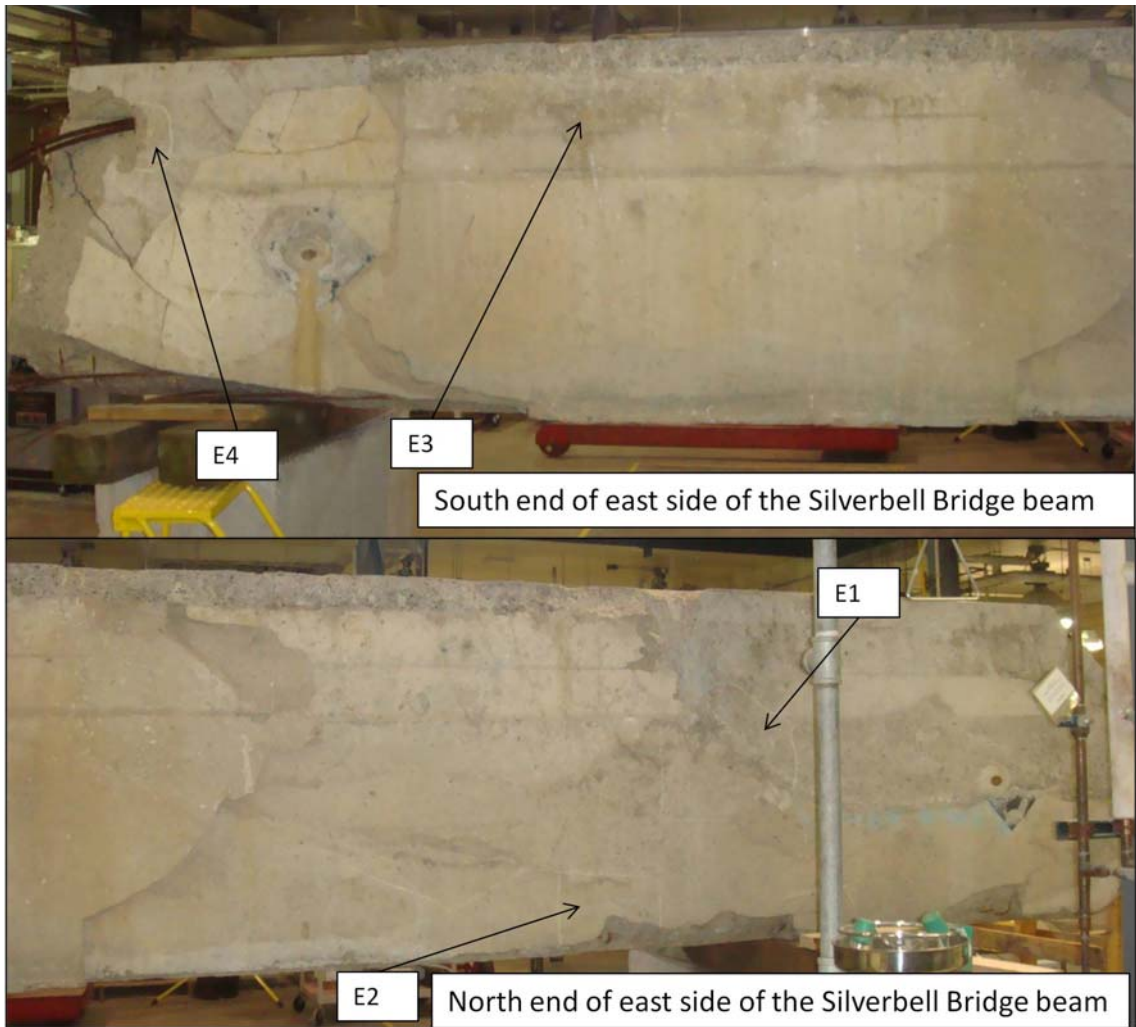
**Figure 6.9 East side of the Silverbell Bridge beam.**

In the Silverbell Bridge, the shear keys between the adjacent box beams were grouted full depth. The thickness of the grout between the box beams was about 2 in. A segment of this grout was still attached to the box beam segment under study in this dissertation. Also, a section of the precast beam was cut during the demolition. Figure 6.22 shows the location of the grout segment and the precast section that was cut. Four locations on the east side of this beam were identified as possible delaminations. These four locations (E1, E2, E3 and E4) were shown in Figure 6.9.

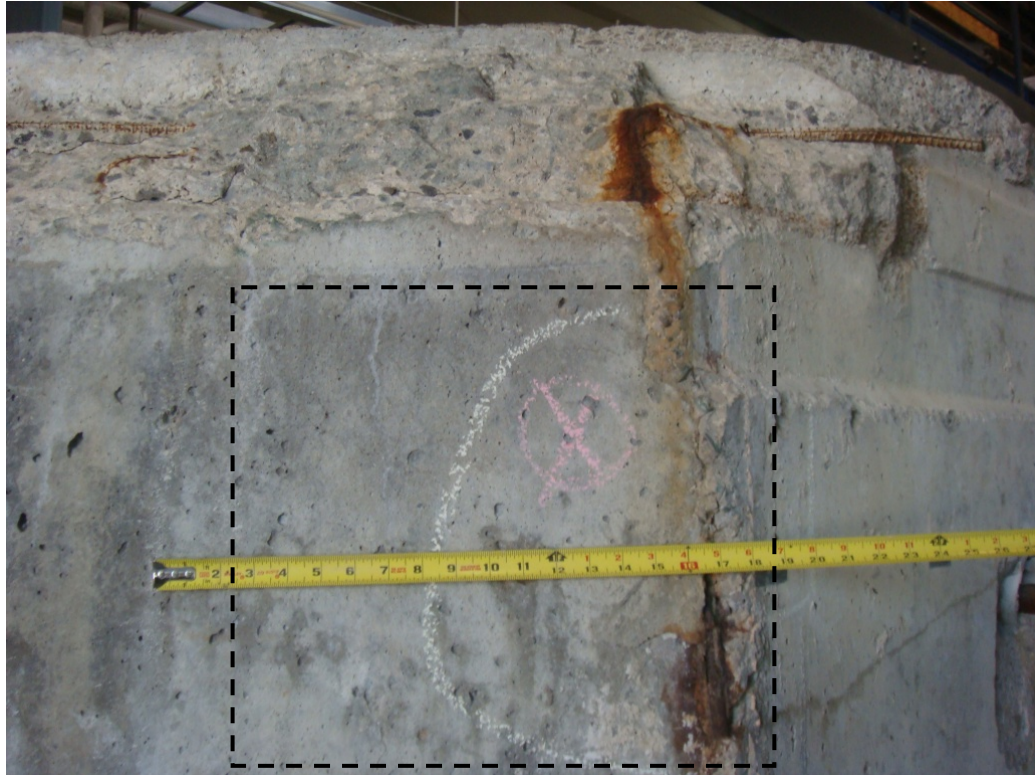
The first delamination identified on the west side is area W1 at the skewed end of the beam. A corroded and exposed stirrup could be observed on the concrete surface. Figure 6.10 shows the visible condition of the concrete surface at the location W1. The dashed line indicates the approximate size of the thermal image. The ambient temperature was 74.1 °F and the ambient humidity was 32.7% during the data collection.

**Figure 6.10 Visible condition of the concrete surface at the location W1.**

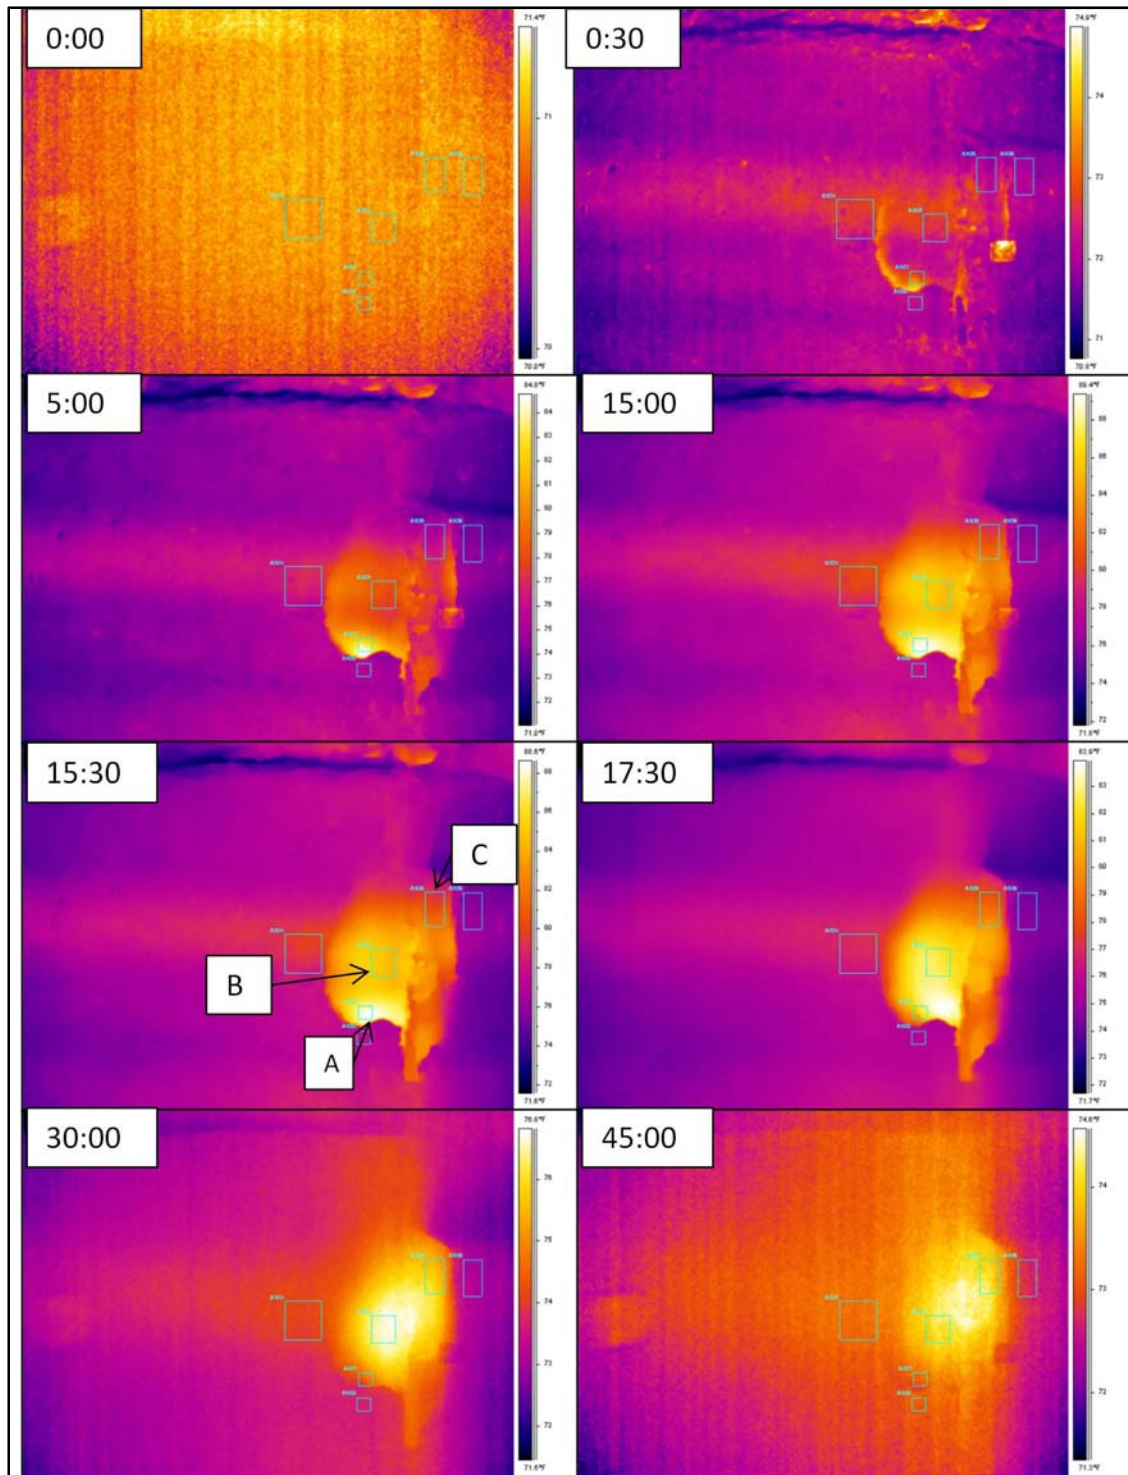
Figure 6.11 shows the thermal infrared images taken from the location W1 at different times during the data collection. Because the depth of this delamination is not constant within the total delaminated area, this area was divided into three sections; A, B, and C. Subarea A is a very small area at the edge of this delamination, which appeared with the highest temperature compared to the other two subareas (B and C) and indicates that the delamination is closer to the concrete surface in the subarea A. Subarea B is located within the delamination on the skewed end of the beam. Subarea C is located close to the skewed end and on the west side of the beam.

**Figure 6.11** Thermal infrared images taken from location W1 during an active infrared thermography test (timestamps on each image represents the relative times to the beginning of the data collection).

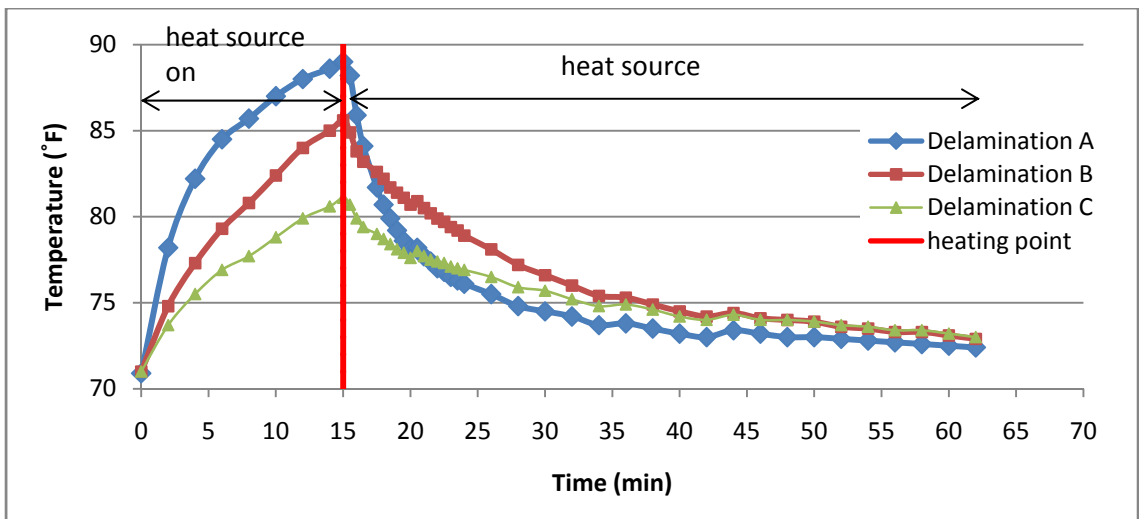
Figure 6.12 shows the plot of the surface temperature variation of concrete above each subarea of delamination located at A, B and C. Temperature values on this graph indicate the average temperature within the area of interest (subarea A, B or C). It can be seen from the plot that the temperature reached a higher value within the subarea A compared to the other two subareas. Also, the maximum average temperature for the subarea B is higher than the maximum average temperature for the subarea C. Comparing the maximum average temperature can be an indicator of deeper or shallower delaminations, however the exact decision on the depth of the delamination cannot be made by just looking at the temperature variation graph due to some non-uniform heating over the skewed end of the beam. Comparing absolute contrast variation plots can give more information regarding the depth of the delaminations.

**Figure 6.12 Temperature variation above the delamination at location W1.**

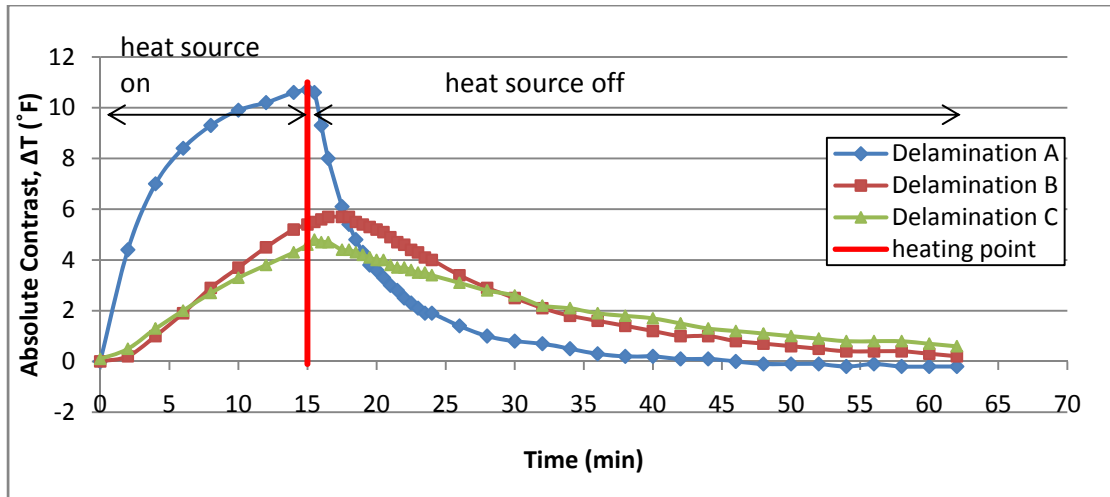
Figure 6.13 shows the absolute contrast variation for the aforementioned subareas (A, B, C) on the delaminated area located at W1. It can be seen from these graphs that the maximum absolute contrast for the subarea A is at the time when the heating was stopped (15 minutes after data collection began). The maximum absolute contrast for subareas B and C appeared at 2 minutes and 30 seconds (17:30) and 30 seconds (15:30) after the heat source was turned off. Based on these results it can be estimated that the maximum depth of this delamination (all subareas) is approximately 1 in. or less.

**Figure 6.13 Absolute contrast variations above the delamination at location W1.**

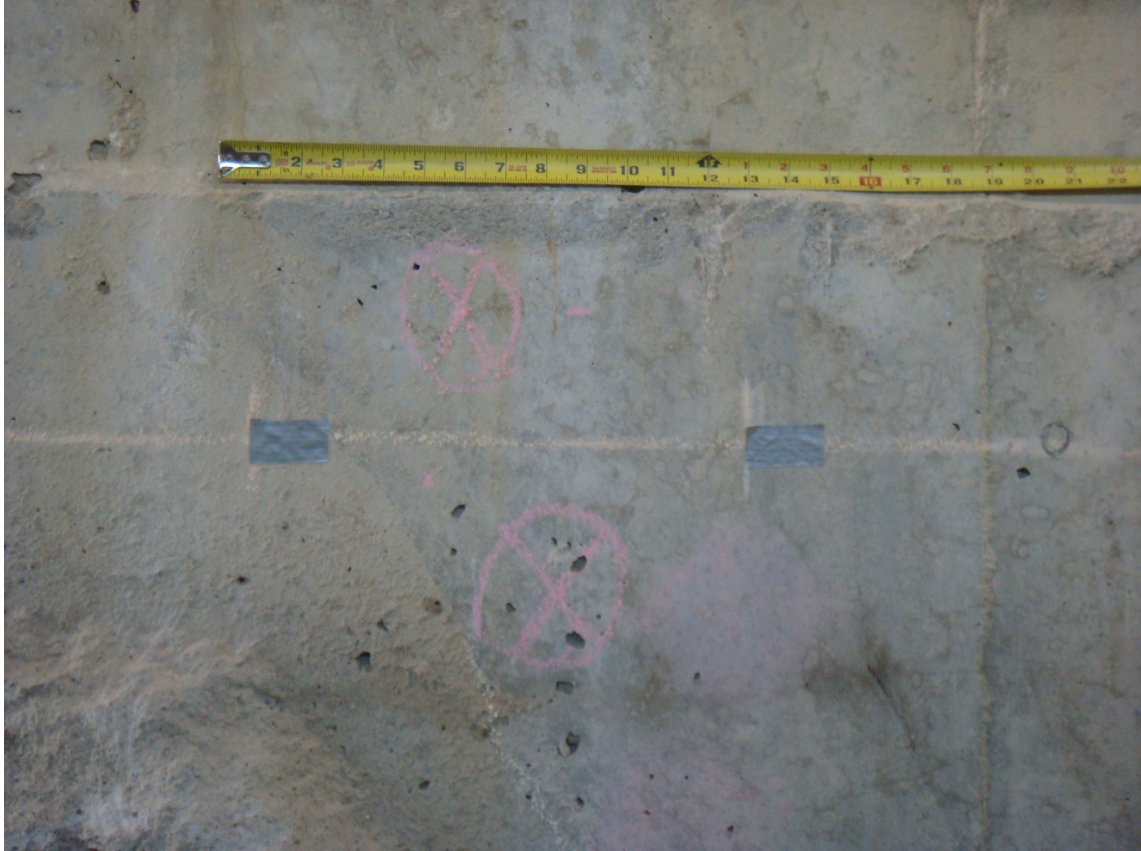
Location W2 was selected on the beam due to the different sound that was heard in this area during the hammer sounding test. There were no apparent signs of map cracking or delaminations on the concrete surface at this location. Figure 6.14 shows the visible condition of the concrete surface at the location W2. Duct tape was placed on the west side of the beam to be able to identify the location of the thermal infrared images collected there.

**Figure 6.14 Visible condition of the concrete surface at the location W2.**

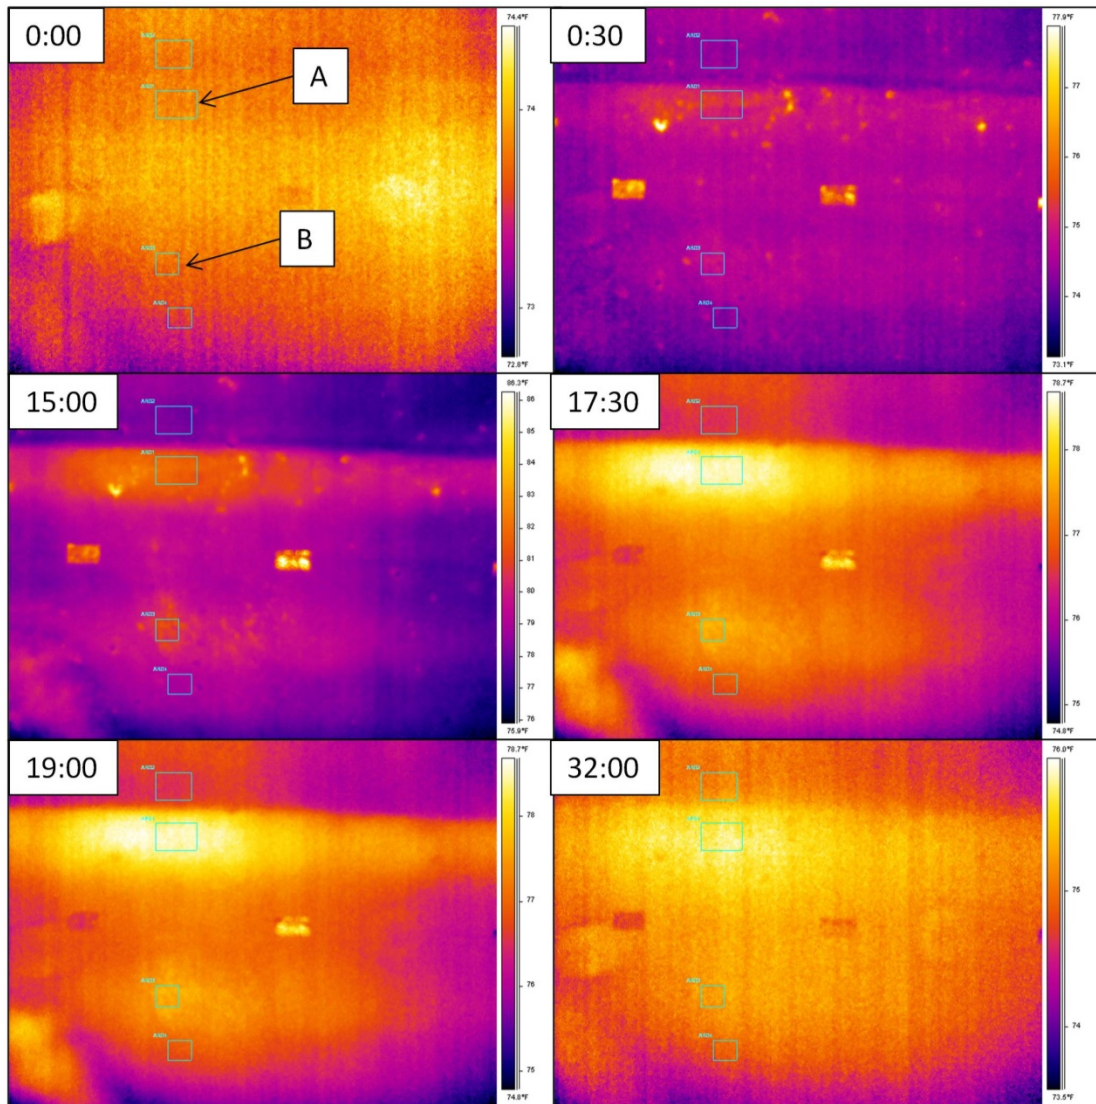
The ambient temperature was 73.4°F and the ambient humidity was 34% during the data collection. Thermal infrared images were taken from the location W2 during the 15 minutes heating period and for about 38 minutes after the heater was turned off. Infrared heater was placed in a way to cover the whole area of interest. Figure 6.15 shows the thermal infrared images taken from location W2 at different timestamps during the active infrared thermography testing. The time at which each image was taken is indicated on the top left side of the image.

Two areas with indicators of delamination were identified on thermal infrared images. Area A is located at the bottom notch of the shear key on the beam and area B is located approximately 12 in. below the shear key. Note that due to the presence of the shear key and an unlevel surface, detection of delaminations at this location can be affected by the

**Figure 6.15 Thermal infrared images taken from location W2 during an active infrared thermography test (timestamps on each image represents the relative times to the beginning of the data collection).**

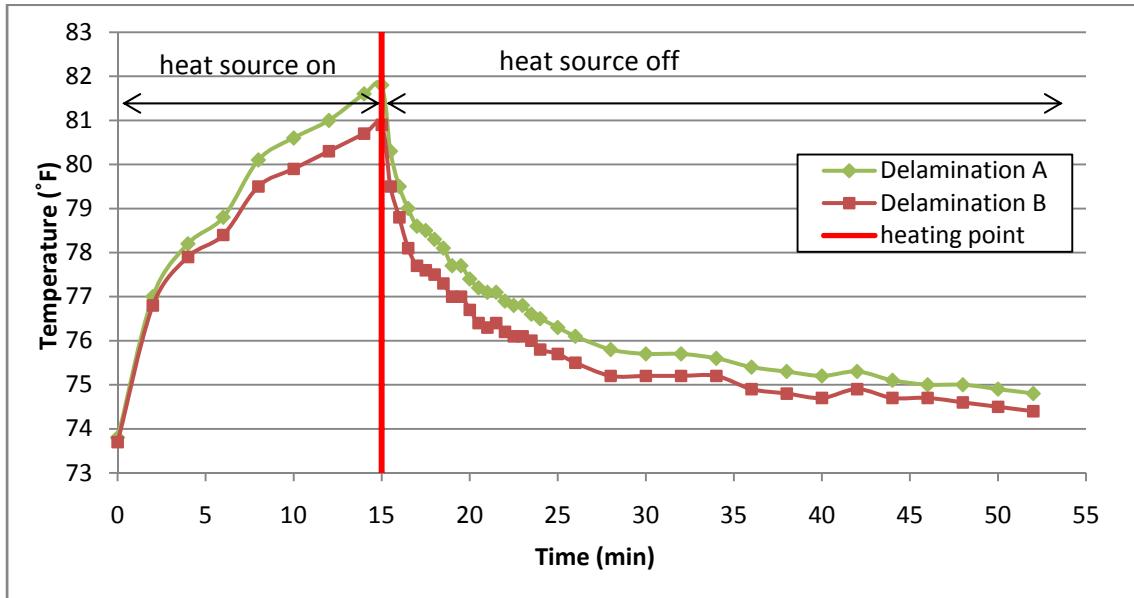
Figure 6.16 plots the surface temperature variation of concrete above each area of suspected delaminations, at A and B. These temperature values are the average surface temperature values within each area. It can be seen from this graph that the surface temperature of delamination A is slightly higher compared to the surface temperature of

delamination B. This higher value of temperature above the area A can be either because delamination A is closer to the surface than delamination B, or because of the different surface roughness or surface color on this area.

**Figure 6.16 Temperature variation above delaminations at location W2.**
